| DOCKETED | |
|---|--|
| Project Title: | Prairie Song Reliability Project |
| Document Title: | The Acton Town Council Comments - Scoping Comments submitted by the Acton Town Council |

Scoping Comments submitted by the Acton Town Council

Subject: Scoping Comments From the Acton Town Council Regarding the Proposed
"Prairie Song" BESS Development.

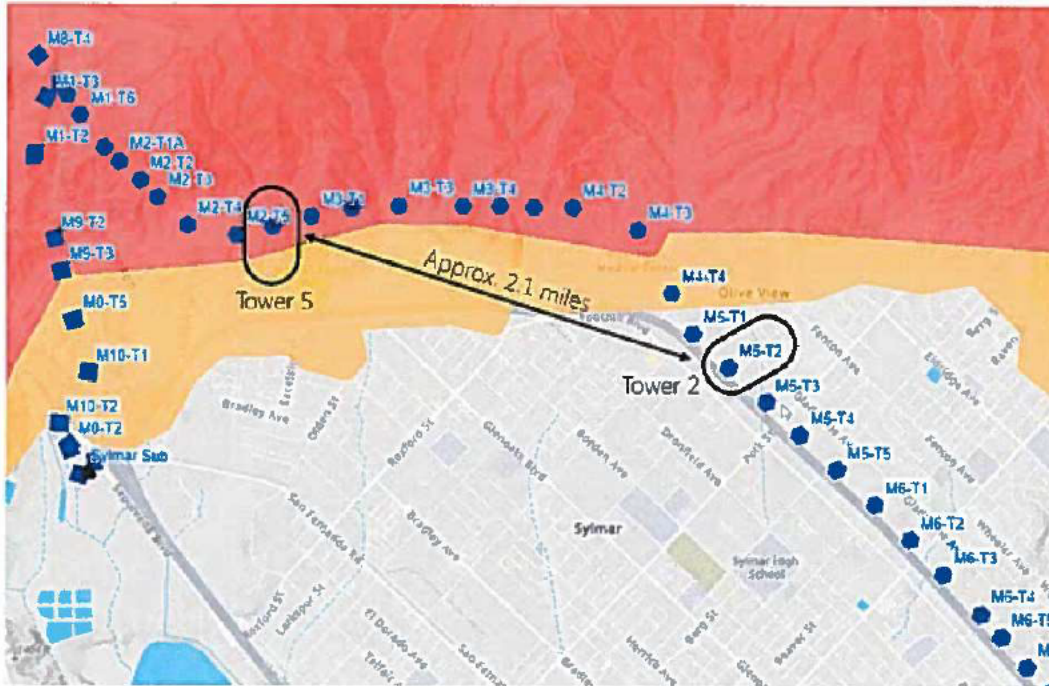
Figure 1: an illustration in SCE’s final report showing the locations of towers M2-T5 and M5-T2. We also see towers M2-T4 and M2-T6 located to the left and right of tower M2-T5, respectively.

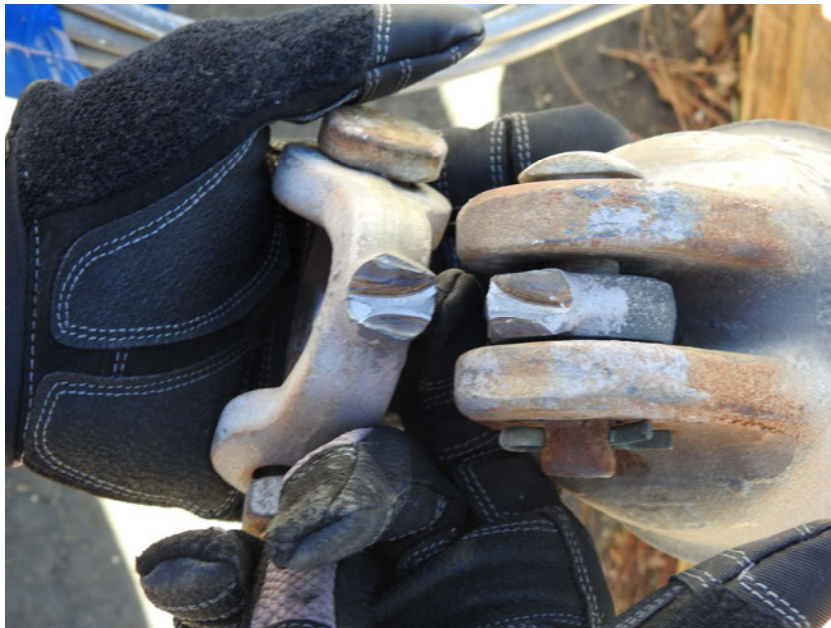
Regarding the Saddleridge fire and the Commission findings pursuant thereto, it is important to note that the fitting which broke appears to have been corroded from the inside (see Figure 5 in Attachment 2); it is assumed that this is why the weakness was not detected during the many inspections that SCE performs. SCE's WMP does mention the Saddleridge Fire (see page 34) but merely states "Los Angeles City Fire Department opined that the cause of the fire was undetermined". Incredibly, SCE fails to point out that the Commission also investigated the Saddleridge fire, and found that the transmission facilities where the fire ignited violated GO-95 in multiple ways.

On October 25, 2019, ESRB inspected evidence at an SCE service yard. One of the items collected was the Y-clevis end fitting that was used to hold the ceramic string insulator onto the B-phase arm of tower M5-T2. The broken ends of the Y-clevis end fitting showed signs of fatigue, e.g., beach marks, and corrosion on the fracture surface (see Figure 5). SCE indicated that it believes that the Y-clevis end fitting, likely a Lindsey brand fitting forged from galvanized steel, was installed in 1970 and had an expected service life of 100+ years.

Figure 5: a photograph taken on October 25, 2019, at the evidence inspection at the SCE service yard, shows corrosion on the failed section of Y-clevis that supported the B-phase 220 kV conductor on tower M5-T2.
