Public Interest Energy Research (PIER) Program  
FINAL PROJECT REPORT

**EFFICIENCY CHARACTERISTICS AND  
OPPORTUNITIES FOR NEW  
CALIFORNIA HOMES (ECO)**

Prepared for: California Energy Commission  
Prepared by: Proctor Engineering Group, Ltd.

MARCH 2011  
CEC-500-2012-062

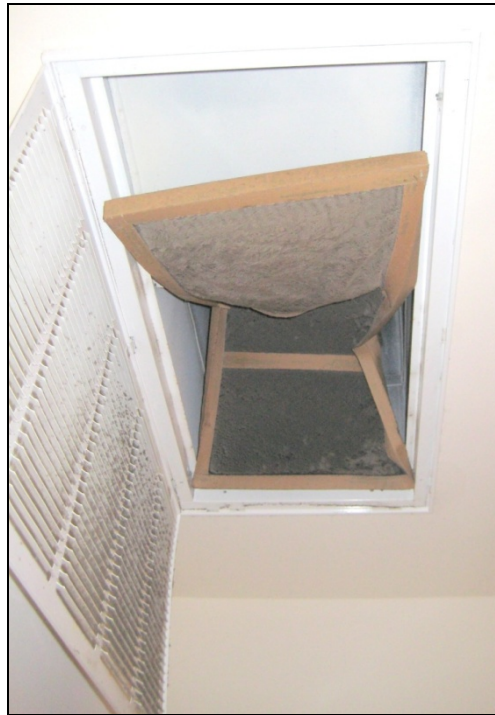
**Figure 13: Unit 9—Dirty Filter**

This 14 inch X 30 inch X 1 inch standard filter is so dirty it is sucked into the return duct that is substantially smaller than the return grille. The home owner is sufficiently embarrassed that he offers to go to the store and bring back a new filter. He is instructed specifically to bring back a low efficiency, low cost filter.

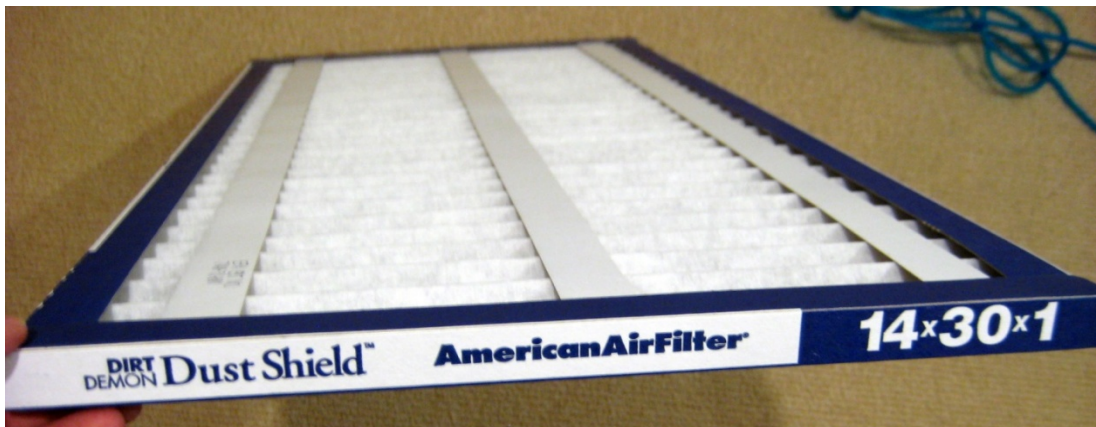
**Figure 14: Unit 9—Replacement Filter Purchased by Homeowner**

The home owner returns with a 14" X 30" X 1" pleated filter. He is pleased because: "This is 16 times better!"

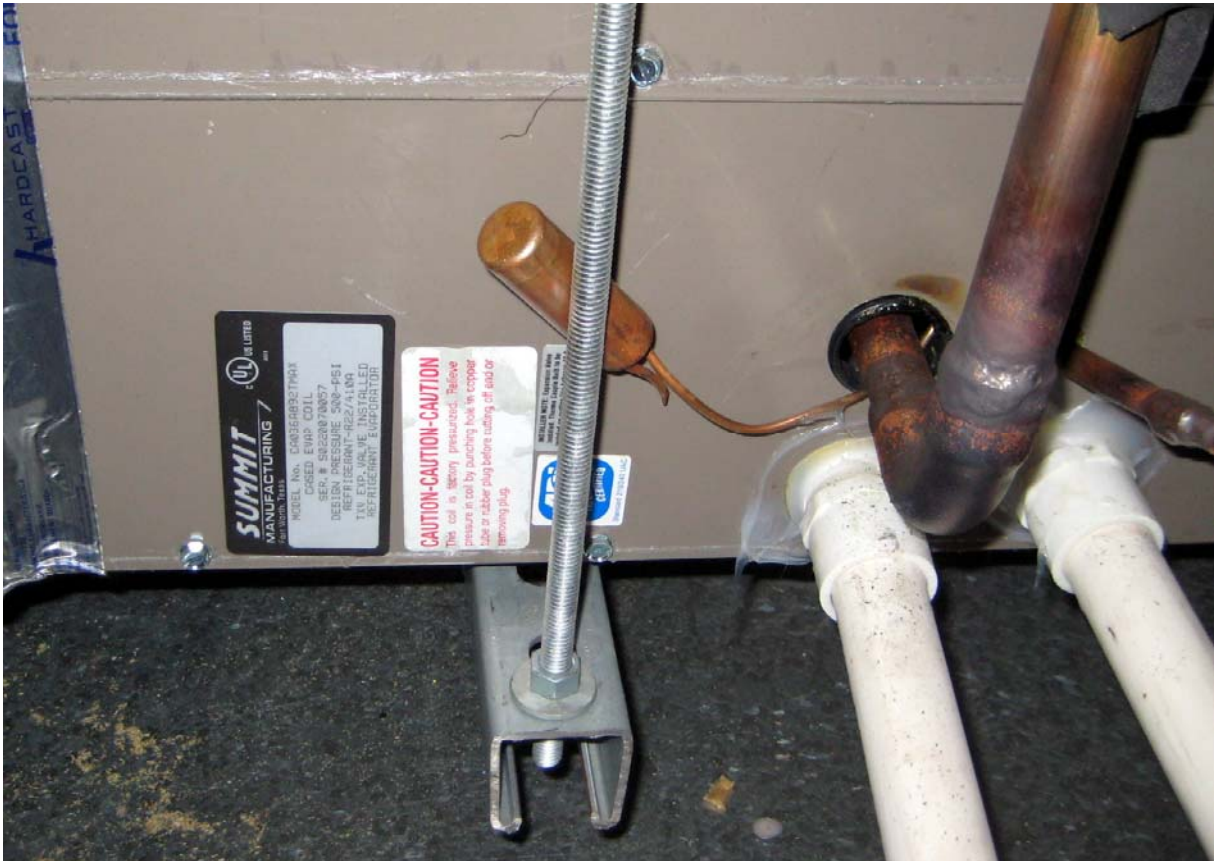
Figure 15: Unit 37—TXV Bulb Installation Error

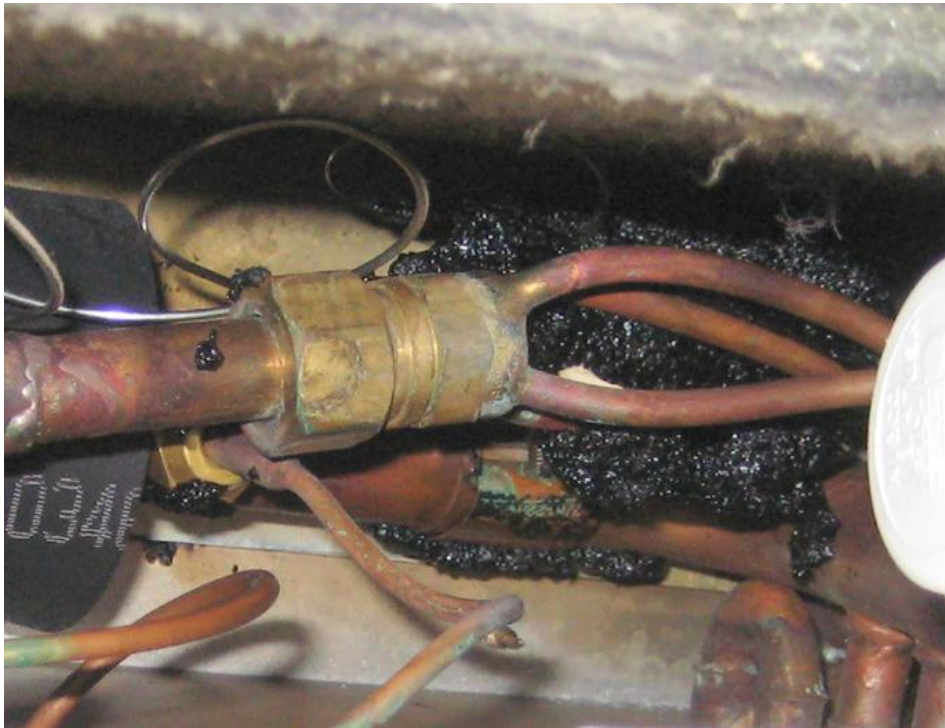
- Unit 58 was borderline on the TXV superheat criterion (superheat was 24°F, Title 24 maximum is 25°F) and was undercharged in the first test. The unit was tested at 76°F ambient. Adding 43.5 oz. of refrigerant (31 percent of factory charge) brought the subcooling to within specification, but the superheat remained high at 26°F. The TXV had the temperature sensing bulb insulated to the cooling suction line. Since Unit 58 is a heat pump, the location is also the hot gas line in the heating mode. The temperature of the hot gas line in the heating mode exceeded the melting point of the insulation and the insulation dripped off, as shown in Figure 16.

**Figure 16: Unit 58—Melted TXV Bulb Insulation**

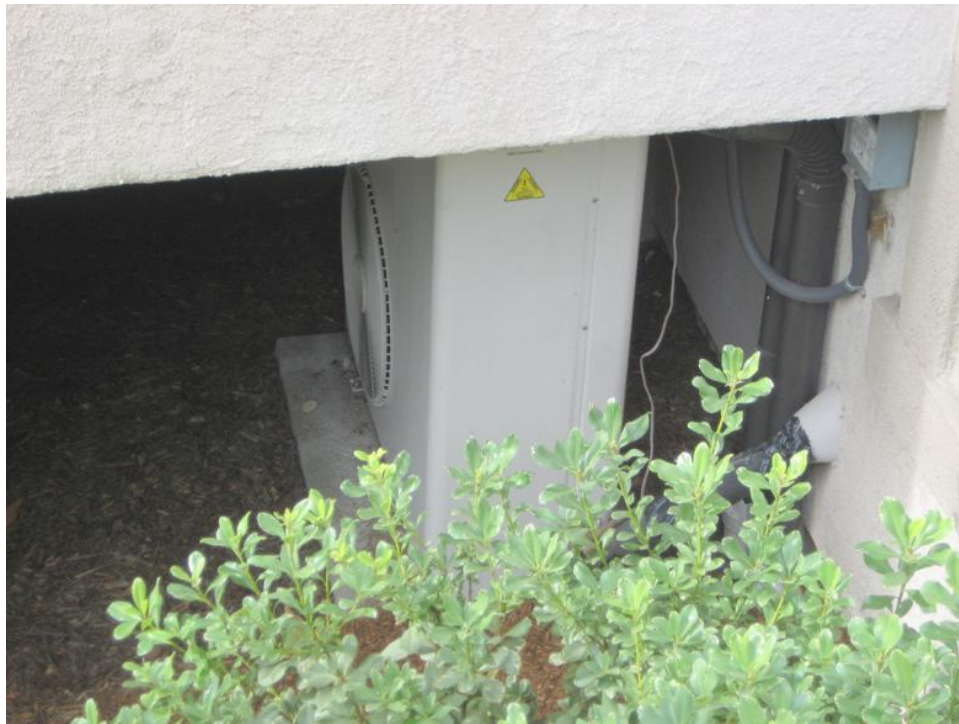
**Figure 17: Unit 72—Condenser Recirculation**

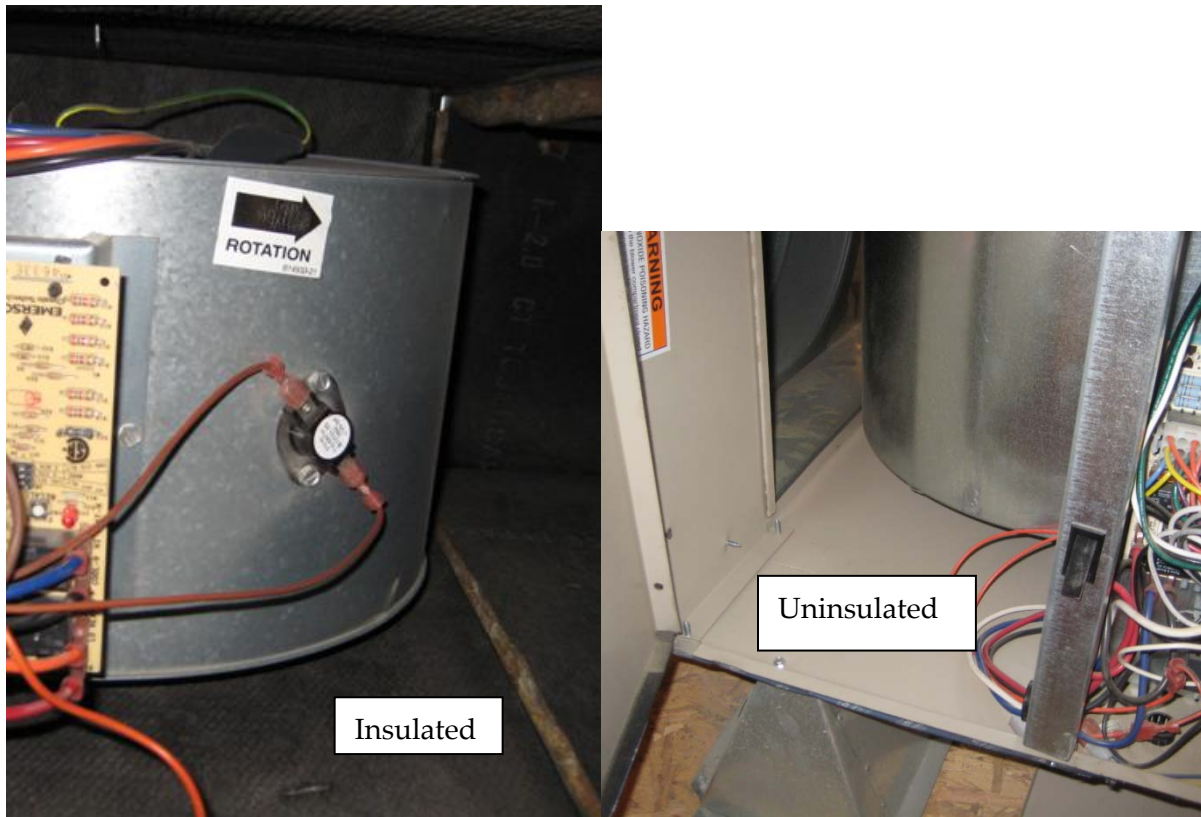
Figure 24: Insulated and Uninsulated Blower Compartments

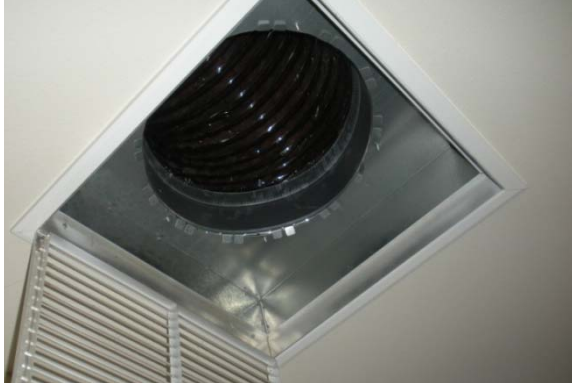
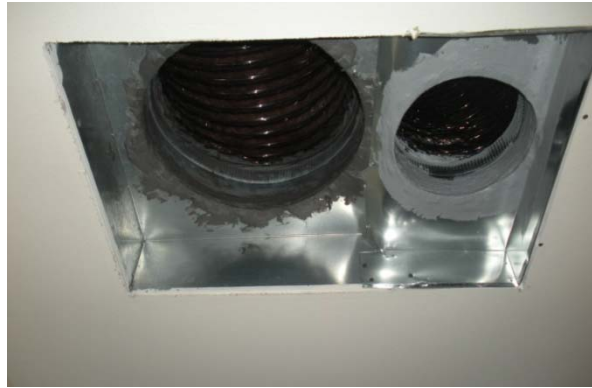
**Figure 29: System 4—Original and Revised Return Can With Added 10 in. Return Duct**

These changes increased the airflow by 32 percent from 280 CFM per ton to 371 CFM per ton. The return system static pressure was reduced from 0.48 IWC to 0.18 IWC. The Normalized Sensible EER increased by 11.3 percent.

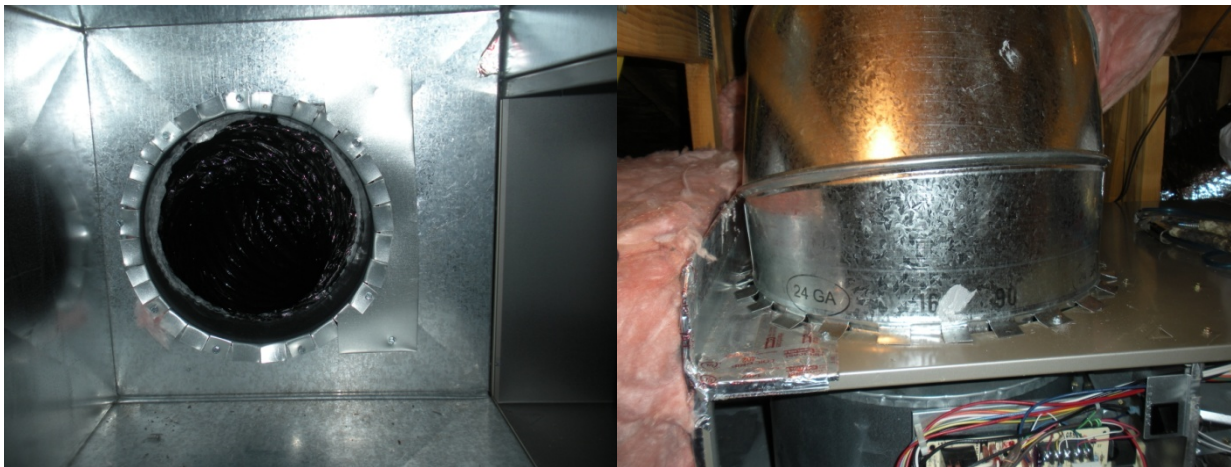
**Figure 30: System 4—New 10 in. to Plenum and 16 in. Into Blower Wheel Inlet Side With Metal Elbow**

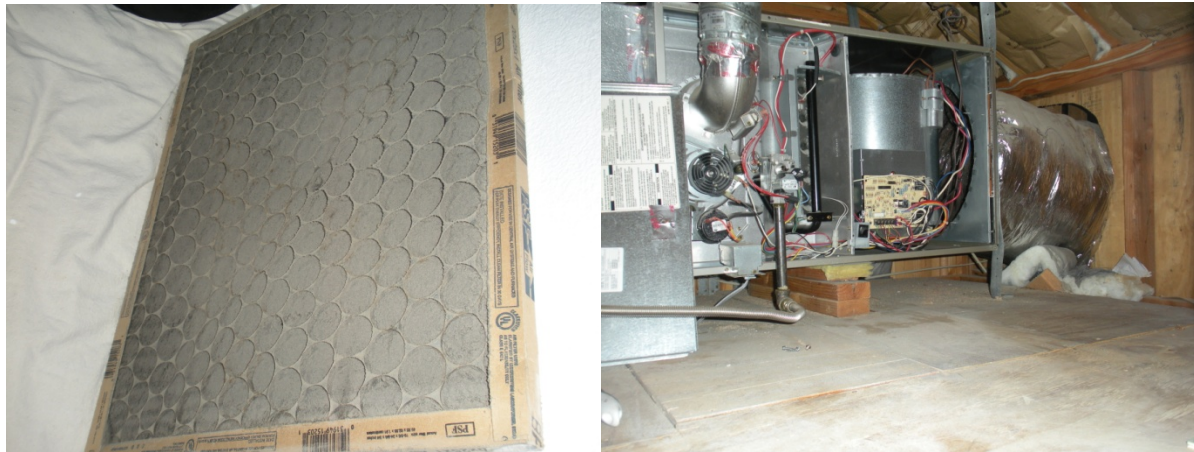
**Figure 31: System 8—Clogged Filter and Original Return Duct Into “Bottom” of Furnace**

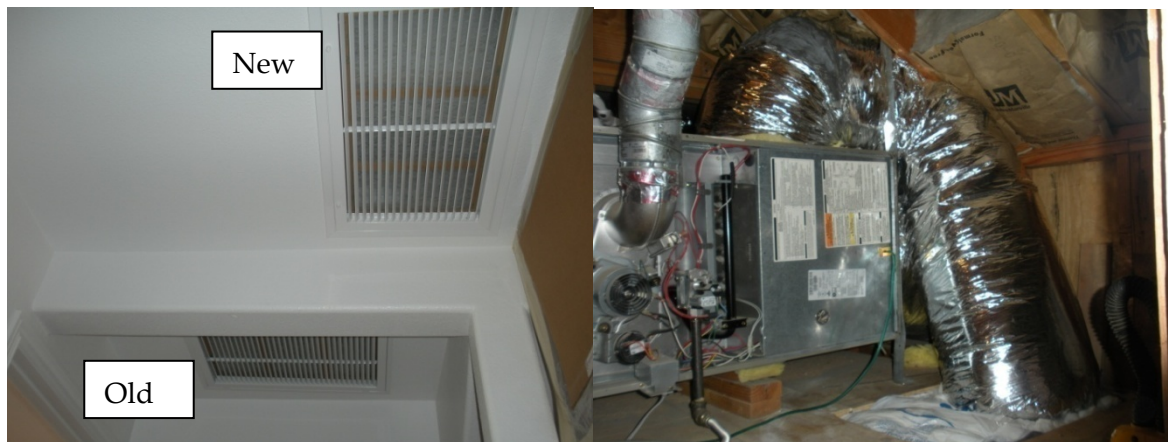
**Figure 32: System 8—New Filter Grille Near Existing Grille and New 12 in. dia. Flex Duct Into Furnace Cabinet**

These changes increased the airflow by 44 percent from 248 CFM per ton to 357 CFM per ton. The return system static pressure was reduced from 0.90 IWC to 0.26 IWC. The Normalized Sensible EER increased by 26.5 percent.

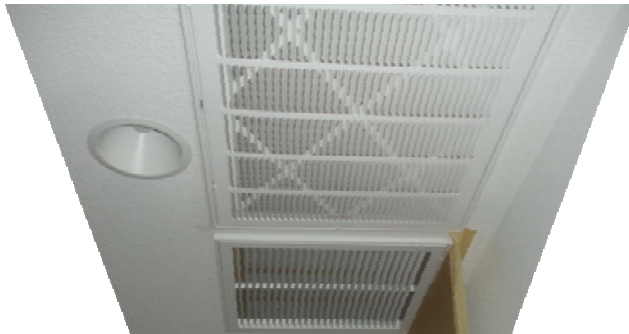
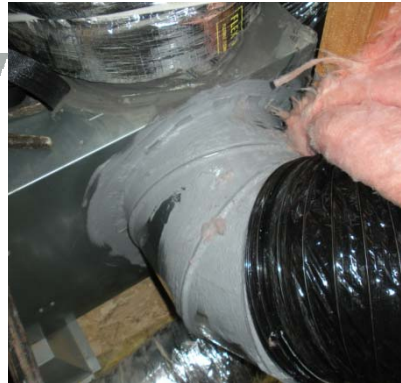
**Figure 33: System 10—New Filter Grille Near Existing Grille and New 14 in. dia. Flex Duct Into Furnace Cabinet**

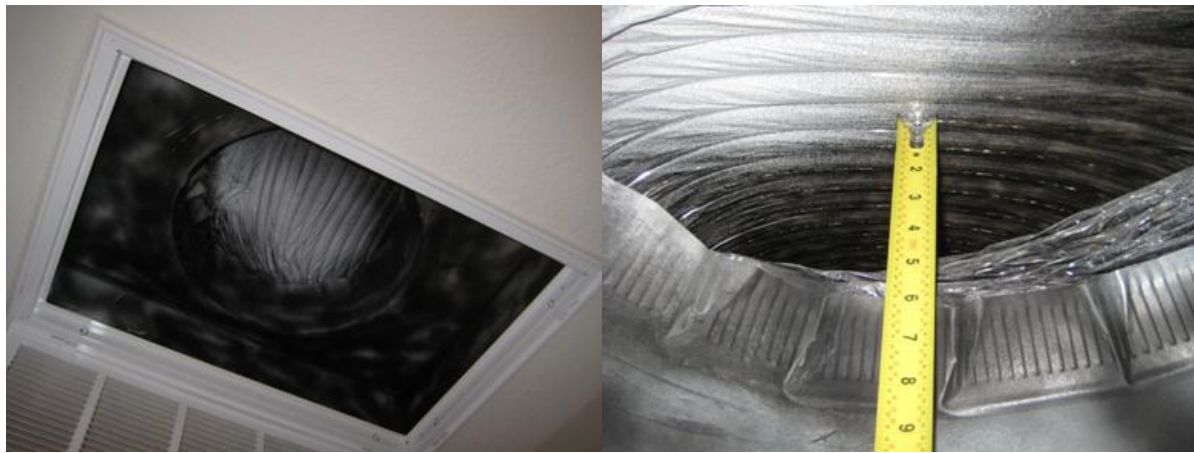
**Figure 34: System 17—Existing Return With 5 in. Opening**

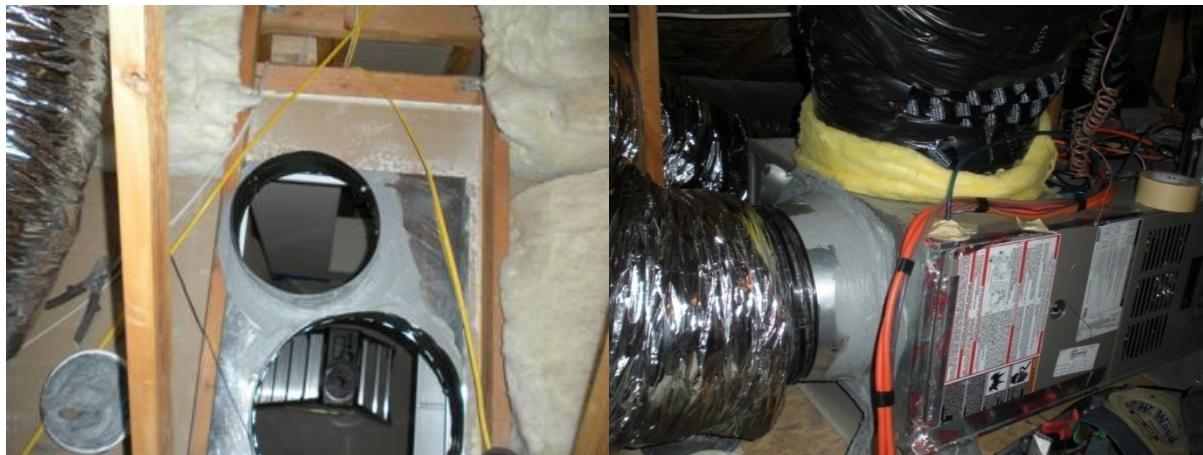
**Figure 35: System 17—New Return Location and Double Ducts Into Blower Compartment**

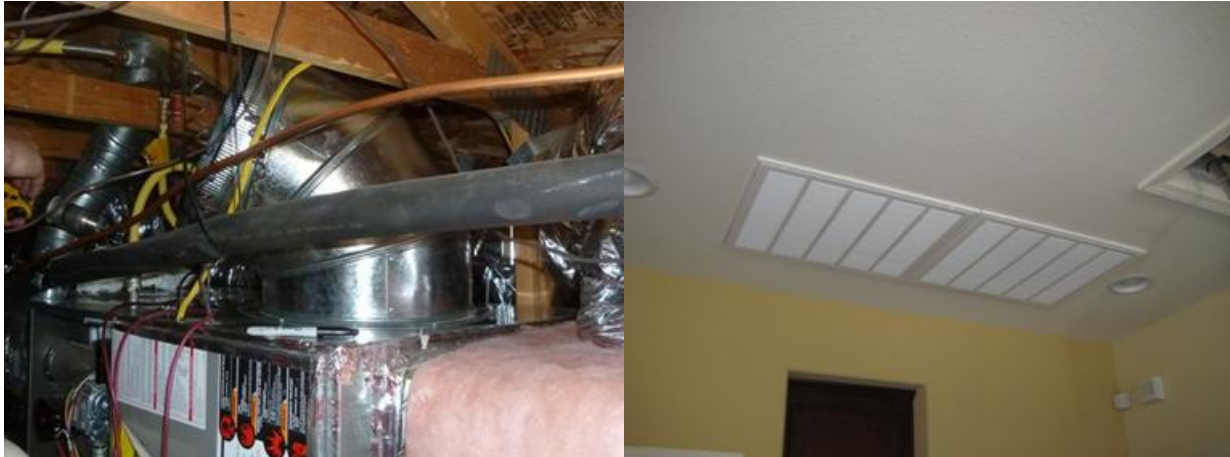
**Figure 36: System 25—Metal Elbow Into Cabinet and New Filter Grille**

This change lowered the return static pressure from 0.39 IWC to 0.10 IWC and increased flow 11 percent. The Normalized Sensible EER increased by 8 percent.

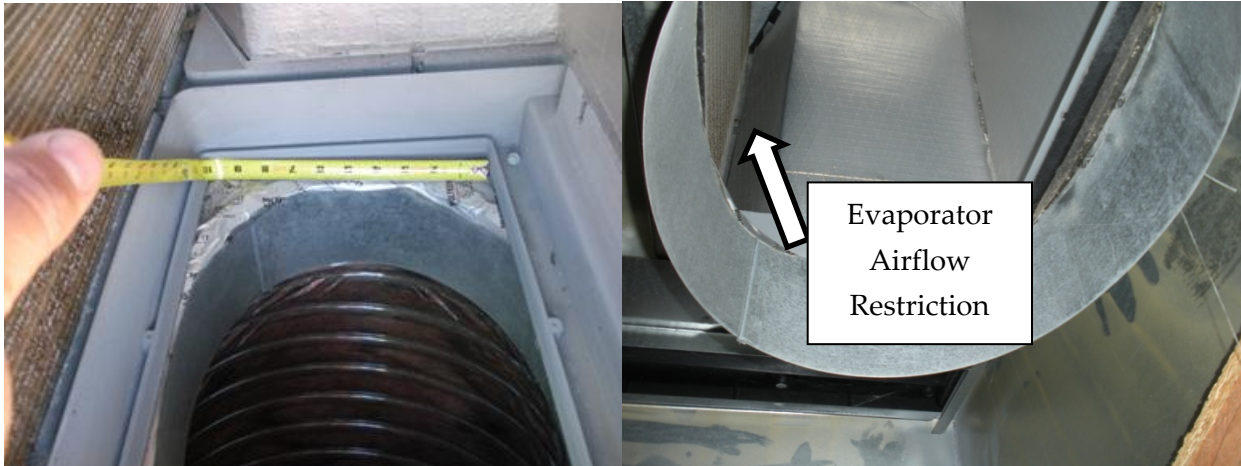
**Figure 37: System 27—“Ovalized” Return Duct and Airflow Restriction to Evaporator Coil**

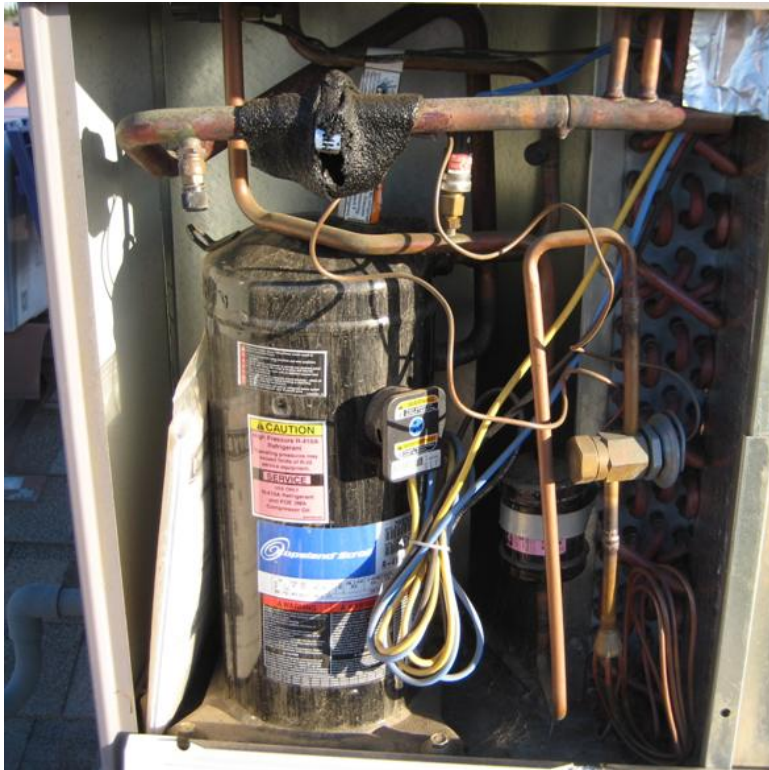
**Figure 38: System 27—Compressor Compartment With Melted TXV Insulation**

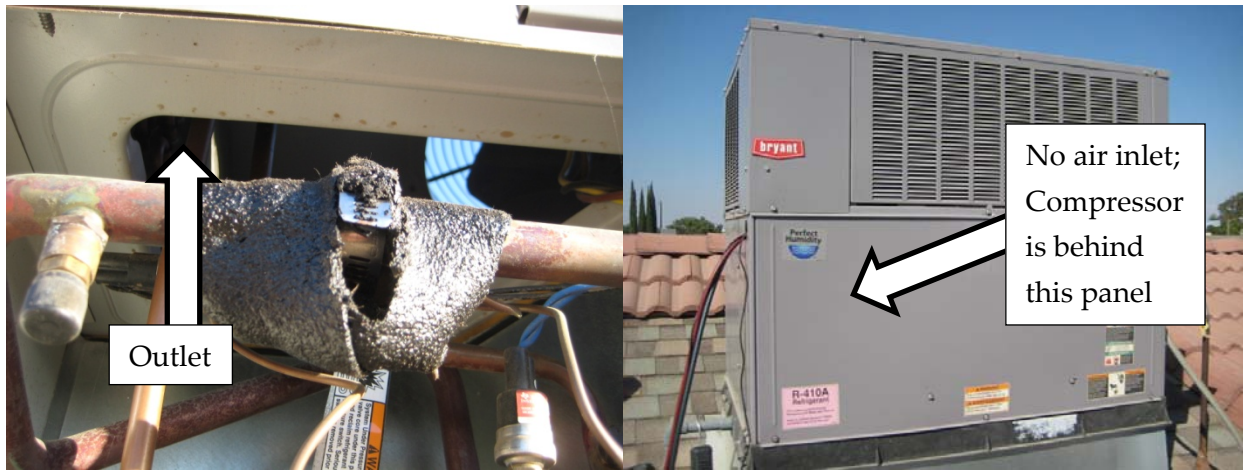
**Figure 39: System 27—Compressor Heat Outlet With No Cooling Inlet**

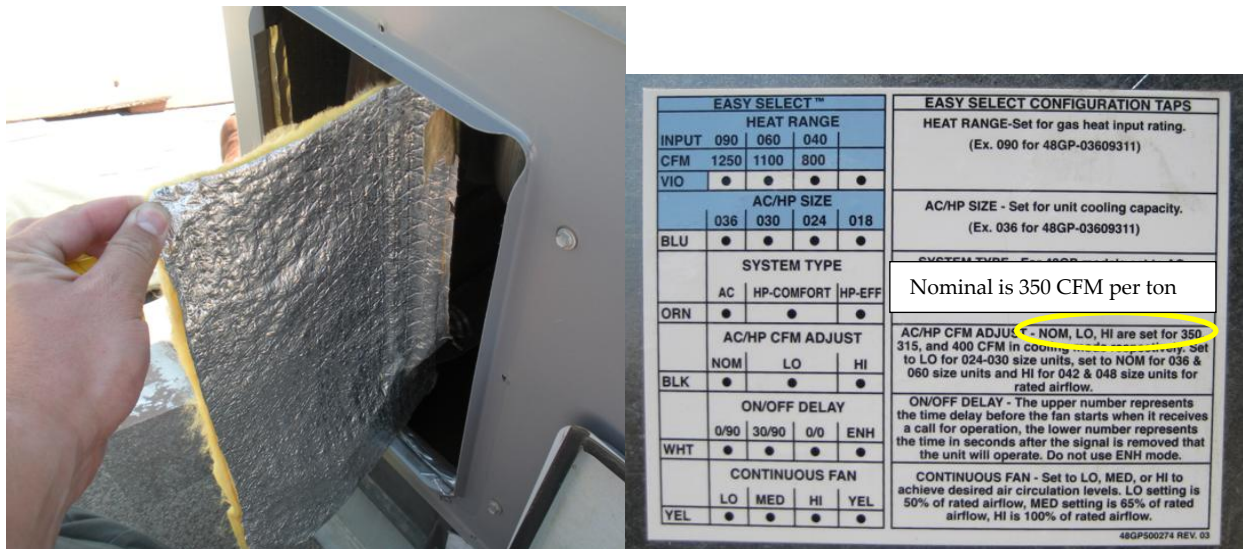
**Figure 40: System 27—Rooftop Unit Cabinet Insulation and Fan Motor Setting Table**

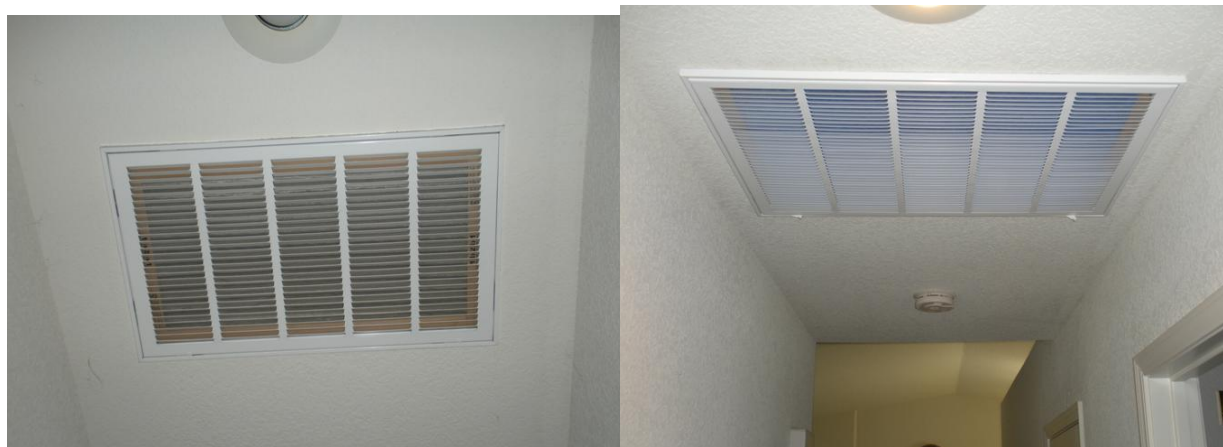
**Figure 41: System 27—Original Return Grille With Pleated Filter and Enlarged Return Grille With “High Flow” Filter**

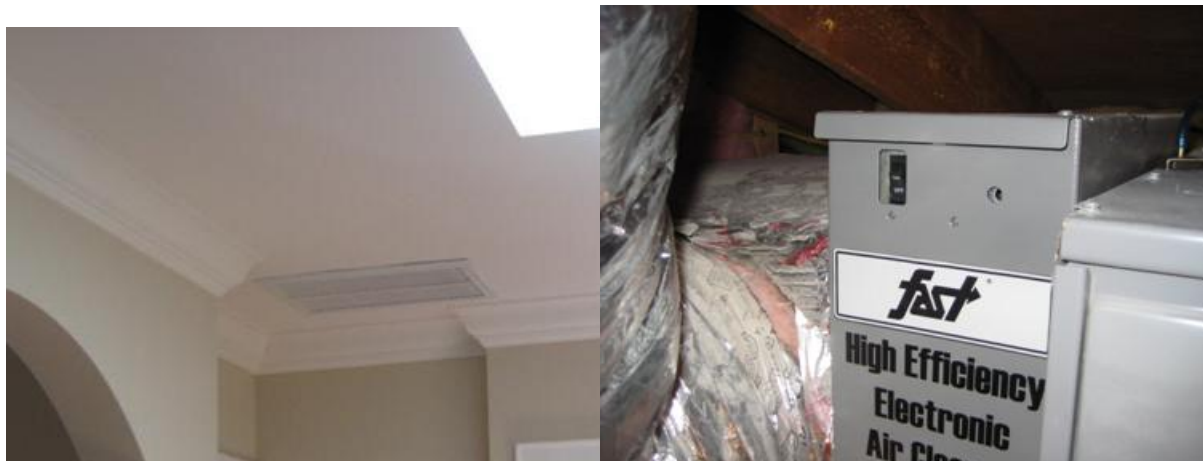
**Figure 42: System 47—Original Return Grille Near Skylight and Side Feed “Bubble Wrapped” Return Plenum and Electronic Air Cleaner**

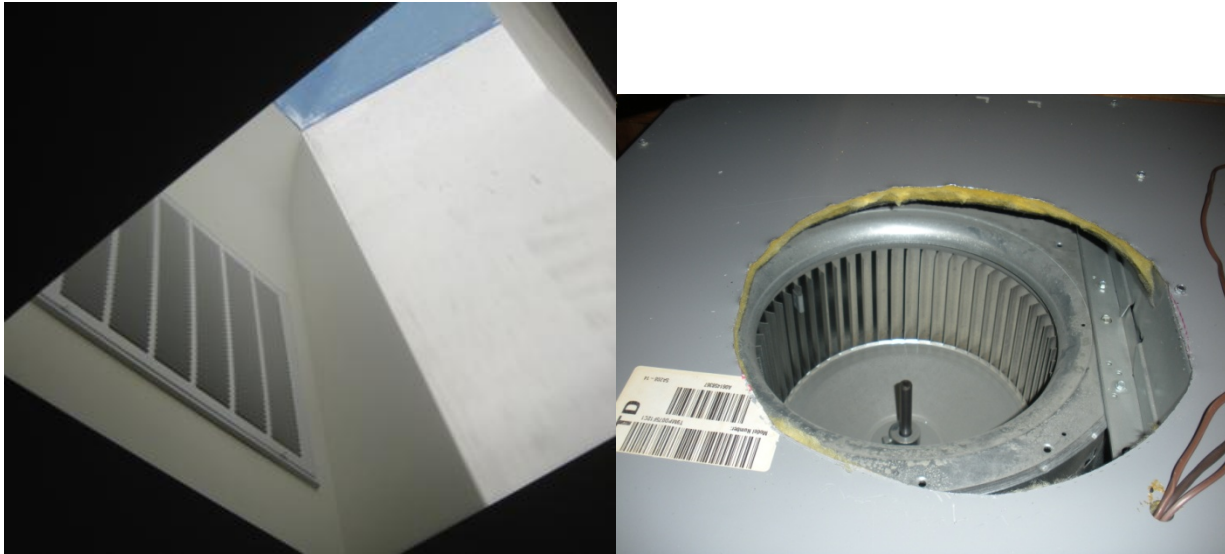
**Figure 43: System 47—New Return Grille in Skylight Channel and New Feed Into Side of Furnace Cabinet**

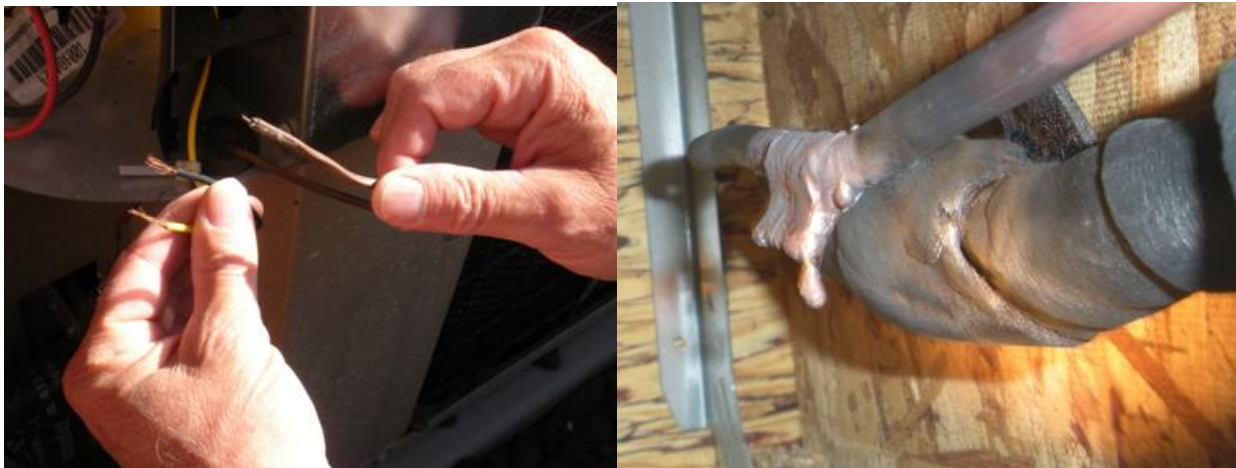
**Figure 44: System 74—Poor Quality Installation: Control Wires Not Connected and Bad Brazing**

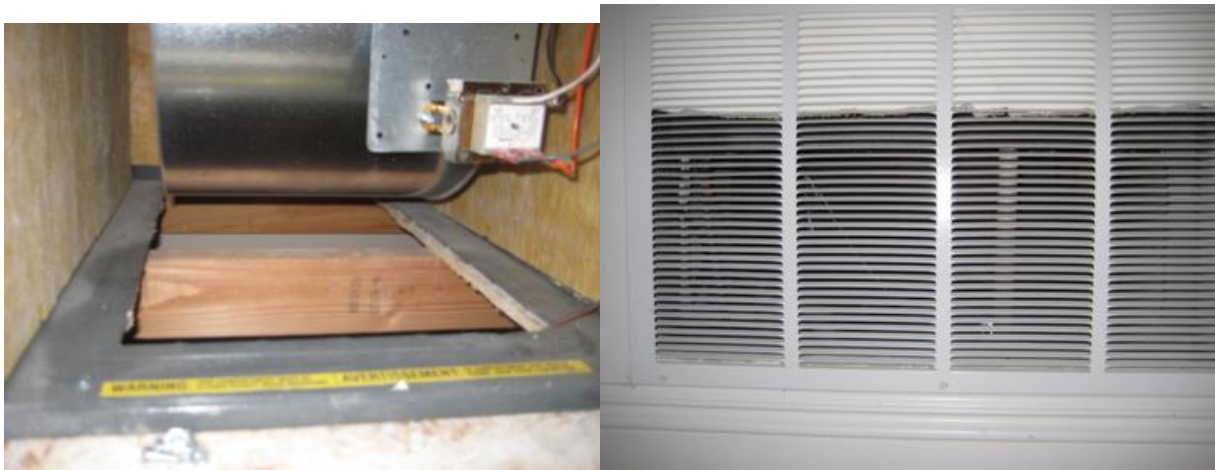
**Figure 45: System 74—Poor Quality Installation: Restricted Return Grille Opening and Restricted Platform Opening**

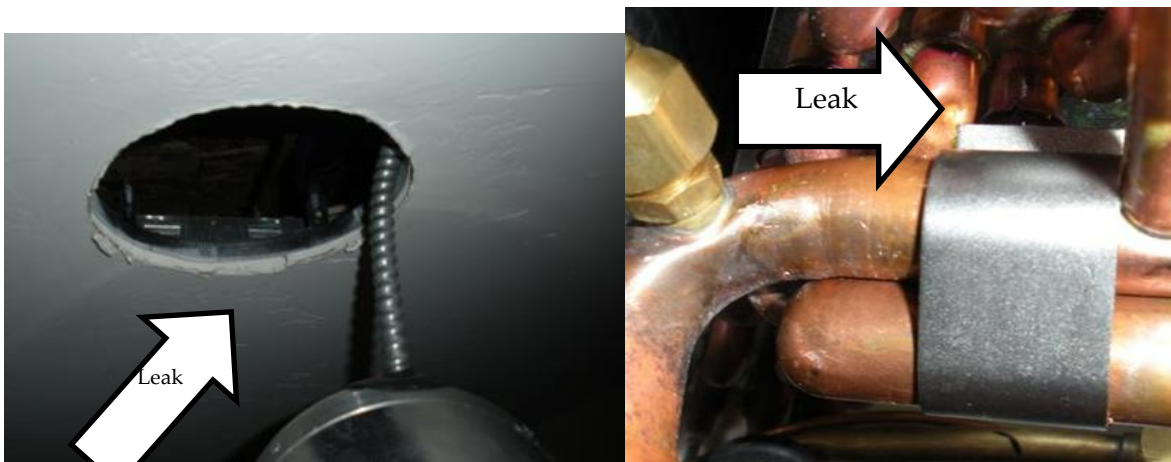
**Figure 46: System 74—Refrigerant Leaks**

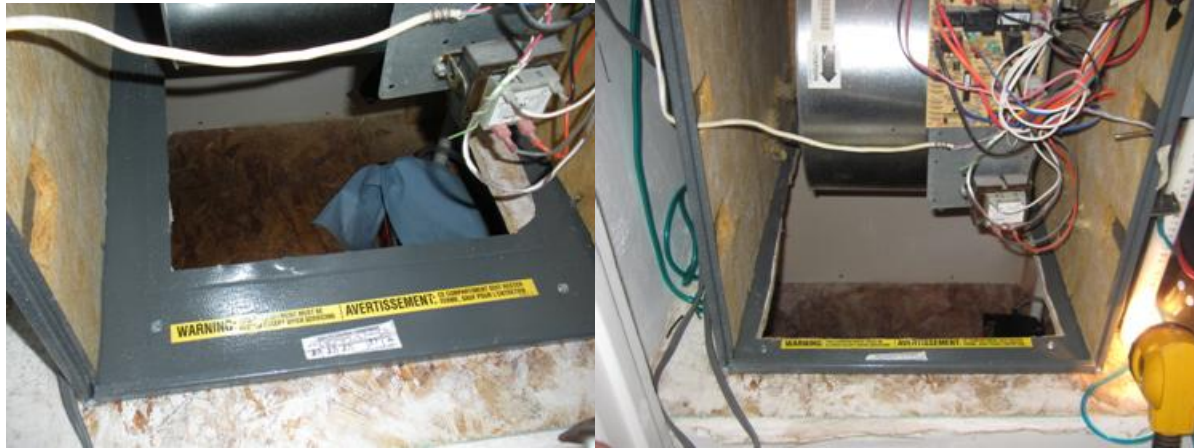
**Figure 47: System 74—Furnace Return Opening Before and After Enlargement**

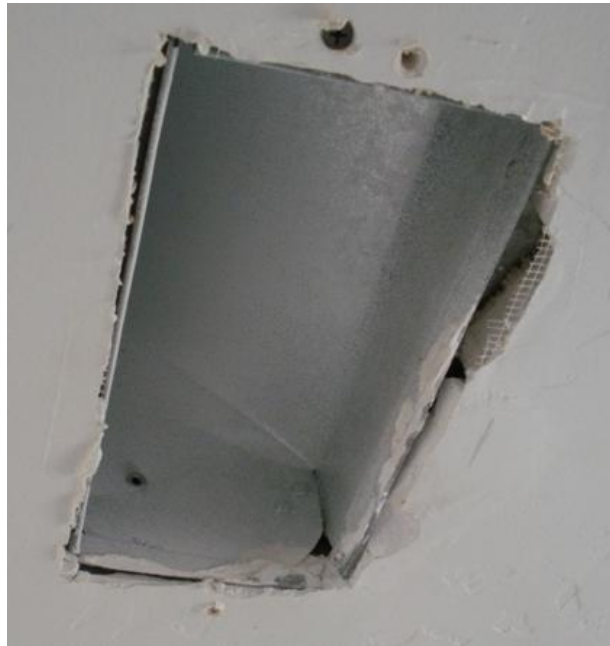
**Figure 48: System 74—One of Many Boot and Boot-to-Drywall Leaks**

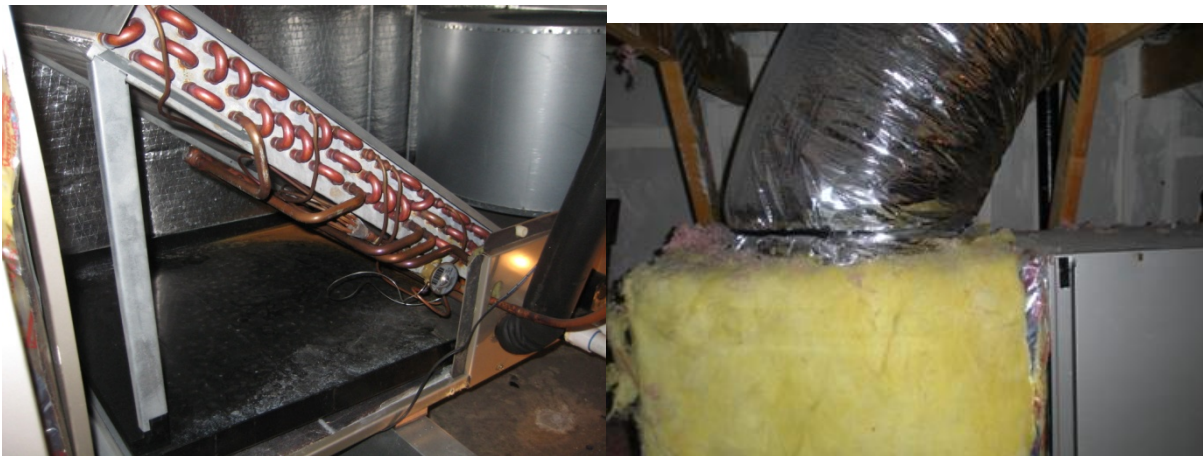
**Figure 49: System 77—Slab Coil and Separate Side Feed Return Plenum**

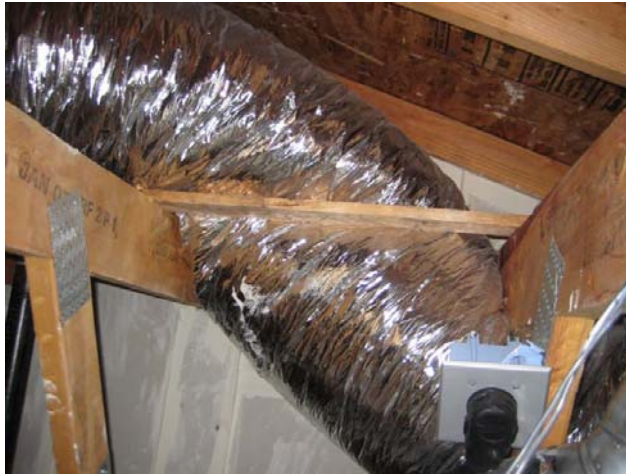
**Figure 50: System 77—One of Multiple Constrictions in the Return Duct**

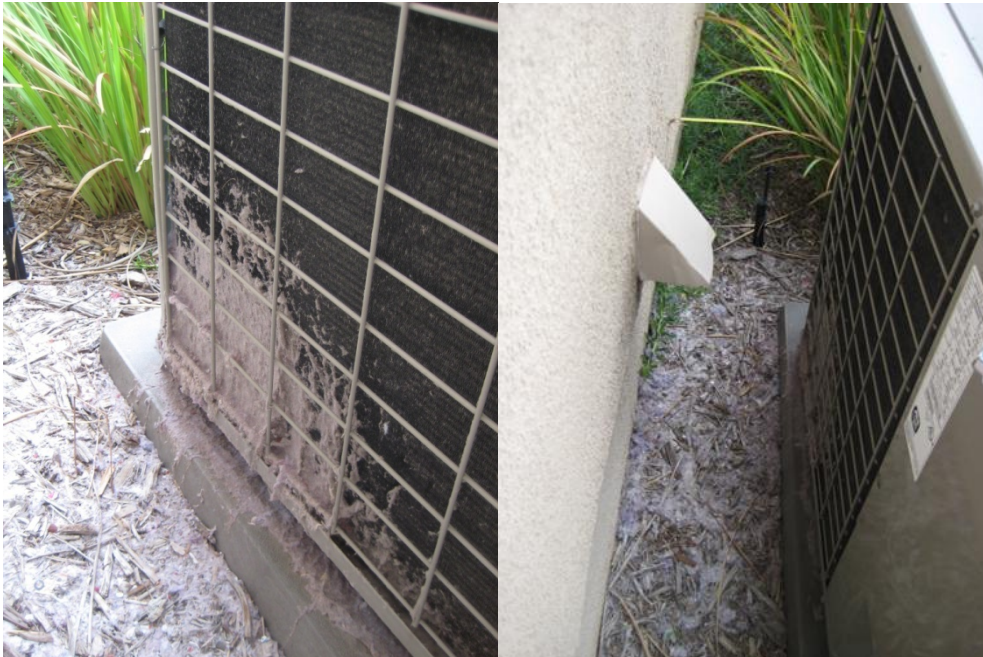
**Figure 51: System 77—Dryer Vent and Lint on the Condenser Coil**

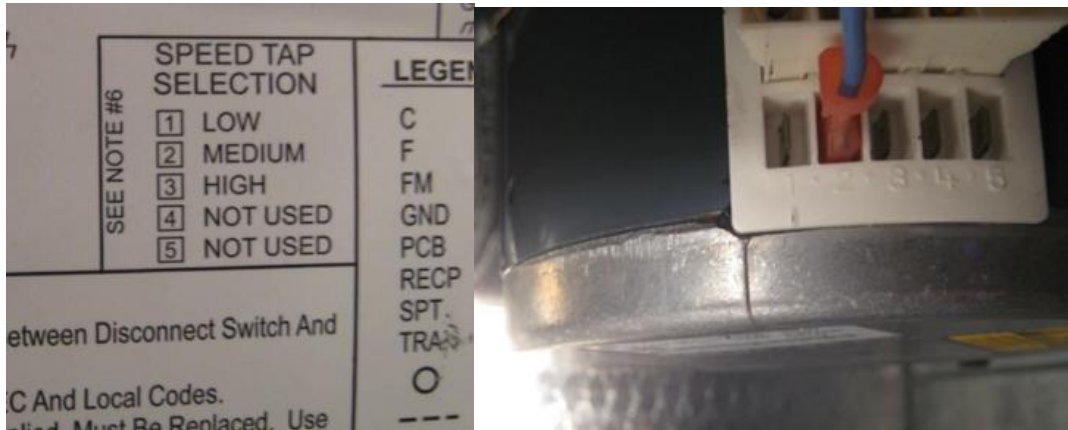
**Figure 52: System 77—Speed Tap on PSC Motor Moved From Medium to High**

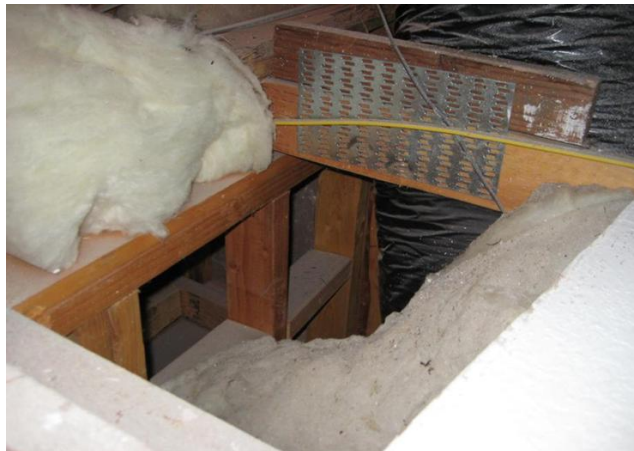
**Figure 57: Leakage between Conditioned Space and Attic**
