| <b>Project Title:</b> | Compliance - Application for Certification of DWR Bottlerock Geothermal Project |

RE: Response to Data Requests Set No. 7 – Bottle Rock Geothermal Power Plant (79-AFC-04C)

# PRELIMINARY GEOTECHNICAL STUDY REPORT

**BOTTLEROCK GEOHAZARDS STUDY  
7385 HIGH VALLEY ROAD  
COBB, CALIFORNIA 95426**

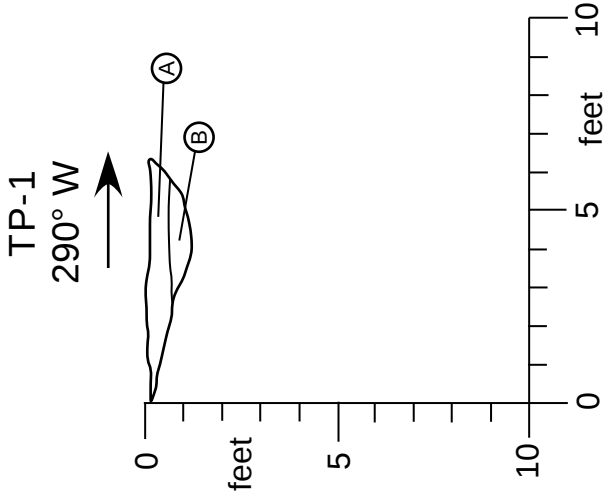
- (A) GRAY BROWN CLAYEY GRAVEL WITH SAND (GC), very dense, dry (Fill)
- (B) GRAY GRAYWACKE SANDSTONE, closely laminated to thinly bedded, closely spaced fractures, hard to very hard, very strong, fresh to slightly weathered

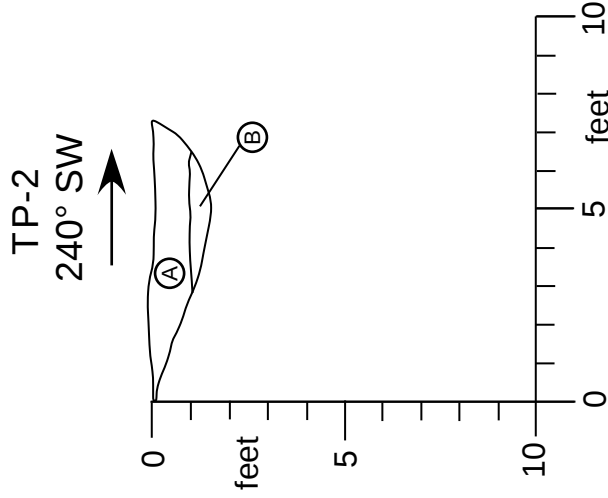
- (A) GRAY BROWN CLAYEY GRAVEL WITH SAND (GC), very dense, dry (Fill)
- (B) GRAY GRAYWACKE SANDSTONE, closely laminated to thinly bedded, closely spaced fractures, hard to very hard, very strong, fresh to slightly weathered

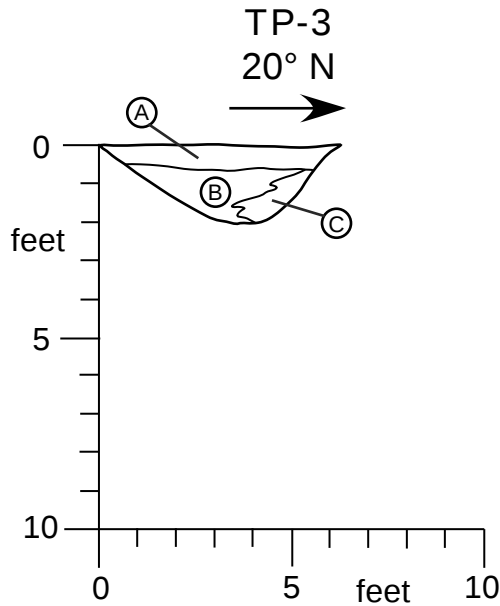
- Ⓐ GRAY BROWN CLAYEY GRAVEL WITH SAND (GC), very dense, dry (Fill)
- Ⓑ GRAY GRAYWACKE SANDSTONE, thinly bedded, closely spaced fractures, hard to very hard, very strong, fresh to slightly weathered
- Ⓒ GRAY BROWN AND RED BROWN INTERBEDDED GRAYWACKE SANDSTONE AND SHALE, thinly bedded to closely laminated, very closely to closely spaced fractures, moderately hard to moderately strong, slightly to moderately weathered

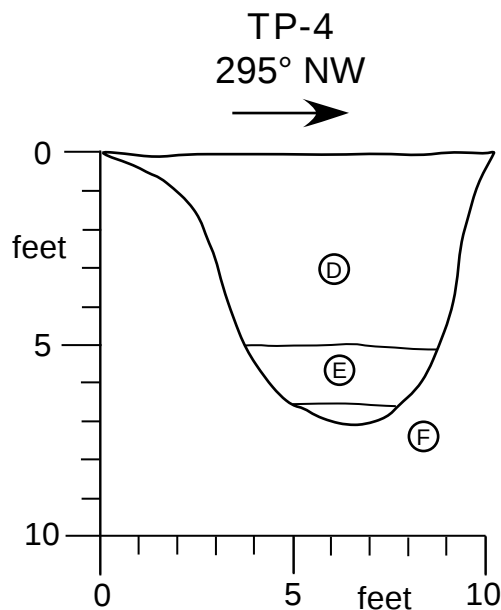
- Ⓓ RED BROWN CLAYEY SAND WITH GRAVEL (SC), dense to very dense, dry, fine to coarse grained sand to 6 inches, rebar at 3 feet (Fill)
- Ⓔ RED BROWN CLAYEY SAND (SC), dense, dry, fine to coarse grained rounded sand, porous (Buried Surface Soil)
- Ⓕ LIGHT BROWN SHALE, firm, friable, highly weathered

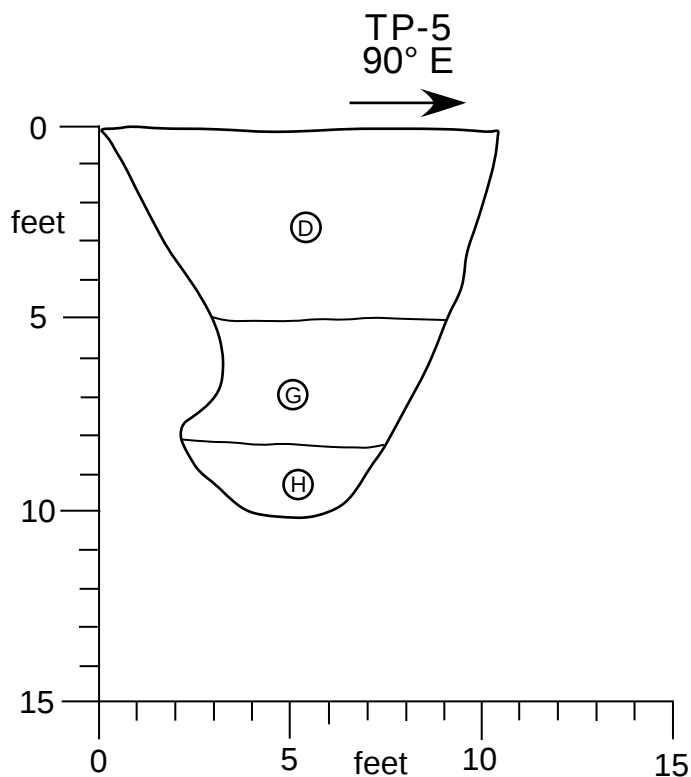
- Ⓓ RED BROWN CLAYEY SAND WITH GRAVEL (SC), very dense, dry, fine to coarse grained sand, fine to coarse angular gravel up to 1 inch in diameter (Fill)
- Ⓖ DARK BROWN CLAYEY SAND (SC), dense, moist, fine grained sand, few rootlets (Buried Surface Soil)
- Ⓗ BROWN SAND WITH CLAY AND GRAVEL (SP-SC), medium dense to dense, moist, fine to coarse grained sand, subrounded gravel up to 1/2" in diameter (Qal)

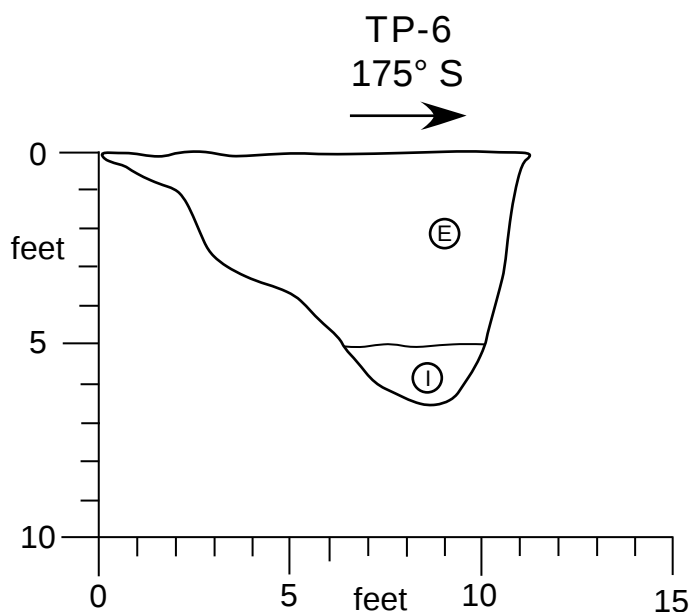
- Ⓔ RED BROWN CLAYEY SAND (SC), very dense, dry, compacted to 6 inches on one side, and porous to 12 inches on the other, fine to coarse grained sand, fine subrounded gravel up to 1/2 inch in diameter
- Ⓘ RED BROWN SANDSTONE, very closely spaced fractures, firm, friable to moderately strong, moderately to highly weathered

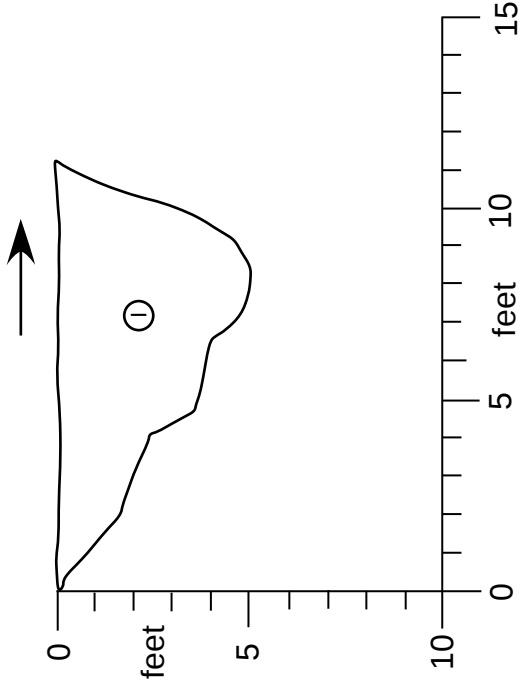
TP-7  
205° SW  
→

① RED BROWN AND GRAY BROWN  
GRAYWACKE SANDSTONE COBBLES  
WITHIN A RED BROWN CLAYEY SAND  
WITH GRAVEL MATRIX (SC), very dense,  
dry

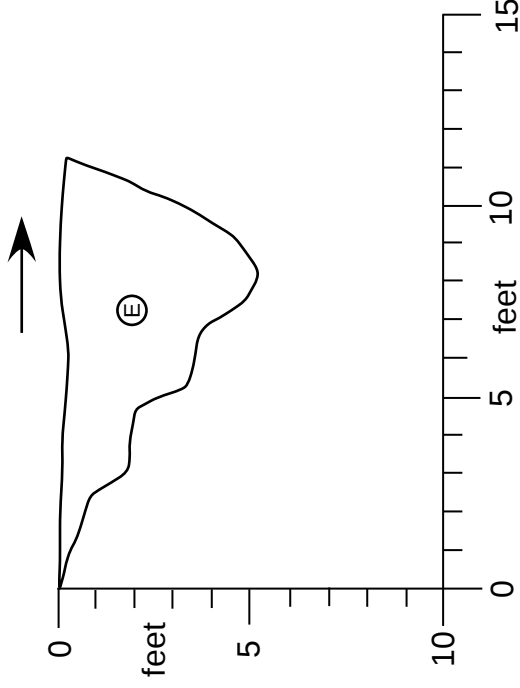
TP-8  
345° NW  
→

⑤ RED BROWN CLAYEY SAND WITH  
GRAYWACKE SANDSTONE  
COBBLES (SC), dense, dry, fine to coarse  
grained rounded sand, porous, cobbles are  
hard, very strong, slightly to moderately  
weathered

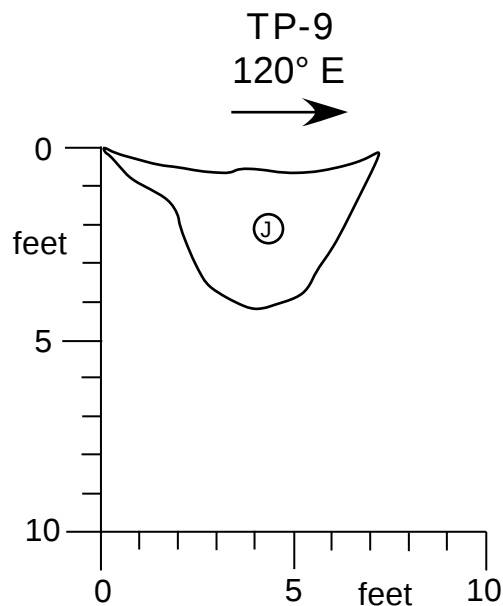
- ① RED BROWN SHALE, firm, friable to weak, locally moderately strong, moderately to highly weathered, porous and completely weathered to 6 inches

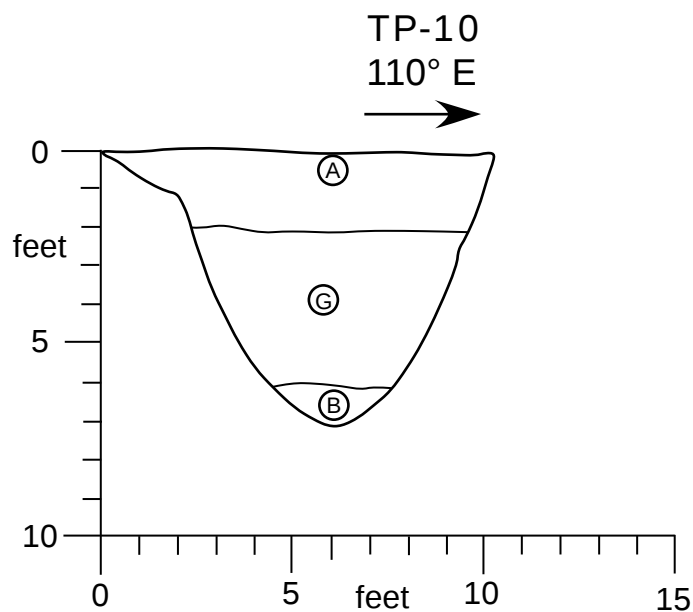
- ① GRAY BROWN CLAYEY SAND WITH GRAVEL (SC), very dense, dry (Fill)
- ② DARK BROWN CLAYEY SAND (SC), very dense, dry
- ③ GRAY BROWN GRAYWACKE SANDSTONE, thinly bedded, closely spaced fractures, hard, strong, slightly to moderately weathered

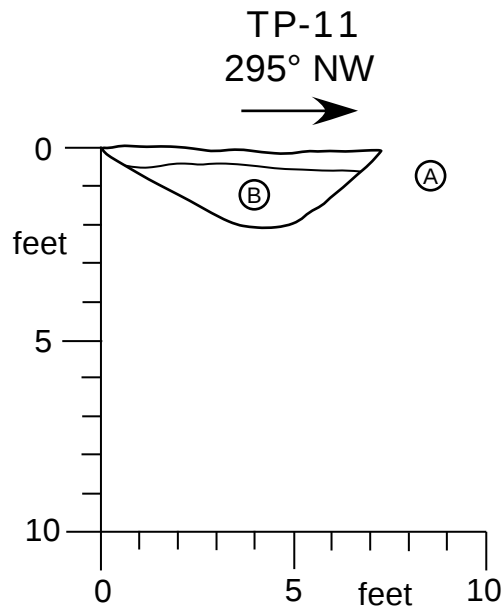
- (A) GRAY BROWN GRAVEL WITH CLAY AND SAND (GP-GC), very dense, dry (Fill)
- (B) GRAY GRAYWACKE SANDSTONE, thinly bedded, closely spaced fractures, hard, strong to very strong, slightly weathered

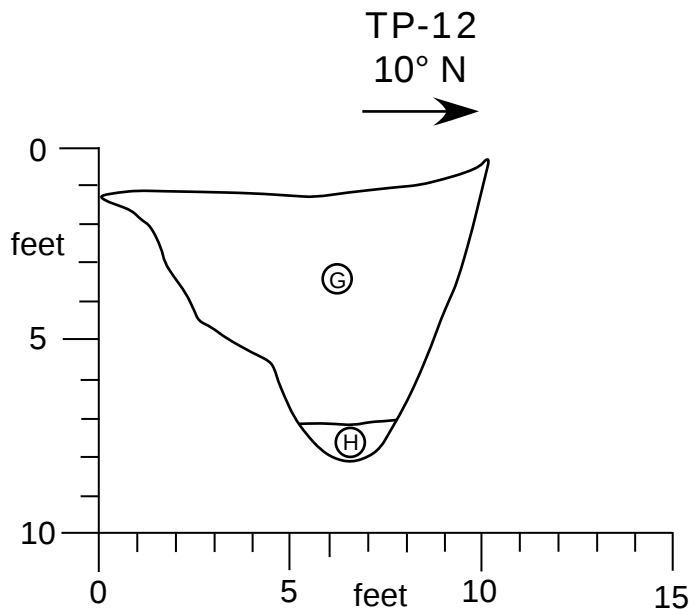
- (G) BROWN CLAYEY SAND (SC), very dense, dry, fine to coarse grained sand, subrounded gravel up to 1/2 inch in diameter, porous to 12 inches
- (H) BROWN SAND WITH CLAY AND GRAVEL (SP-SC), medium dense to dense, dry, fine to coarse grained sand, rounded gravel up to 1/2" in diameter

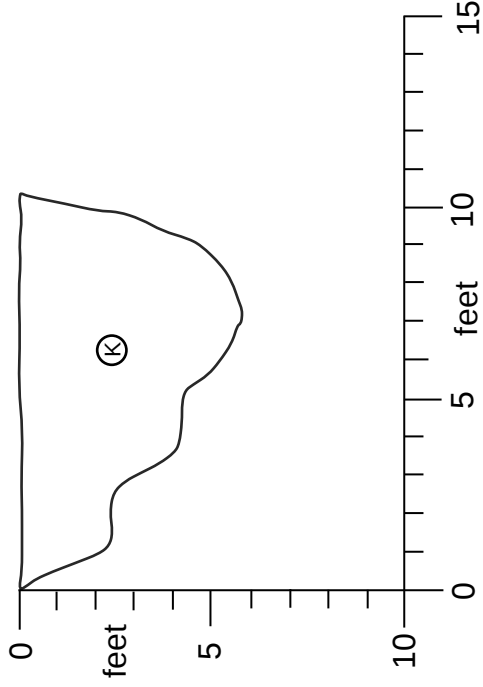
TP-13  
25° NE

Weak, porous surface soils, such as those found along the well and pipeline locations (TP-6, TP-12, TP-13), appear hard and strong when dry but will lose strength rapidly and settle under the load of fills, foundations, and slabs as their moisture content increases and approaches saturation. The moisture content of these soils can increase as the result of rainfall, periodic irrigation or when the natural upward migration of water vapor through the soils is impeded by, and condenses under fills, foundations, and slabs. The detrimental effects of such movements can be remediated by strengthening the soils during grading. This is typically achieved by excavating the weak soils and replacing them as properly compacted (engineered) fill. Alternatively, foundation support can be obtained by a foundation system that gains support below the weak surface soils.

(K) DARK BROWN SANDY CLAY WITH GRAVEL (CL), very stiff to hard, moist, fine to coarse grained sand, rounded gravel up to 1 inch in diameter, porous to 6 inches
