Docket Number:	06-AFC-09C
Project Title:	Colusa Generating Station - Compliance
TN #:	231056
Document Title:	Annual Compliance Report 2018
Description:	Annual compliance Report
Filer:	Anwar Ali
Organization:	PG&E
Submitter Role:	Applicant
Submission Date:	12/10/2019 12:58:48 PM
Docketed Date:	12/10/2019

**Subject: Colusa Generating Station (06-AFC-9)
Condition of Certification COM-7 (BIO-2; HAZ-1; Noise-8; Soil and Water 2, 7, 8, 9;
TLSN-3; VIS-1, 3; Waste-5 – Annual Operating Report**

Appendix A
Site Photo

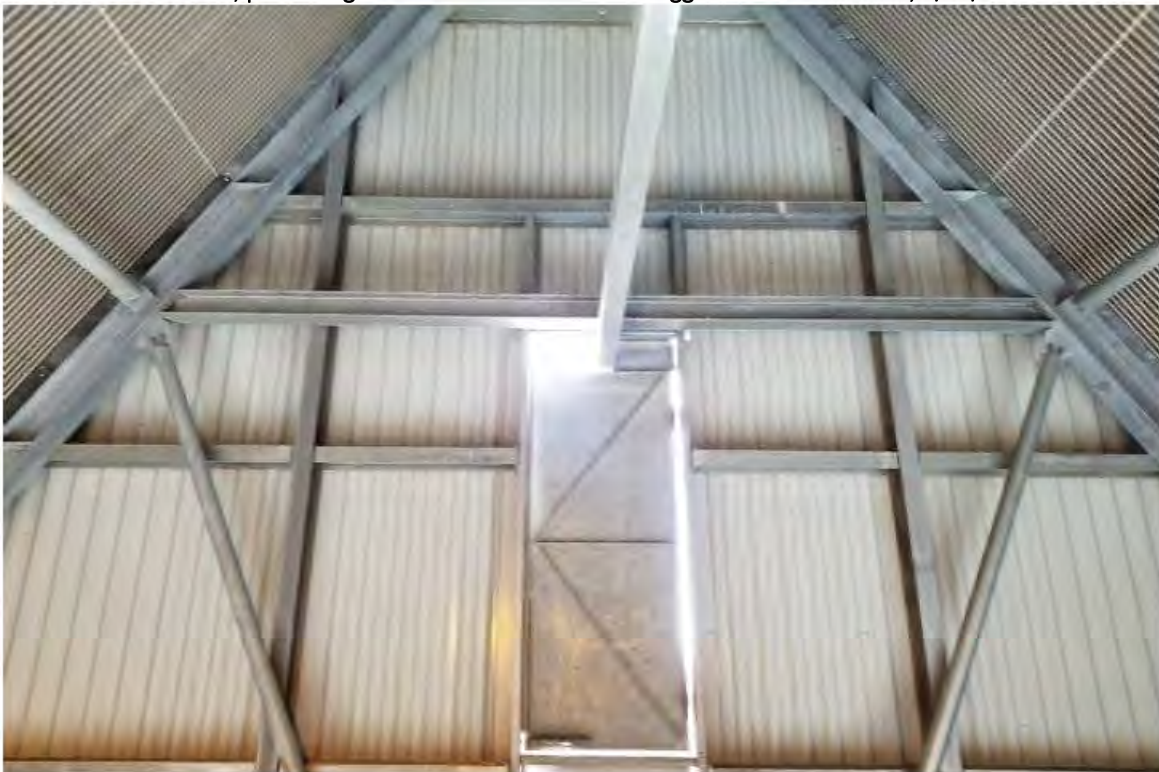
Photo 2, Panel left off access door to street #5 in ACC, 2/22/18.

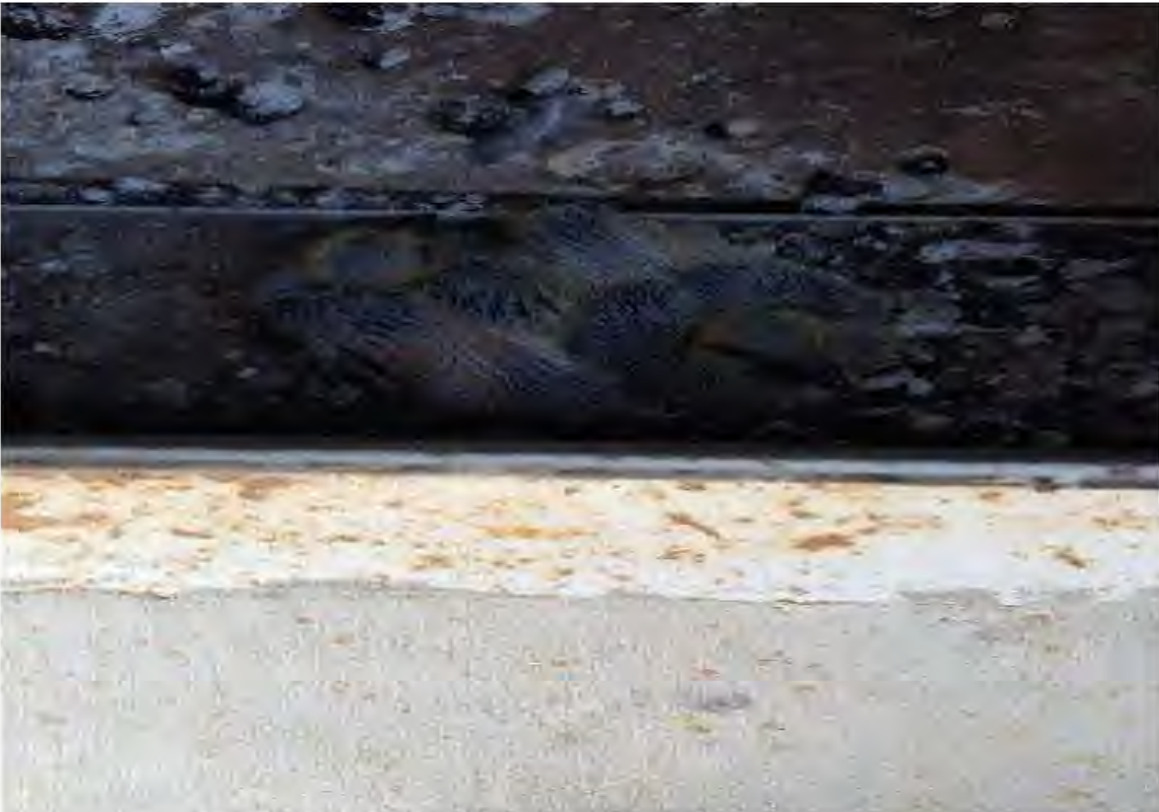
Photo 4, of juvenile pigeons as observed by CGS staff in combustion turbine enclosure, 3/8/18.

March 8th, the DB was contacted by CGS staff regarding 2 juvenile pigeons observed in the Combustion Turbine (CT) enclosure (Photo 4). The DB instructed CGS staff to not disturb the pigeons and to alert other staff to their presence. The area was easily accessed by the adult pigeons and it was in an area that did not impact CGS operation, so the juvenile pigeons were left in place.

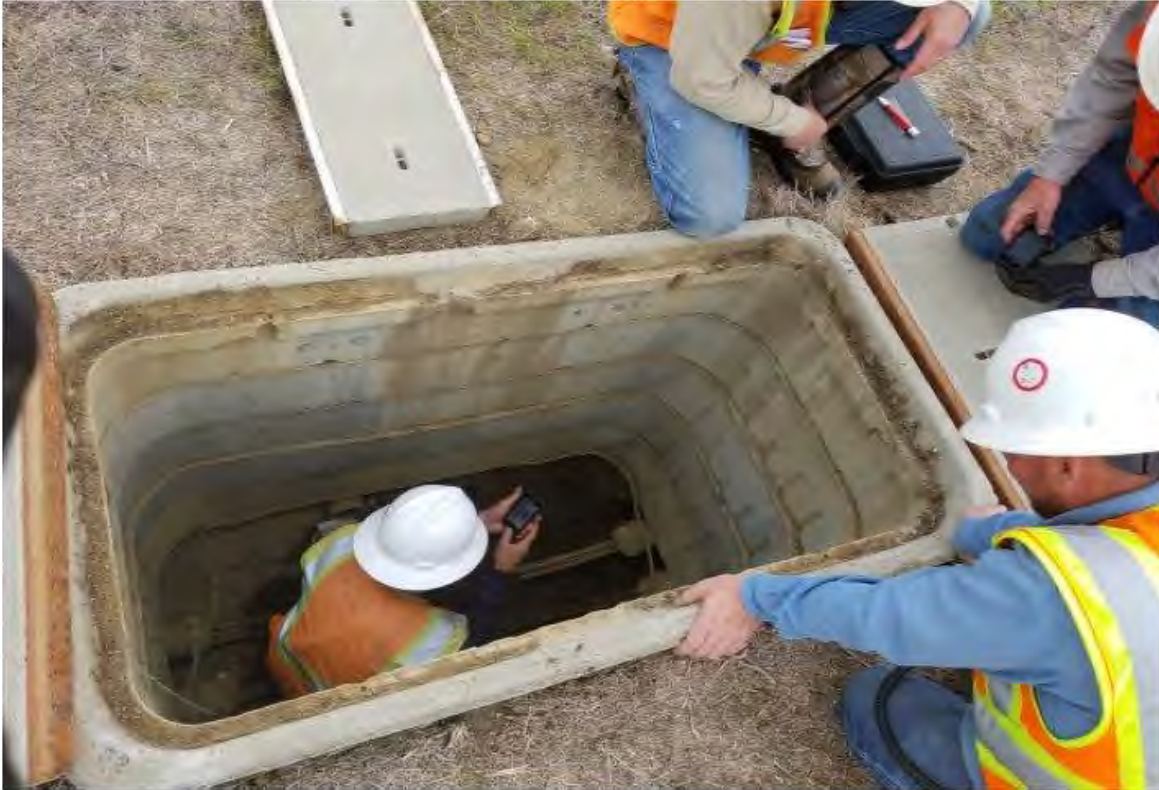
Photo 9, of waterline vault work to facilitate addition of self-cleaning screens at canal pumps, 4/10/18.

April 10th, the DB was requested to be on site by the CGS MS to monitor the opening and potential entry into several utility vaults along the water line access road. The CGS MS believed there was a high potential for rattlesnakes to be inside of the vaults. The DB also performed a pre-disturbance survey for the cement pad for the canal pump self-cleaning screen project, no wildlife was observed. Several underground utility vaults were inspected, all of them had sign of rodents and 1 vault contained a rattlesnake rattle (Photo 9).

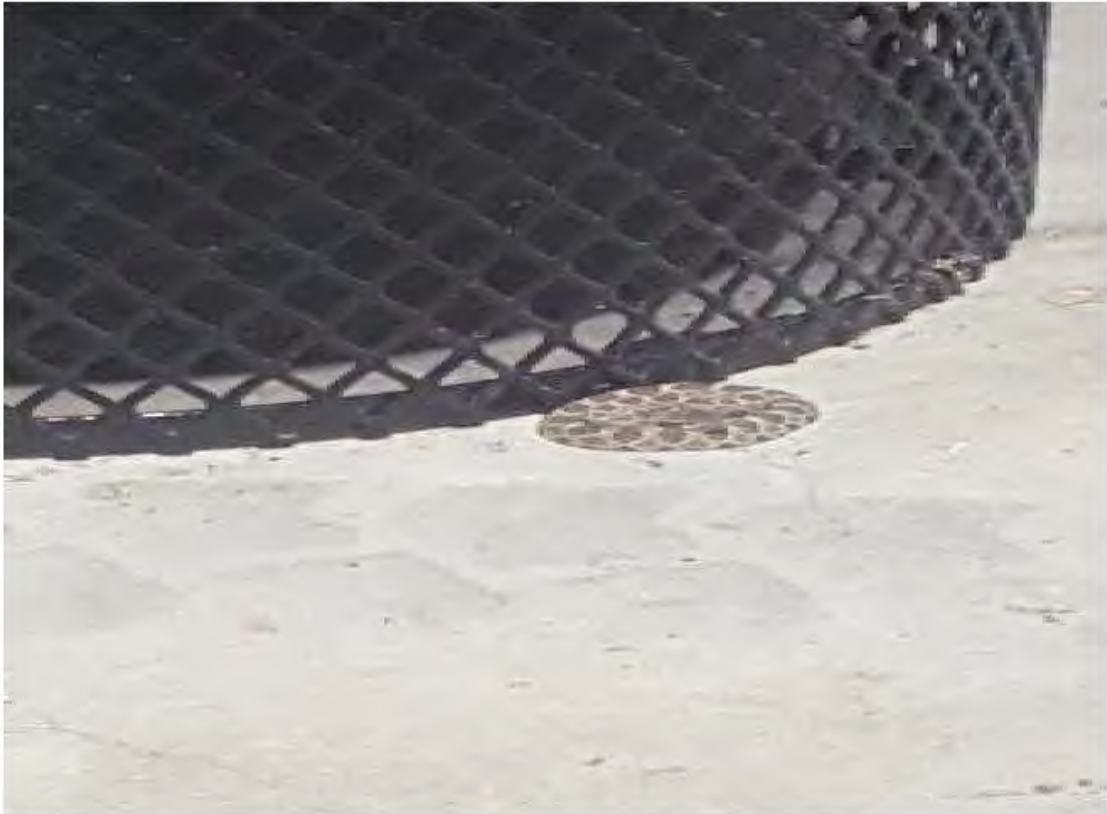
Photo 19, of juvenile rattlesnake #28 as observed within the CGS water treatment building, 5/9/18.

May 9th, the DB monitored fire-abatement mowing. During the monitoring, a rattlesnake (#27) was observed in the water treatment building coiled by a trash can (Photo 19). Later that morning a mower operator reported a rattlesnake (#28) along the outside of the western most perimeter fencing. Rattlesnake (#29) was reported to the DB by the mower operator when the rattlesnake was accidentally killed during mowing. Rattlesnake (#30) was reported to the DB by the gate guard, the snake was observed going under the guard shack. Rattlesnake (#31) was observed in a culvert at the Tehama-Colusa canal intake area. All 4 live rattlesnakes were safely captured and released offsite and the dead rattlesnake was disposed of. Also, while conducting pre-mowing surveys, the DB captured a large gopher snake and a green racer (*Coluber constrictor*) which were both safely released off site away from the mower.

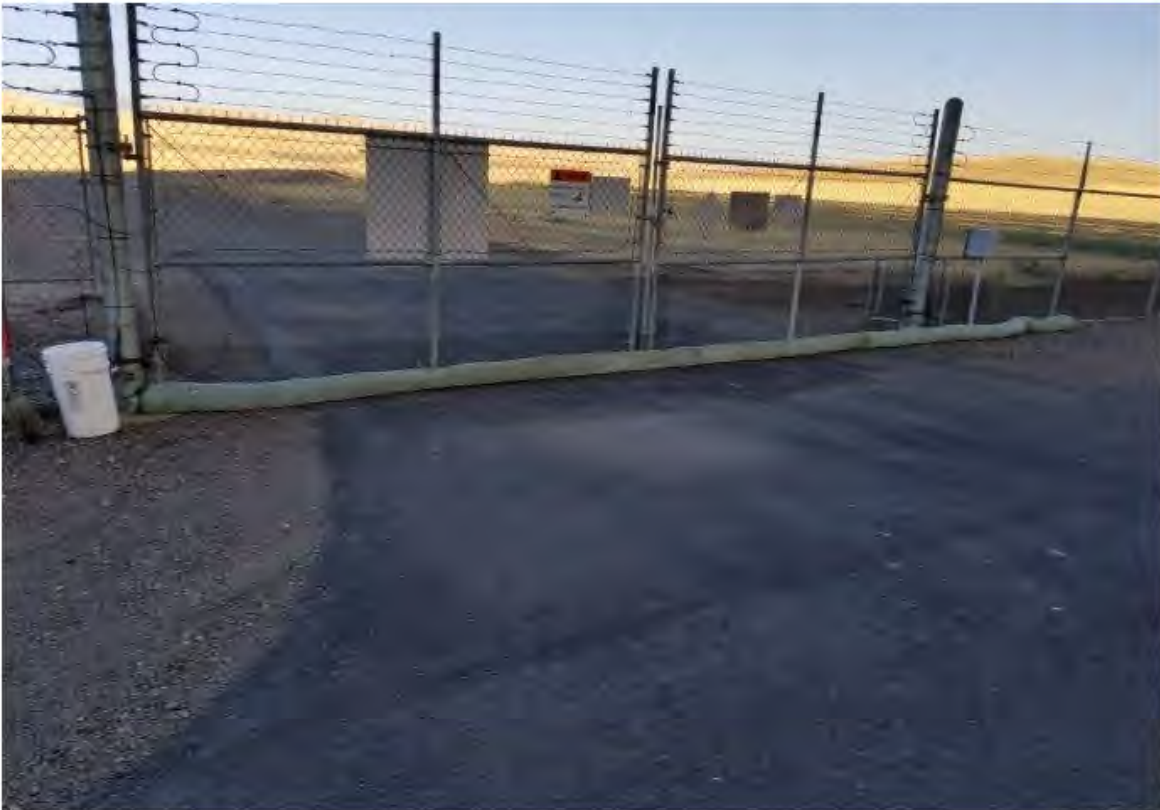
Photo 36, of fiber core roll placed at bottom of back gate to help keep snakes out, 6/14/18.

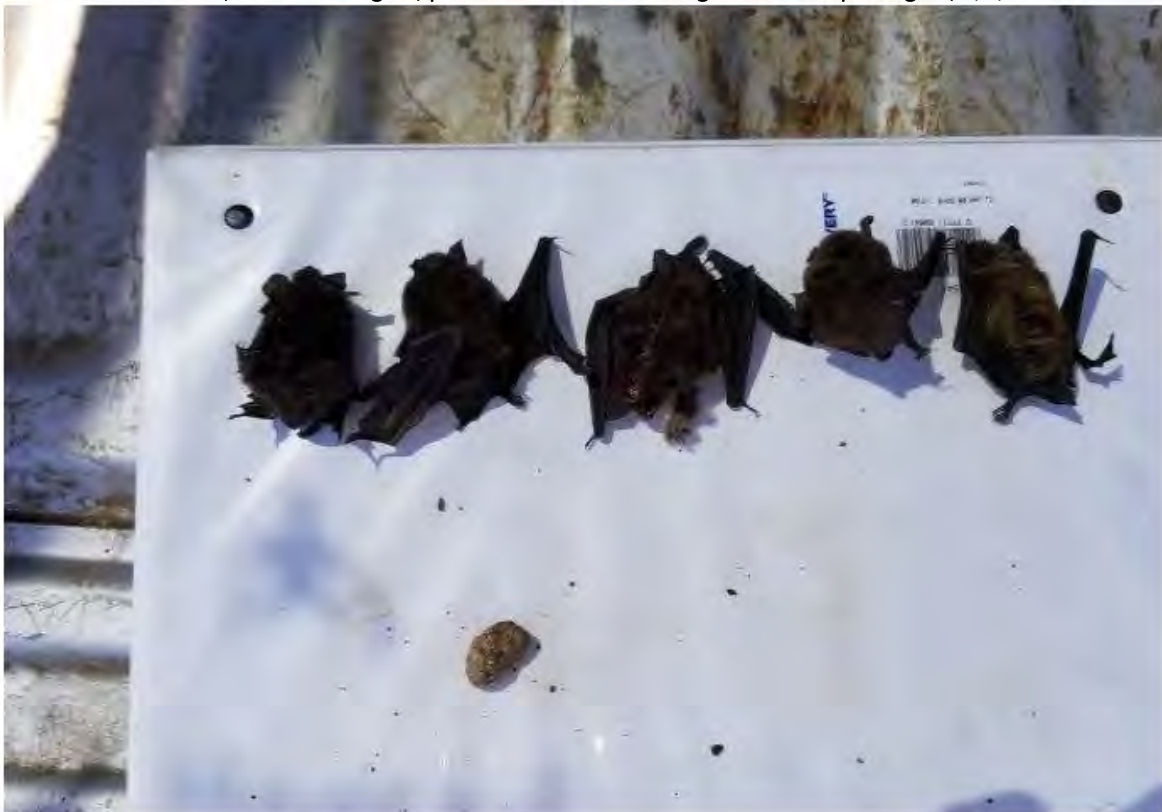
Photo 46, 5 dead Myotis sp. bats observed under ACC during general biology surveys, 7/9/18.

In 2018, bat fatalities were observed under the air-cooled condenser (ACC) structure and around the CGS site. The bat fatalities that were observed included 403 non-special-status bats (*Myotis* sp. and Mexican free-tailed bats), 15 big brown bats and 5 red bats (CDFW Species of Special Concern). This was an increase in bat fatalities from 2017 when 173 non-special-status bats (*Myotis* sp. and Mexican free-tailed bats), 3 big brown and 7 red bats (CDFW Species of Special Concern) were observed. There were less red bat fatalities in 2018 than there were in 2017. Not all of the 2018 bat fatalities can be attributed to the ACC unit as there was a general increase in bat carcasses and live bats observed throughout the facility. Additionally, some of the bat carcasses had talon marks, or were decapitated, which is indicative of owl predation. Also, numerous owl pellets were observed on the ground under the ACC unit. Examination of the owl pellets determined that they contained bat wings and bat skeletal remains. The marked increase in bat fatalities may be influenced by continued changes in farming practices around CGS. When CGS commenced operation, the adjacent farms were in rice production, and over the past several years the adjacent farms have been converted to walnut orchards. The DB will continue to monitor and report on site bat fatalities during 2019.

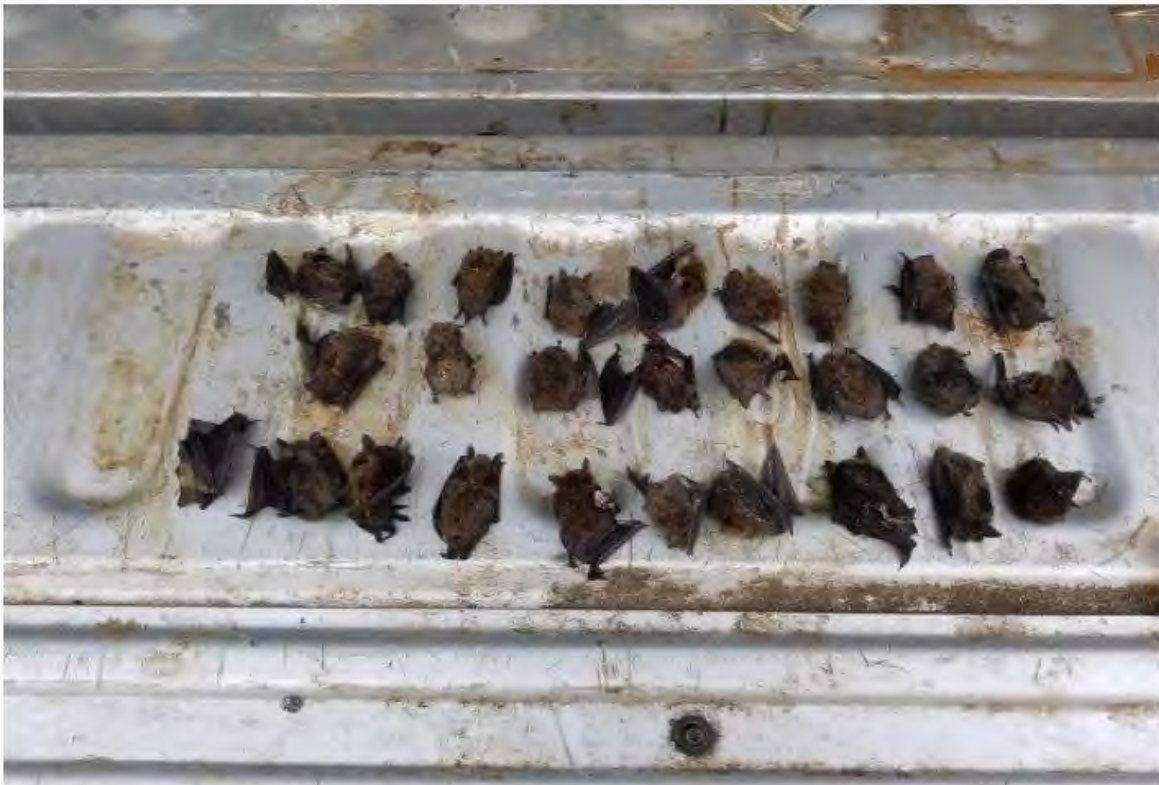
Photo 48, of 27 dead Myotis sp. bats observed and collected during general wildlife and rattlesnake surveys, 7/13/18.

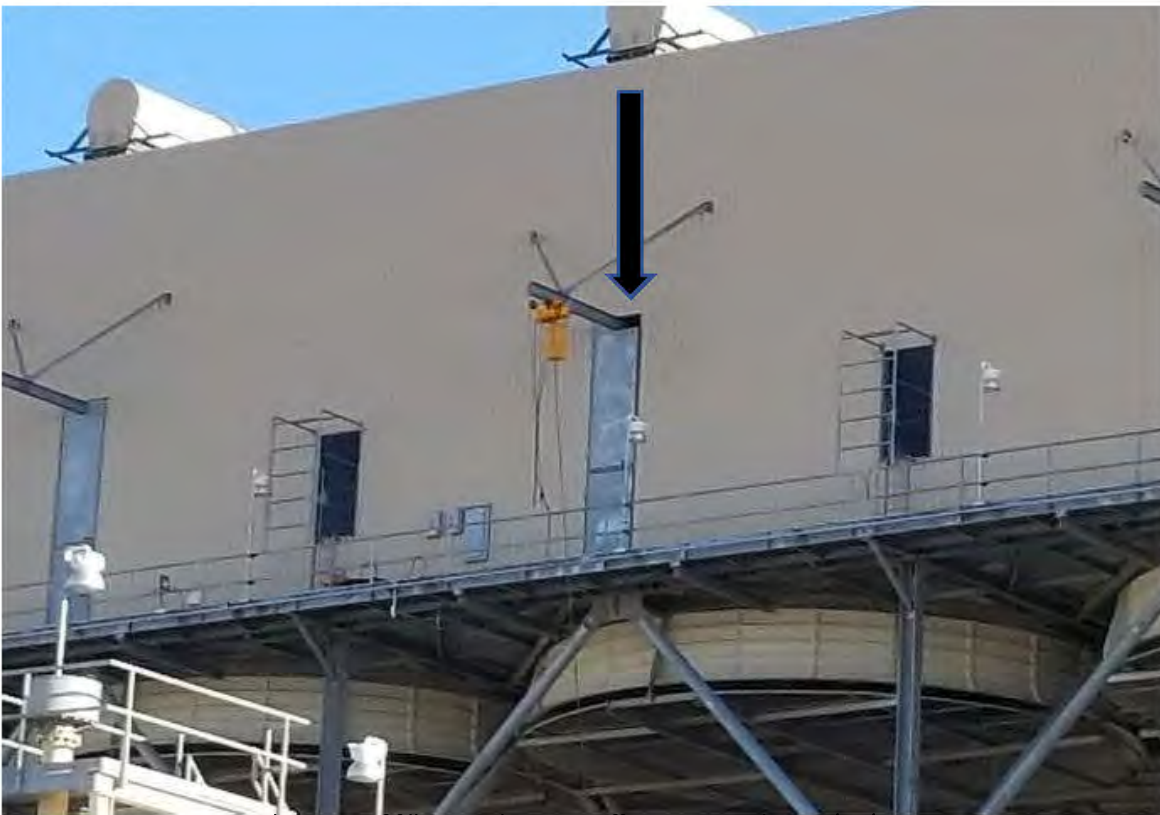
Photo 52, of filler panel missing off ACC access door, 7/16/18.

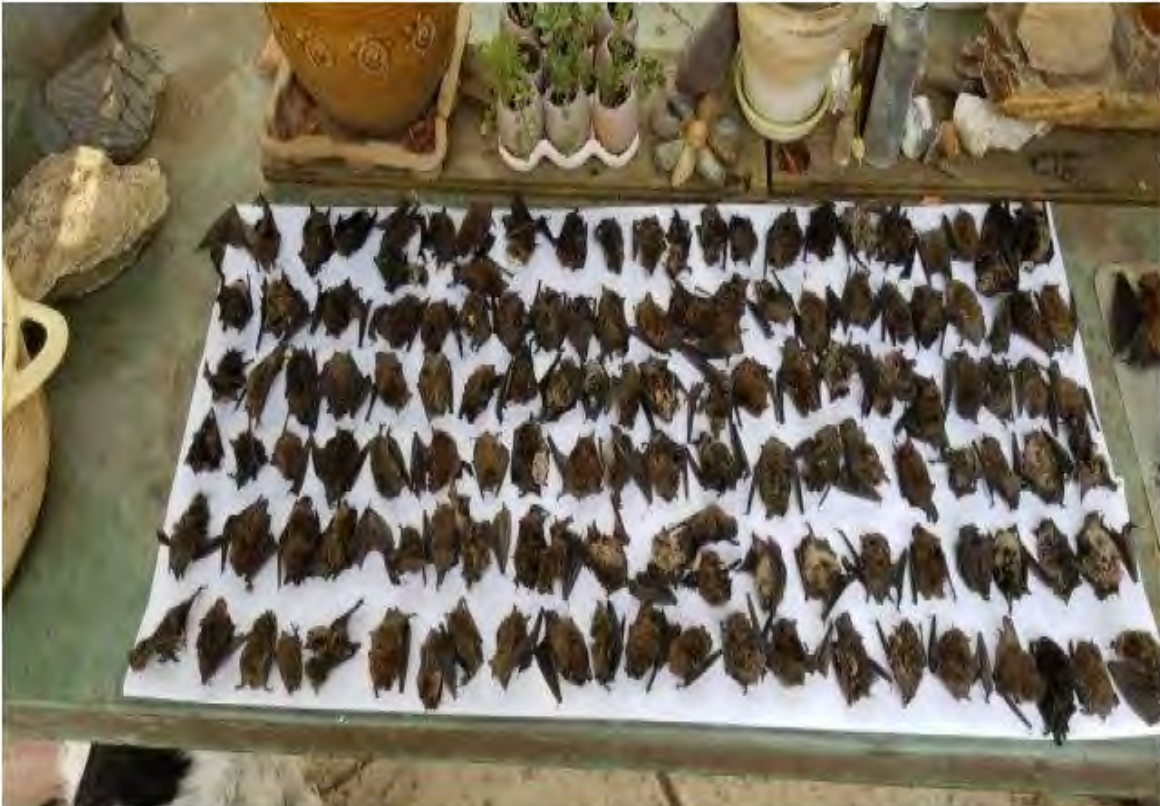
Photo 61, of 128 Myotis sp. bats collected under ACC during general wildlife and rattlesnake surveys, 8/10/18.

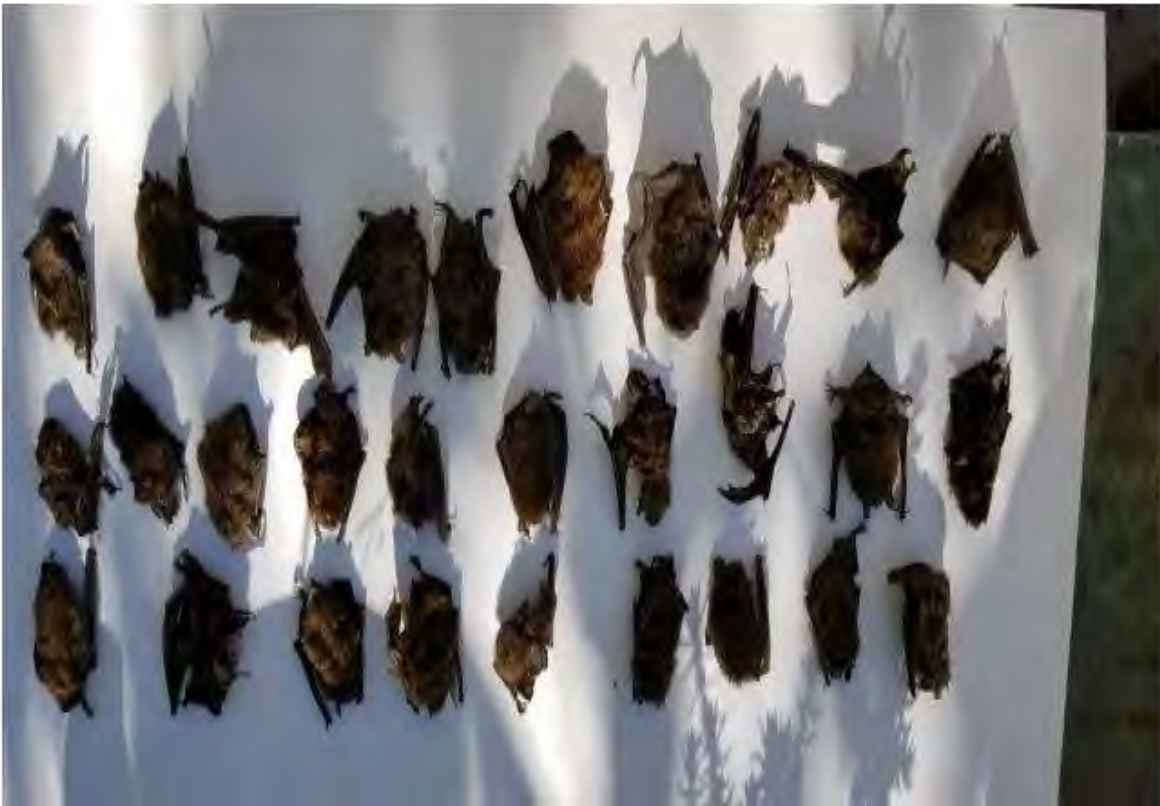
Photo 80, of 29 dead Myotis sp. bats observed under the ACC structure, 10/11/18.
