<b>Docket Number:</b>	06-AFC-09C
<b>Project Title:</b>	Colusa Generating Station - Compliance
<b>TN #:</b>	232288
<b>Document Title:</b>	2019 Annual Compliance Report
<b>Description:</b>	Annual Compliance Report
<b>Filer:</b>	Anthony TJ Gomez
<b>Organization:</b>	Pacific Gas and Electric
<b>Submitter Role:</b>	Applicant
<b>Submission Date:</b>	3/3/2020 7:55:01 AM
<b>Docketed Date:</b>	3/3/2020

**COLUSA GENERATING STATION COMPLIANCE MATRIX BASED ON CEC FINAL DECISION**

This Colusa Generating Station (CGS) Biological Resources Annual Compliance Report, 2019 fulfills the California Energy Commission (CEC) requirement in the Verification for Condition of Certification (COC) BIO-2 Sub-section 8. "Designated Biologist Duties, BIO-2, Sub-section 8; The duties of the Designated Biologist are to maintain written records of the tasks specified above and those included in the Biological Resources Mitigation Implementation and Monitoring Plan, (BRMIMP). Summaries of these records shall be submitted in the annual compliance report.

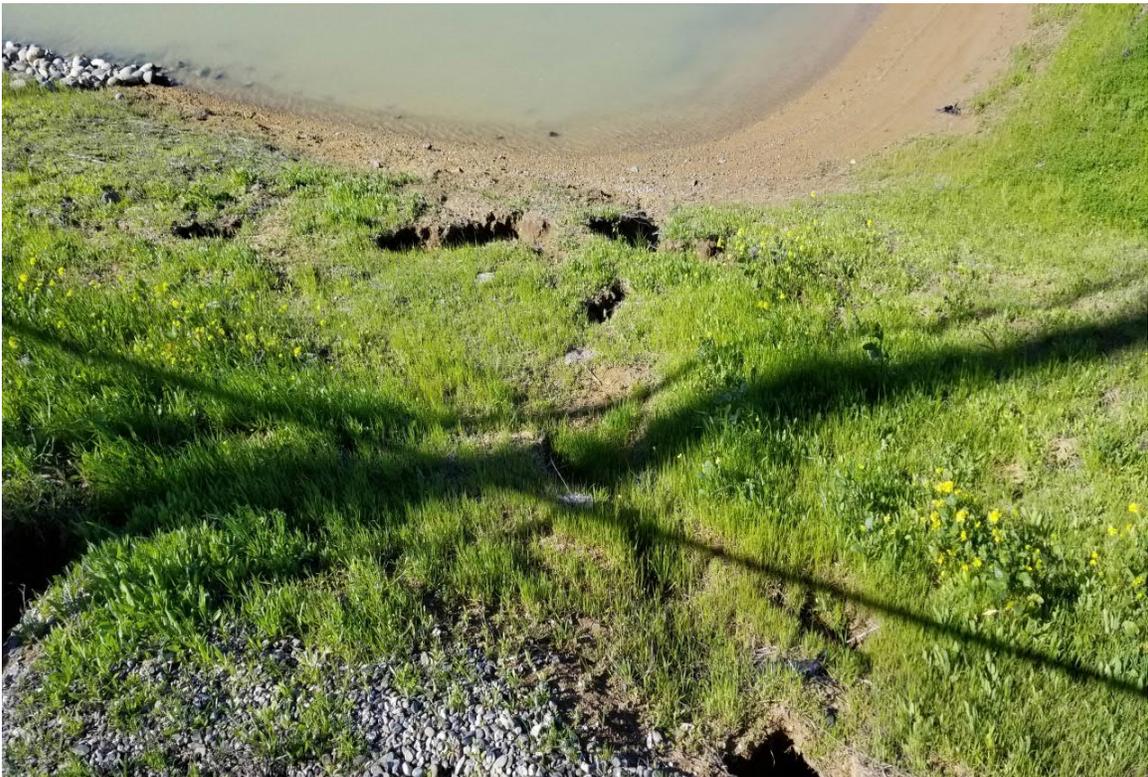
March 13<sup>th</sup>, the DB was on site to survey the switchyard slopes for erosion areas that will need backfilled prior to the 2019 rattlesnake season. Erosion was observed on all sides of the switchyard and the CGS Maintenance Supervisor was informed of the observations (Photos 2-5).

Photo 2, photo of erosion as observed in northeast corner of detention pond, 3/13/19.

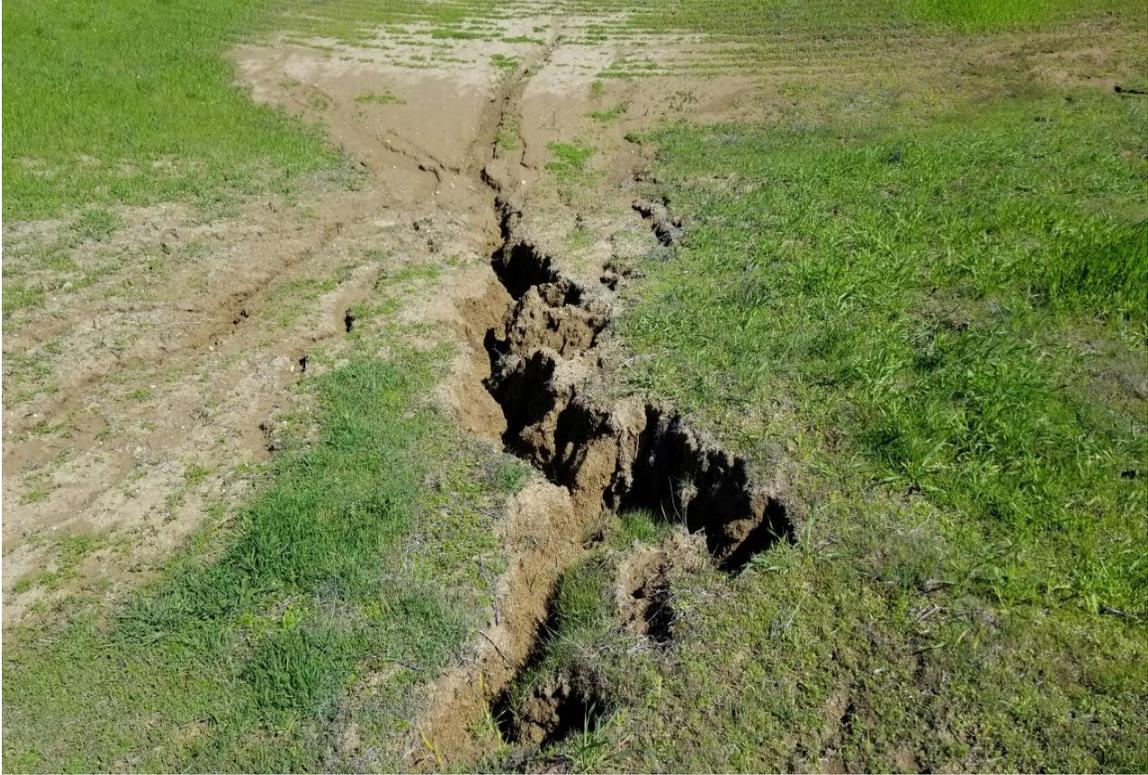
Photo 3, of erosion area east of switchyard as observed, 3/13/19.

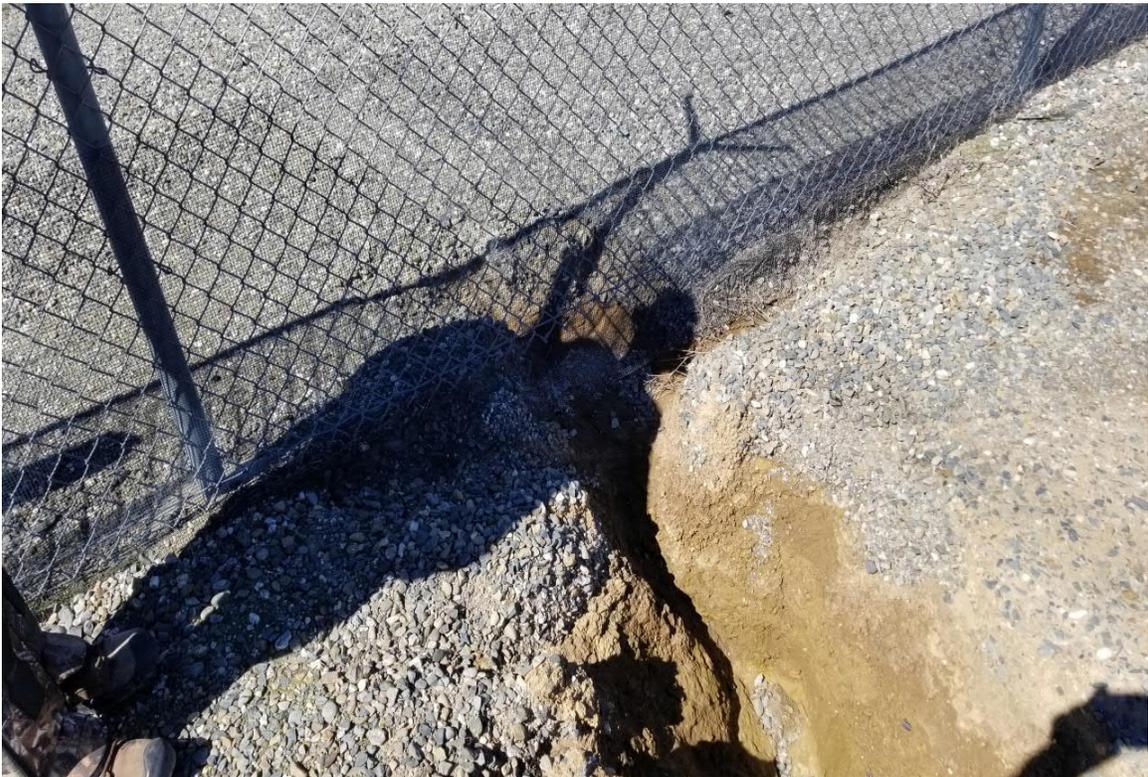
Photo 4, of erosion under and through perimeter fence east side of switchyard, 3/13/19.

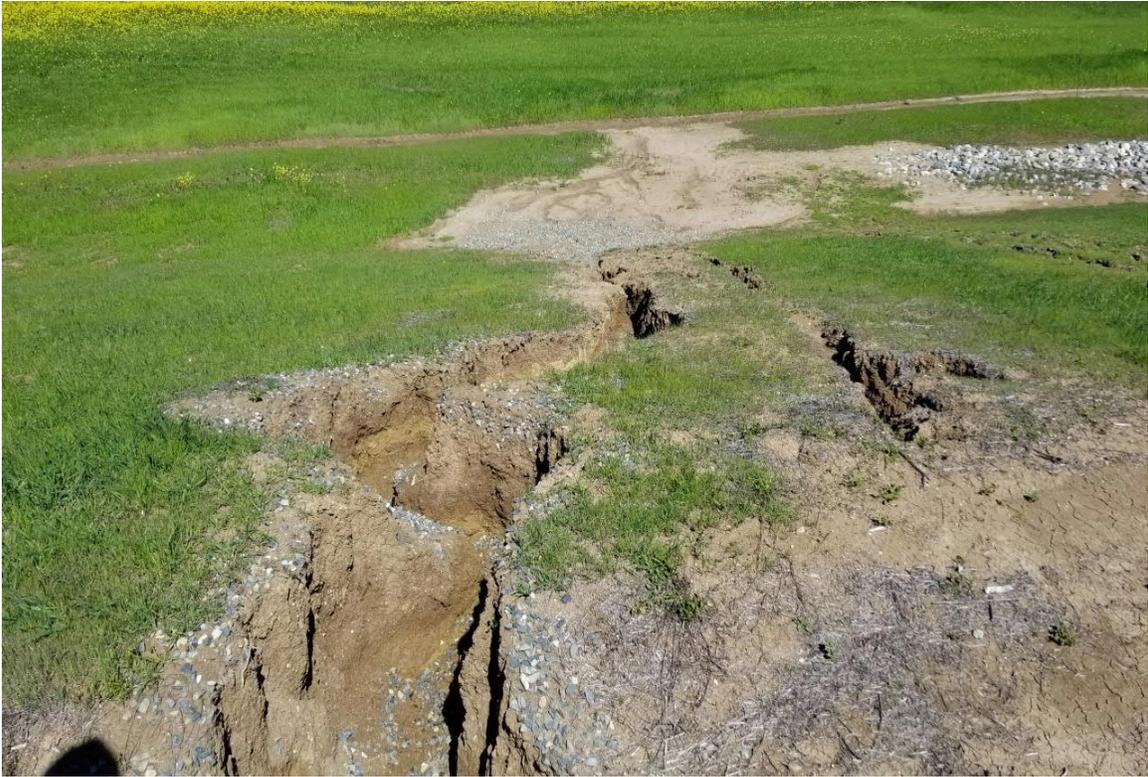
Photo 5, of erosion area north slope of switchyard, 3/13/19.

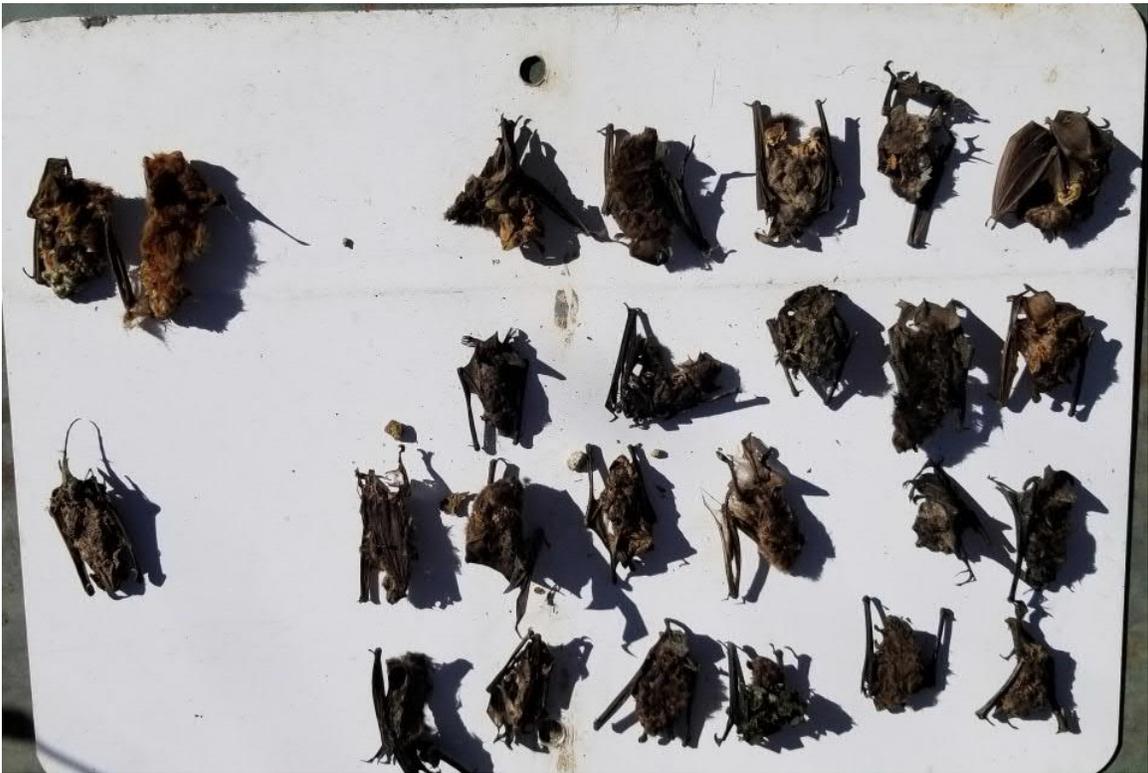
Photo 6, bat carcasses observed under the ACC, 3/21/19.

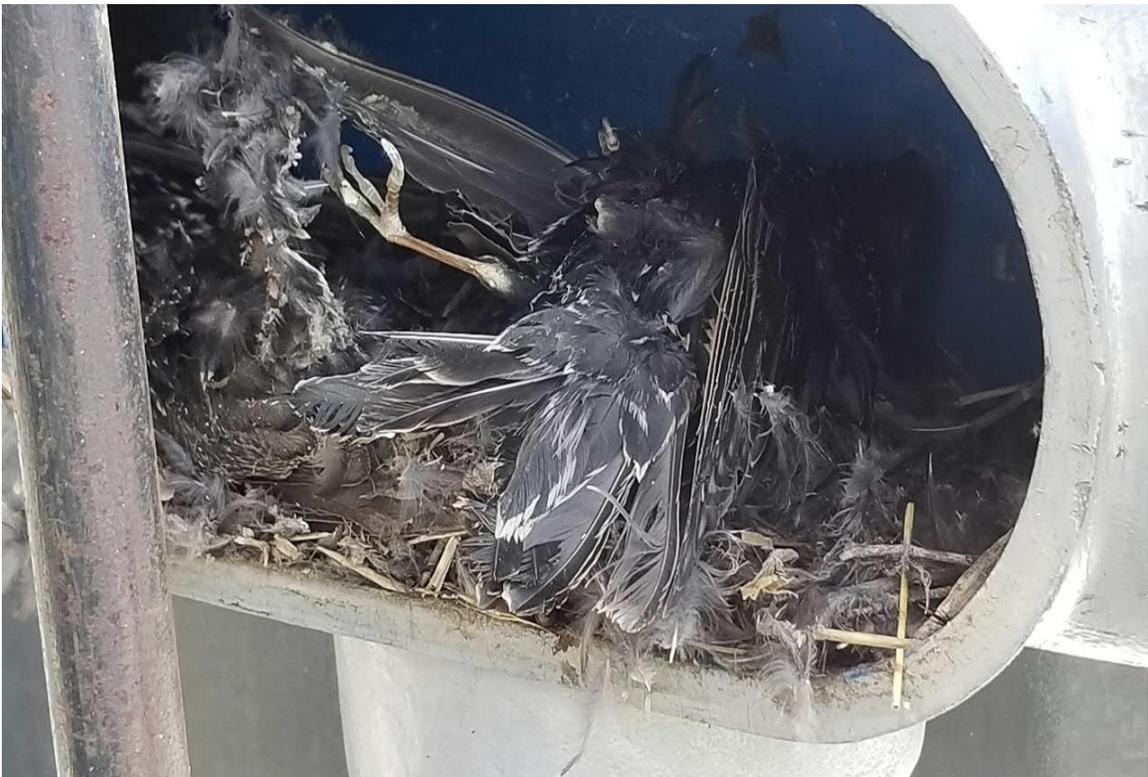
Photo 16, of dead European starlings observed in a junction box associated with steam turbine, 5/8/19.

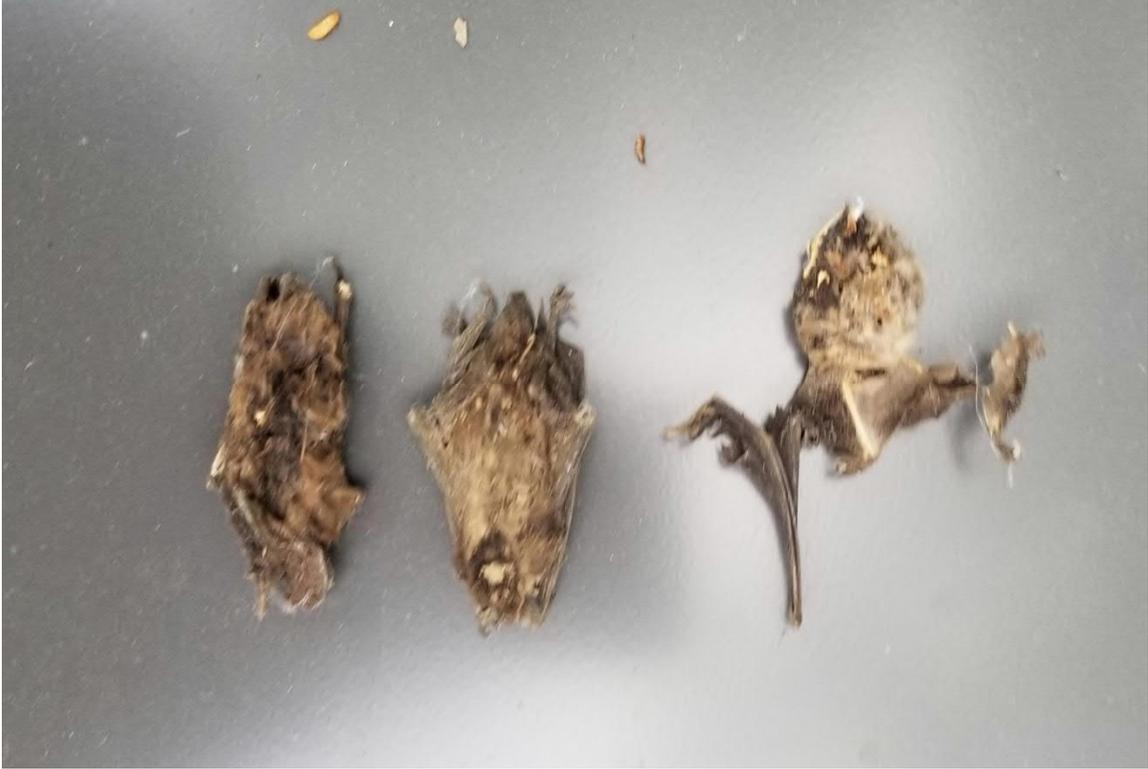
June 11<sup>th</sup>, the DB was on site to conduct focused surveys for rattlesnakes inside and outside of the facility and to survey for bat carcasses under the ACC. During the outside survey a large gravid female rattlesnake #33 was observed in the snake fence U-turn at the back CGS gate (Photo 19). No other rattlesnakes were observed outside of the facility. Rattlesnake #34 was observed inside the CGS warehouse (Photo 20). Both rattlesnakes were safely captured and released off site. 3 *Myotis* sp. bat carcasses were observed under the ACC (Photo 21). All 3 carcasses appeared to be older and dried out.

Photo 21, of 3 Myotis sp. bat carcasses observed under the CGS ACC, 6/11/19.

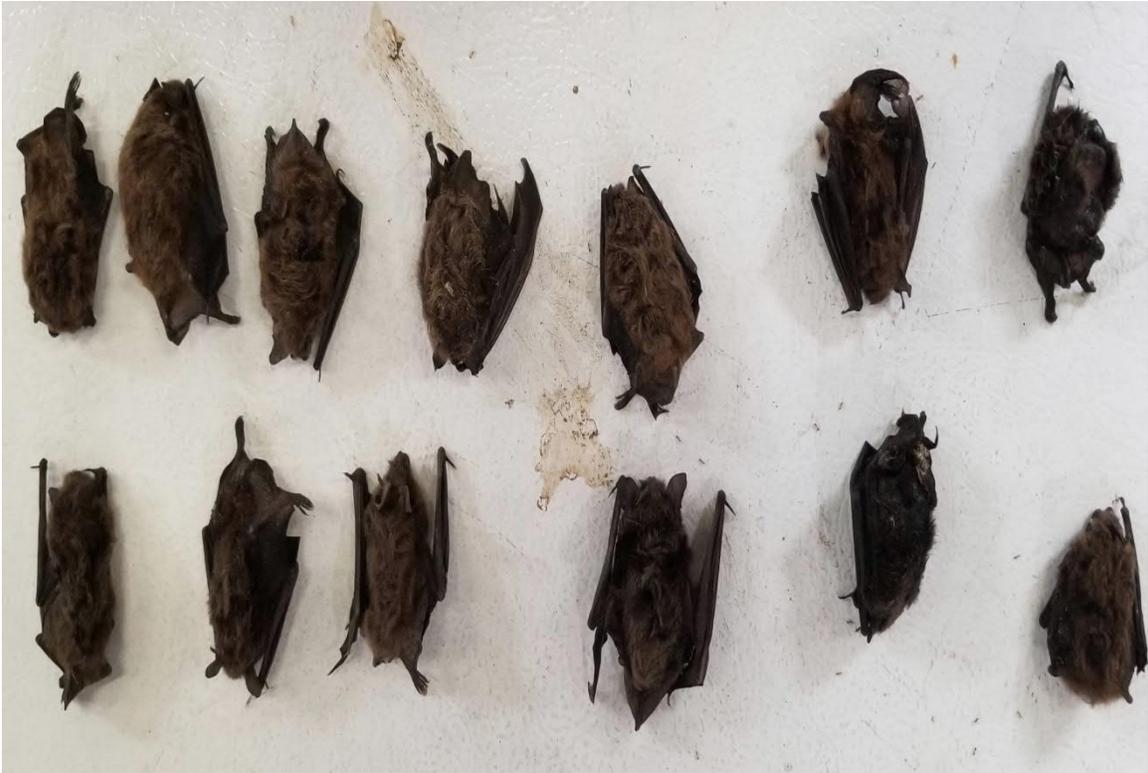
July 24<sup>th</sup>, the DB was on site to conduct focused surveys for rattlesnakes inside and outside of the facility and to survey for bat carcasses under the ACC. The outside and inside the facility rattlesnake surveys were negative. During the bat carcass survey the DB observed; 15 *Myotis* sp. bat carcasses, 13 were fresh carcasses and 2 were older (Photo 25).

Photo 25, of 13 fresh *Myotis* sp. carcasses observed under ACC during bat carcass survey, 7/24/19.

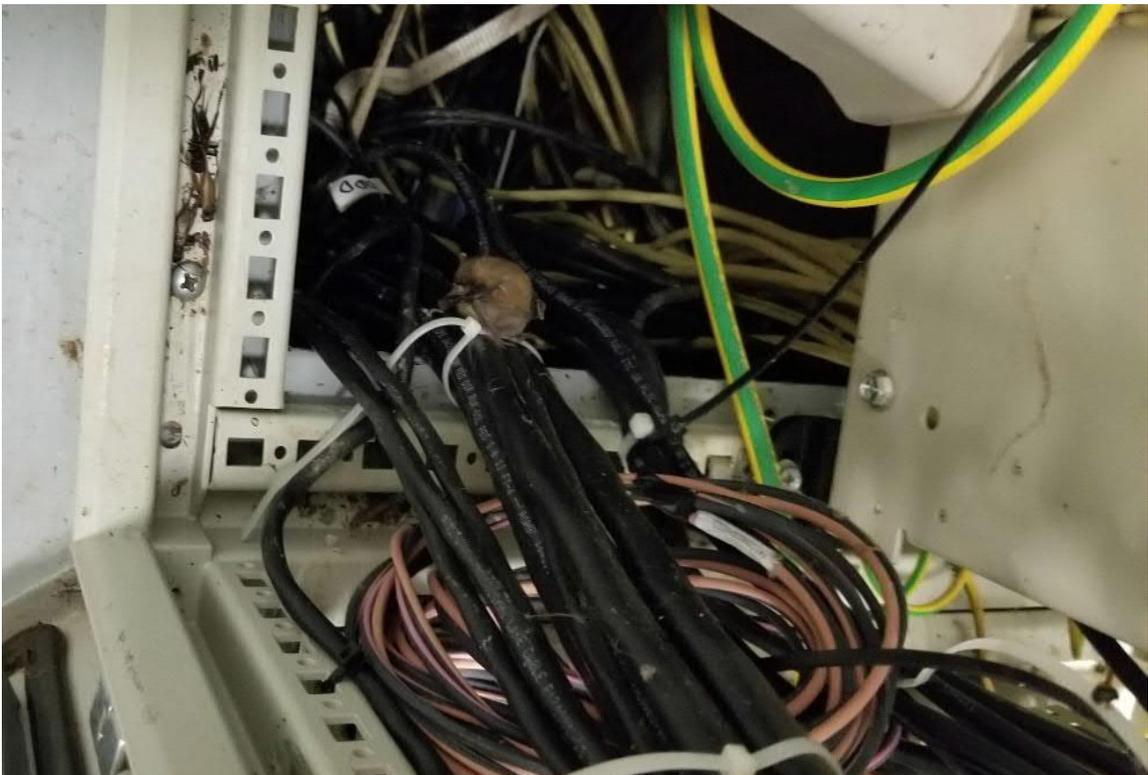
Photo 26, of big brown bat as observed inside a control computer within the ACC PDC room, 8/28/19.

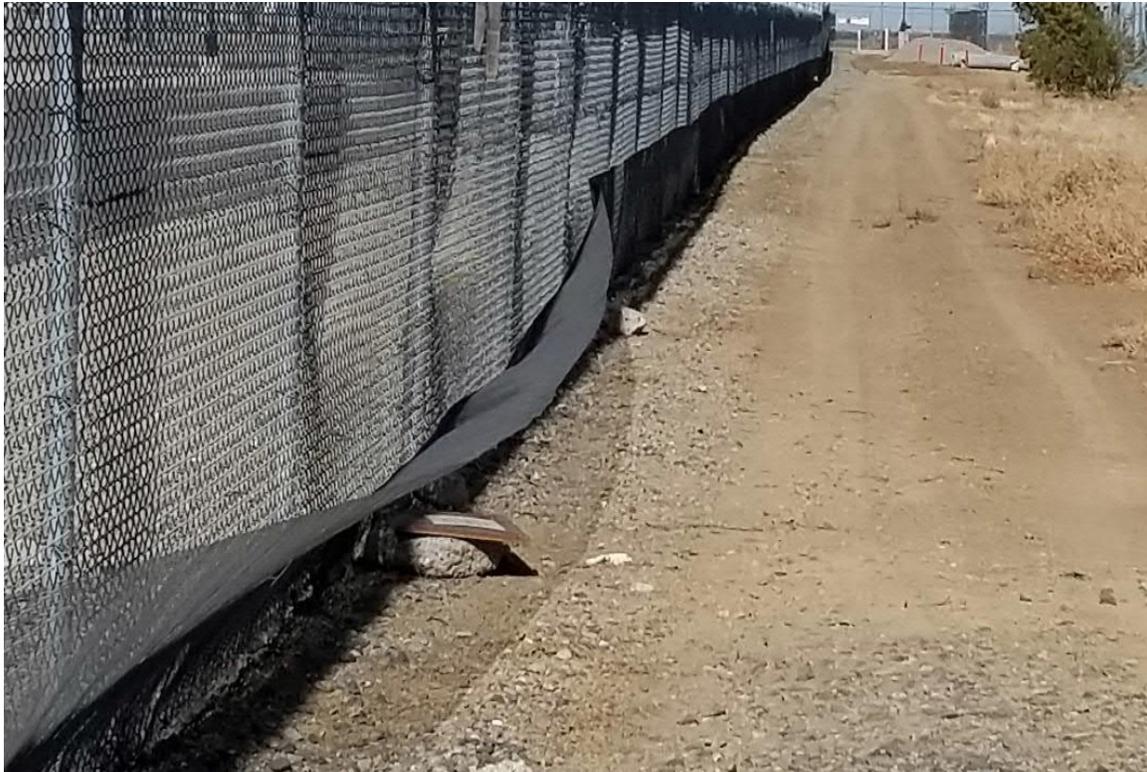
Photo 32, of snake fencing falling off perimeter fence after high wind event, 10/13/19.

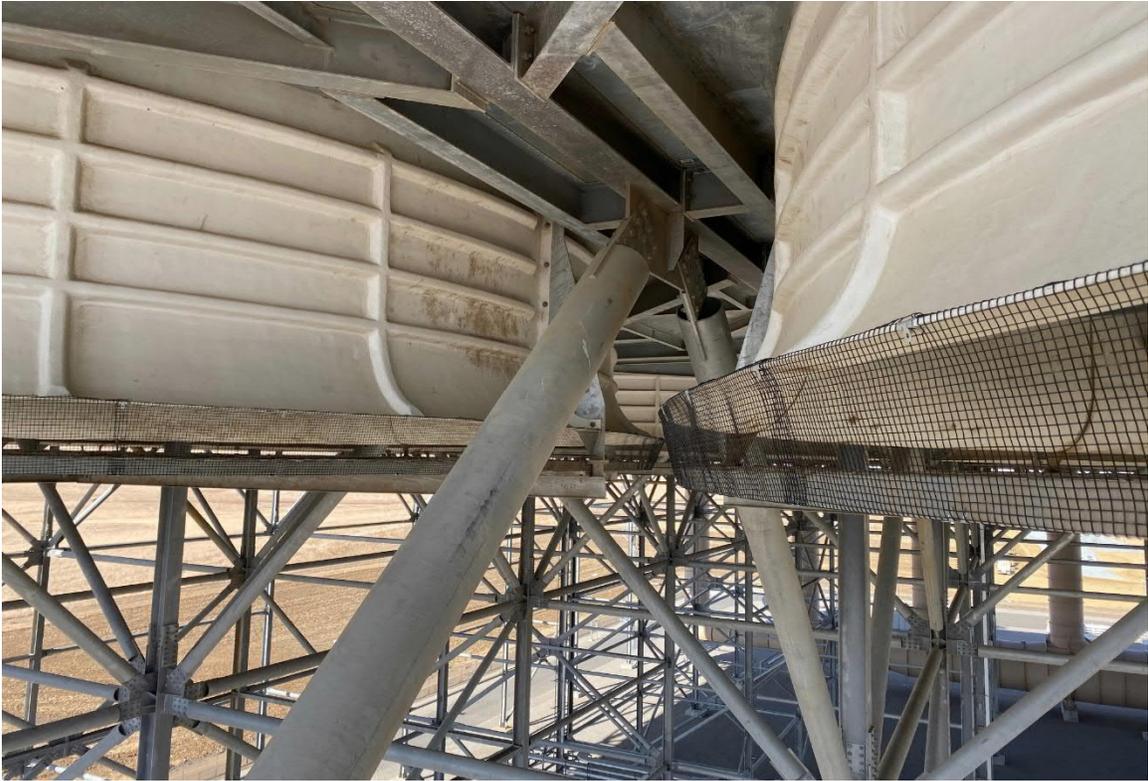
Photo 33, of screening installed around fan plenum base to exclude birds and bats from ACC, 11/11/19.

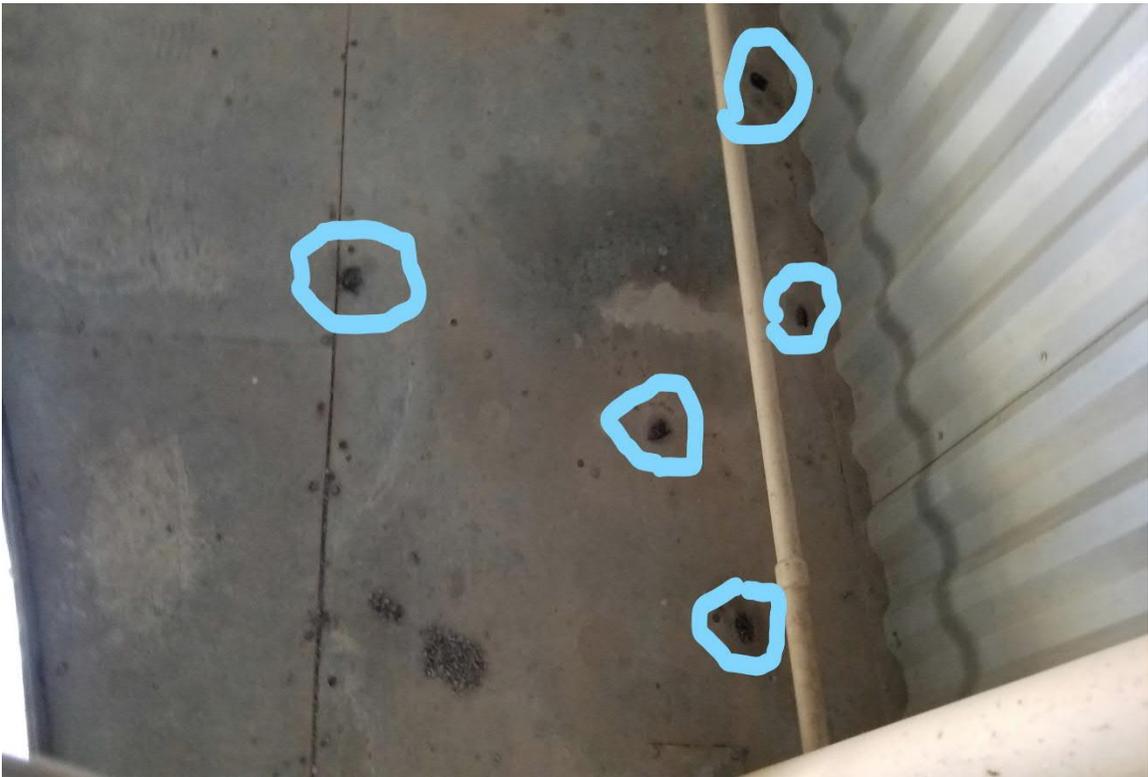
Photo 36, of inside an ACC cell, blue circles represent bat carcasses as observed on floor of ACC, 12/16/19.

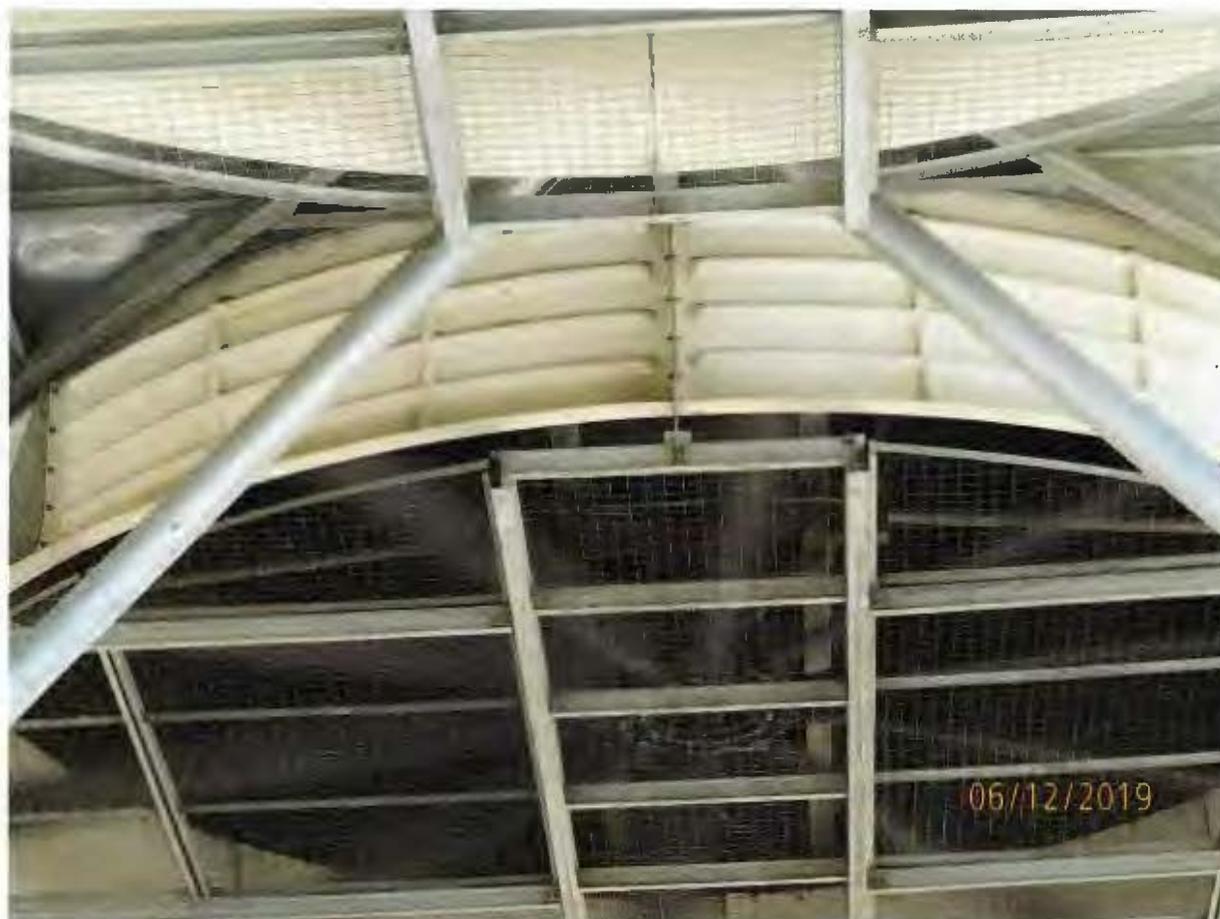
**Photograph 3: Closer view of fan and grate. Note gap between fan housing and grate**

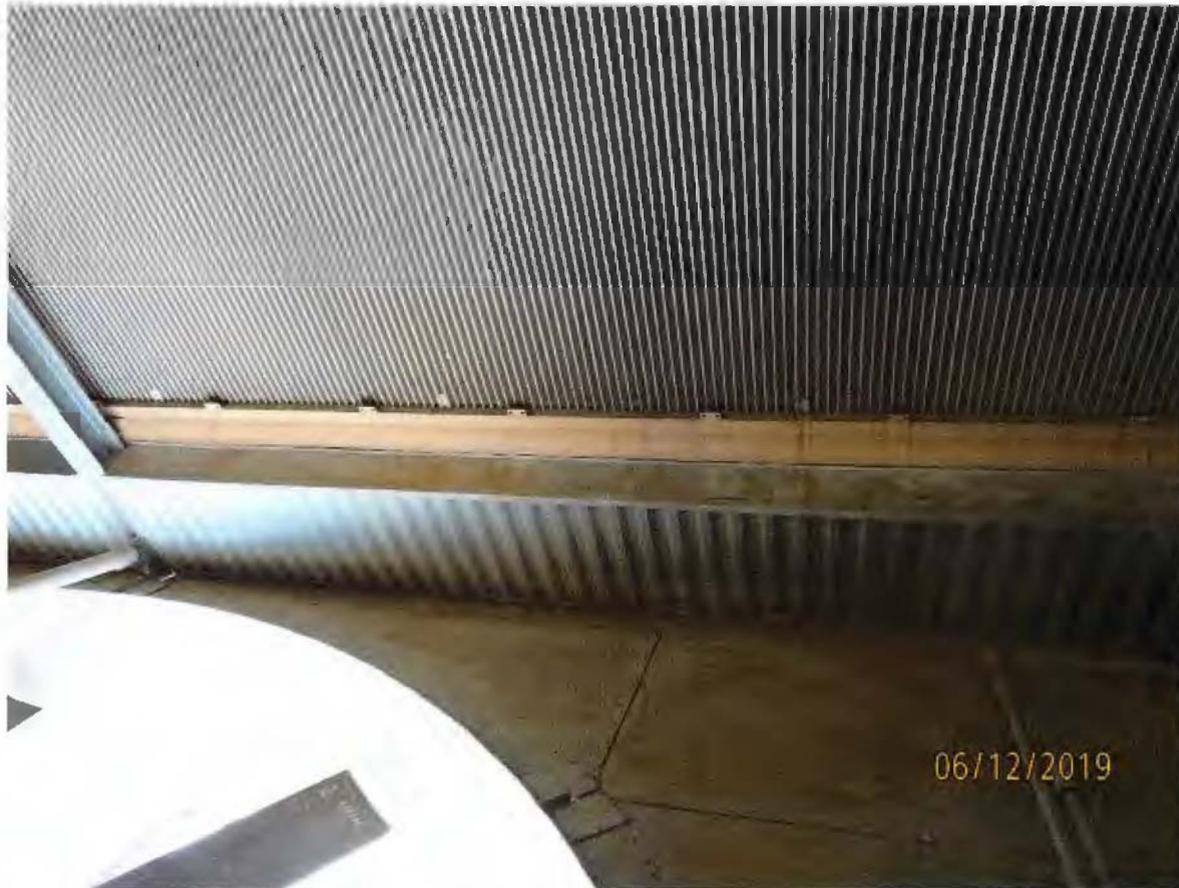
**Photograph 4: Inside ACC cell looking at wall where bats hold on at night and roost**

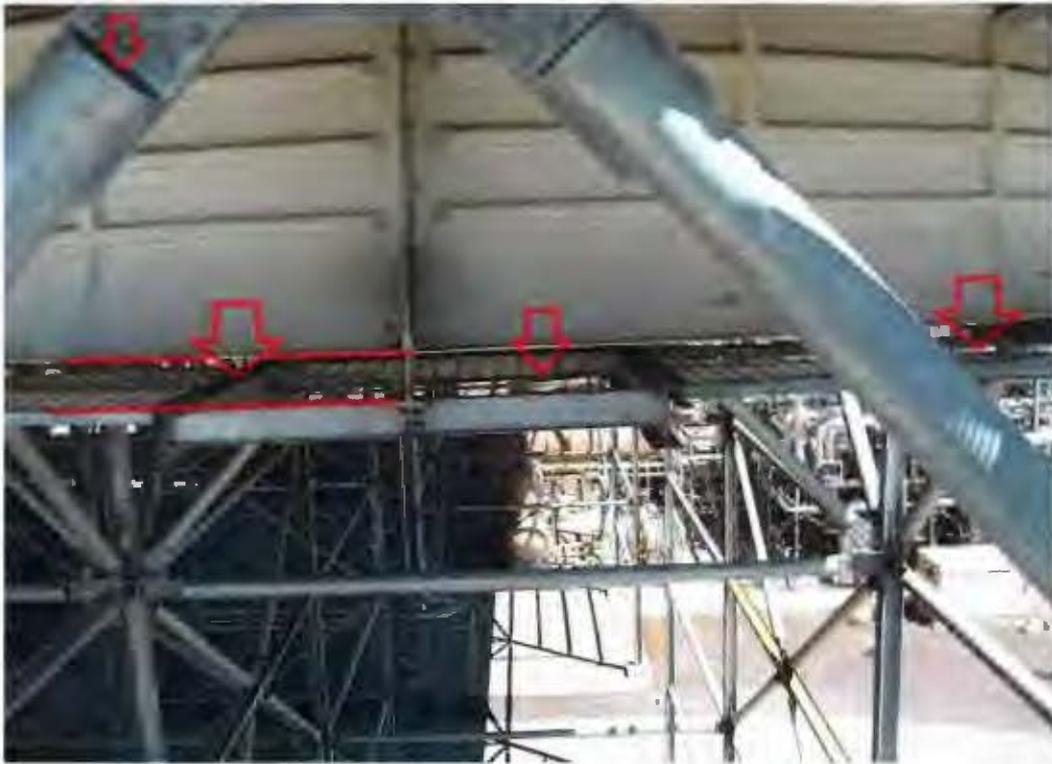
**Photo 2. Side view with left side arrow indicating tubular cavity in infrastructure, and midground arrows and lines indicating gap between housing around fan (plenum) and grate.**

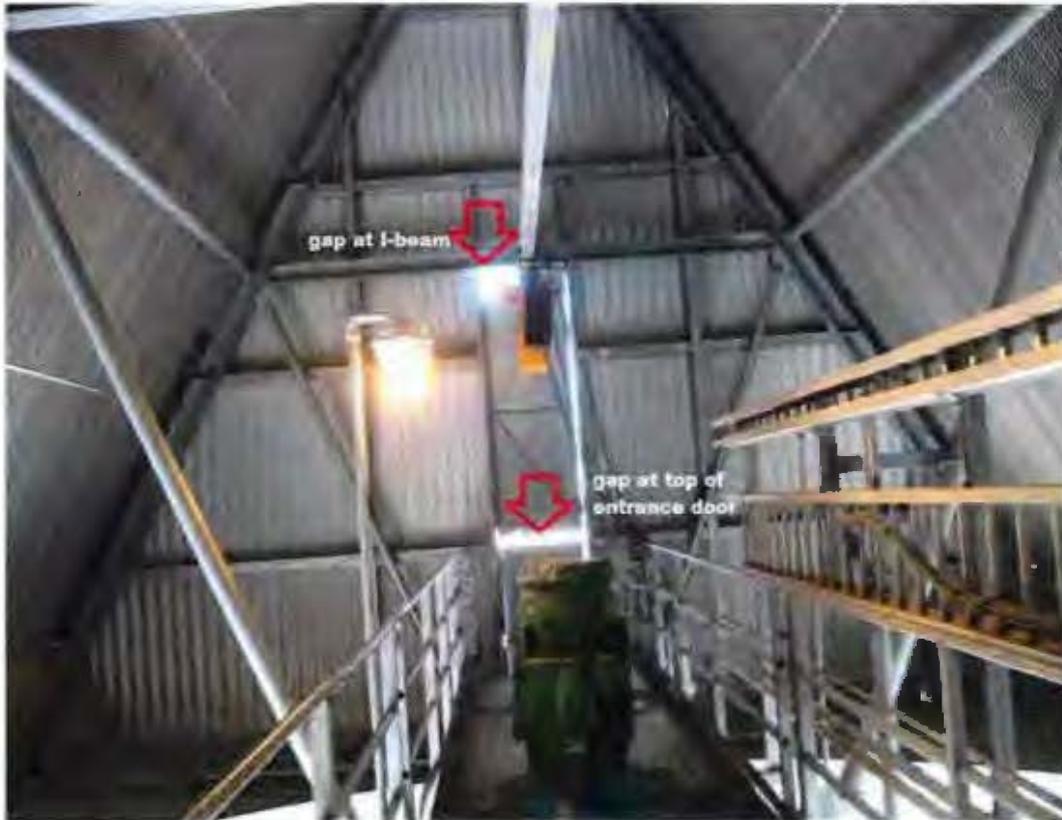
Photo 4. Interior of room above fan with red arrows indicating bat-accessible gaps by I-beam and above door on June 6, 2016. On August 11, 2016 metal flashing was installed in the two gaps identified by arrows.
