<b>DOCKETED</b>	
<b>Docket Number:</b>	87-AFC-01C
<b>Project Title:</b>	COMPLIANCE-Luz Solar Electric Generating System Cogeneration AFC (150 MW) Units III-VII.
<b>TN #:</b>	241138
<b>Document Title:</b>	Petition to Amend Boundary Change Appendix B Part I - SEGS III-VII
<b>Description:</b>	N/A
<b>Filer:</b>	Scott Galati
<b>Organization:</b>	DayZenLLC
<b>Submitter Role:</b>	Applicant Representative
<b>Submission Date:</b>	1/11/2022 2:18:22 AM
<b>Docketed Date:</b>	1/11/2022

## **APPENDIX B**

Monthly Compliance Reports and Biological Memorandum

Subject: SEGS III-VII Decommissioning (87-AFC-01C) Monthly Compliance Report for June 2021

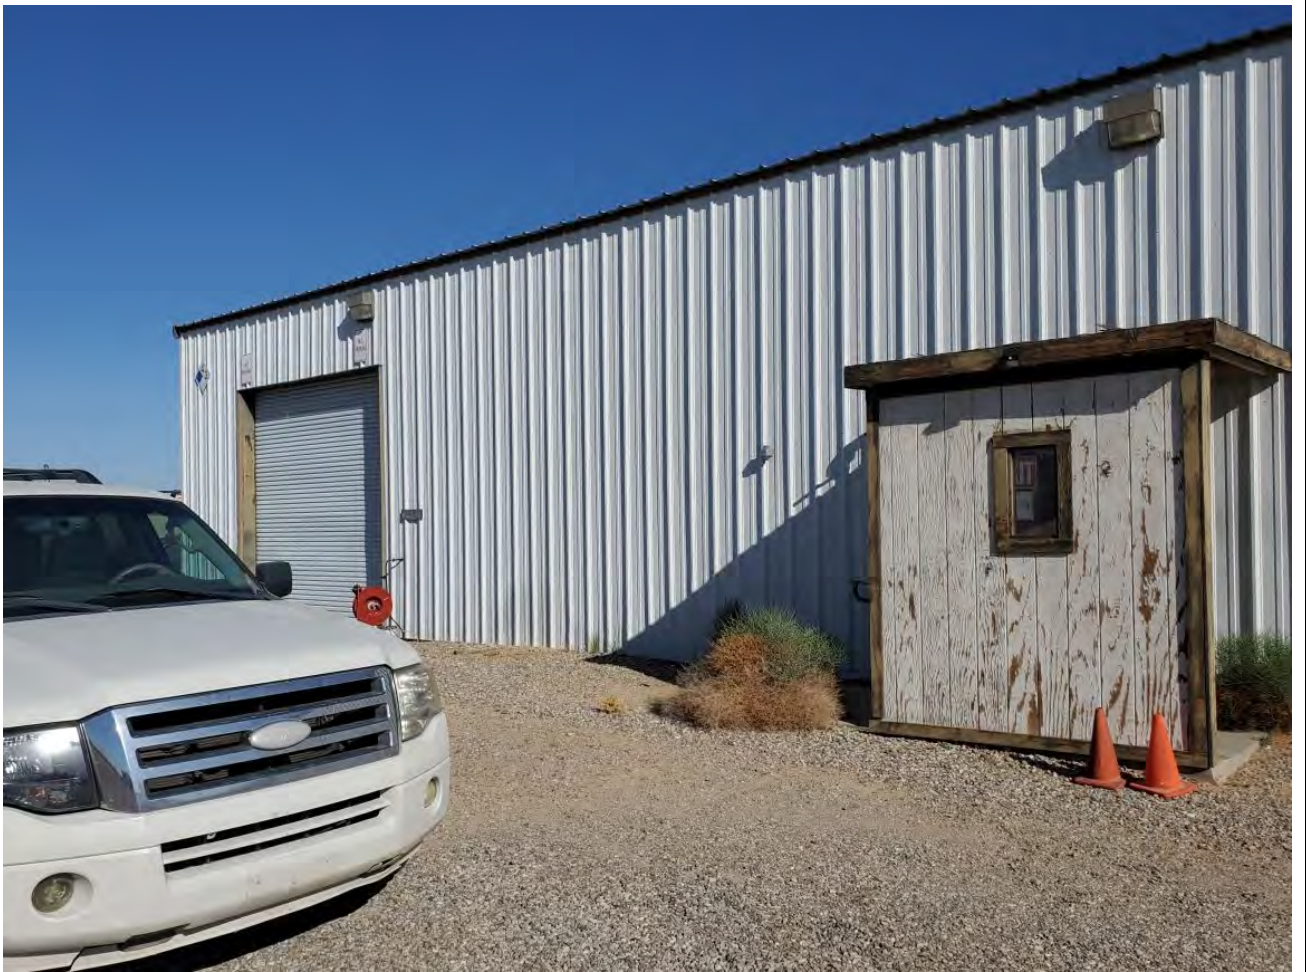
Photo 9: Flooring in the Guard Building

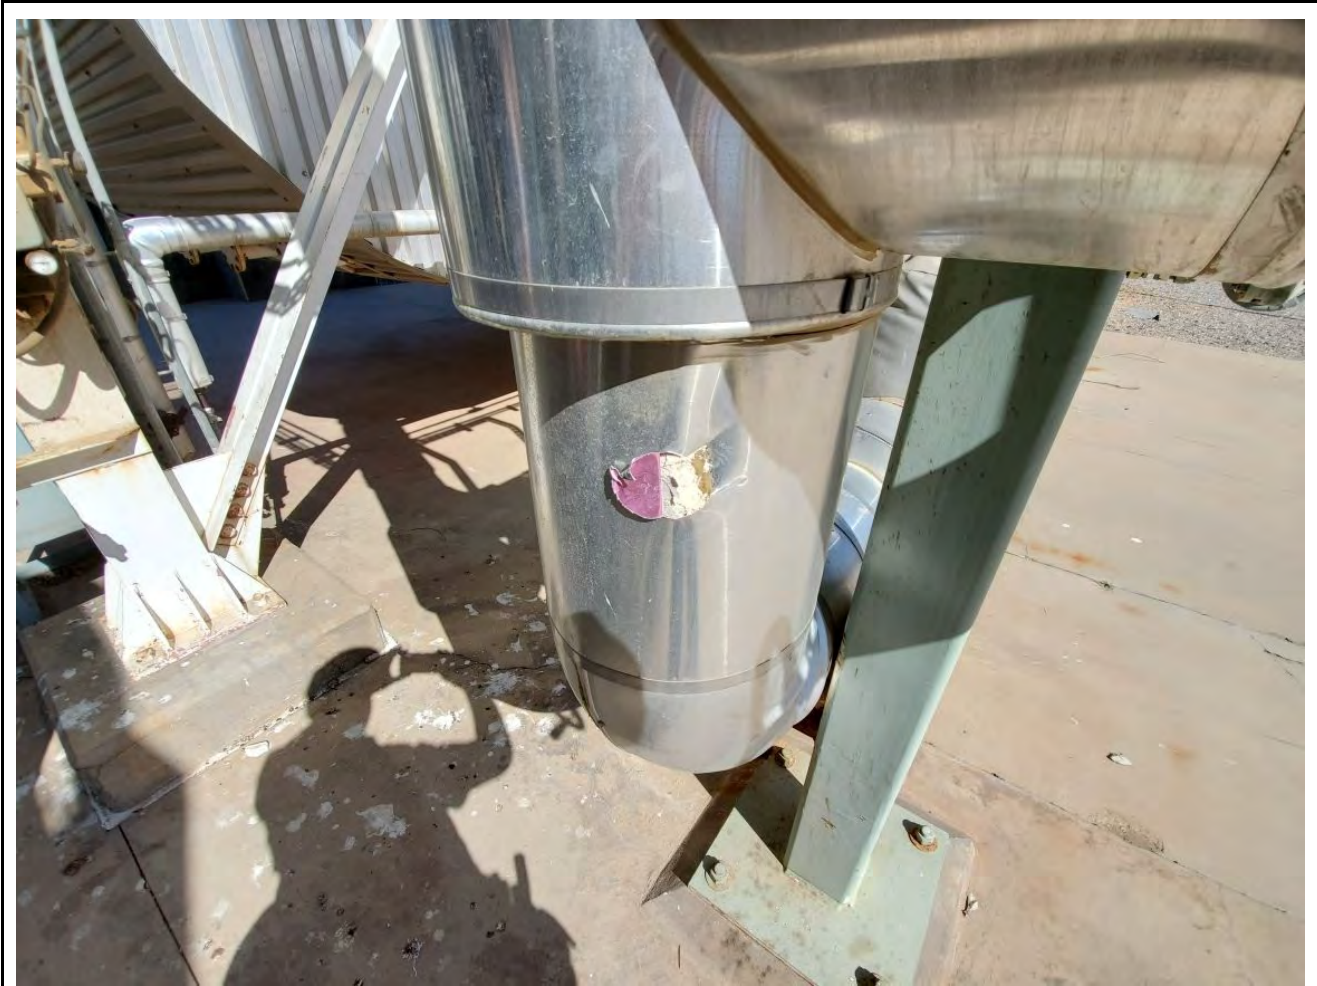
Photo 25: Typical fiberglass boiler insulation

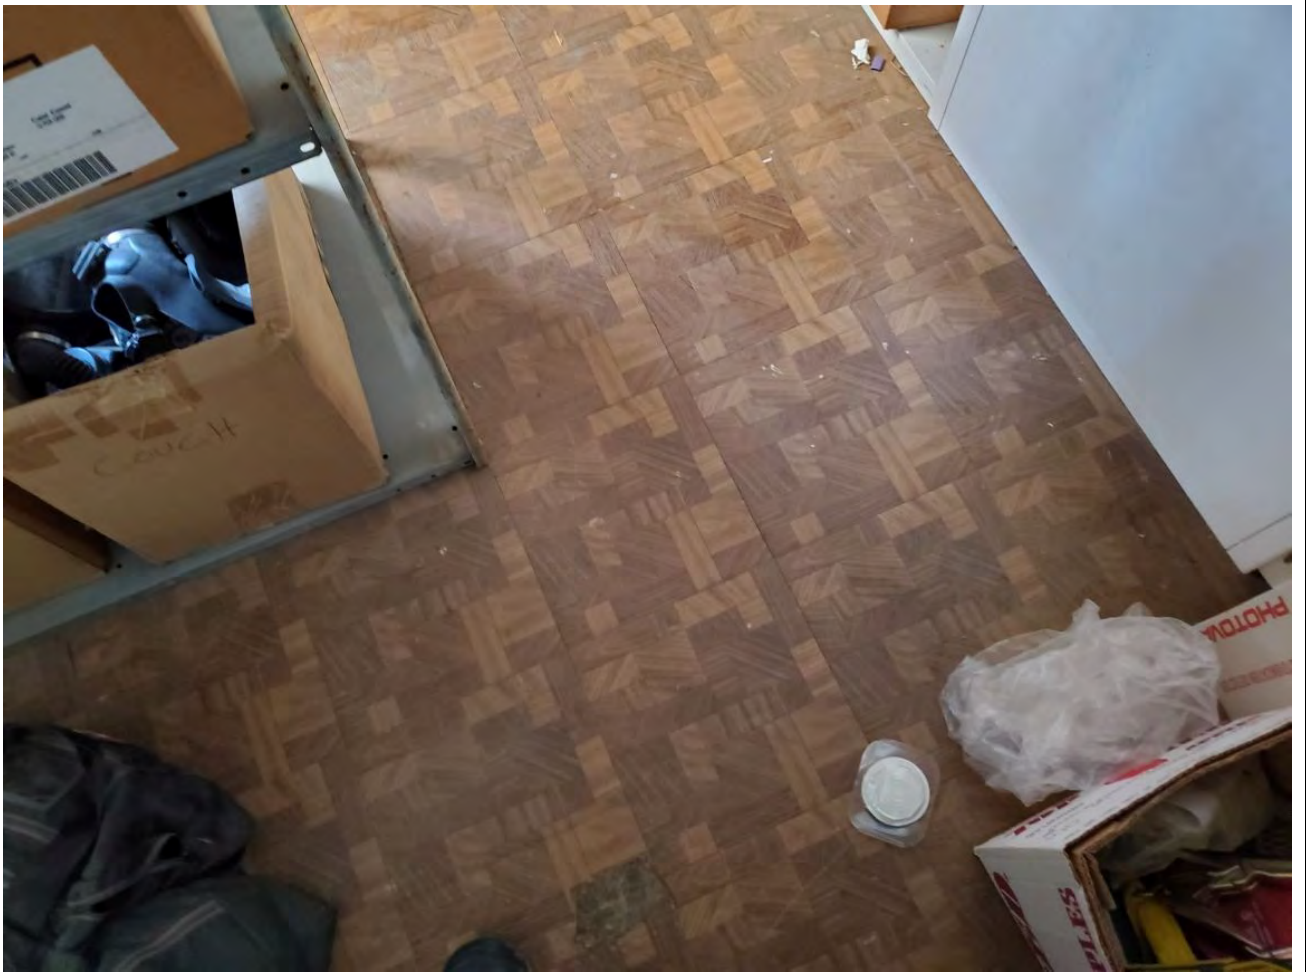
Photo 41:12 x 12 vinyl floor tile in the fire house

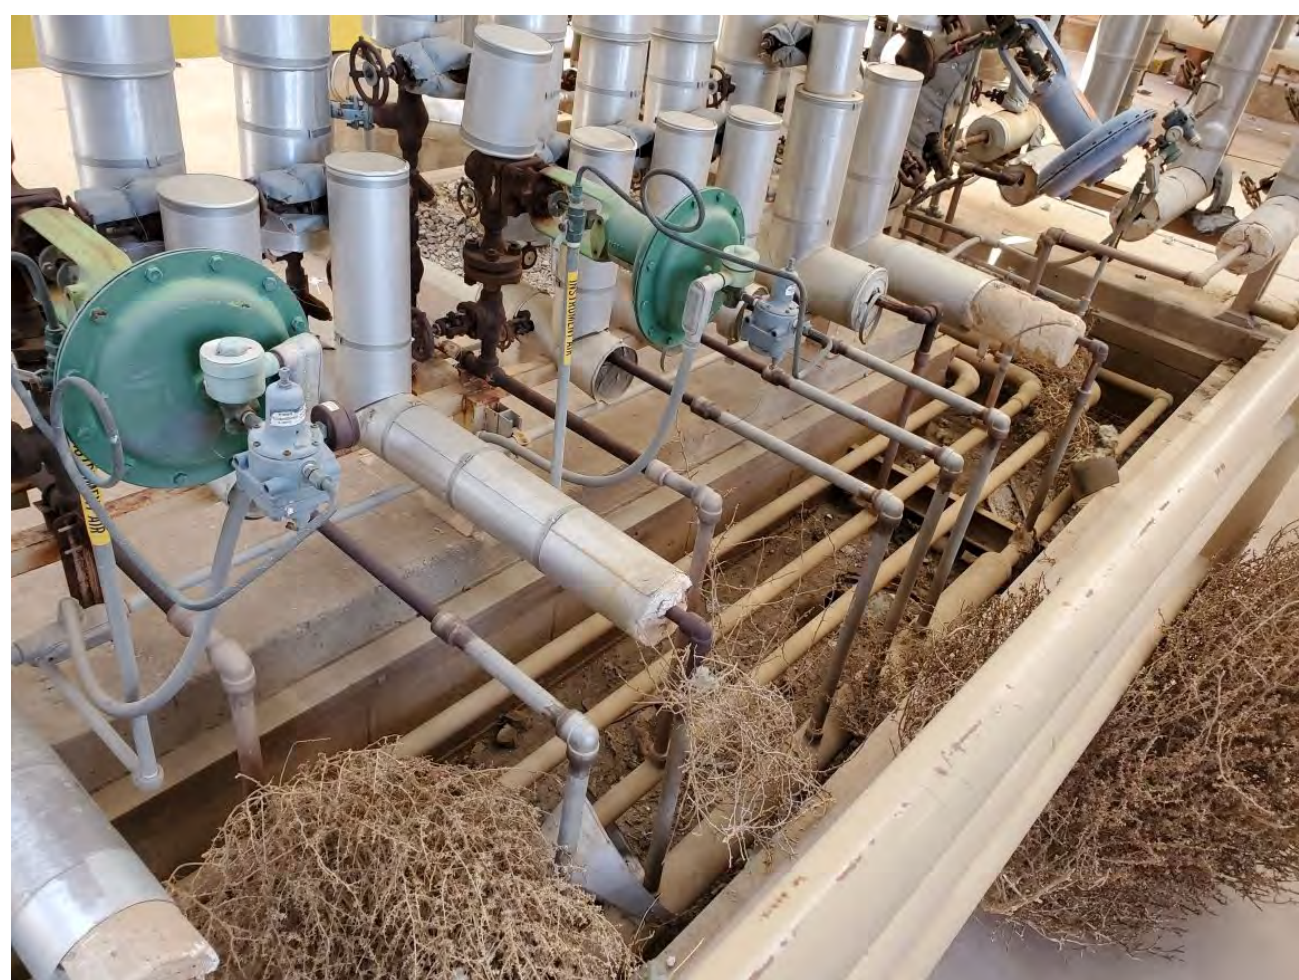
Photo 56: Fiberglass pipe insulation at the SEGS VII generator sir cooler

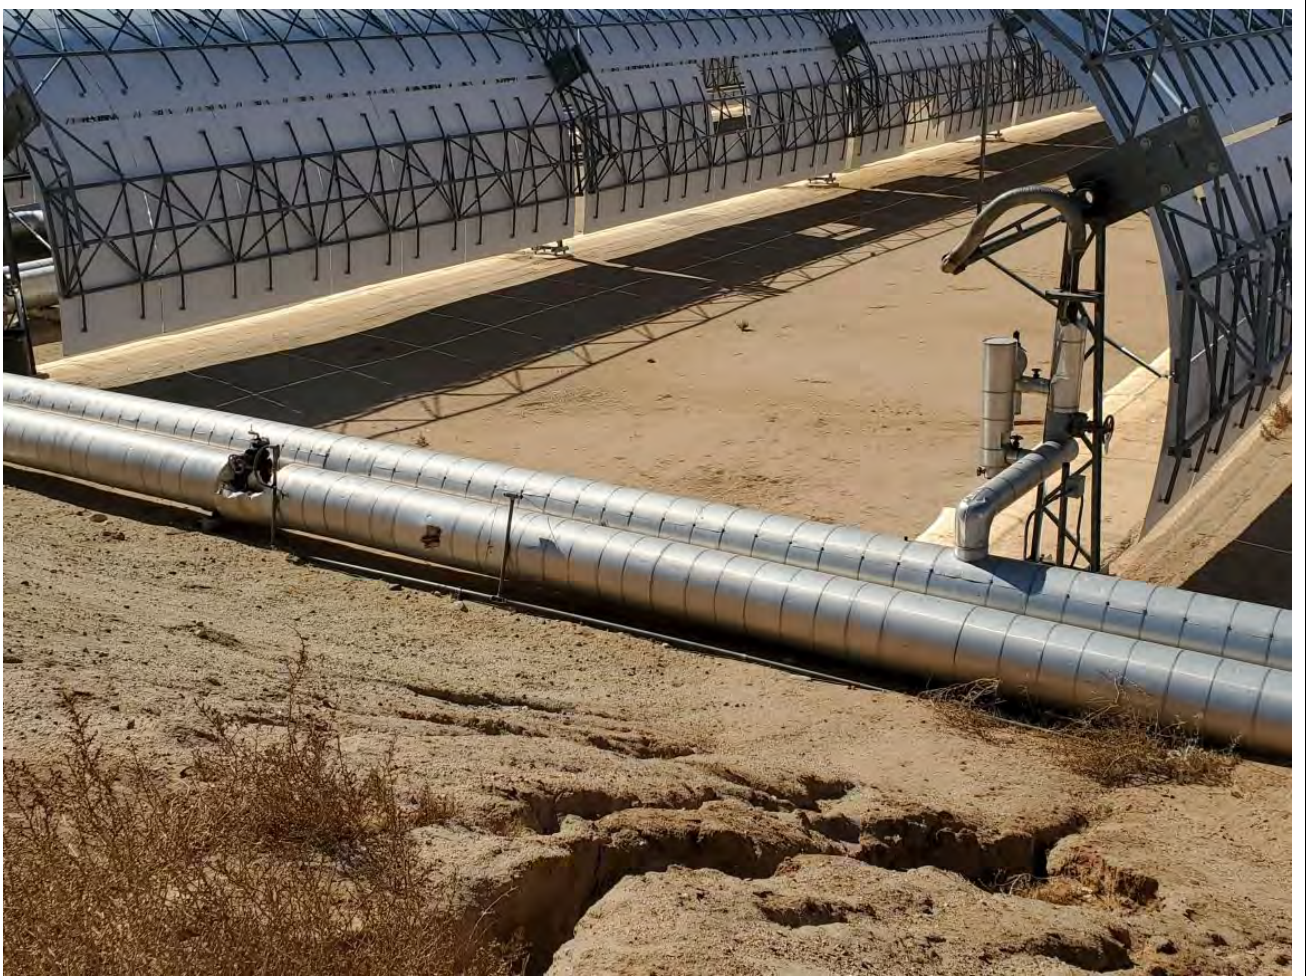
Photo 57: Exposed pre-formed block pipe insulation in the SEGS VII area

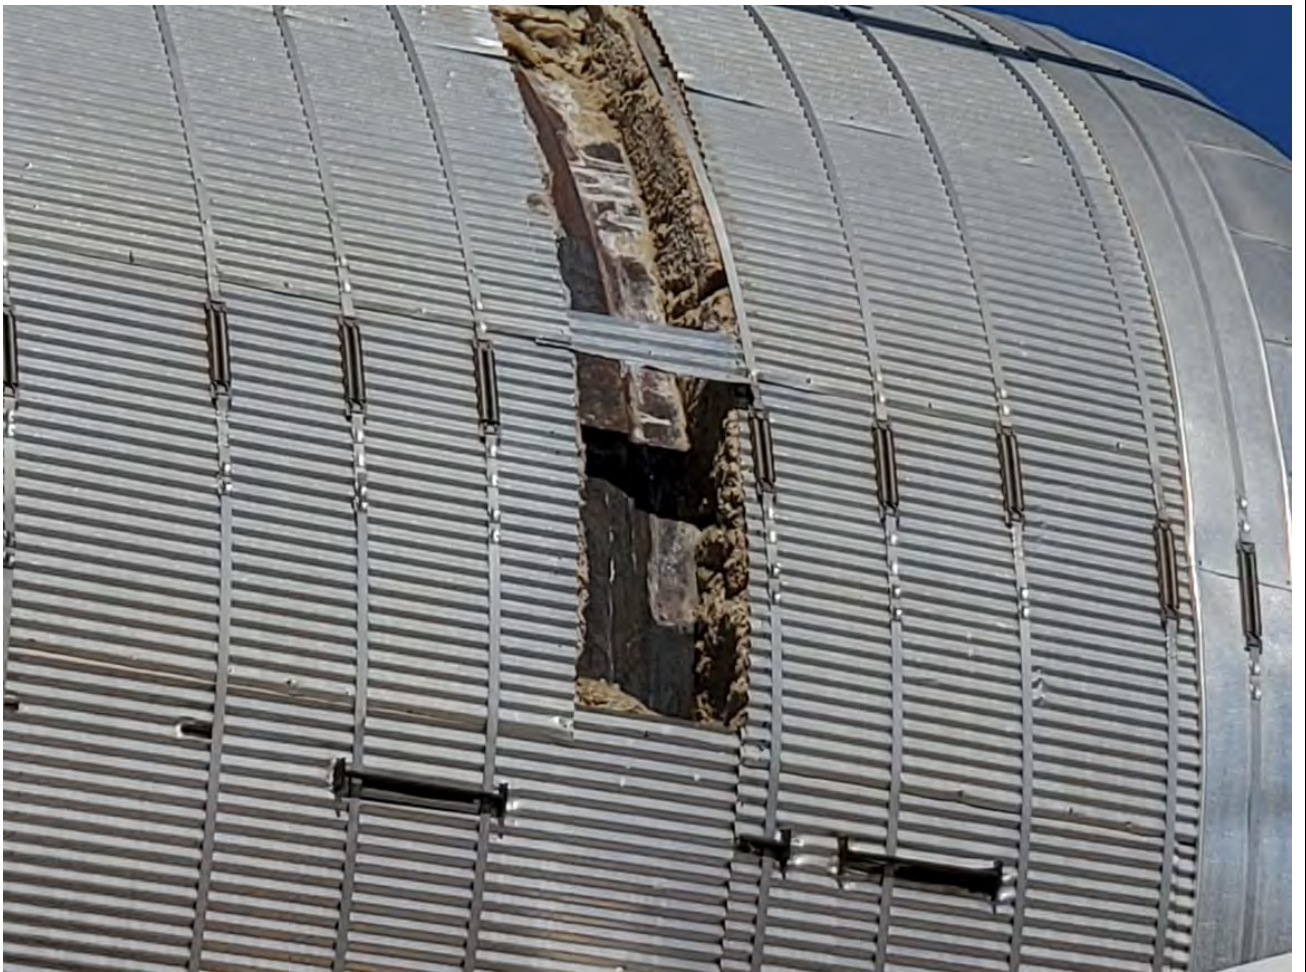
Photo 58: Fiberglass-insulated HTF piping

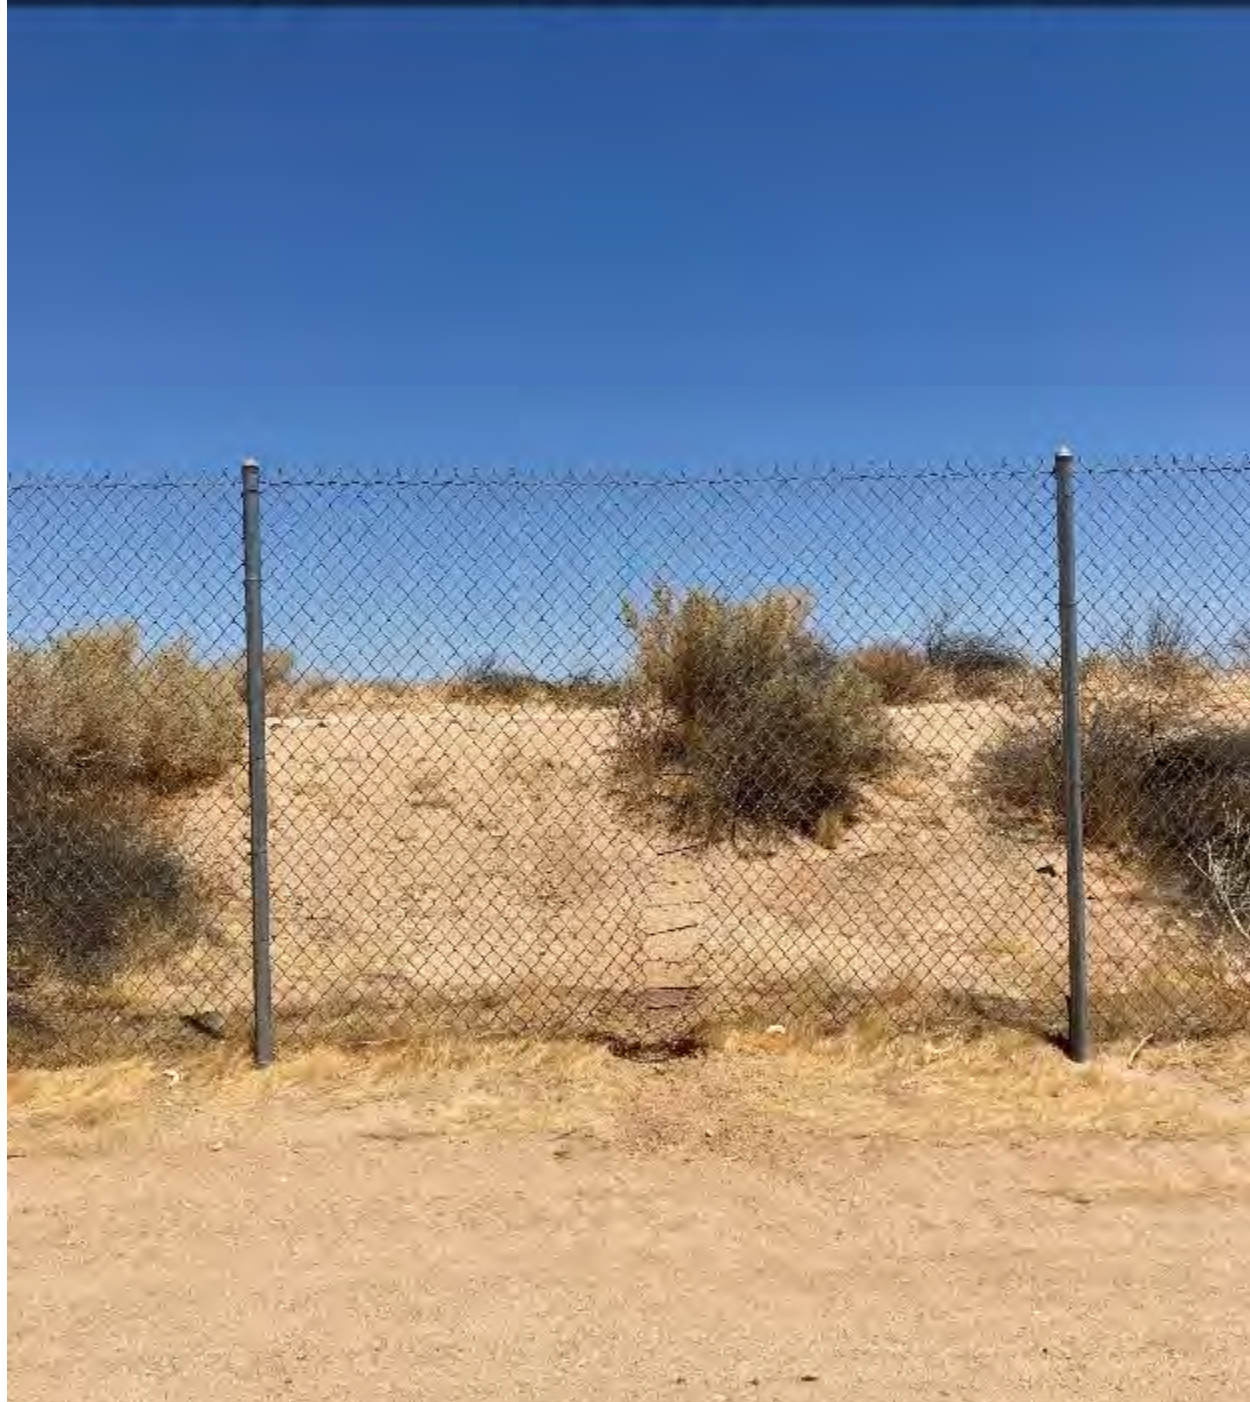
SEGSV: Small  
patched hole in  
fence

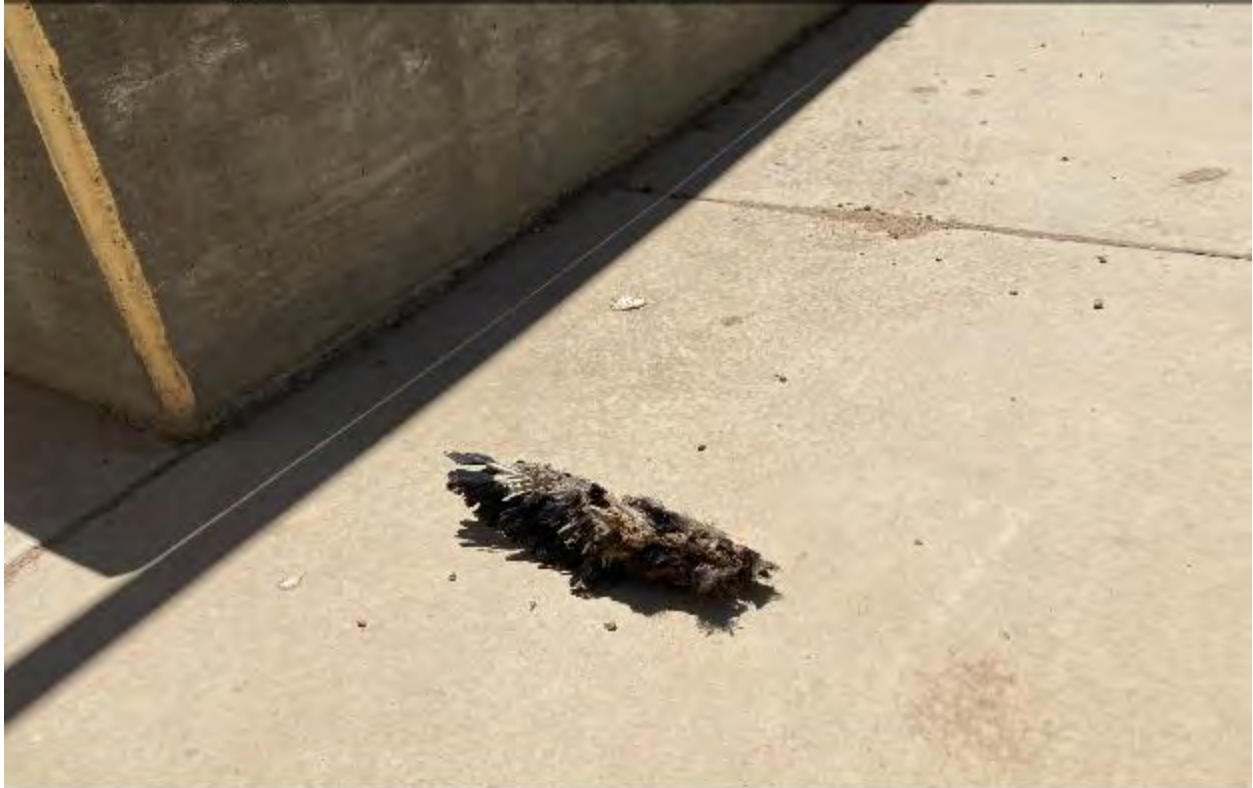
SEGSIV: Bird carcass  
observed

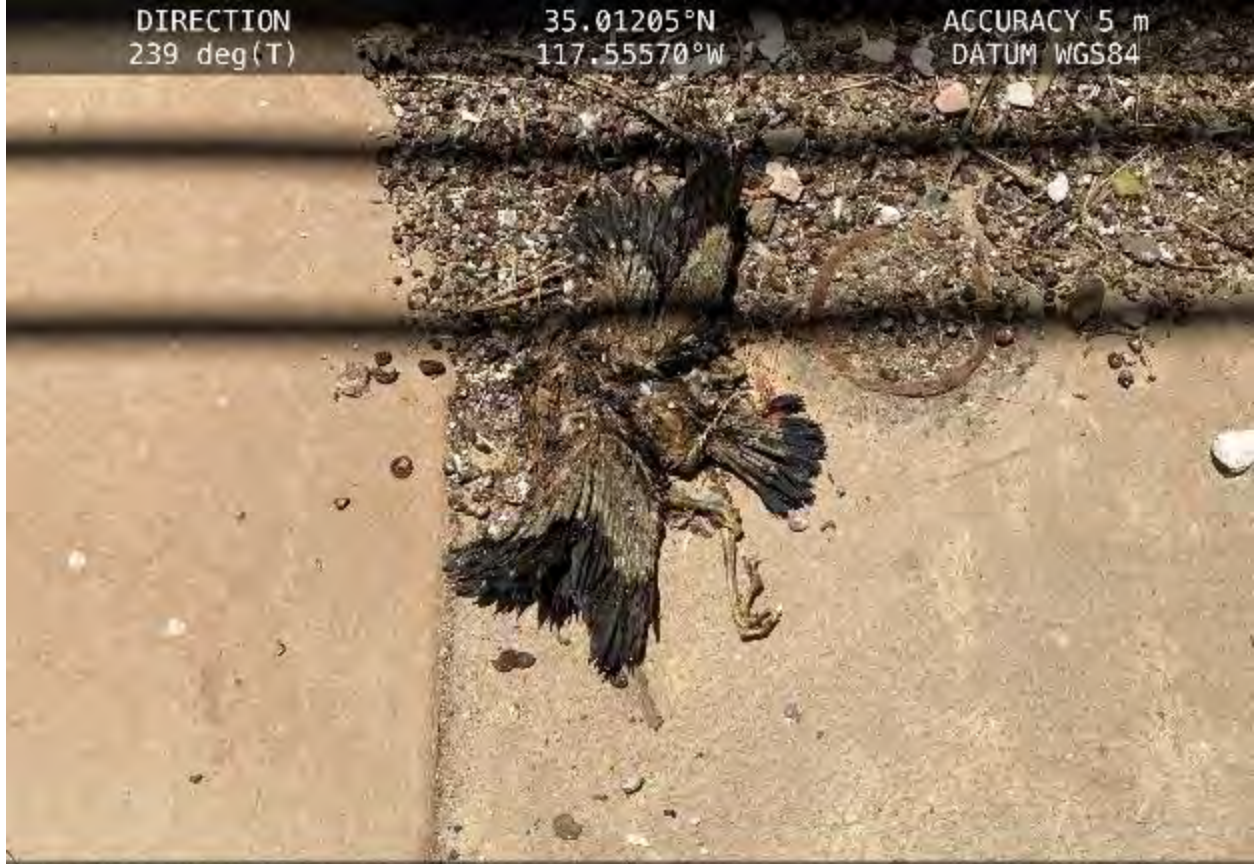
SEGSIV: Bird carcass  
observed

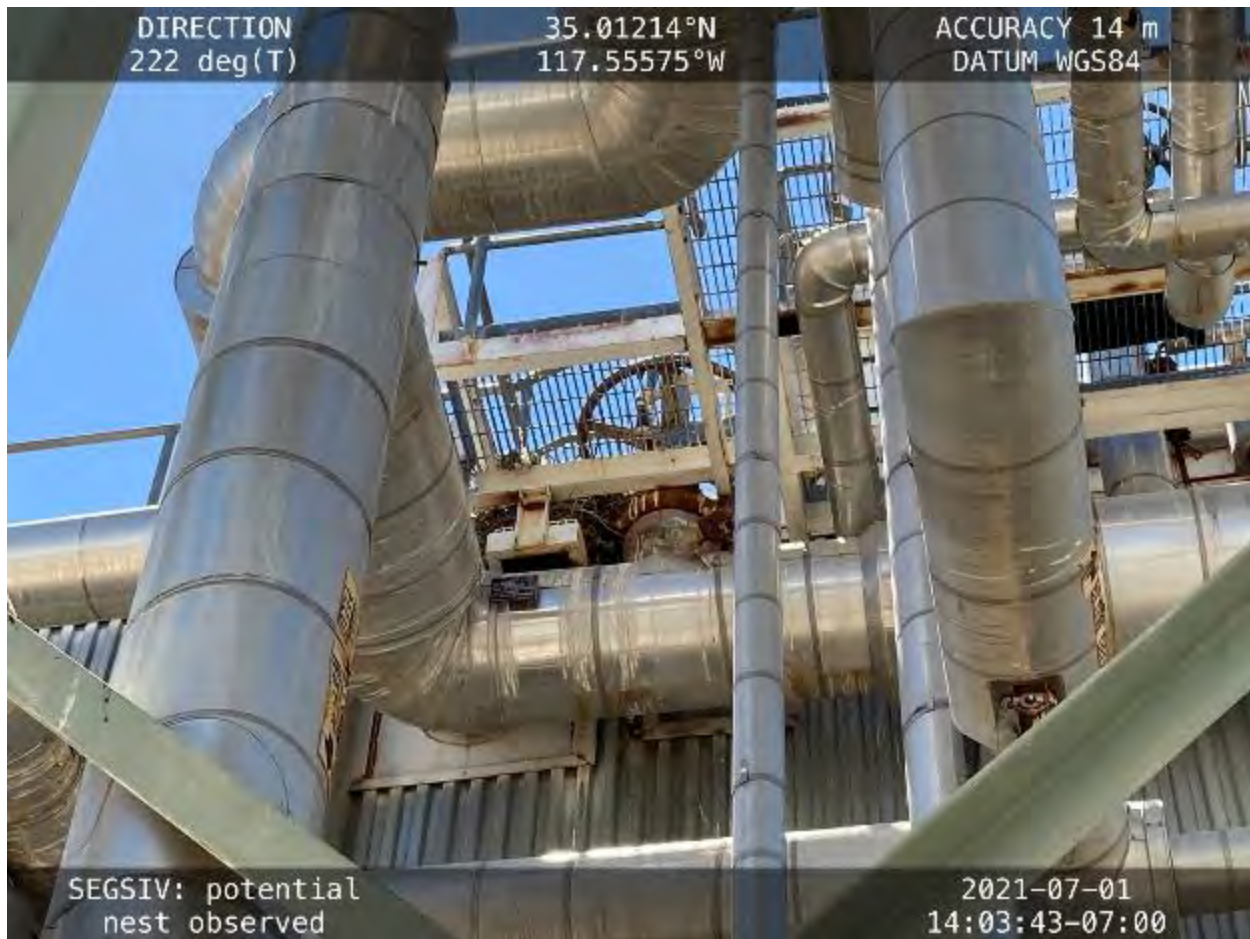
SEGSIV: potential  
nest observed

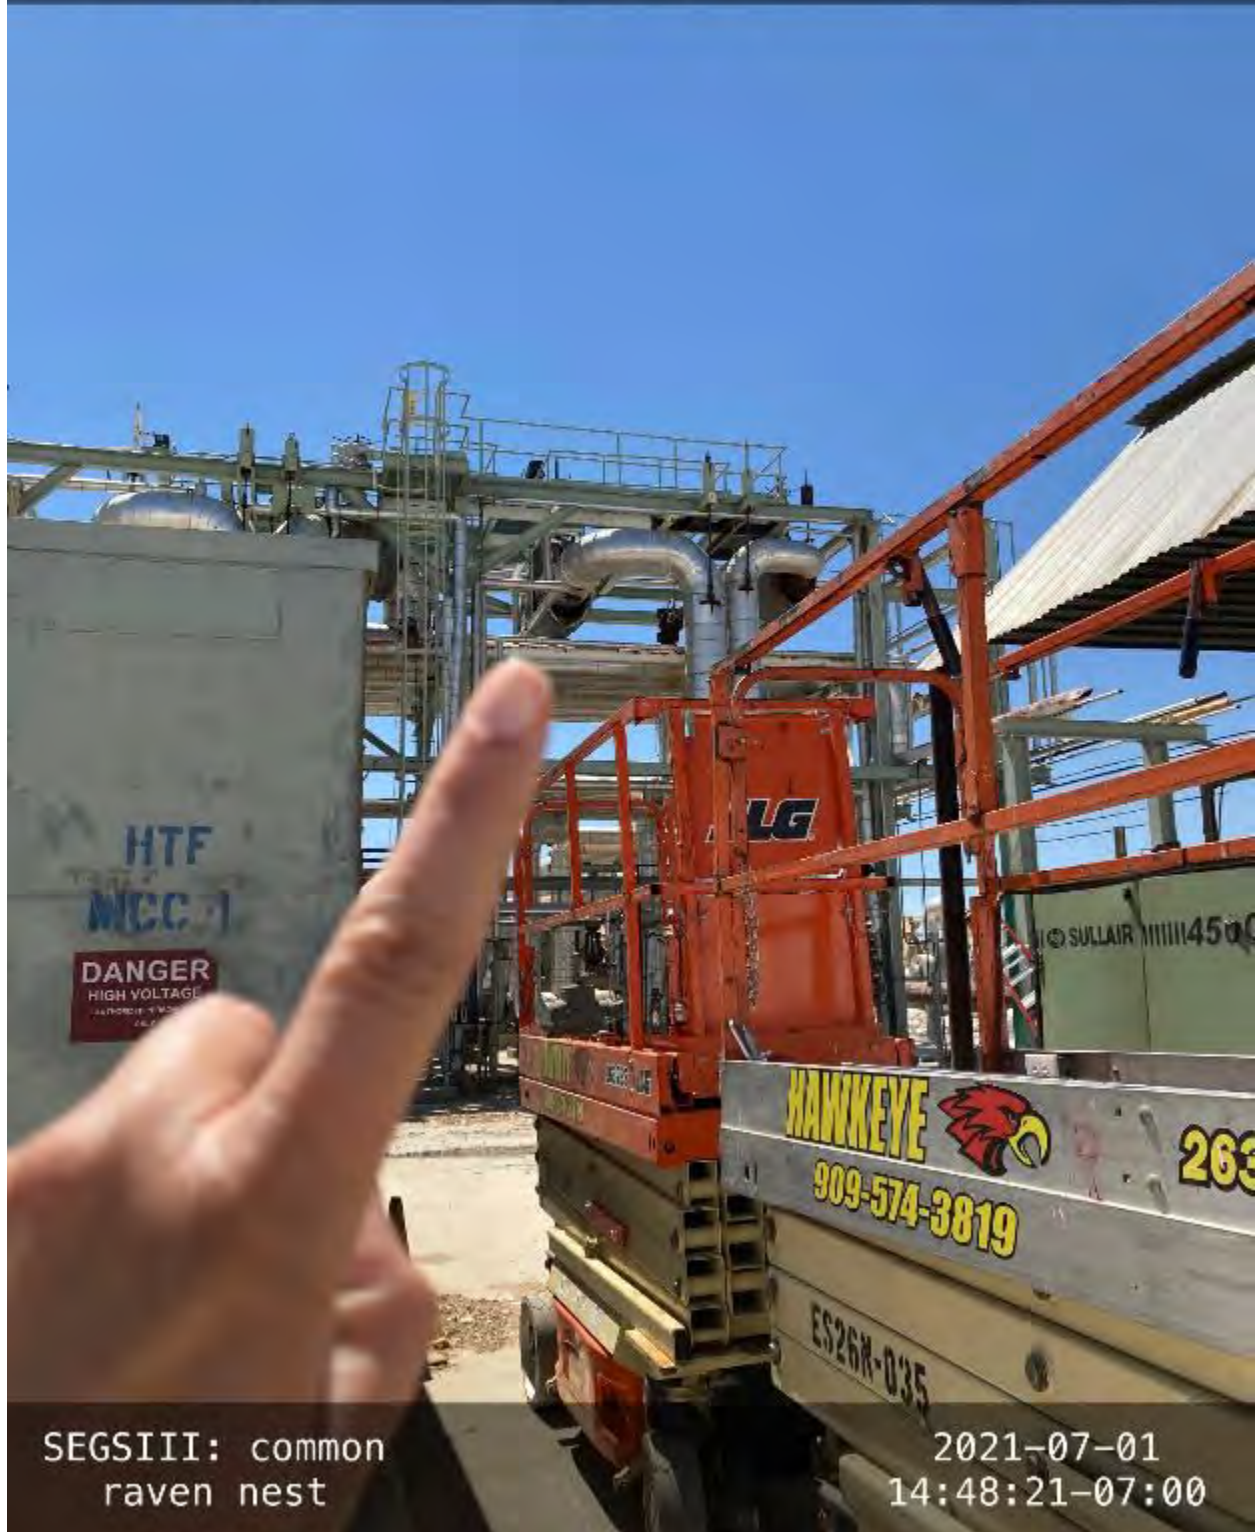
SEGSIII: common  
raven nest

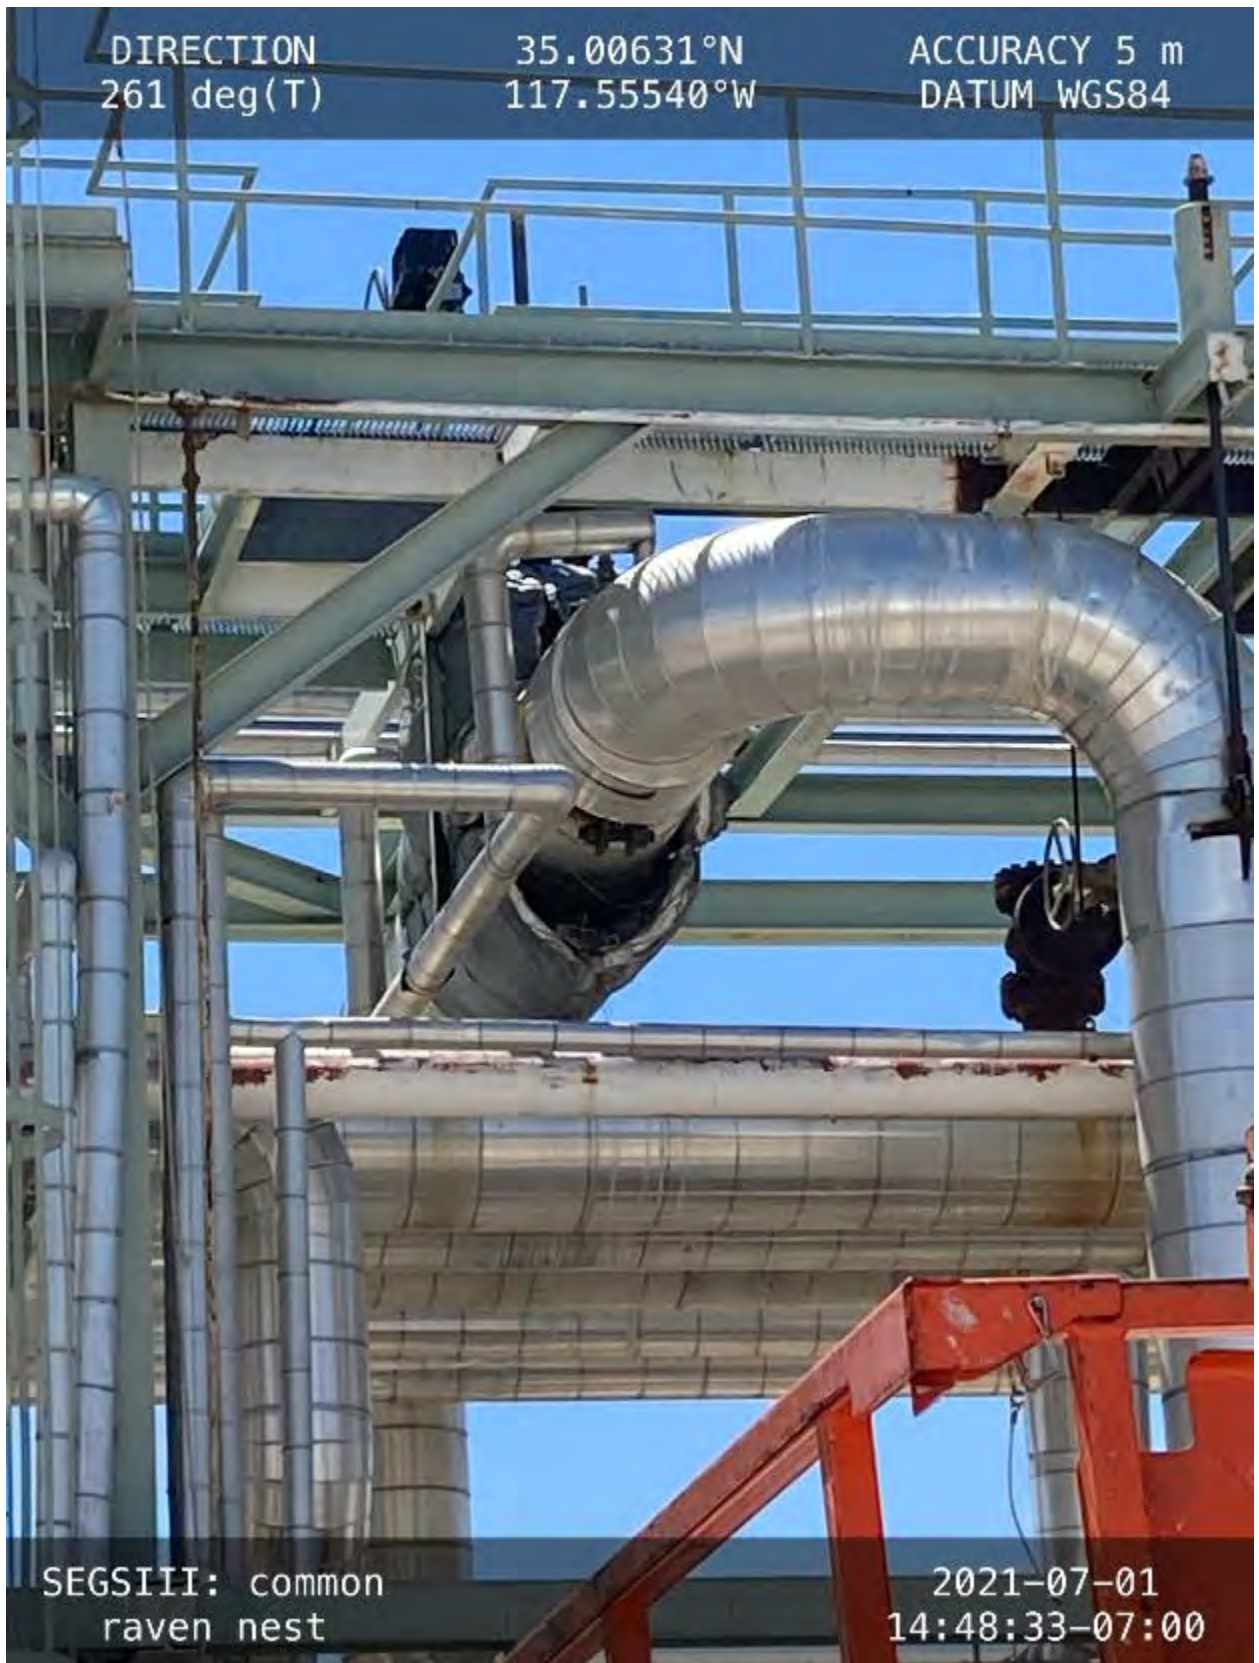
SEGSIII: common  
raven nest

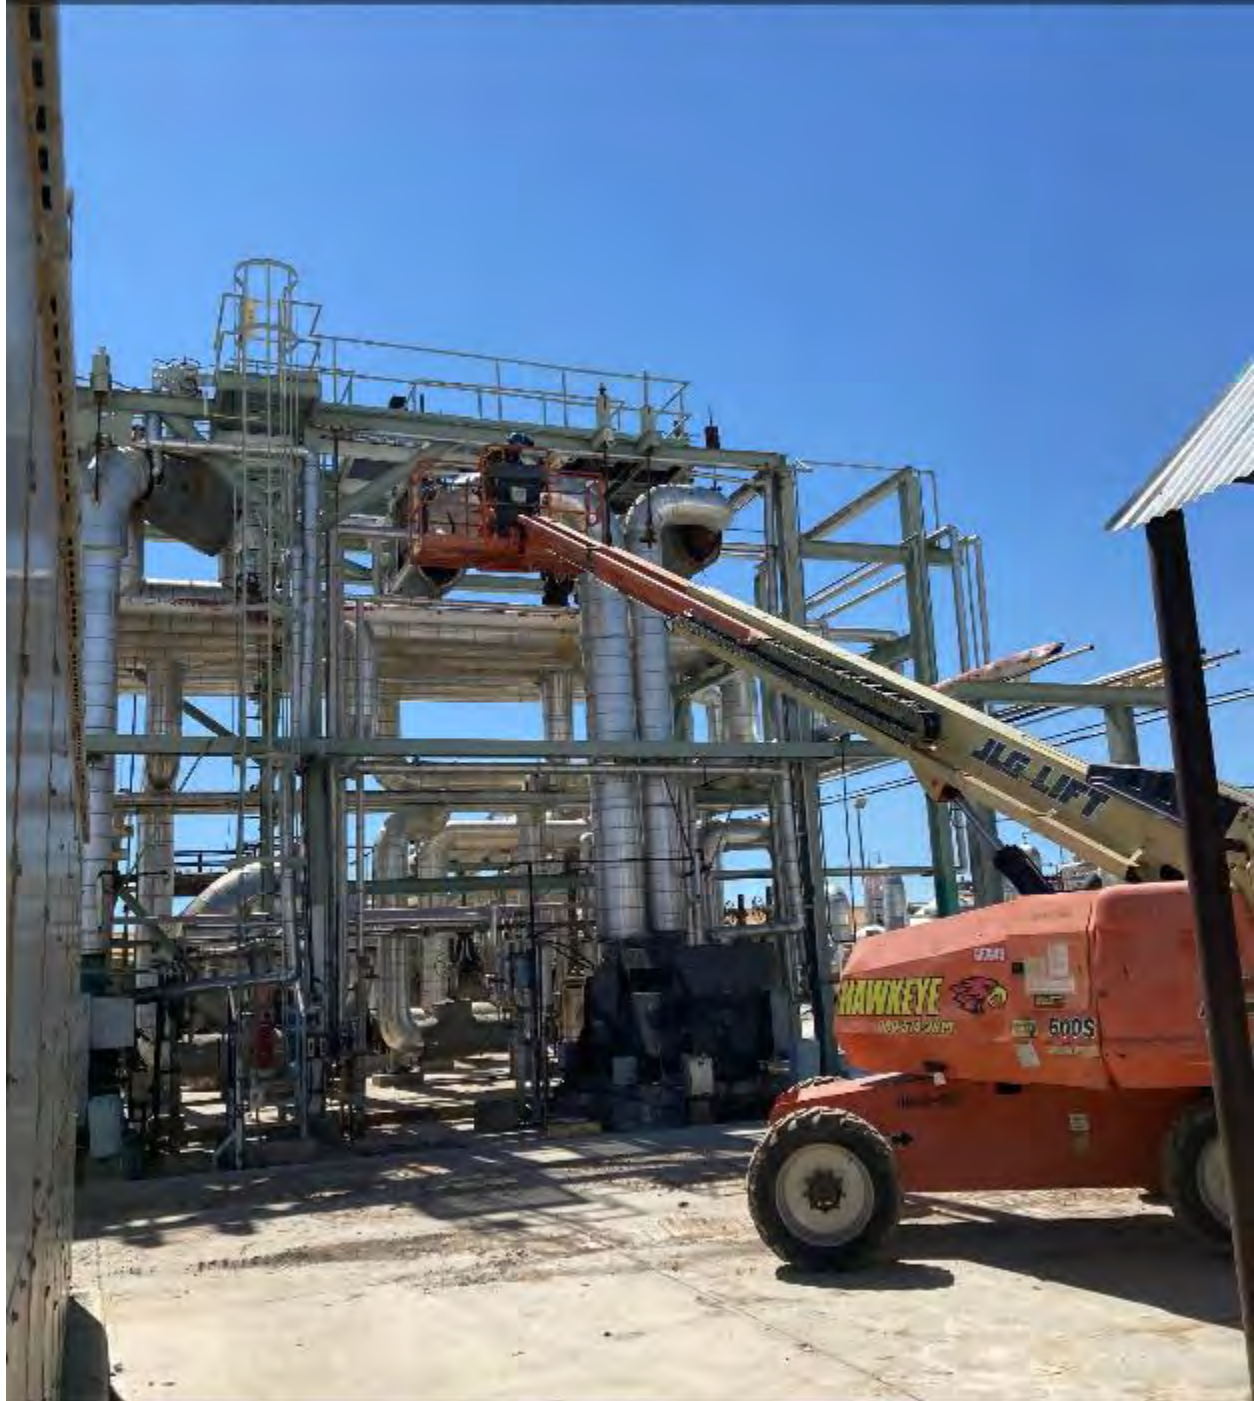
SEGSIII: common  
raven nest

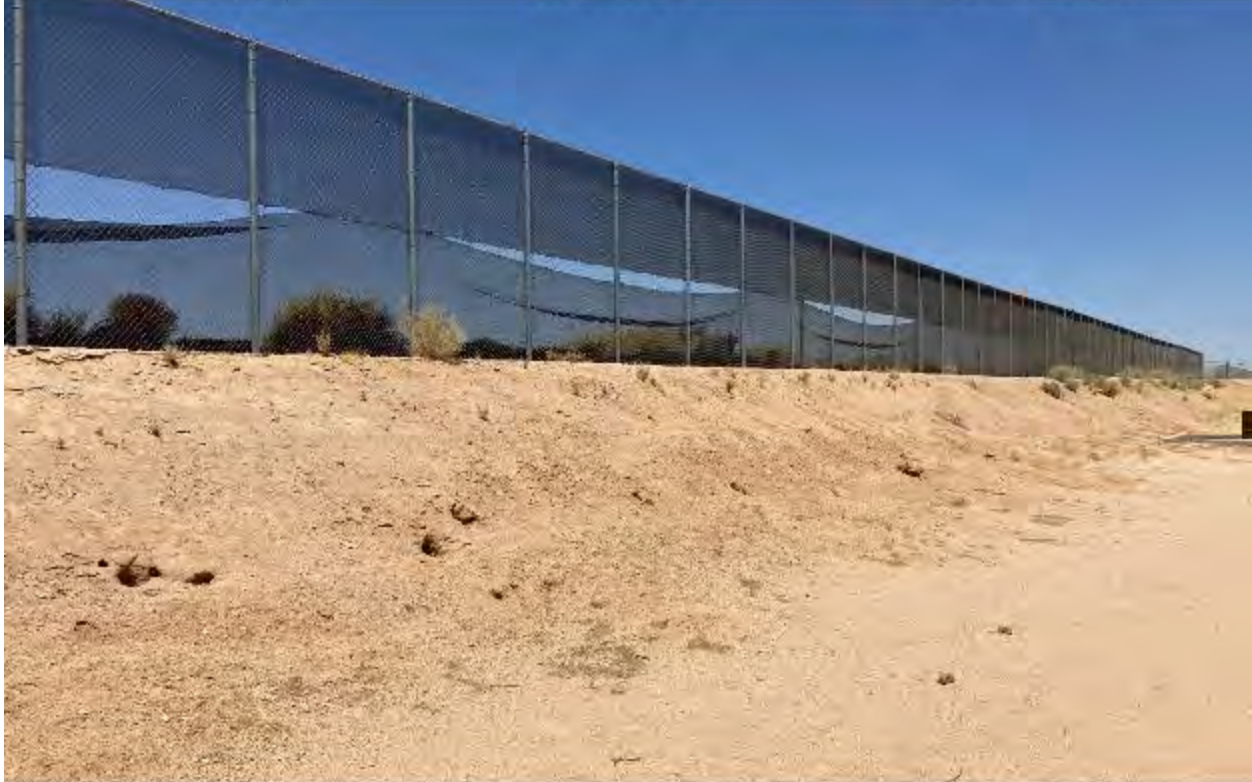
SEGSIV: potential  
burrows observed

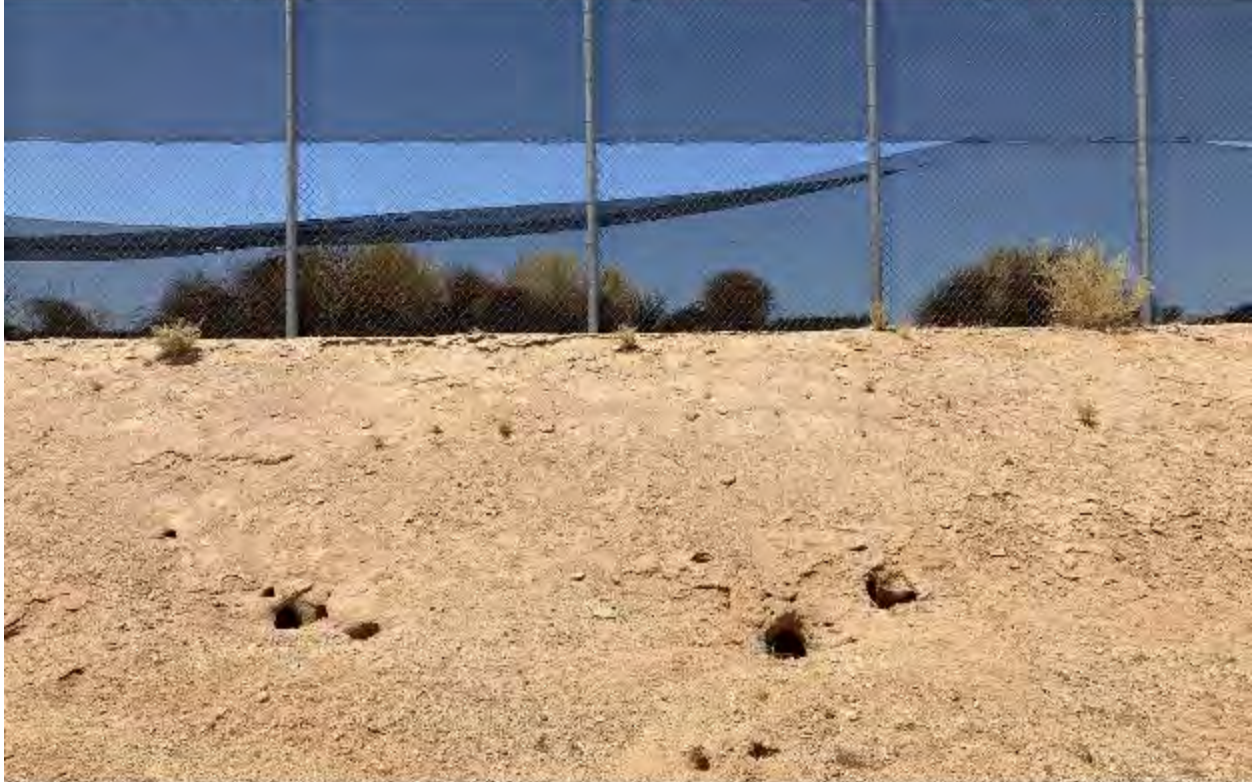
SEGSIV: potential  
burrows observed

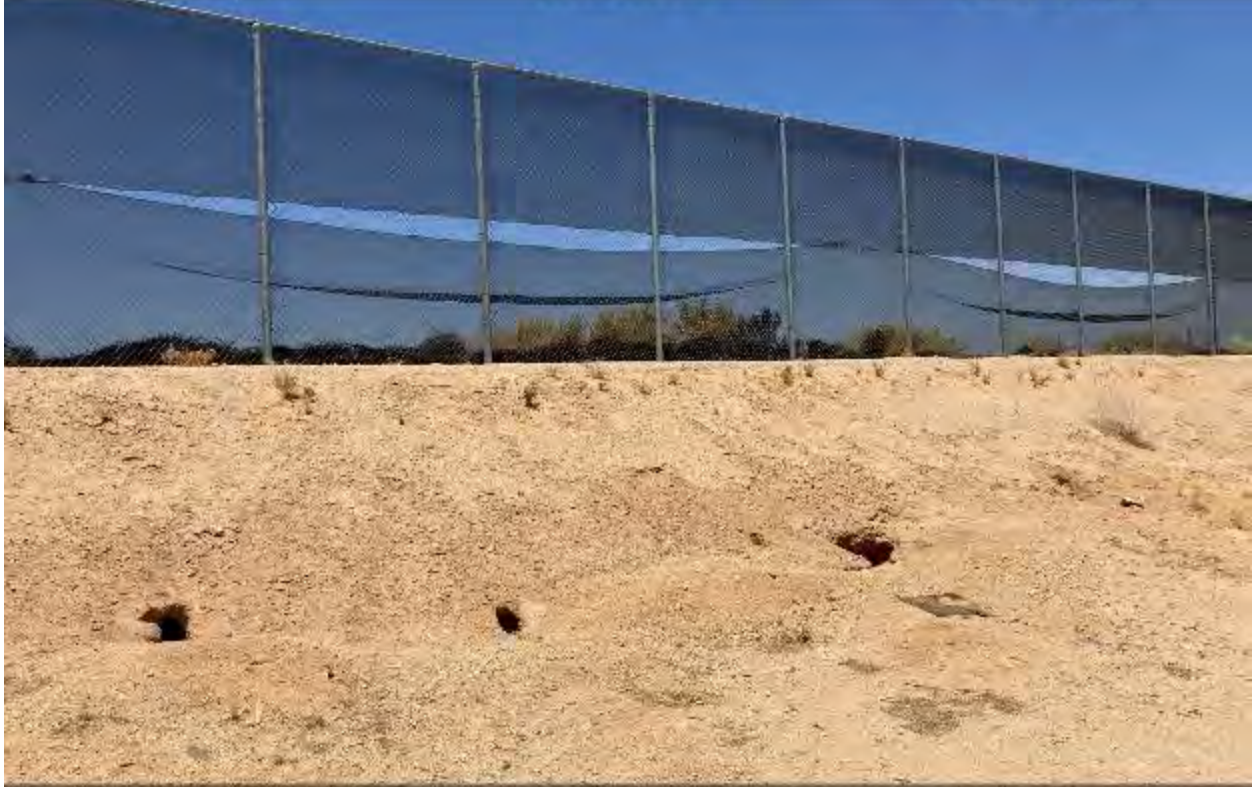
SEGSIV: potential  
burrows observed
