<b>DOCKETED</b>	
<b>Docket Number:</b>	87-AFC-01C
<b>Project Title:</b>	COMPLIANCE-Luz Solar Electric Generating System Cogeneration AFC (150 MW) Units III-VII.
<b>TN #:</b>	241138
<b>Document Title:</b>	Petition to Amend Boundary Change Appendix B Part I - SEGS III-VII
<b>Description:</b>	N/A
<b>Filer:</b>	Scott Galati
<b>Organization:</b>	DayZenLLC
<b>Submitter Role:</b>	Applicant Representative
<b>Submission Date:</b>	1/11/2022 2:18:22 AM
<b>Docketed Date:</b>	1/11/2022

## **APPENDIX B**

Monthly Compliance Reports and Biological Memorandum

Subject: SEGS III-VII Decommissioning (87-AFC-01C) Monthly Compliance Report for June 2021

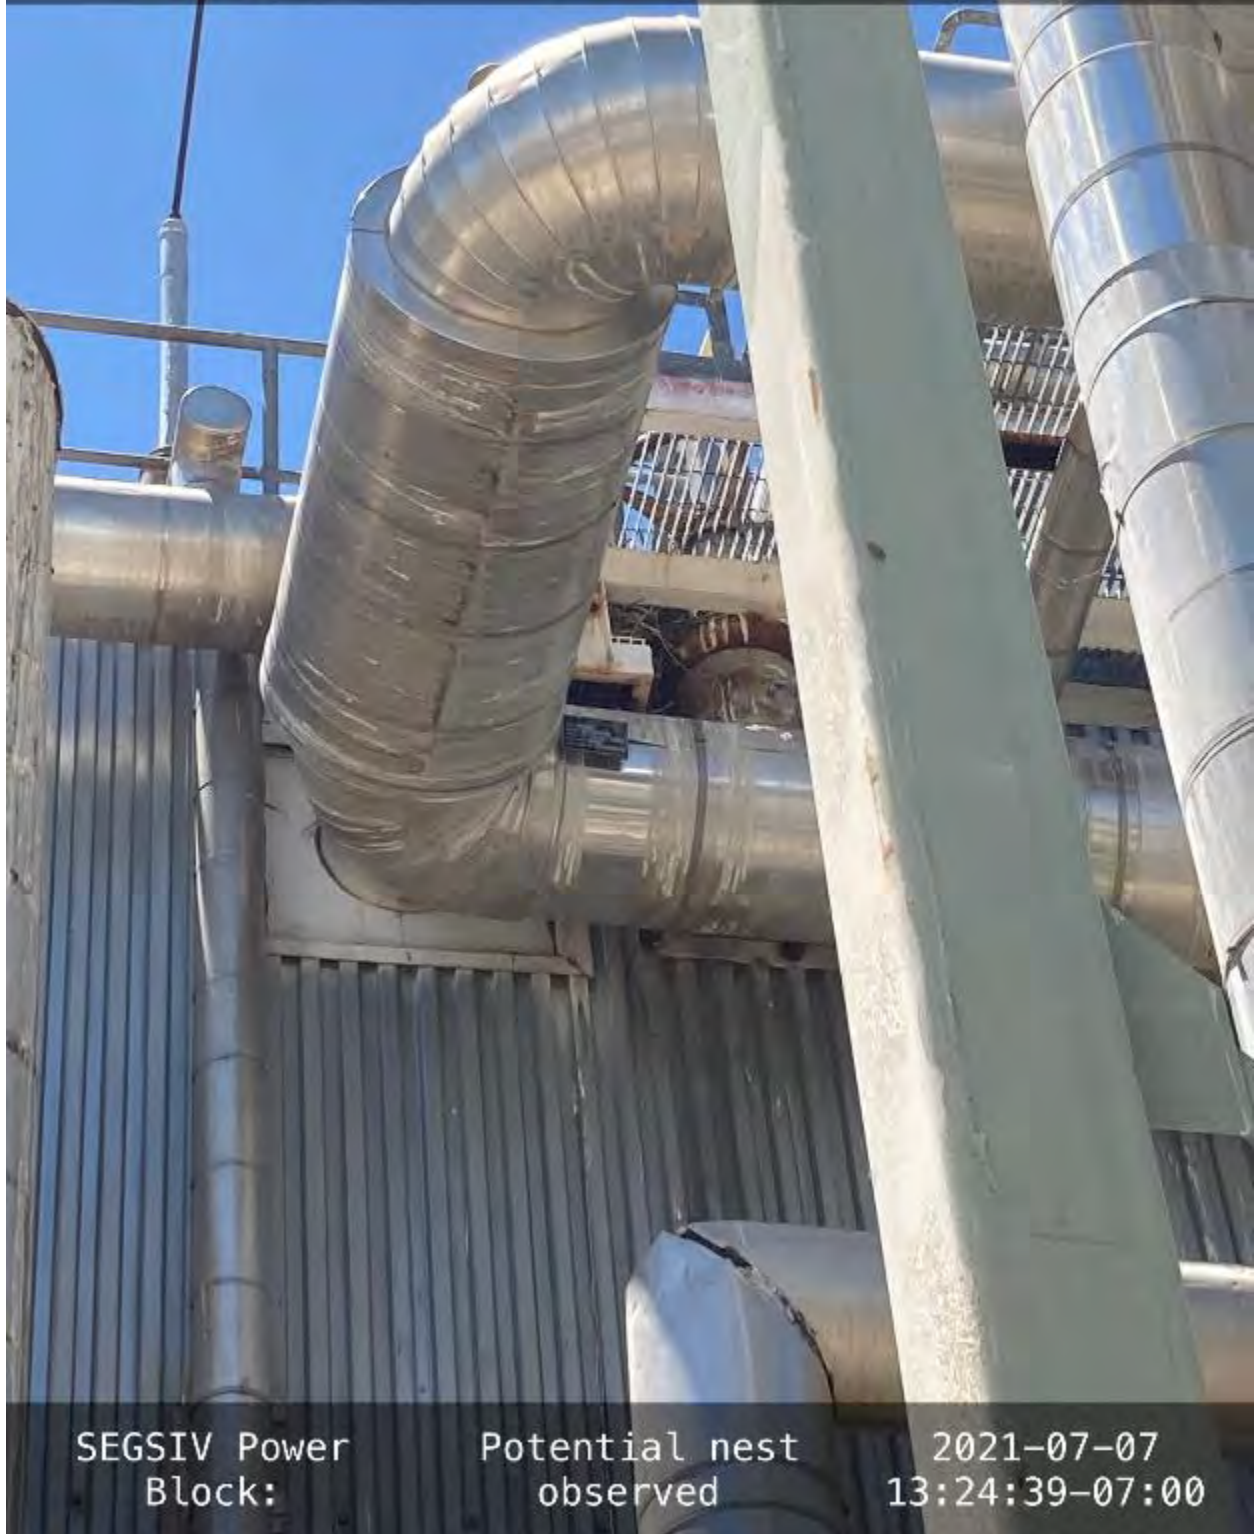
SEGSIV Power  
Block:

Potential nest  
observed
