Subject Biological Resources Assessment following May 2021 Incident

Project Name Russell City Energy Center

Date June 1, 2021

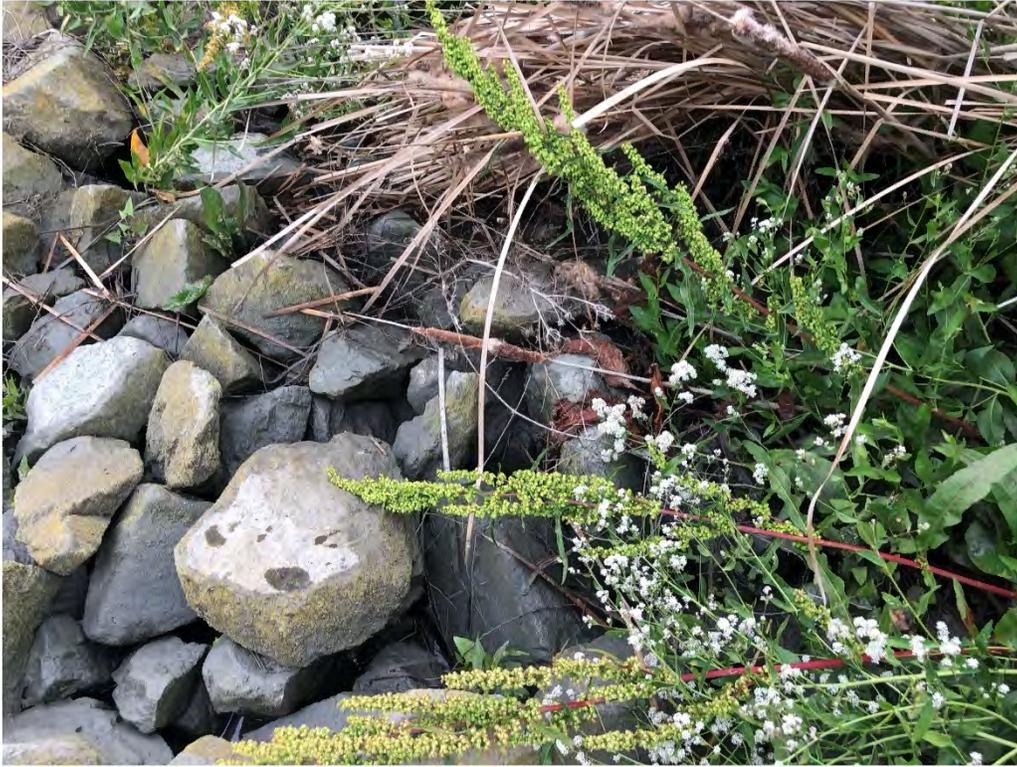
Photo 3. Close-up of vegetation and substrate at confluence of stormwater outlet channel and drainage ditch. No staining, discoloration, solids, sheen, odor or any abnormal substances were observed.

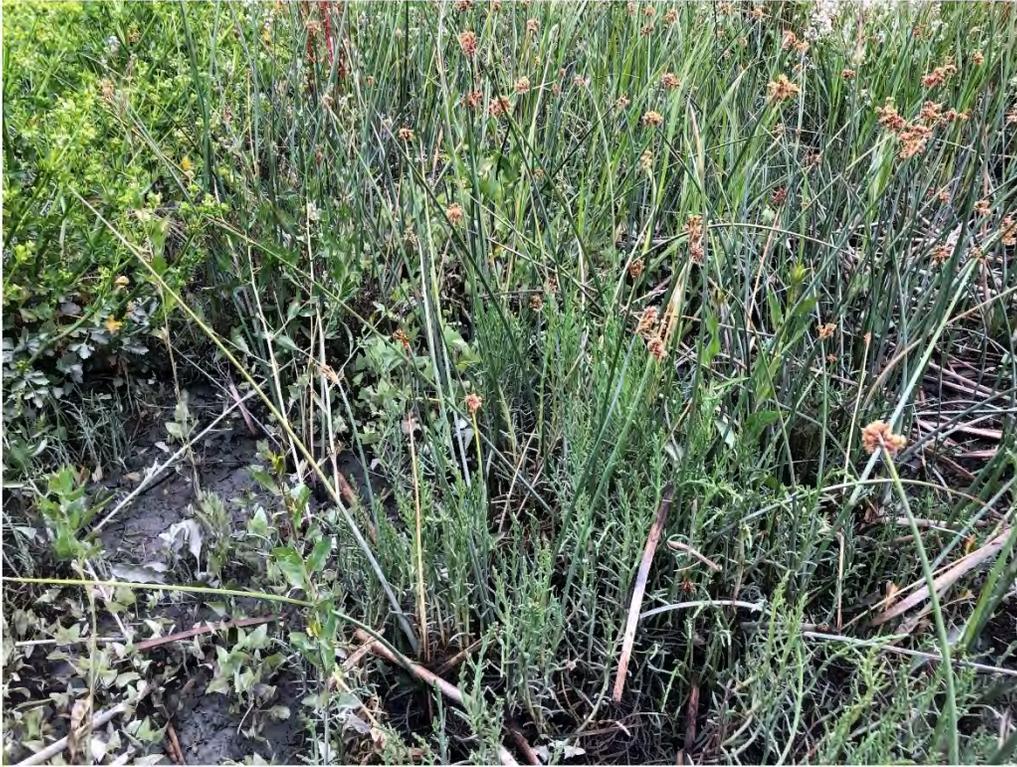
(*Salicornia pacifica*) present (Photo 7). I did not observe staining, discoloration, solids, sheen, odor, or any abnormal substances on the wetland vegetation or in the channel. This completed my assessment of the off-site areas.

Photo 7. Close-up of vegetation on tidal channel banks. No staining, discoloration, solids, sheen, odor or any abnormal substances were observed.

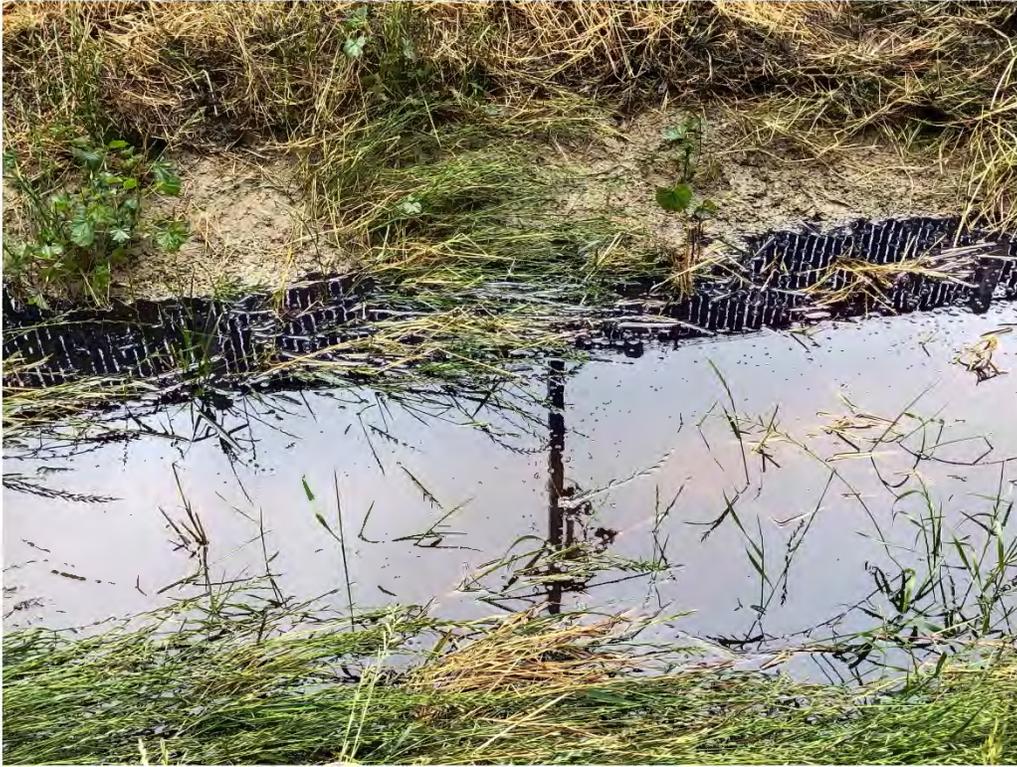
Photo 11. Close-up view of stormwater collection channel.
