**CALIFORNIA
ENERGY COMMISSION**

STAFF REPORT

Russell City Energy Center May 2021 Incident: Root Cause Gap Analysis

April 2022 | CEC-700-2022-XXX

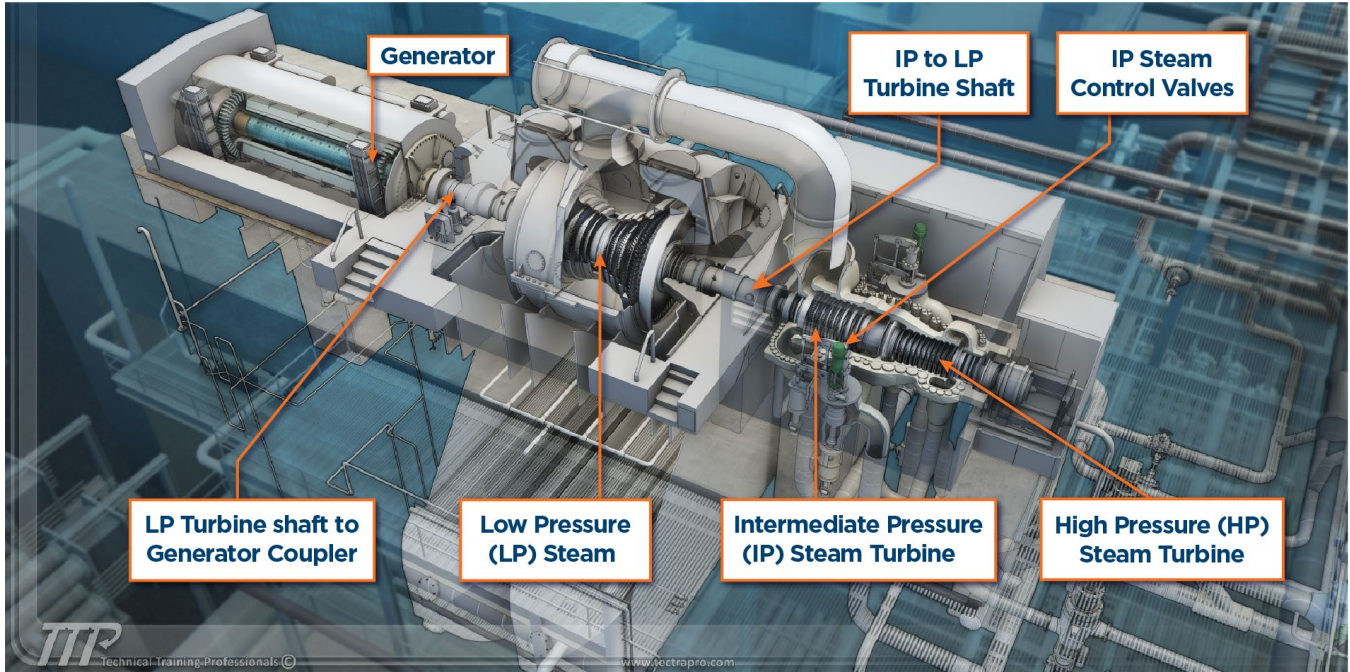
Figure 2.1: Steam Turbine Generator

During the initial onsite inspection, the CEC staff observed that the STG shaft was fractured at the exit point of the intermediate pressure (IP) section to the low-pressure section, and the shaft was ejected from the STG. The CEC staff examined the turbine shaft that entered the low-pressure (LP) section and found that the shaft was twisted. The metal casing of the LP section had separated, breaking bolts in the process.

The black charring and soot in the area around the casing were clear evidence that there was a fire at the exit of the LP section to the steam turbine's generator. The LP section casing was severely damaged from the overspeed event. The drive shaft connecting the LP section to the generator was fractured at each end and had been thrown from the enclosure.

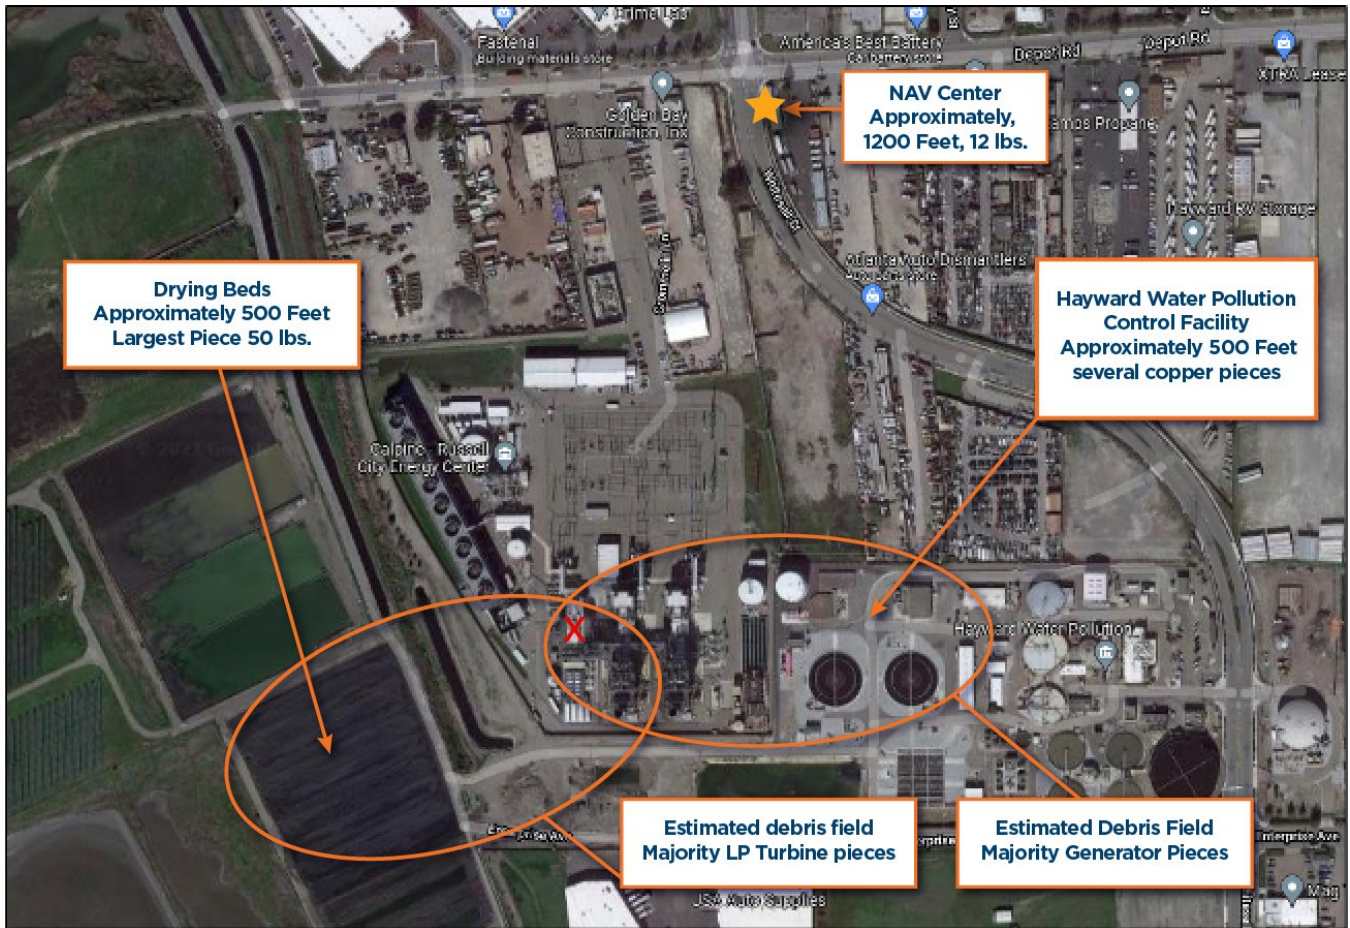
Figure 2.2: Debris Field

Steam turbine generator debris field

The CEC staff then inspected the Hayward Navigation Center complex and met with the Housing Care Coordinator for Bay Area Community Services, the organization that operates the Hayward Navigation Center. Using data from the inspections at the HPWCF facility and the Hayward Navigation Center complex, the CEC staff created a map of the metal pieces found (Figure 2.2). Most of the metal pieces were found to the west of RCEC. These steel metal pieces ranged up to 50 lbs. Most of the small copper pieces of metal were found toward the east side of the power plant. The locations of the metal pieces released during the overspeed event are consistent with having been thrown from a rotating shaft.

The outlier of the debris field is the 12-pound piece of the LP turbine blade root. The blade root was discovered in the Hayward Navigation Center complex (Figure 2.2). The Hayward Navigation Center complex has multiple trailers on site serving people experiencing homelessness. The trailer used for meal preparation and eating was damaged when the 12-

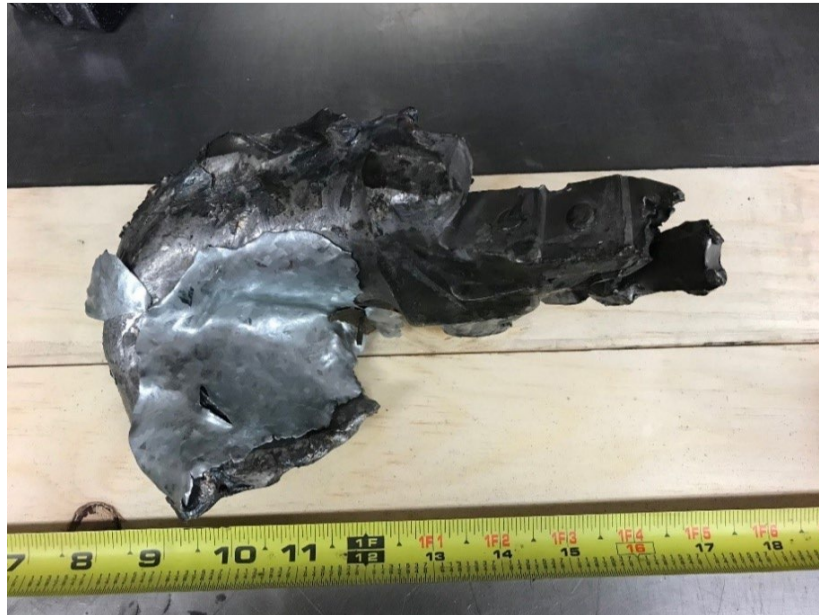
Figure 2.3: RCEC Metal Piece

pound metal piece traveled 1,200 feet, penetrated through the trailer's roof, and landed on the floor (Figure 2.3). No individuals were in the trailer at the time since it was after operating hours. There was no damage to the floor of the trailer.

The metal piece traveled approximately 1,200 feet and weighed 12 lbs.
Credit: Hayward Navigation Center Staff

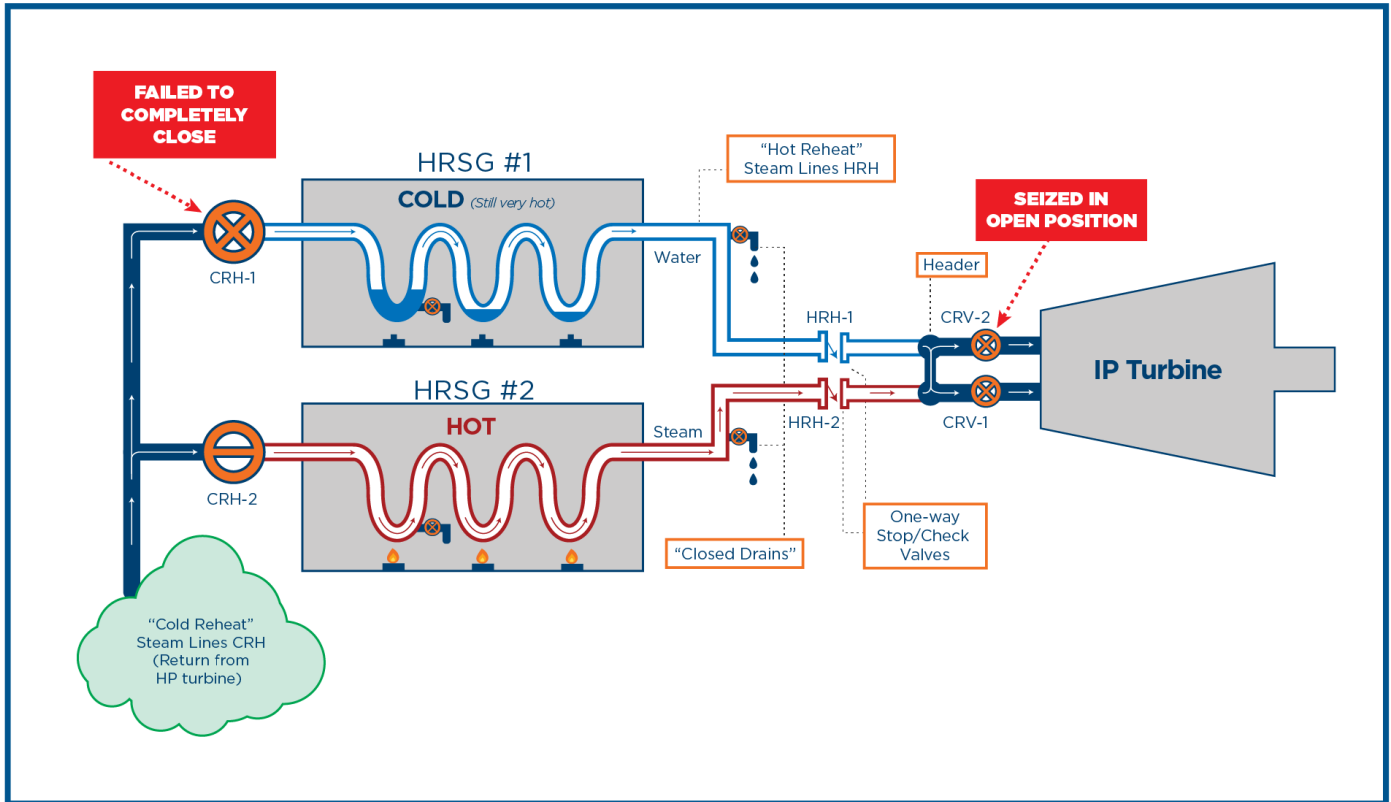
Figure 3.1: Russell City HRSG Reheater Schematic

Over the two days operating in that 1x1 configuration, the steam produced in HRSG-2 continued to leak past the CRH-1 valve into the offline and much cooler HRSG-1 causing the steam to condense into water. Enough water condensed in the off-line HRSG-1 to collect a substantial quantity of water in the section of the offline HRSG1 known as the reheater (Figure 3.1). Because of the large quantity and high temperature of the condensing superheated steam, the condensed water remained near its boiling point and at an elevated pressure.

Schematic of RCEC’s HRSG reheater path to the IP section of the steam turbine
