# Investigation Report

## Calpine Russell City Steam Turbine/Generator Event

### May 27, 2021

Calpine Corporation - Russell City Energy Center

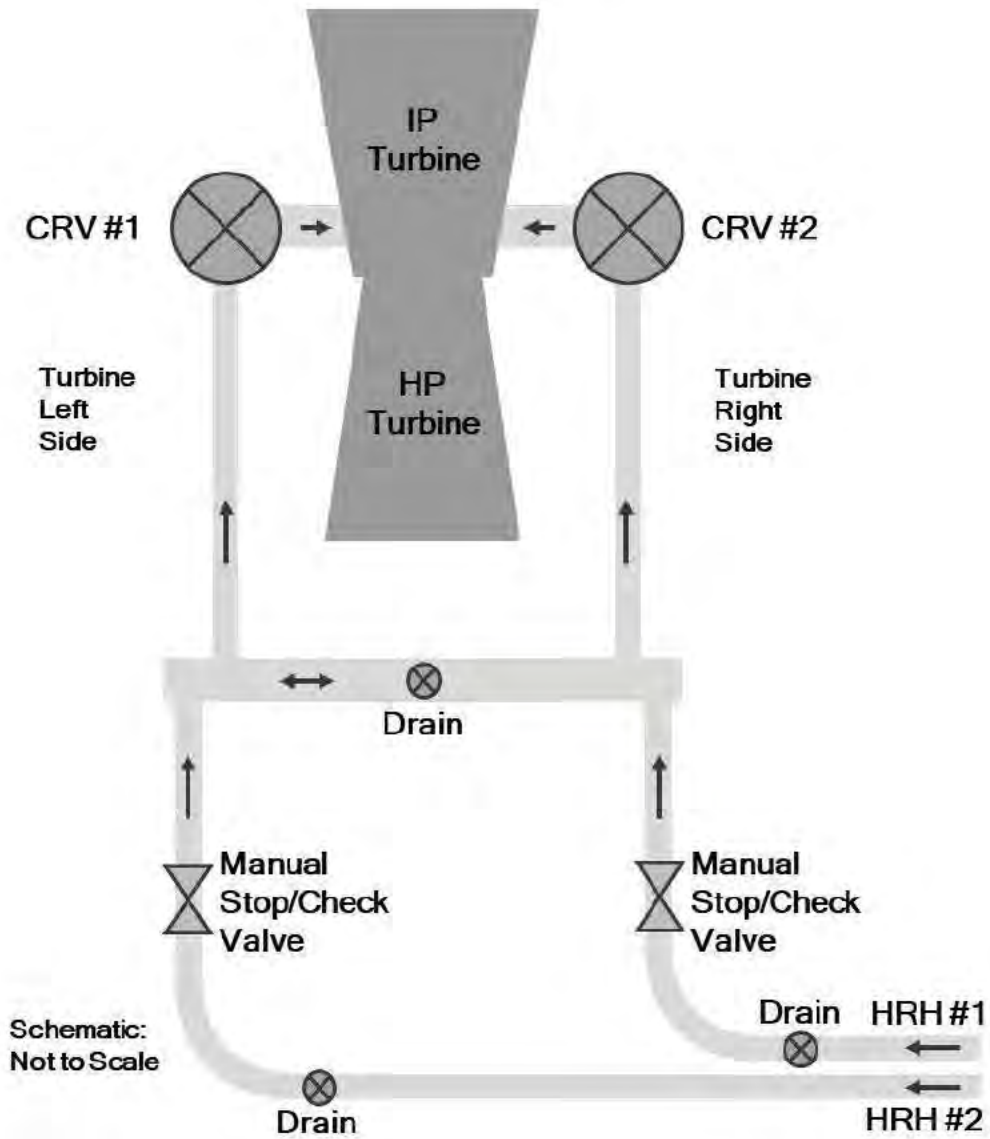
Figure 4-1. Arrangement of HRH Piping and Valves Upstream from the IP Turbine

These drain valve tests confirmed that a significant amount of water remained in the HRH #1 piping after the event. The possibility of checking for water in the HRSG #1 RH harps was discussed with plant personnel, but an appropriate drain was not present and testing was not feasible without destructively cutting into the system.

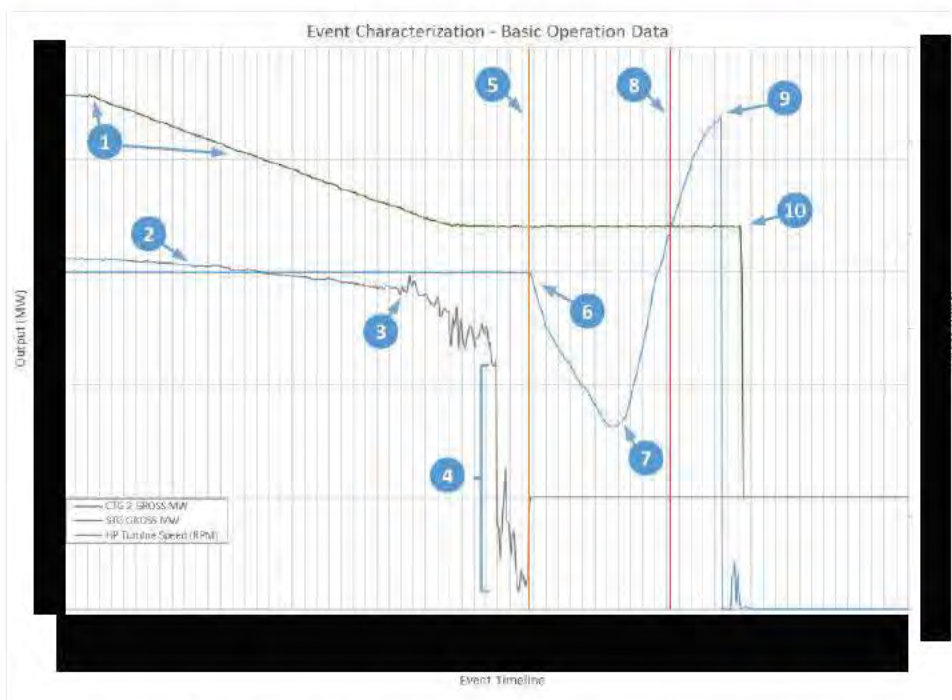
**Figure 5-1 - Event Characterization - Basic Operation Data**

Prior to the event and as part of the shutdown procedure, the operator initiated a (1) load reduction for CT 2 load to [REDACTED] MW at approximately [REDACTED]. As the reduction in CT output occurred, the (2) output of the STG began to decline accordingly. Both the CT and STG load reductions were smooth until approximately [REDACTED] when the (3) STG load began to fluctuate in an inconsistent manner with respect to the CT load reduction. At [REDACTED]

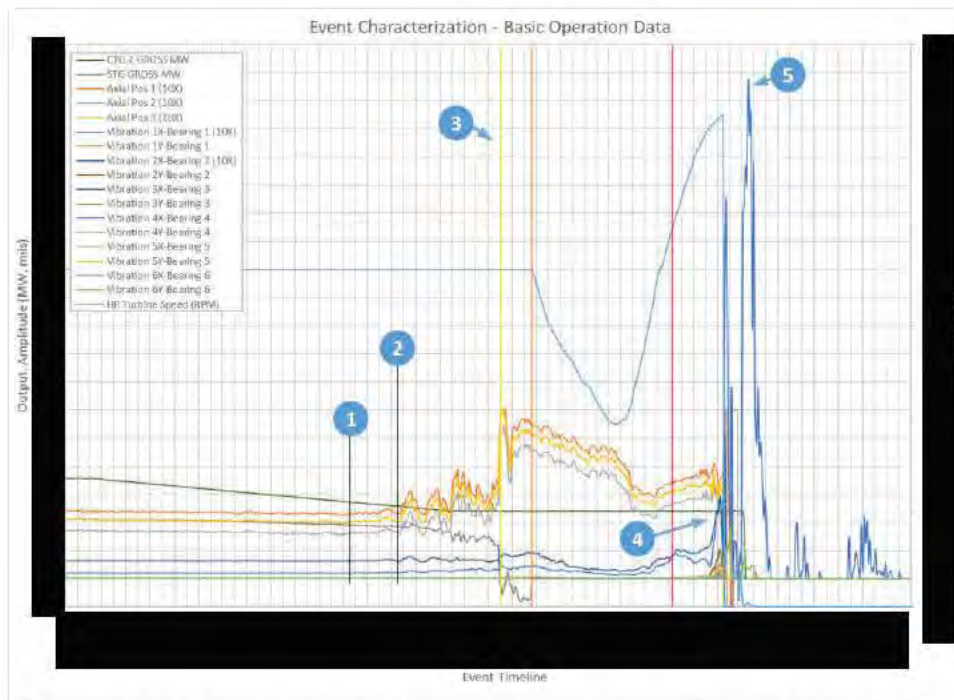
**Figure 5-2 - Event Characterization - Basic Operation Data (Continued)**

Minor trends (1) are visible beginning at [REDACTED] in **Figure 5-2** with the axial position probes and radial bearing 1X and 2X appearing inconsistent with prior operation, although these would likely not raise concern until a more significant (2) step change occurs at [REDACTED] within the axial position probes. The second (2) step change is consistent with STG load fluctuations identified in **Figure 5-1**.

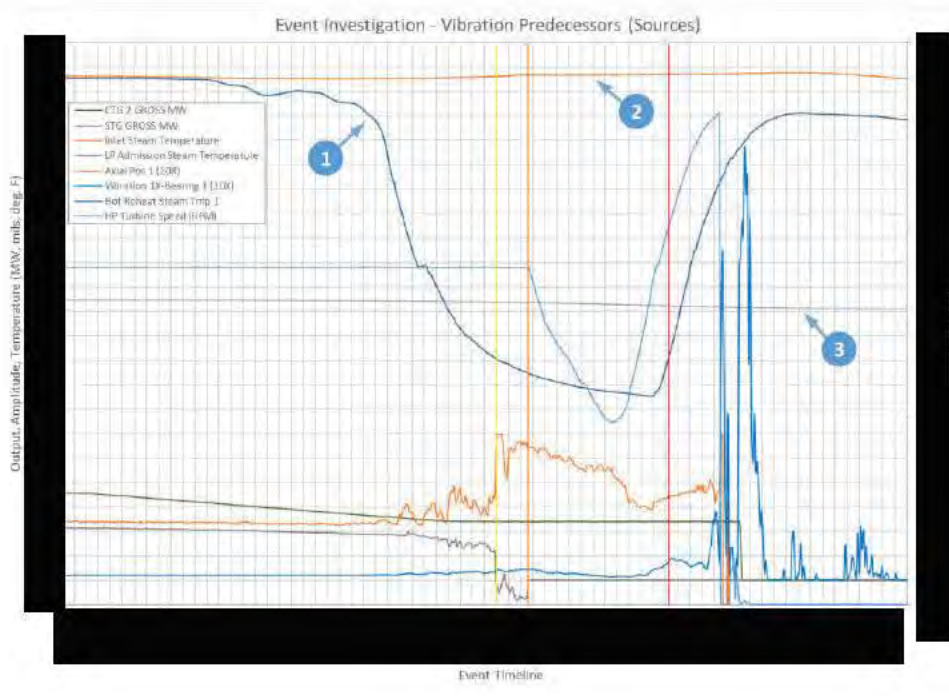
Figure 5-3 - Event Investigation - Vibration Predecessors

Based on the operational data review of STG speed, power output and vibrations, it has been identified that the overspeed event was substantially initiated by a water induction event. Review of HP, IP and LP inlet temperatures was utilized to isolate the turbine section that initially experienced this water induction. The IP section showed a significant reduction in temperature prior to the event and corresponding with the initial minor vibration trends identified in Figure 5-2. As shown in Figure 5-3, HP steam (2) inlet temperature and (3) LP admission steam temperature remained steady throughout the event, however, the (1) HRH steam entering through the right of the IP turbine showed a rapid reduction in temperature consistent with the induction of liquid water vs. steam.

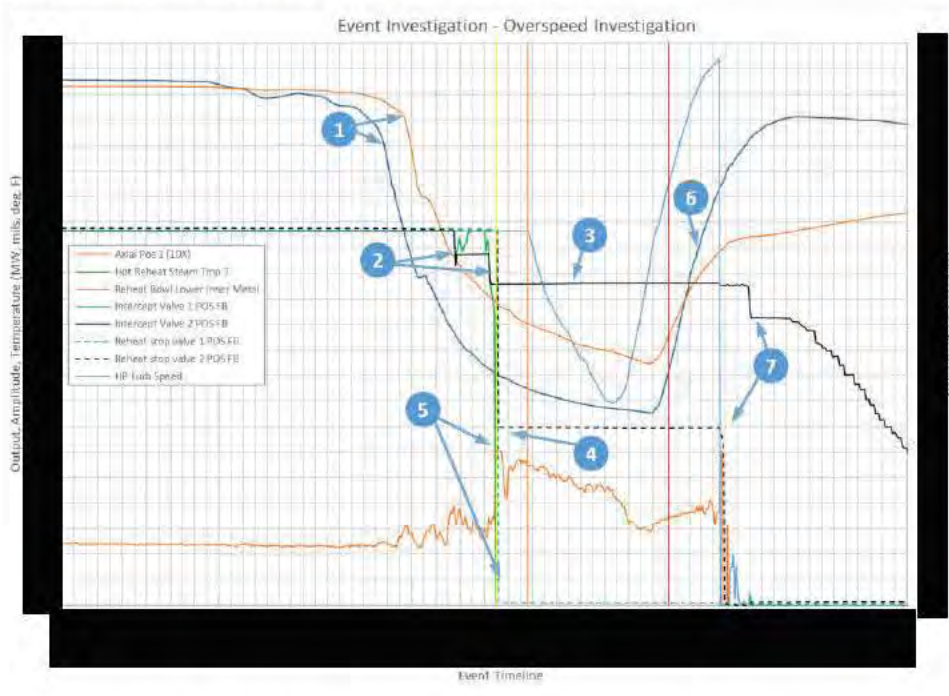
Figure 5-4 - Event Investigation - Overspeed Investigation

Figure 5-4 shows that (1) both the right HRH pipe beneath the STG and the right IP lower bowl temperatures were rapidly reduced from operating temperatures of approximately [REDACTED] to less than [REDACTED] when (2) both CRV IVs began to throttle in response to shutdown activities as described in Section 4.4. At this time, the right HRH pipe and IP lower bowl showed the presence of water versus the left HRH pipe and IP lower bowl, providing explanation as to why the IV #2 was (3) unable to close in response to flow throttling and RSV #2 in response to the trip command to (4) close all stop valves. At the time of the steam turbine trip, the left IP lower bowl temperature had begun to drop below [REDACTED] indicating a much smaller volume of water had entered through the left HRH pipe, allowing (5) IV #1 and RSV #1 to throttle and close as commanded.

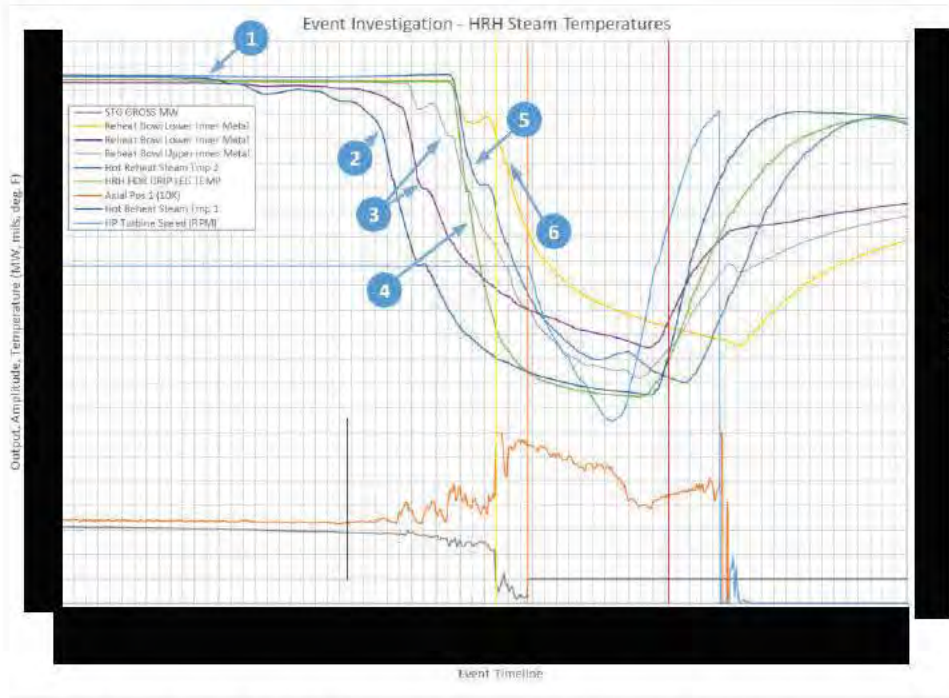
**Figure 5-5 - Event Investigation - HRH Steam Temperatures**

An (1) initial temperature disturbance occurred in the right HRH pipe beneath the STG prior to the initial vibration changes as previously highlighted in **Figure 5-2**. This disturbance was followed by a (2) significant drop in temperature in the same HRH pipe. Next, (3) the right, lower IP reheat bowl thermocouple, followed by the upper IP reheat bowl thermocouple, showed a sharp reduction in temperature, indicating that water was churning in the ST flow path. These significant temperature disturbances precede the axial vibration shift and the reverse power occurrence by less than one minute.

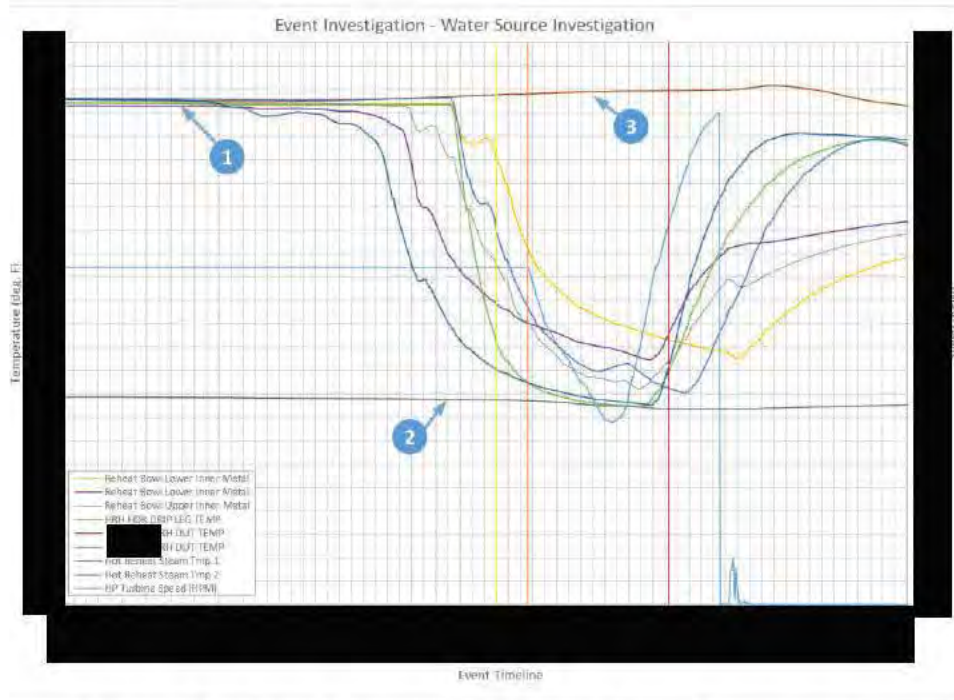
Figure 5-6 - Event Investigation - Water Source Investigation

During the initial shutdown of CT 2, (1) all left and right HRH pipe and reheat bowl thermocouple temperatures are aligned with the (3) output temperature of HRSG #2 RH, which was in service at the time. As the temperatures of the HRH pipe and IP bowls dropped, those temperatures became consistent with the (2) output temperature of HRSG #1 RH, which was out of service at the time. The HRSG #2 HRH outlet temperature remained at a (3) relatively consistent temperature throughout the event and only began to fall once CT 2 was tripped by the control room operator. This data gives a clear indication of the source of water in the water induction event is HRSG #1 RH and associated piping.

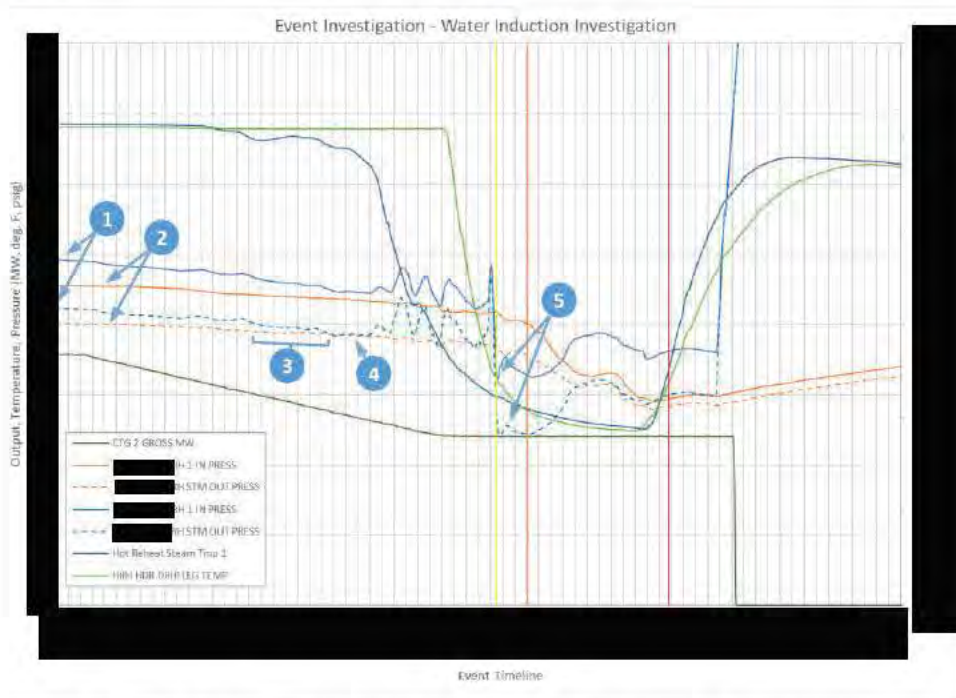
Figure 5-7 - Event Investigation - Water Induction Investigation

During normal operation prior to the event, (1) the inlet and exit pressures of HRSG #2 RH were greater than the (2) corresponding pressures of HRSG #1 which was out of service. As CT 2 load was reduced as part of the normal shutdown sequence, both (3) HRSG #2 RH inlet and outlet pressures declined with reduced CT output / exhaust temperatures, as expected. Later in the shutdown, the (4) outlet pressure of HRSG #2 RH drops below the outlet pressure of HRSG #1 RH, and the timing of this is consistent with the HRH #1 pipe showing the rapid temperature reduction. Immediately prior to the steam turbine trip, (5) both the inlet and outlet pressures of HRSG #2 RH drop below the corresponding pressures from HRSG #1 and remain below for approximately 1 minute.

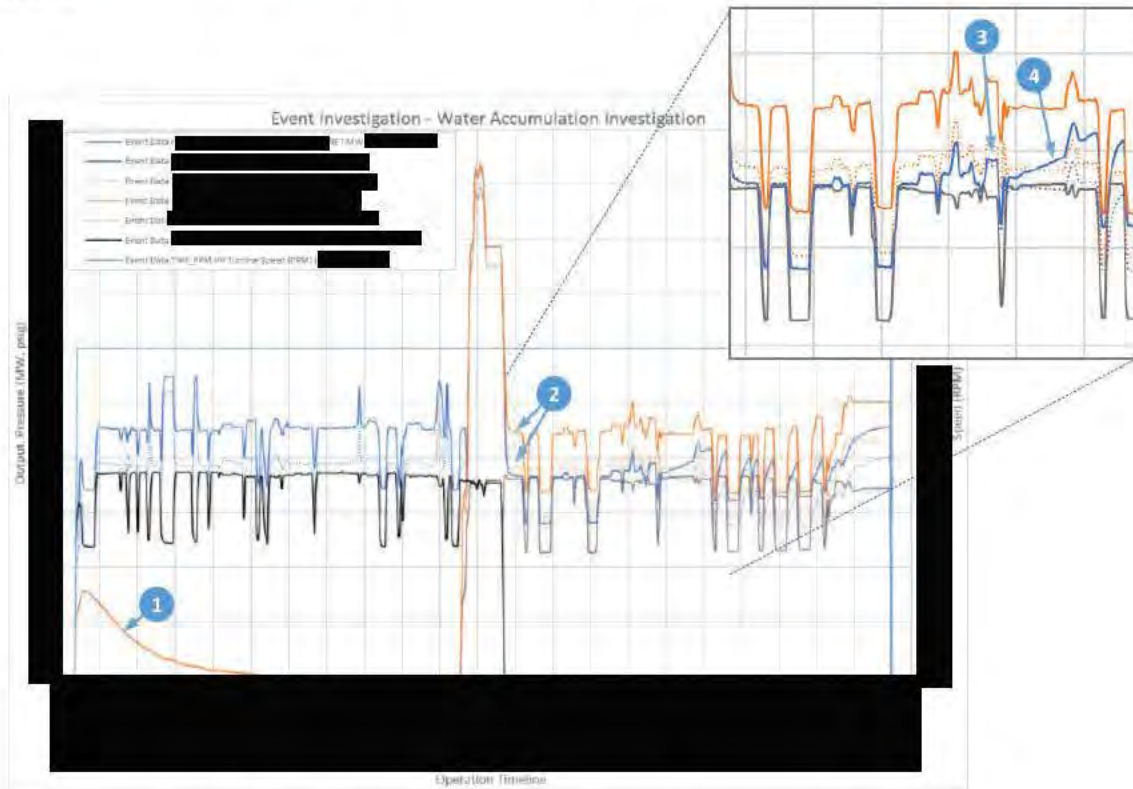
**Figure 5-8 - Event Investigation - Water Accumulation Investigation**

Notable to the investigation, at the start of the 1x1 operation with block 1, (1) HRSG #2 RH inlet and outlet pressures increase upon startup of the STG to approximately [REDACTED], but this pressure decays off over the [REDACTED]. Both HRSG #2 RH inlet and outlet pressures were equivalent throughout this time period, indicating that the RH circuit was pressurized and free of obstructions from inlet to exit.

Unlike how HRSG #2 RH pressure levels decayed as HRSG #1 came online on 5/23/21, (2) HRSG #1 RH held pressure throughout the remaining operation of block 2. Initially, with block 1 offline, the differential pressure across HRSG #1 RH inlet and outlet locations remained very low [REDACTED], which indicates unobstructed flow of steam through the reheater circuit. However, at approximately [REDACTED], the (3) HRSG #1 RH inlet pressure began to rise, holding an increased level of pressure over the HRSG #1 RH exit. The (4) HRSG #1 RH inlet pressure continued to increase, driving towards the CRH pipe pressure through the remaining operation, with the exception of CT 2 load reductions, which also dropped the CRH pressure.

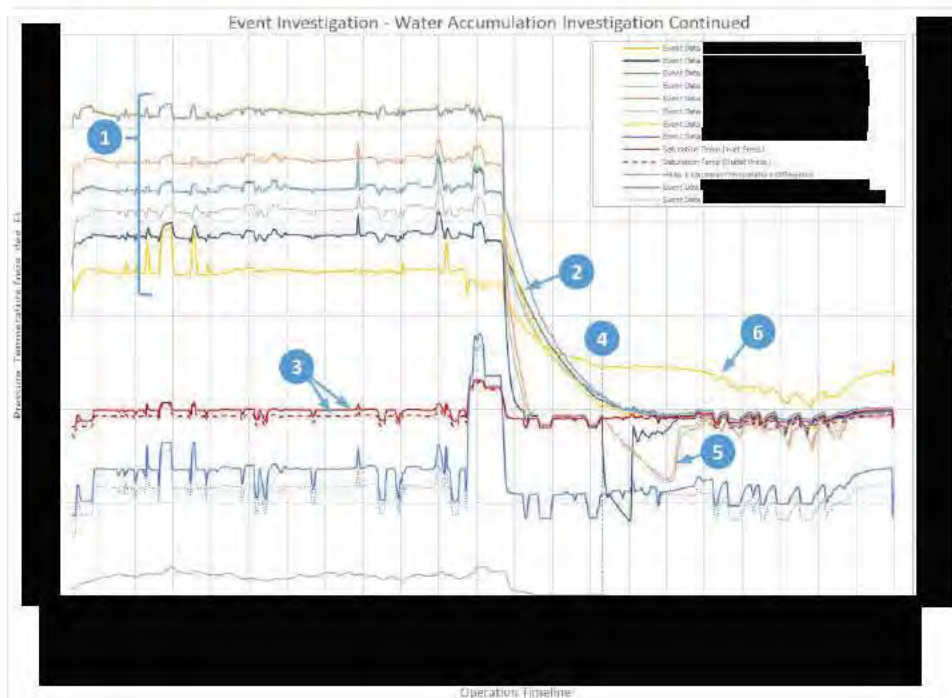
**Figure 5-10 - Water Accumulation Investigation Temperature Plot**

Temperature traces (1) show representative temperatures through the RH circuit including the inlet, 3 harps, and outlet; these traces show that the RH steam was steadily increasing in temperature when HRSG #1 was in service. These temperatures (2) decline after HRSG #1 is taken out of service. RH harp 1 drain ( ) temperatures, followed by harp 3 drain ( ) temperatures, decline first, followed by drops in temperature at the upper region thermocouples.

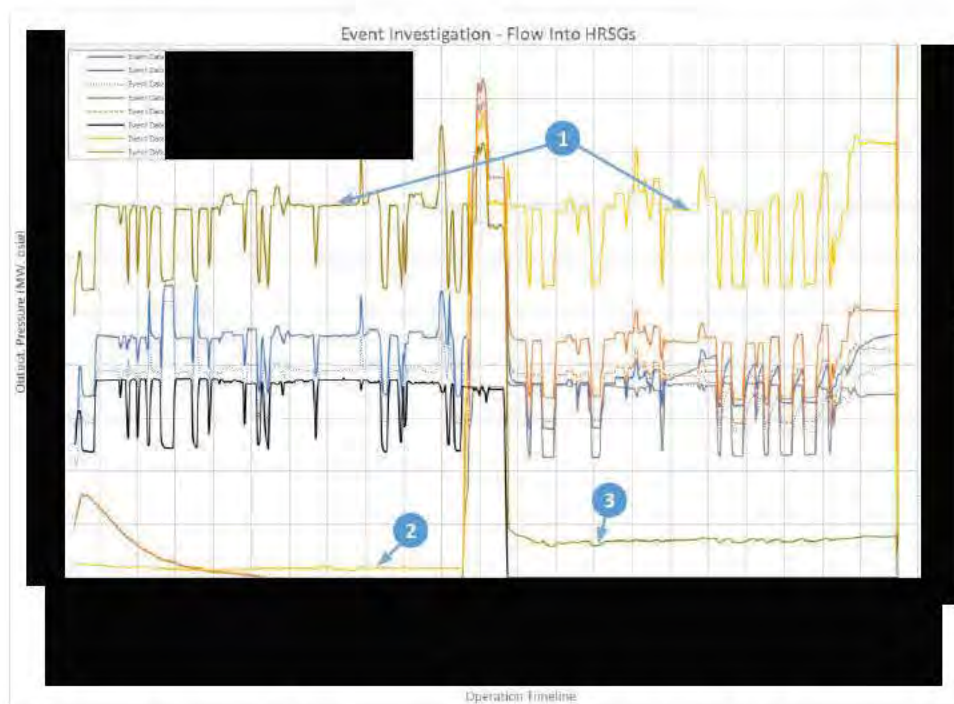
**Figure 5-12 - Event Investigation Flow into HRSGs**

The CRH Flow Balance Flowmeter is in-line downstream of the HRSG CRH SV, CRH flow balance valve and HP bypass piping. As shown in Figure 5-12, (1) both HRSG #1 and HRSG

#2 recorded approximately [REDACTED] of steam flow during steady, full load operation. While low levels of flow through the flowmeters are unlikely to provide accurate readings, a relative comparison can be drawn between the offline CRH flow into the HRSGs. While offline, (2) HRSG #2 showed approximately [REDACTED] where (3) HRSG #1 recorded [REDACTED].

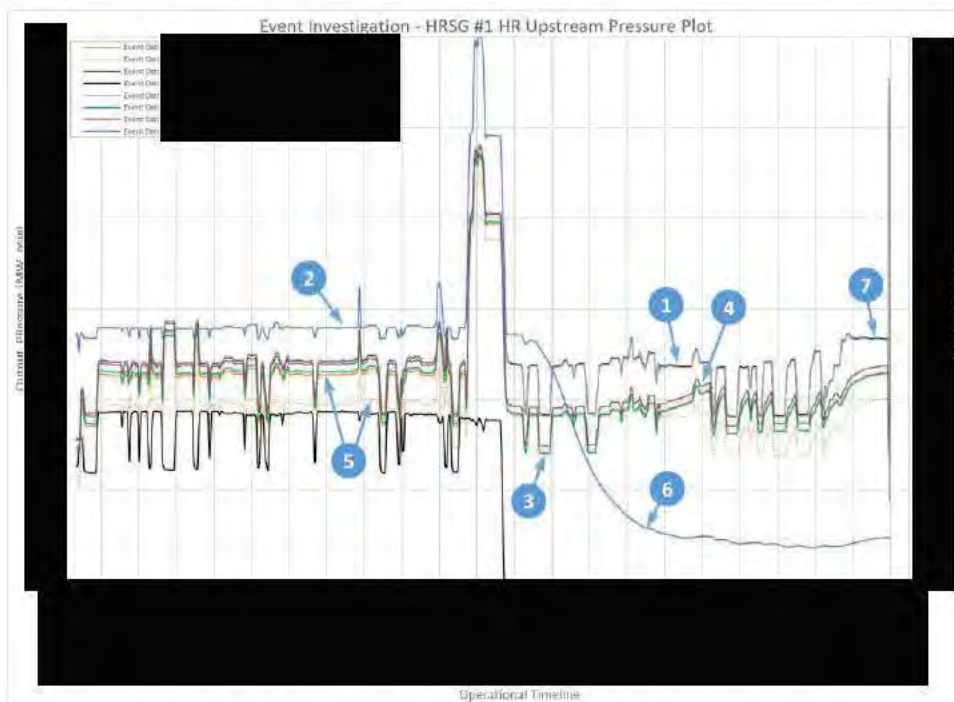
**Figure 5-13 - HRSG #1 HR Upstream Pressure Plot**

Plotted in **Figure 5-13**, the pressures upstream of HRSG #1 are shown for the (1) CRH pipe upstream of the CRH SV, (2) HP bypass system (plotted on the secondary Y scale), (3) CRH flow meter, (4) IP superheater, and both the (5) RH inlet and outlet. Initially, after the shutdown of block 1, the HP bypass system remained at approximately [REDACTED]. However, after approximately [REDACTED], the (6) pressure bleeds off to less than [REDACTED]. Throughout the majority of block 2's operation, both CRH pipes remain at approximately [REDACTED] sig with the exception of the [REDACTED] prior to the event where the pressure (7) increases to approximately [REDACTED] without a load increase on CT 2.

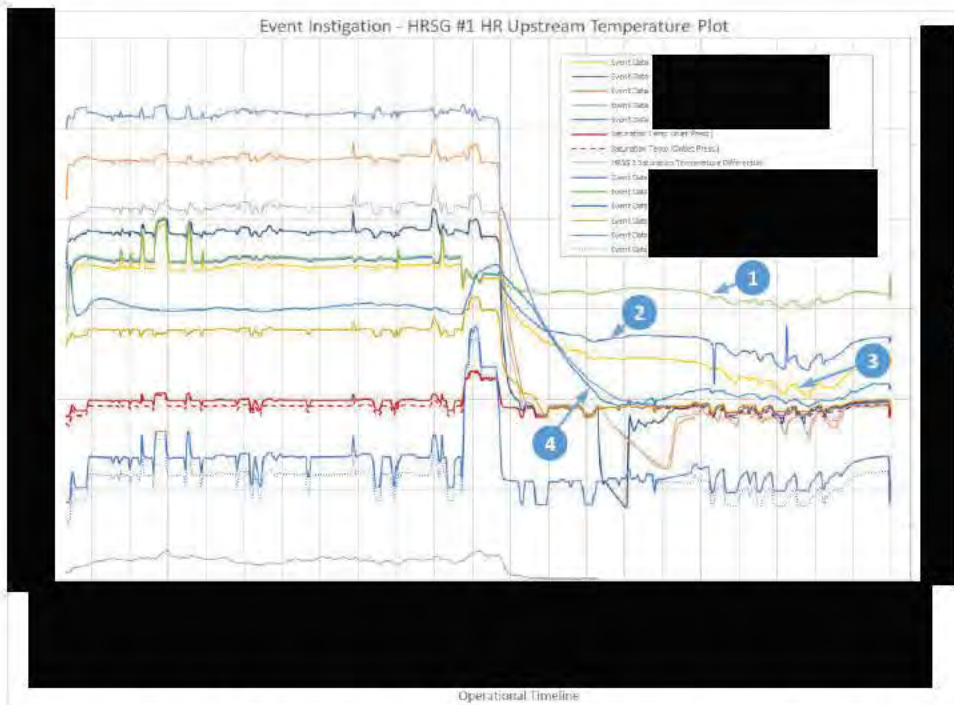
Figure 5-14 - HRSG #1 HR Upstream Temperature Plot

- Based on the low supply pressure from the IP superheater and the {Figure 5-14 (3)} temperatures within the IP superheater piping, it is unlikely that this contributes any significant steam flow or pressurization of the HRSG #1 RH.

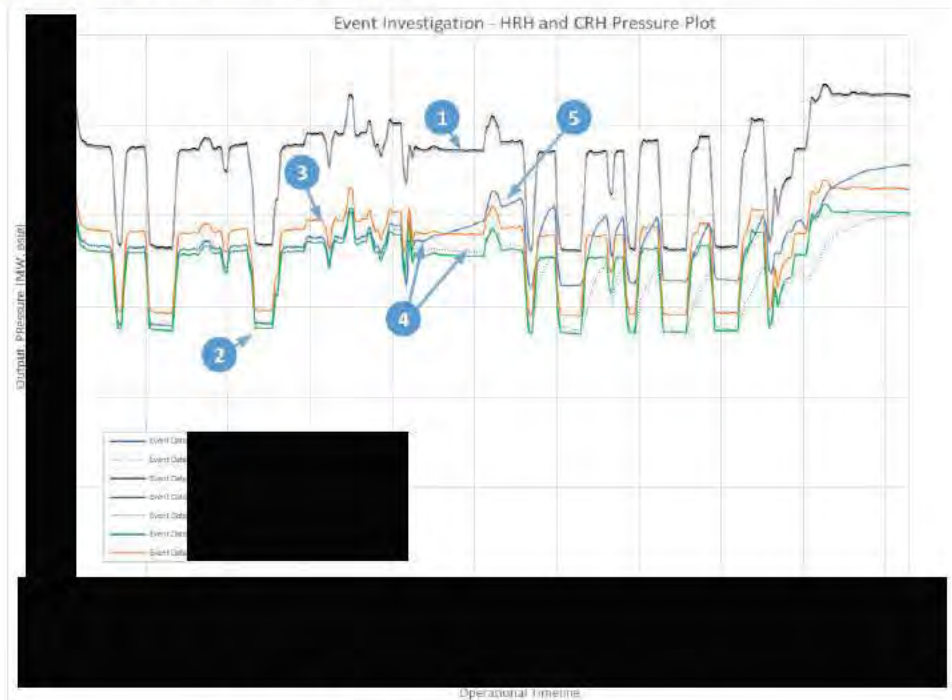
**Figure 5-15- CHR and HRH Pressure**

The (1) CRH pipes to HRSG #1 and #2 remain the highest pressure within the CRH and HRH piping systems throughout the approximately [REDACTED] of operation prior to the event. Due to flow losses in the piping and valves, (2) the inlet pressure of the IP ST downstream of the CRVs is the lowest pressure. The (3) outlet pressure of HRSG #2 RH, which is in service, is initially greater than both the (4) inlet and outlet pressure of HRSG #1 RH. However, as the loop seals form within HRSG #1, (5) the inlet pressure of the HRSG #1 RH begins to exceed the outlet pressure of the HRSG #2 RH.

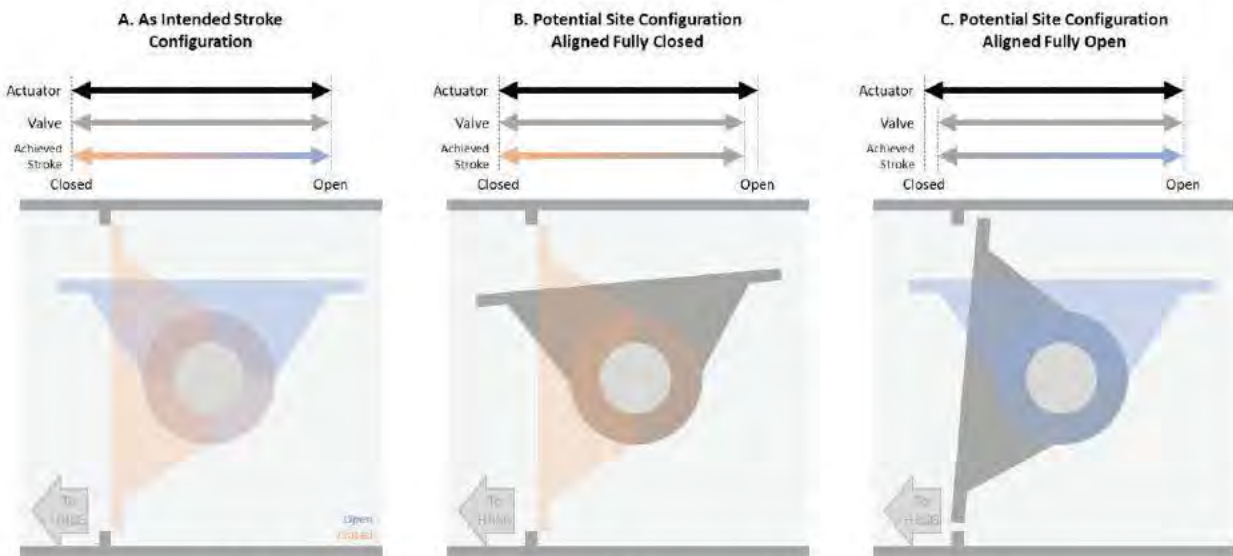
**Figure 5-16 - CRH Stop Valve Component Stroke Depiction**

Both the actuator and valve were disassembled with no notable findings impacting the stroke of the valve. The valve stem and yoke bearing were identified with galling damage which was noted to potentially increase actuator load but would not significantly impact the range of stroke. Disassembly of the gearbox identified a heavily damaged gear box shaft roller bearing. The bearing components had been trapped within the worm and quarter gear further damaging the gearbox. This damage increased the gearbox backlash and resulted in reduced valve stroke.

Had the gearbox been able to efficiently translate the full actuator motion to the valve, both positions in **Figure 5-16A** could have been achieved. The fully opened position is depicted in blue and the fully closed position is shown in orange. Intermediate positions are shown as grey in depictions B and C.

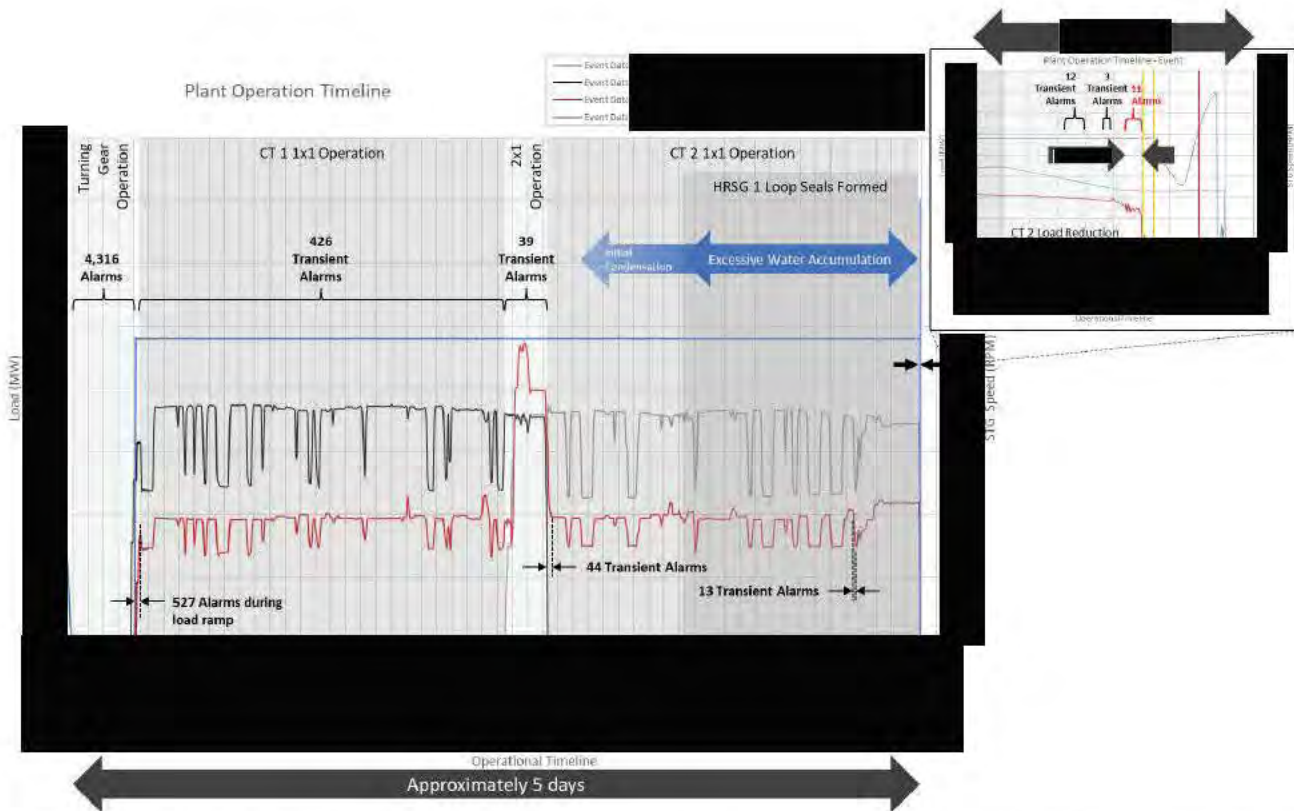
Figure 5-17 - Plant Operation Timeline ( [redacted] ) with [redacted] Alarm Overlay

Of the 5,391 alarms, 5,352 occurred from the start of turning gear operation up to [redacted] prior to [redacted] to the event. The 5,352 alarms occurred prior to water accumulation in offline and transient conditions and do not present abnormal operating conditions. Of these alarms, 5,308 occurred on turning gear or with HRSG 1 online in conditions that would not condense or accumulate water within the HRSG. The remaining 44 alarms occurred in 1x1 operation as block 1 was shutting down with HRSG 1 still at operating temperature. Based on the CT and HRSG operation time periods, these alarms would not have been associated with large amounts of water accumulating within the offline HRSG. These alarms are not related to the event or its precursors.
