<b>DOCKETED</b>	
<b>Docket Number:</b>	01-AFC-07C
<b>Project Title:</b>	01-AFC-7C Russell City Energy Company
<b>TN #:</b>	246122
<b>Document Title:</b>	Attachment A Photos Figures 17, 25-37 to Investigation Report Calpine Russell City Steam Turbine Event
<b>Description:</b>	***Please See Report TN242911*** Attachment A Photos Figures 17, 25-37 to Investigation Report Calpine Russell City Steam Turbine Event
<b>Filer:</b>	Patricia Carlos
<b>Organization:</b>	California Energy Commission
<b>Submitter Role:</b>	Commission Staff
<b>Submission Date:</b>	9/15/2022 3:27:25 PM
<b>Docketed Date:</b>	9/15/2022

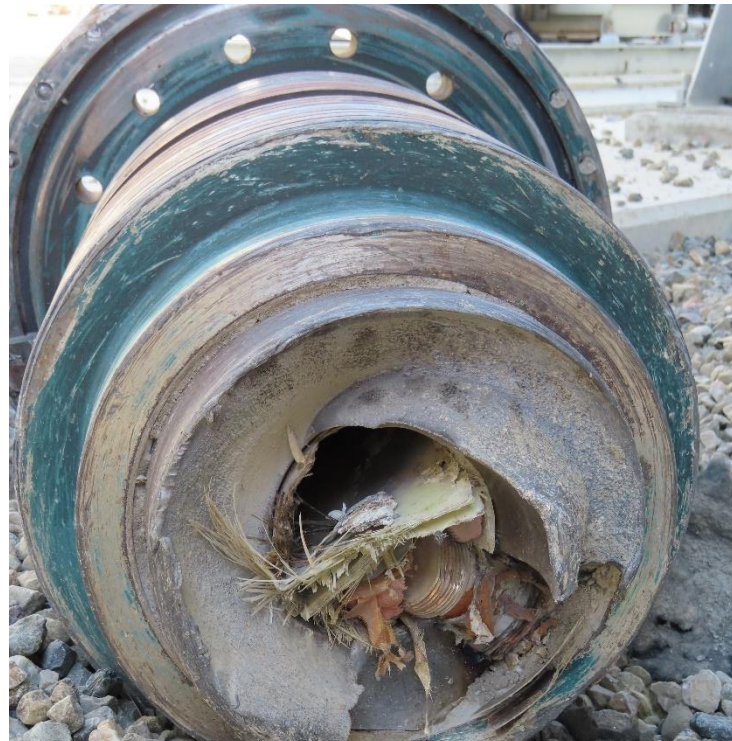
Figure 17. Generator exciter shaft fracture surface.

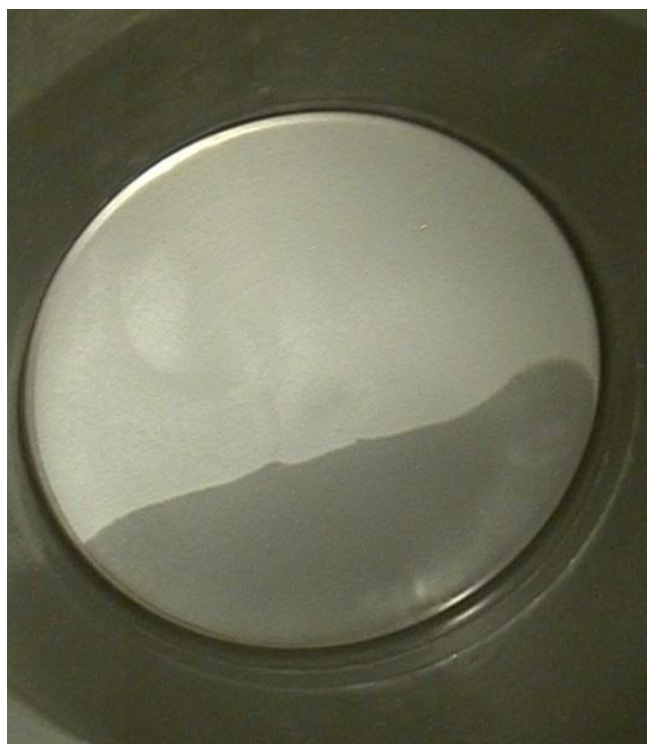
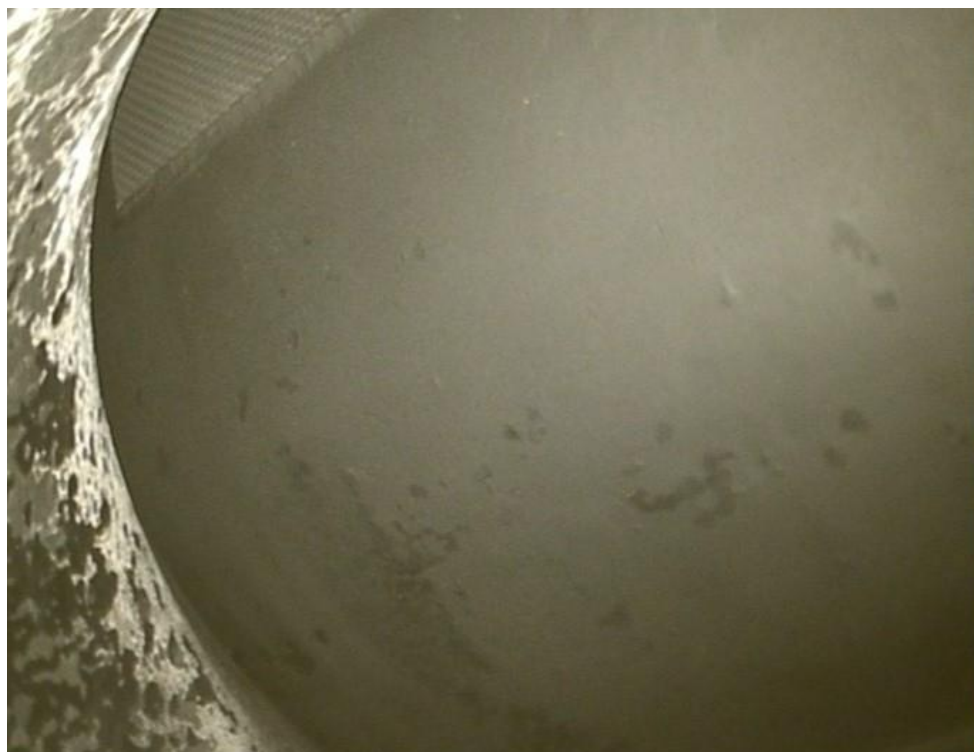
Figure 25. Borescope image of the HRH 2 manual stop / check valve disk (upper image) and CRV 1 basket (lower image) from the HRH 2 piping.

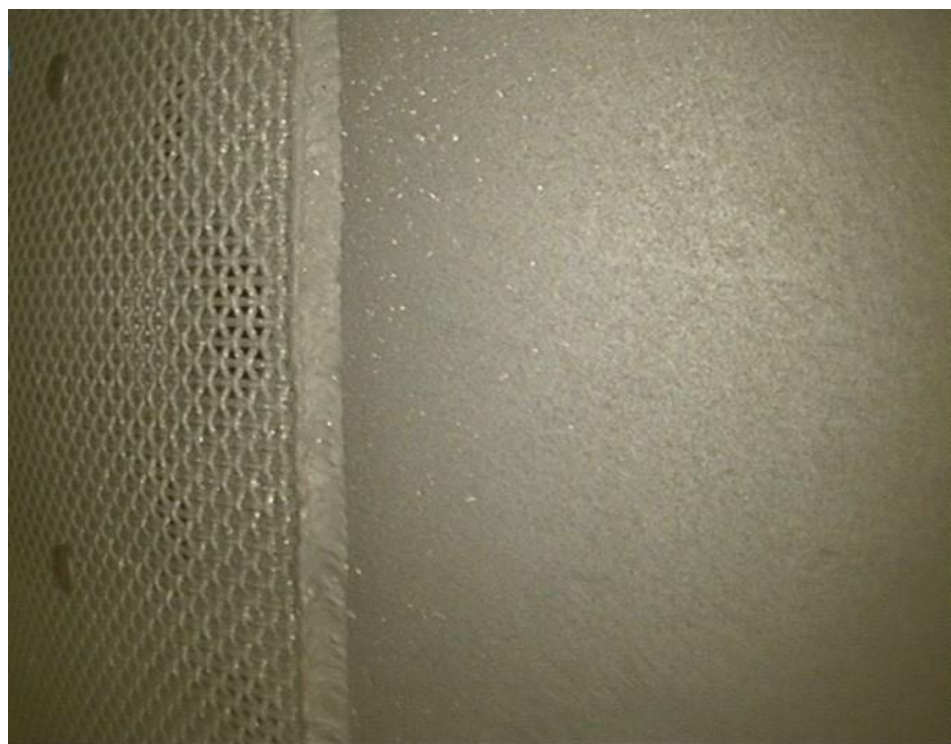
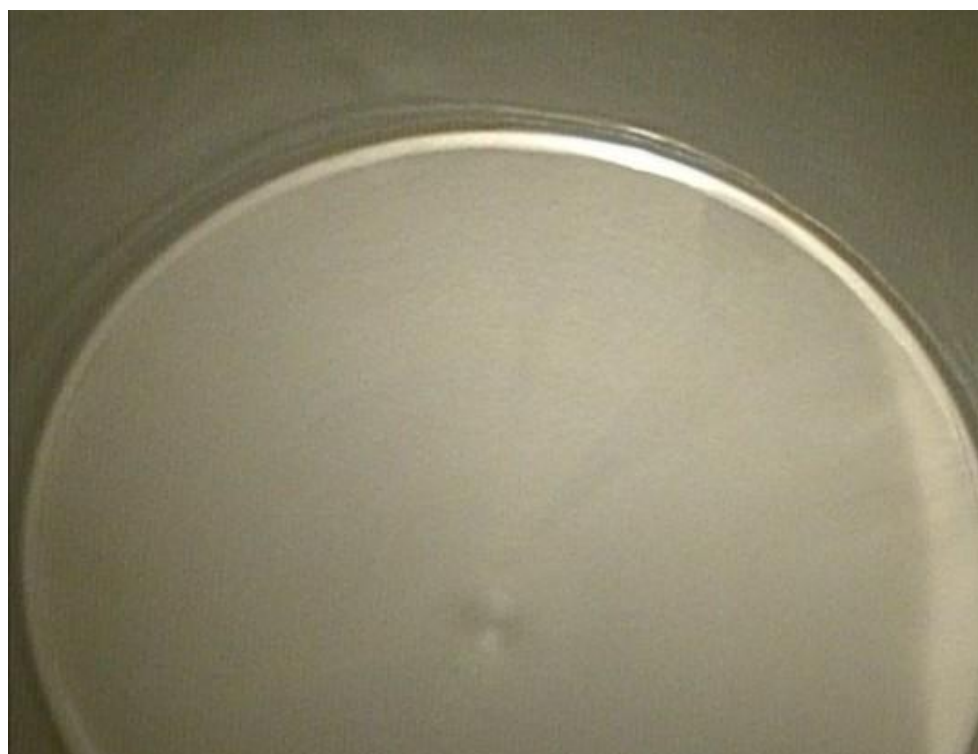
Figure 26. Borescope image of the CRV 1 basket (upper image) and the HRH 1 manual stop / check valve disk (lower image).

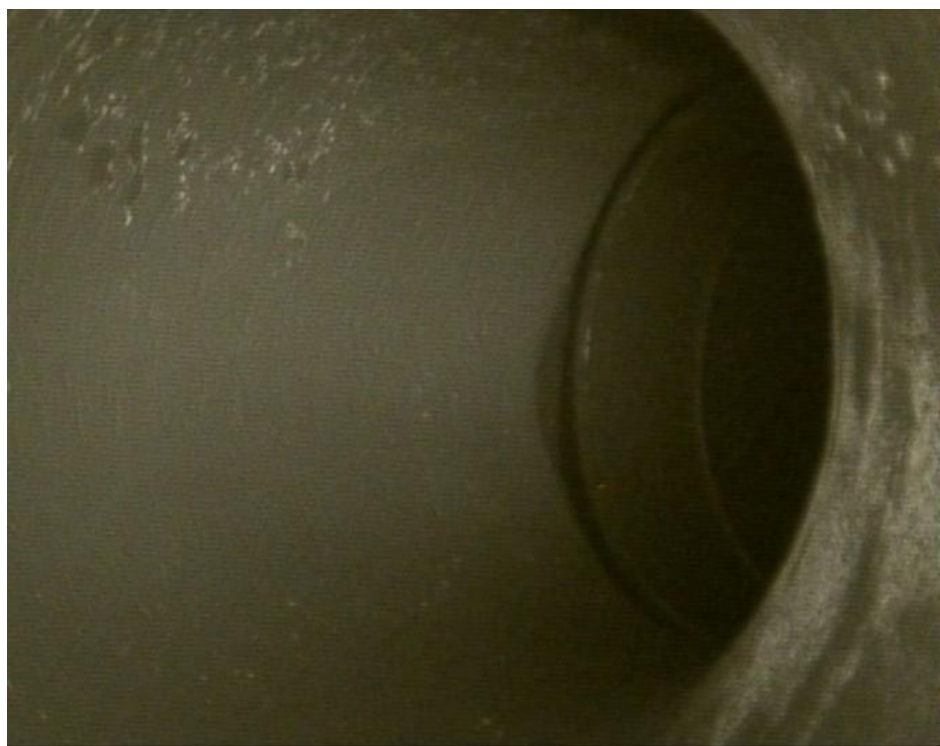
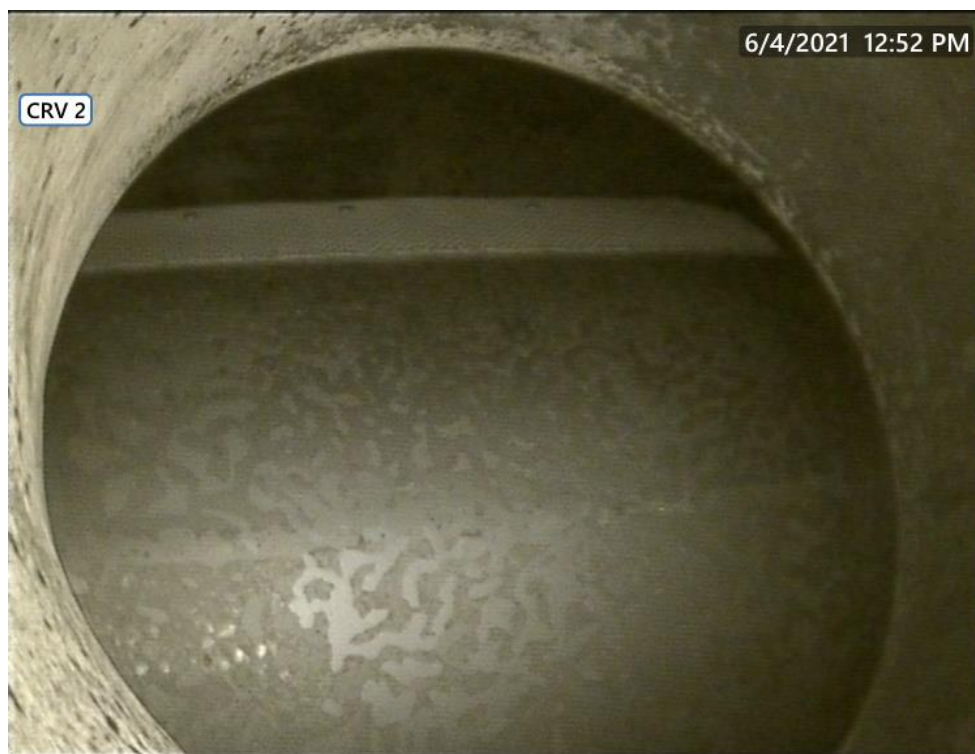
Figure 27. Borescope image of the HRH 1 piping showing oxide exfoliation (upper image) downstream of the manual stop / check valve and the CRV 2 basket (lower image).

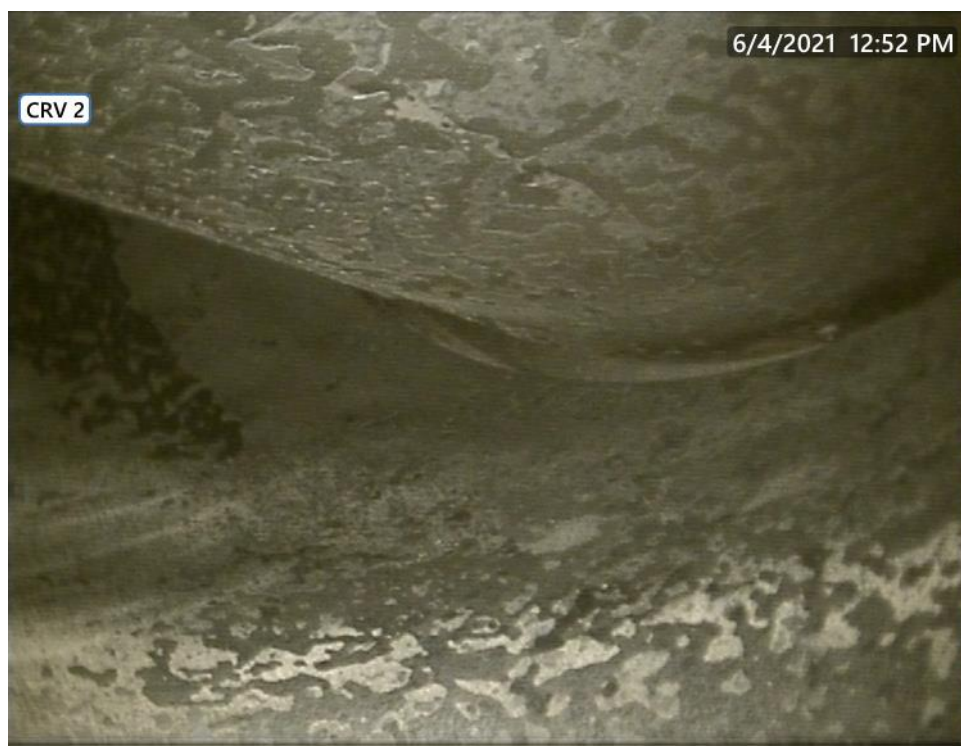
Figure 28. Borescope image of the CRV 2 basket showing oxide exfoliation.

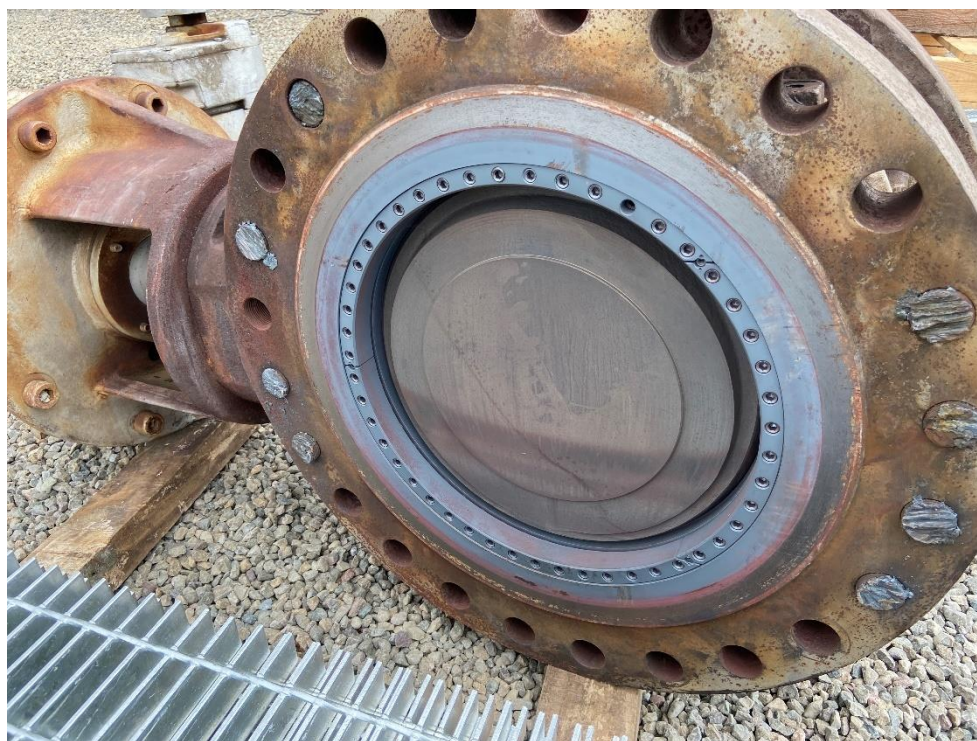
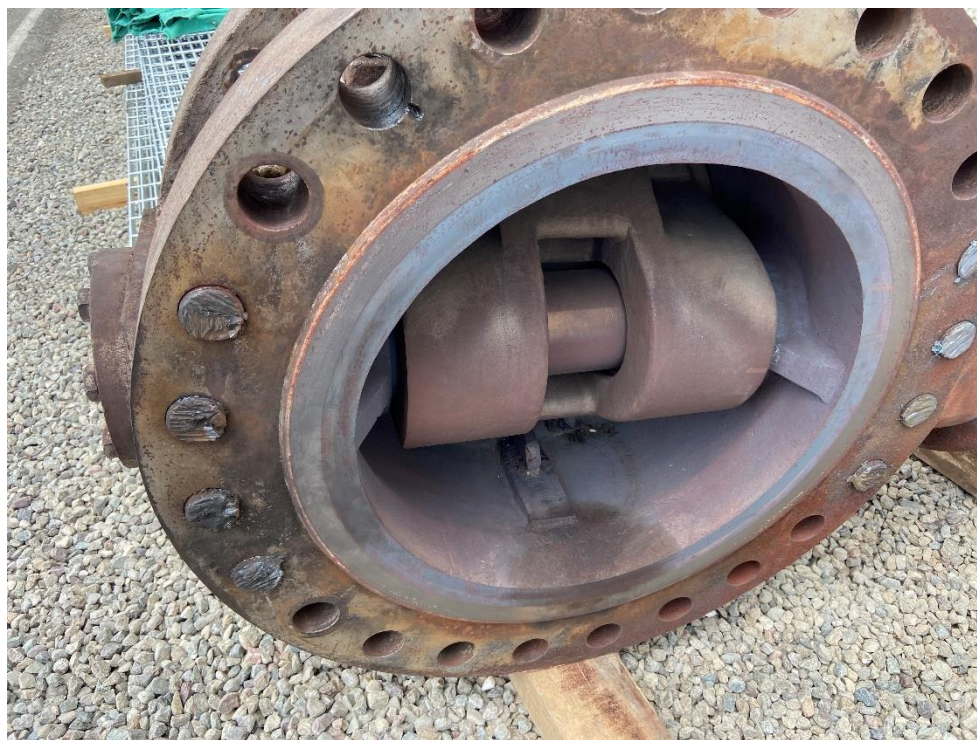
Figure 29. Views of the HRSG 1 CRH stop valve.

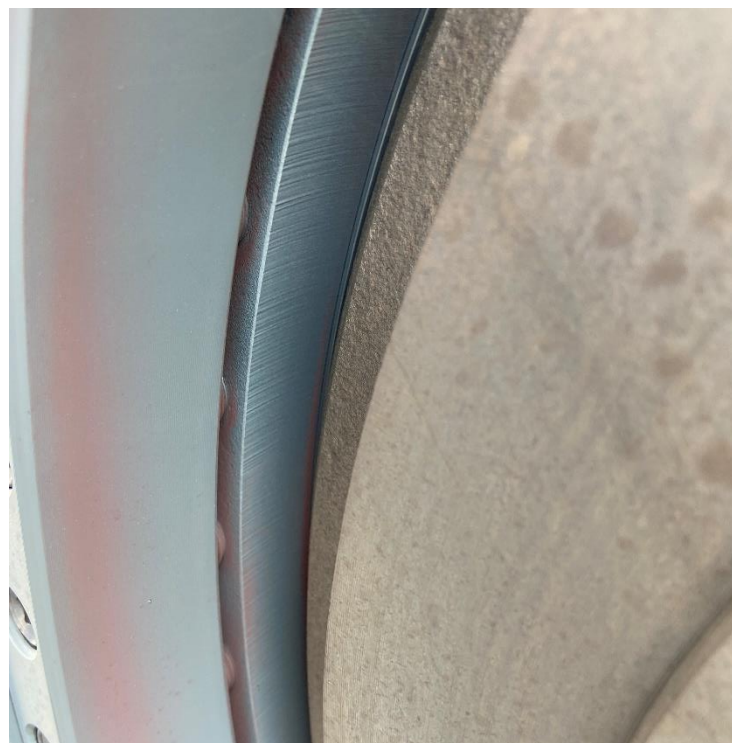
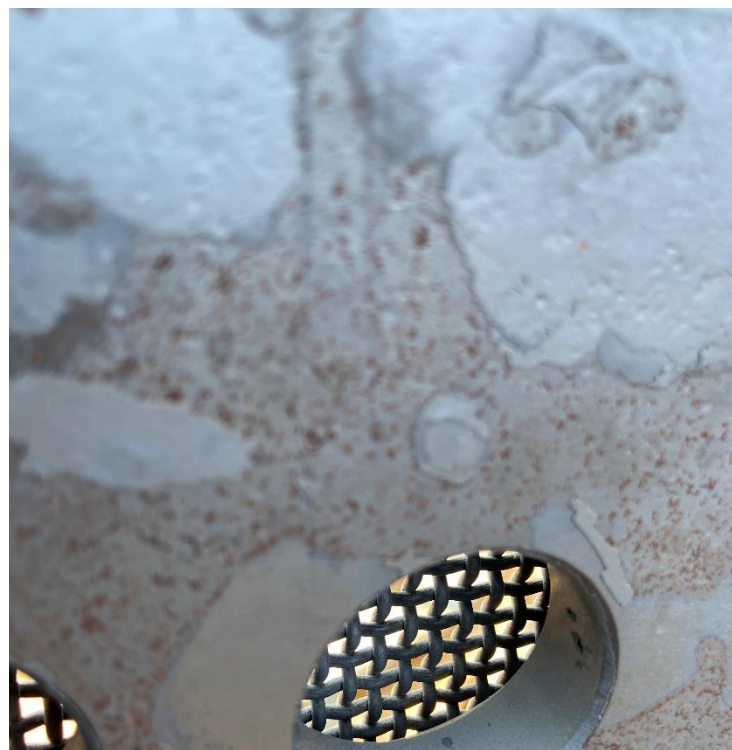
Figure 30. Views of the HRSG 1 CRH stop valve seat area (upper image) and the oxide exfoliation on the CRV 2 basket (lower image).

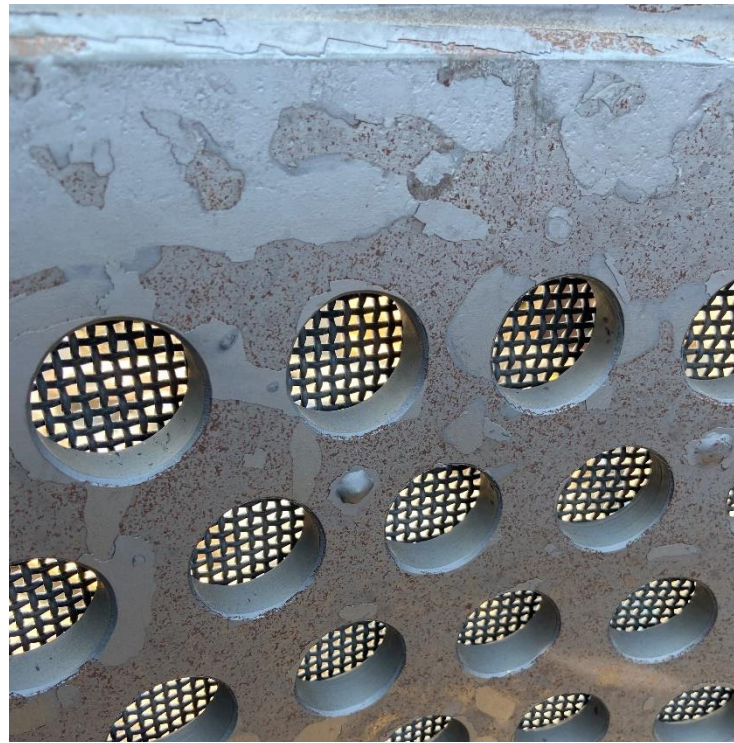
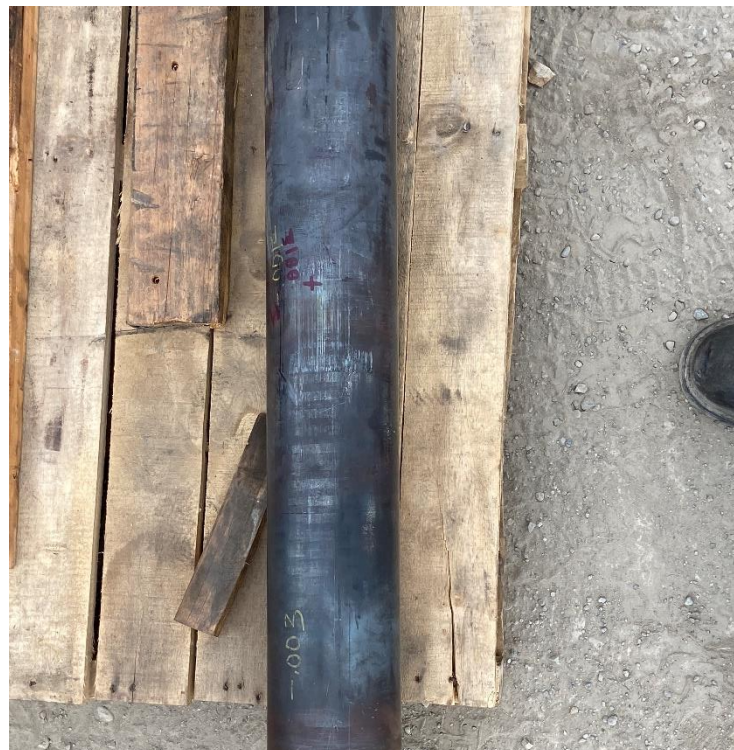
Figure 31. Views of oxide exfoliation on the CRV 2 basket (upper image) and the CRV 2 intercept valve stem with runout measurements (lower image).

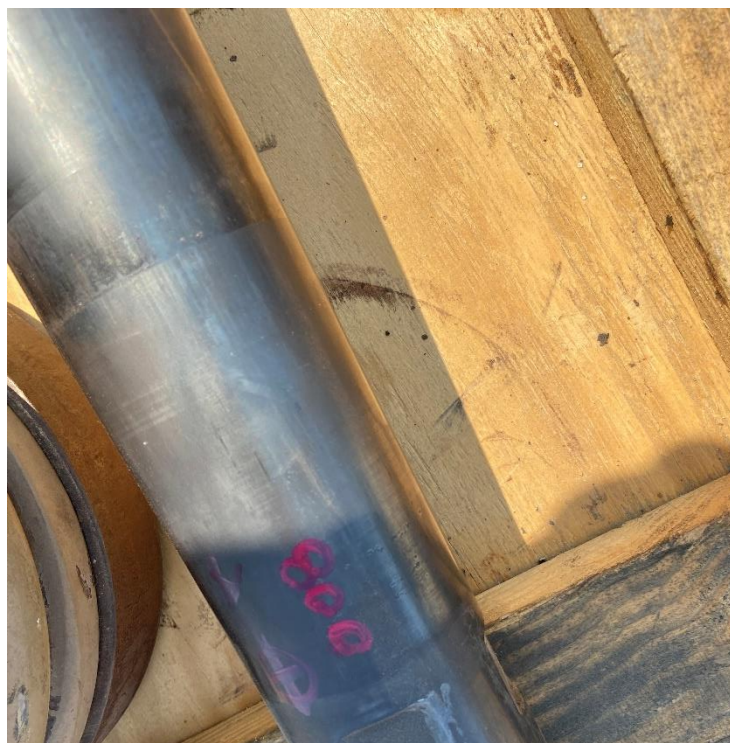
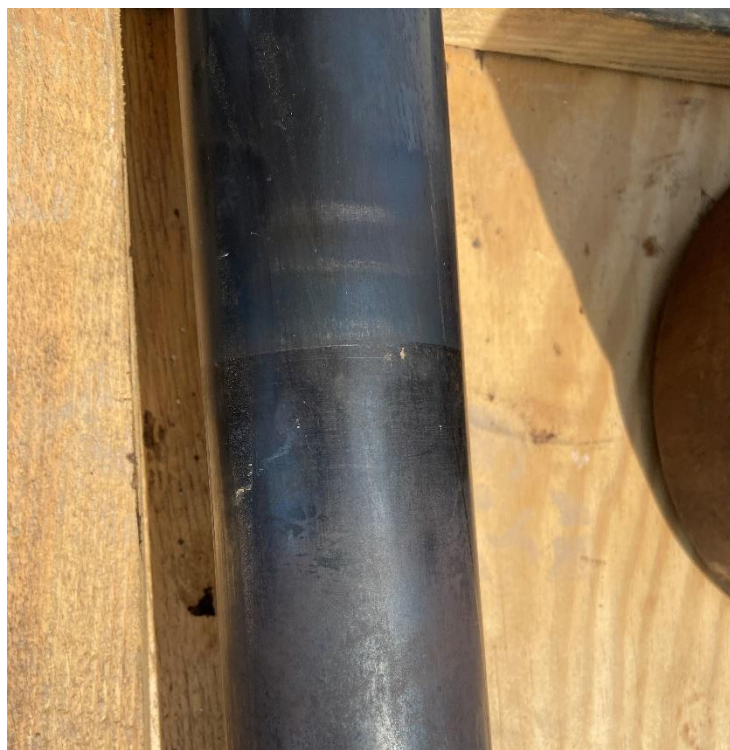
Figure 32. Views of the CRV 2 intercept valve stem with runout measurements and witness marks.

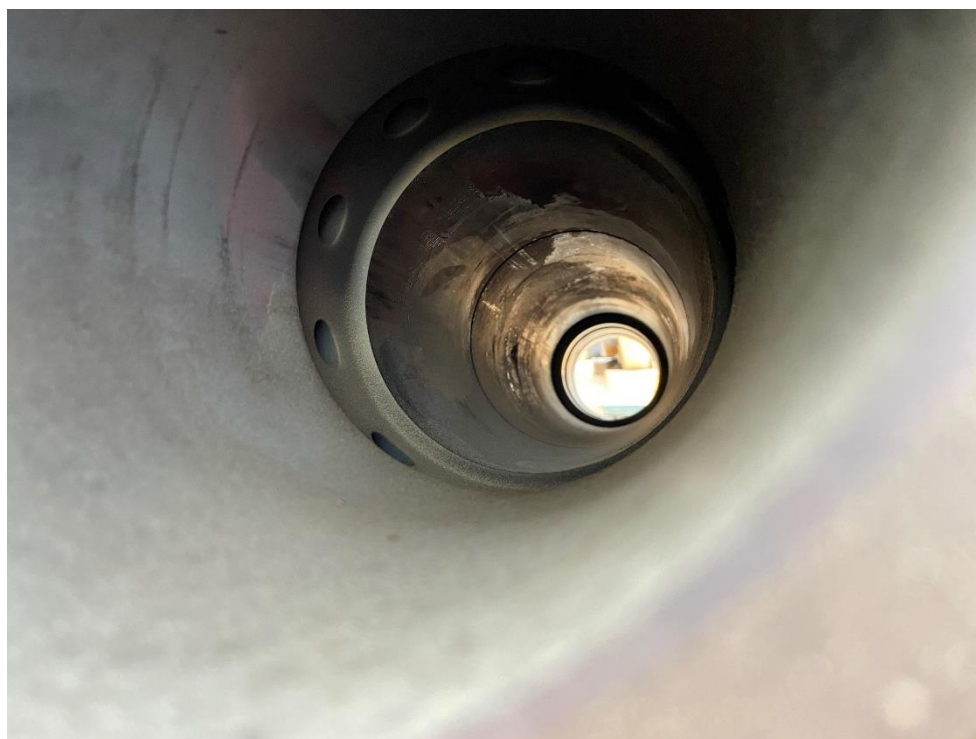
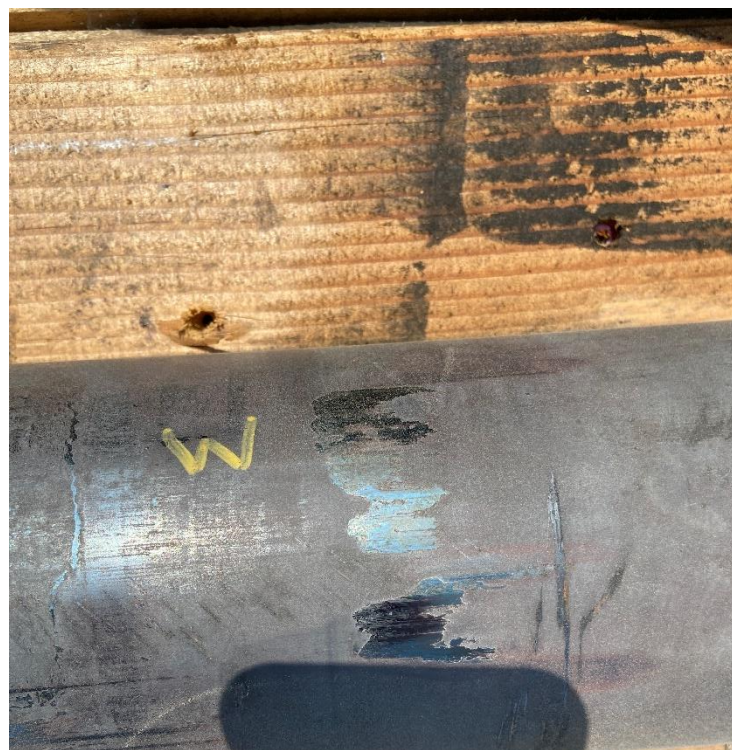
Figure 33. Views of the CRV 2 stop valve bushings (upper image) and stem witness marks (lower image).

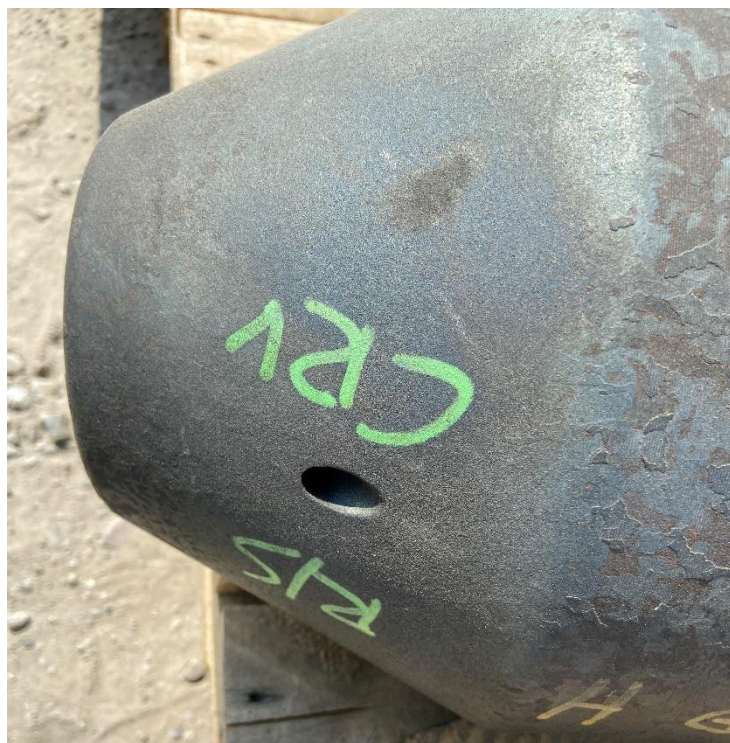
Figure 34. View of the CRV 2 stop valve bonnet with oxide exfoliation.

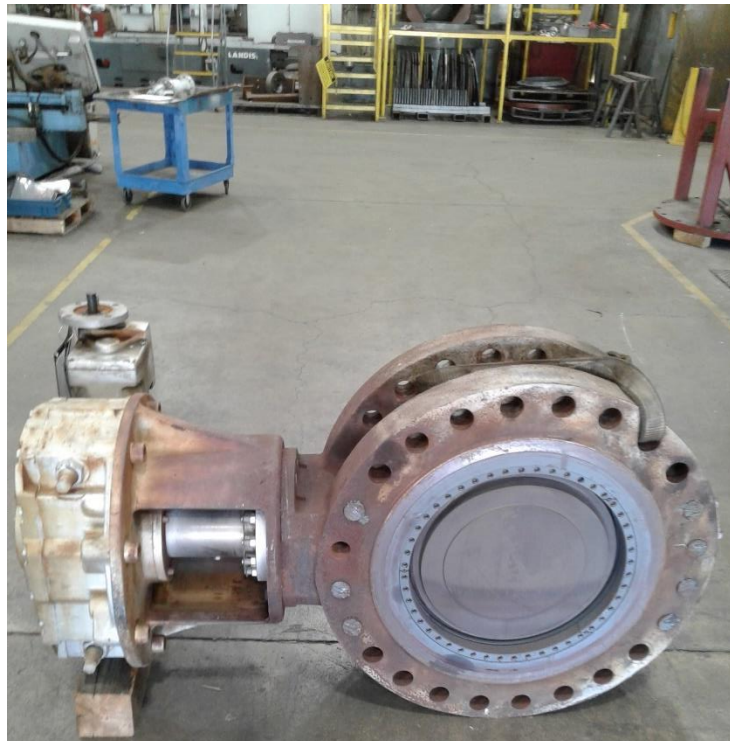
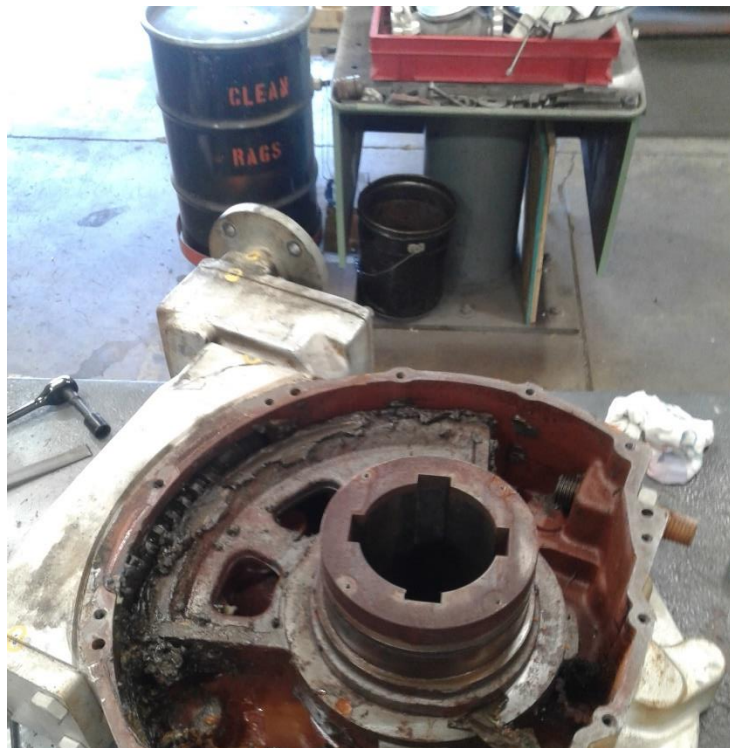
Figure 35. Images from the Bay Valves service center showing the HRSG 1 CRH stop valve (upper image) as received and disassembled gearbox (lower image).

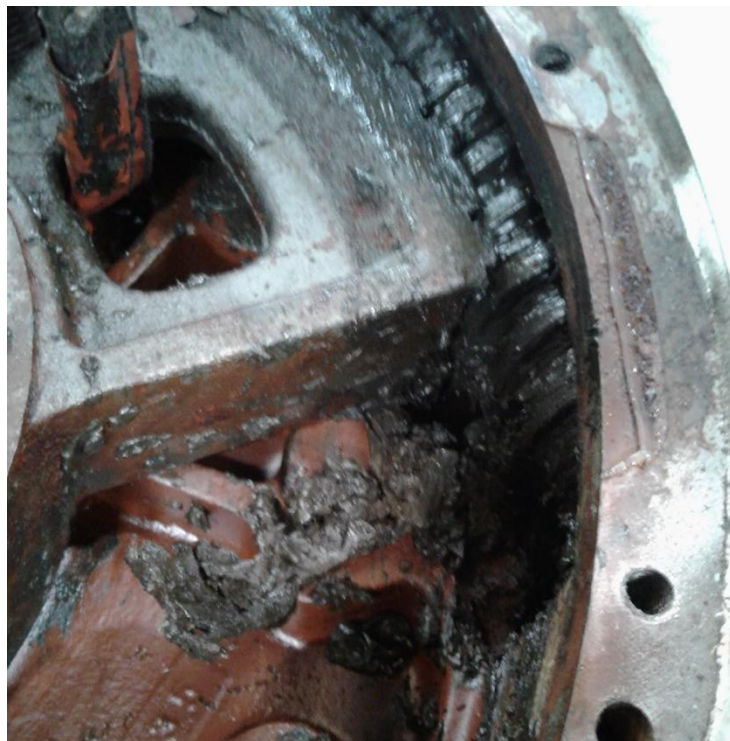
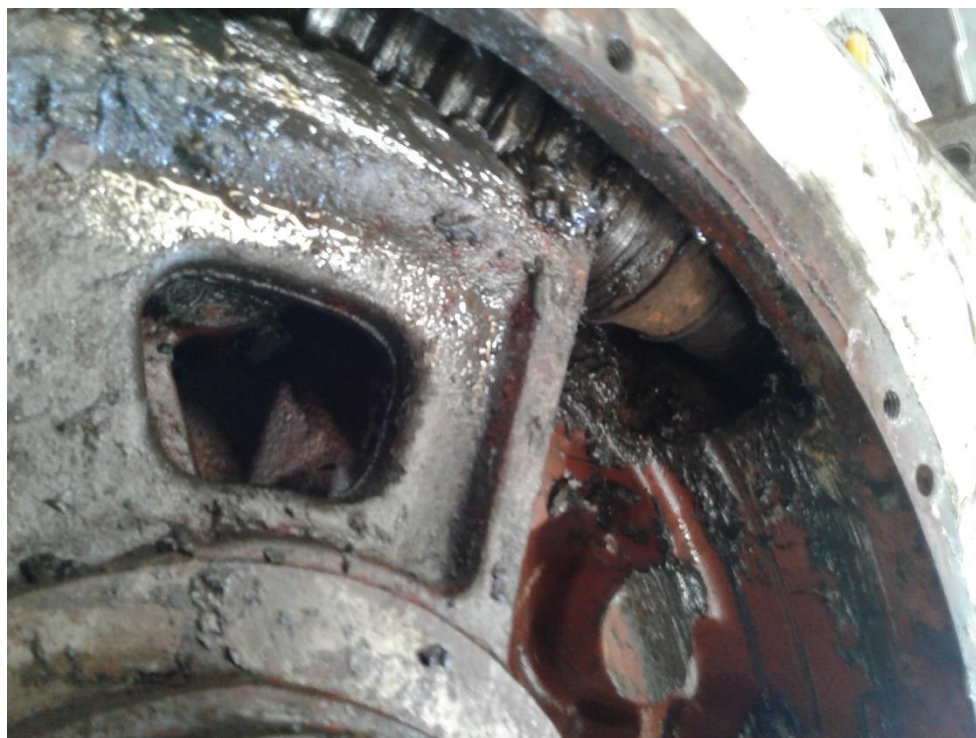
Figure 36. Additional images from the Bay Valves service center showing the disassembled gearbox.

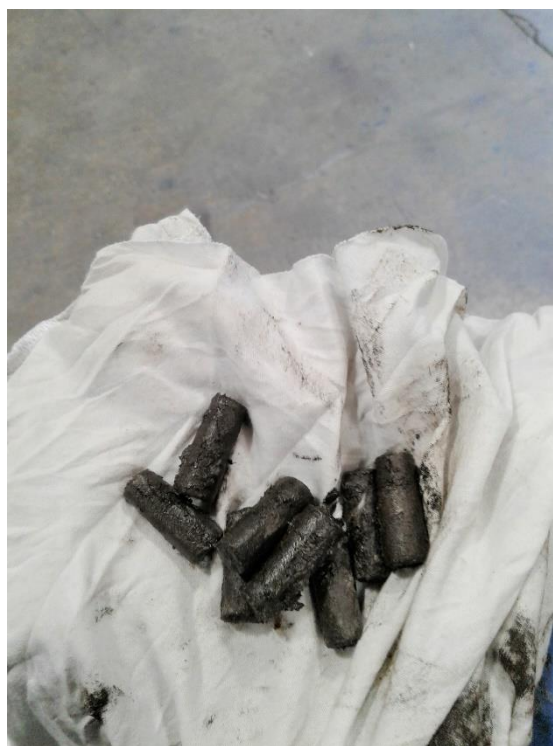
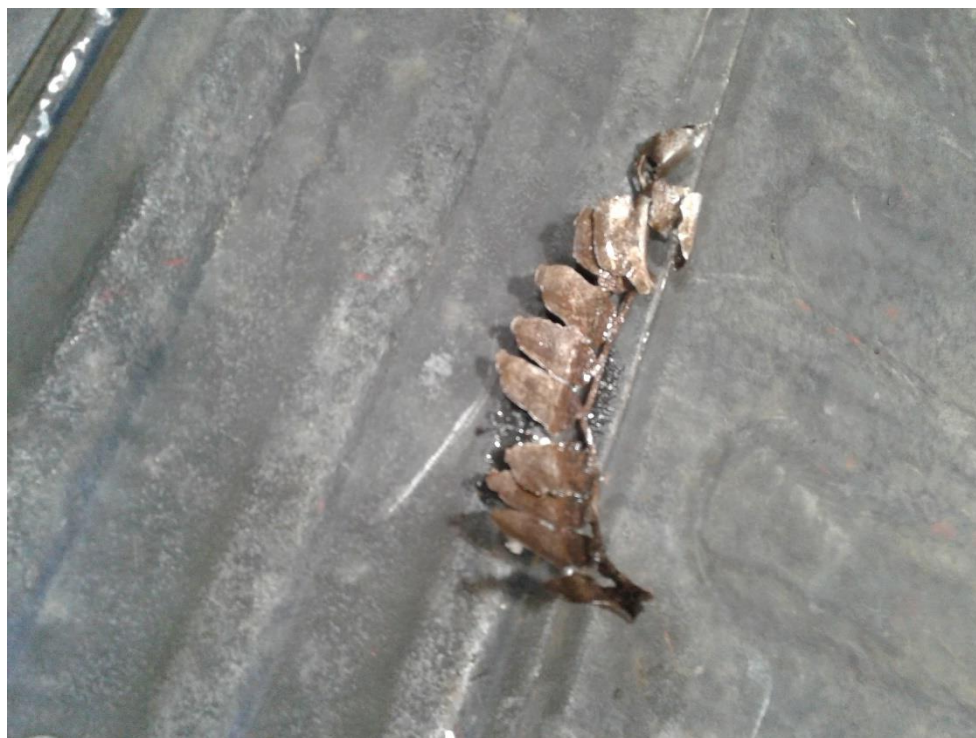
Figure 37. Images from the Bay Valves service center showing the HRSG 1 CRH stop valve damaged gearbox bearing components.
