| <b>DOCKETED</b> | |
|---|---|
| <b>Project Title:</b> | STACK SVY03A Data Center Campus |
| <b>Document Title:</b> | SVY03A SPPE Application Appendices C-E - Part IV of VI |

## Arborist Report 2023

Subject Re: Tree removal and replacement for new building construction at 26062 Eden Landing Road, Hayward, CA 94545

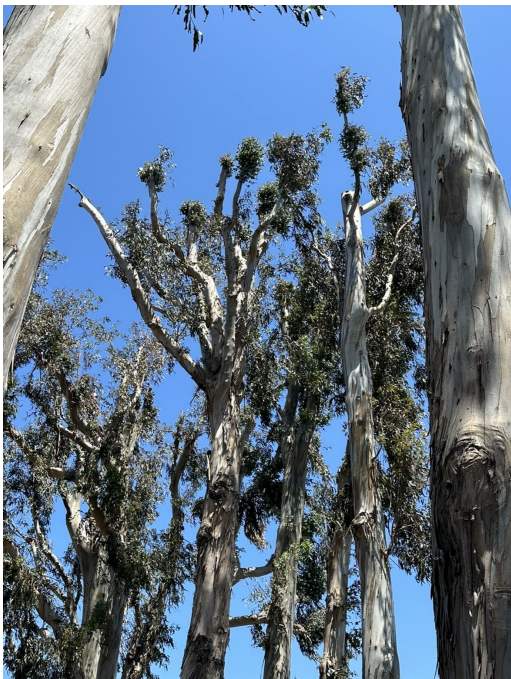
There are 50 trees on the property, 47 of which are protected (#1-18 & 20-48). All of the trees surveyed are proposed for removal to facilitate the proposed construction. 32 of the trees surveyed are in poor condition (#2-5, 8, 10, 13, & 25-48). Trees (#1, 6-7, 9, 11, 12, 14-16, 20-24, 49, and 50). No trees were given good or excellent tree condition ratings. A large grove of Blue Gum Eucalyptus trees were observed at the center of the property (#25-48). Recent eucalyptus tree failures were observed in the grove. All of the eucalyptus trees have been topped and are recommended to be removed regardless of the proposed construction as they are hazardous to the site. The site at Eden Landing Road looks to be in fair condition; various trees have not been well maintained in the past. The topography of the land is flat. All of the trees will need to be replaced per the appraised values of the trees. **(Picture showing topped eucalyptus trees)**
