### **Inverters Behaving Badly**

Lou Fonte Senior Advisor, Grid Assets

California Energy Commission IEPR Workshop June 20, 2018

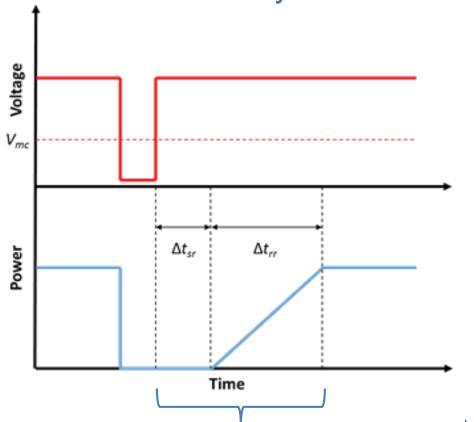
### Momentary Cessation Example

**V**<sub>mc</sub>: voltage threshold where momentary cessation occurs

**Δt**<sub>sr</sub>: delay of current injection after voltage recovers

$\Delta t_{rr}$ : ramp duration of recovery in current injection

Inverters often return within <u>tens of</u> <u>seconds</u> when voltage conditions stabilize.

NERC Alert recommends that delay time be no longer than <u>0.1 sec</u>, and the total time to return upon voltage stabilization no longer than one sec
