STAFF REPORT

Russell City Energy Center May 2021 Incident: Root Cause Gap Analysis

April 2022 | CEC-700-2022-004

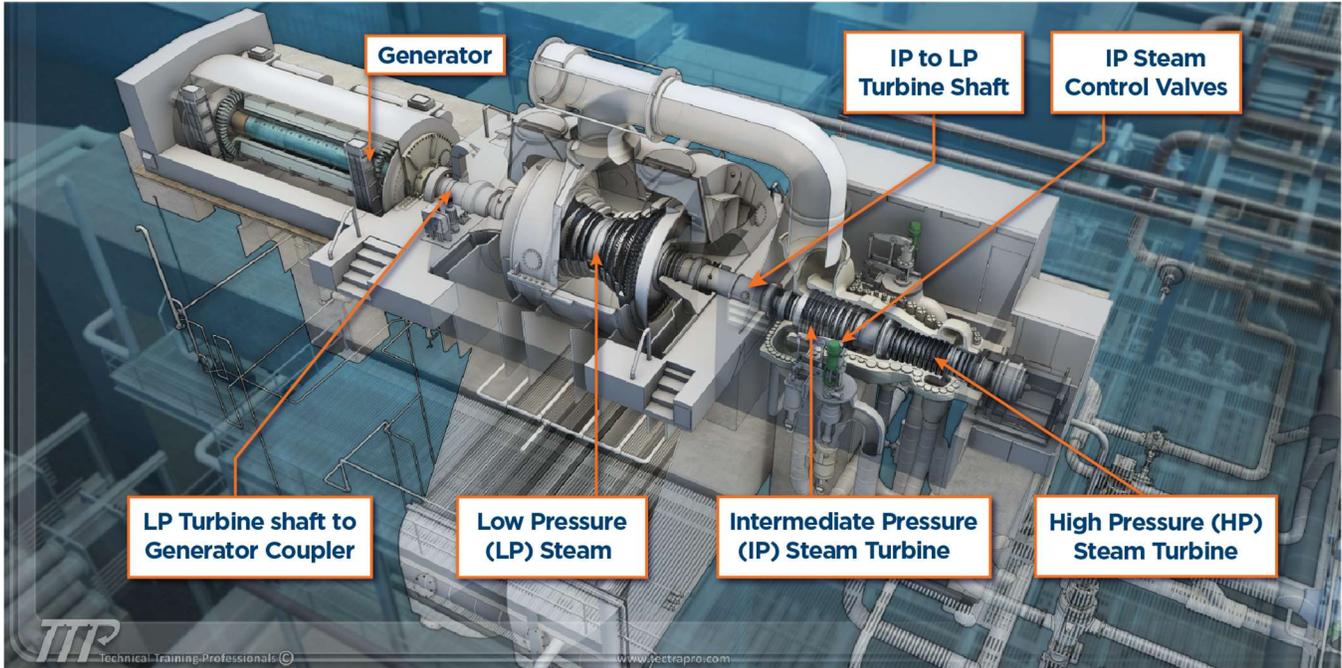
Figure 2.1: Steam Turbine Generator

During the initial onsite inspection, the CEC staff observed that the STG shaft was fractured at the exit point of the intermediate pressure (IP) section to the low-pressure section, and the shaft was ejected from the STG. The CEC staff examined the turbine shaft that entered the low-pressure (LP) section and found that the shaft was twisted. The metal casing of the LP section had separated, breaking bolts in the process.

The black charring and soot in the area around the casing were clear evidence that there was a fire at the exit of the LP section to the steam turbine's generator. The LP section casing was severely damaged from the overspeed event. The drive shaft connecting the LP section to the generator was fractured at each end and had been thrown from the enclosure.

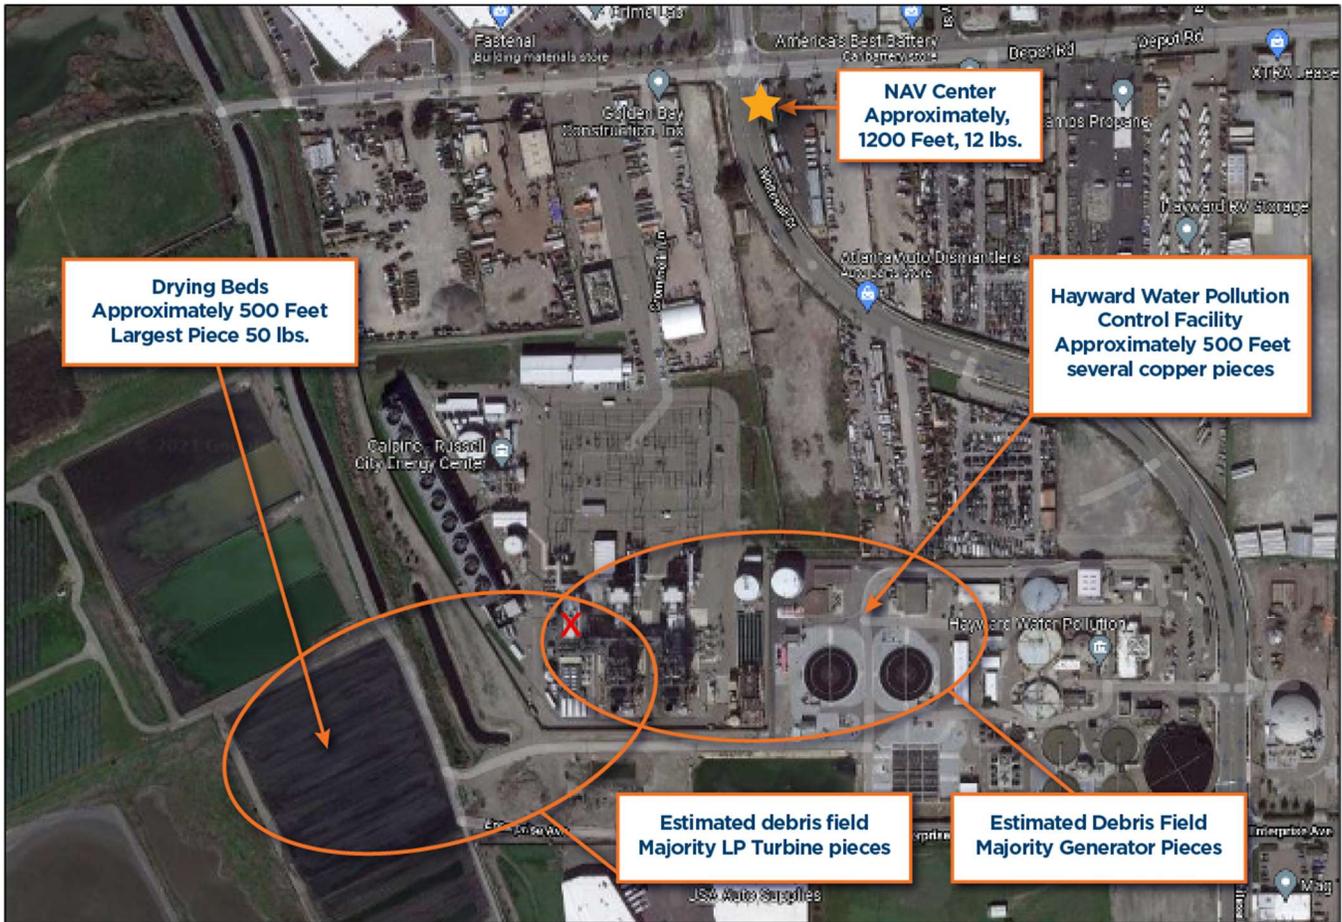
Figure 2.2: Debris Field

Steam turbine generator debris field

The CEC staff then inspected the Hayward Navigation Center complex and met with the Housing Care Coordinator for Bay Area Community Services, the organization that operates the Hayward Navigation Center. Using data from the inspections at the HPWCF facility and the Hayward Navigation Center complex, the CEC staff created a map of the metal pieces found (Figure 2.2). Most of the metal pieces were found to the west of RCEC. These steel metal pieces ranged up to 50 lbs. Most of the small copper pieces of metal were found toward the east side of the power plant. The locations of the metal pieces released during the overspeed event are consistent with having been thrown from a rotating shaft.

The outlier of the debris field is the 12-pound piece of the LP turbine blade root. The blade root was discovered in the Hayward Navigation Center complex (Figure 2.2). The Hayward Navigation Center complex has multiple trailers on site serving people experiencing homelessness. The trailer used for meal preparation and eating was damaged when the 12-

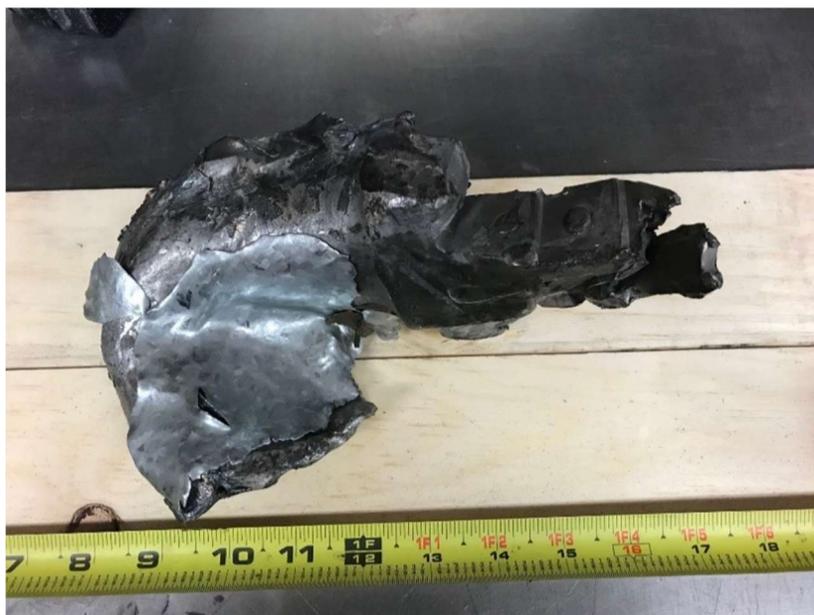
Figure 2.3: RCEC Metal Piece

pound metal piece traveled 1,200 feet, penetrated through the trailer's roof, and landed on the floor (Figure 2.3). No individuals were in the trailer at the time since it was after operating hours. There was no damage to the floor of the trailer.

The metal piece traveled approximately 1,200 feet and weighed 12 lbs.
Credit: Hayward Navigation Center Staff

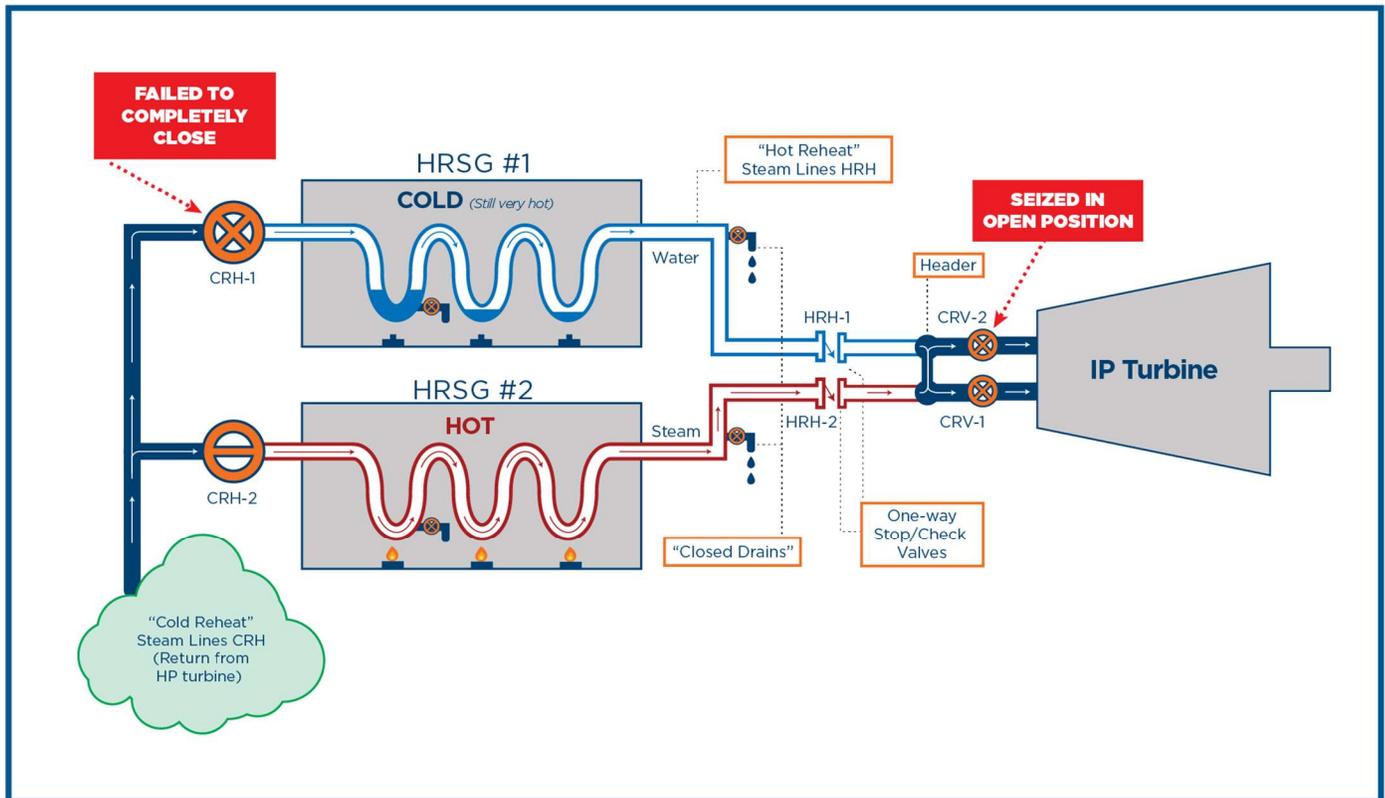
Figure 3.1: Russell City HRSG Reheater Schematic

Over the two days operating in that 1x1 configuration, the steam produced in HRSG-2 continued to leak past the CRH-1 valve into the offline and much cooler HRSG-1 causing the steam to condense into water. Enough water condensed in the offline HRSG-1 to collect a substantial quantity of water in the section of the offline HRSG-1 known as the reheater (Figure 3.1). Because of the large quantity and high temperature of the condensing superheated steam, the condensed water remained near its boiling point and at an elevated pressure.

Schematic of RCEC’s HRSG reheater path to the IP section of the steam turbine

1. Steam leakage past the not-completely closed CRH-1 steam isolation valve allowed water to condense and accumulate in the out-of-service HRSG-1 reheater section.
2. Accumulated water was not detected and drained from the HRSG-1.
3. The HRH-1 stop/check valve in the steam line between the HRSG-1 reheat section and the STG had not been closed into a blocked position which allowed the water to be drawn into the IP section of the STG as described above in "Incident Causation."
