PROJECT: Eastern Colorado Desert Preserve

RE: WHF 2021 Annual Monitoring Report

2021 Monitoring Site Form

Eastern Colorado Desert Preserve

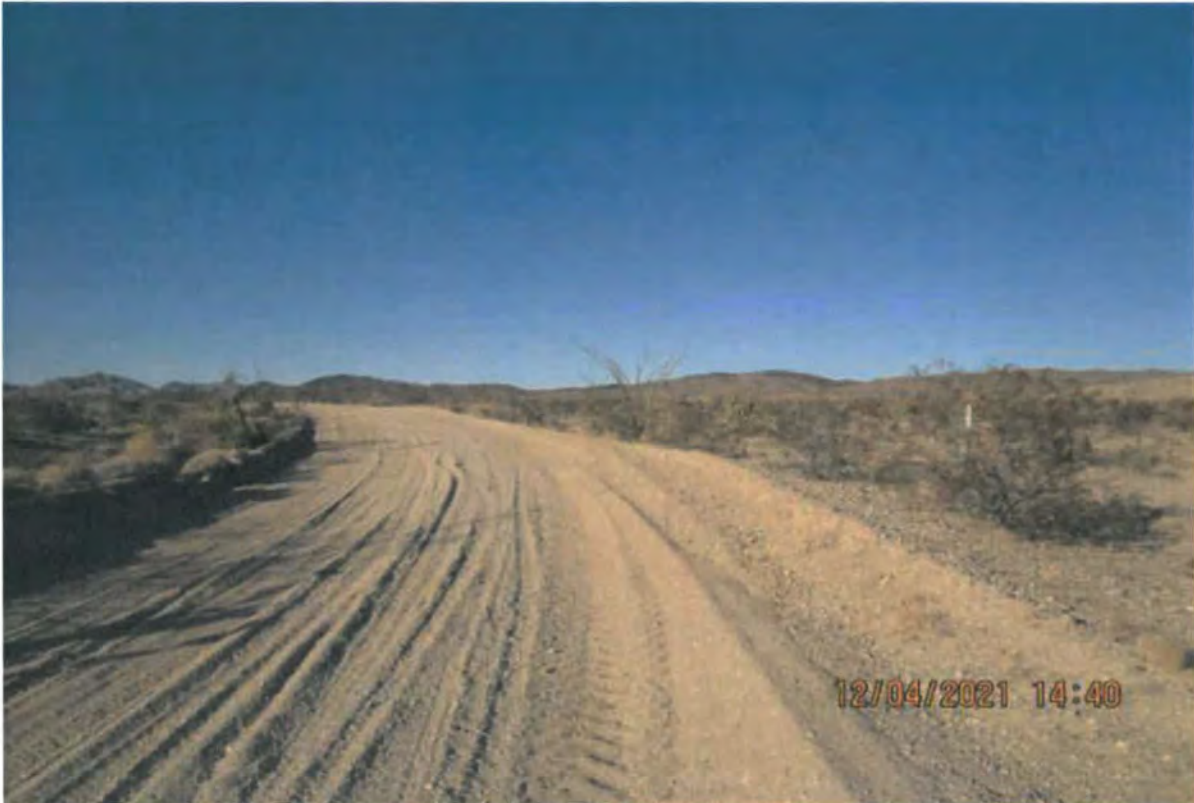
Bradshaw Trail, a public thoroughfare, occurs along the west edge with Wildlands Inc. signs posted along the northeast side (ECDP 1 Photo 5). There is no evidence of recent intrusion from Bradshaw Trail onto the Property.

5. View looking northwesterly along Bradshaw Trail from the southern edge of the Property (660,903mE, 3,702,612mN).

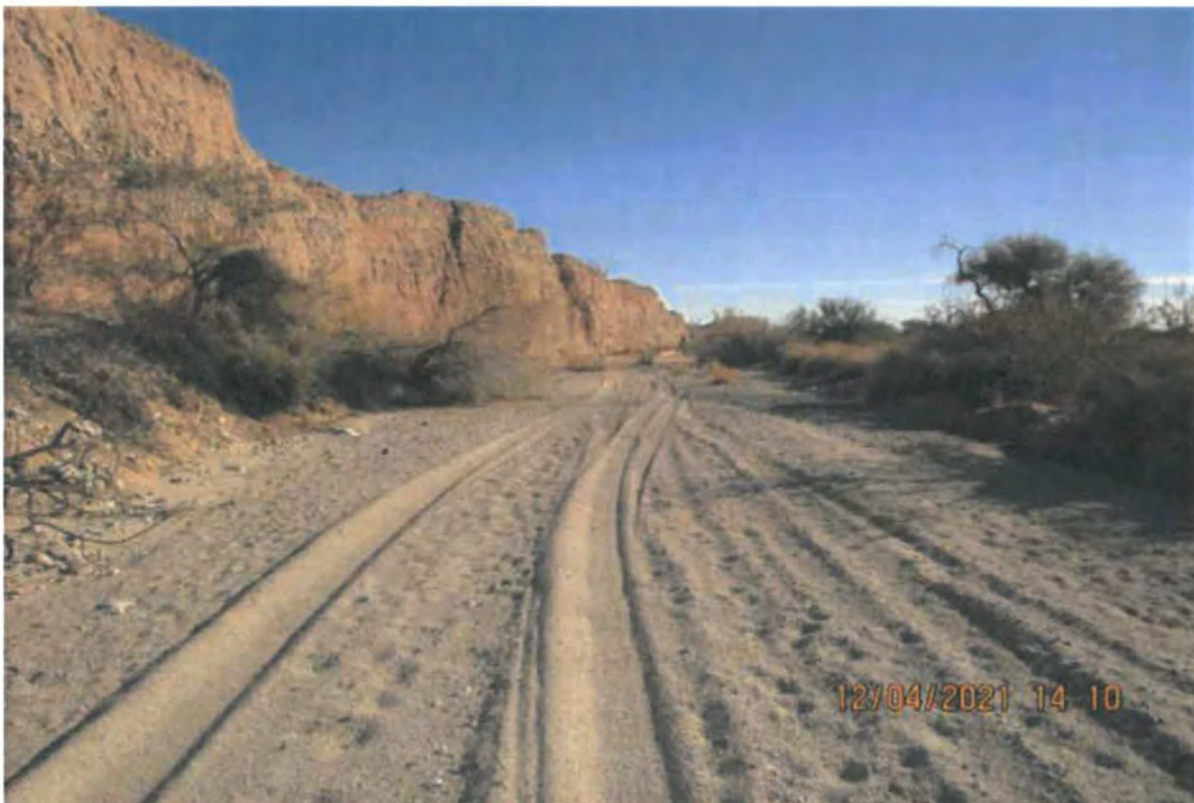
Recent OHV use was evident in the main wash of Arroyo Seco as well as in its feeder washes (ECDP 1 Photos 6-7). The Site was accessed from Bradshaw Trail, south of the Property. Older vehicle tracks are present along ridges in the east portion (ECDP 1 Photo 8), but there is no evidence of recent use.

6. View looking southerly at recent OHV tracks in Arroyo Seco (661,259mE, 3,702,751mN).

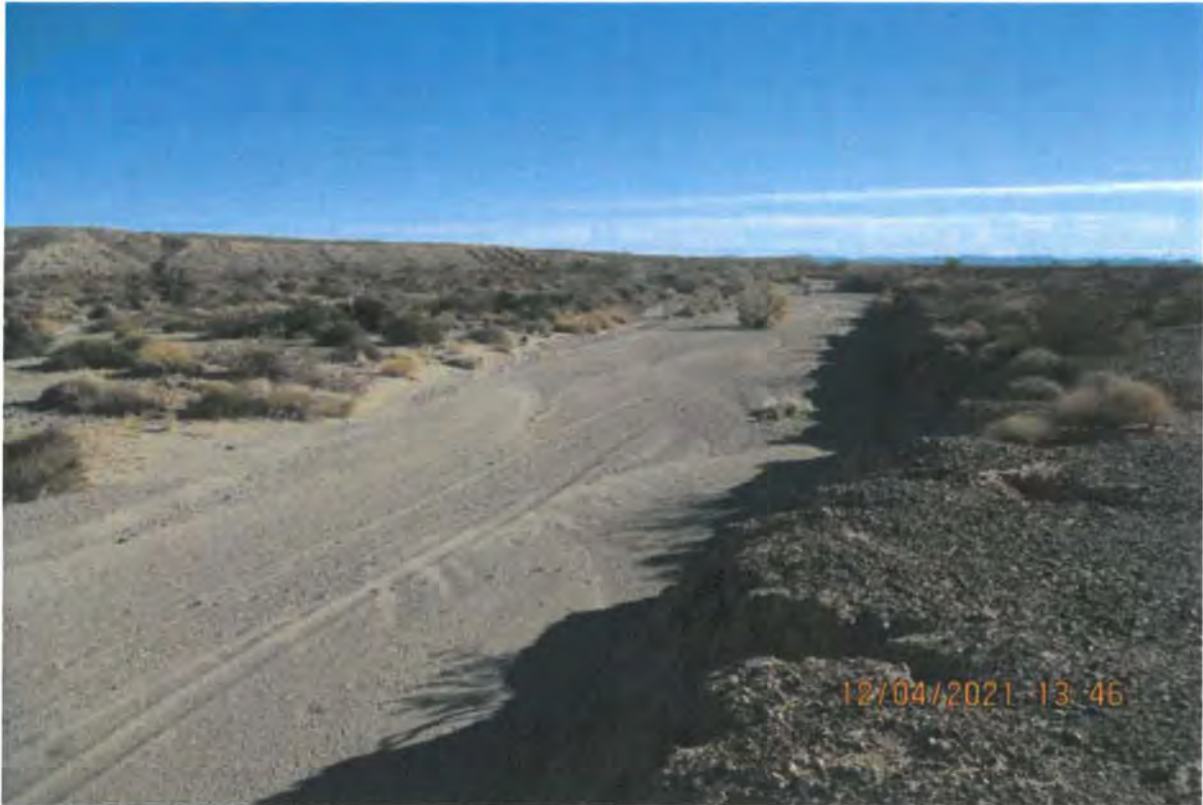
7. Looking southeasterly at recent OHV tracks in a tributary of Arroyo Seco as seen from the north portion of the Property (660,816mE, 3,703,311mN).

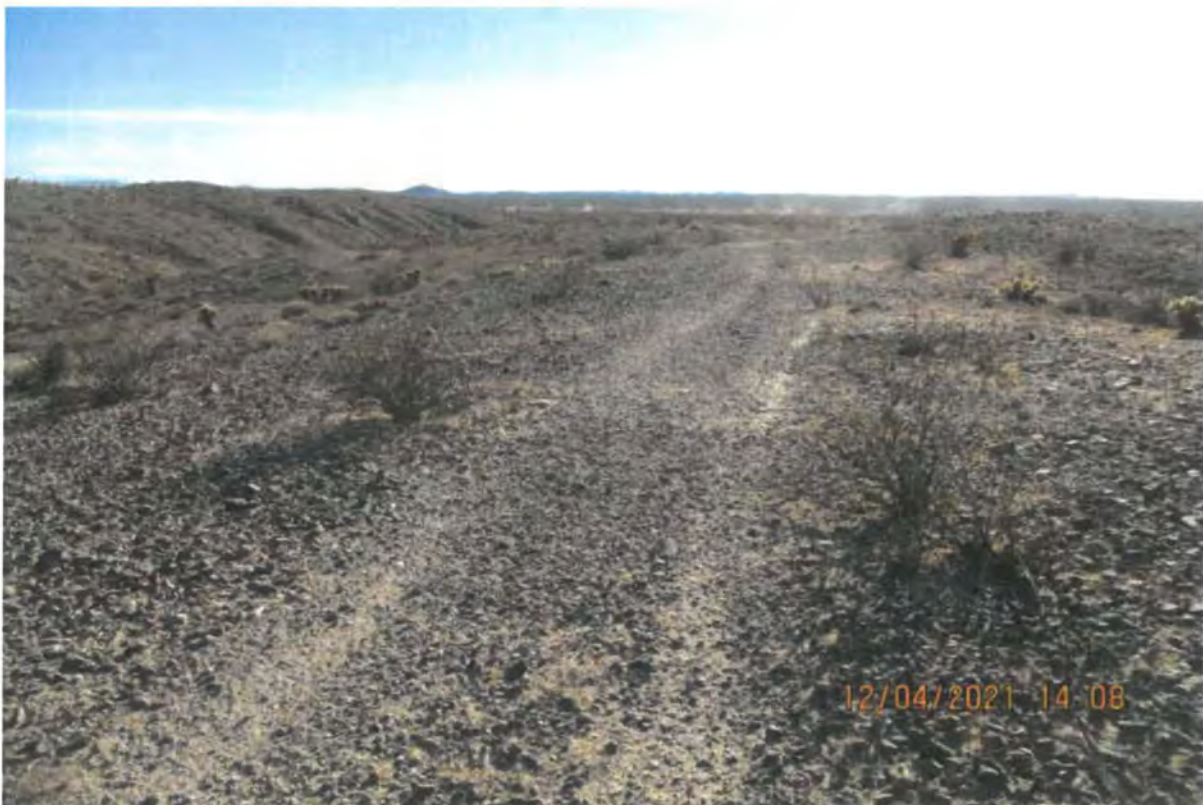
8. View looking southerly from the north edge of the Property at old OHV tracks along a north-south trending ridge located in the eastern hilly portion (661,425mE, 3,703,339mN).

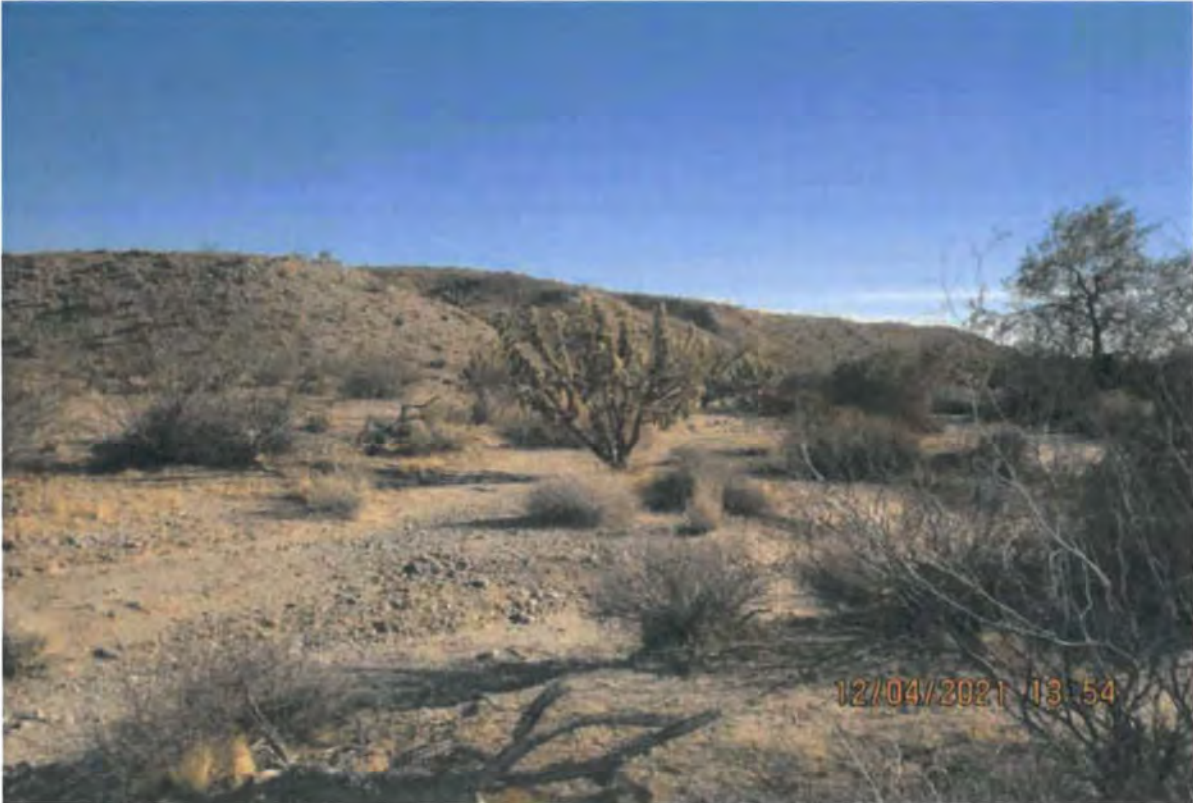
ECDP 1: The rare (endemic) Munz cholla (*Opuntia munzii*) is on-site (ECDP 1 photo 9).

9. Several rare Munz cholla are located on the Property; this individual is located in the north-central portion of the Property (661,108mE, 3,703,267mN).

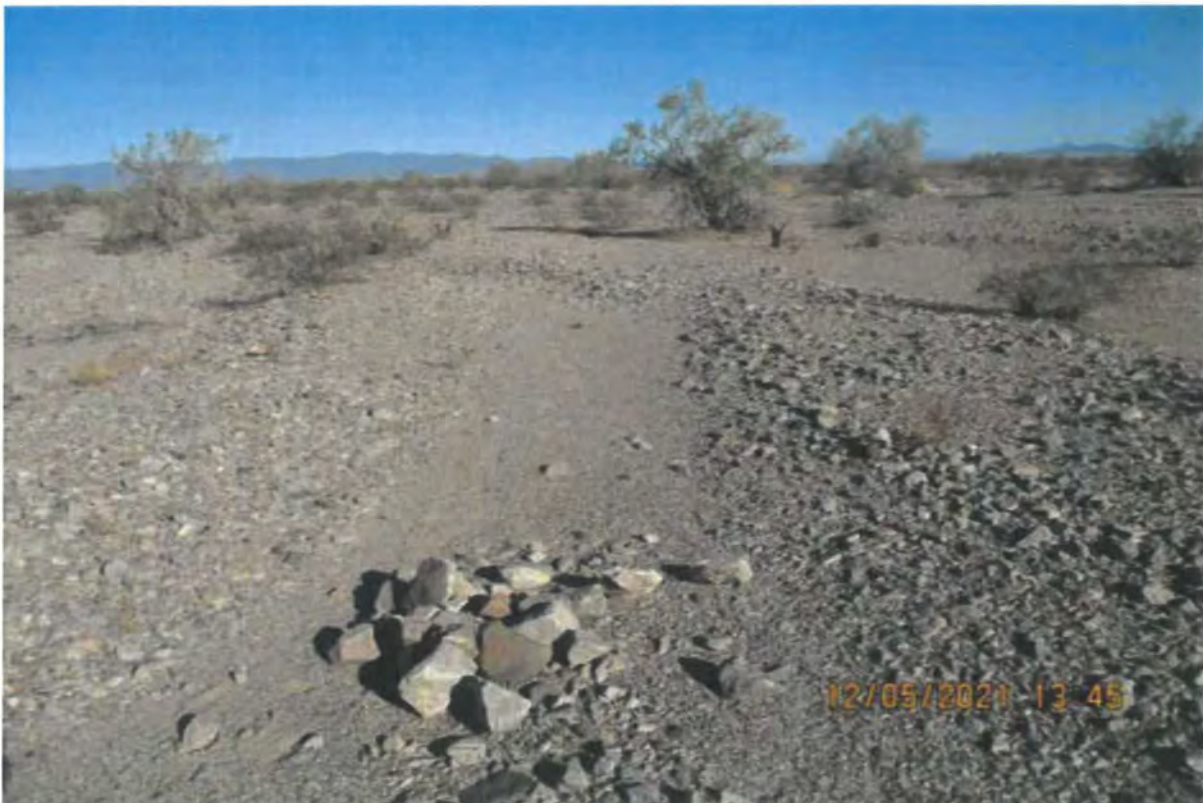
2. View looking northeast from the southwest corner; note the collapsed rock cairn (675,651mE, 3,714,418mN).

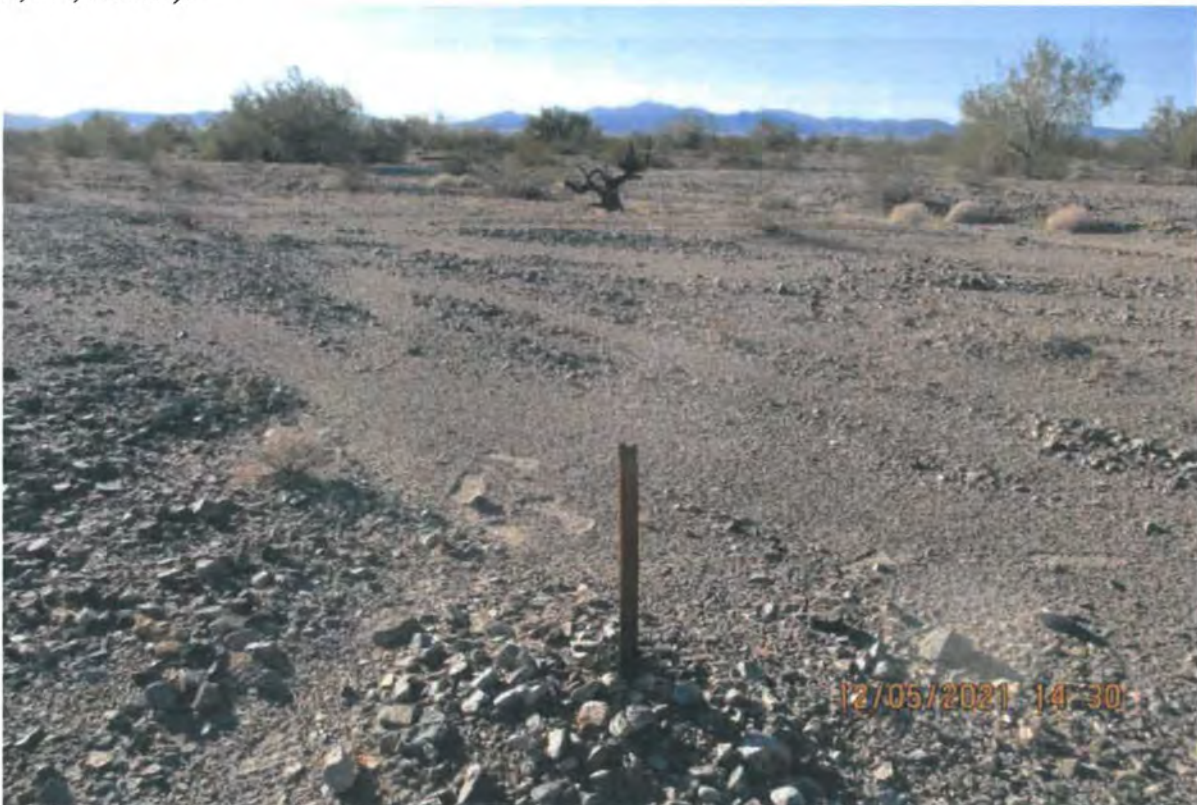
4. View looking southwest from the northeast corner of the Property; note the wood stake. The fresh footprints are made by others that have recently visited the corner (676,434mE, 3,715,240mN).

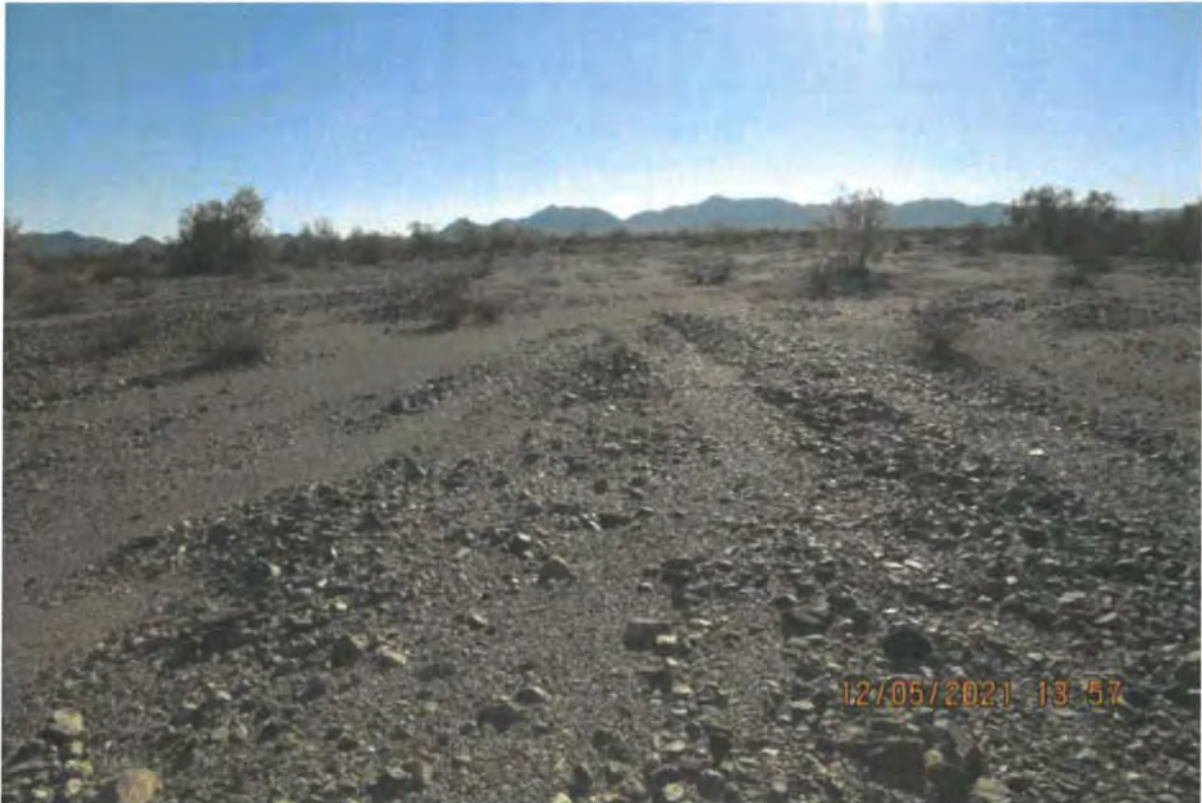
The Property is crisscrossed by Patton-era tank and vehicle tracks (ECDP 2 Photo 5; 676,099mE, 3,714,635mN), but no new vehicle pathways are present.

5. View looking south at an example of Patton-era tank and vehicle tracks found throughout the Property (676,099mE, 3,714,635mN).

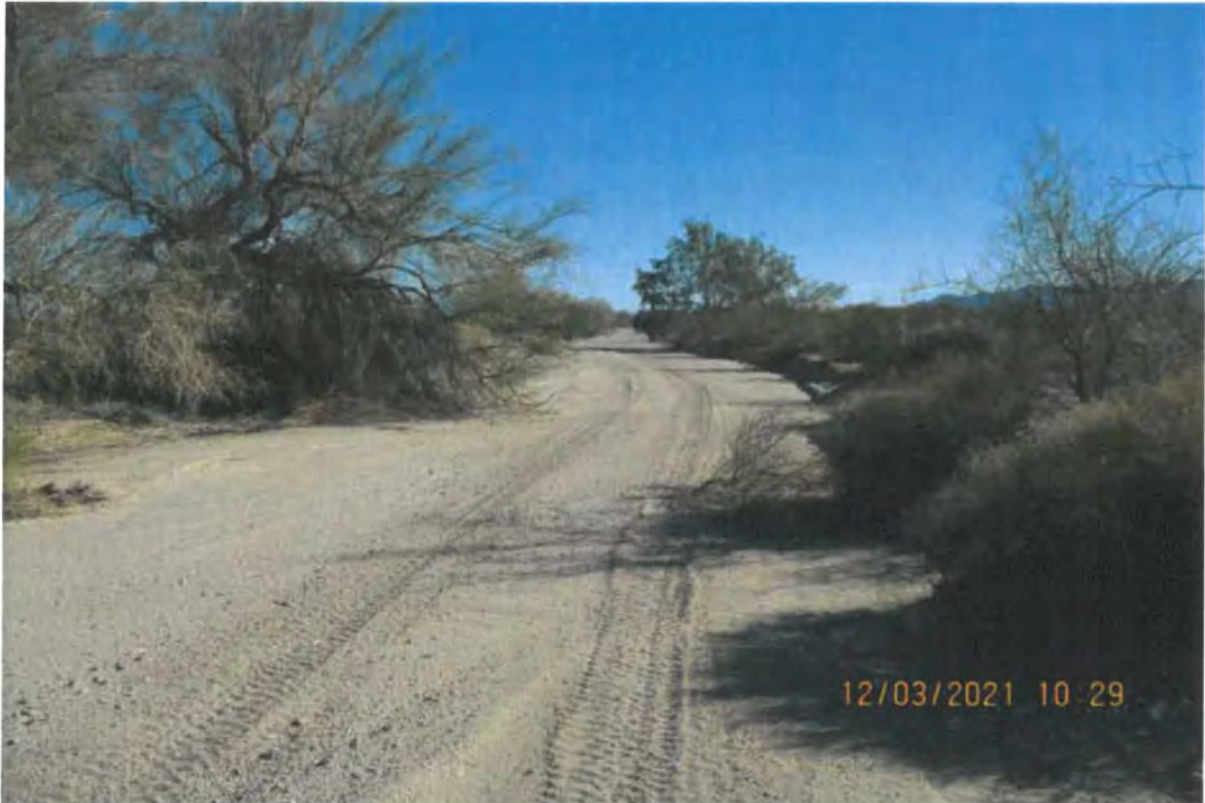
The washes are used as OHV trails (ECDP 4 Photo 5; 640,933mE, 3,731,471mN). WWII tank tracks are present throughout the Property (ECDP 4 Photo 9 640,889mE, 3,730,127mN).

Recreational use of the washes is evident from OHV track, especially in the northern portion.

5. An example of recent OHV use of on-site washes. View is looking easterly along the north edge of the Property (640,933mE, 3,731,471mN).

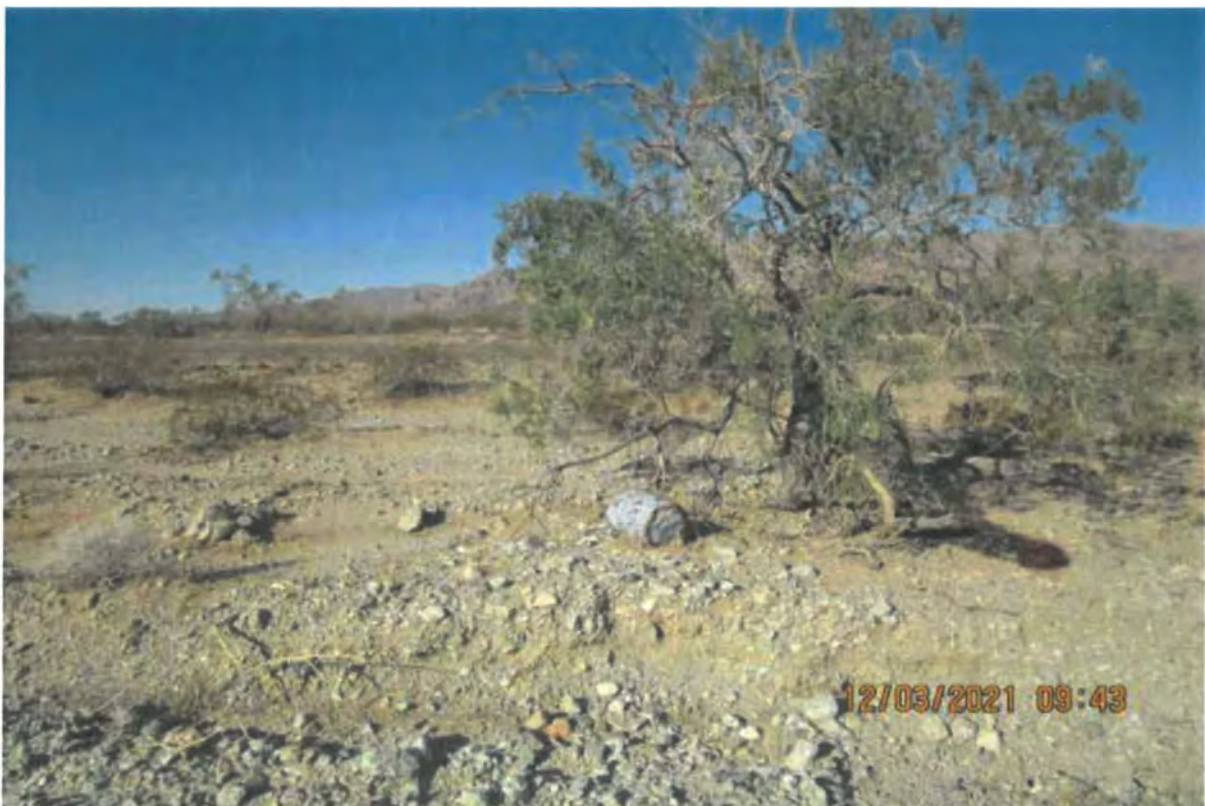
There is a moderate number of debris scattered through the Property. Most trash is old, but there is some recent trash likely blown in from the highway (ECDP 4 Photos 6, 8, 12).

6. A five-gallon water can (suspected military waste) found in the central portion of the Property (641,138mE, 3,730,355mN).

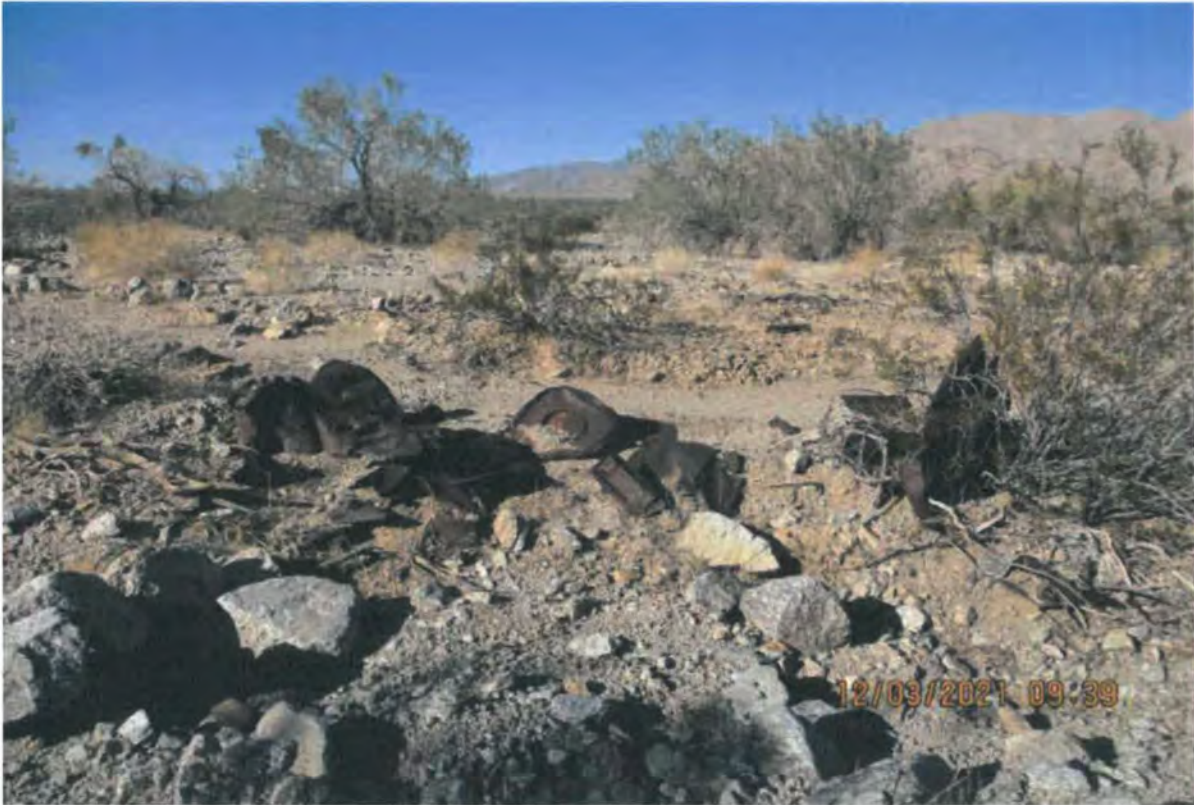
7. Partially buried disintegrating/dismantled 55-gallon drums (2-3) that contain a hardened petroleum product found ~ 350 feet north of the southwest corner of the Property (640,893mE, 3,729,960mN).

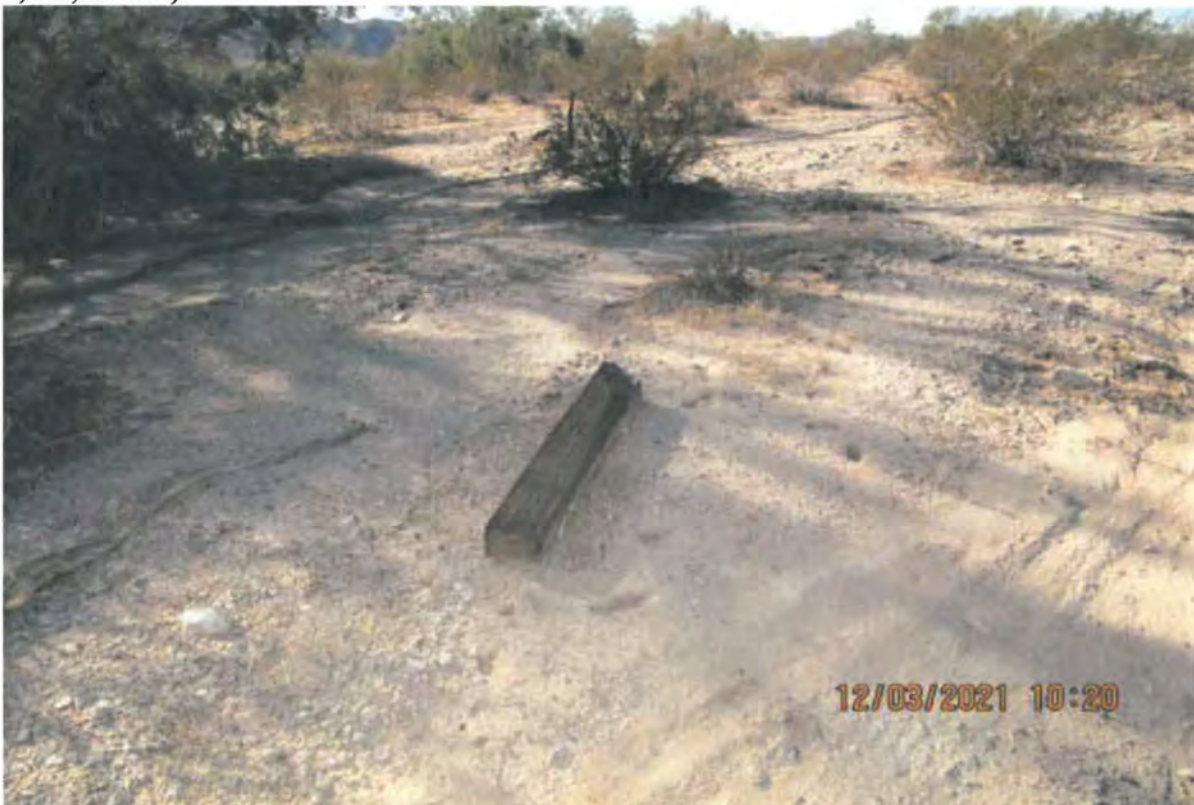
8. One of roughly two dozen sections of pressure-treated railroad ties that are widely scattered over the north portion of the Property (641,088mE, 3,731,246mN).

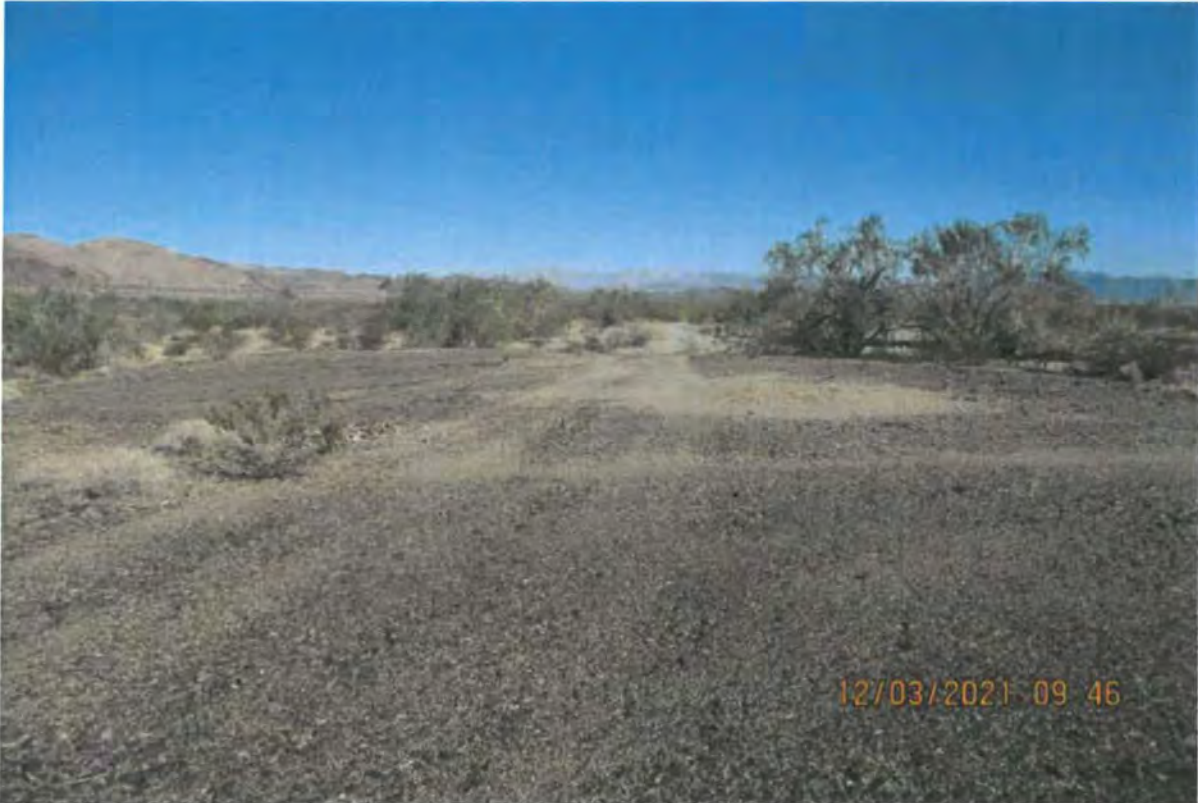
9. Looking northeasterly at Patton-era tank tracks as seen from the west edge of the Property (640,889mE, 3,730,127mN).

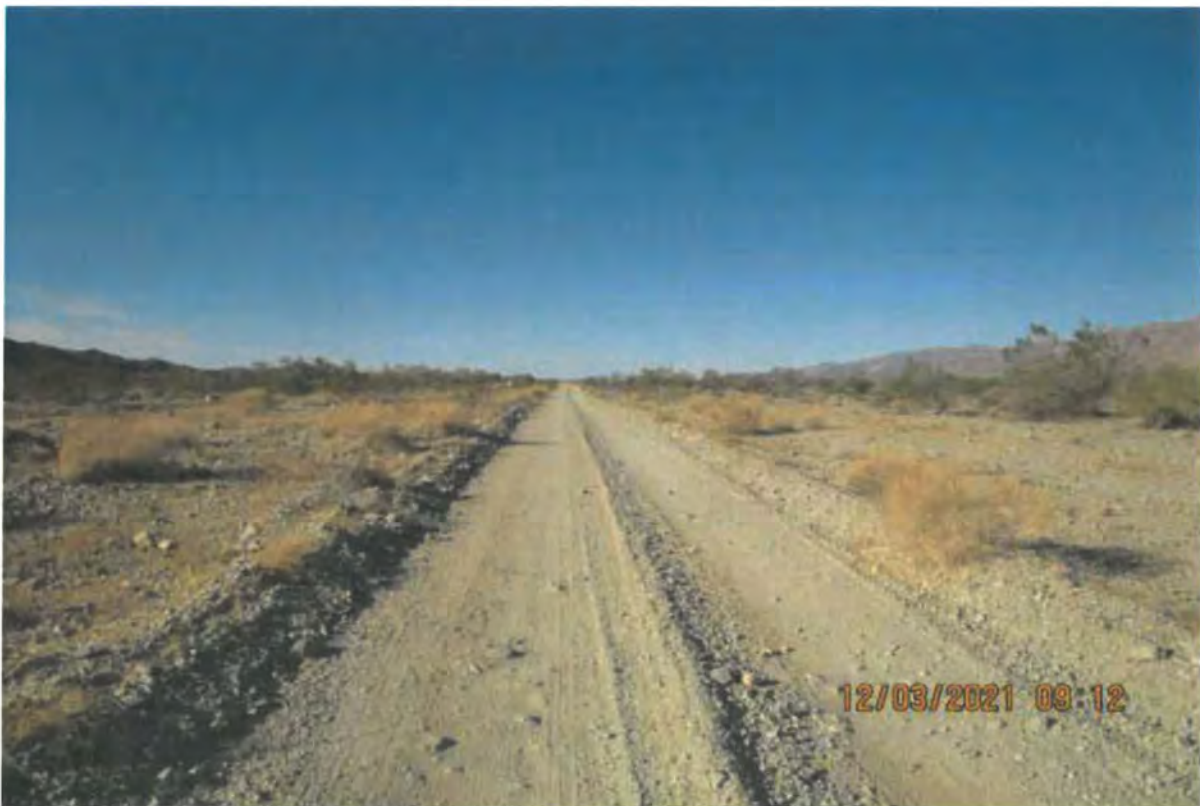
There is a maintenance road associated with the underground natural gas pipeline immediately south of the property (ECDP 4 Photo 10).

10. Looking southwesterly along the high-pressure natural gas pipeline that is adjacent (south) of the southeast corner of the Property (641,302mE, 3,729,859mN).

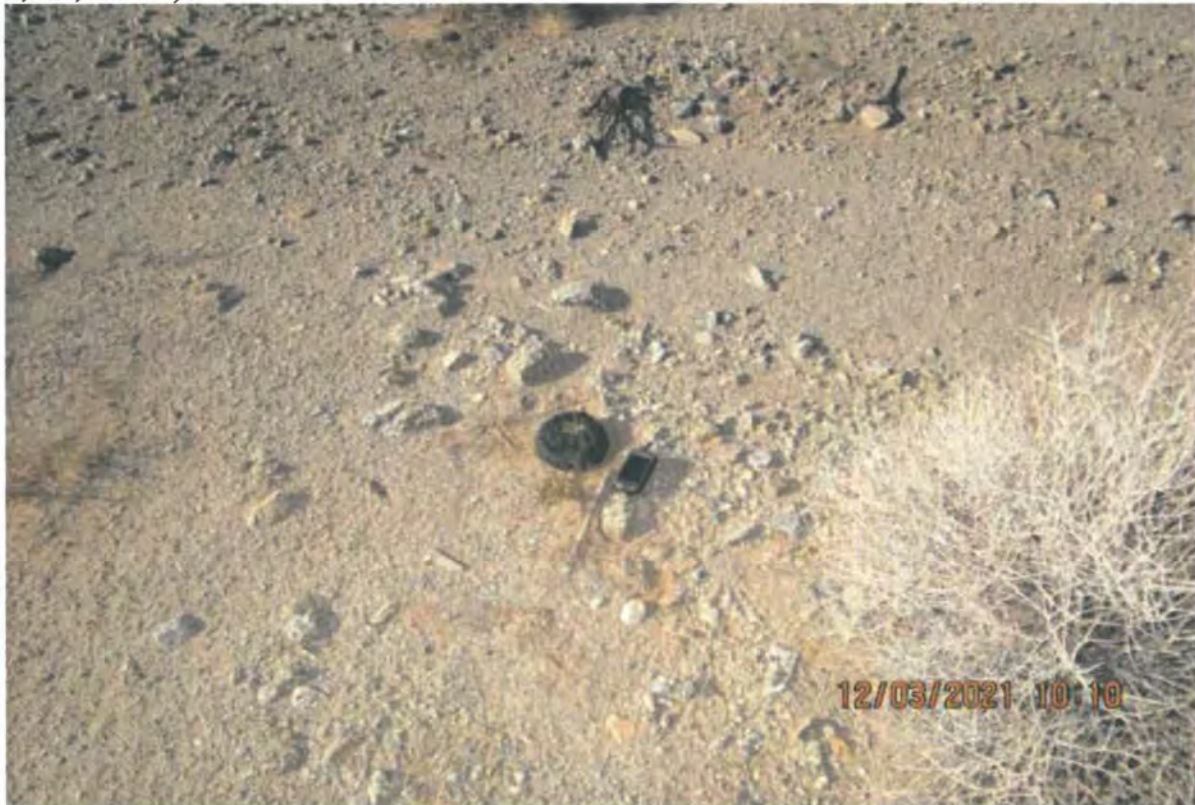
12. One of a handful of tar globules found on-site (640,997mE, 3,730,970mN). This material is identical to the material found at the 55-gallon drums located at the southwest edge of the Property (see photo 7).
