Mr. Fred Redell  
Abengoa Solar  
11500 West 13<sup>th</sup> Avenue  
Lakewood, CO 80215-4406**Subject: Abengoa Mojave Solar Project Compensatory Mitigation Site Details**

### Mojave Solar Mitigation Site Assessment

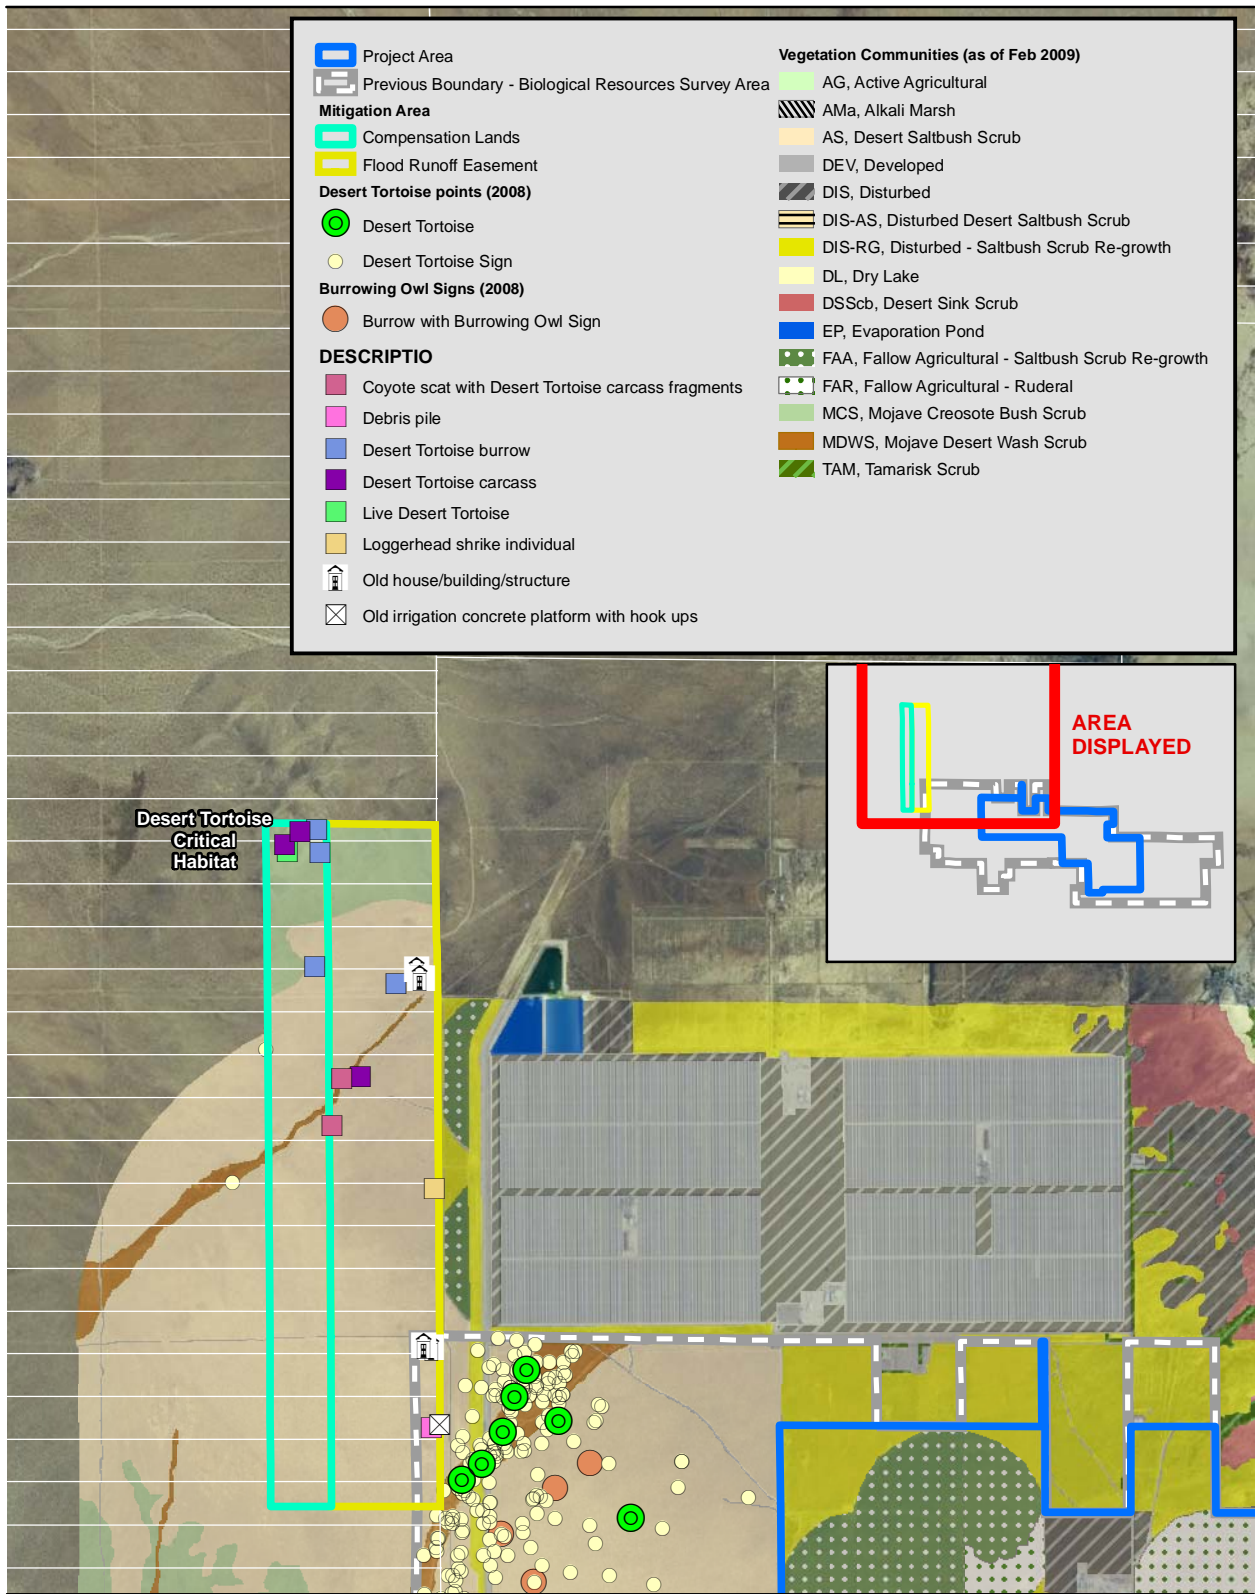
## Mitigation Site Assessment Results

The enclosed figure, titled "Mitigation Site Assessment Results," shows the proposed 118.2 acre proposed compensatory mitigation site ("Site"), located northwest of the Project site. The figure also depicts the biological resources documented within and adjacent to the Site, as well as the location of existing abandoned structures and debris piles. The pertinent items are discussed in the following sections relating to the remaining three items requested by the CEC.

Overall disturbance of the Site is very low. There are few dirt roads (two small narrow roads traverse the Site east to west) and no large berms, ditches, or other signs of site disturbance. There are five partially or almost completely demolished structures (each consisting of a foundation and portions of standing walls) located entirely within the flood runoff easement lands to the east of the Site. The locations of these structures are depicted on the enclosed "Mitigation Site Assessment Results" figure. The structures are all made of stone and cement and appear to have been store houses or buildings used during historical sheep ranching, adjacent on the eastern side of the Site. Old sheep bones are scattered throughout the Site, indicating the historical presence of sheep. One main barbed wire fence is located along the eastern border of the flood control easement. One additional barbed wire fence exists within the Site and runs east to west along one of the dirt access roads. This fence is very old and does not appear to be hindering the movements of any wildlife. There are two debris piles located within the flood runoff easement to the east of the Site. One debris pile is located next to some of the old structures in the northern section of the Site, and the other debris pile is located in the southern section of the Site adjacent to an old irrigation platform (see the "Mitigation Site Assessment Results" figure). Both of these debris piles consist of old tires, plywood boards, and various metal scraps.

As noted in the discussion of Item 2, above, the disturbance of the Site is relatively low. No structures or debris piles are present on the Site. Therefore, no additional work is required to remove any impediments to having the Site provide compensation for Project impacts to biological resources, prior to conserving the land.
