**BEFORE THE PUBLIC UTILITIES COMMISSION OF THE STATE OF CALIFORNIA**

**ORDER INSTITUTING INVESTIGATION REGARDING  
SAN ONOFRE NUCLEAR GENERATING STATION  
UNITS 2 AND 3**

Attachment A: July 18, 2012 San Onofre Nuclear Generating Station – NRC  
Augmented Inspection Team Report

On March 19, 2012, an Augmented Inspection Team (AIT) was dispatched to San Onofre Nuclear Generating Station to gather facts and understand the circumstances surrounding the January 31, 2012 Unit 3 primary-to-secondary leak and failure of eight steam generator tubes to maintain structural integrity as required by plant technical specifications during testing the week of March 13, 2012. The primary-to-secondary leak was the result of a single tube in Unit 3 steam generator 3E0-88 failing to maintain structural integrity.

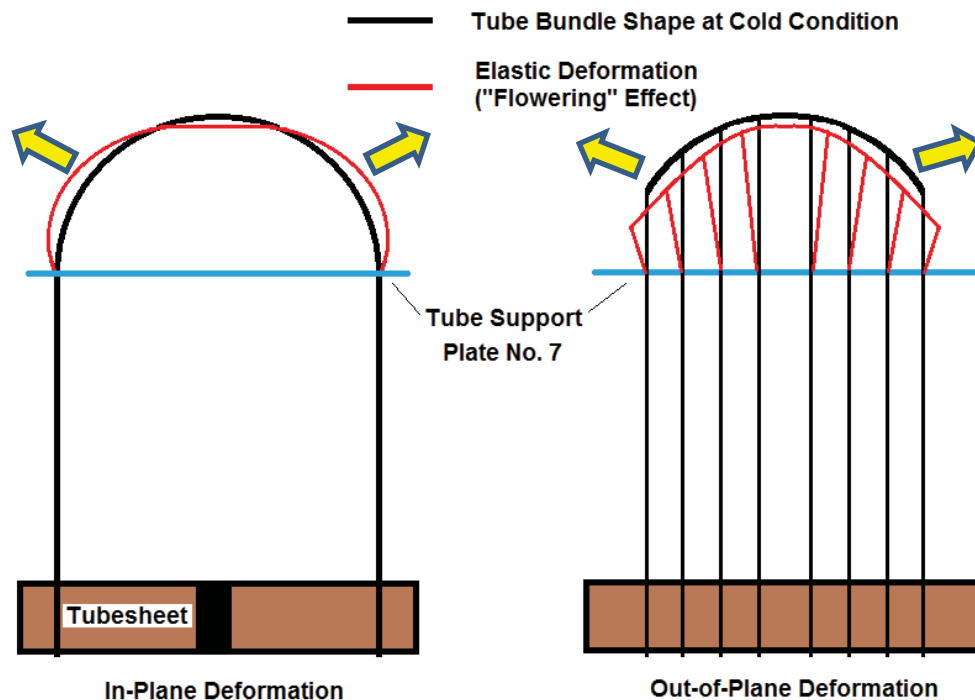
### Description of "Flowering" Effect (Conceptual Drawing – For Illustration Purposes Only)

The failure mechanism model also considered a fluid dynamic effect associated with the spreading of the tubes in the U-bend region during normal operating conditions. This effect was informally referred to as "flowering," due to the characteristic shape in which the tube bundle spreads transverse to the plane of the u-bends at normal operating conditions. "Flowering" was described as the elastic deformation of the anti-vibration bar structure and the tube bundle in the U-bend region, as a result of thermal expansion and fluid dynamic pressure acting on the secondary side of the tubes (see figure below). The deformation caused by the "flowering" effect was believed to result in multiple areas of no contact between the anti-vibration bars and the tubes, which minimized resistance to in-plane motion of the u-bend area of the tubes.

Mitsubishi considered that the collective contribution of the factors described above resulted in conditions in the U-bend that were highly susceptible to excessive tube vibration. The in-plane vibration of the tubes in the U-bend region allowed direct contact between free-span sections of the tubes, resulting in the unanticipated tube-to-tube wear.

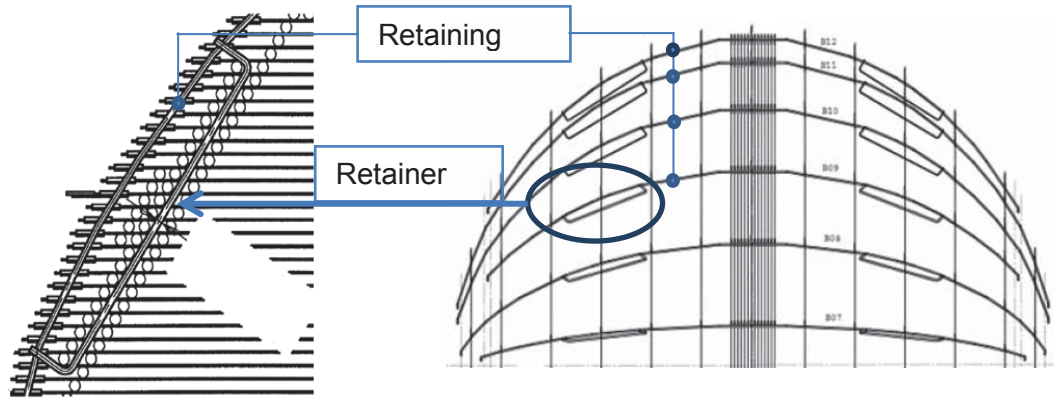
**Retainer Bar Design and Location of Affected Tubes (For Illustration Purposes Only)**

(1) Introduction: The team identified an unresolved item associated with the design of the retainer bars in Unit 2 and Unit 3 replacement steam generators.

Description: In February 2012, the licensee identified wear indications in Unit 2 replacement steam generators at the tube locations in contact with the retainer bars (see figure below). Some of the indications showed excessive wear with a maximum degradation of 90 percent through wall.

The team identified that the design of the replacement steam generators did not expect any potential vibration concerns in the area of the tube bundle where the retainer bars were located. The basis for Mitsubishi's design philosophy relied on the following factors:

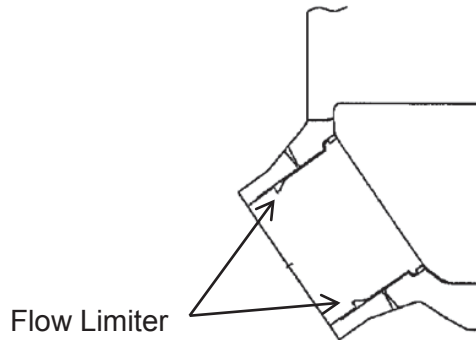
#### **Replacement Steam Generator Primary Inlet Nozzle (For Illustration Purposes Only)**

- Flow Limiter for Primary Inlet Nozzles** – The replacement steam generators were designed with a flow limiter located in the primary inlet nozzle (see figure below) in order to make the reactor coolant system flow similar to the flow rate of the

original steam generator and not exceed the maximum allowable reactor coolant system flow rate. The licensee's evaluation for the engineering design package determined that although the original steam generators had a number of plugged tubes, the reactor coolant system flow rate of the original steam generators was near the design requirement. Because the replacement steam generators has 377 more tubes than the original steam generators, and contained tubes with u-bends versus "square bends", the pressure drop of the replacement steam generators with no plugged tubes would be much less than the original steam generators resulting in a higher flowrate.

The flow limiter was designed to ensure the total "best estimate" reactor coolant flow rate with the replacement steam generators installed would not exceed 106.5 percent of the design volumetric flow rate of 396,000 gallons per minute at a reactor coolant system cold leg temperature of  $T_{\text{cold}} = 540.9^{\circ}\text{F}$ . For Unit 2 replacement steam generators, the flow limiter diameter to nozzle inner diameter ratio was 0.94 while the ratio for Unit 3 steam generators was 0.915 due to Unit 3 reactor coolant pump replacement. The flow limiter dimensions resulted from a scaled model test performed by Mitsubishi and it was designed to be machined as part of the nozzle base metal.

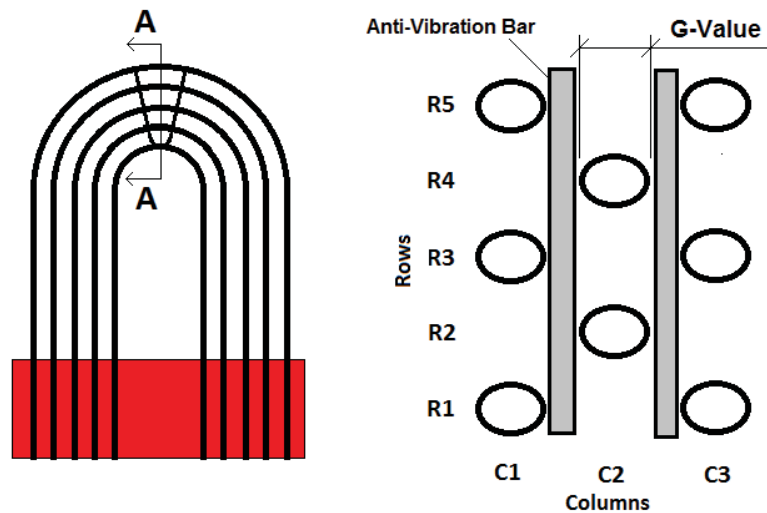
#### Description of G-Value Parameter (Conceptual Drawing – For Illustration Purposes Only)

- Dimensional Controls of Anti-Vibration Bar Structure – According to Mitsubishi's preliminary cause evaluation taking place at the time of this inspection, the controls of critical dimensions affecting the clearances between the tube and the anti-vibration bars were gradually improved throughout the fabrication of the Unit 2 and Unit 3 steam generators. This improvement on dimensional controls was a consideration for the determination of the failure mechanism leading to tube-to-tube wear in Unit 3.

The first dimensional control under consideration was the improvement of tube roundness in the section of the tubes that was bent to form the U-bend shape. During fabrication of Unit 2 steam generator 2E0-89, the supplier of tubular product for Mitsubishi (i.e. Sumitomo), experienced quality issues to meet the G-values established in the design specifications, resulting in a high number of tube rejections. The G-value was a measure of departure from roundness, or "ovality," after the tubes were bent and it was controlled in order to control the gap between tubes and anti-vibration bars (see figure below). The G-values were measured at different locations along the U-bend section of the tubes for a selected number of tubes per row, as established in Mitsubishi's procedure. The acceptance criteria for G-value varied depending on the row where the tubes were installed. The acceptance criteria also remained the same throughout the fabrication of Unit 2 and Unit 3 replacement steam generators.

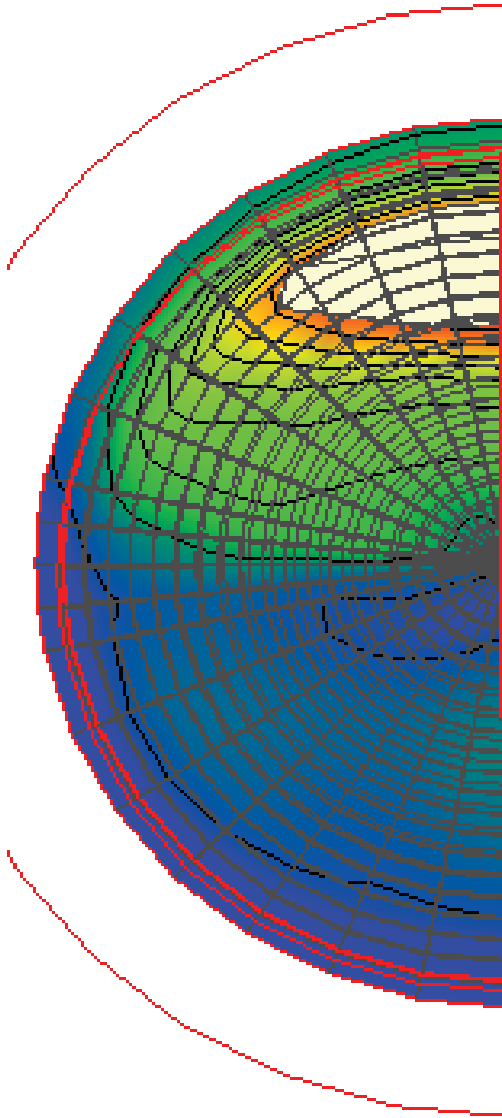
**Figure 5**

The ATHOS code predicted regions of high void fraction and high steam velocities are superimposed with tube-to-tube wear indications from Unit 3 steam generator 3E0-88

The NRC analysis indicated a correlation with the tube-to-tube wear based on a combination of high void fraction and high steam velocities. It should be noted that the traditional forcing function, fluid velocity squared times density, does not show good agreement with the tube-to-tube wear patterns. This indicated that the high quality steam fluid velocities and high void fraction may be sufficiently high to cause conditions in the generators conducive for onset of fluid-elastic instability.

The above analyses apply equally to Units 2 and 3, so it does not explain why the accelerated fluid-elastic instability wear damage was significantly greater in Unit 3 steam generators. The ATHOS thermal-hydraulic model predicts bulk fluid behavior based on first principals and empirical correlations and as a result it is not able to evaluate mechanical, fabrication, or structural material differences or other phenomena that may be unique to each steam generator. Therefore this analysis cannot account for these mechanical factors and differences which could very likely also be contributing to the tube degradation.

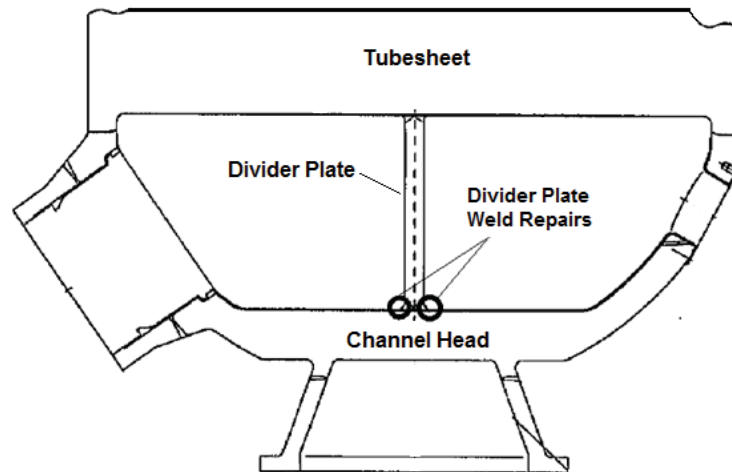
**Location of Divider Plate Weld Repairs in Unit 3 Steam Generators (For Illustration Purposes Only)**

On March 18, 2009, Mitsubishi identified cracking indications in the weld between the divider plate and the channel head of Unit 3 replacement steam generator 3E0-88 (see figure below), after completion of the ASME Section III hydrostatic test on the secondary side. The extent of condition investigation also identified similar cracking indications in Unit 3 replacement steam generator 3E0-89. As discussed in Section 4 of this report, the cause of the cracking was attributed to the air carbon-arc gouging process used to remove the clad weld from the channel head. The team reviewed information associated with the repair of the cracking indications to assess whether the repair activities resulted in relevant differences in design and fabrication that could be considered as contributing factors for the cause of the tube-to-tube wear issue in Unit 3.
