Docket Number:	06-AFC-10C
Project Title:	Midway Peaking Project - Starwood Power-Midway LLC
TN #:	269508
Document Title:	Monthly Compliance Report (MCR No 4) - March 2026 2 of 3
Description:	MONTHLY COMPLIANCE REPORT (MCR No. 4) - MARCH 2026 - EVAPORATION POND LINING & BESS
Filer:	Rena Eddy
Organization:	California Energy Commission
Submitter Role:	Public Agency
Submission Date:	4/16/2026 4:04:25 PM
Docketed Date:	4/16/2026

Paleontological Resources Monthly Monitoring Summary Report (PAL-5)

**Subject: Paleontological Resources Summary Report, March 2026, Midway BESS
Interconnection Project, Unincorporated Fresno County, California**

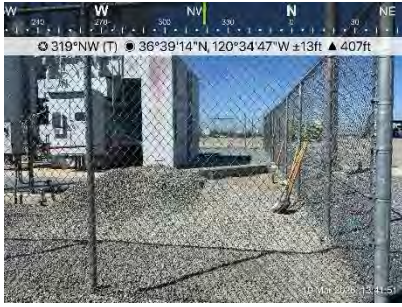
Gravel inside the transformer gate that was moved.

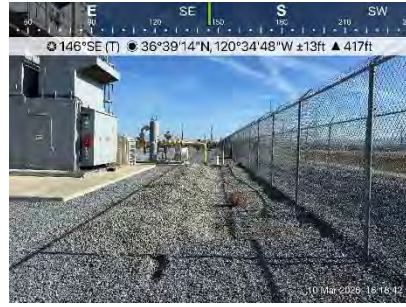
Gravel running from NE to SW that was cleared for hydrovacung to occur tomorrow.

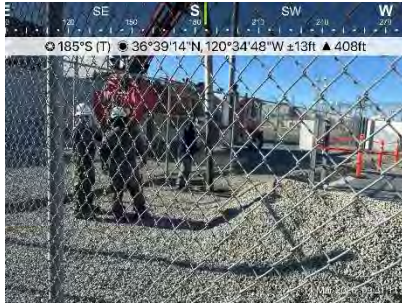
Holes that were excavated using the hydrovac

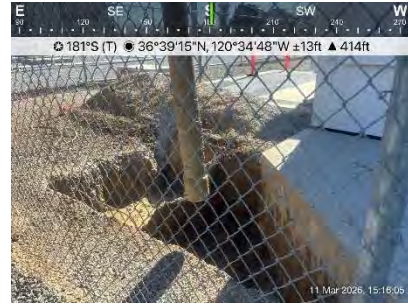
Box that was made, 3ft depth. Transformer is the box in the top right of the photo.

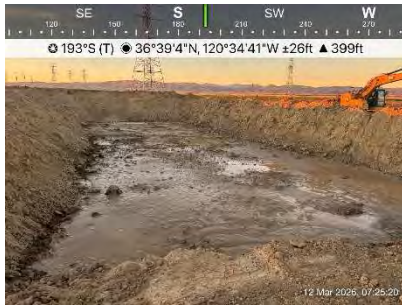
Spoil dump site that was inspected. However, it's a conglomerate for all "wet spoils" from across the entire plant so it is contaminated with spoils from outside if monitoring jurisdiction.

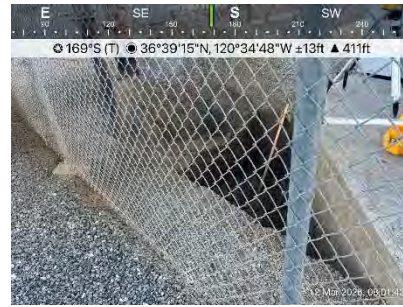
Continuation of trench from the 3ft pit.

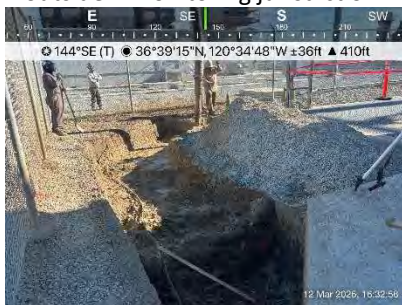
End of day, extent of trench

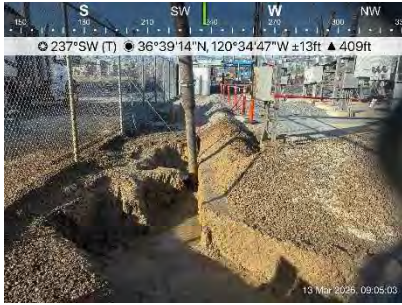
Beginning of day, trenching continuing

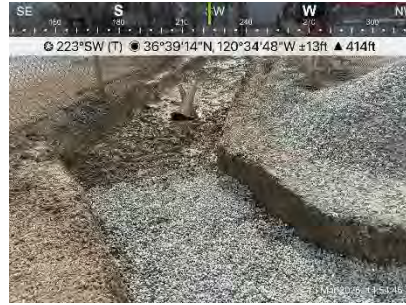
End of day, extent of hydrovacuuming for the day. Crew loaded gravel into dried section of the trench.

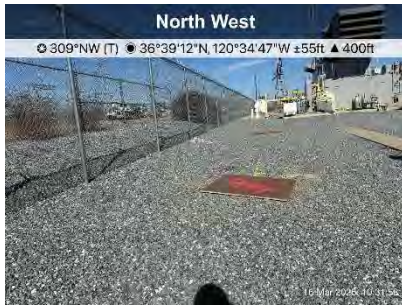
Potholes after they were excavated and covered for safety.

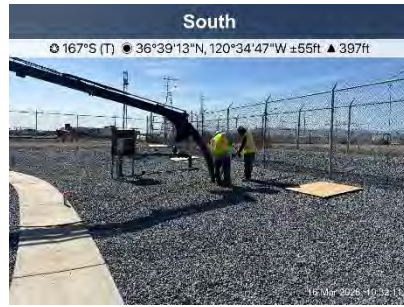
Crew making the potholes at designated distances from each other

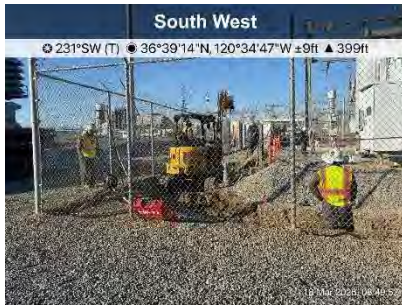
Beginning of day, first usage of excavator inside of the GSU

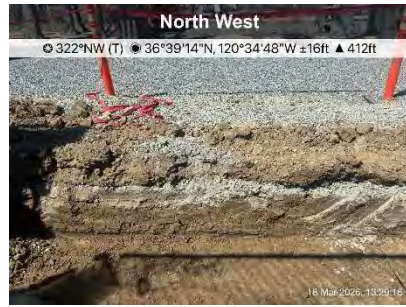
Sidewall of trench

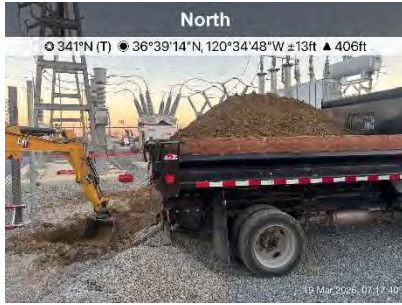
Spoil inspection after removal.

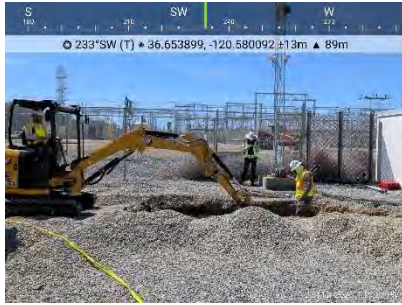
Active trenching

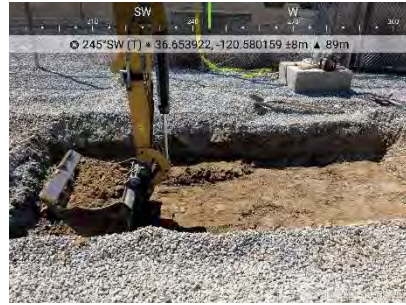
Depth of trench 2ft.

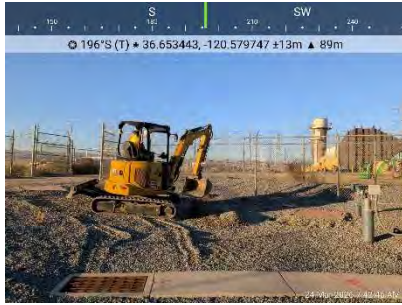
Gravel removal at S end of plant fenceline

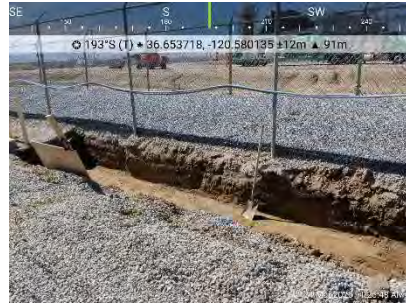
Max 3ft depth at middle of fenceline

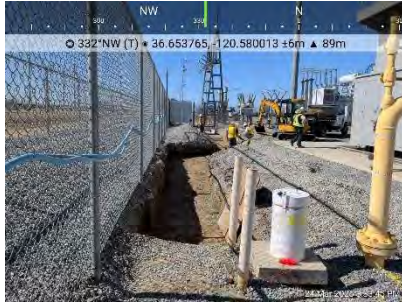
End of day trenching. Around mid point reached.

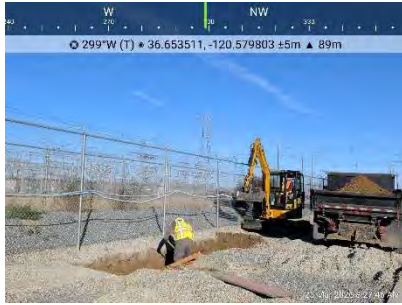
Start of day trenching along innerpeaker plant fence.

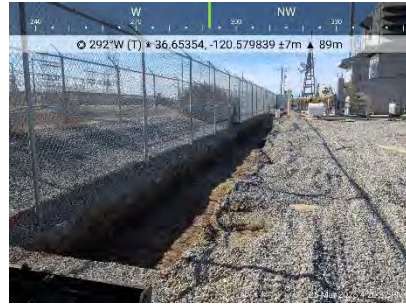
End of day trench (1/2)

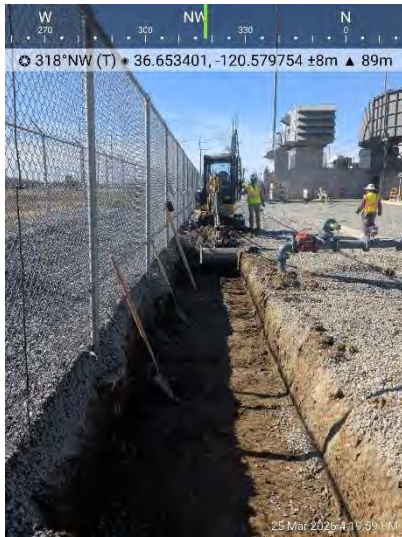
End of day trench (2/2)

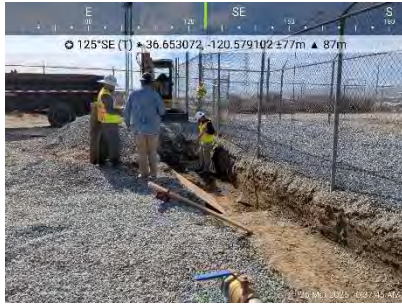
End of day trench.
