#### EL SEGUNDO ENERGY CENTER PROJECT, DOCKET NO. 00-AFC-14C, CONDITION OF CERTIFICATION COMPLIANCE-7, 2018 ANNUAL COMPLIANCE REPORT, DOCKET NO. 00-AFC-14C

#### RE: EL SEGUNDO ENERGY CENTER PROJECT, DOCKET NO. 00-AFC-14C, CONDITION OF CERTIFICATION COMPLIANCE-7, 2018 ANNUAL COMPLIANCE REPORT, DOCKET NO. 00-AFC-14C

Eighth Year Annual Report El Segundo Shoreline Monitoring Program At El Segundo, California

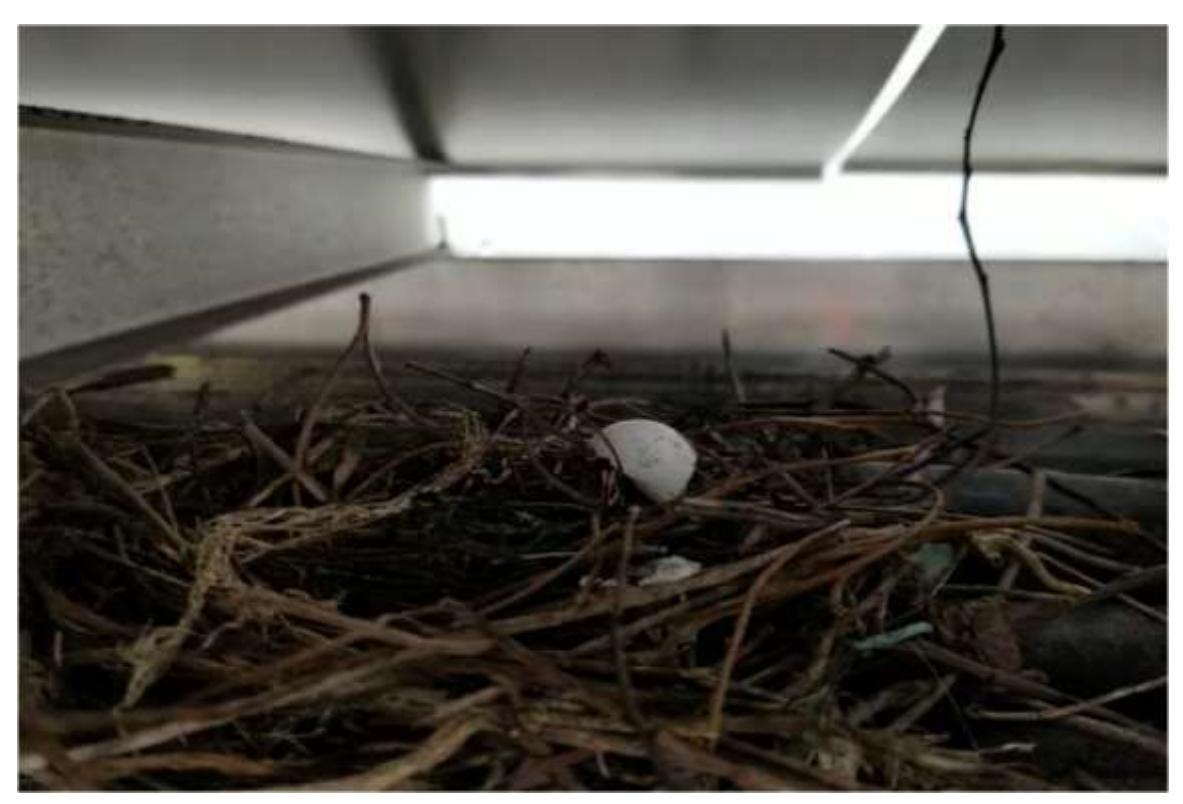
Figure 1. Cable rack and location of the two nests.

Two abandoned nests are still visible in the cable rack along the wall adjacent to the administration buildings (Figure 1). The abandoned nests were first observed during the December 26<sup>th</sup> 2017 monitoring event. Neither nest showed signs of recent activity, including old or fresh fecal matter, and there were no birds nearby during the survey. The nests were situated approximately 15-20 feet apart from each other. An updated photograph of the better constructed of the two nests is shown in Figure 2.

Since December 26, 2017, MBC monitors have been checking two nests in the cable rack along the wall adjacent to the administration buildings (Figure 1). The better-constructed nest was found to have an egg during the October 2, 2018 survey that was not there previously. During the December 2018 survey monitors observed that the egg had been broken but remained in the nest (Figure 2). Due to the absence of any discernable fecal matter, there was no evidence that the nest had contained a live hatchling or constant parental tending at any point.

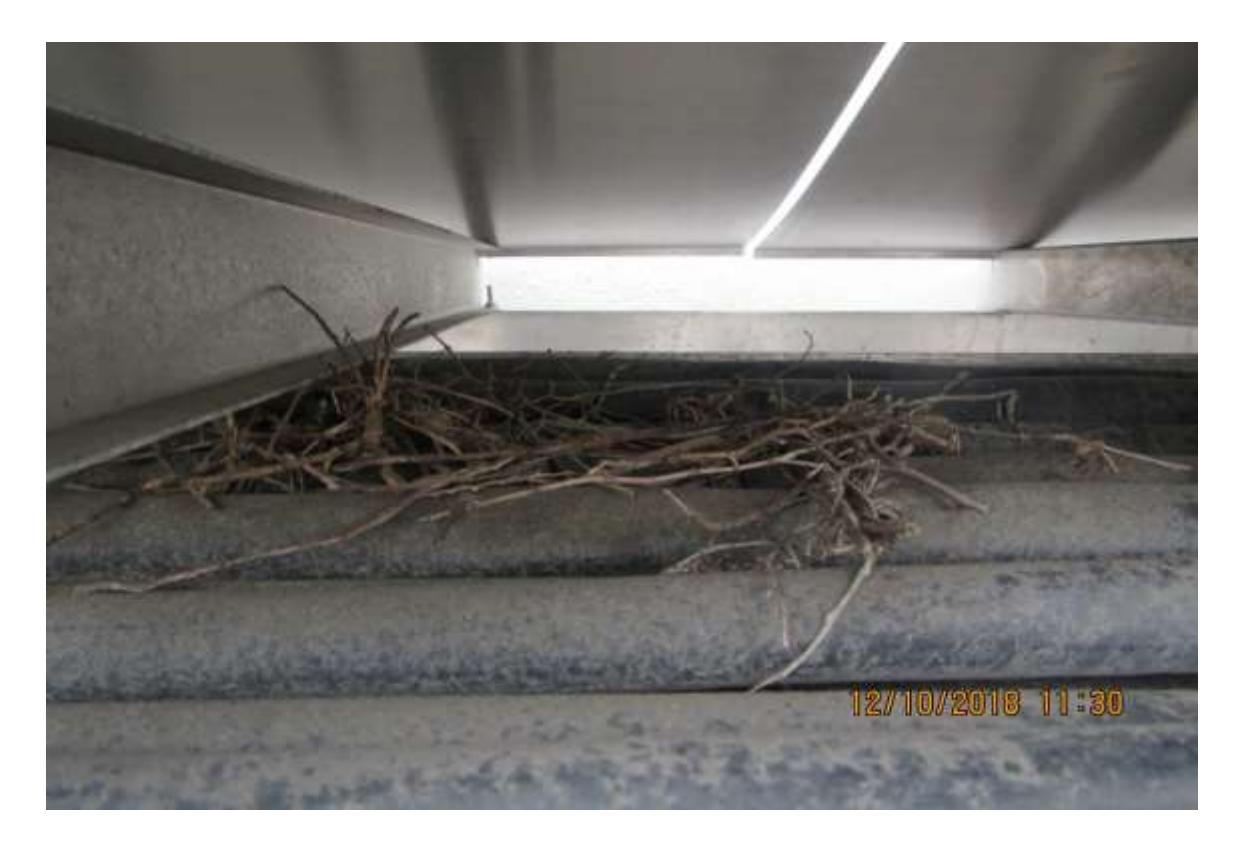
Figure 2. Nest with cracked egg (image taken from a video of nest and egg area).

There were no plants or birds listed as threatened or endangered by the federal or state governments that were observed during the survey. One of the two nests MBC has been monitoring possesses a broken egg, with no further signs of activity. The second nest has been inactive since its original observation. The roadways, parking lots and vegetated areas within the plant were very clean and housekeeping measures appear to be successful. This survey marks the last of 2018 for biological monitoring.
