DOCKETED	
Docket Number:	19-SPPE-04
Project Title:	SJ2
TN #:	242961-1
Document Title:	SJC02 Arborist Report
Description:	N/A
Filer:	Jerry Salamy
Organization:	Jacobs
Submitter Role:	Applicant Consultant
Submission Date:	5/6/2022 4:06:03 PM
Docketed Date:	5/6/2022

RE: Development impacts upon existing trees. 1657 Alviso-Milpitas Road Milpitas, CA

APPENDIX C: Construction Footprint Overview

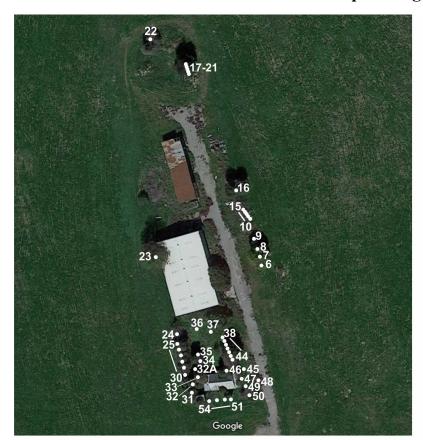
APPENDIX E: General Tree Location Map Enlargements

TREES #6-54 are recommended for removal.

- 1. With the permits in hand, remove trees #6-77, and #80-84.
- 2. If deemed necessary, erect and maintain tree protection fencing where needed for the duration of the project per San Jose Municipal Code 13.32.130.
- 3. At the final landscape phase, plant 250 fifteen-gallon replacement trees. Genus/species and planting site locations to be determined.

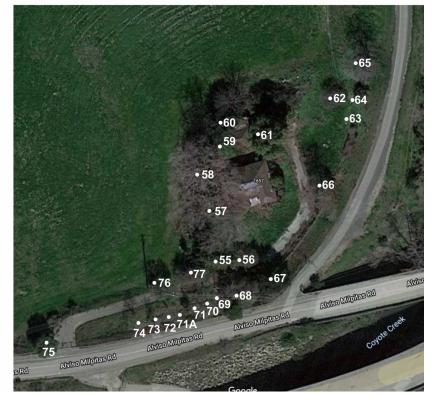
TREES #55-77 are recommended for removal.

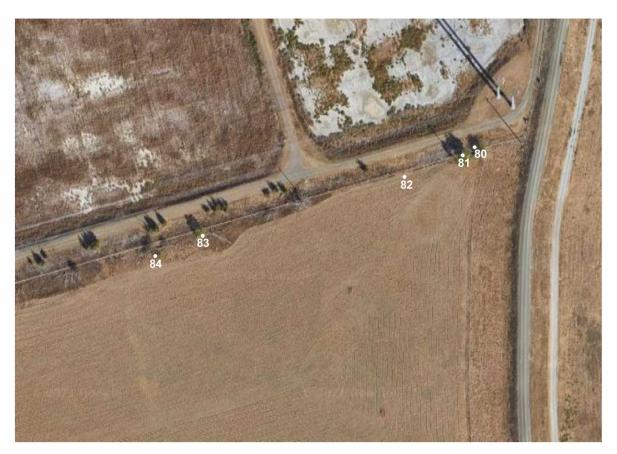
APPENDIX F: General Tree Location Map Enlargement

TREES #80-84: Northernmost property line are recommended for removal.
