RESPONSES TO CEC STAFF DATA REQUEST SET 2

AVAIO Pittsburg Backup Generating Facility (24-SPPE-01)

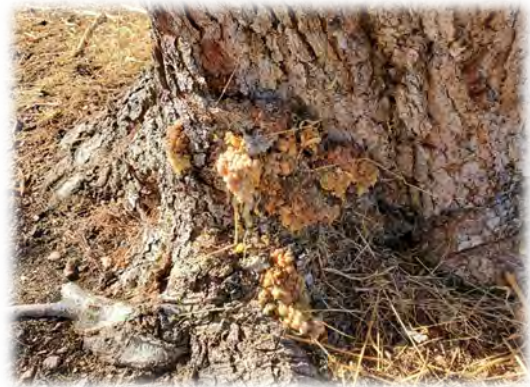
Pines vary greatly in their susceptibility to sequoia pitch moth. If conifers must be pruned, prune only from October through January so that injuries begin closing before the egg-laying female pitch moths appear in the spring. Scraping away or prying off resinous pitch is the only direct method of controlling pitch masses and larvae, except possibly for pruning off smaller branches. If resin masses are carefully excised, larvae or pupae can be found and killed. Properly removing pitch masses from all nearby tree can reduce reinfestations and control local moth populations. Once the borer is removed, sap flow will slow and the wound will close. (Dreistadt pg. 191)

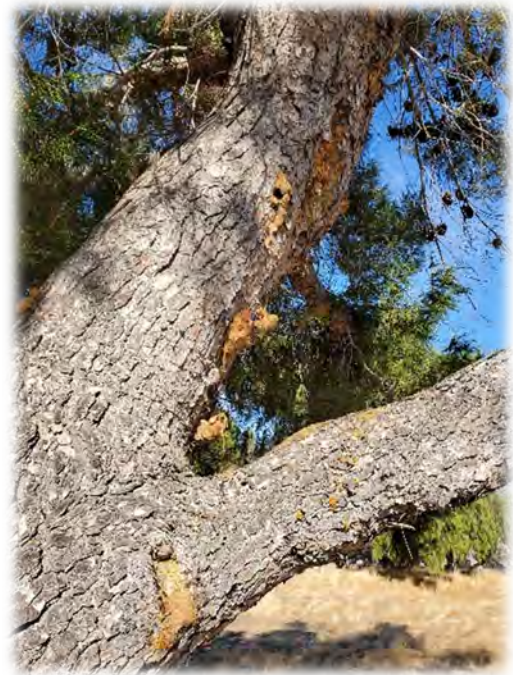
Red Turpentine Bark Beetle

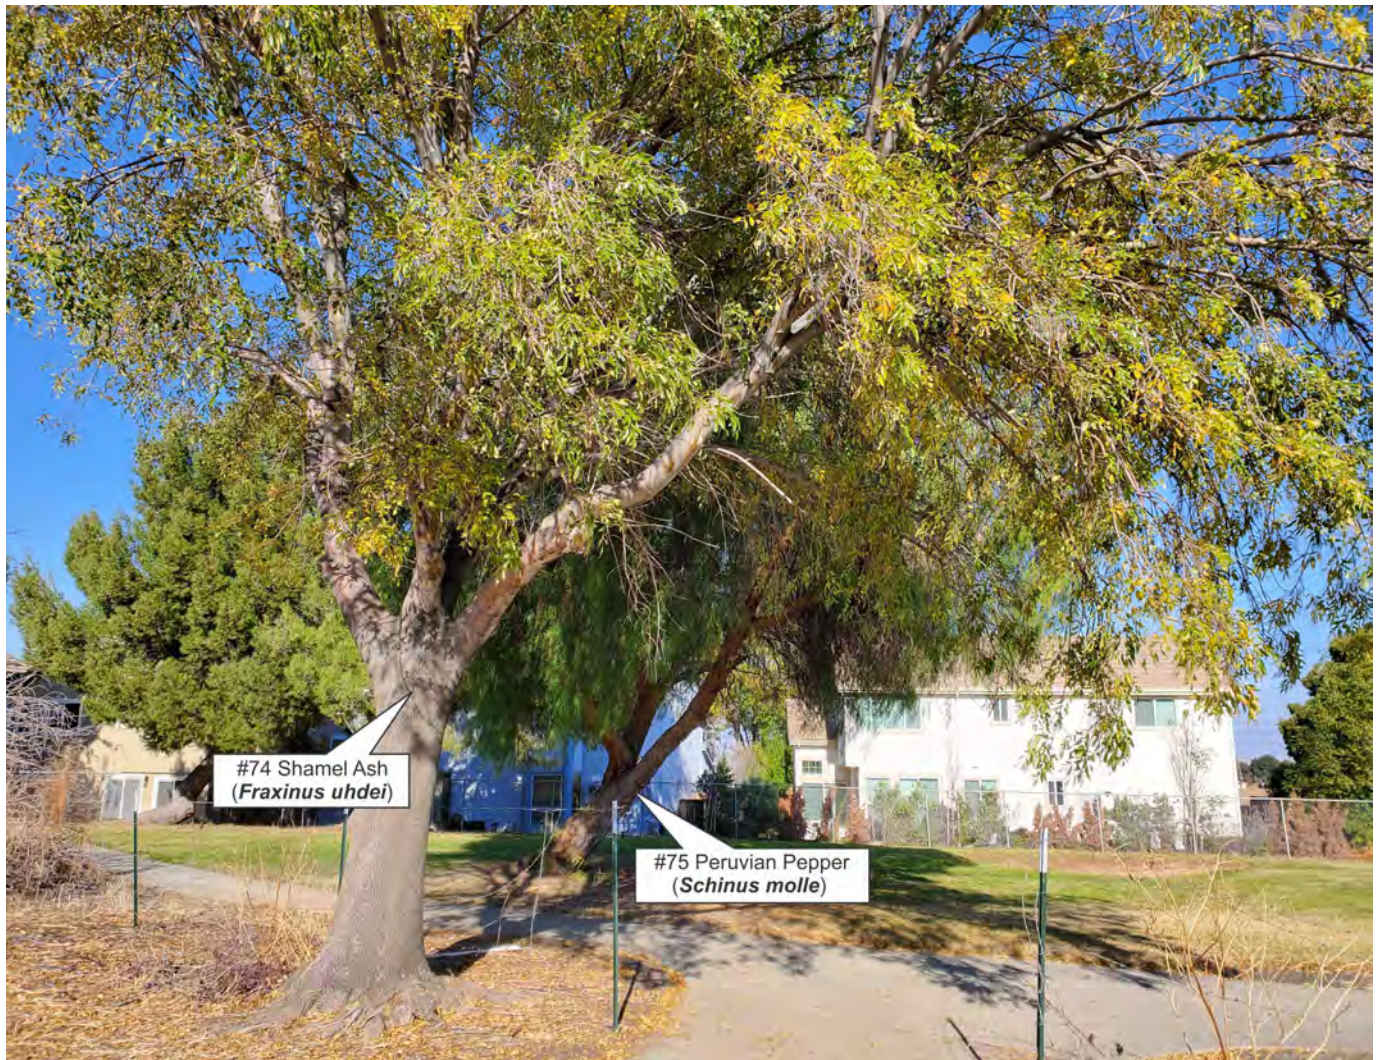
This area intentionally left blank.

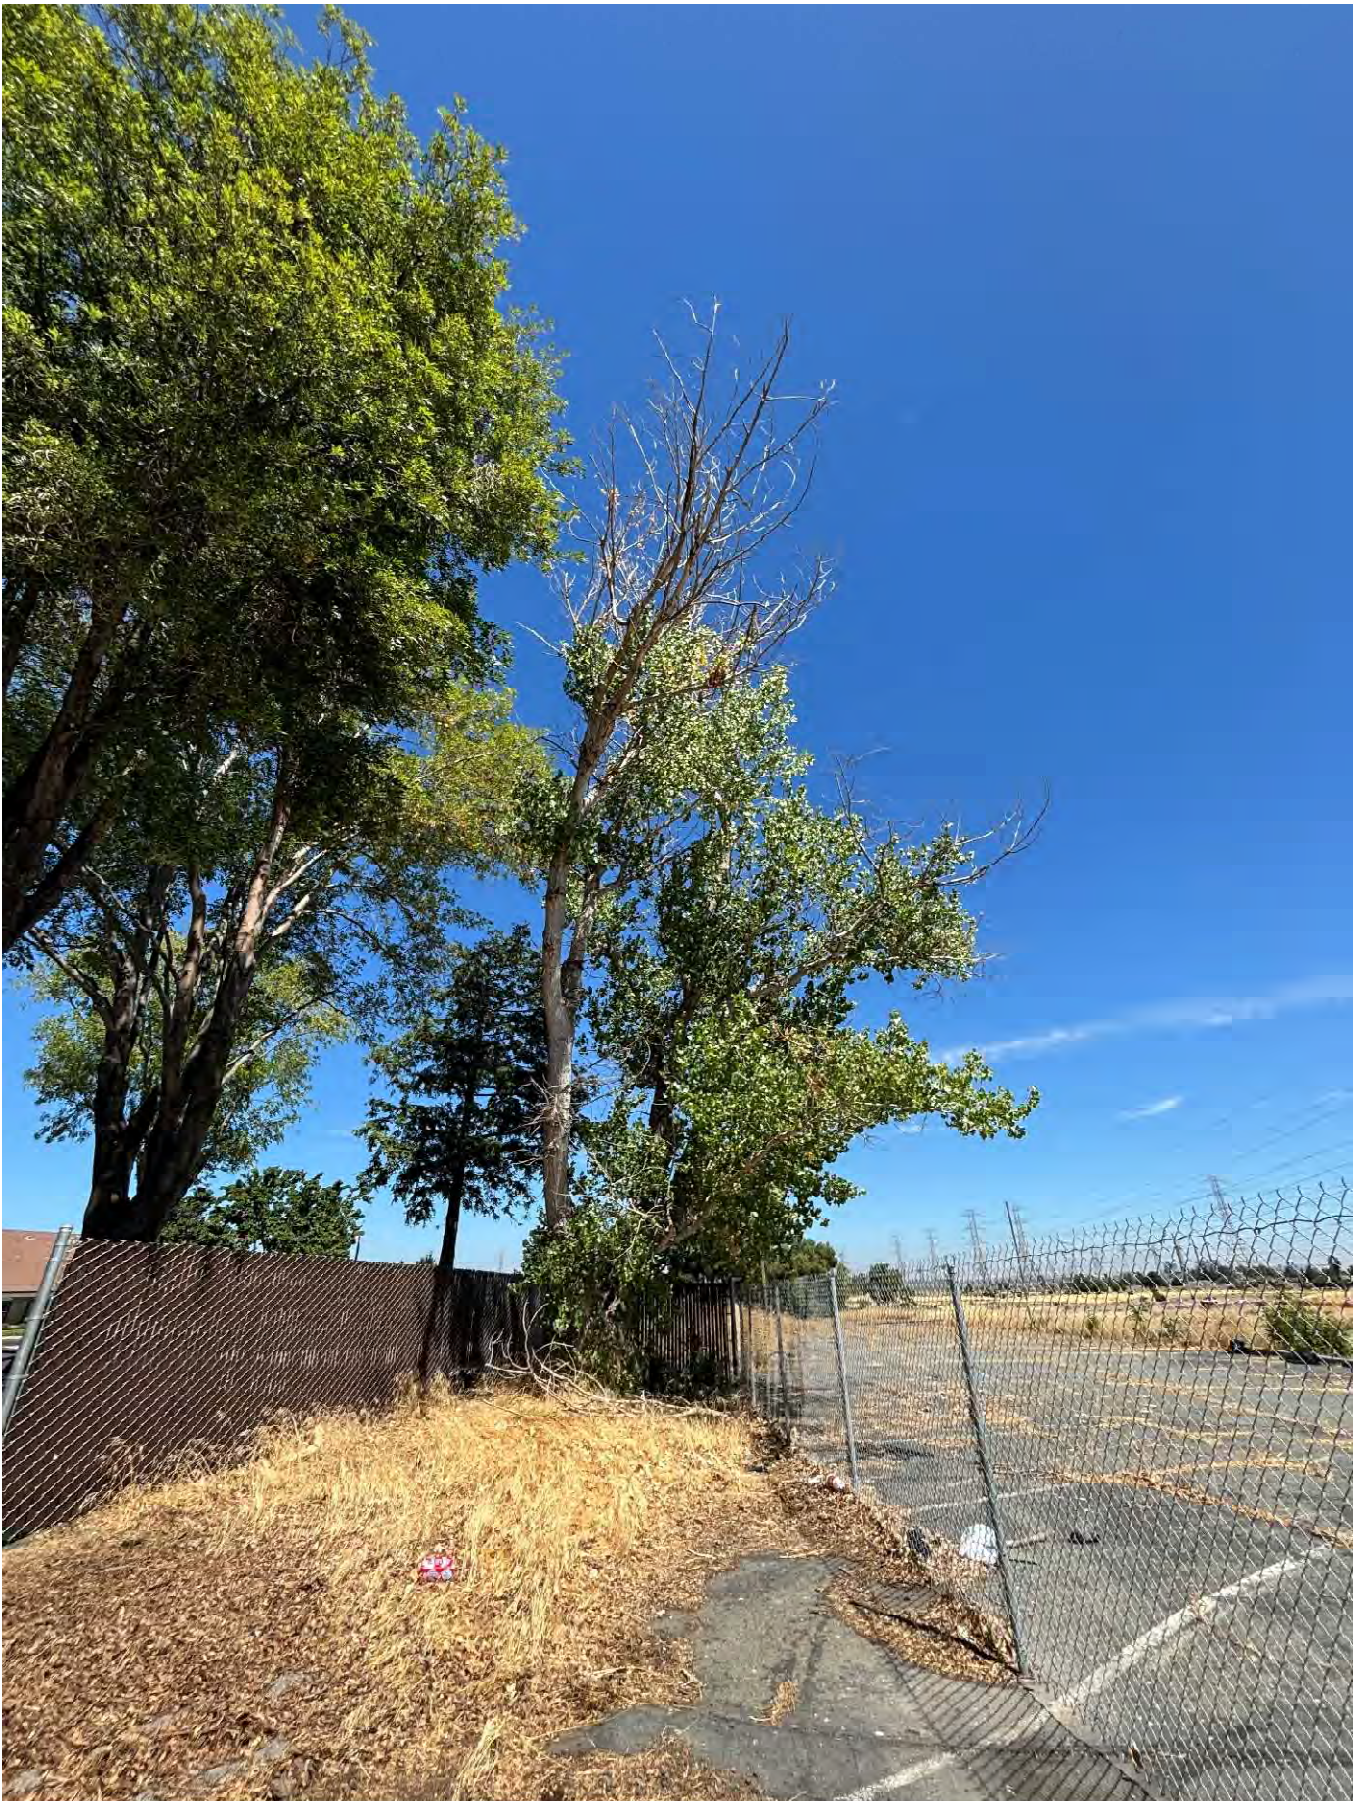
Image 2: Tree #298 Black Cottonwood – Dead limbs, previous limb failure, and cavity nester hole

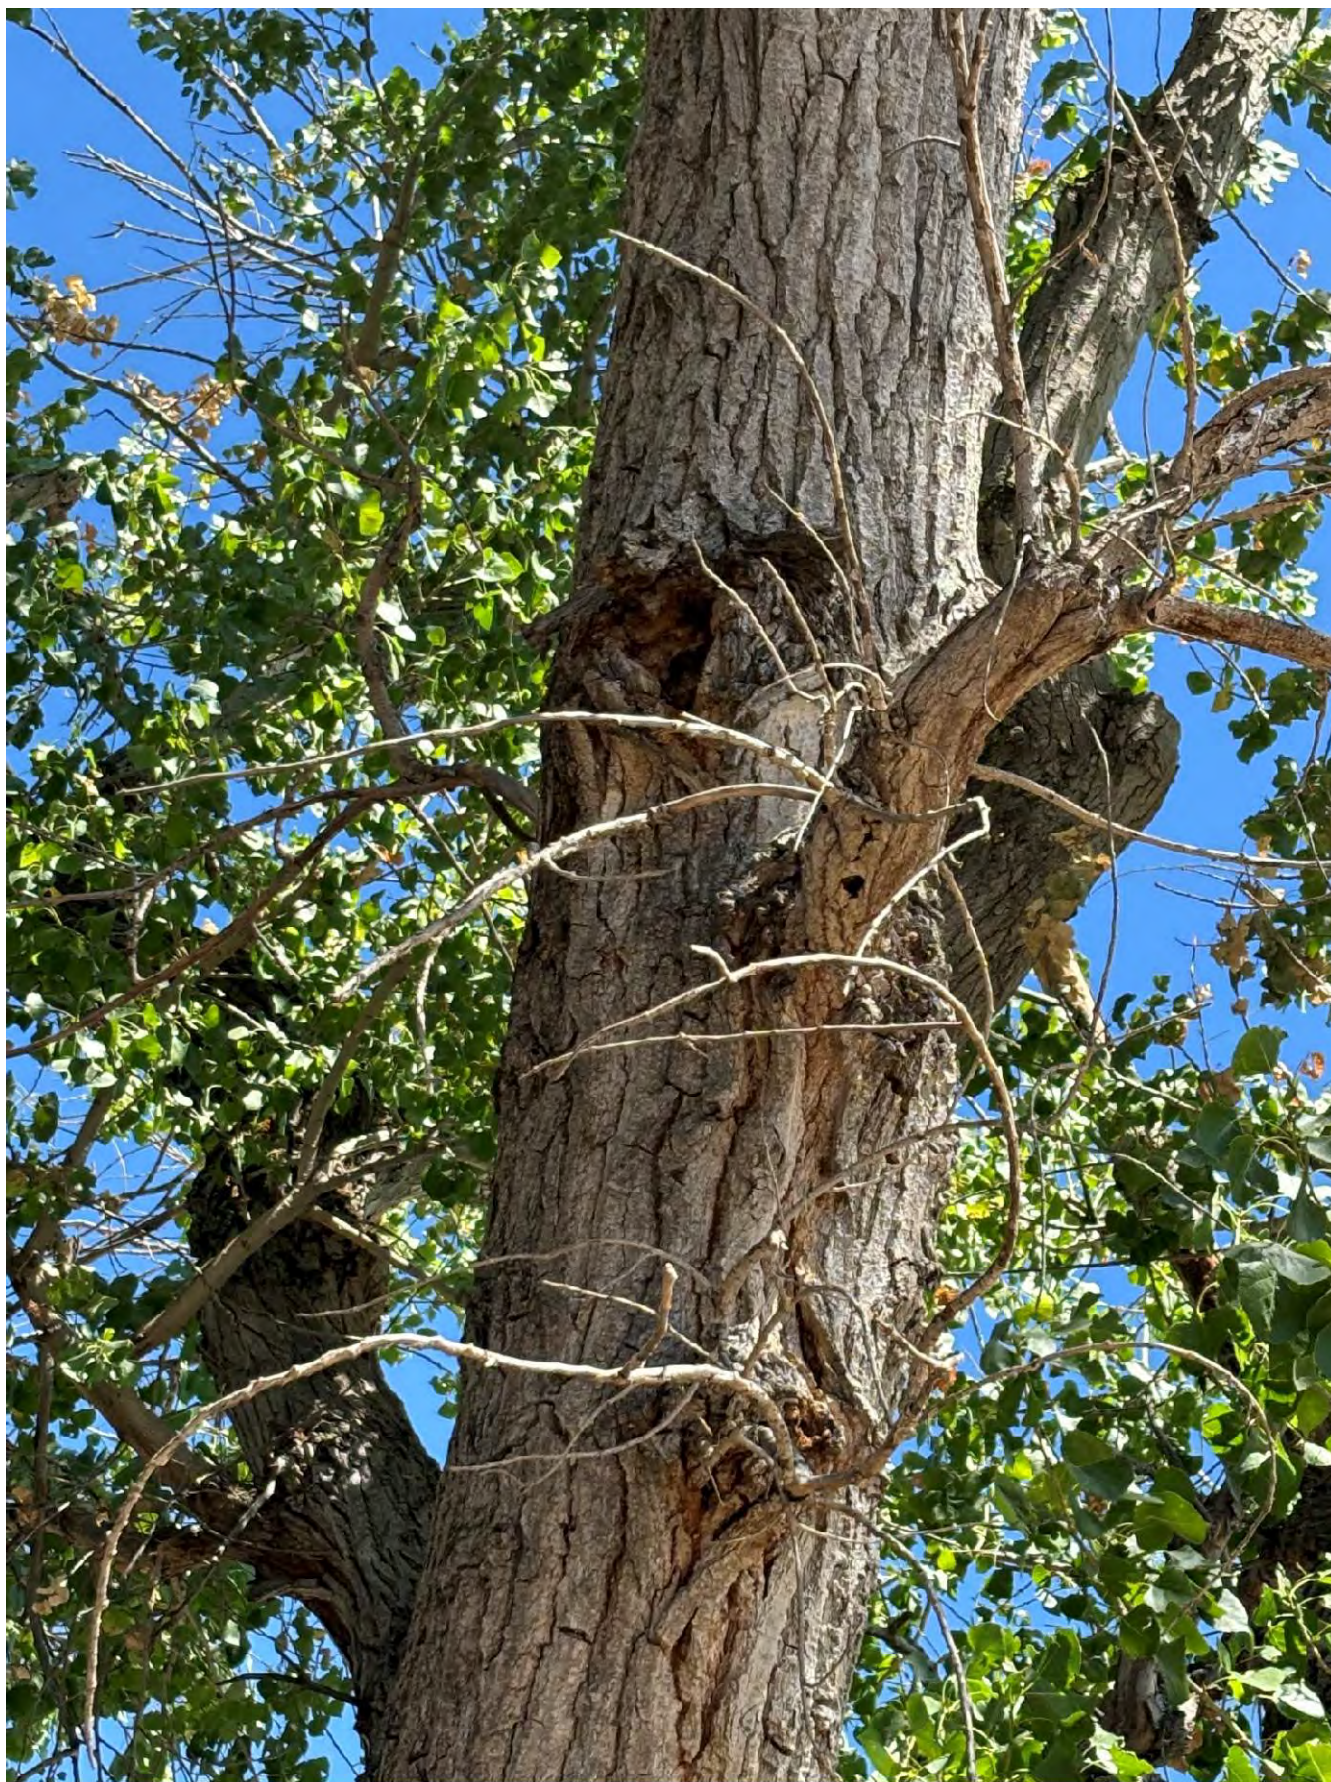
Image 3: Tree #298 Black Cottonwood – Dead Limbs and Cavity Nester Holes
