#### CALIFORNIANS FOR GREEN NUCLEAR POWER, INC. REPLY COMMENTS APPENDIX IN RESPONSE TO ALJ FITCH'S PROPOSED DECISION DATED MARCH 18, 2019 RE ADOPTING PREFERRED SYSTEM PORTFOLIO FOR 2017-2018 INTEGRATED RESOURCE PLAN

# Exhibit A Pacific Gas and Electric Company Natural Gas Transmission Pipeline Rupture and Fire San Bruno, California September 9, 2010

# **Pipeline Accident Report**

Pacific Gas and Electric Company Natural Gas Transmission Pipeline Rupture and Fire San Bruno, California September 9, 2010

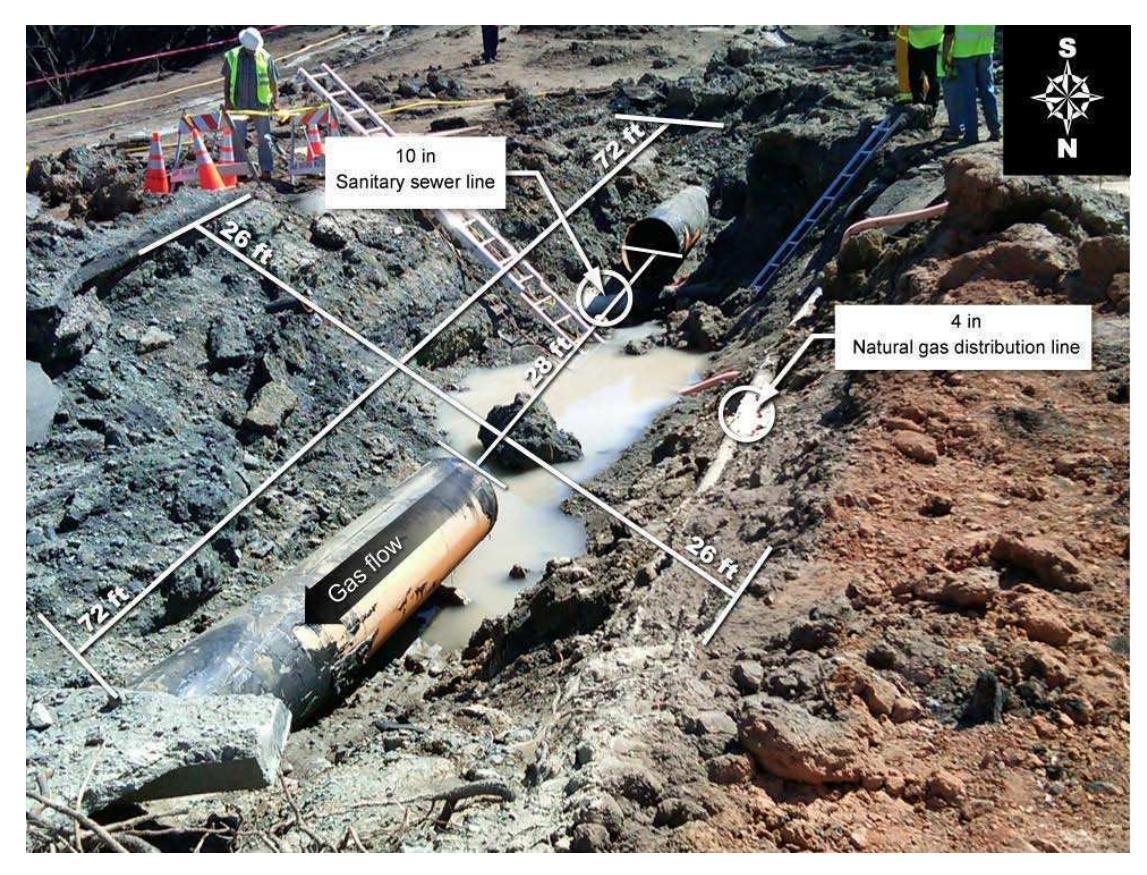
Figure 1. Picture of crater and ruptured pipeline.

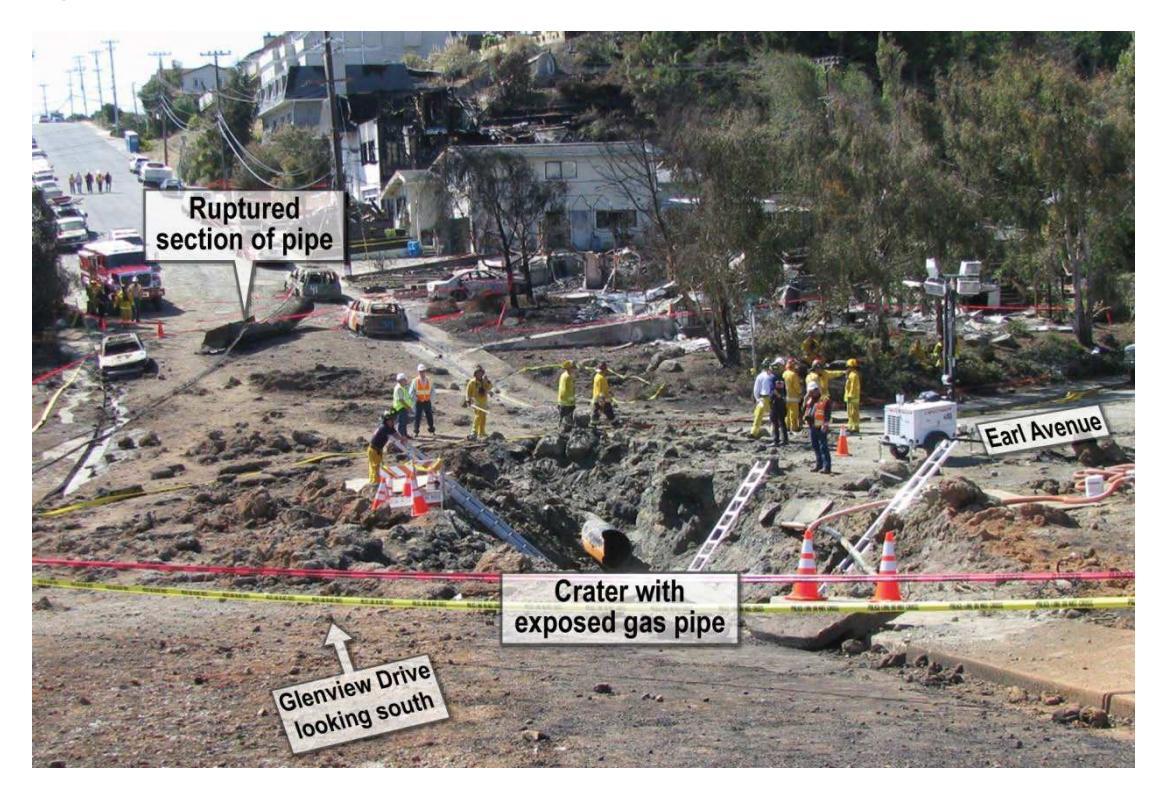
Figure 2. Picture of ejected pipe section.

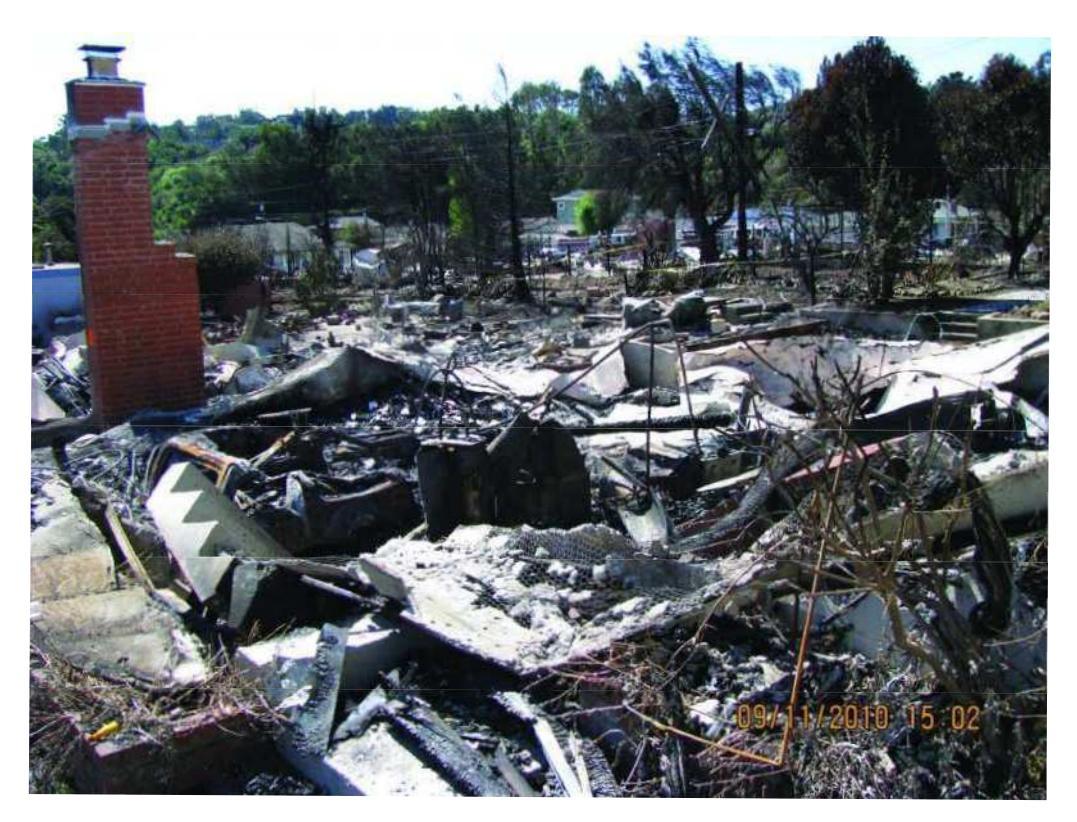
Figure 12. Picture of destroyed houses.

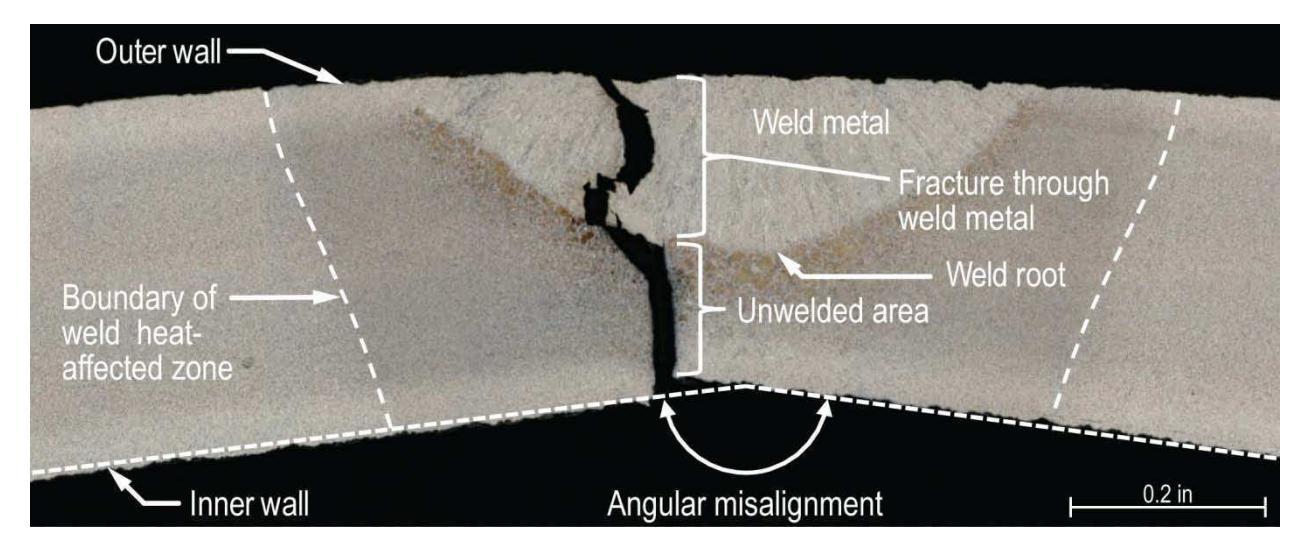
Figure 19a. Picture showing cross section of longitudinal seam in pup 1.

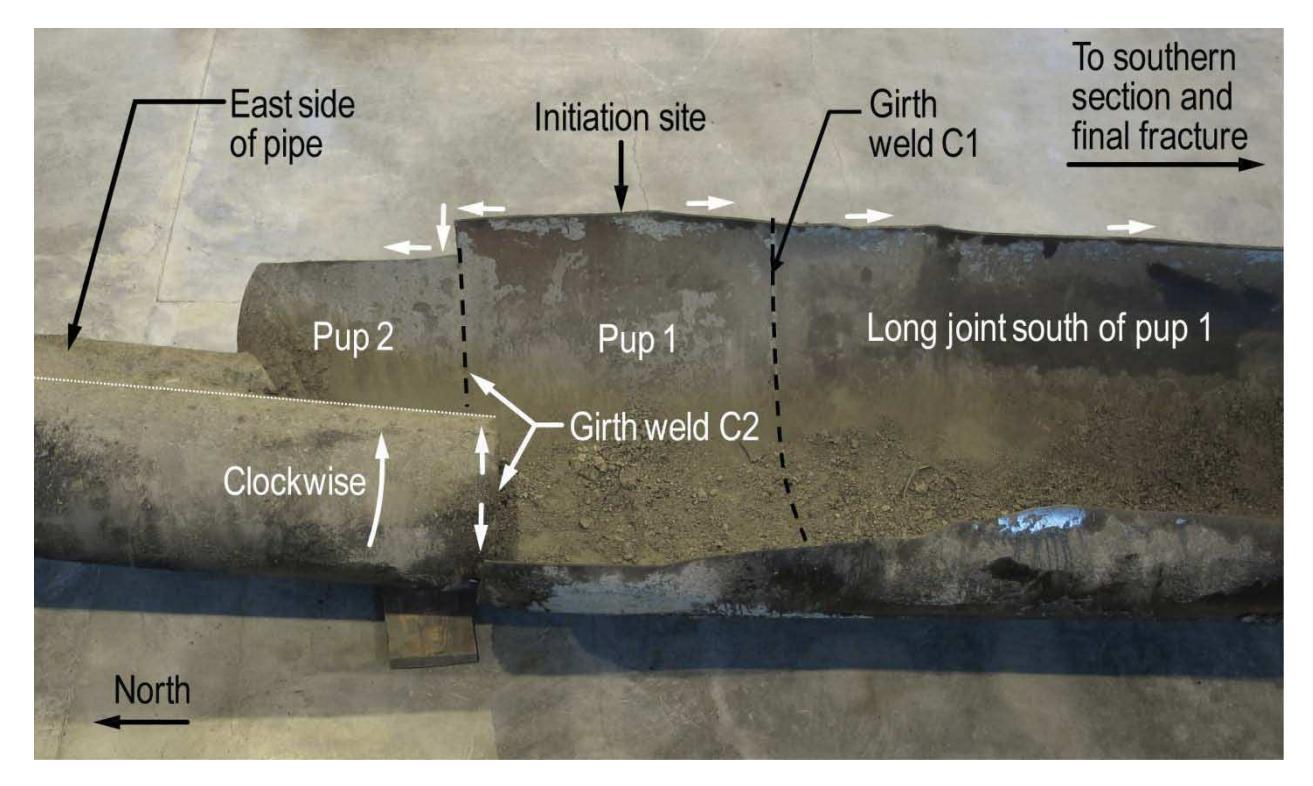
Figure 20. Picture of pipe section with white arrows showing direction of crack propagation.

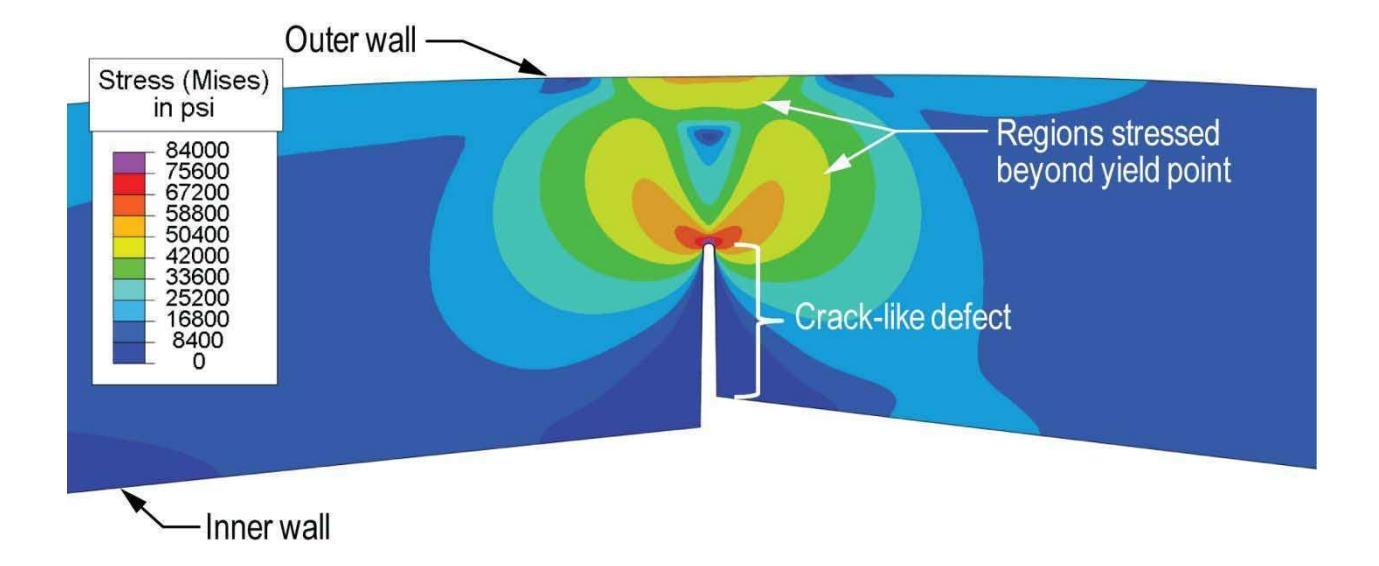
**Figure 22a.** Stress contours at an internal pressure of 375 psig for the finite element model of the weld geometry similar to pup 1. Contour values are the same as in figure 22b.

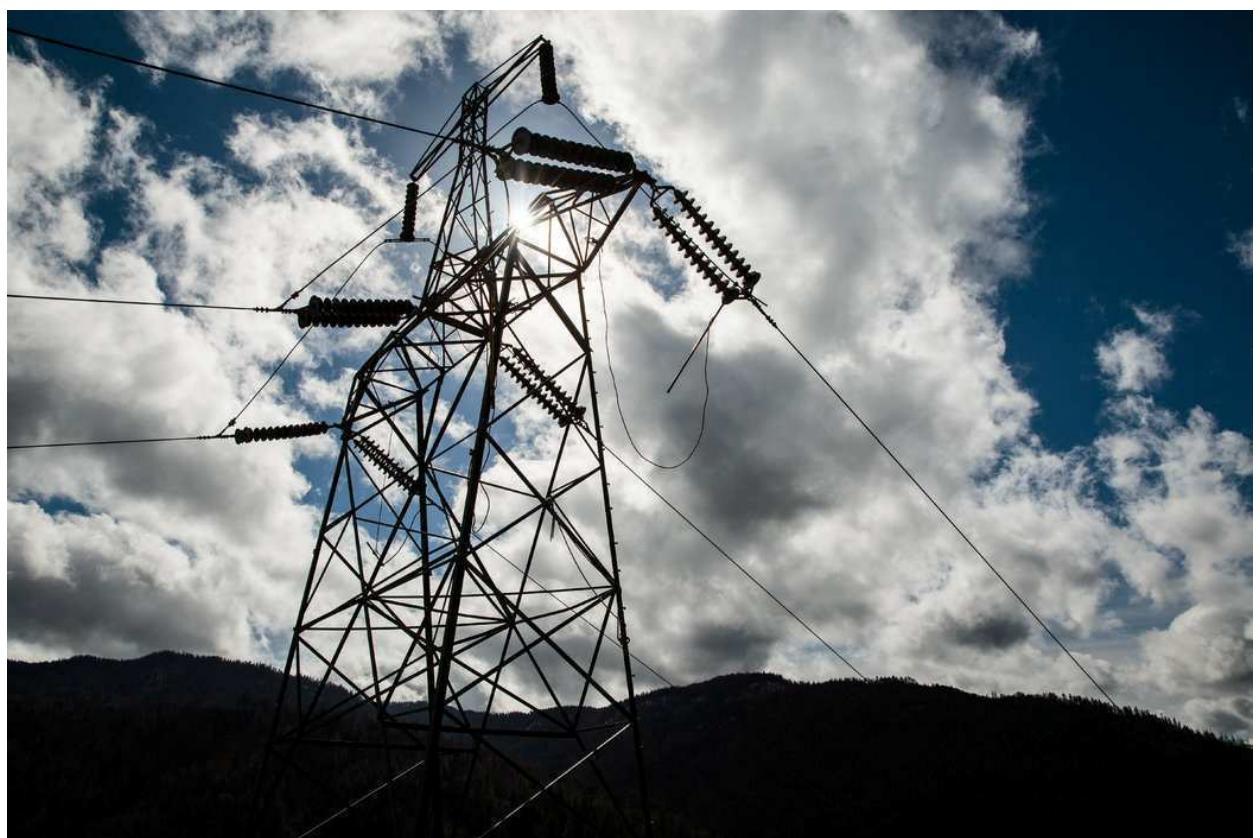
Long before the failure suspected in the Paradise fire, a company email had noted that some of PG&E's structures in the area, known for fierce winds, were at risk of collapse. It reported corrosion of one tower so severe that it endangered crews trying to repair the tower. The company's own guidelines put Tower 27/222 a quarter-century beyond its useful life — but the tower remained.

Tower 27/222. Utility experts have been incredulous that Pacific Gas & Electric let it stand for so long. Max Whittaker for The New York Times

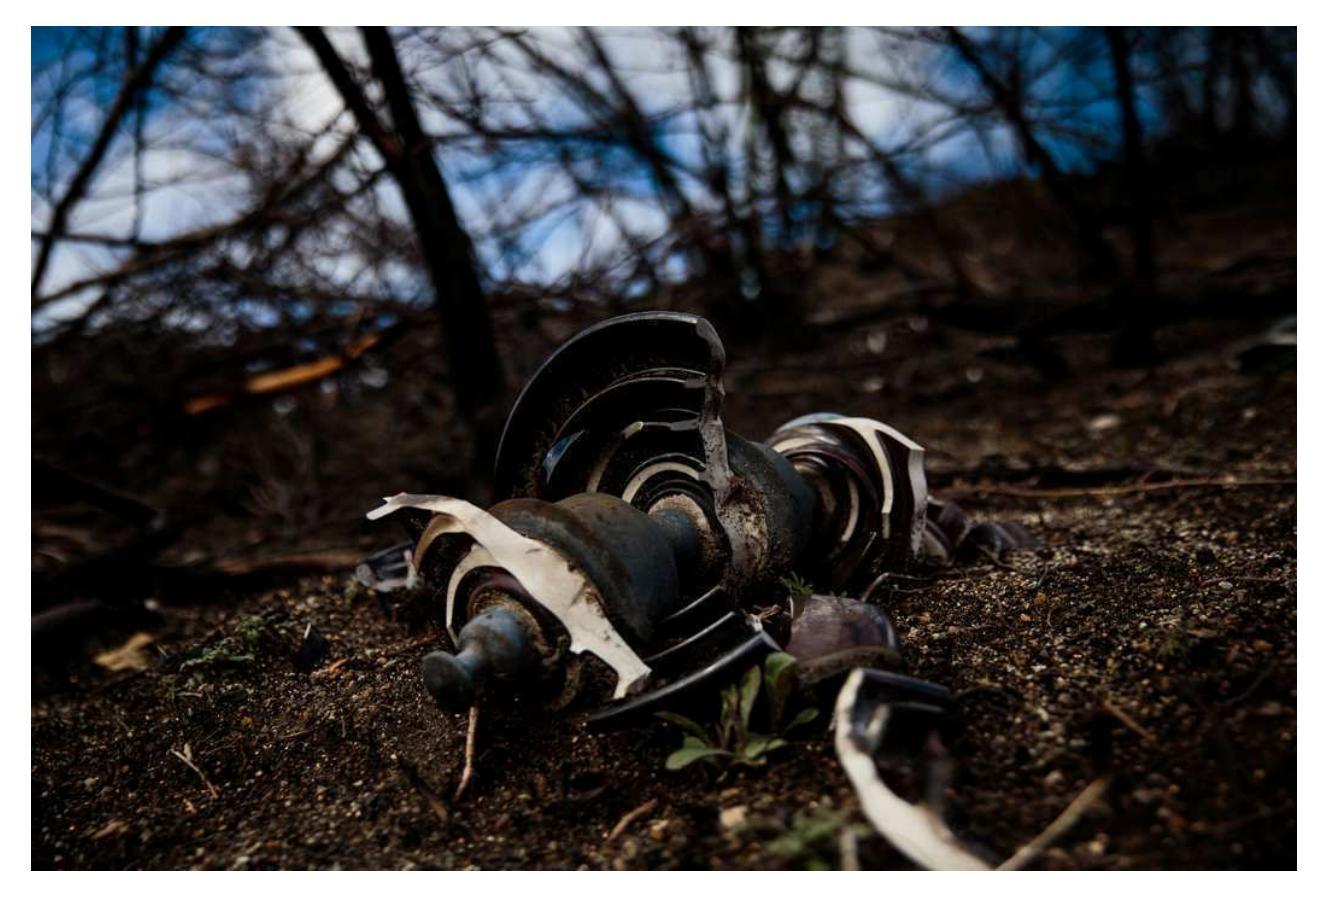
A broken insulator underneath a PG&E transmission line outside the town of Pulga, Calif.Max Whittaker for The New York Times
