Project Reference: Victorville 2

Addendum to Response to DR29-1

**Architectural Assessment and Evaluation
of Eight Properties on the Victorville 2 Hybrid Power Project Site**

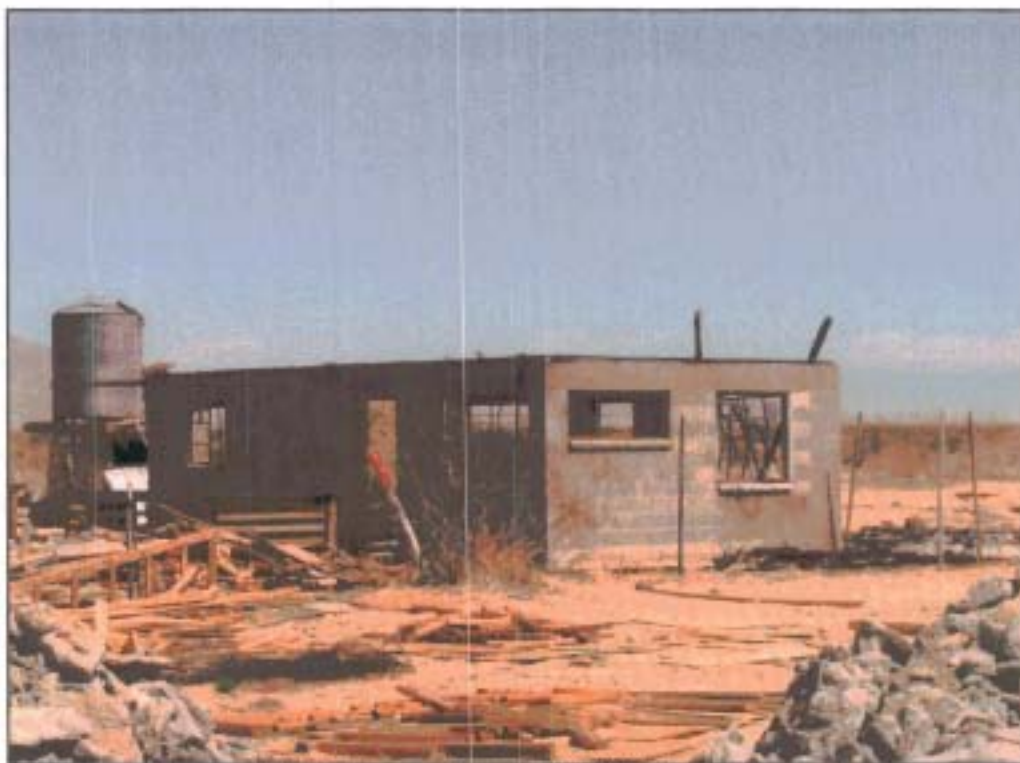
Photograph 1. Dwelling on Parcel No. 0460-232-31, looking southeast.

Parcel No. 0460-232-31 contains a dwelling, a well with pump and water tank, several trailers, and a large quantity of miscellaneous debris. The dwelling is a simple, small, modestly scaled, single-story rectangular block measuring 18 by 26 feet (Photograph 1). The foundation is slab-on-grade and the walls are concrete block. The windows are varied in size, but are (or were) all steel casement sash. At some point in the past, the building was severely damaged by fire, which destroyed the roof, the doors, and several of the windows.

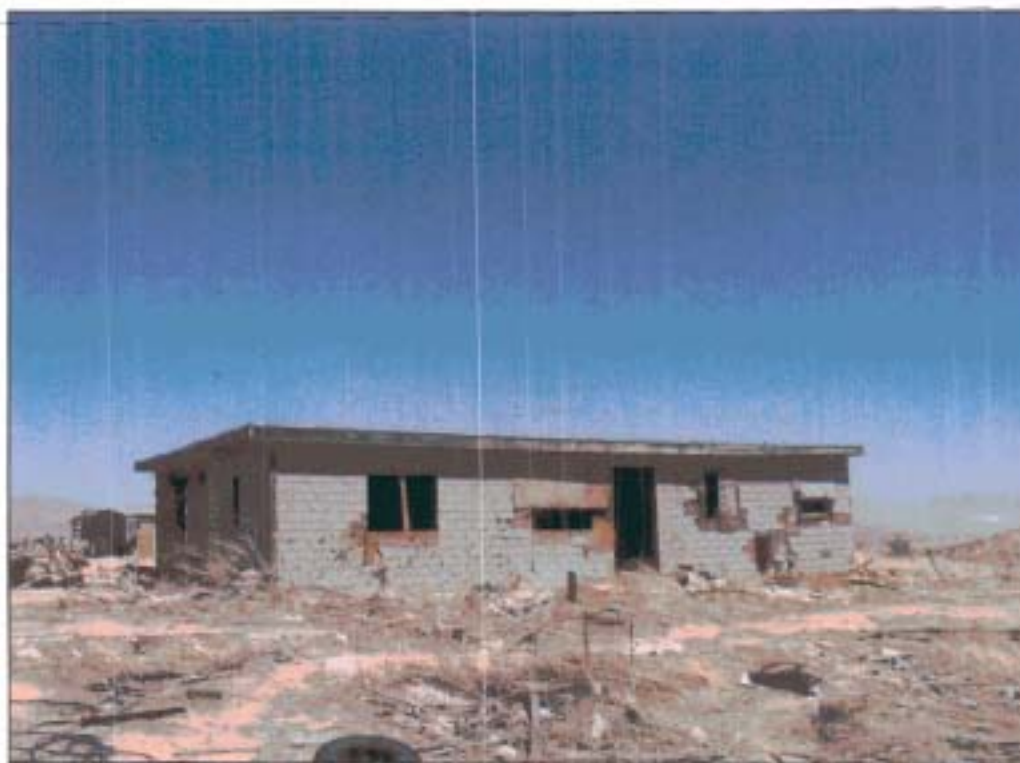
Photograph 2. Dwelling on Parcel No. 0460-232-38, looking east-southeast.

Parcel No. 0460-232-38 contains a dwelling, a shed, a well with pump and water tank, a trailer, and a large quantity of miscellaneous debris. The dwelling is a simple, relatively large but modestly scaled single-story rectangular block measuring 25 by 35 feet (Photograph 2). The foundation is slab-on-grade and the walls are wood frame, sheathed with plywood and asphalt shingles. The building has a low-pitched shed roof with overhanging eaves; the roofing is asphalt roll. The doors, windows, and portions of the walls are missing. The building is a derelict, in very poor

condition; it is not clear if it was actually finished or if it has been partially dismantled. The shed, located north of the dwelling, is built of wood frame with plank siding and has partially collapsed.

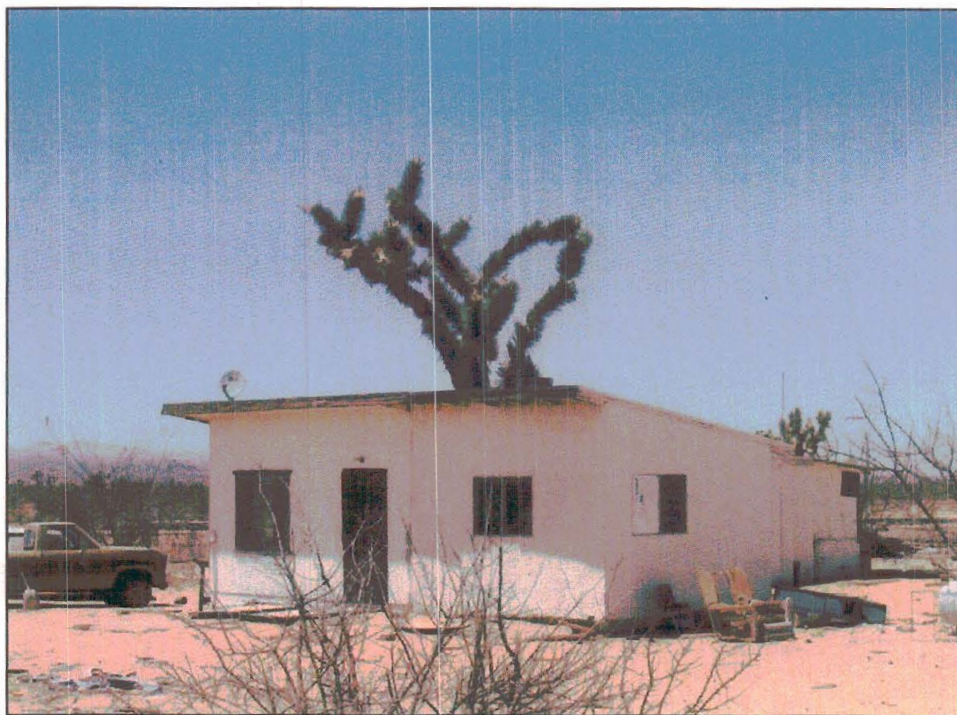
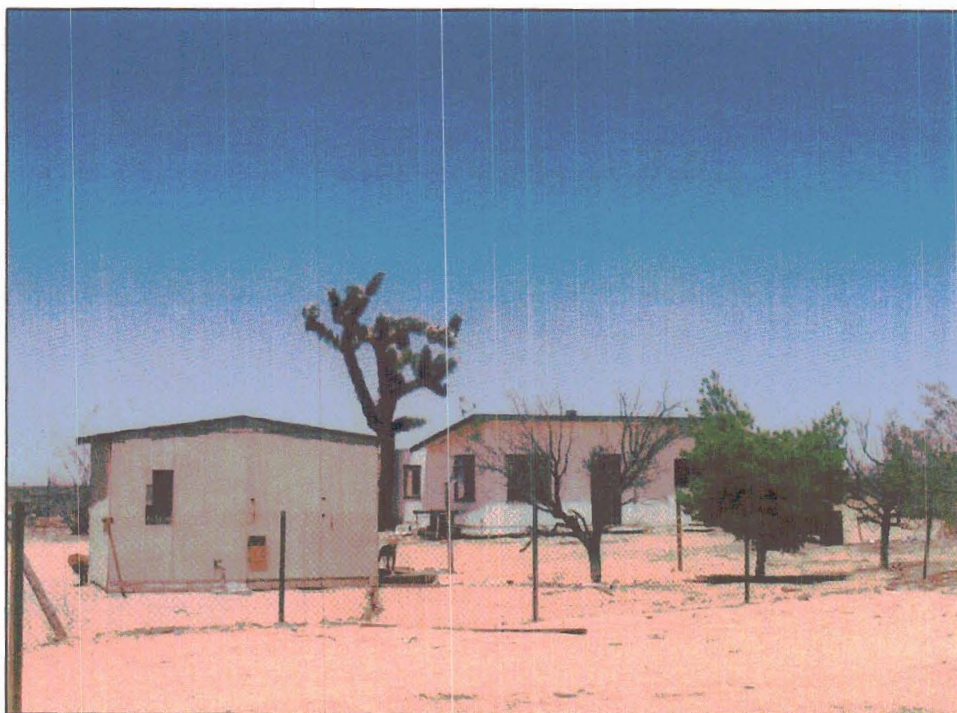
Parcel No. 0460-242-18 contains a dwelling and a pump house (Photographs 3 and 4). The dwelling is a simple, small, modestly scaled, single-story rectangular block with rooms added on the rear. Maximum dimensions are approximately 20 by 30 feet. The foundation is slab-on-grade and the walls are wood frame, sheathed with a mix of composite wood siding, plywood, and stucco. The building has a shed roof with overhanging eaves. The front door is wood panel and the windows are aluminum sliding sash; three of the windows have 1 by 4 exterior casing. The pump house, southwest of the dwelling, is built of wood frame with plywood siding. The buildings are in poor to fair condition. The dwelling has been extensively altered over the years; the latest additions and the aluminum windows probably date to the 1970s.

Photograph 3. Dwelling on Parcel No. 0460-242-18, looking northwest.

Photograph 4. Overview of Parcel No. 0460-242-18, looking north-northeast.

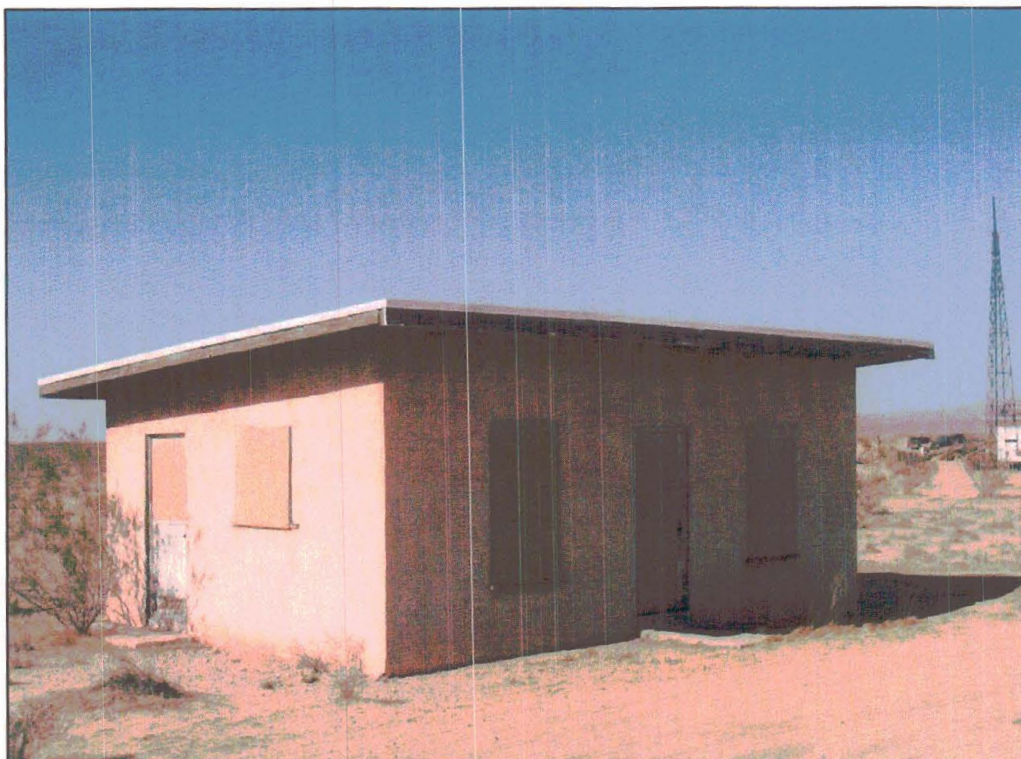
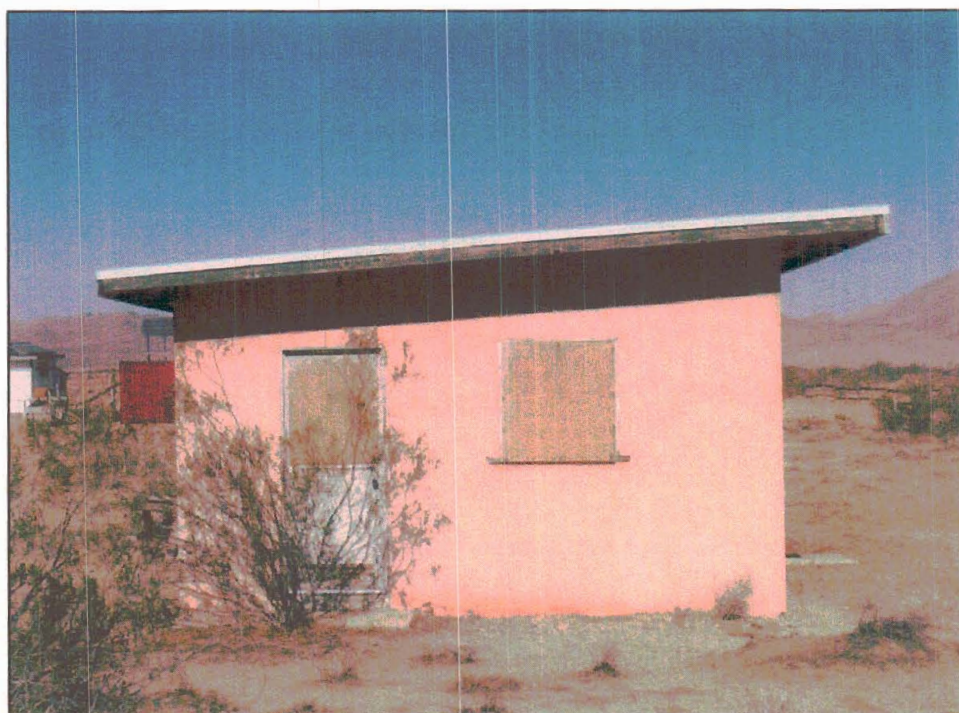
Parcel No. 0460-242-20 contains a dwelling and a privy. The dwelling is a simple, small, modestly scaled, single-story rectangular block measuring 16 by 20 feet (Photographs 5 and 6). The foundation is slab-on-grade and the walls are wood frame, sheathed with stucco. The building has a shed roof with overhanging eaves; the roofing is asphalt roll. The doors are wood panel; the windows are not visible, having been boarded up. The privy, northwest of the dwelling, is also built of stuccoed wood frame. The dwelling is in fair condition; the privy is collapsing. As far as can be discerned, the building has not been altered.

Photograph 5. Dwelling on Parcel No. 0460-242-20; view looking east-northeast.

Photograph 6. Dwelling on Parcel No. 0460-242-20; view looking east.

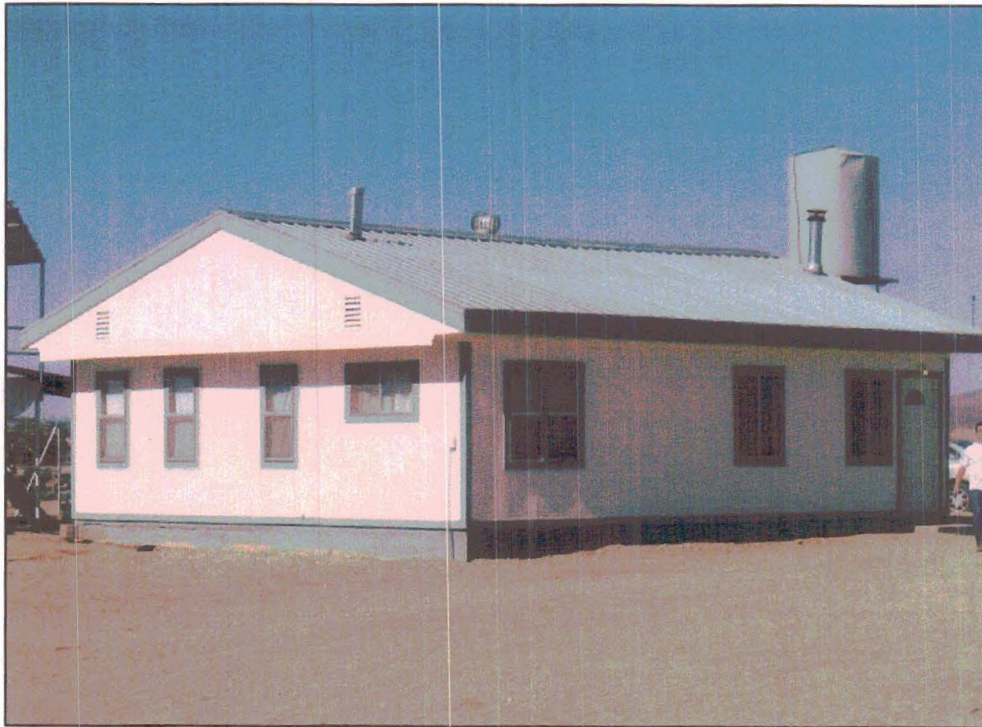
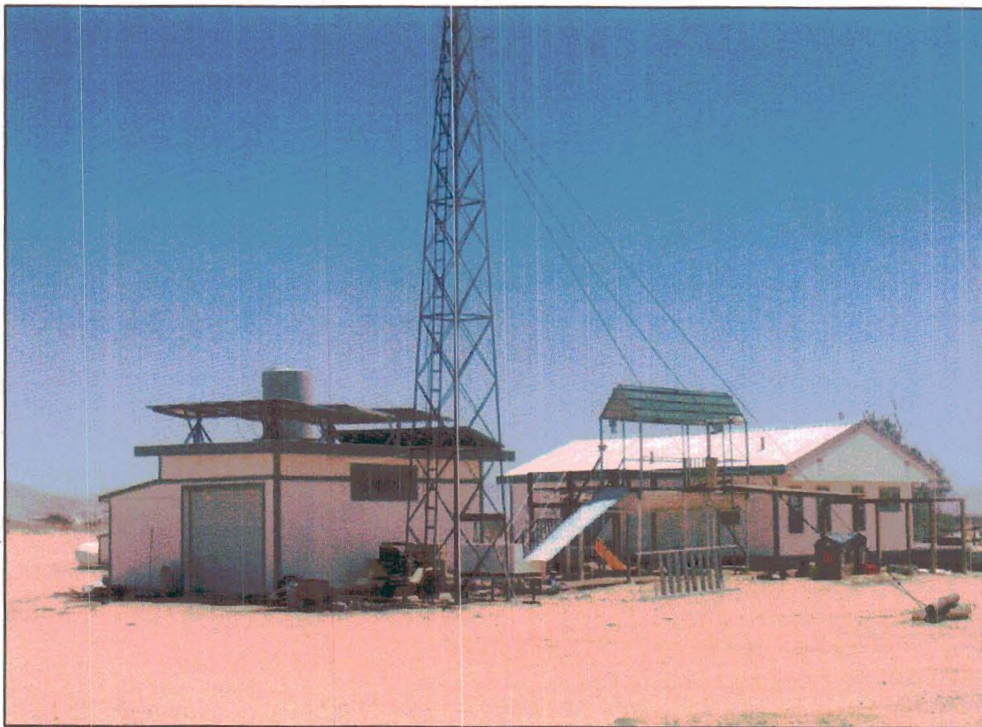
Parcel No. 0460-242-21 contains a dwelling, a garage, a well with pump and water tank, and a wind energy generator (Photographs 7 and 8). The dwelling is a simple, relatively large but modestly scaled single story rectangular block measuring 30 by 30 feet. The foundation is slab-on-grade and the walls are wood frame, sheathed with composite wood siding. The building has a gabled roof with overhangs on all sides; the roofing is corrugated metal. The doors are wood panel; the windows are aluminum sliding sash. The garage, north of the dwelling, is of similar construction. The buildings are in good condition, having recently been entirely remodeled.

Photograph 7. Dwelling on Parcel No. 0460-242-21, looking northeast.

Photograph 8. Overview of Parcel No. 0460-242-21, looking southeast.

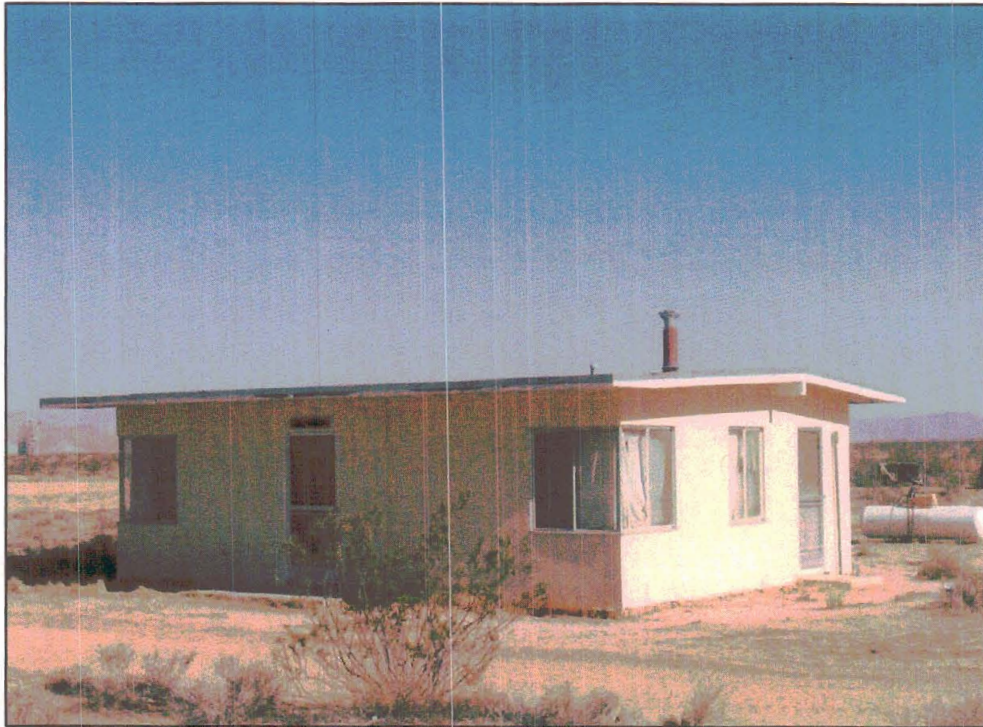
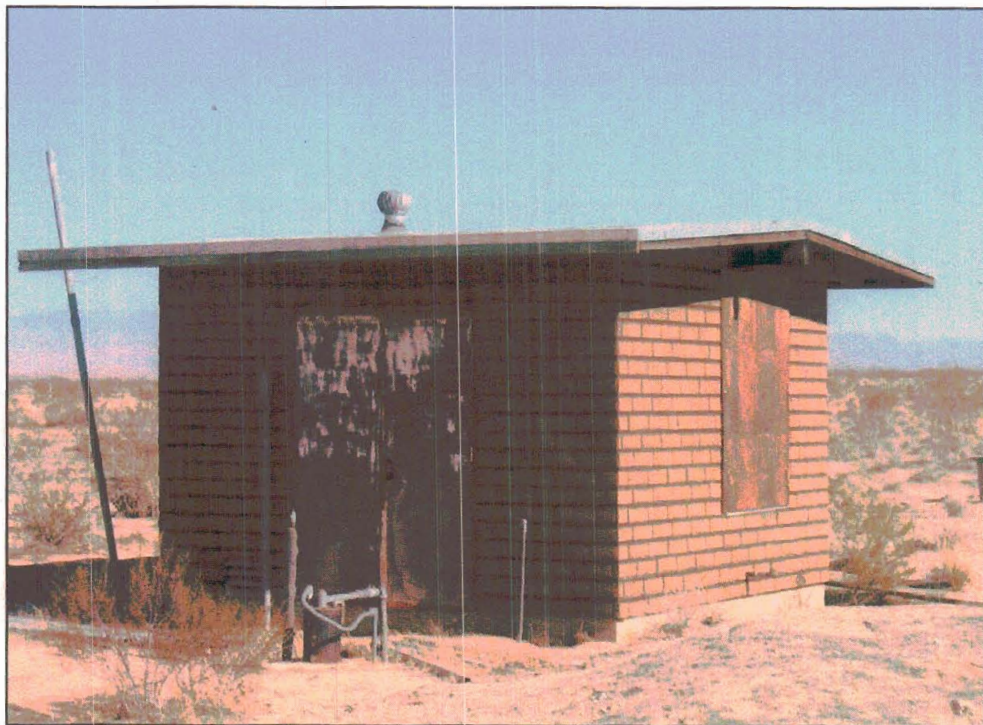
Parcel No. 0460-242-25 contains a dwelling and a pump house (Photographs 9 and 10). The dwelling is a simple, small, modestly scaled, single-story rectangular block measuring 21 by 25 feet. The foundation is slab-on-grade and the walls are wood frame, sheathed with stucco. The building has a low-pitched gabled roof with overhanging eaves; the roofing is asphalt roll. The front door is flush wood hollow-core and the side door is wood panel. The windows are aluminum casement sash; three are corner windows. The pump house, southwest of the dwelling, is of similar construction except that it is sheathed with asphalt shingles. The buildings are in fair condition; no alterations are apparent.

Photograph 9. Dwelling on Parcel No. 0460-242-25, looking east-southeast.

Photograph 10. Shed on Parcel No. 0460-242-25, looking east-southeast.

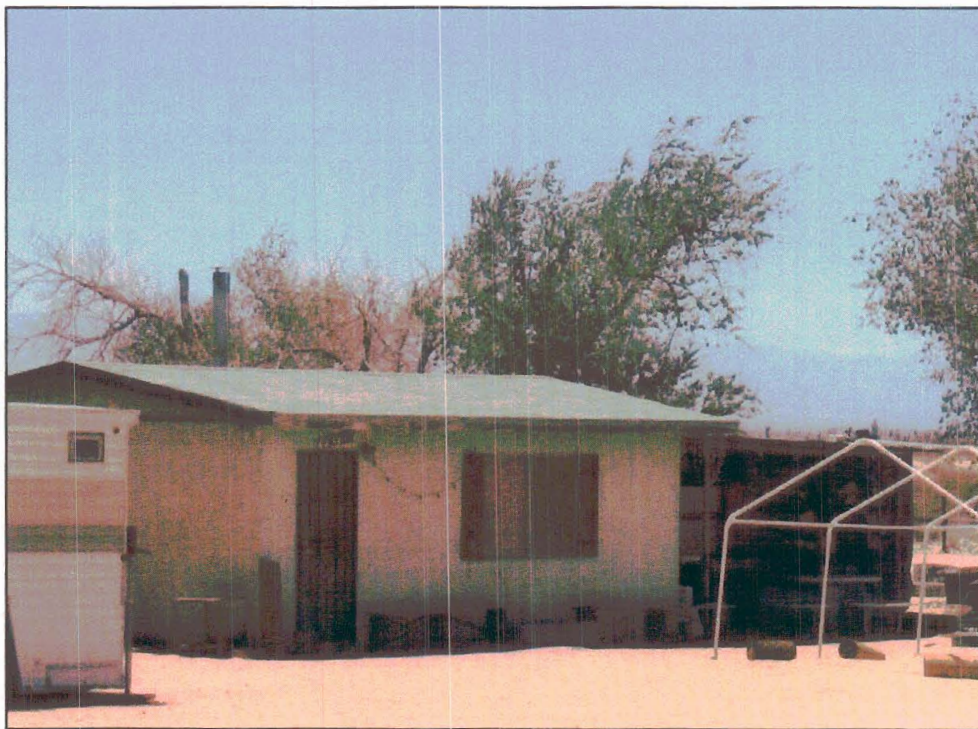
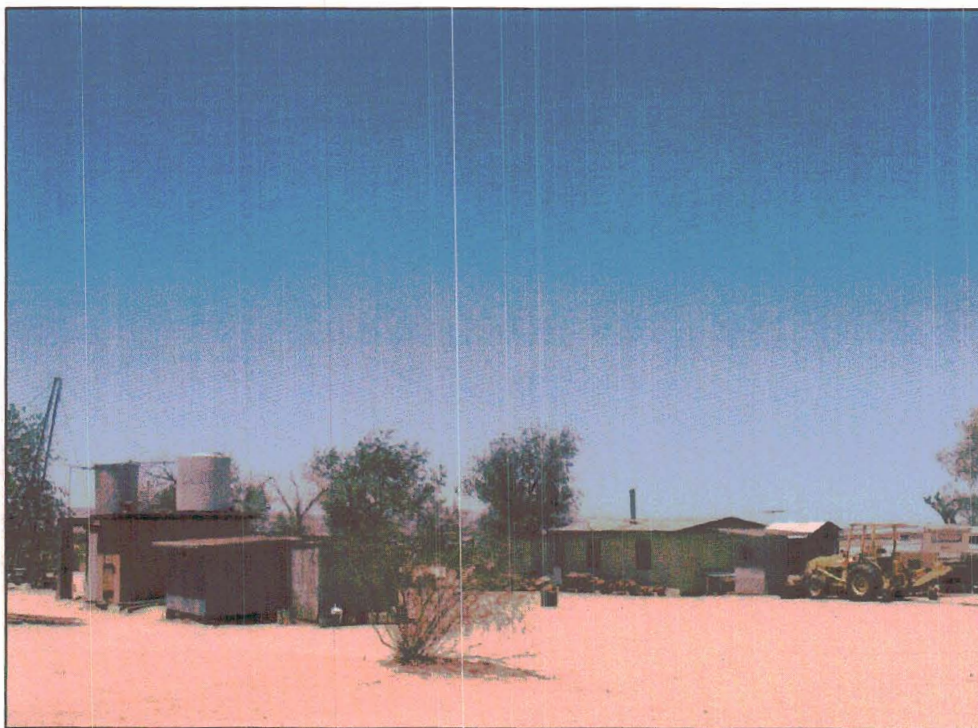
Parcel No. 0460-242-26 contains a dwelling, a pump house, and three sheds (Photographs 11 and 12). The dwelling is a simple, small, modestly scaled, single-story rectangular block measuring 18 by 22 feet. The foundation is slab-on-grade and the walls are wood frame, sheathed with stucco. The building has a gabled roof with overhanging eaves; the roofing is asphalt shingle. The front door is flush wood hollow-core; the windows are aluminum sliding sash. On the west side of the dwelling is a porch, partially enclosed with corrugated metal. The pump house, south of the dwelling, is built of concrete block. The sheds are built of wood frame, sheathed with plywood,

stucco, and corrugated metal. The buildings are in fair condition. The porch appears to have been added to the dwelling shortly after it was built; the aluminum windows were probably installed in the 1970s.

Photograph 11. Dwelling on Parcel No. 0460-242-26, looking southwest.

Photograph 12. Overview of Parcel No. 0460-242-26, looking northwest.

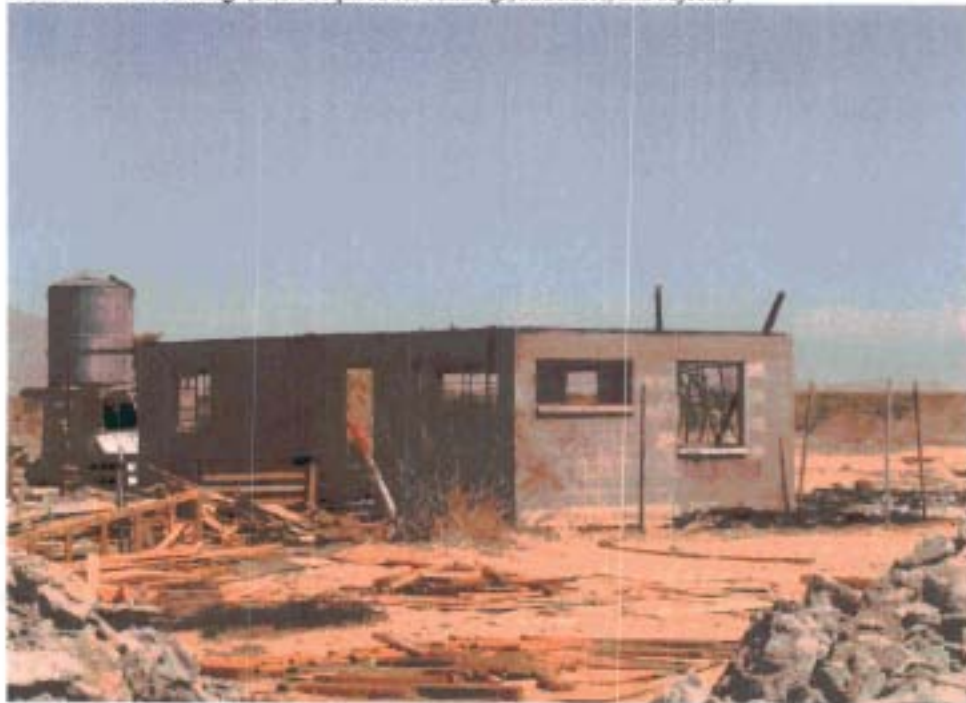
P5b. Description of Photo: (view, date, accession #) View of dwelling looking southeast, July 2007, accession # VV2-034

The property contains a dwelling, a well with pump and water tank, several trailers, and a large quantity of miscellaneous debris. The dwelling is a simple, small, modestly scaled, single-story rectangular block measuring 18 by 26 feet. The foundation is slab-on-grade and the walls are concrete block. The windows are varied in size, but are (or were) all steel casement sash. At some point, the building burned, which destroyed the roof, the doors, and several of the windows.

This property, located on a terrace west of the Mojave River, is one of several in the immediate area that were acquired and occupied in the middle to late 1950s. The dwelling, which dates to that time, has been severely damaged by fire. It does not appear to be eligible for the National Register. Evaluated under National Register Criteria A and B, it is not associated with any significant events or persons in history; under Criterion C, it does not possess any architectural significance. It does not embody distinctive characteristics of a type, period, or method of construction, it does not represent the work of a master builder, nor do it possess high aesthetic value. Because of the lack of significance, integrity is not an issue.

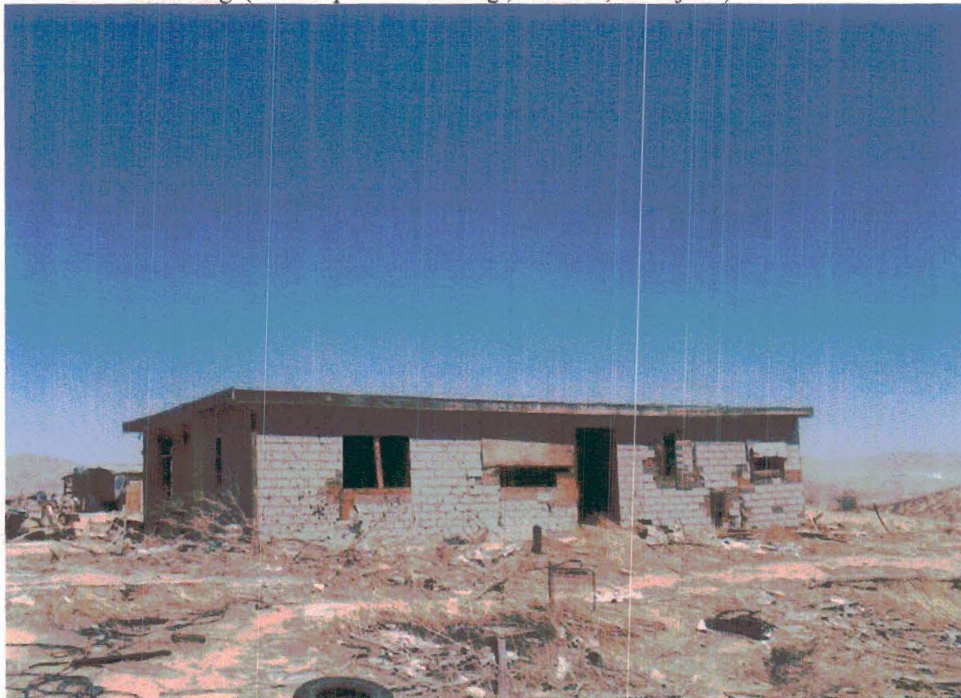
P5b. Description of Photo: (view, date, accession #) View of dwelling looking east-southeast, July 2007, accession # VV2-031

The property contains a dwelling, a shed, a well with pump and water tank, a trailer, and a large quantity of miscellaneous debris. The dwelling is a simple, relatively large but modestly scaled single-story rectangular block measuring 25 by 35 feet. The foundation is slab-on-grade and the walls are wood frame, sheathed with plywood and asphalt shingles. The building has a low-pitched shed roof with overhanging eaves; the roofing is asphalt roll. The doors, windows, and portions of the walls are missing. The building is in very poor condition; it is not clear if it was actually finished or if it has been partially dismantled. The shed, located north of the dwelling, is built of wood frame with plank siding; it has partially collapsed.

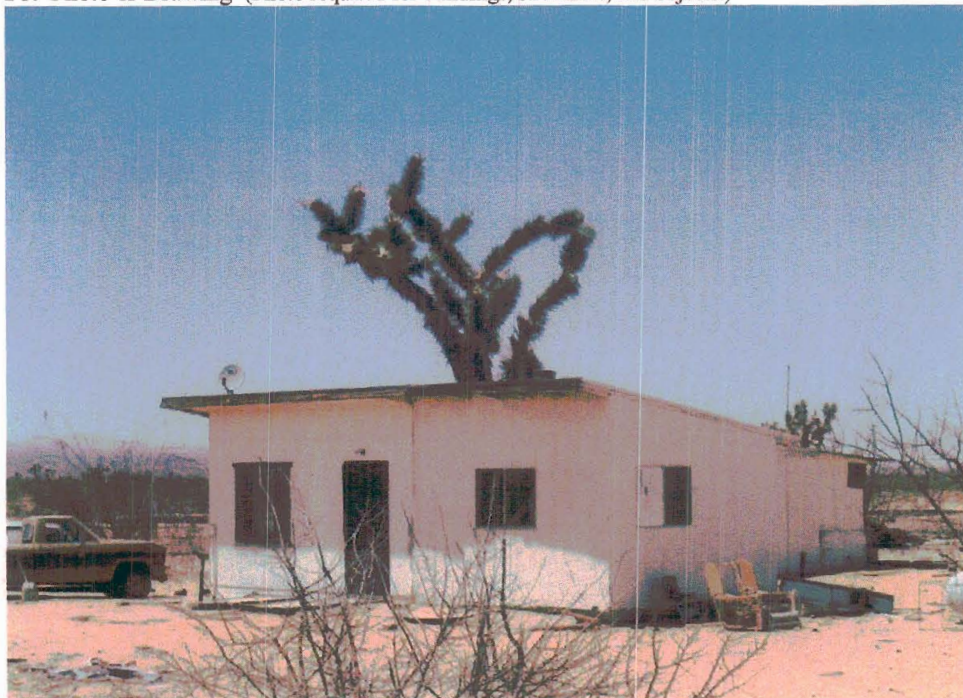
P5b. Description of Photo: (view, date, accession #) View of dwelling looking northwest, July 2007, accession # VV2-025

The property contains a dwelling, a pump house, and a large quantity of miscellaneous debris. The dwelling is a simple, small, modestly scaled, single-story rectangular block with rooms added on the rear. Maximum dimensions are approximately 20 by 30 feet. The foundation is slab-on-grade and the walls are wood frame, sheathed with a mix of composite wood siding, plywood, and stucco. The building has a shed roof with overhanging eaves. The front door is wood panel and the windows are aluminum sliding sash; three of the windows have 1x4 exterior casing. The pump house, southwest of the dwelling, is built of wood frame with plywood siding. The buildings are in poor to fair condition.

This property, located on a terrace west of the Mojave River, is one of several in the immediate area that were acquired and occupied in the middle to late 1950s. The dwelling, which dates to that time, is in poor to fair condition and has been extensively altered. It does not appear to be eligible for the National Register. Evaluated under National Register Criteria A and B, it is not associated with any significant events or persons in history; under Criterion C, it does not possess any architectural significance. It does not embody distinctive characteristics of a type, period, or method of construction, it does not represent the work of a master builder, nor do it possess high aesthetic value. Because of the lack of significance, integrity is not an issue.

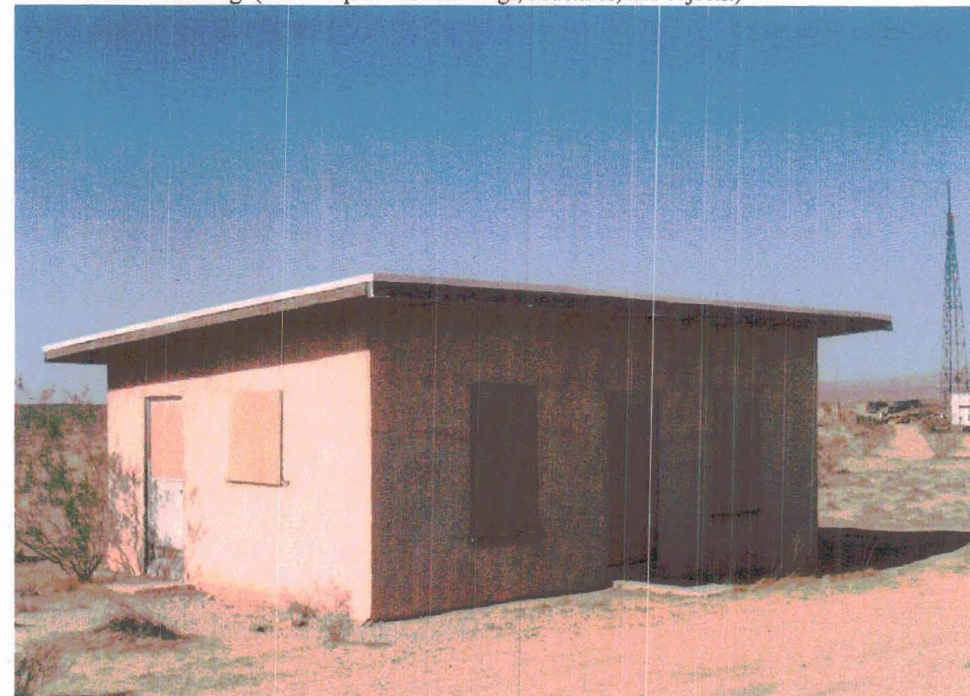
P5b. Description of Photo: (view, date, accession #) View of dwelling looking east-northeast, July 2007, accession # VV2-009

The property contains a dwelling and a privy. The dwelling is a simple, small, modestly scaled, single-story rectangular block measuring 16 by 20 feet. The foundation is slab-on-grade and the walls are wood frame, sheathed with stucco. The building has a shed roof with overhanging eaves; the roofing is asphalt roll. The doors are wood panel; the windows are not visible, having been boarded up. The privy, northwest of the dwelling, is also built of stuccoed wood frame. The dwelling is in fair condition; the privy is collapsing.

This property, located on a terrace west of the Mojave River, is one of several in the immediate area that were acquired and occupied in the middle to late 1950s. The dwelling on the property, which dates to that time, is in fair condition and as far as can be discerned has not been altered. It does not appear to be eligible for the National Register. Evaluated under National Register Criteria A and B, it is not associated with any significant events or persons in history; under Criterion C, it does not possess any architectural significance. It does not embody distinctive characteristics of a type, period, or method of construction, it does not represent the work of a master builder, nor do it possess high aesthetic value. Because of the lack of significance, integrity is not an issue.

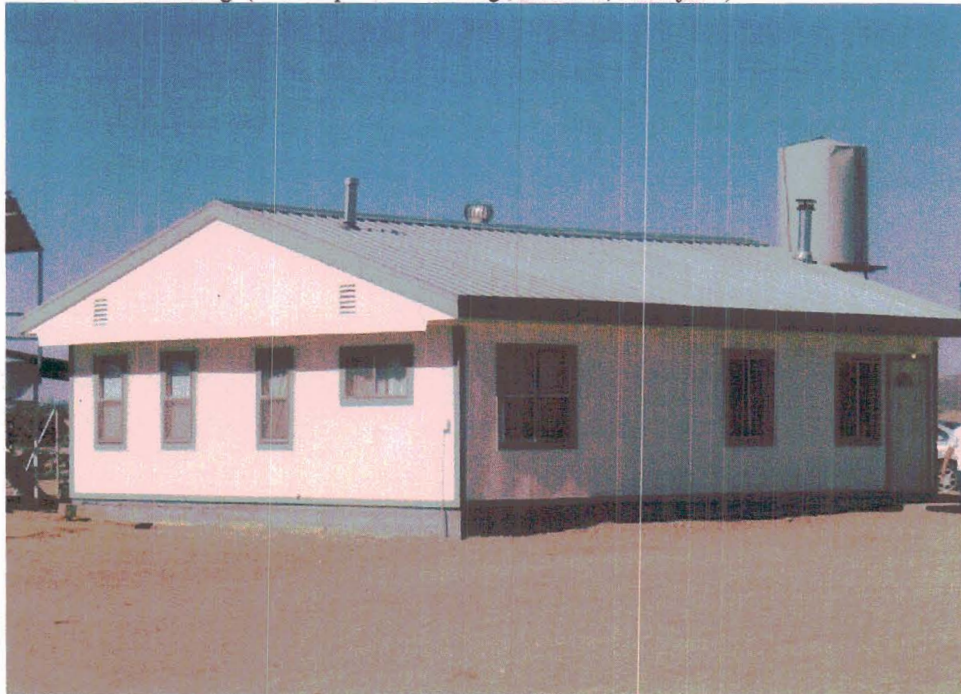
P5b. Description of Photo: (view, date, accession #) View of dwelling looking northeast, July 2007, accession # VV2-005

The property contains a dwelling, a garage, a well with pump and water tank, and a wind generator. The dwelling is a simple, relatively large but modestly scaled single story rectangular block measuring 30 by 30 feet. The foundation is slab-on-grade and the walls are wood frame, sheathed with composite wood siding. The building has a gabled roof with overhangs on all sides; the roofing is corrugated metal. The doors are wood panel; the windows are aluminum sliding sash. The garage, north of the dwelling, is of similar construction. The buildings are in good condition.

This property, located on a terrace west of the Mojave River, is one of several in the immediate area that were acquired and occupied in the middle to late 1950s. The dwelling, which dates to that time, is in good condition and has been extensively altered. It does not appear to be eligible for the National Register. Evaluated under National Register Criteria A and B, it is not associated with any significant events or persons in history; under Criterion C, it does not possess any architectural significance. It does not embody distinctive characteristics of a type, period, or method of construction, it does not represent the work of a master builder, nor do it possess high aesthetic value. Because of the lack of significance, integrity is not an issue.

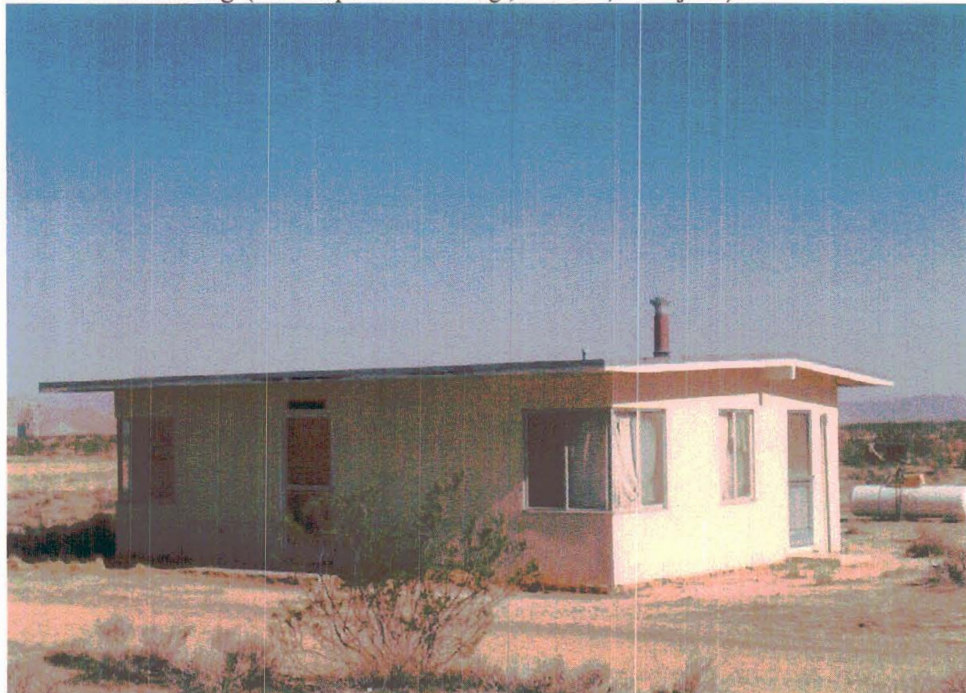
P5b. Description of Photo: (view, date, accession #) View of dwelling looking east-southeast, July 2007, accession # VV2-006

The property contains a dwelling and a pump house. The dwelling is a simple, small, modestly scaled, single-story rectangular block measuring 21 by 25 feet. The foundation is slab-on-grade and the walls are wood frame, sheathed with stucco. The building has a low-pitched gabled roof with overhanging eaves; the roofing is asphalt roll. The front door is flush wood hollow-core and the side door is wood panel. The windows are aluminum casement sash; three are corner windows. The pump house, southwest of the dwelling, is of similar construction except that it is sheathed with asphalt shingles. The buildings are in fair condition.

This property, located on a terrace west of the Mojave River, is one of several in the immediate area that were acquired and occupied in the middle to late 1950s. The dwelling on the property, which dates to that time, is in fair condition and has not been altered. It does not appear to be eligible for the National Register. Evaluated under National Register Criteria A and B, it is not associated with any significant events or persons in history; under Criterion C, it does not possess any architectural significance. It does not embody distinctive characteristics of a type, period, or method of construction, it does not represent the work of a master builder, nor do it possess high aesthetic value. Because of the lack of significance, integrity is not an issue.

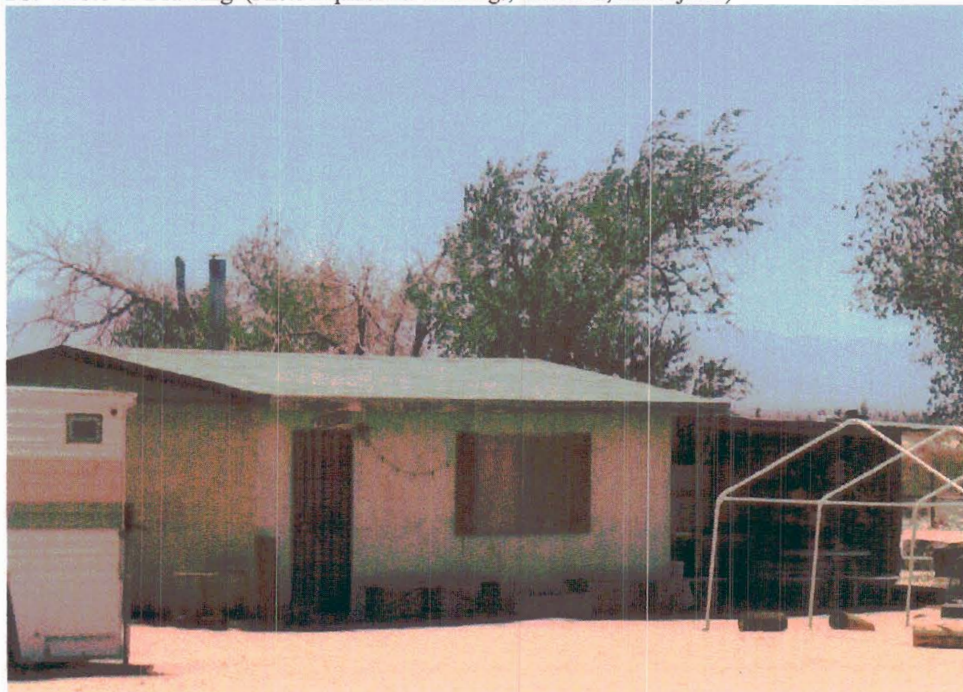
P5b. Description of Photo: (view, date, accession #) View of dwelling looking southwest, July 2007 accession # VV2-020

The property contains a dwelling, a pump house, and three sheds. The dwelling is a simple, small, modestly scaled, single-story rectangular block measuring 18 by 22 feet. The foundation is slab-on-grade and the walls are wood frame, sheathed with stucco. The building has a gabled roof with overhanging eaves; the roofing is asphalt shingle. The front door is flush wood hollow-core; the windows are aluminum sliding sash. On the west side of the dwelling is a porch, partially enclosed with corrugated metal. The pump house, south of the dwelling, is built of concrete block. The sheds are built of wood frame, sheathed with plywood, stucco, and corrugated metal. The buildings are in fair condition.

This property, located on a terrace west of the Mojave River, is one of several in the immediate area that were acquired and occupied in the middle to late 1950s. The dwelling on the property, which dates to that time, is in fair condition and has been altered. It does not appear to be eligible for the National Register. Evaluated under National Register Criteria A and B, it is not associated with any significant events or persons in history; under Criterion C, it does not possess any architectural significance. It does not embody distinctive characteristics of a type, period, or method of construction, it does not represent the work of a master builder, nor do it possess high aesthetic value. Because of the lack of significance, integrity is not an issue.

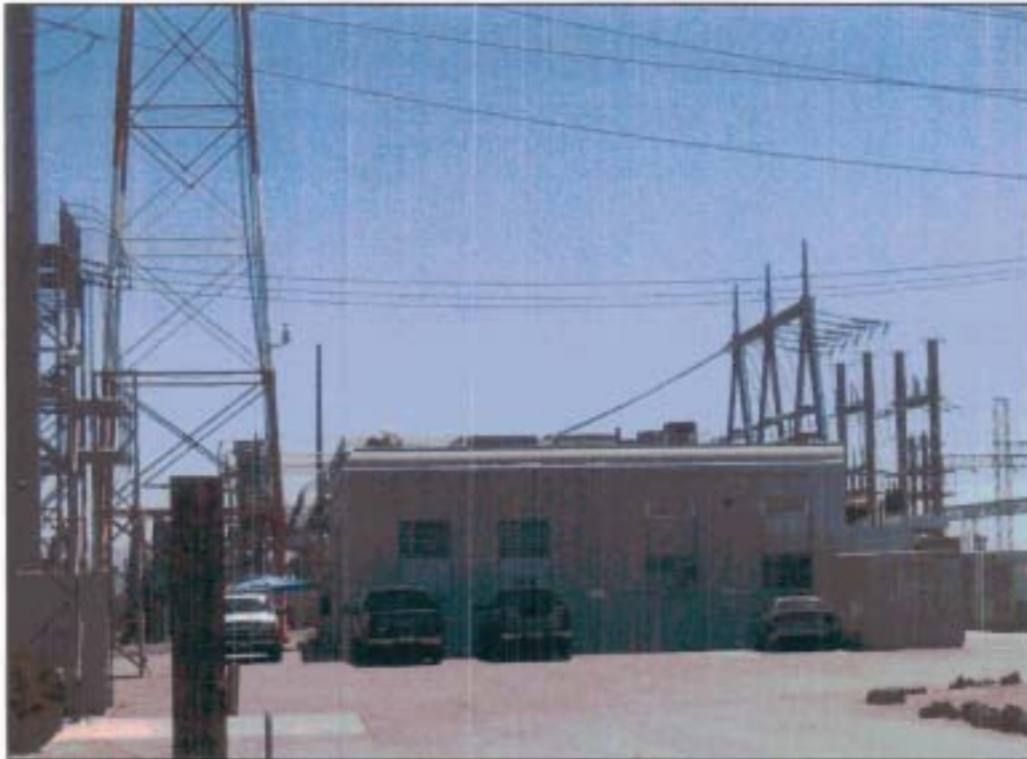
Photograph 1. Test Office, Victorville Substation; view looking east-southeast.

eligible for the NRHP under Criterion C. Accordingly; WSA recommends that the test office be considered a historic resource for the purposes of CEQA.

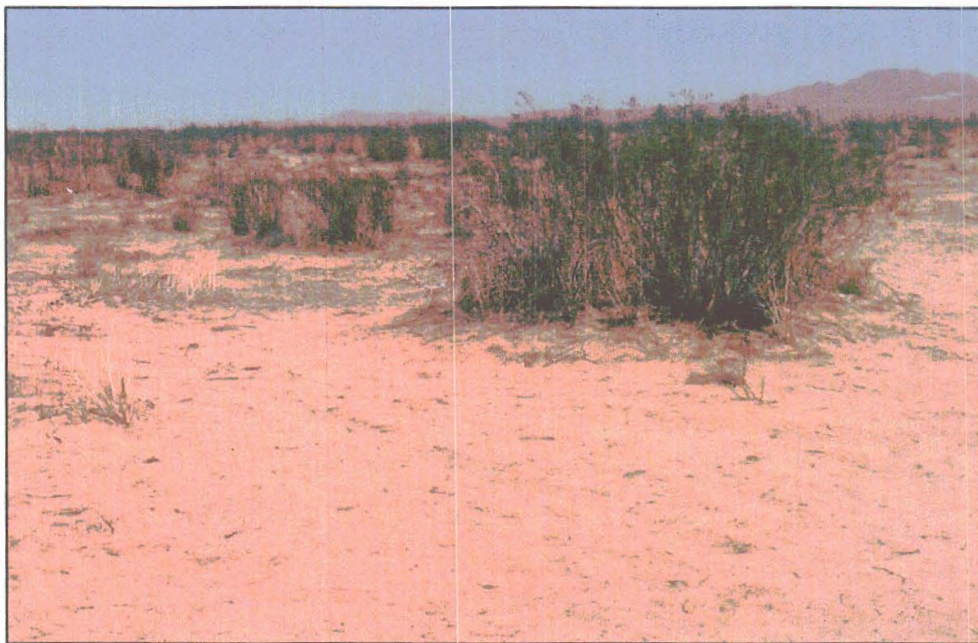
Photo 4: Parcel 0460-242-19, View NE.

Parcel 0460-242-19 is situated between parcels 242-18 and 242-20, two of the parcels with restricted access, and north of 242-26, the third restricted parcel. Modern trash was scattered over parcel 0460-242-19. This appeared to have been blown over from the adjacent properties. The survey was conducted in twenty meter transects, in a north-south direction. No prehistoric or historic resources were observed (Photo 4).

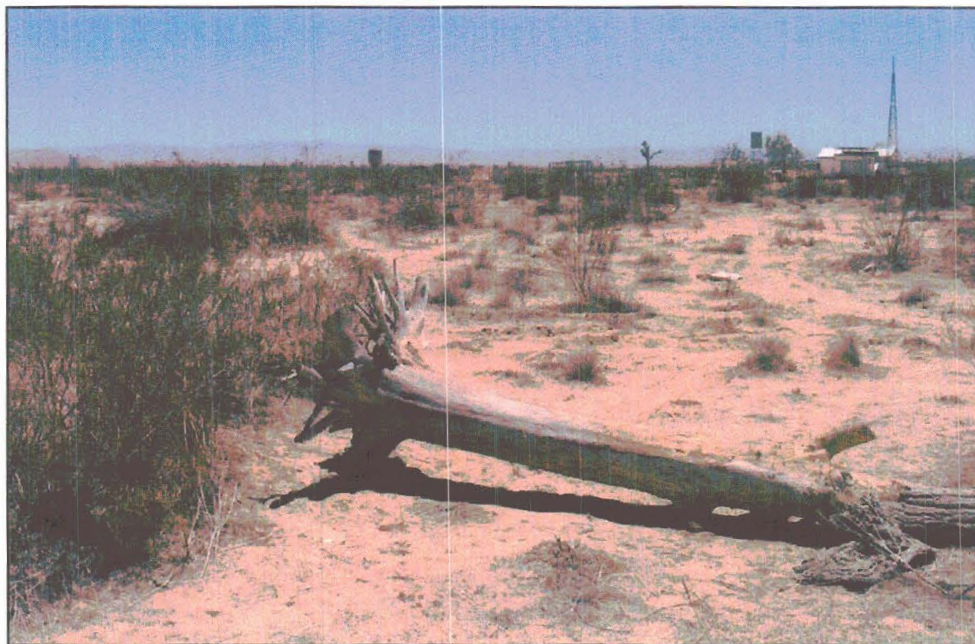
Photo 5: Parcel 0460-242-21, View SE.

Parcel 0460-242-21 is situated east of parcel 242-20, and north of parcel 242-24. In the southern portion of the parcel, there are two standing structures, both in excellent condition. In the northern portion of the parcel is open land. A few pieces of modern trash were evident. These appeared to have blown in from surrounding properties. Wood logs are lined up to mark the northern edge of the property. Dirt roads mark the east, west, and southern boundaries. No prehistoric or historic resources were observed (Photo 5).
