Docket Number:	25-OPT-02
Project Title:	Prairie Song Reliability Project
TN #:	264474
Document Title:	App 3-2E Waste Discharge Requirements Application Part 2
Description:	N/A
Filer:	Erin Phillips
Organization:	Dudek
Submitter Role:	Applicant Consultant
Submission Date:	6/27/2025 9:18:48 AM
Docketed Date:	6/27/2025

Appendix 3.2E

Waste Discharge Requirements Application
2 of 3

Aquatic Resources Delineation Report

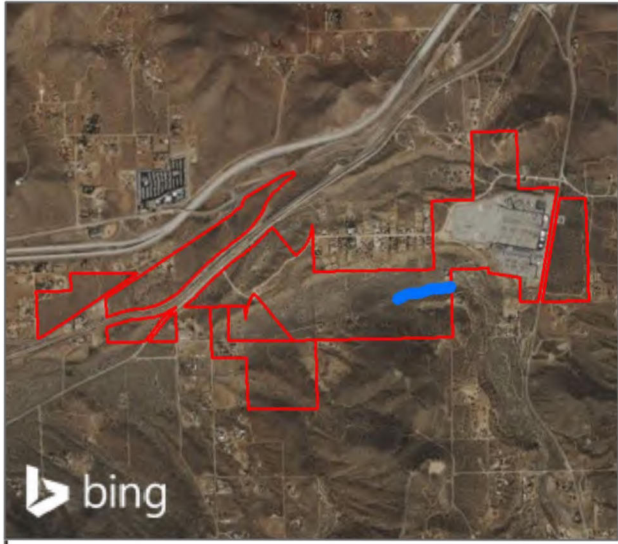
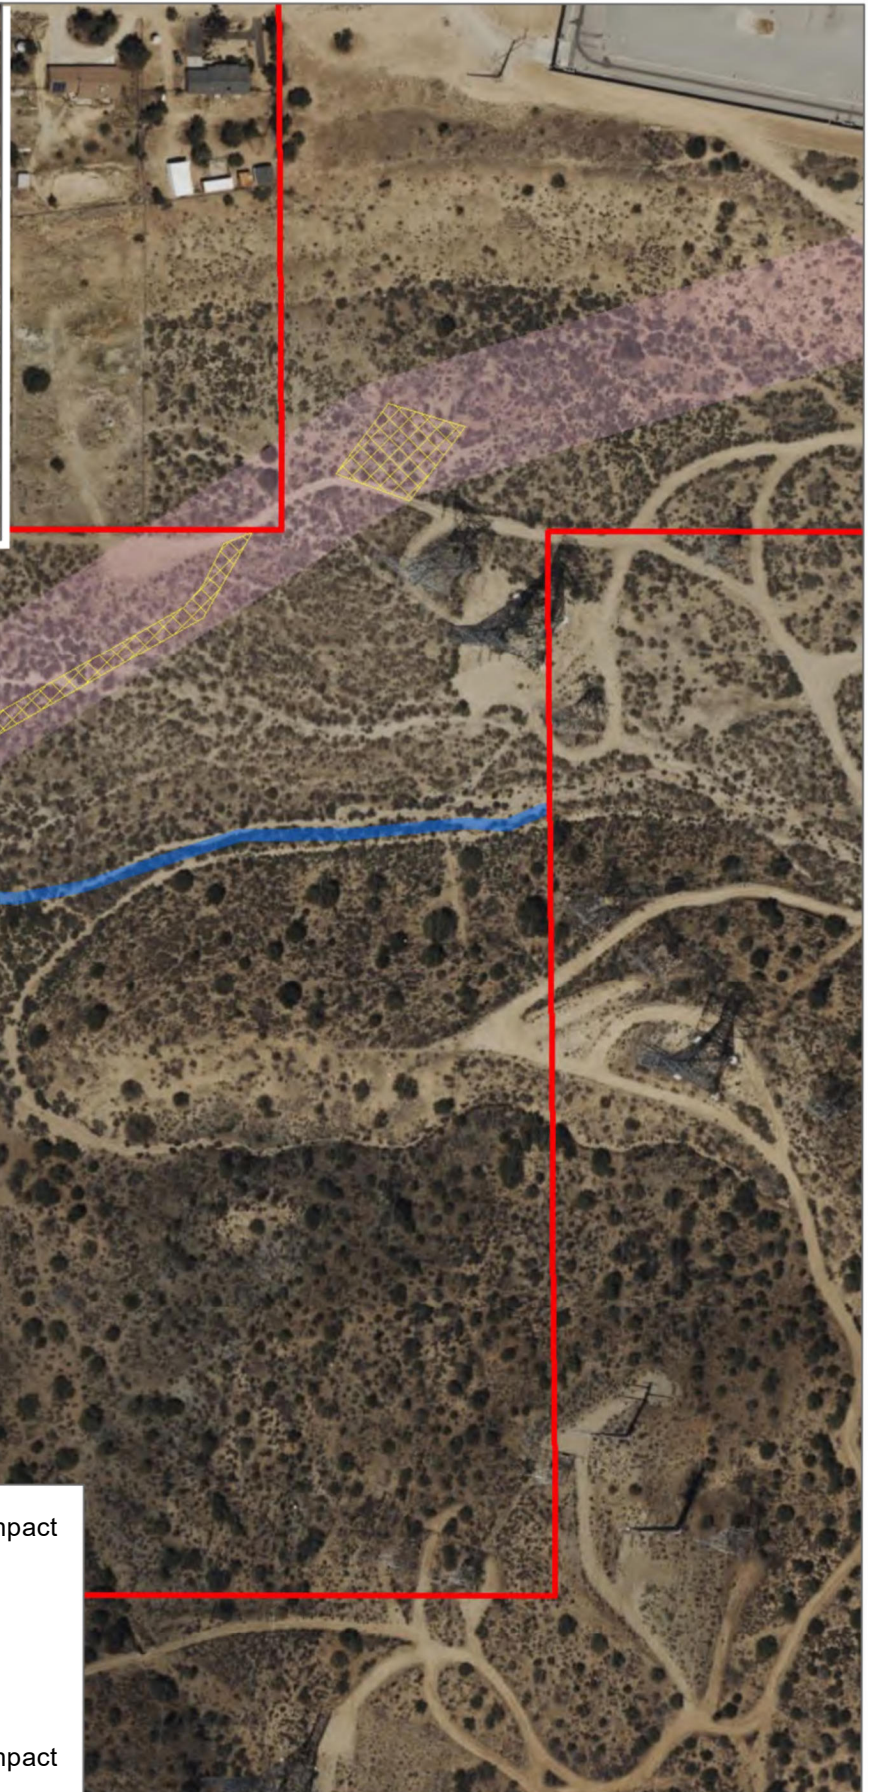
Figure 4 - NWW-5
Jurisdictional Waters Impacts
Prairie Song Reliability Project

- Access Roads and Tower Pads-Permanent-Impact
- Project Boundary
- Waters of the State
- Impacts**
- Both Gen-Tie-Temporary Impact
- SCE Gen-Tie-Temporary Impact
- Access Roads and Tower Pads-Permanent-Impact

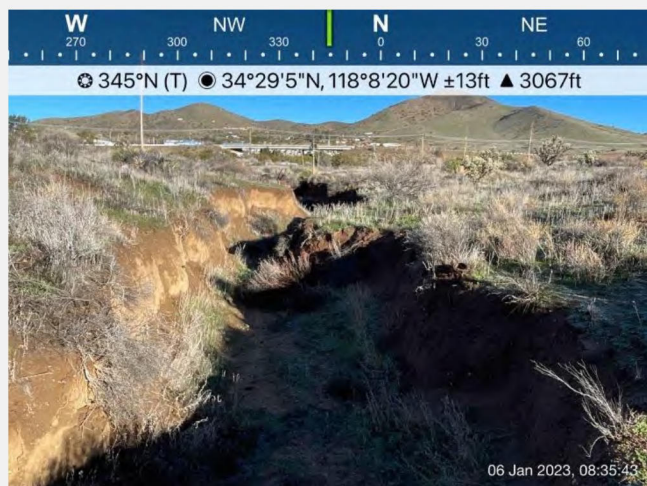
Photo 1. NWW-1b at OHWM form point, looking upstream.

NWW-1b is located entirely within the BESS portion of the Review Area. The feature merges with NWW-1a in the Review Area to become NWW-1c. NWW-1c becomes undefined to the southwest of the Review Area. NWW-1b has been classified as R4SBA which means it is a riverine feature that is intermittent and has a streambed that is temporarily flooded for brief periods. The soil type associated with the feature is Greenfield sandy loam, 2 to 9 percent slopes and the associated vegetation communities are *Atriplex canescens* Association, *Ephedra viridis* Association, *Juniperus californica* / *Adenostoma fasciculatum* - *Eriogonum fasciculatum* Association, and *Juniperus californica* / herbaceous Association.

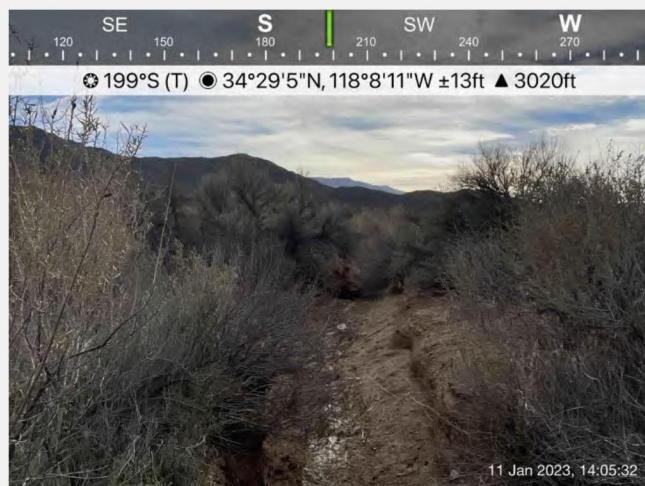
Photo 2. NWW-2 at OHWM form point, looking downstream.

NWW-2 is found in the gen-tie portion of the Review Area. Its headwaters are located less than three miles to the east-northeast of the Review Area in the upper Soledad Canyon. NWW-2 has been classified as R4SBA which means it is a riverine feature that is intermittent and has a streambed that is temporarily flooded for brief periods. The feature loses a defined OHWM downstream of the Review Area at the intersection of Carson Mesa Road and Searchlight Ranch Road and does not connect with the Santa Clara River. The soil type3 associated with NWW-2 are Hanford coarse sandy loam, 2 to 9 percent slopes and Terrace escarpments. The associated vegetation communities are *Atriplex canescens* Association, *Ericameria nauseosa* - *Juniperus californica* / herb Association, *Juniperus californica* / *Adenostoma fasciculatum* - *Eriogonum fasciculatum* Association, and *Juniperus californica* / herbaceous Association.

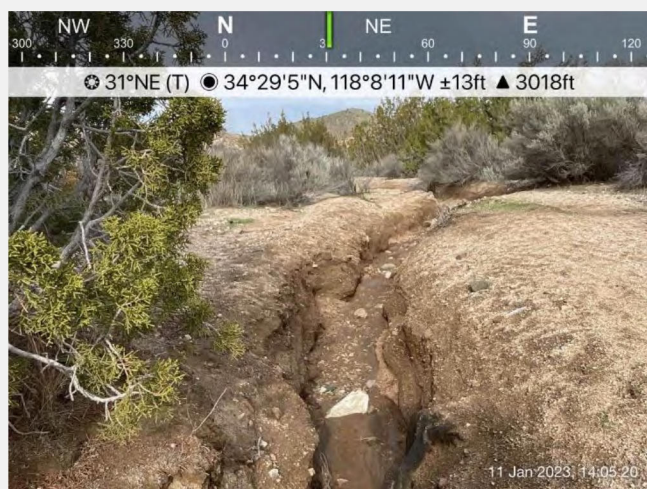
Photo 3. NWW-2 at OHWM form point, looking upstream.

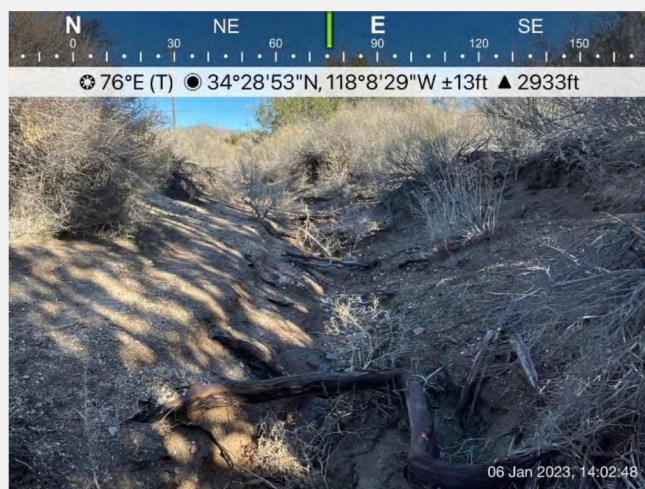
Photo 4. NWW-2 near Carson Mesa Road.

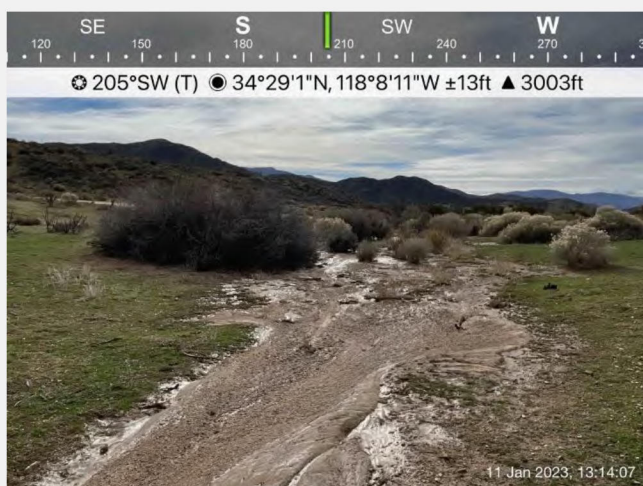
Photo 6. NWW-3 at OHWM form point, looking downstream.

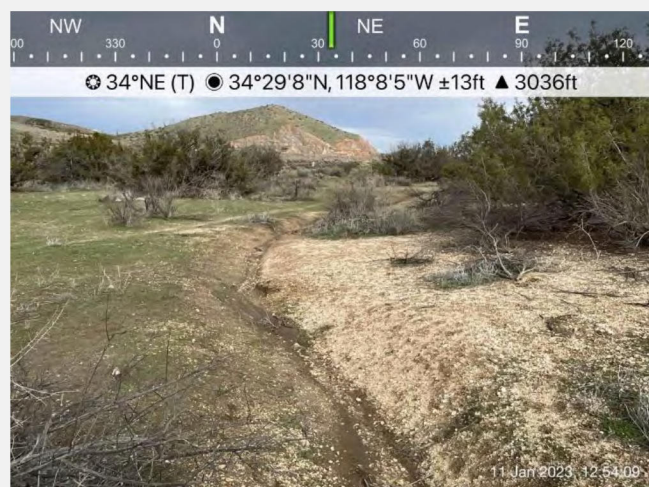
Photo 7. NWW-4 at OHWM form point, looking upstream.

NWW-4 is found entirely within the gen-tie portion of the Review Area. The feature loses its defined OWHM within the Review Area. The soil type associated with NWW-4 is Hanford coarse sandy loam, 2 to 9 percent slopes. The associated vegetation community is *Juniperus californica* / *Adenostoma fasciculatum* - *Eriogonum fasciculatum* Association.

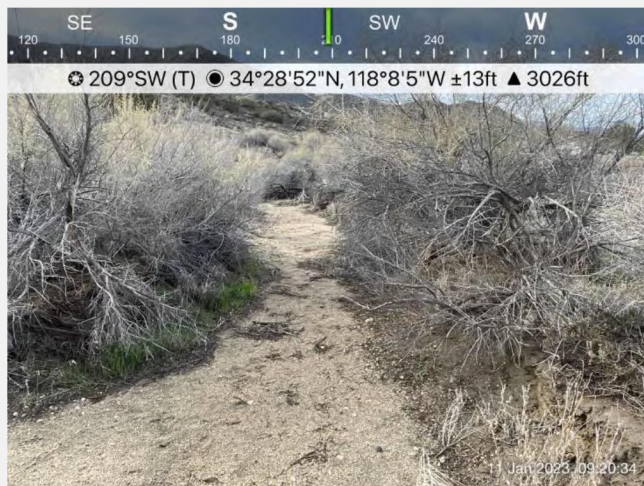
Photo 9. NWW-5 at OHWM form point, looking downstream.

NWW-5 is the main drainage feature of Kentucky Springs Canyon and is within the gen-tie portion of the Review Area. The feature loses its defined OWHM to the west of the Review Area at a residential/equestrian property but then has a defined OWHM between that property and Carson Mesa Road. It is expected that waters from NWW-5 flow across Carson Mesa Road and into NWW-2. The soil types associated with NWW-5 are Hanford coarse sandy loam, 2 to 9 percent slopes and Terrace escarpments. The associated vegetation communities are *Artemisia tridentata* Association, *Atriplex canescens* Association and *Juniperus californica* / herbaceous Association.

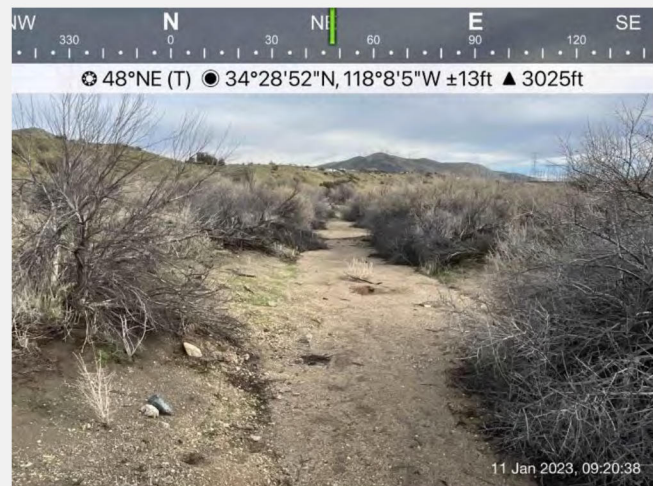
Photo 10. NWW-5 at OHWM form point, looking upstream.

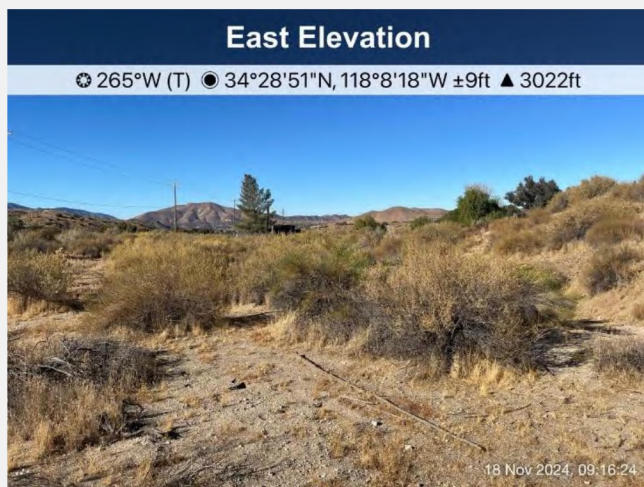
Photo 11. NWW-5 near its terminus at equestrian property.

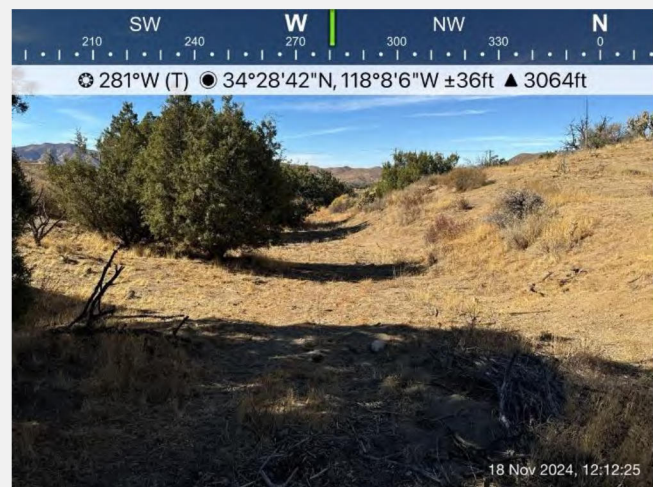
Photo 12. NWW-6 at OHWM form point, looking downstream.

NWW-6 is found entirely within the gen-tie portion of the Review Area. The feature loses its defined OWHM to the at a residential/equestrian property adjacent to the Review Area. The soil types associated with NWW-6 are Hanford coarse sandy loam, 2 to 9 percent slopes and Terrace escarpments. The associated vegetation community is *Juniperus californica* / herbaceous Association.
