PHASE I ENVIRONMENTAL SITE ASSESSMENT REPORT

Trimble aka Northtown

350 and 370 West Trimble Road San Jose, California 95131

September 17, 2024

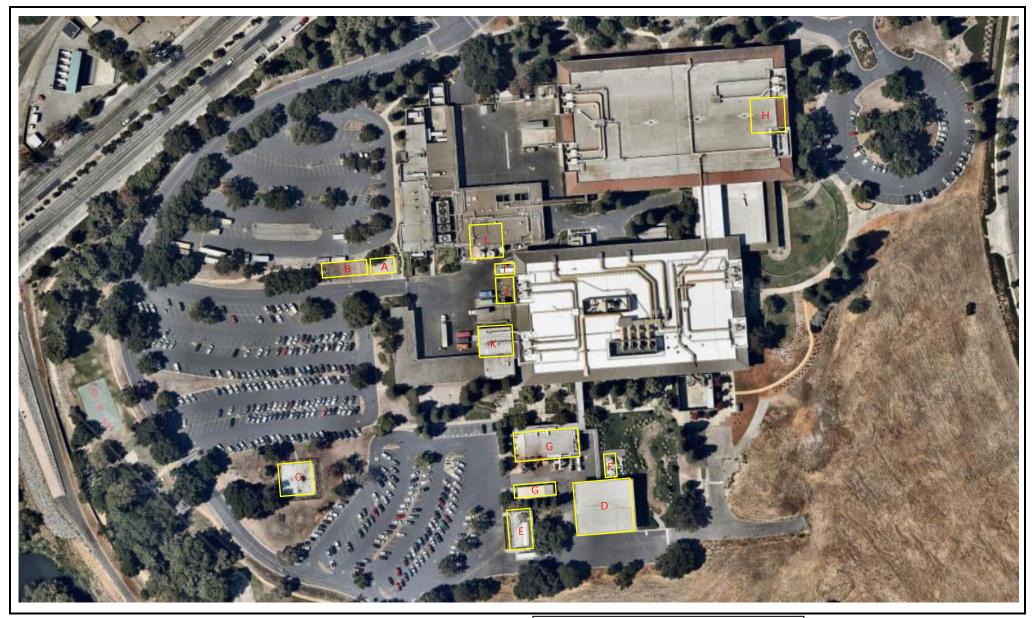
350 & 370 West Trimble Road San Jose, Santa Clara County, California SITE PLAN FIGURE 2A

- A 12,000-Gallon Diesel UST
- B 2 x 12,000-Gallon Fuel Oil USTs (Never Used)
- C 150,000-Gallon Fire Water Bladder and Fire Pump House G Gas Vault/Bulk Chemical Feed
- D Anhydrous Ammonia Storage

- Arsenic scrubber
- Waste Solvent and Stripper AST in-ground Vault
- K Former Bag House
- Wastewater Treatment System
