# Genesis Solar Energy Project

## Summary Report for Revegetation

June 2024

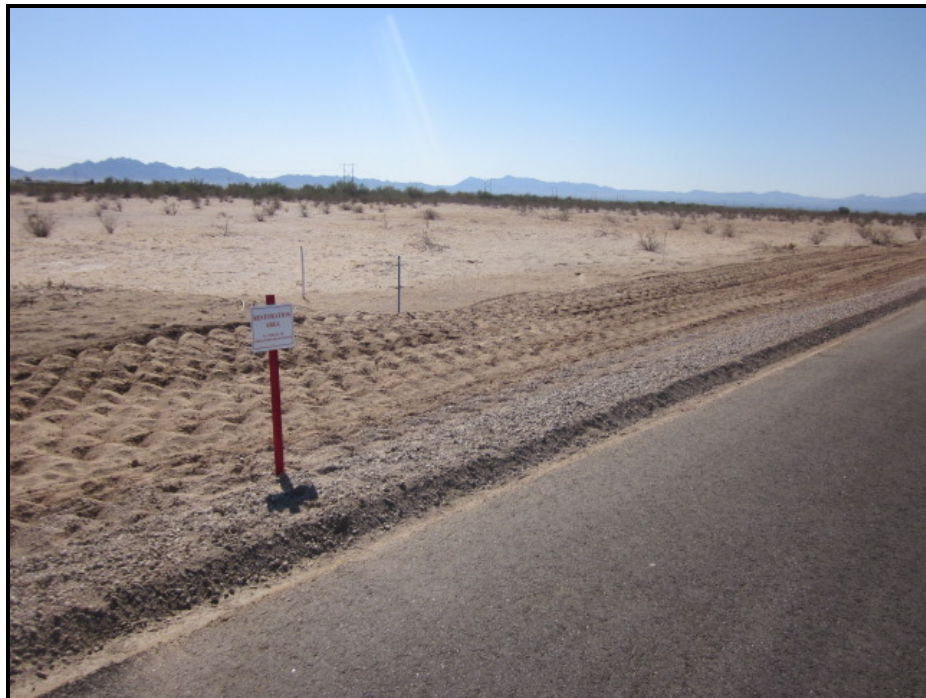
FIGURE 1. Sheep's foot imprinting on the southern road shoulder after seeding in Fall 2011.

Following seed drilling, a sheep's foot roller was used to imprint the soil, to catch seed, water, and sediments (Figure 1). A water truck with a side-sprayer wet the imprinted area repeatedly to create a crust on the newly disturbed soil, in an attempt to stabilize that surface from wind erosion.

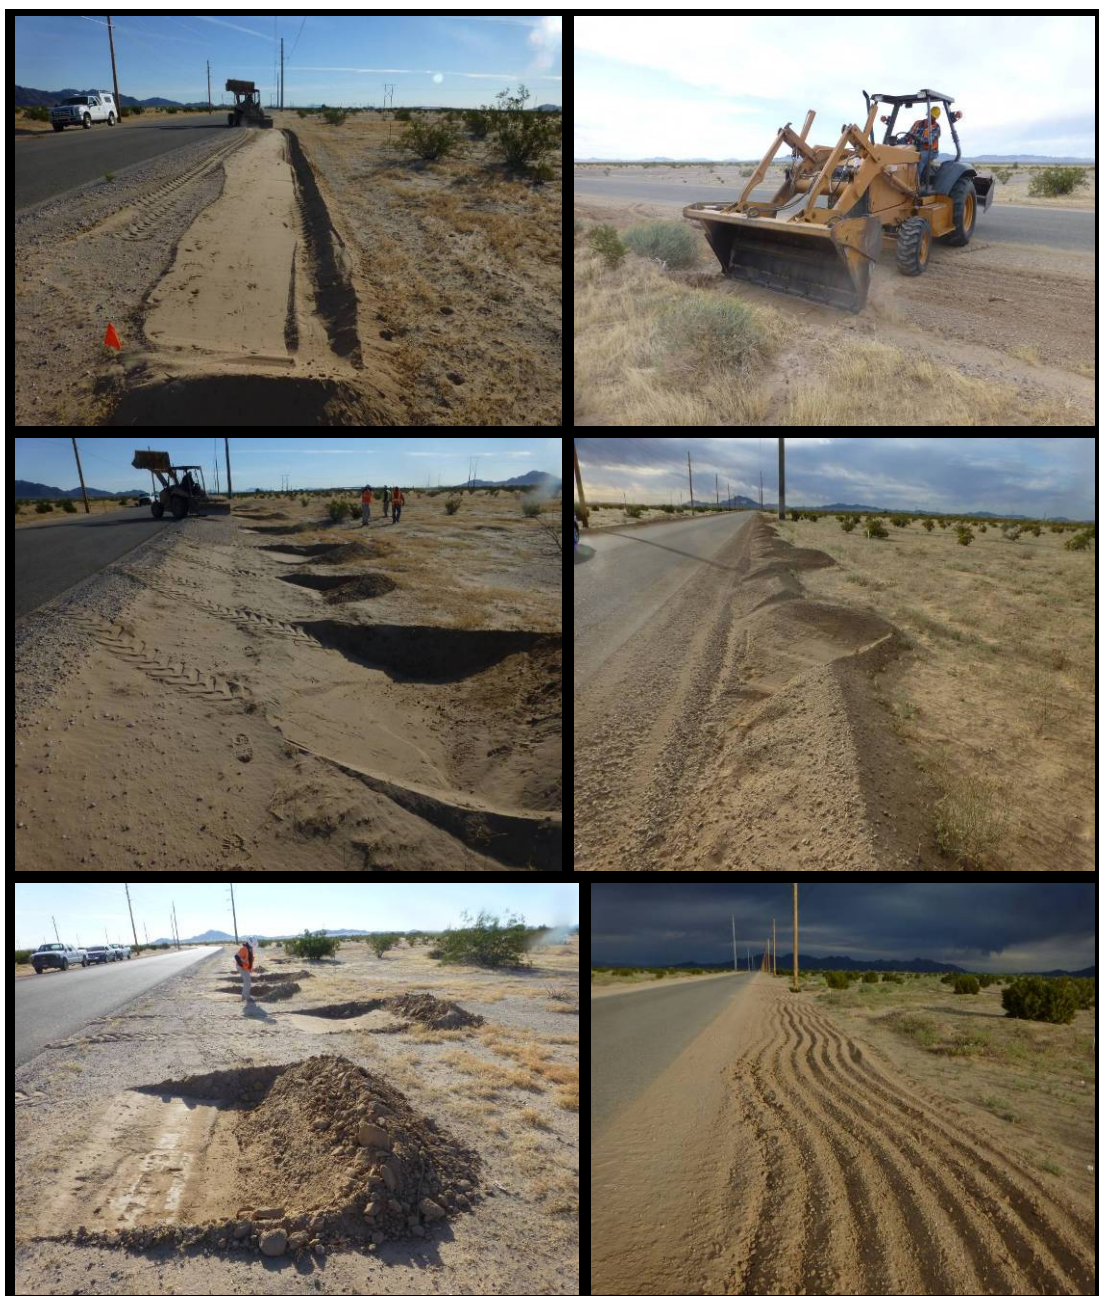
**FIGURE 2.** Different swale configurations created to capture moisture, sediment and seed. Techniques on the left were implemented experimentally on portions of the southern access road shoulder in Fall 2013. Those on the right were implemented in March 2014 on remaining areas on the southern road shoulder and on the northern road shoulder.

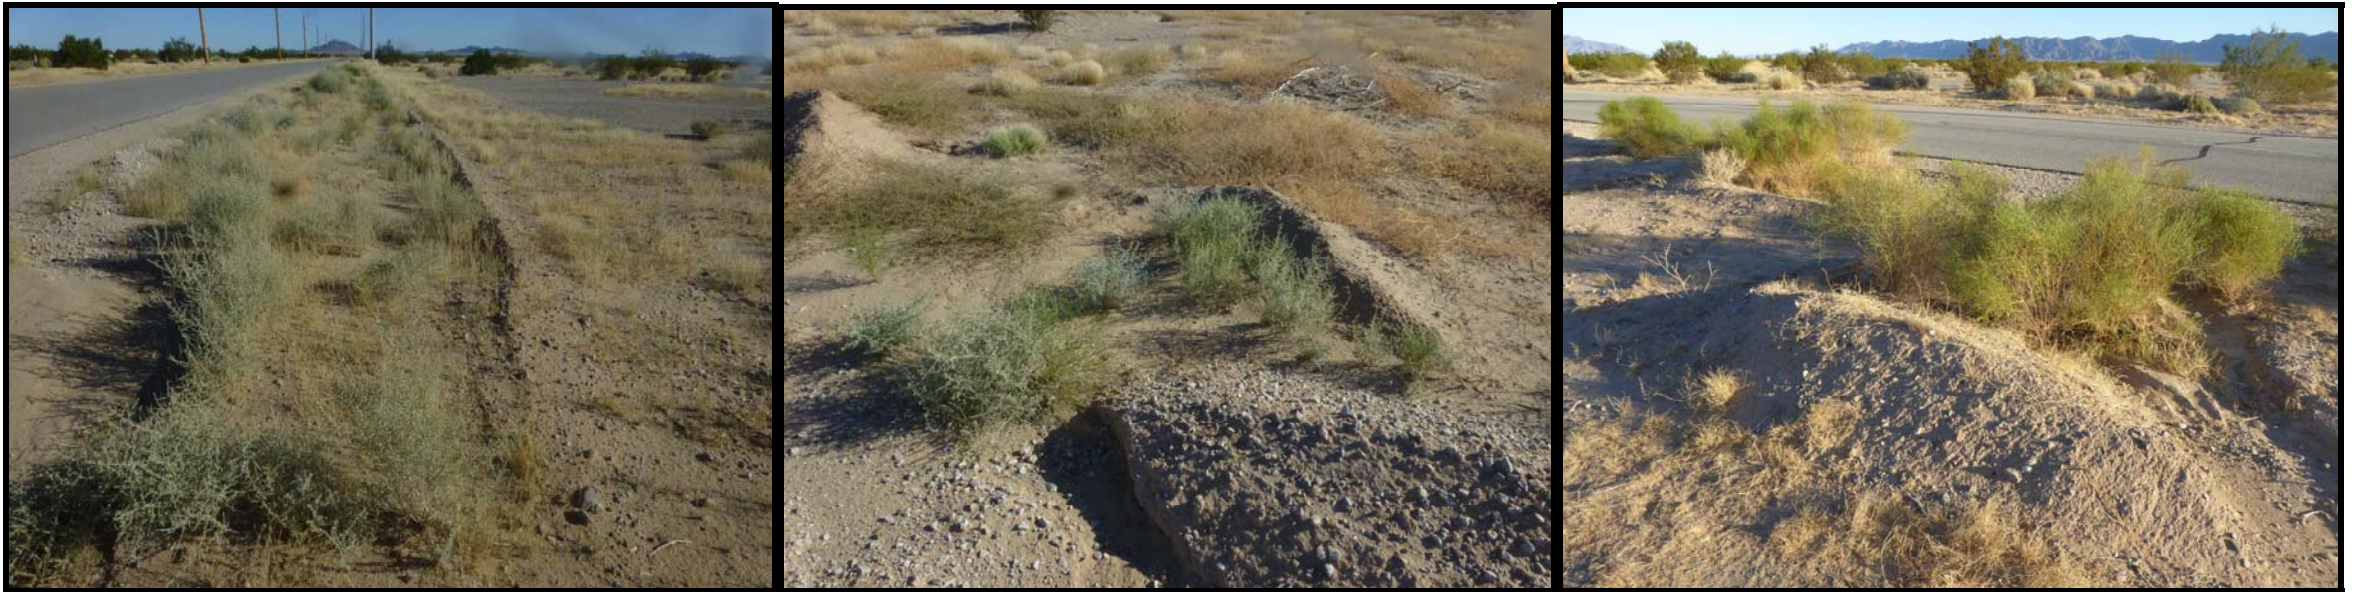
**FIGURE 3.** Examples of seedling growth in created swales, October 2014 (first two photos) and October 2015.

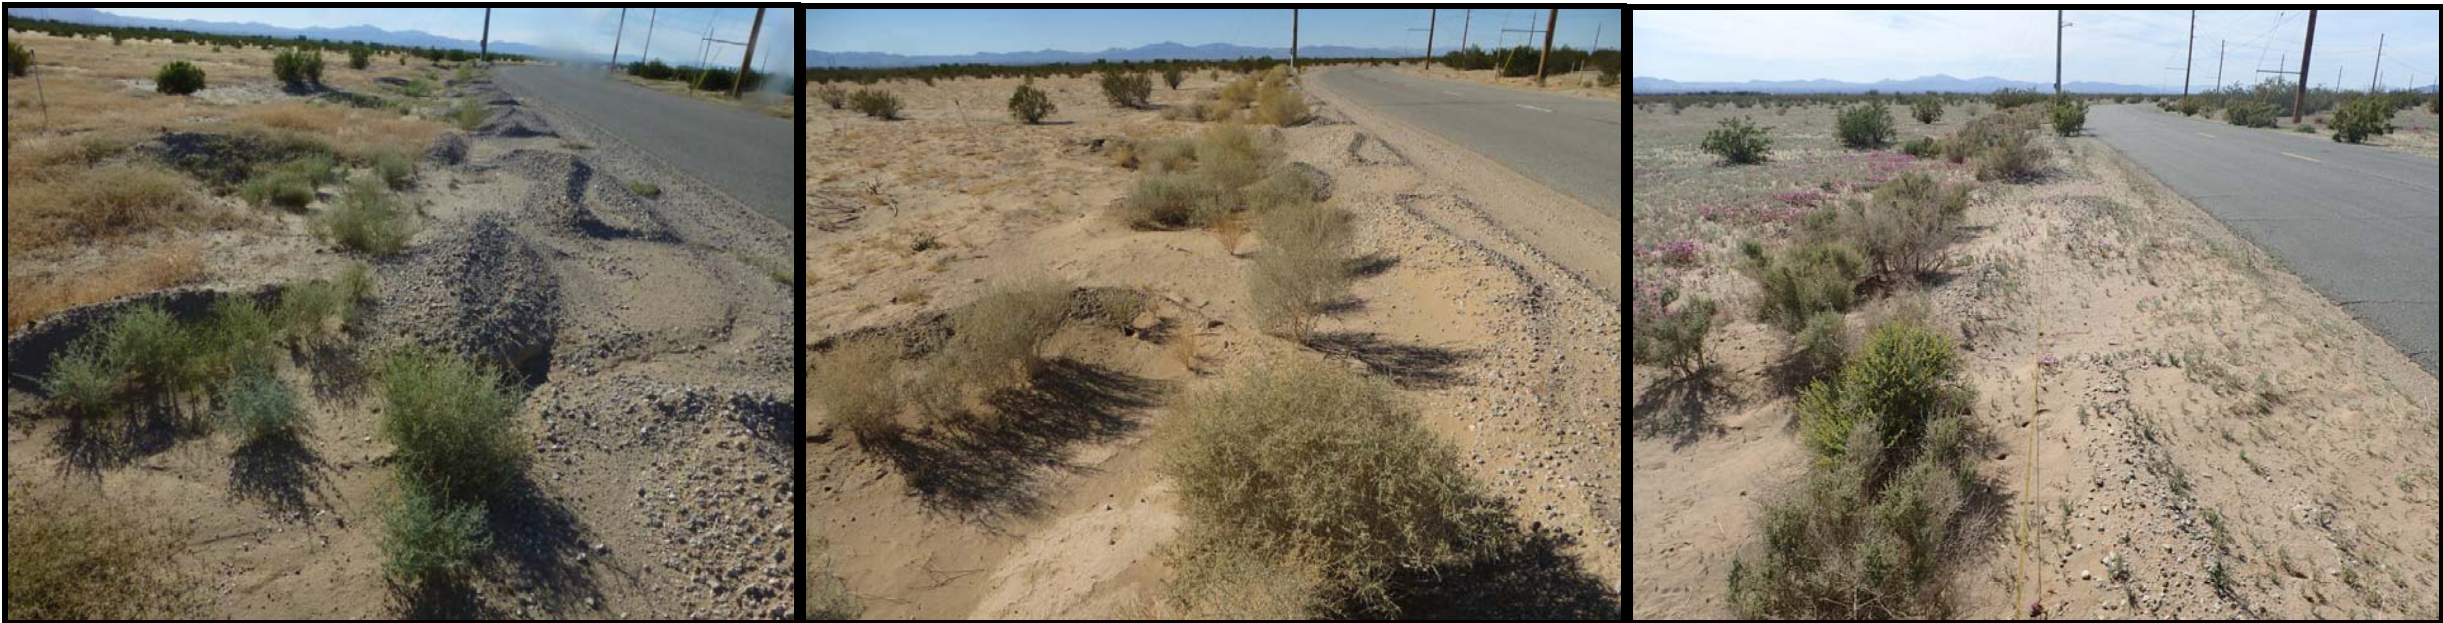
**FIGURE 4.** Transect BS2 - Example of high growth of seeded shrub species in created berms and swales through time. The upper photo is from October 2014, one year after restoration; the middle shows continued high survival and growth in November 2015; the lower is from 2024, the vegetation thriving.
