| <b>Project Title:</b> | Willow Rock Energy Storage Center |
| <b>Document Title:</b> | Willow Rock CURE Data Request Set 1 Response, Attachment DR103-1_Part 1 |

| <b>HOLE #</b> | <b>ZEV-CH-01-23</b> | | |
| <b>DATE</b> | <b>9/30/2022</b> | | |

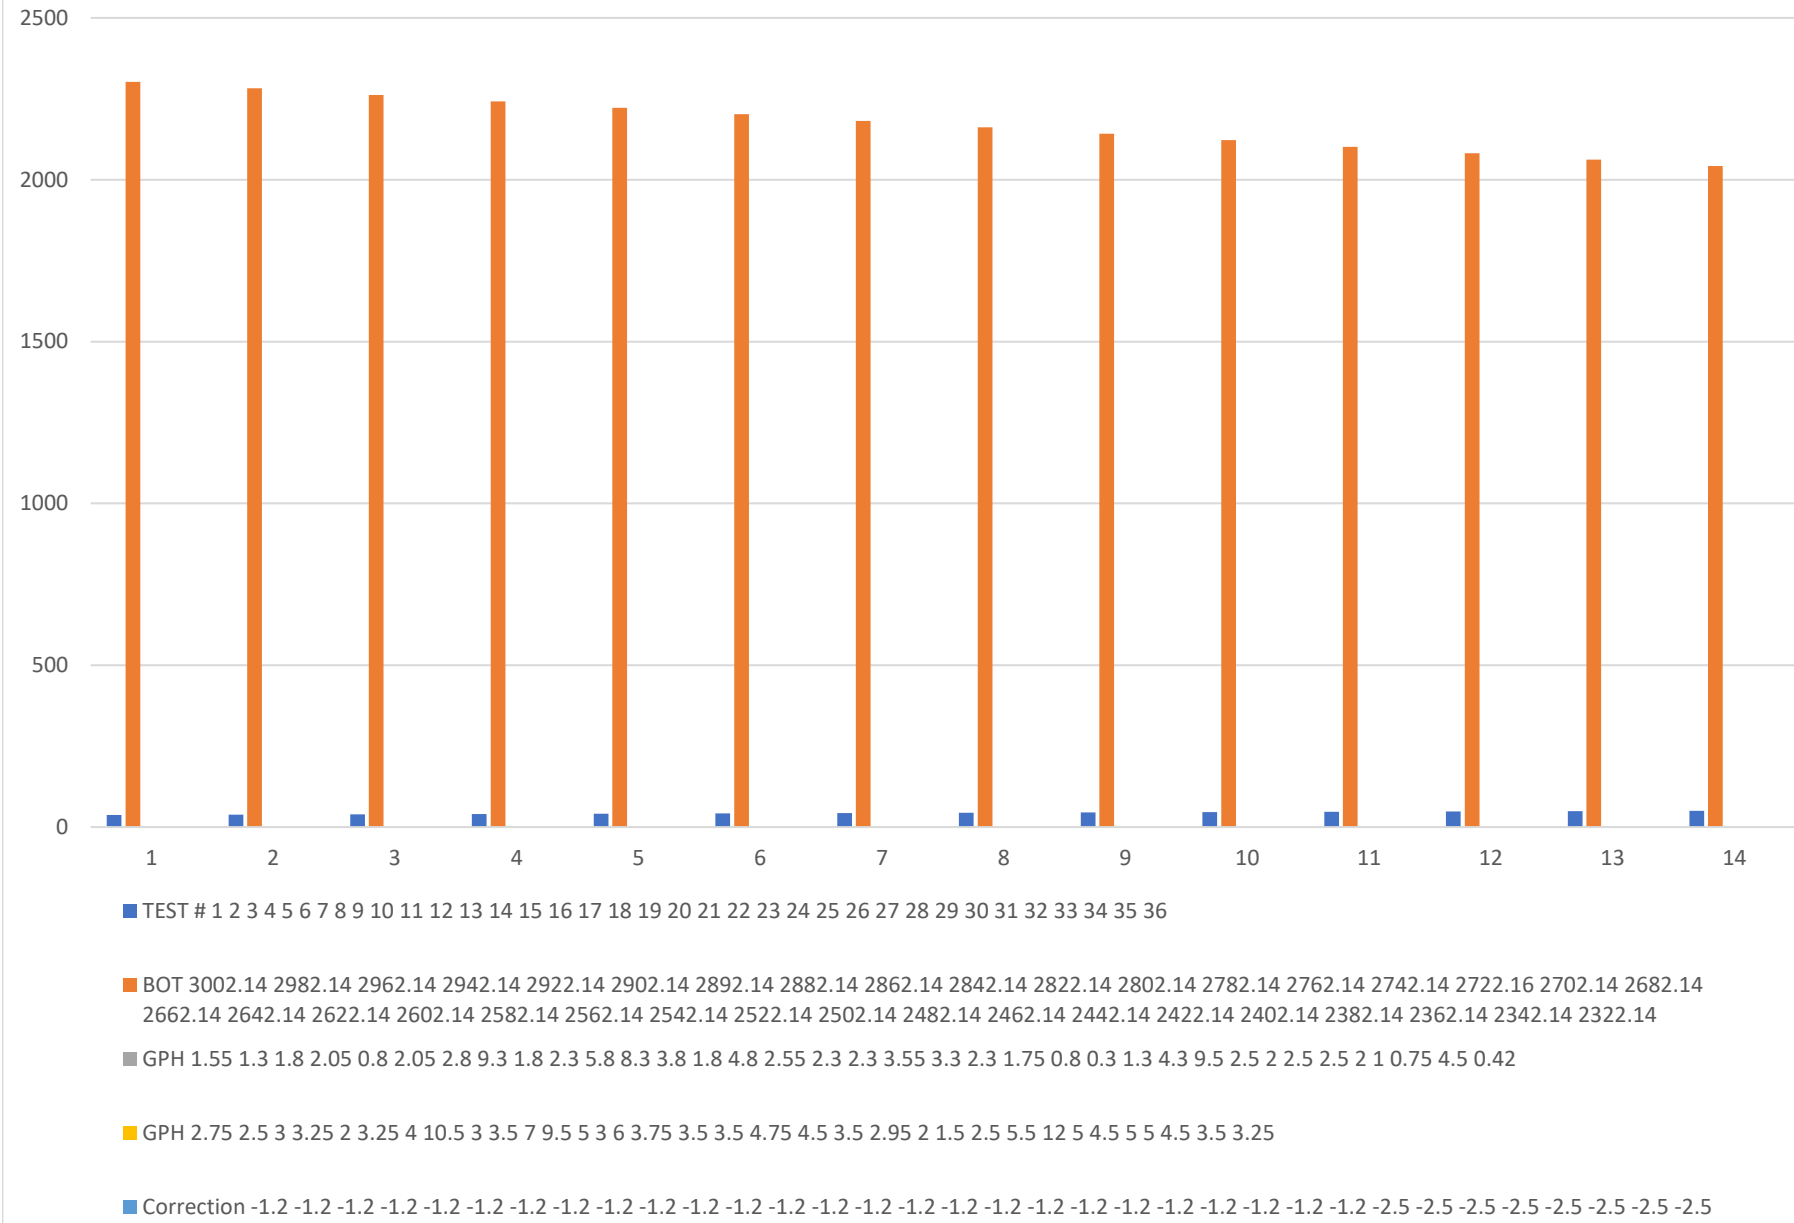
Chart Title

Test 1 1 cup= 4.47' At 5 min the test illustrates water finding new pathways /or opening fractures
