Docket Number:	24-OPT-02
Project Title:	Compass Energy Storage Project
TN #:	265490
Document Title:	Staff Site Visit Report
Description:	Staff site visit report for the July 16, 2025 site visit.
Filer:	Lorenzo Cano
Organization:	California Energy Commission
Submitter Role:	Commission Staff
Submission Date:	8/8/2025 4:41:24 PM
Docketed Date:	8/8/2025

Site Visit Report

DOCKET NO.	24-OPT-02
PROJECT NAME	Compass Energy Storage Project
PROJECT LOCATION	29251 Camino Capistrano San Juan Capistrano, California
SITE VISIT DATE/TIME	July 16, 2025/11:30
PROJECT MANAGER	Renee Longman
SITE VISIT TEAM LEAD	Kevin DeLano
SITE VISIT REPORT NUMBER	CESP_24-OPT-02_20250716_SVR

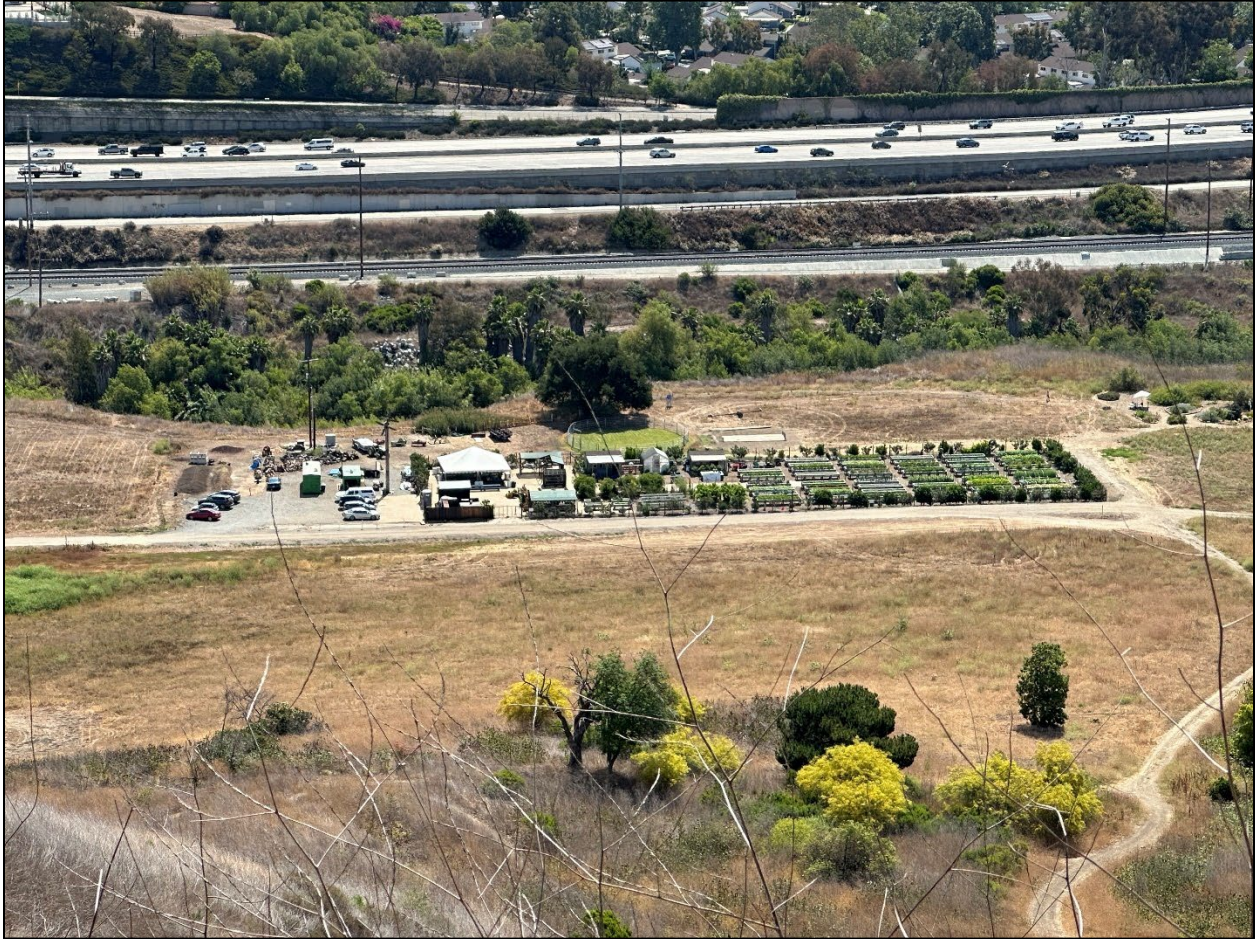
Photograph 1: View east of proposed project location taken from the top of the western embankment. Note the location is currently being used as a community garden (Peace Garden).

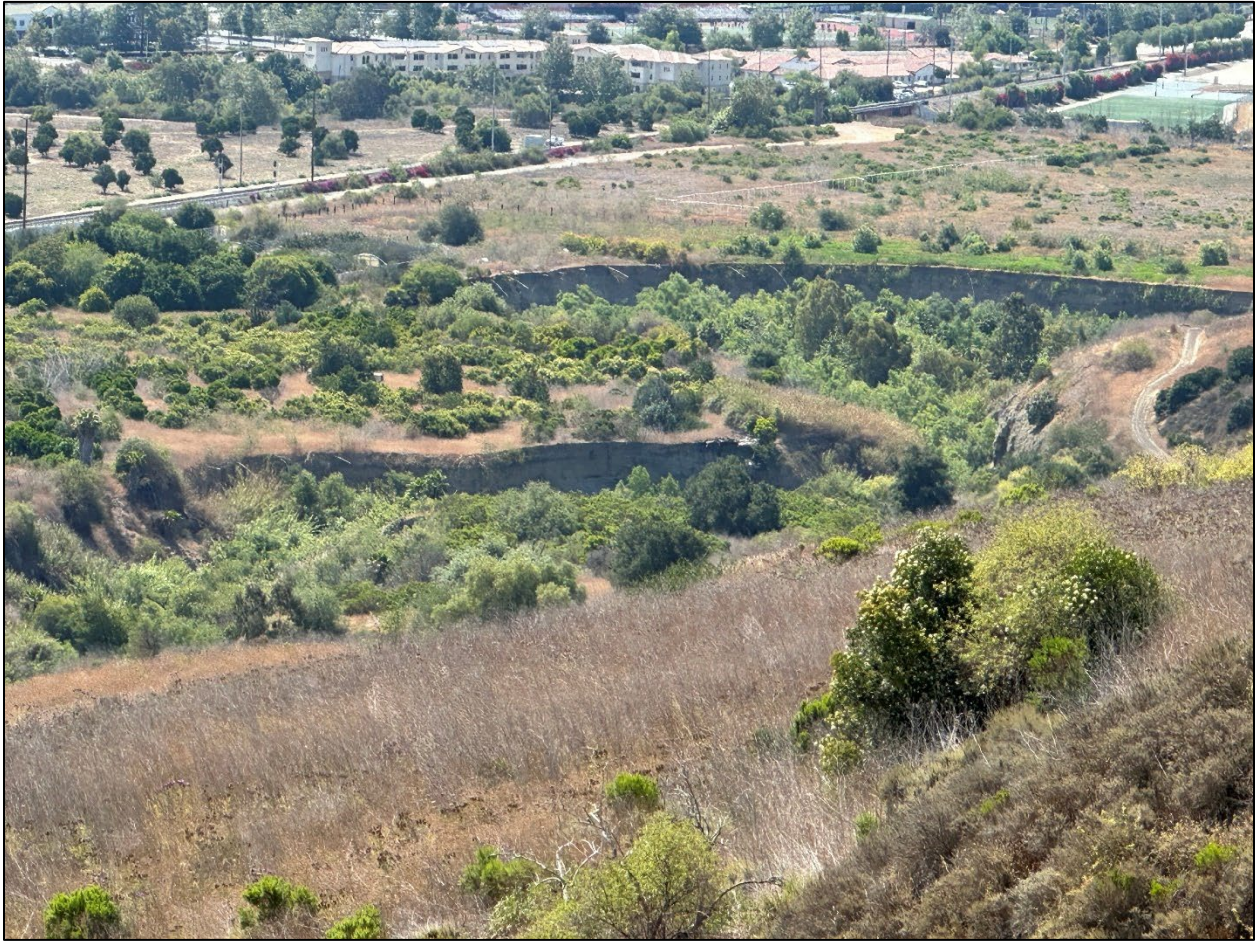
Photograph 2: View southeast from the top of the western embankment. Close-up of Oso Creek stream erosion downstream from proposed site.

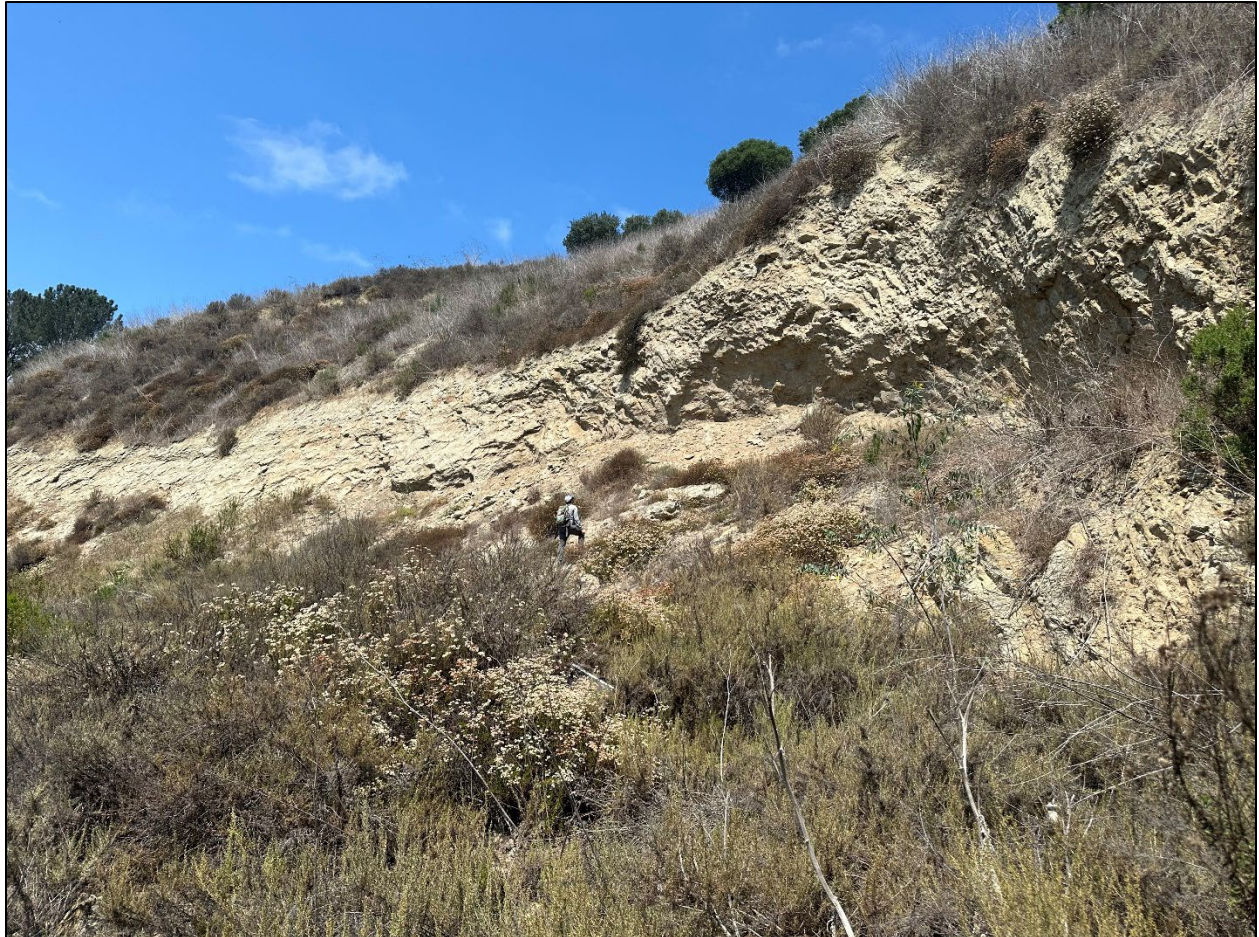
Kevin DeLano and James Ackerman accessed the Bluff Trail via Treethrone Circle. Photos were taken from an elevated position of the proposed project site and surrounding area. Of primary interest was the landslide headscarp below the Bluff Trail that exposed the marine sedimentary rock of the Mio-Pliocene age Capistrano Formation (Photograph 3).

Photograph 3: View west of a landslide headscarp west of the project site exposing the marine sedimentary rock of the Mio-Pliocene age Capistrano Formation. Kevin DeLano in the foreground.

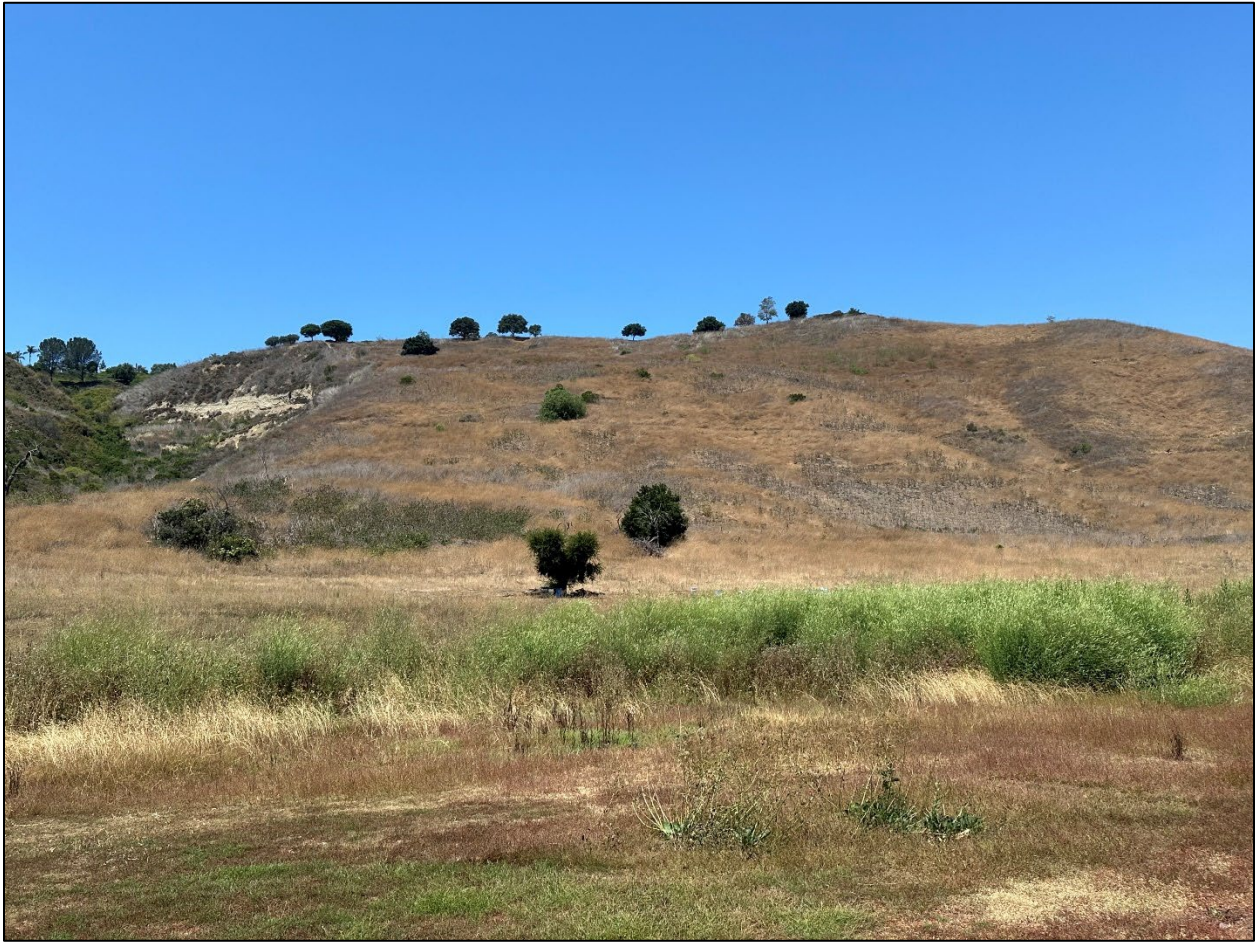
**Photograph 4: View southwest of Bluffs from project site, near the community gardens.
Landslide scarp in left background**

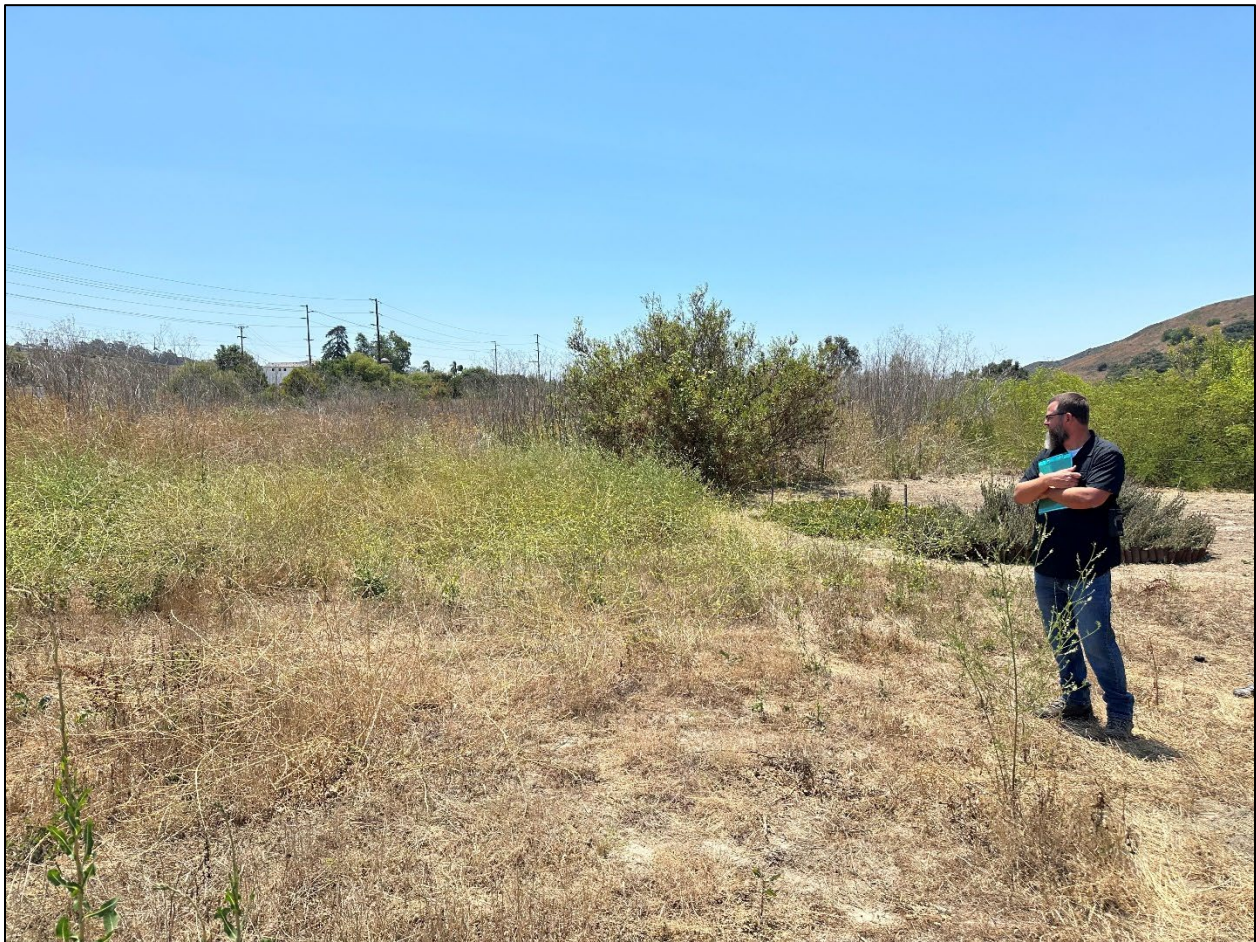
One of the areas that CEC staff were concerned about was the proposed level spreader site (Photograph 3). CEC staff is concerned that stormwater introduced from the level spreader could exacerbate the condition of slumping along the Oso Creek stream embankment in response to erosion. Much of this area was covered with tall grasses, shrubs and small trees. While there, CEC staff also observed the “ravine” identified in the updated aquatic resources report (Dudek 2024b). Although this feature was identified as having high erosion potential, CEC staff suspects this is lateral spreading associated with the slumping of the Oso Creek stream embankment (Photographs 6 thru 8). The feature bottom was irregular, showed no signs of sediment accumulation, and varied from approximately 1 to 2.5 feet in depth. CEC staff also observed an area of streambank slumping along Oso Creek.

Photograph 5: View south of proposed level spreader area. Justin Wood, Aspen biologist in right foreground.

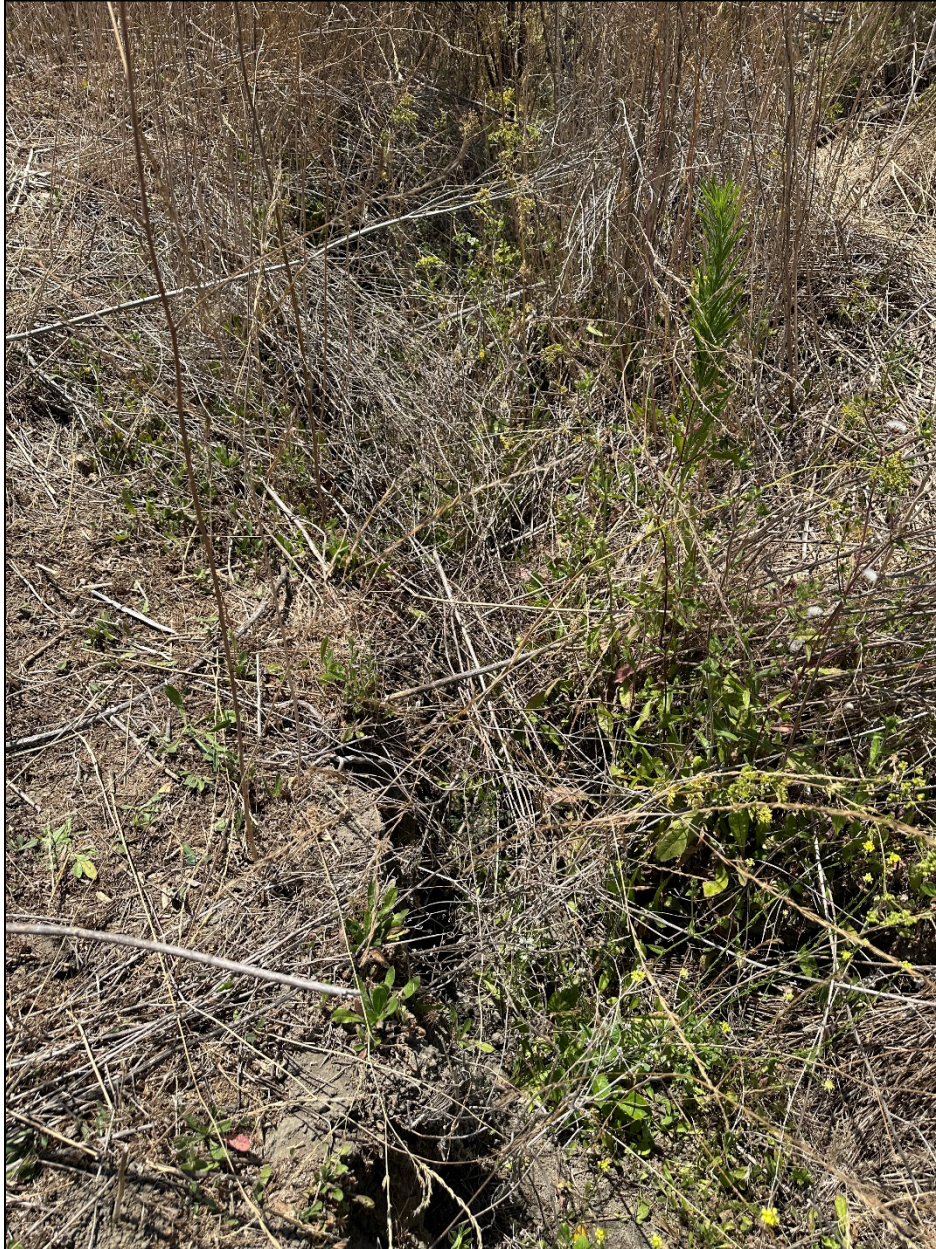
Photograph 6: View south of ravine identified in Aquatic Resources Delineation, obscured by foliage. Possible lateral spreading feature.

- 1145:** Justin Amirault begins site walk.
- 1200:** Arrive at area for proposed level spreader.
- 1210:** Investigate ravine identified in aquatic resources delineation report (suspect this is lateral spreading associated with streambank slumping).

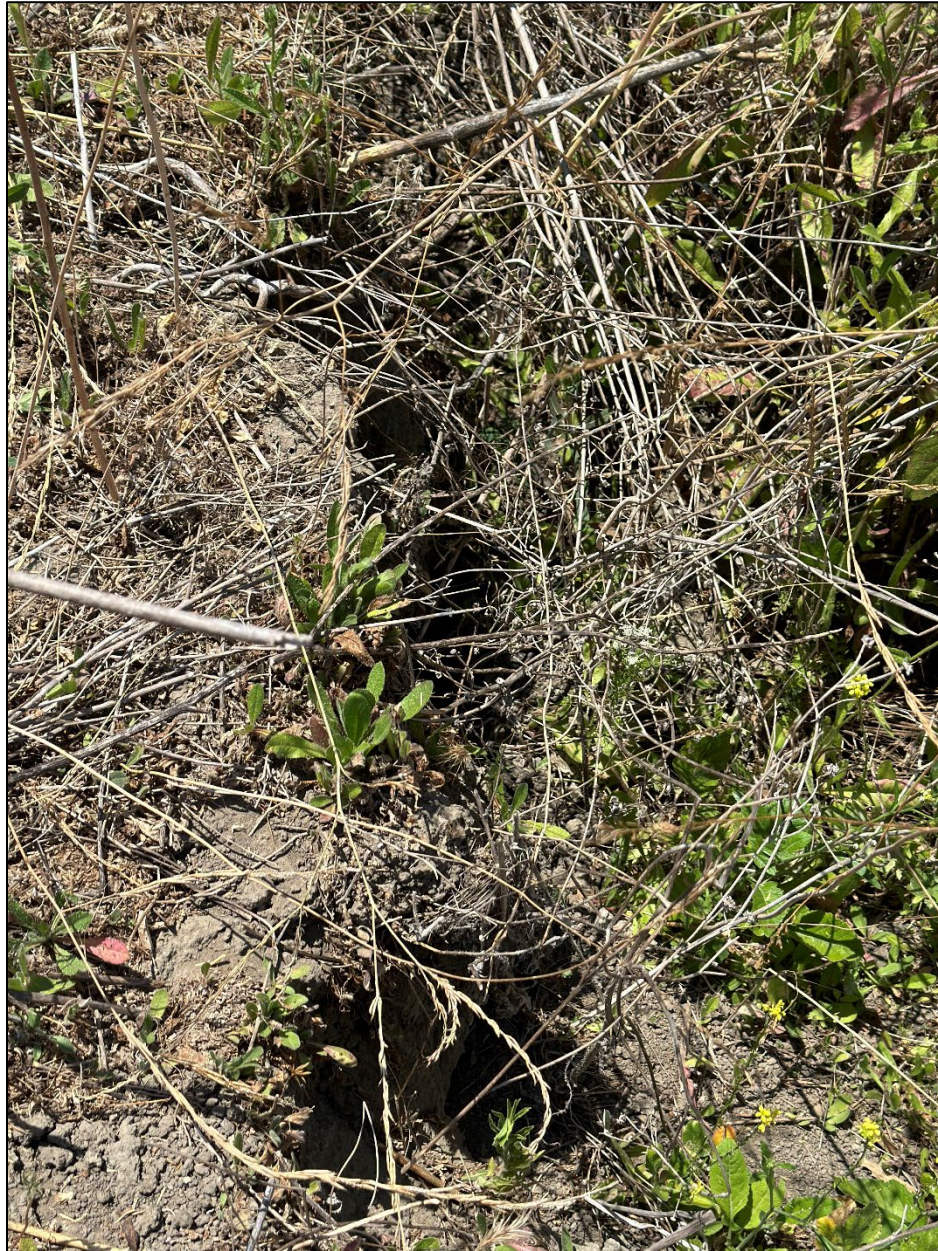
Photograph 7: Close-up of possible lateral spreading feature.

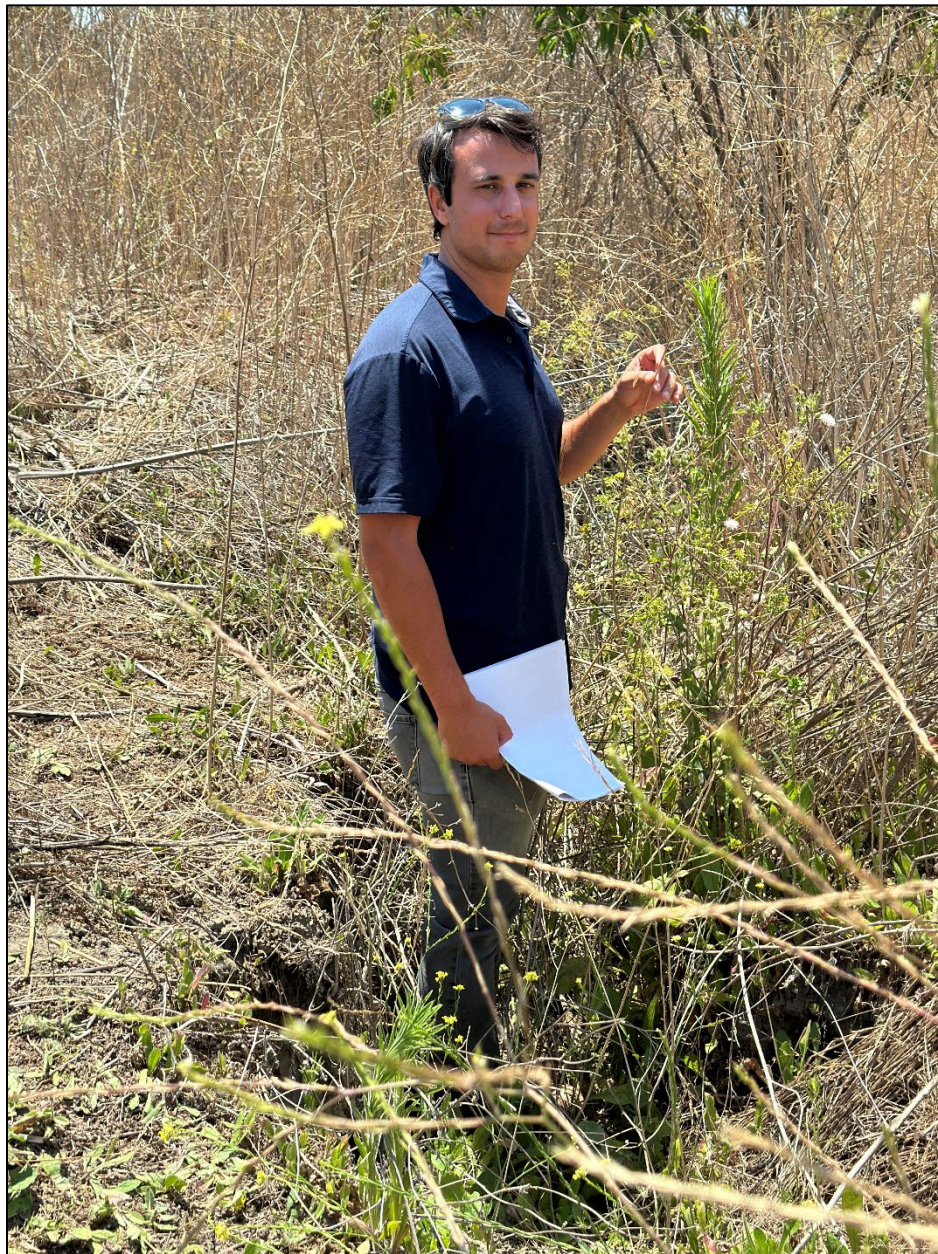
Photograph 8: View south of possible lateral spreading feature. Justin Amirault (Engie) in foreground for scale of depth.

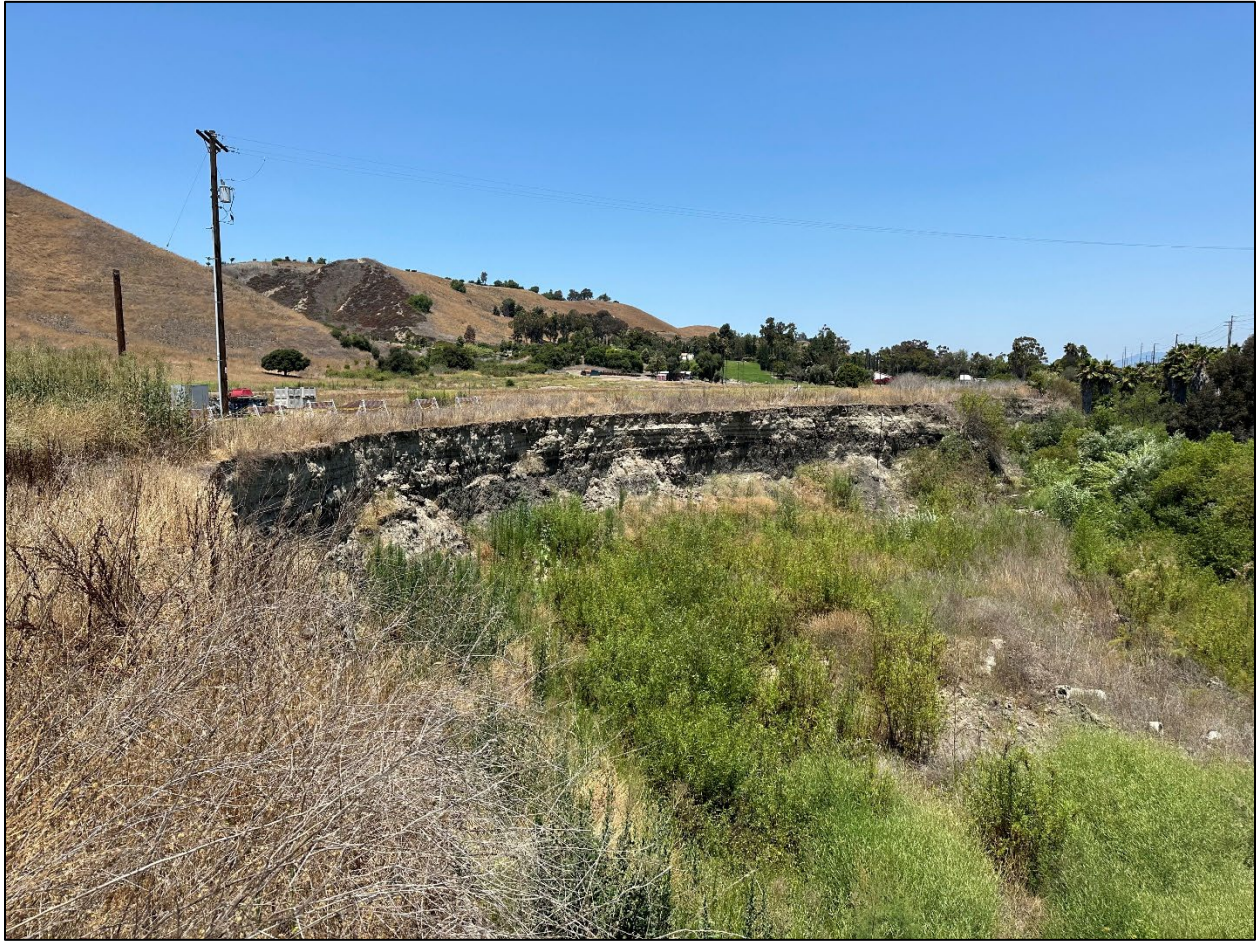
Another area of primary concern was the large-scale slumping of the Oso Creek streambank, immediately east of the Peace Gardens (Photographs 9 & 10). According to a 2021 geotechnical/geomorphic evaluation report, lateral migration of Oso Creek in this area averaged 12 feet and was a maximum of 45 feet annually between 2014 and 2021. The report also noted that the stream morphology was described prior to the 1970s as about 6 feet deep, sloping with little to no lateral migration. Current conditions are incised to depths of 50 feet with steep embankments (Geosyntec 2021). Based on the design plans (Dudek 2024a), the current location of the streambank in this area is within 60 feet of the proposed facility.

Photograph 9: View north-northwest of slumping resulting from Oso Creek streambank erosion, immediately east of the project site.

CEC observations made during this site visit to the proposed Compass site confirmed some of the concerns regarding slope stability and streambank slumping impacts along Oso Creek. These issues will be pursued further in supplemental data requests to the applicant.

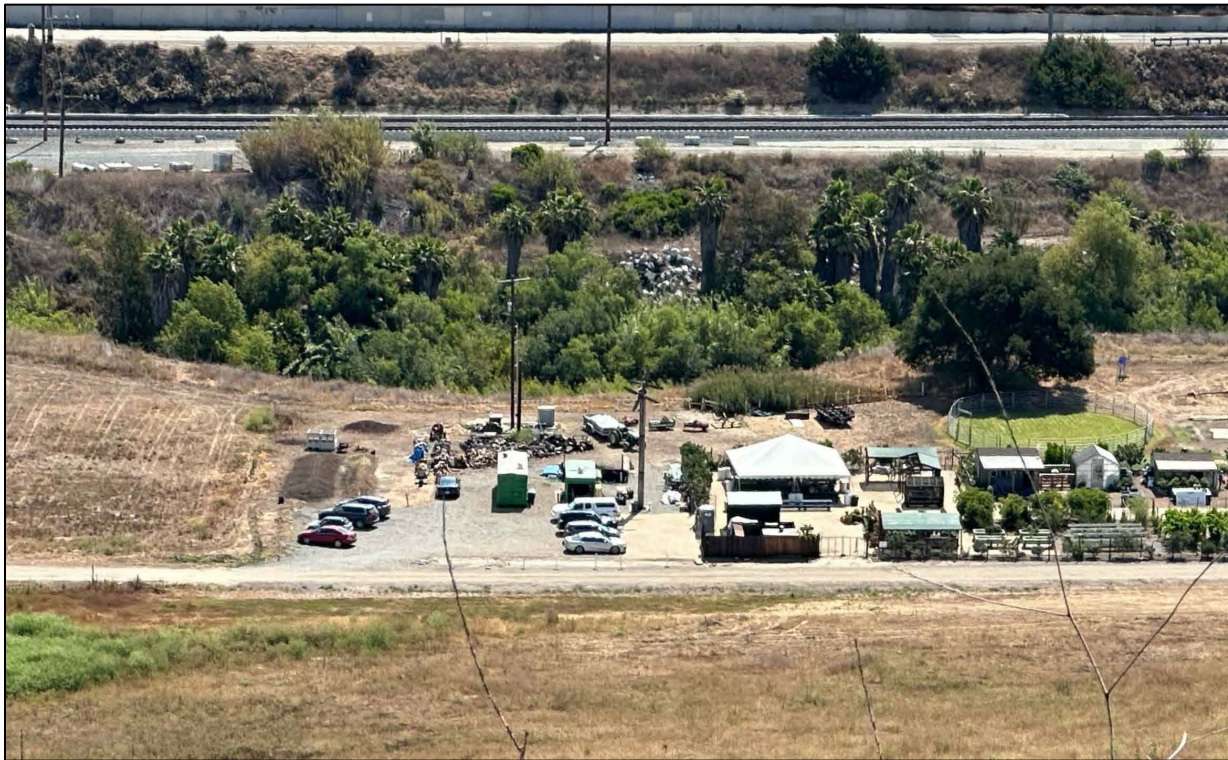
Photograph 10: Close-up view of large streambank slumping near current Peace Gardens and proposed Compass facility.

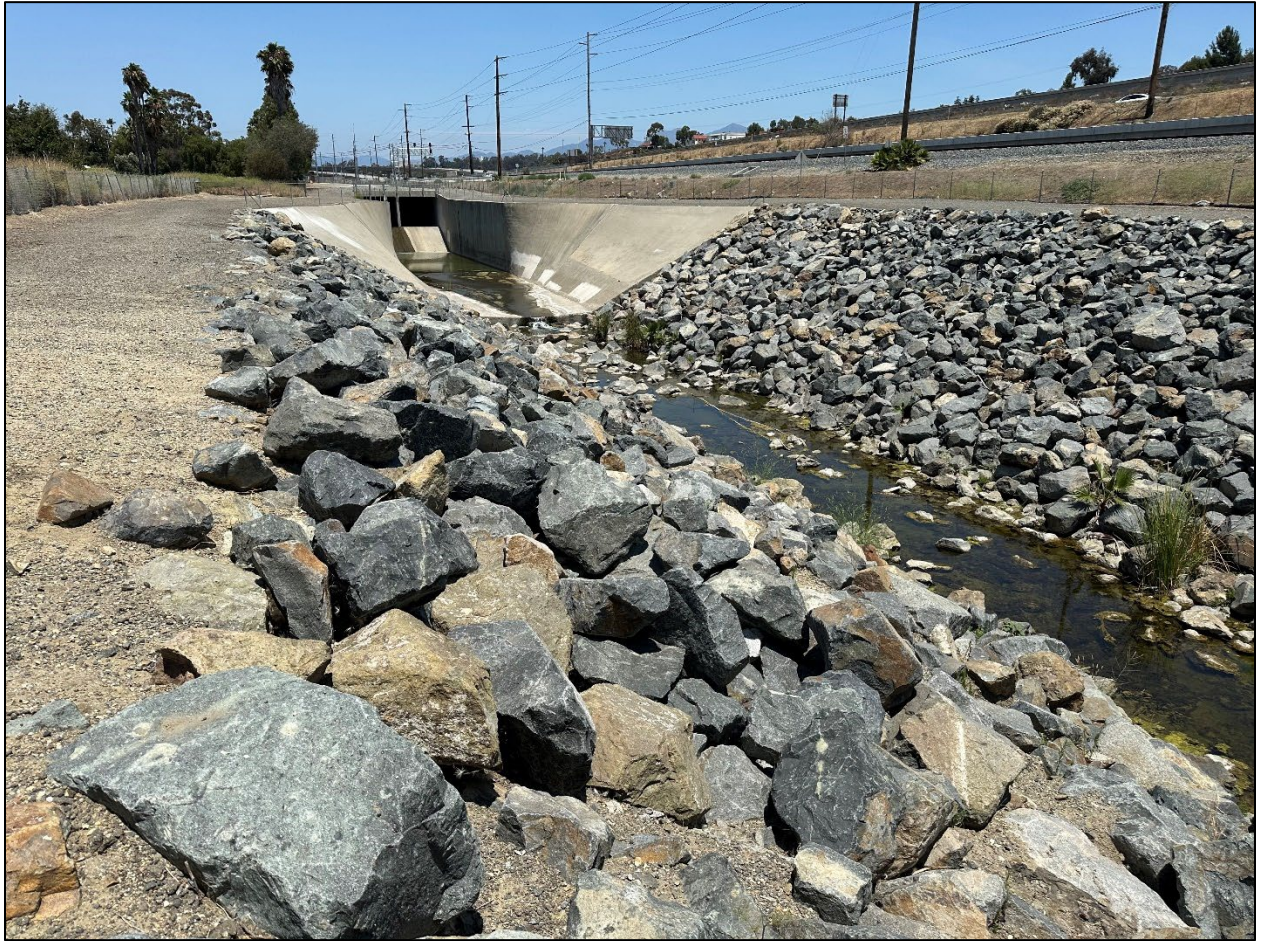
Photograph 11: View north-northeast of subway channel structure

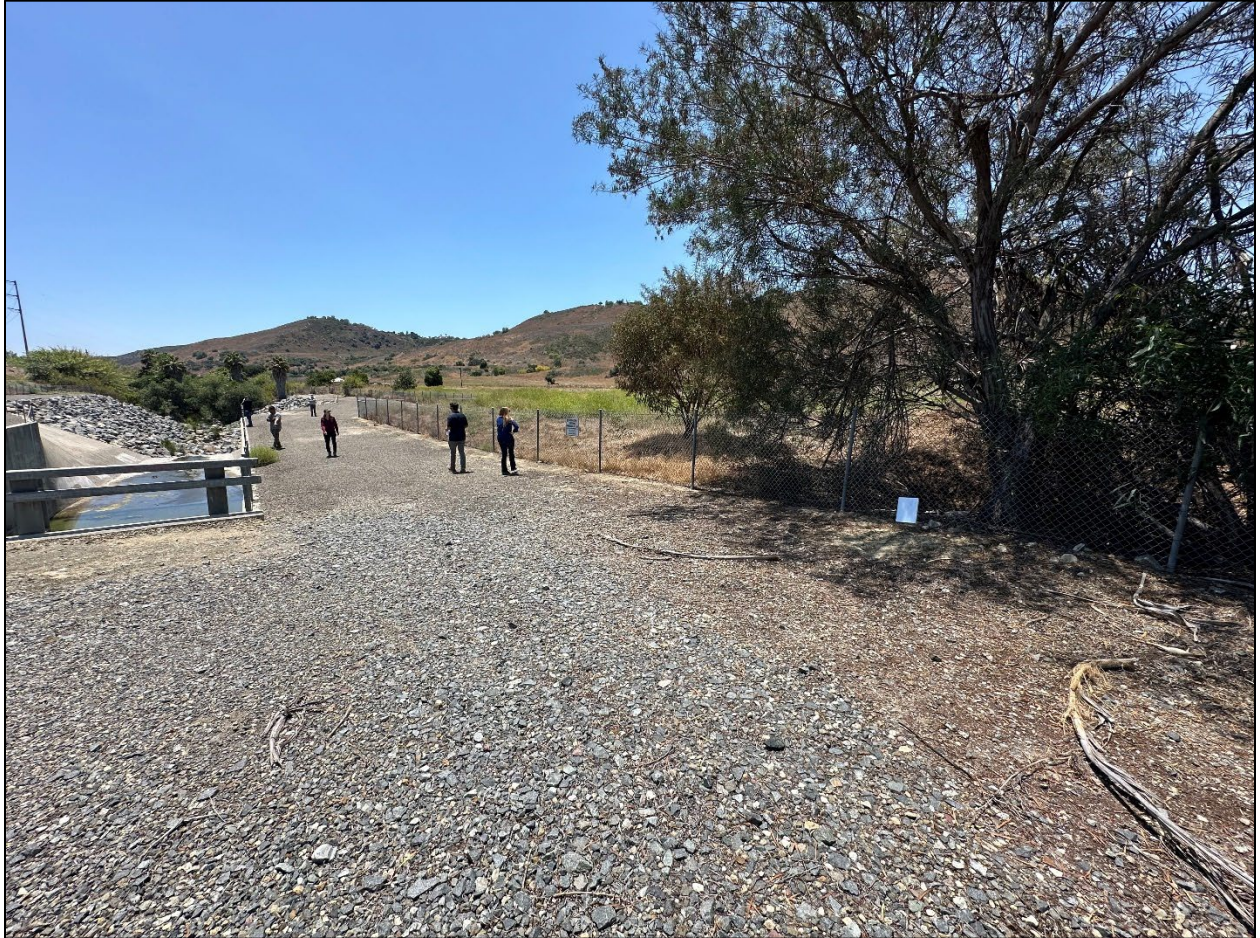
The proposed location for discharge of on-site stormwater pumped from the underground storage system is the stormwater inlet immediately west of the concrete channel structure (Photograph 12)

Photograph 12: View south-southwest along the subway channel structure. Storm drain inlet proposed as the discharge point for on-site stormwater is on the mid right behind the clipboard.
