Docket Number:	24-OPT-03
Project Title:	Soda Mountain Solar
TN #:	265739
Document Title:	Response to CEC's Request for Information dated July 31 2025
Description:	Response to DR REV 2 DR BIO-1 Response to DR REV 2 DR BIO-2 Supplement to Appendix AA Determination of Infeasibility for DR BIO-20 LADWP Information
Filer:	Hannah Arkin
Organization:	Resolution Environmental
Submitter Role:	Applicant Representative
Submission Date:	8/21/2025 2:16:01 PM
Docketed Date:	8/21/2025

**Subject: Revised Response to REV2 DR BIO-2 Soda Mountain Solar Access Road Assessment
Project Site, in the San Bernardino County, California**

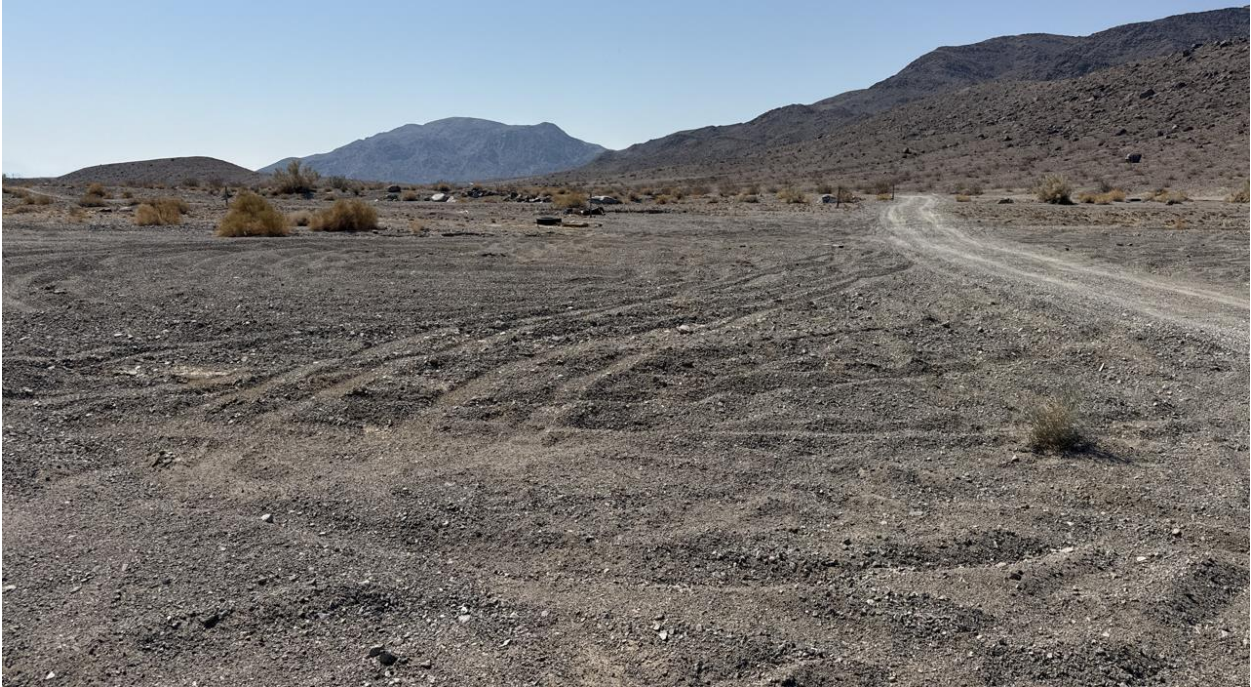
Photograph 1. Photo showing streambed and disturbed vegetation/soil adjacent to access road near the northeastern portion. Photo taken facing south.

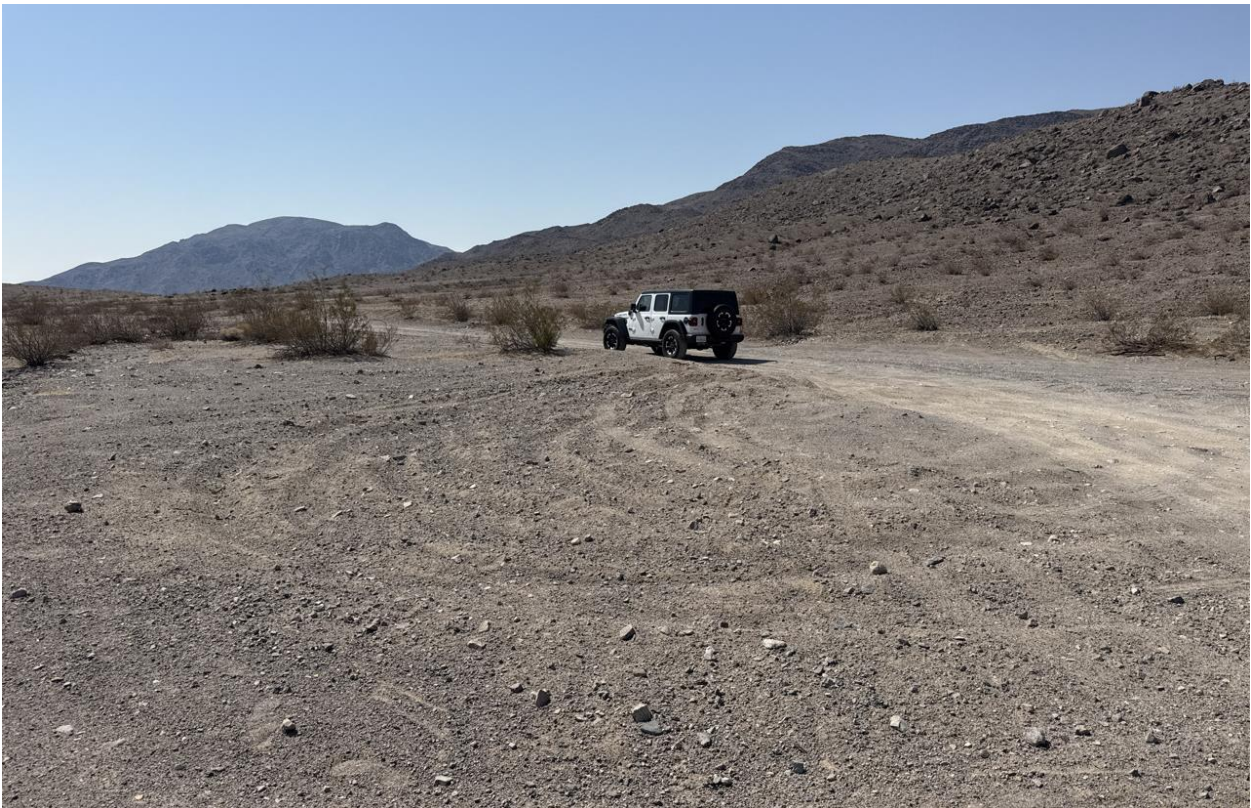
Photograph 2. Photo showing disturbed soil/vegetation adjacent to access road and creosote bush scrub near the northeastern portion. Photo facing south.

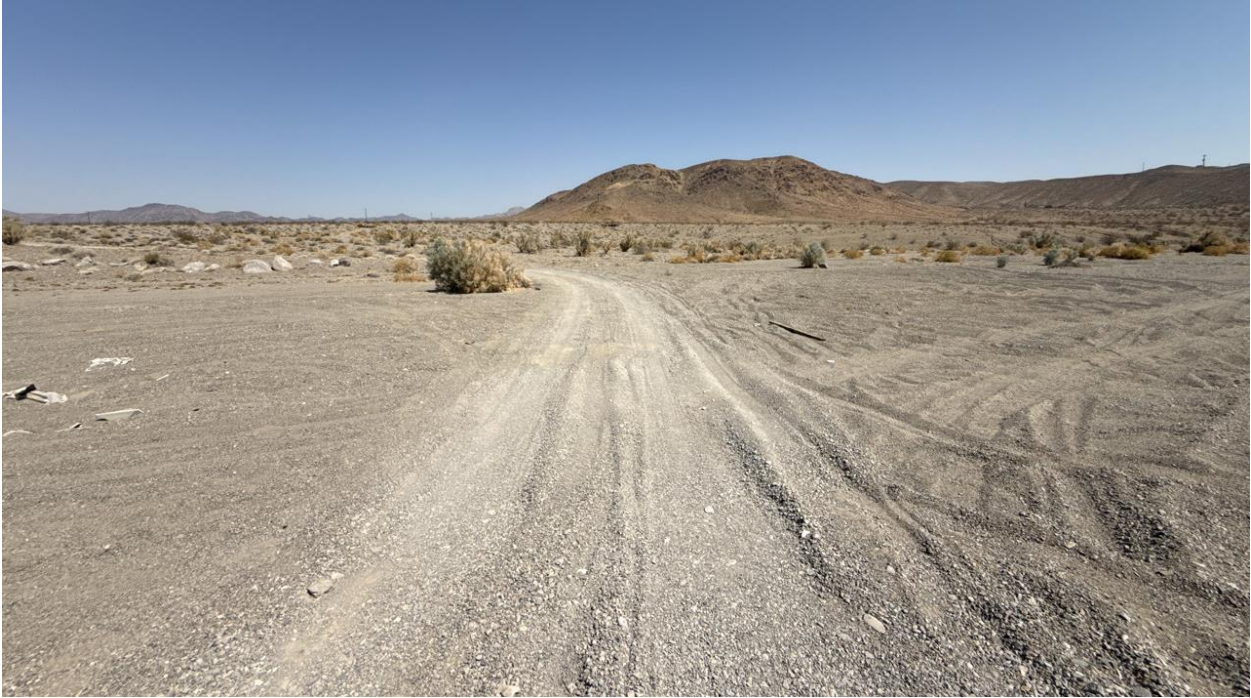
Photograph 3. Photo showing disturbed soil/vegetation adjacent to access road and streambed near the northeastern portion. Photo taken facing north.

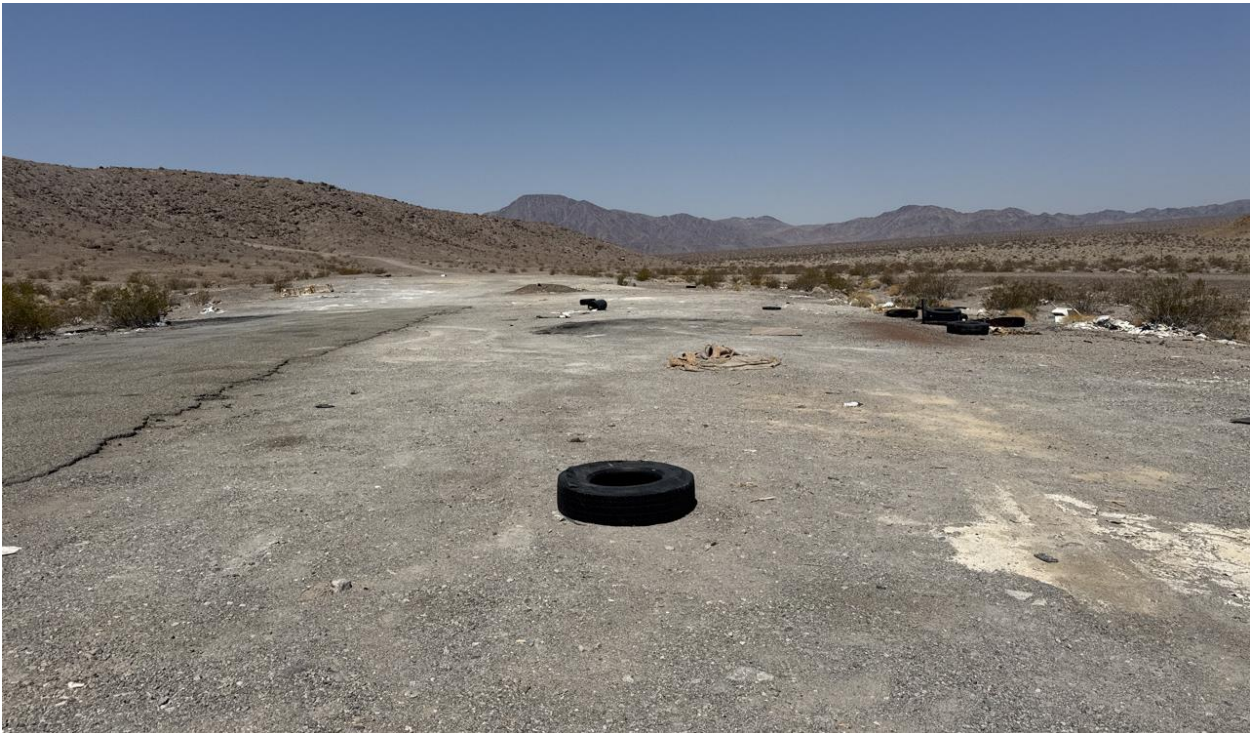
Photograph 4. Photo showing disturbed land cover adjacent to access road near the northeastern portion. Photo taken facing west.

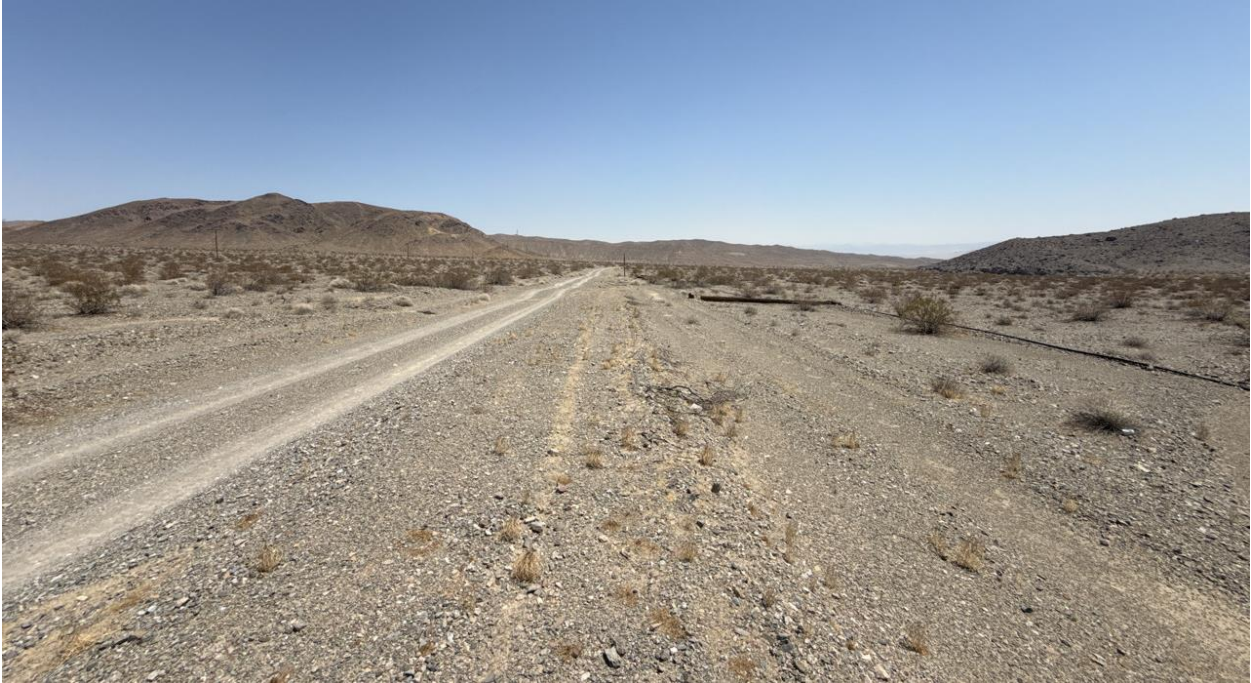
Photograph 5. Photo showing disturbed soil and vegetation adjacent to access road. Creosote bush – white bursage scrub near the northeastern portion. Photo taken facing northeast.

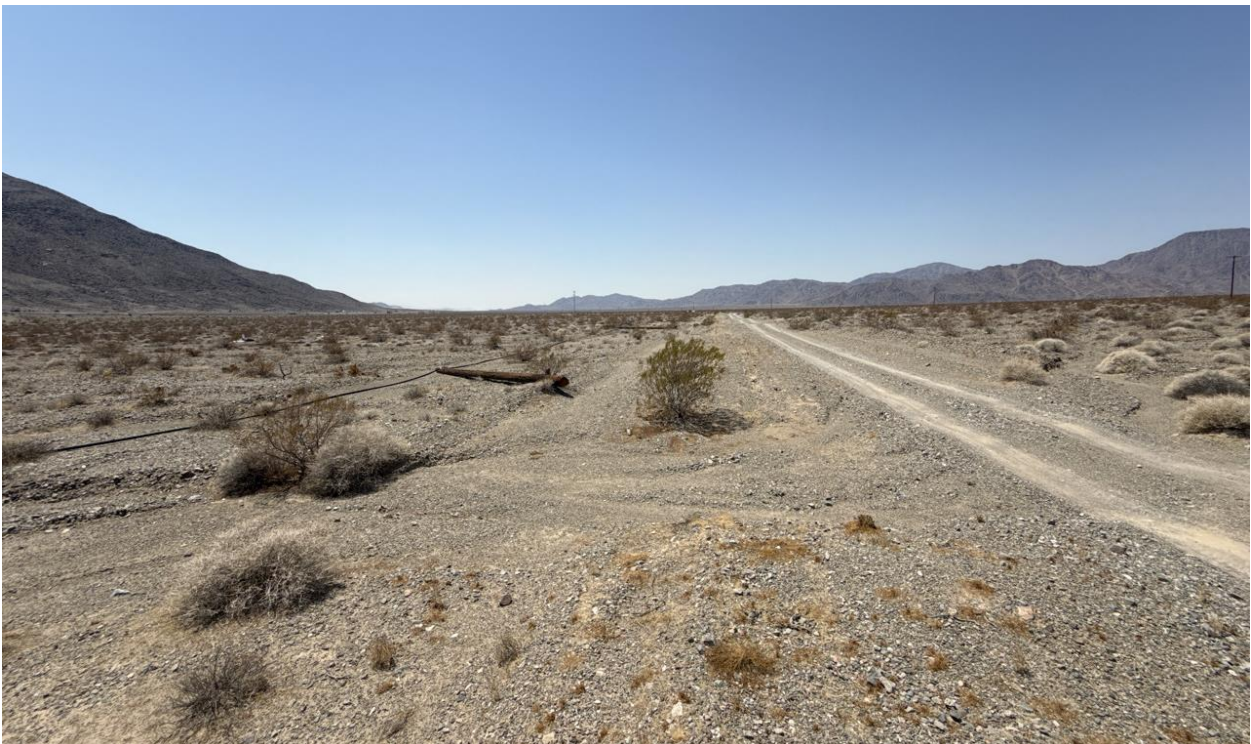
Photograph 6. Photo showing access road and creosote bush – white bursage scrub near the northeastern portion. Photo taken facing southwest.

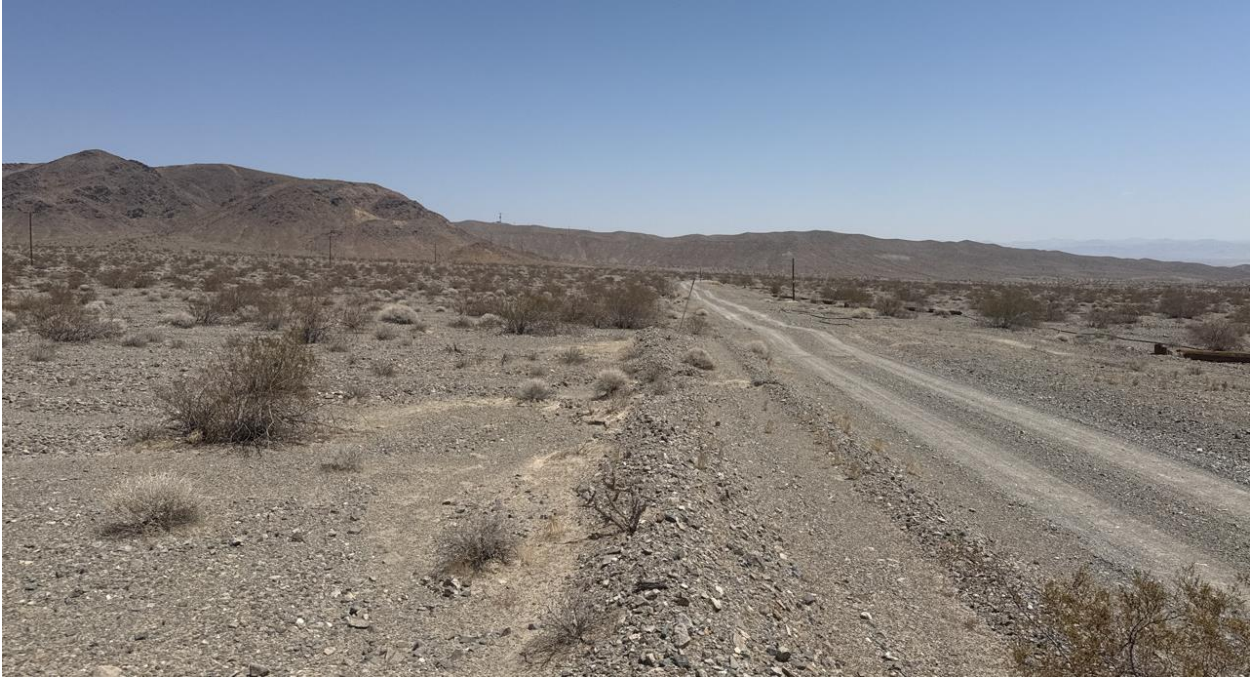
Photograph 7. Photo showing access road and creosote bush – white bursage scrub near the northeastern portion. Photo taken facing northeast.

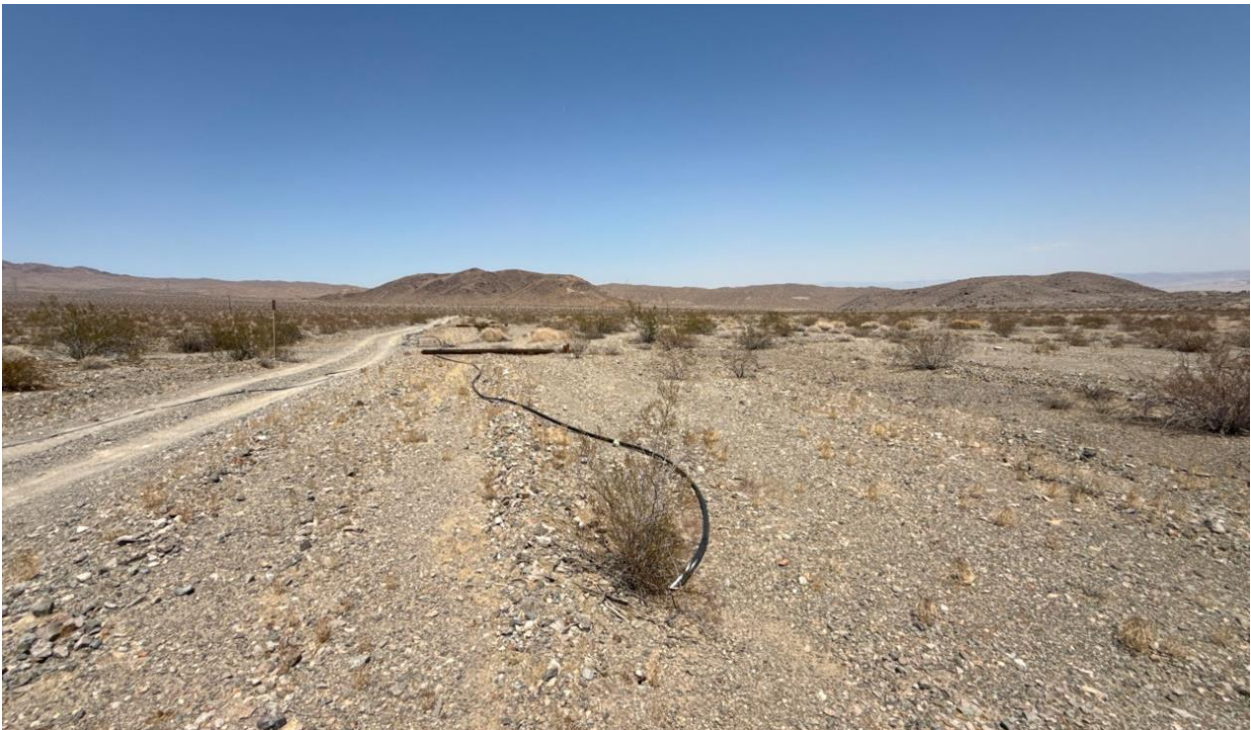
Photograph 8. Photo showing access road and creosote bush – white bursage scrub near the northeastern portion. Photo taken facing northeast.

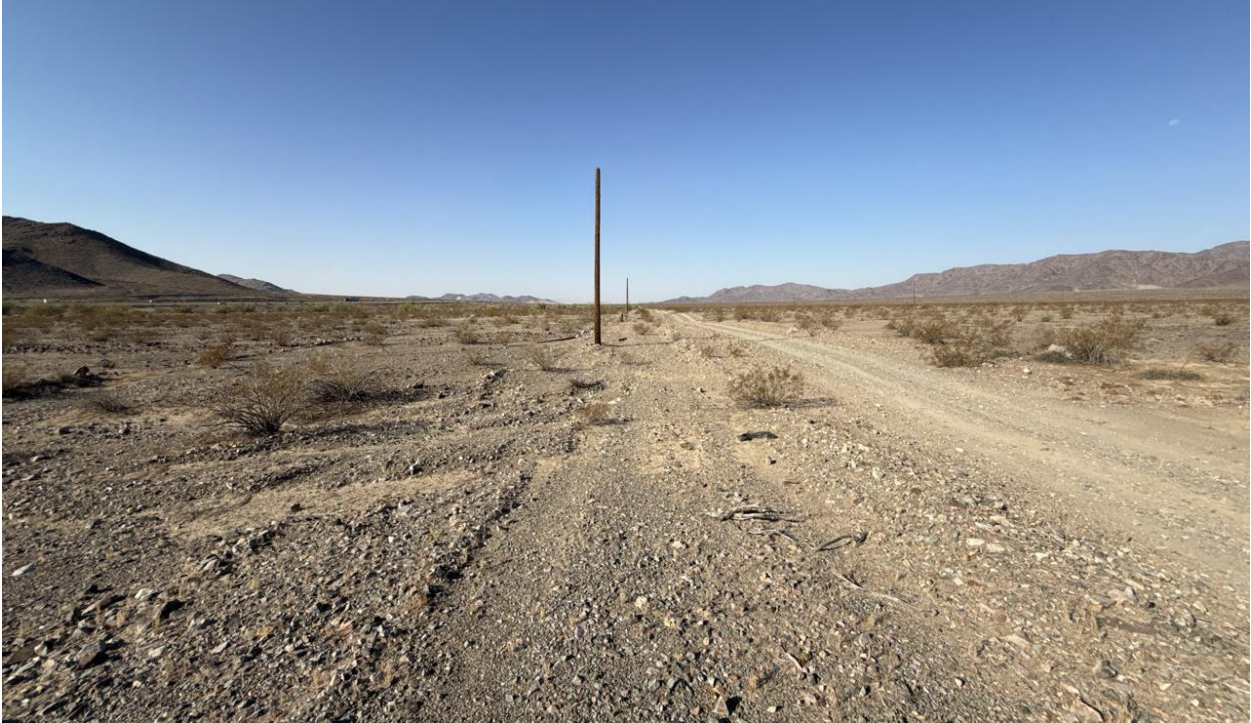
Photograph 9. Photo showing disturbed vegetation/soils adjacent to access road and creosote bush scrub near the central portion. Photo taken facing southwest.

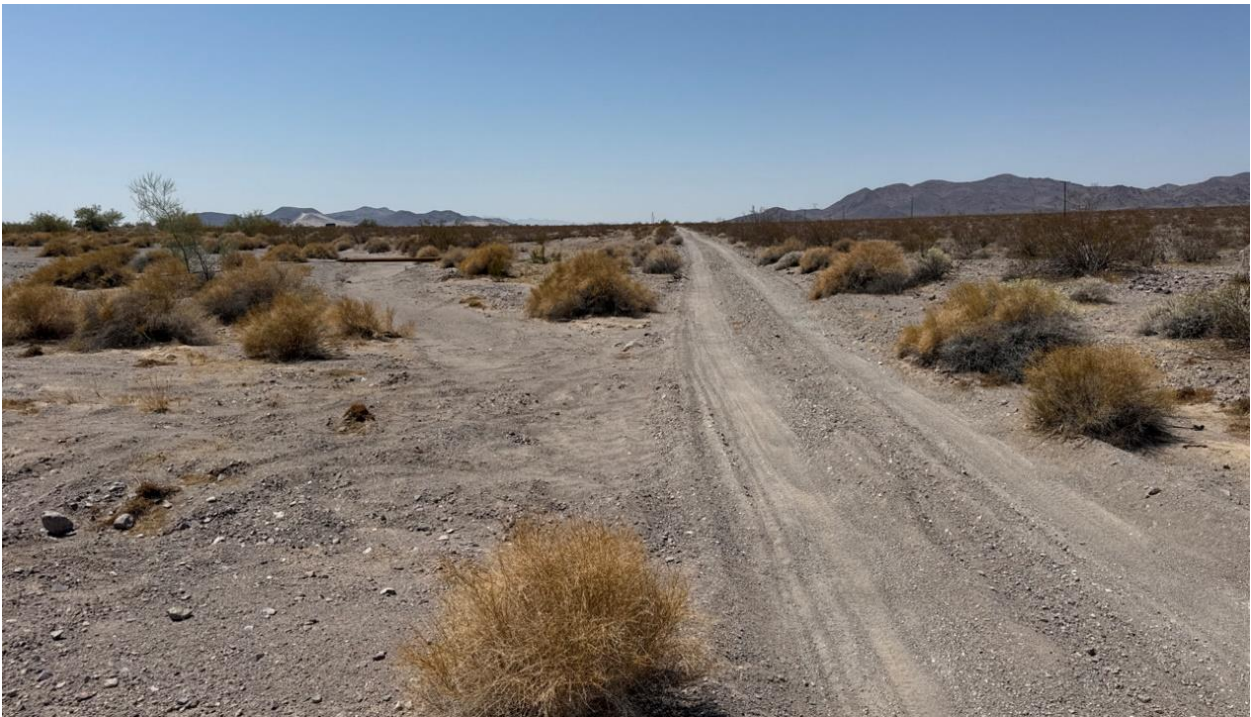
Photograph 10. Photo showing access road and cheesebush – sweetbush scrub near the southwestern portion. Photo taken facing northeast.

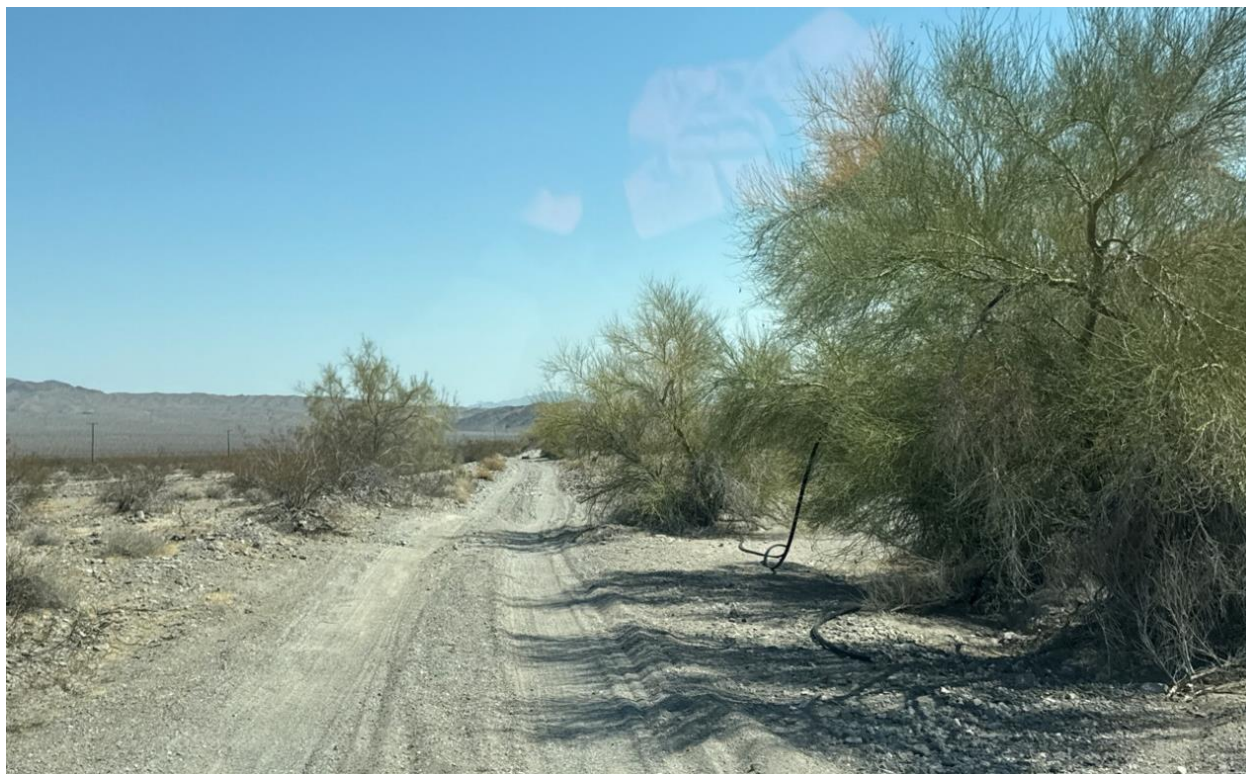
Photograph 11. Photo showing access road and creosote bush scrub with blue palos verde (*Parkinsonia florida*) near the southwestern portion. Photo taken facing northeast.

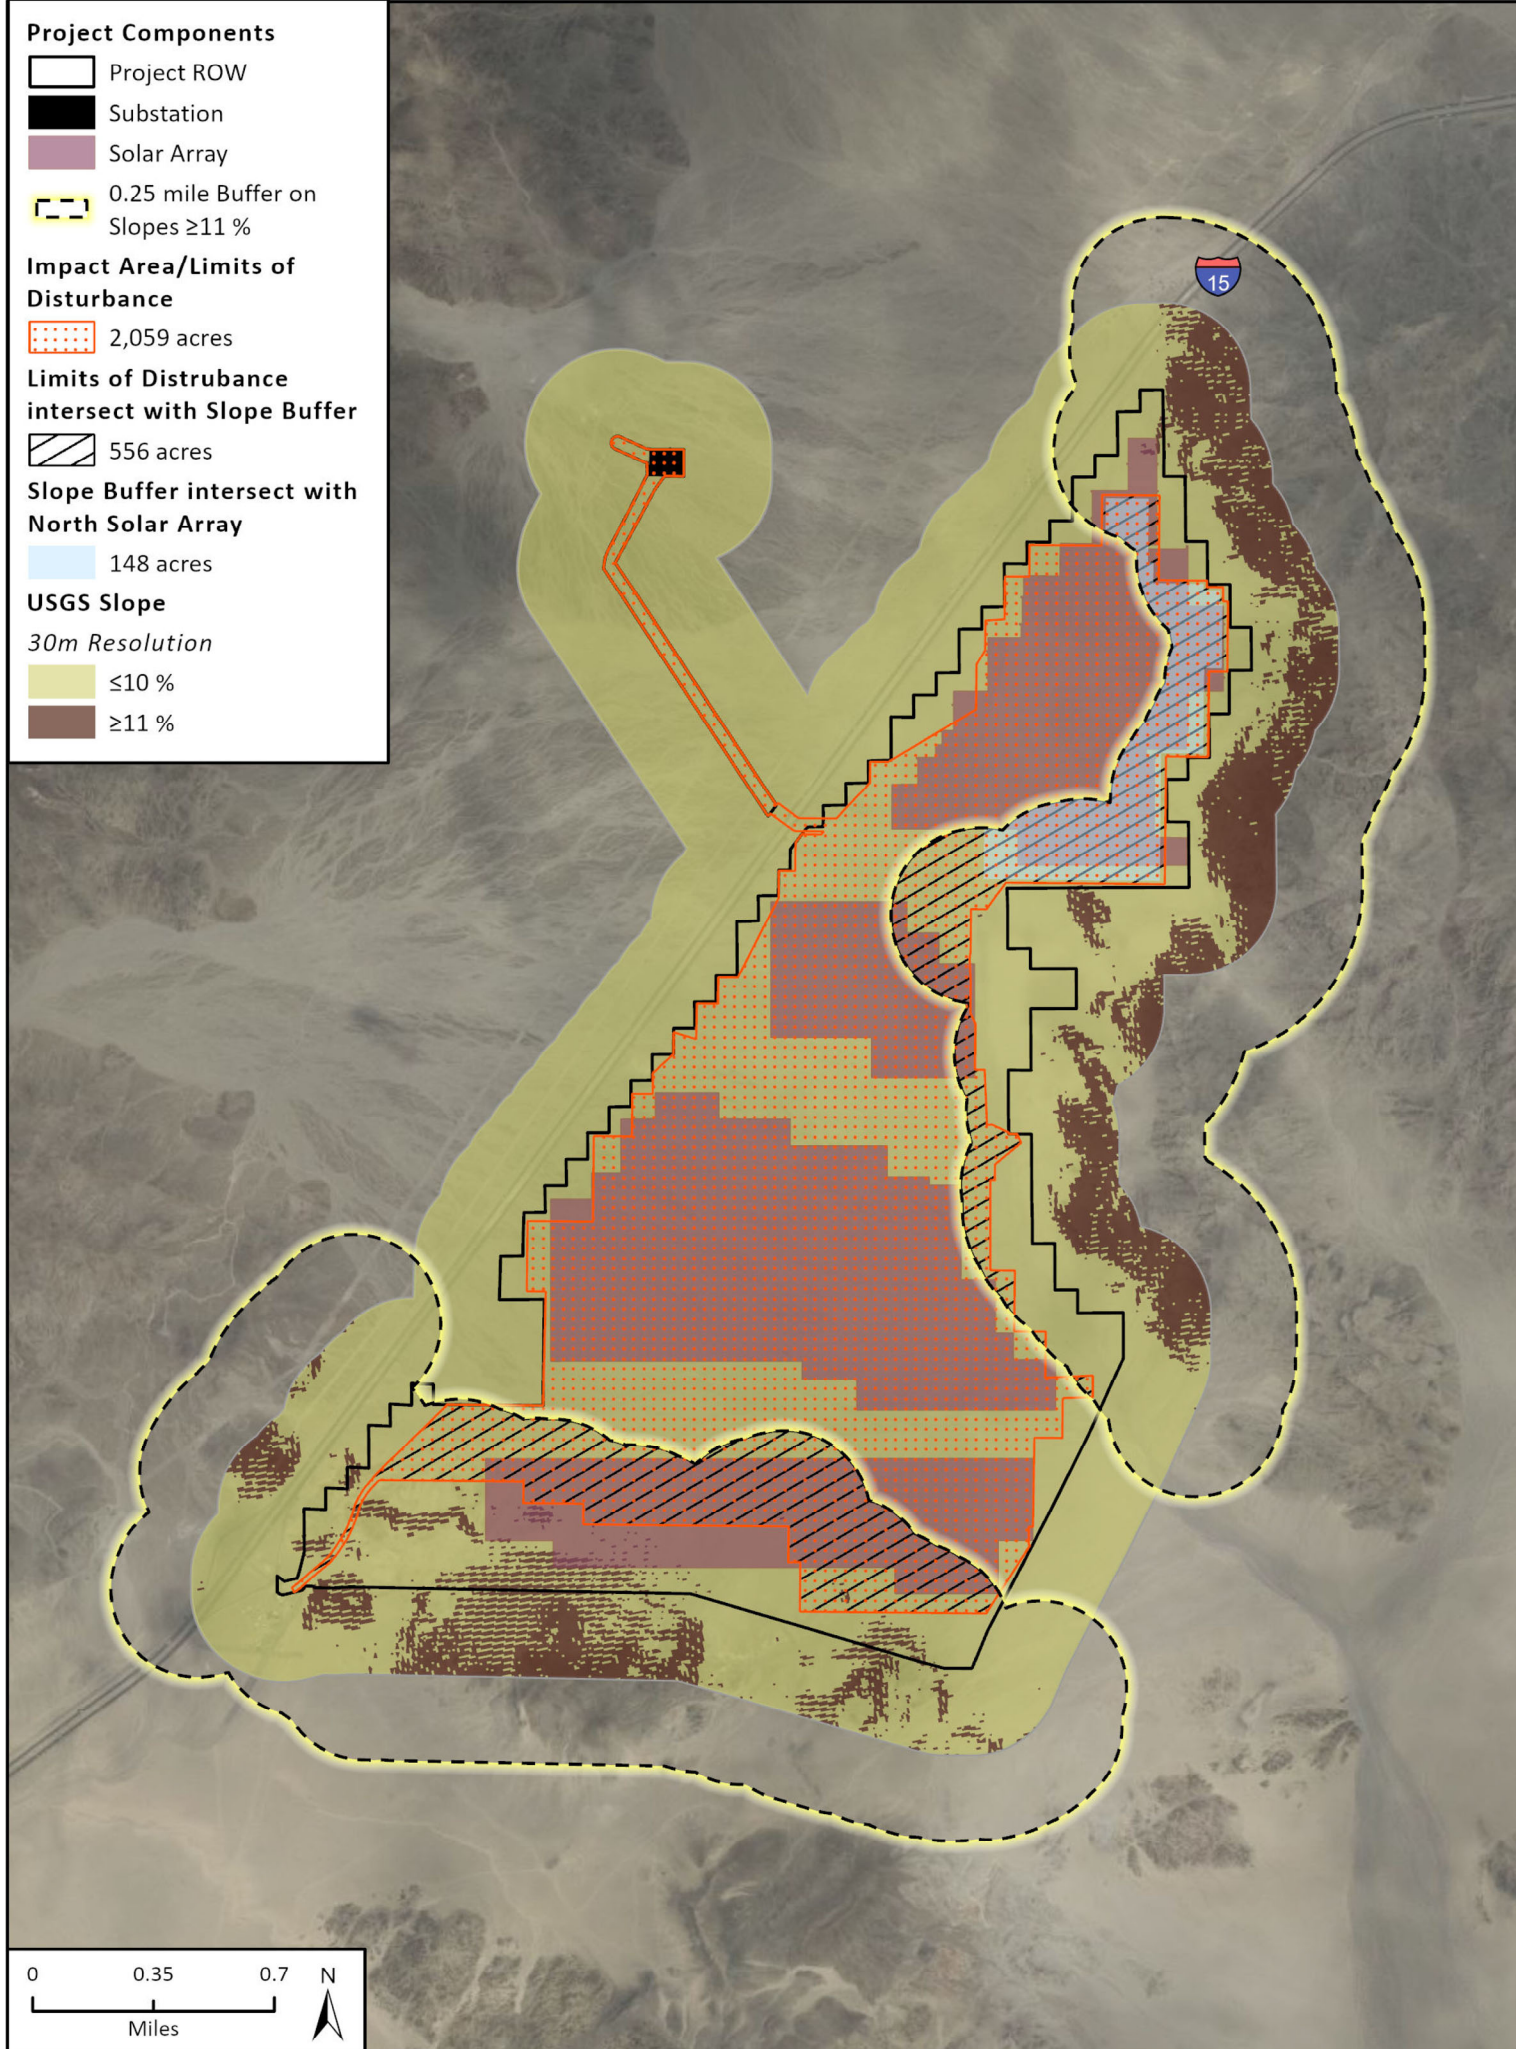
**Supplement to Appendix AA Determination of
Infeasibility for DR BIO-20**

- Project ROW
- Substation
- Solar Array
- 0.25 mile Buffer on Slopes $\geq 11\%$

- 2,059 acres

- 556 acres

- 148 acres

30m Resolution

- $\leq 10\%$
- $\geq 11\%$

Attachment 2 provides refined calculations that determine implementing a 0.25-mile buffer from areas with 10% slope would result in a reduction to the total project footprint of 556 acres, rather than the previously estimated 236 acres. All references in Appendix AA to 236 acres should be replaced with 556 acres.
