| <b>Document Title:</b> | Response to DR REV 2 DR BIO-1 - Part 1 |
| <b>Description:</b> | Revised Aquatic Resources Delineation - Part 1 |

# Soda Mountain Solar Project

## Aquatic Resources Delineation

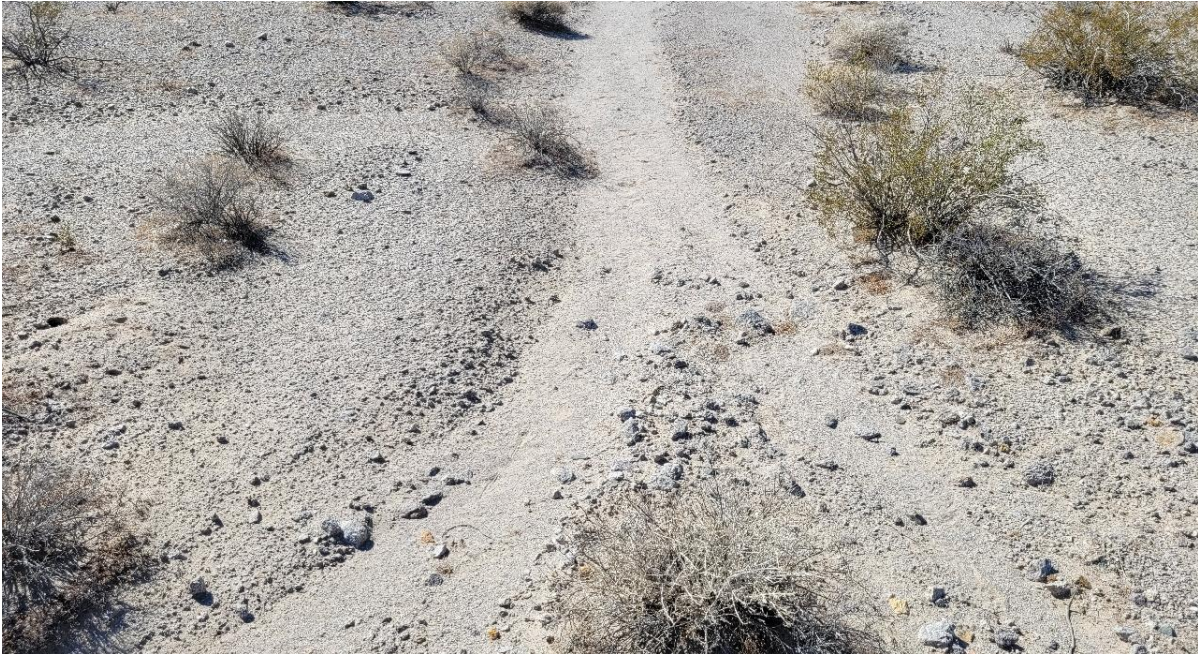
**Photo Point E-4-1 (East Array).** Northwestern facing representative photograph facing downstream of a small drainage exhibiting indicators of an OHWM (see Figure 10 Page 12).

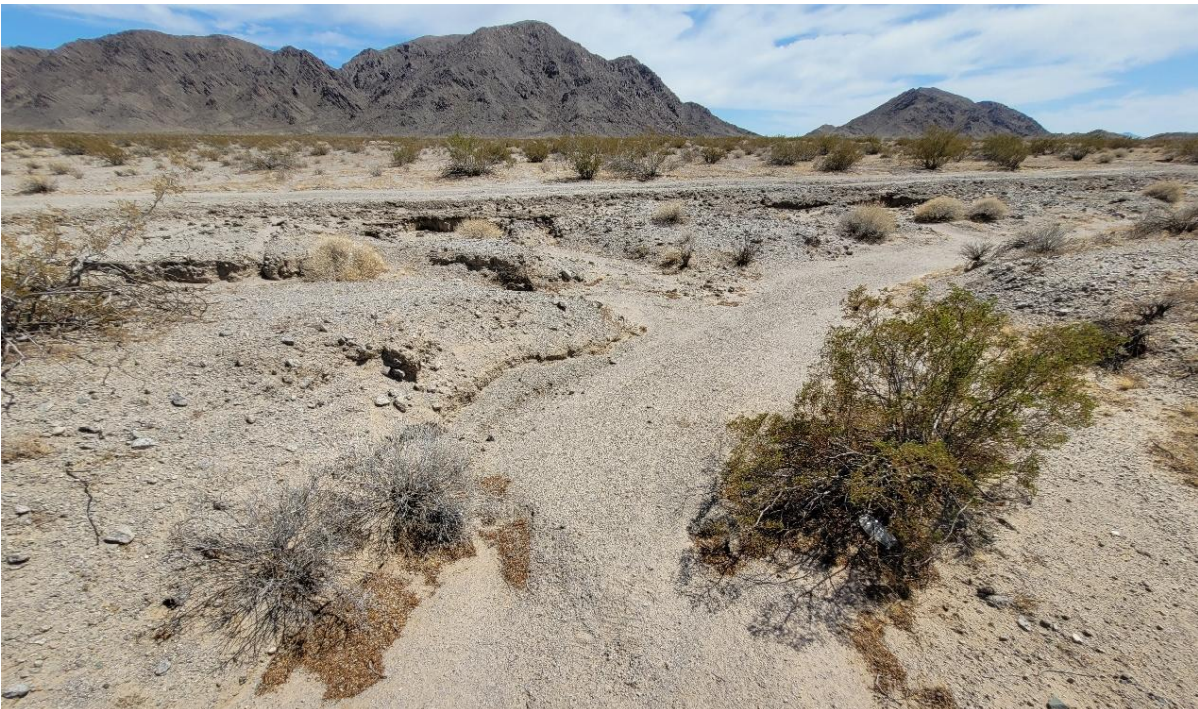
**Photo Point E-6-3 (East Array).** Southeast facing representative photograph of an upstream portion of a drainage exhibiting indicators of an OHWM (see Figure 10 Page 15).

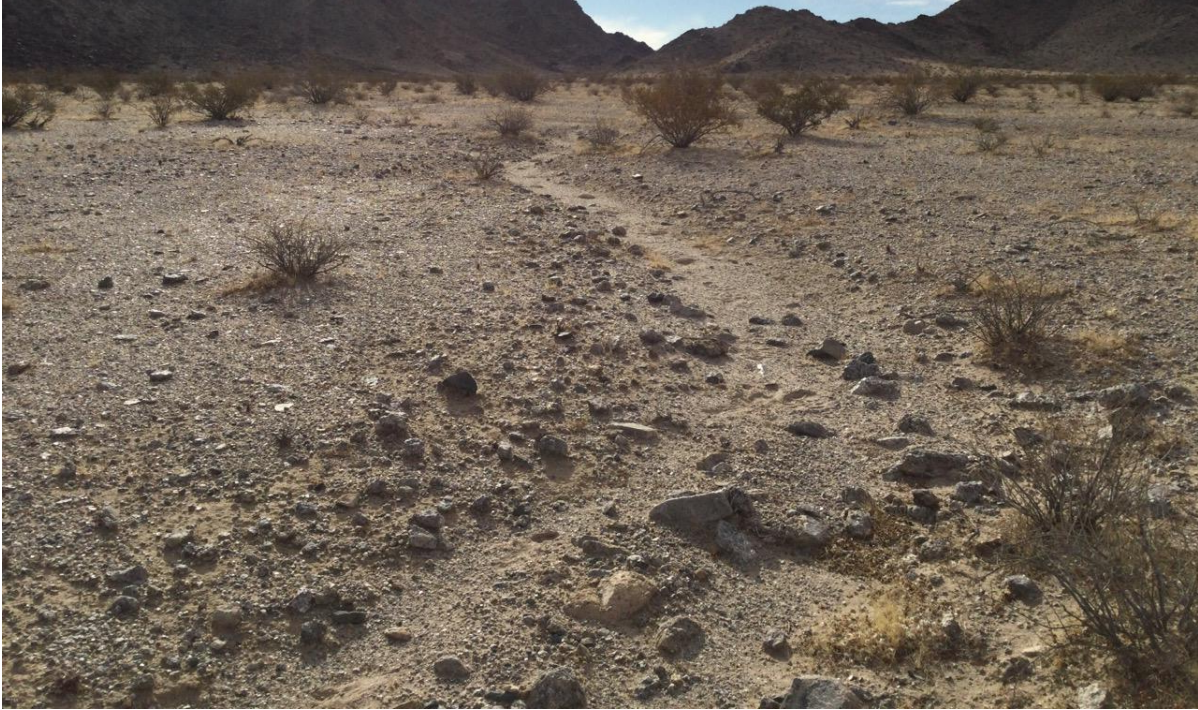
**Photo Point E-11-3 (East Array).** East facing representative photograph illustrating indicators of an OHWM, corresponding to the EK-003 Datasheet (see Figure 10 Page 26).

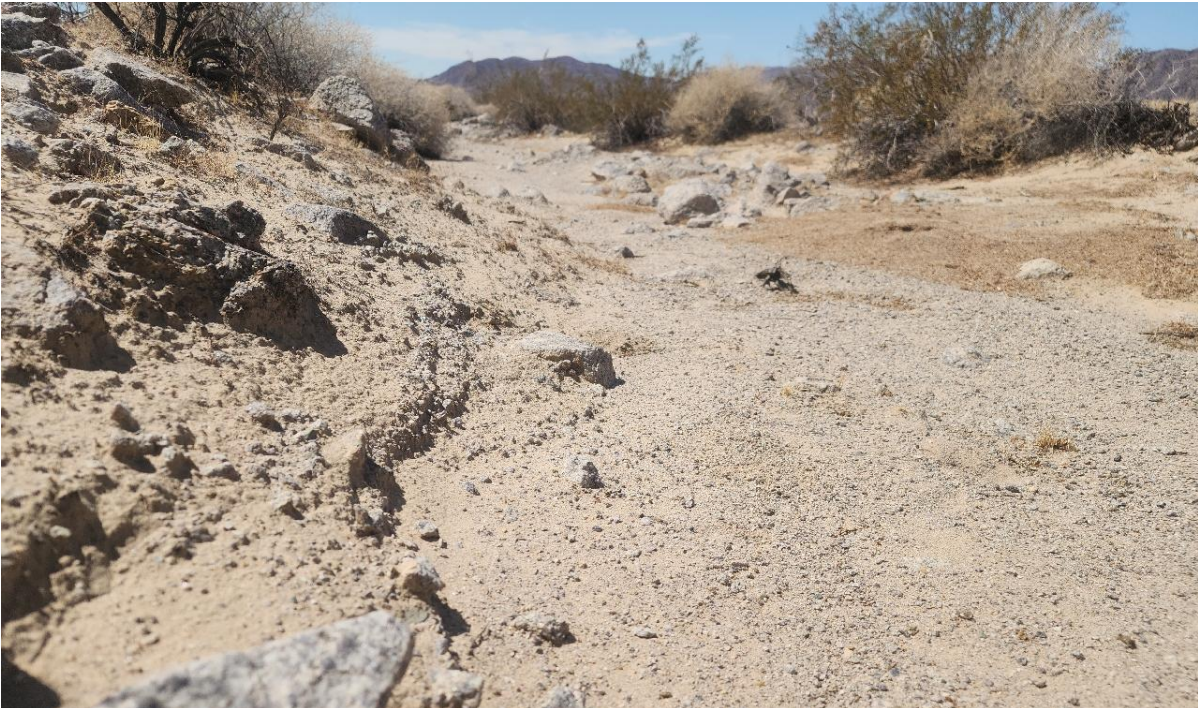
**Photo Point E-7-3 (East Array).** West facing representative photograph illustrating an OHWM and no riparian vegetation, corresponding to the ATG-004 Datasheet (see Figure 10 Page 16).

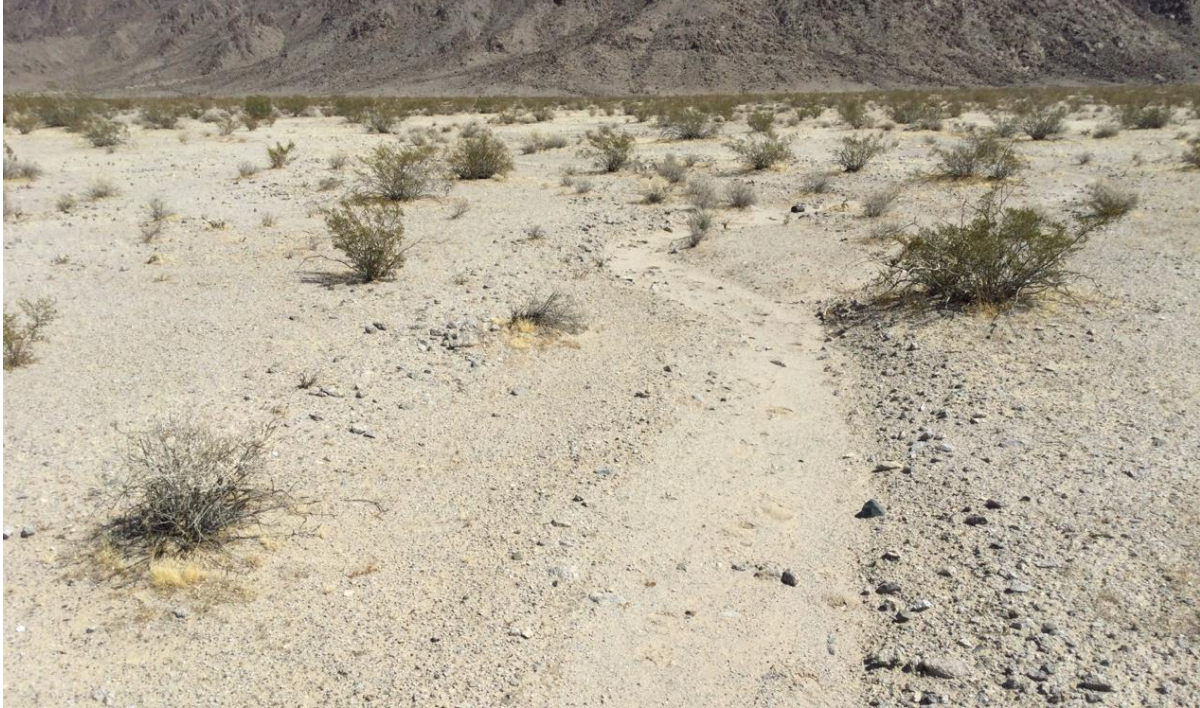
**Photo Point E-9-2 (East Array).** East facing representative photograph illustrating an upstream portion of a drainage exhibiting an OHWM and no riparian vegetation, corresponding to the EK-004 Datasheet (see Figure 10 Page 18).

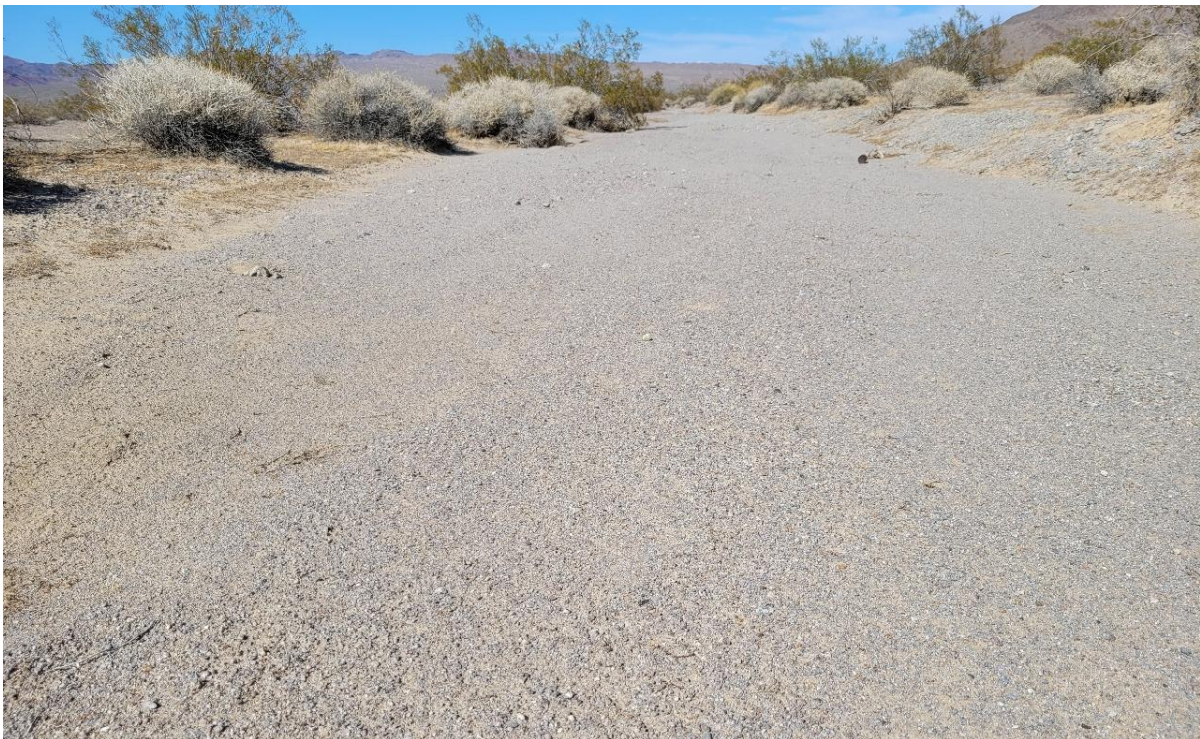
**Photo Point E-5-3 (East Array).** Northeast facing representative photograph illustrating indicators of an OHWM, corresponding to the KG-003 Datasheet (see Figure 10 Page 15).

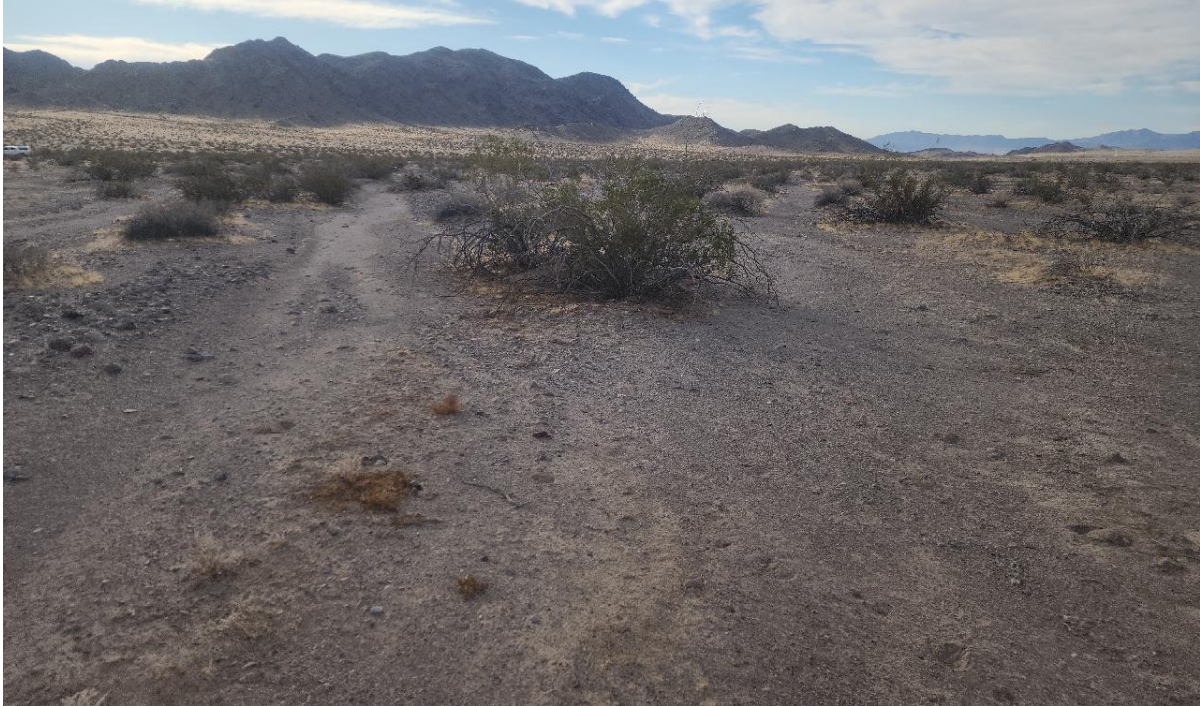
**Photo Point S1-3-2 (South Array 1).** East facing representative photograph illustrating an upstream portion of a drainage exhibiting an OHWM and no riparian vegetation, corresponding to the ATG-003 Datasheet (see Figure 10 Page 25).

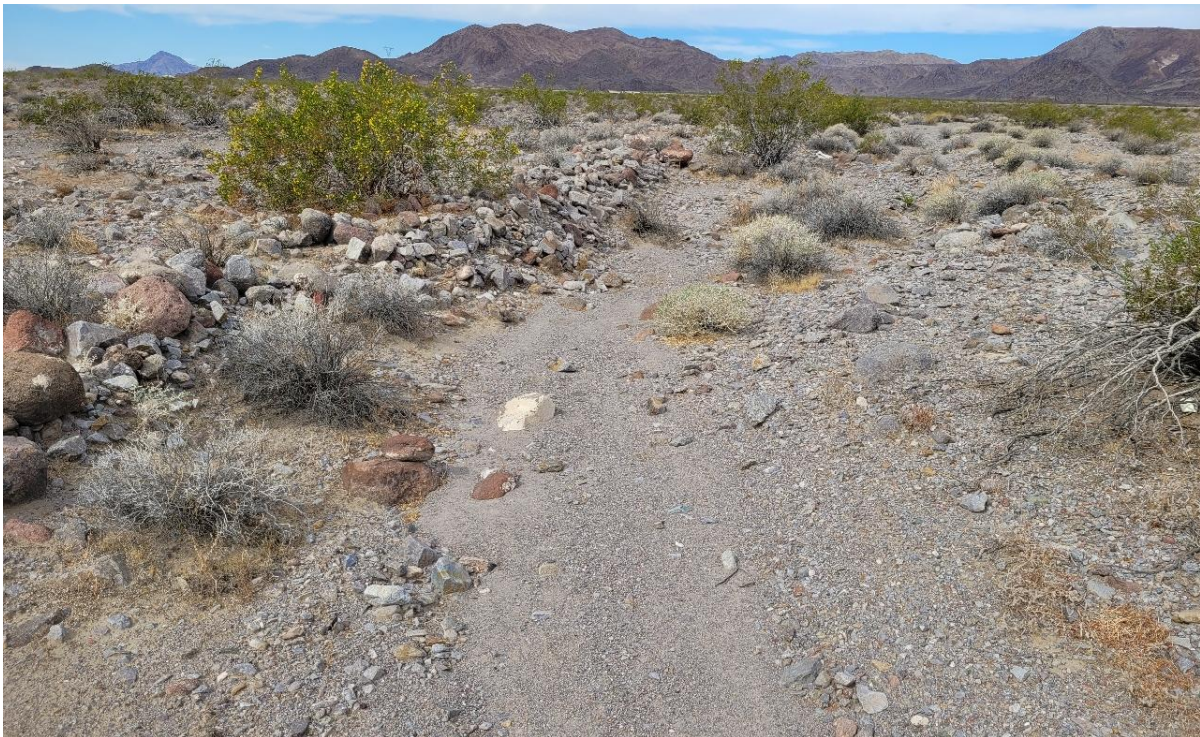
**Photo Point S1-5-2 (South Array 1).** Southwest facing representative photograph illustrating indicators of an OHWM, corresponding to the KG-001 Datasheet (see Figure 10 Page 30).

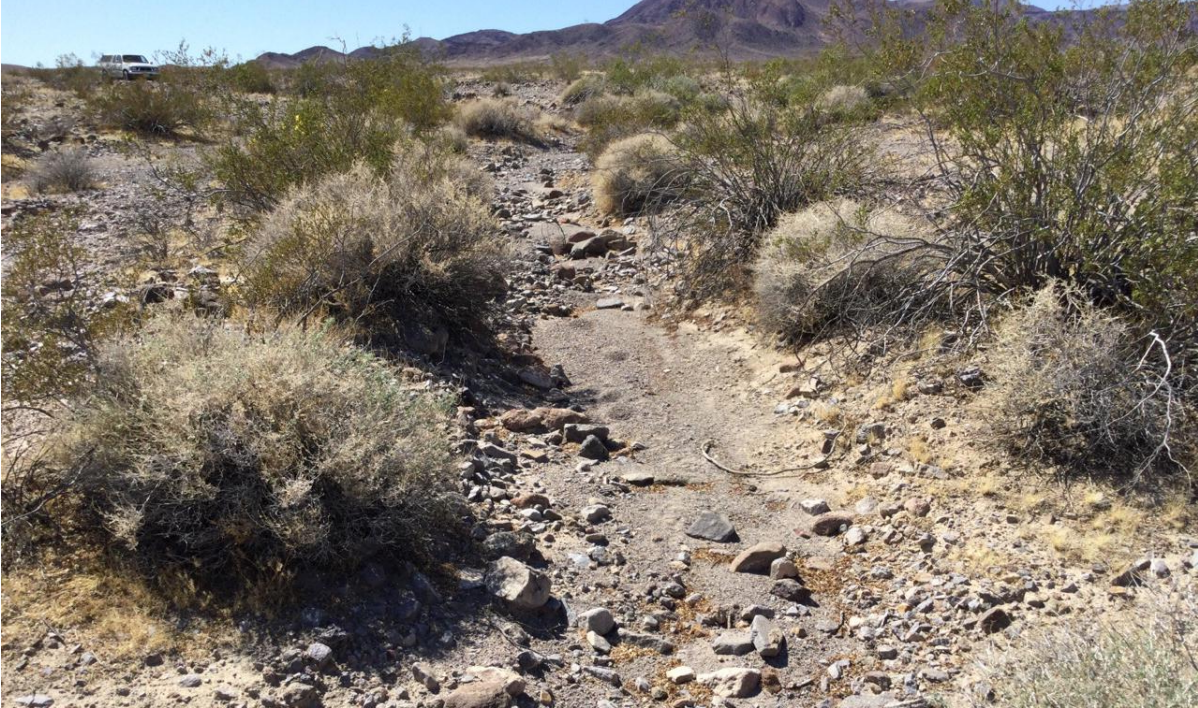
**Photo Point S2-14-1 (South Array 2).** West facing representative photograph of an upstream drainage feature exhibiting indicators of an OHWM (see Figure 10 Page 42).

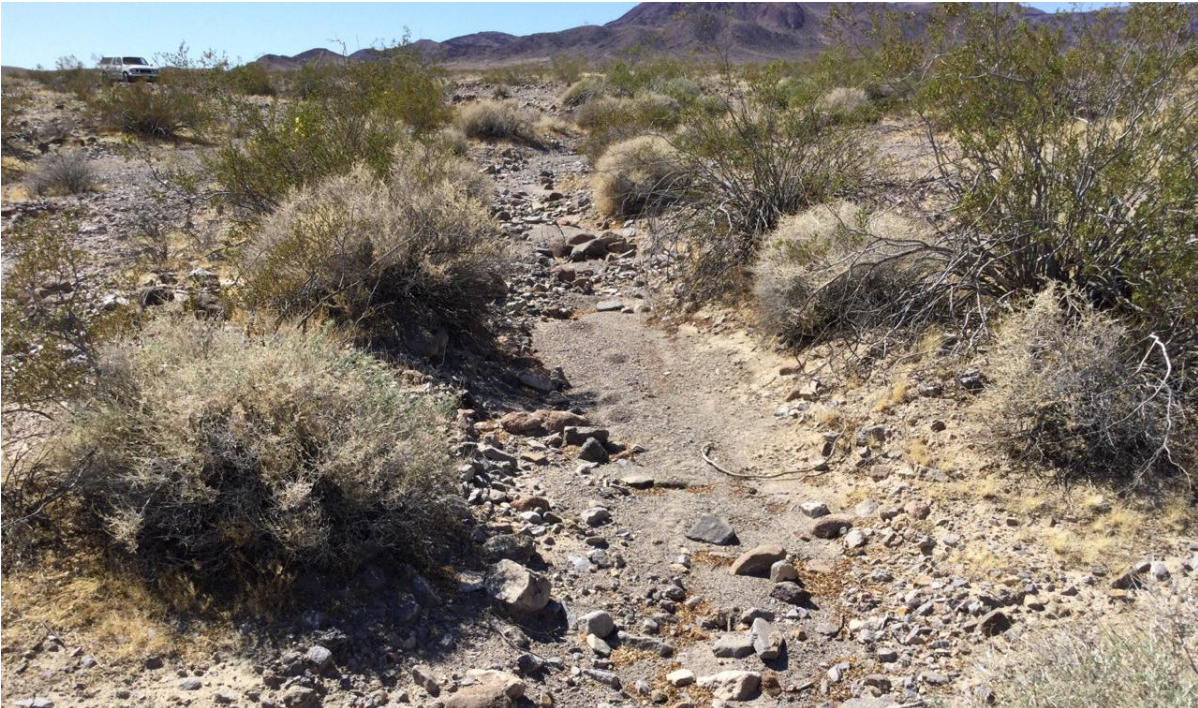
**Photo Point S2-5-2 (South Array 2).** East facing representative photograph of a downstream drainage feature exhibiting indicators of an OHWM, corresponding to the EK-001 Datasheet (see Figure 10 Page 39).

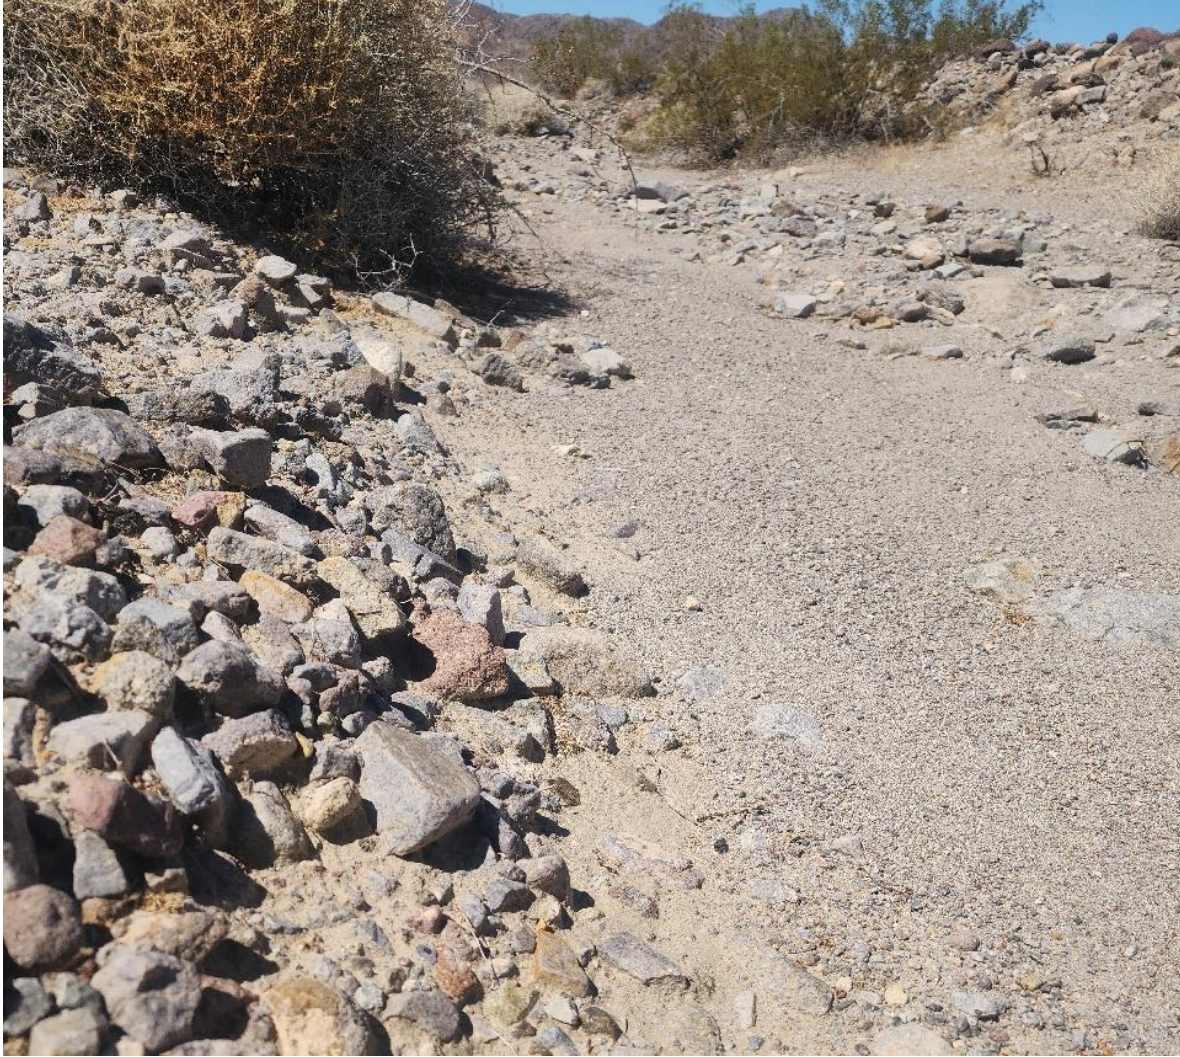
**Photo Point S2-6-2 (South Array 2).** West facing representative photograph of a drainage feature exhibiting indicators of an OHWM, corresponding to the ATG-002 Datasheet (see Figure 10 Page 37).

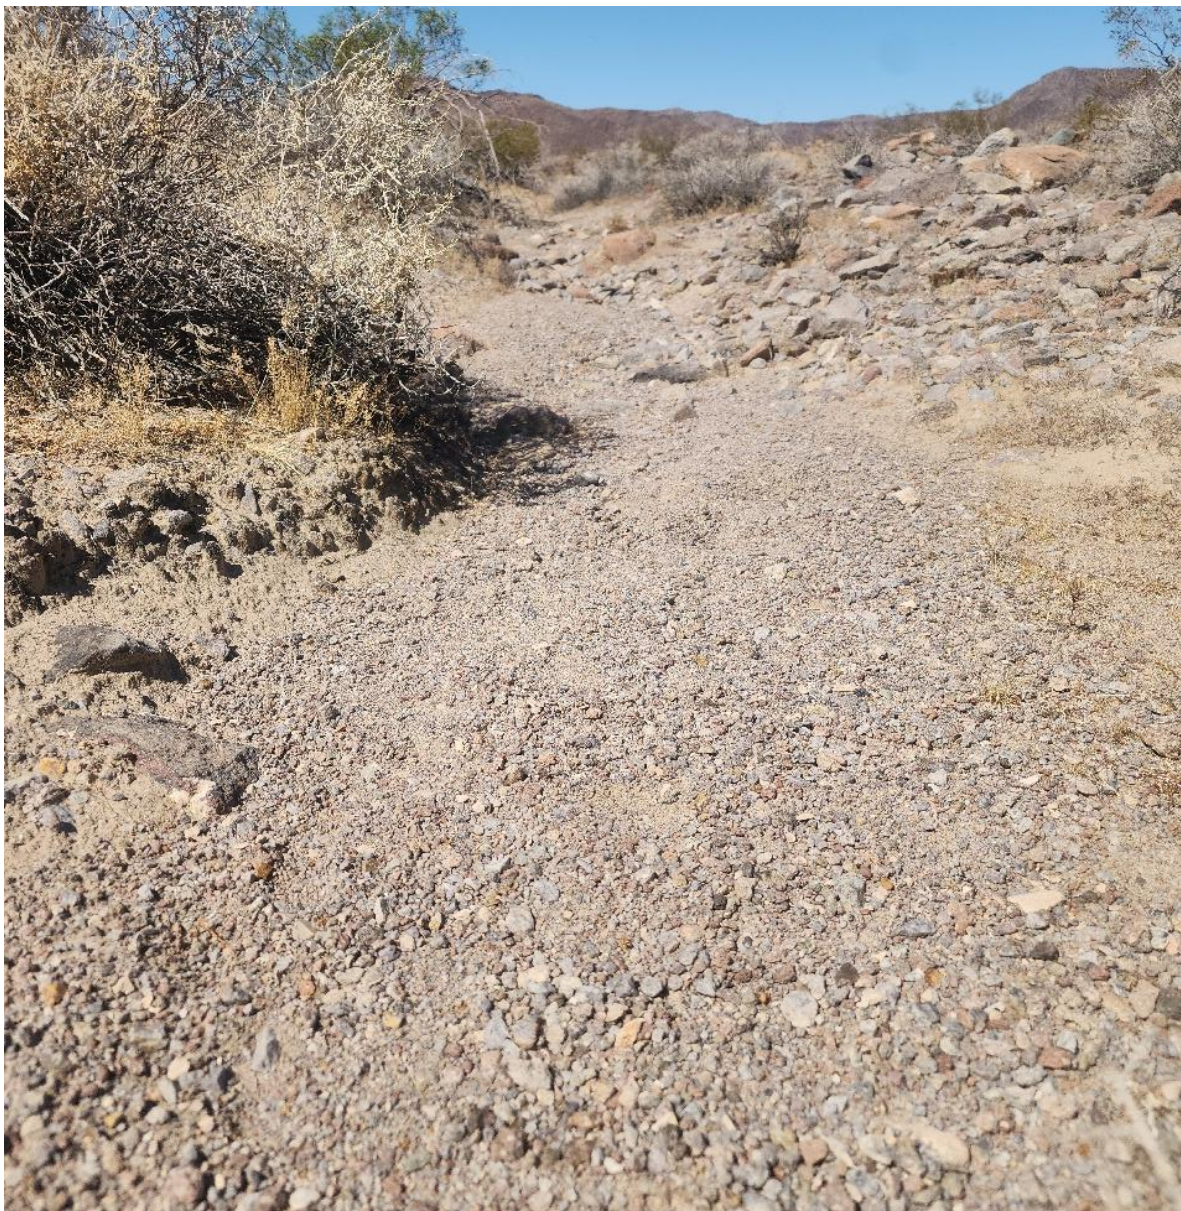
**Photo Point S2-8-1 (South Array 2).** East facing representative photograph of an downstream drainage feature exhibiting indicators of an OHWM, corresponding to the EK-001 Datasheet (see Figure 10 Page 37).

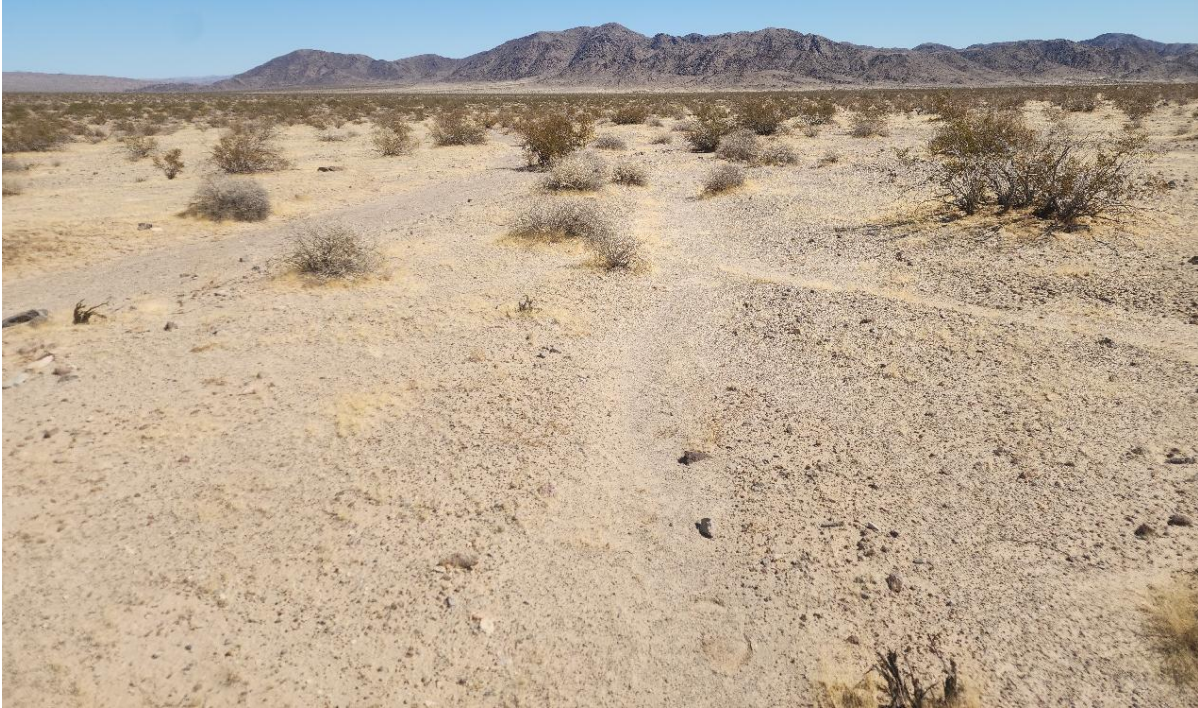
**Photo Point S3-2-1 (South Array 3).** Northeast facing representative photograph of drainages in the Study Area exhibiting weak indicators of a bed and bank and change in substrate (see Figure 10 page 46).

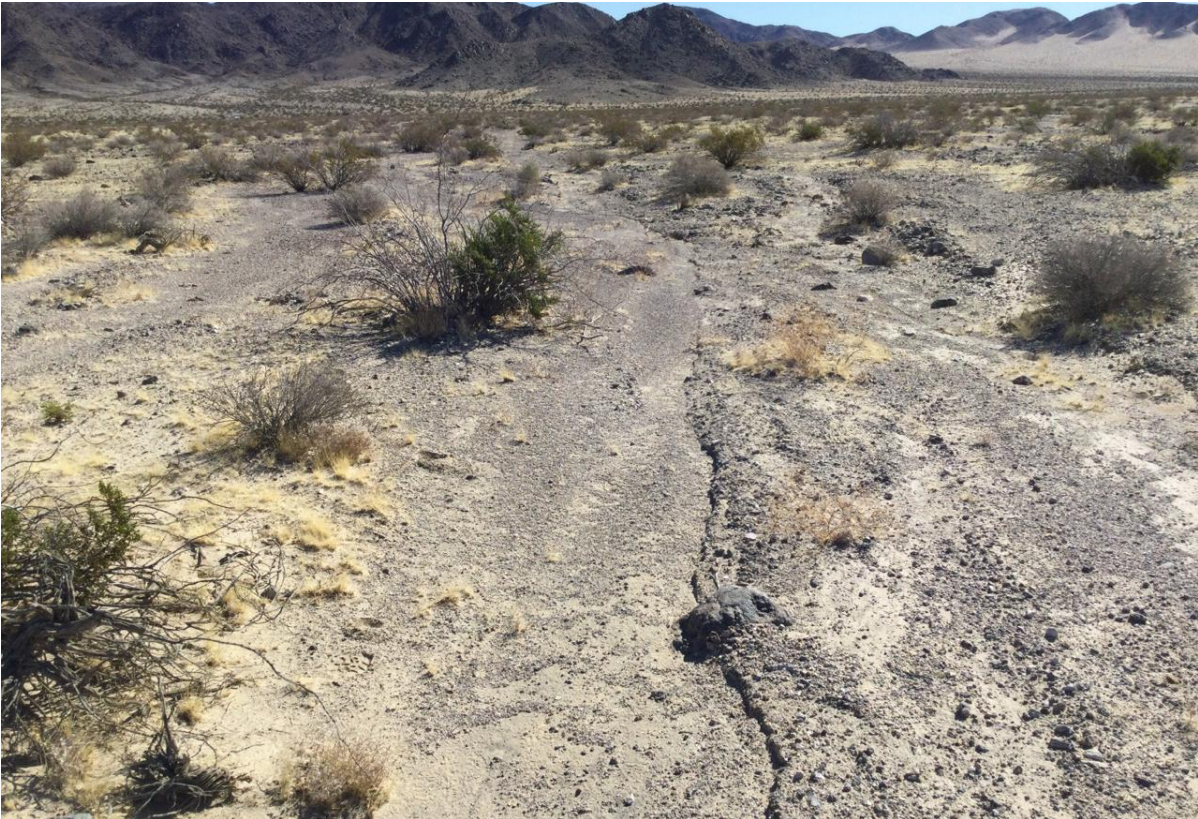
**Photo Point S3-7-1 (South Array 3).** East facing representative photograph of drainages in the Study Area exhibiting weak indicators of a bed and bank and change in substrate (see Figure 10 Page 51).

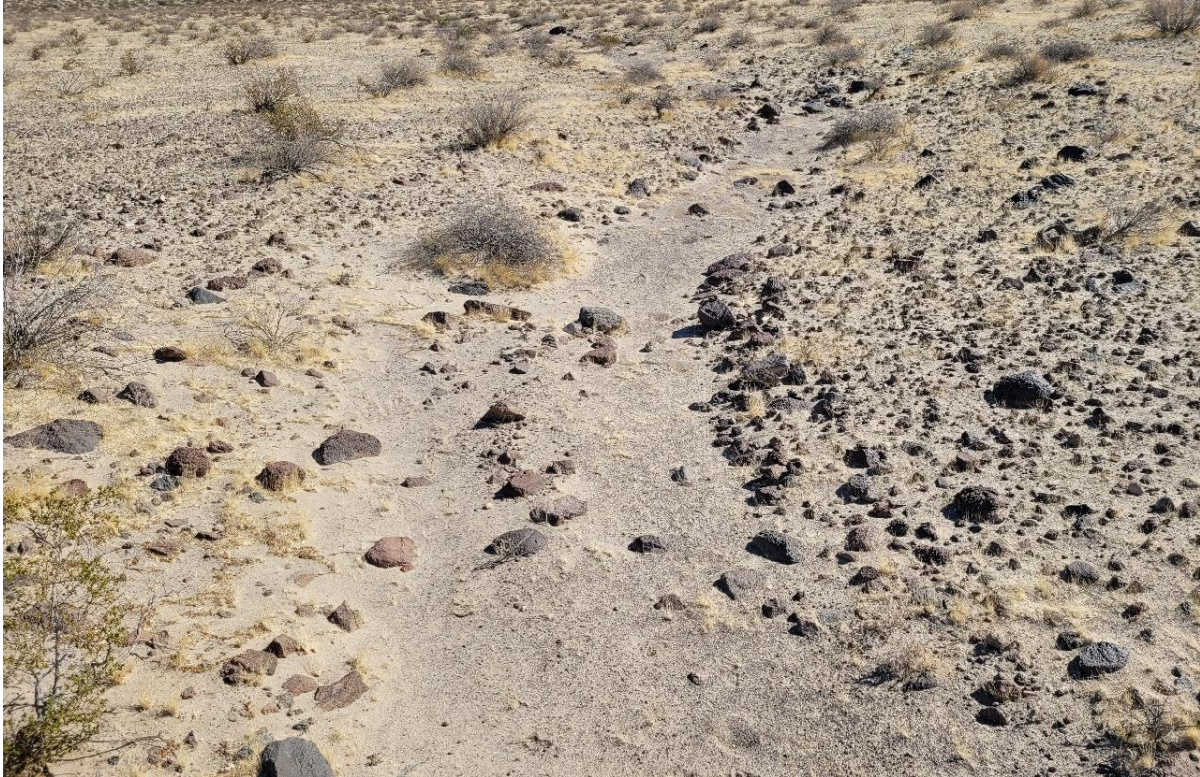
**Photo Point S3-8-1 (South Array 3).** Northeast facing representative photograph of drainages in the Study Area exhibiting weak indicators of a bed and bank and change in substrate (see Figure 10).

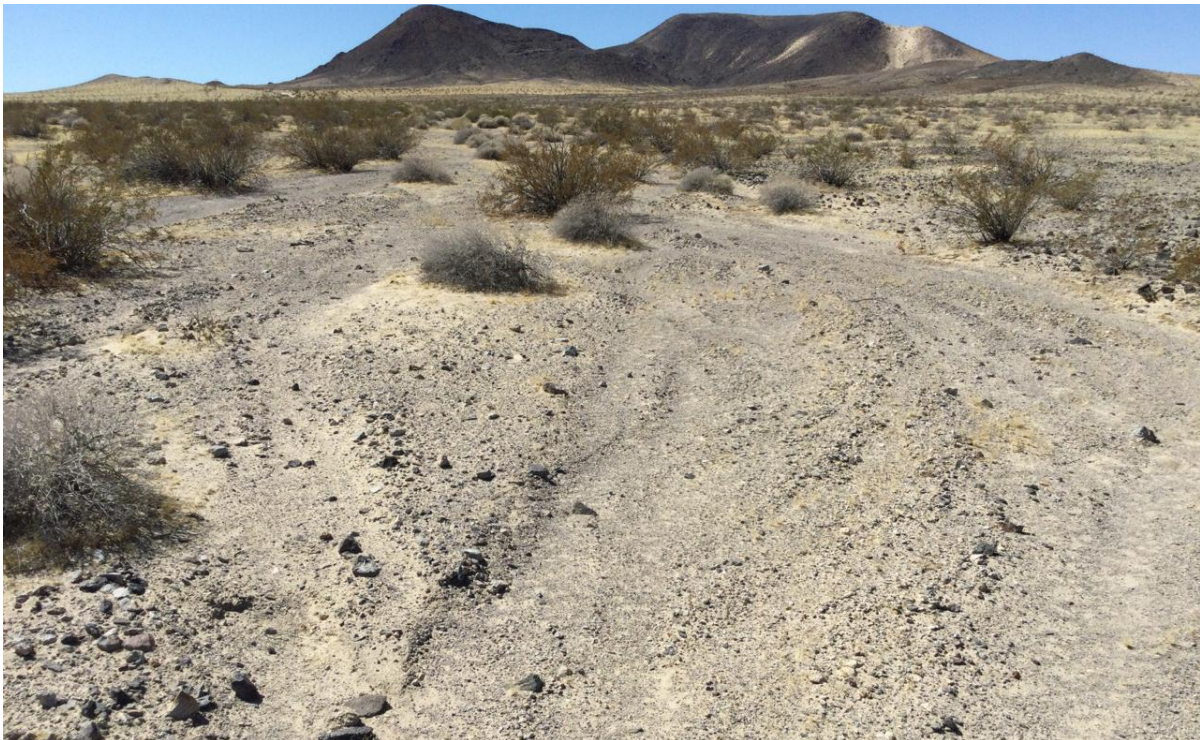
**Photo Point S3-11-1 (South Array 3).** West facing representative photograph of drainages in the Study Area exhibiting weak indicators of a bed and bank and change in substrate (see Figure 10).

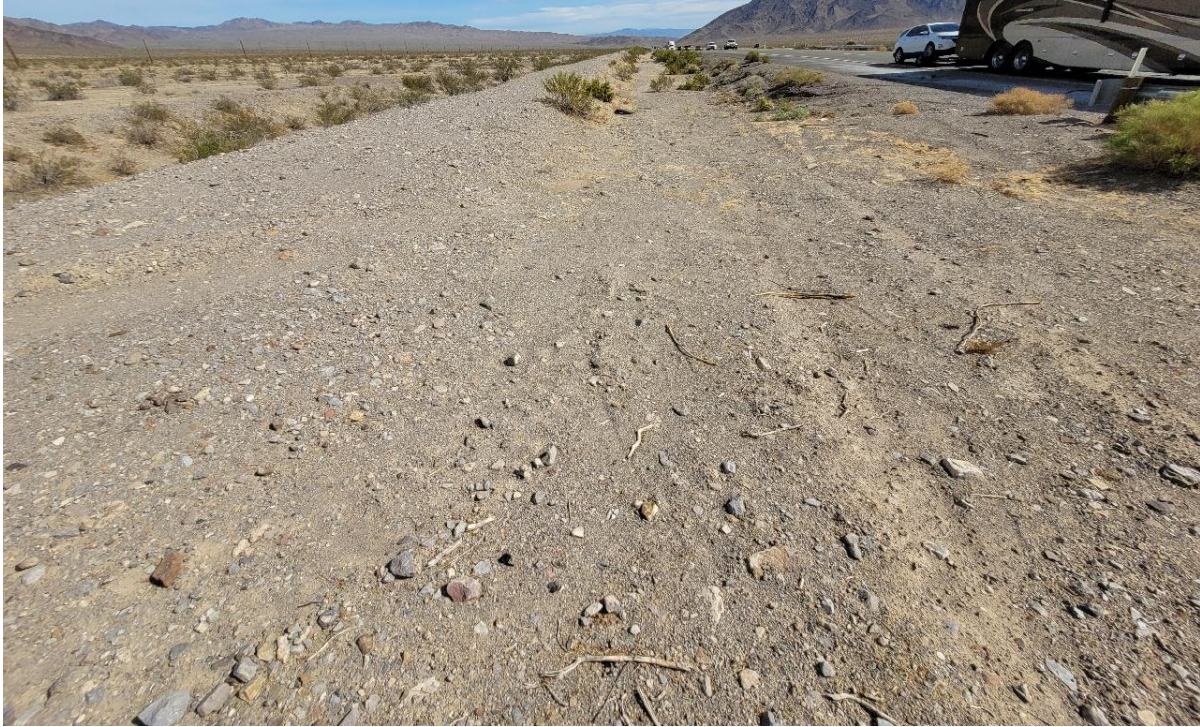
**Photo Point T-1 (Gen-Tie Corridor).** Northeast facing representative photograph illustrating a floodplain control ditch paralleling Interstate 15, facing downstream (see Figure 10 Page 19).

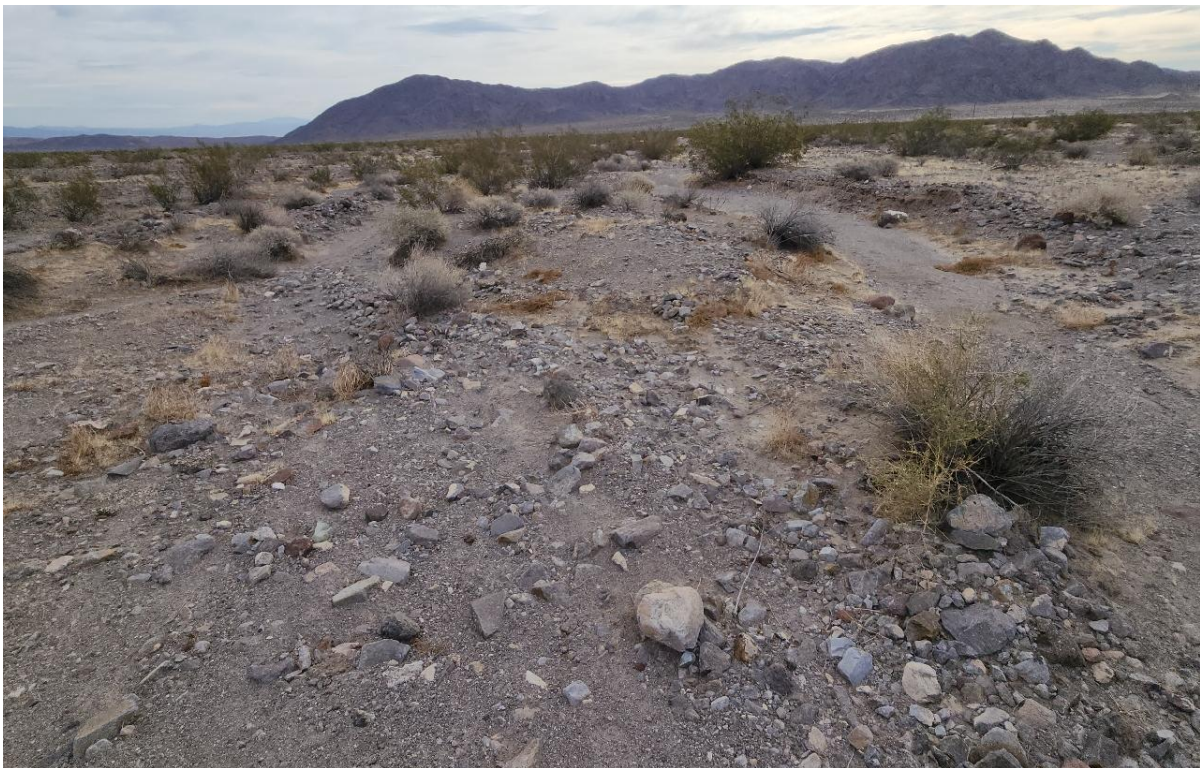
**Photo Point T-11 (Gen-Tie Corridor).** East facing representative photograph illustrating braided drainages, facing downstream (see Figure 10 Page 21).

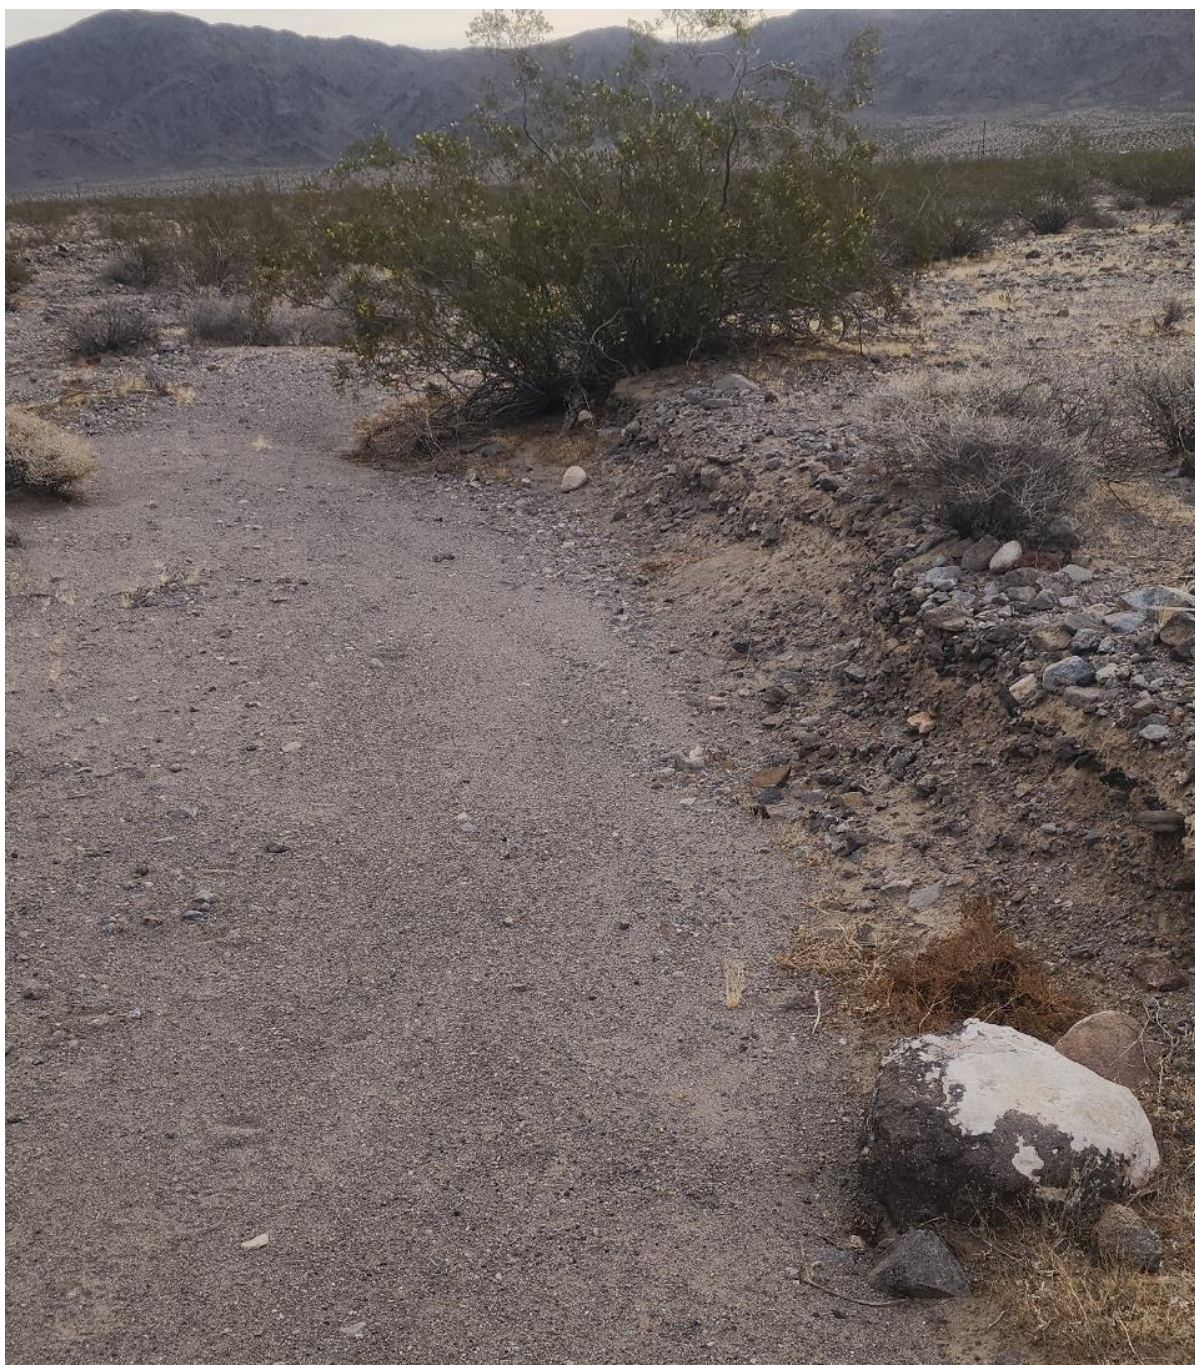
**Photo Point T12 (Gen-Tie Corridor).** East facing representative photograph illustrating indicators of an OHWM in a drainage feature, corresponding to ATG-005 Datasheet (see Figure 10 Page 21).

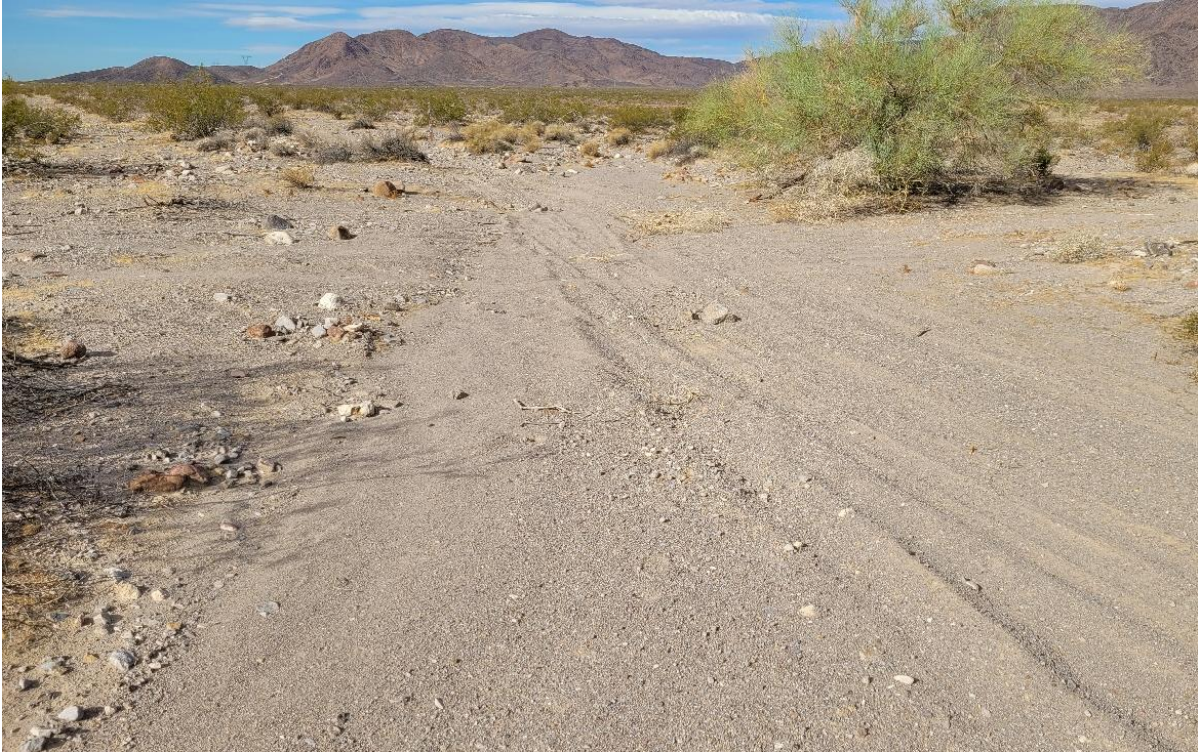
**Photo Point T-5 (Gen-Tie Corridor).** West facing view of drainage where indicators have been disturbed by vehicular activities (see Figure 10 Page 20).

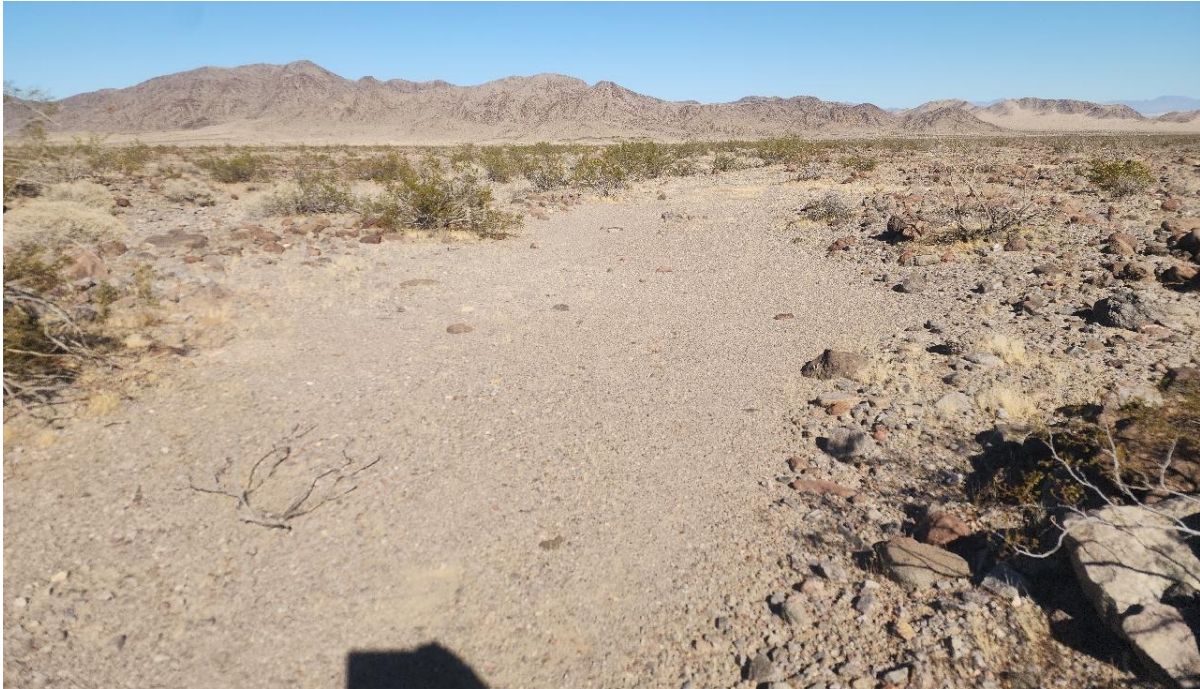
**S2-13-2 (South Array 2).** East facing view of a representative area exhibiting indicators of sheet flow and swales with no obvious indicators of an OHWM (see Figure 10 Page 37).
