Comprehensive Biological Survey Report

Reclaimed Wind LLC

Viracocha Hill Battery Energy Storage System October 2, 2025

Project Name: Viracocha Hill Battery Energy Storage System

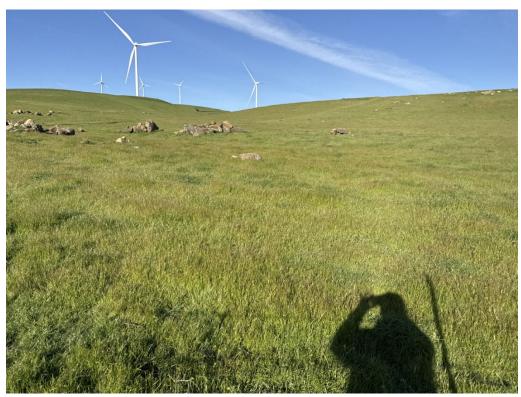
Photo 1: Photo capturing area where the NHD mapped a flowline in the northwestern portion of the BSA. No OHWM indicators or wetland indicators observed. Photo taken on March 18, 2025, facing west.

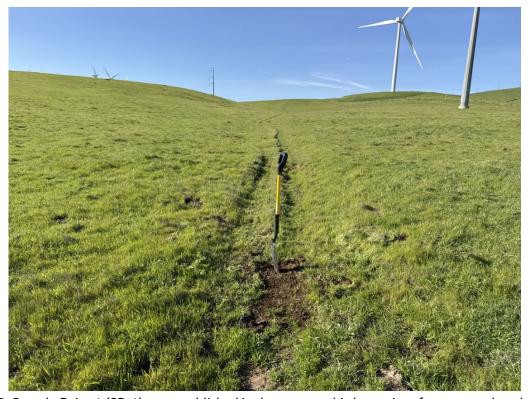
Photo 2: Sample Point 1 (SP-1) was established in the topographic low point of a vegetated swale where saturation was potentially visible on aerial imagery. No indicators of wetland hydrology or hydric soils observed. Photo taken on March 18, 2025, facing south.

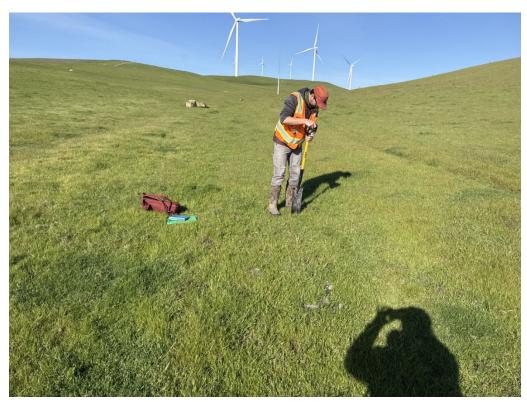
Photo 3: Overview of a vegetated swale at SP-2 where an NHD flowline was mapped. No OHWM indicators or wetland indicators observed. Photo taken on March 18, 2025, facing west.

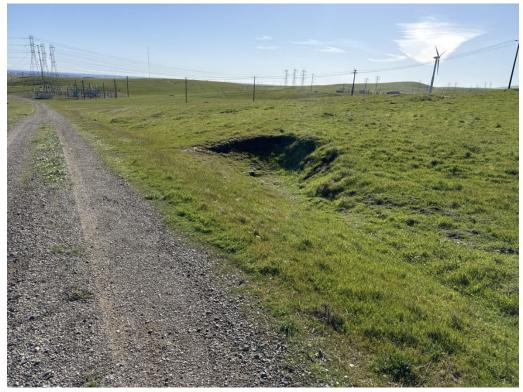
Photo 4: Culvert inlet along the south side of the exisiting access road. No aquatic resources were delineated in this area. Photo taken on March 18, 2025, facing east.

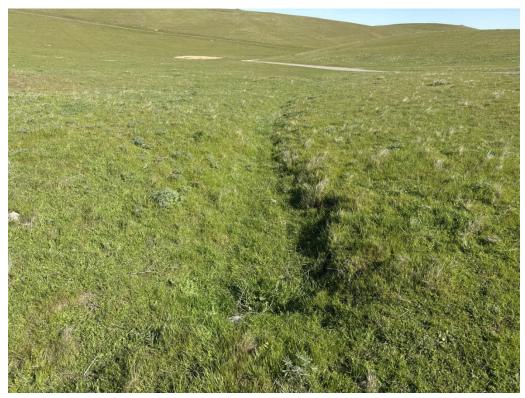
Photo 5: A vegetated swale at culvert outlet at SP-3. No OHWM indicators or wetland indicators observed. Photo taken on March 18, 20205; facing north.

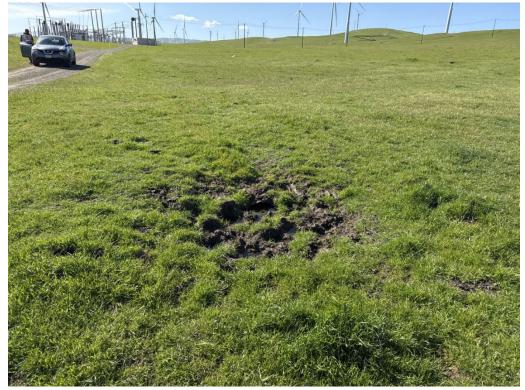
Photo 6: A small depression formed at culvert outlet at SP-.4; facing south. No hydric soils or OHWM indicators observed. Photo taken on March 18, 2025.

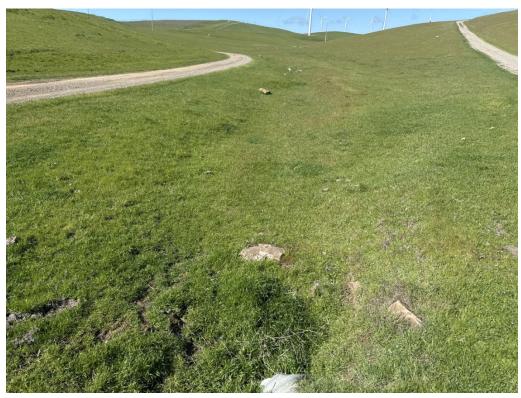
Photo 7: A vegetated swale at culvert outlet. No OHWM indicators or wetland indicators observed. Photo taken on March 18, 2025, facing southwest.

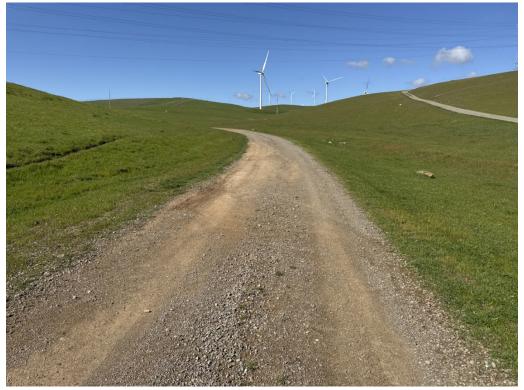
Photo 8: Photo taken at a mapped NHD flowline at the access road. No OHWM indicators observed. Photo taken on March 18, 2025, facing west.

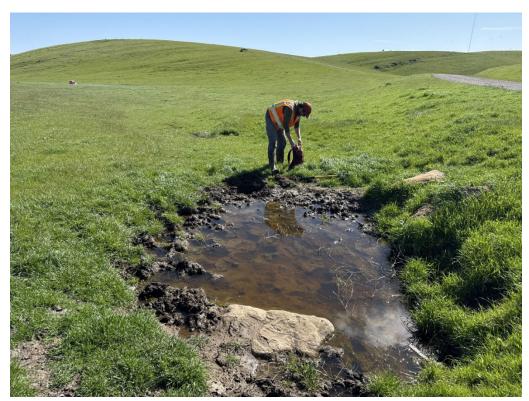
Photo 9: Pooling water observed in a depression at SP-5 but the area lacked hydric soils indicator. Pooling water assumed to be caused by recent rain events and there was no defined OHWM. Photo taken on March 18, 2025, facing east.

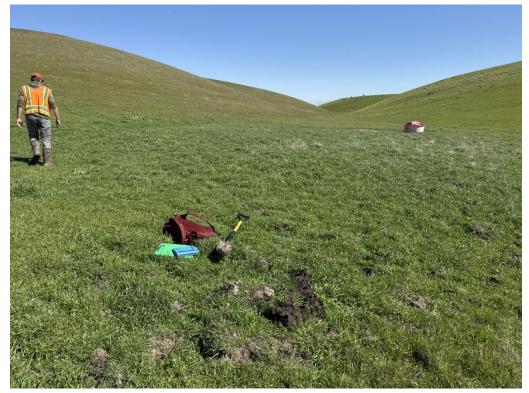
Photo 10: Photo taken in the central portion of WET-1 at SP-6a; facing northeast. Photo taken on March 18, 2025.

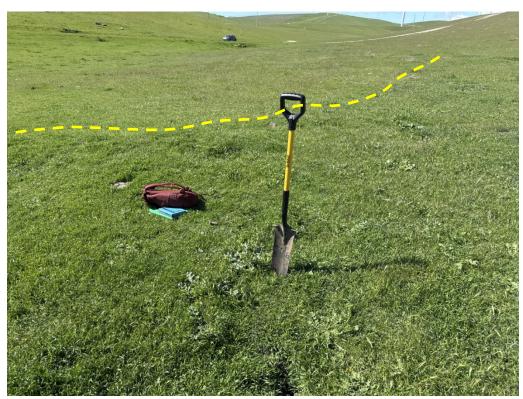
Photo 11: Photo taken at the delineated boundary of WET-1 at SP-6b where vegetation composition changes and no hydric soils were observed. The dashed yellow line shows WET-01 in the background. Photo taken on March 18, 2025.

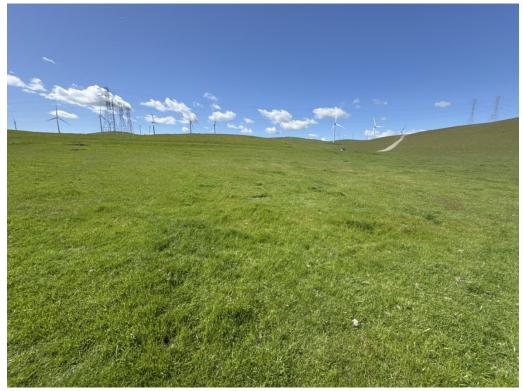
Sample point SP-5 was established in a ponded area located immediately downslope of a culvert outlet (Confidential Figure 3 and Photo 12 in Appendix F). Although hydrophytic vegetation and wetland hydrology were present, this feature lacked hydric soils and OHWM indicators. The area was heavily compacted from cattle and is subject to saturation and inundation at the surface, but not in the subsurface. Therefore, no aquatic resources were delineated in this area.

Photo 12: Photo in an area the NHD mapped a flowline adjacent to WET-1. No OHWM indicators or wetland indicators observed. Photo taken on March 18, 2025, facing southwest.

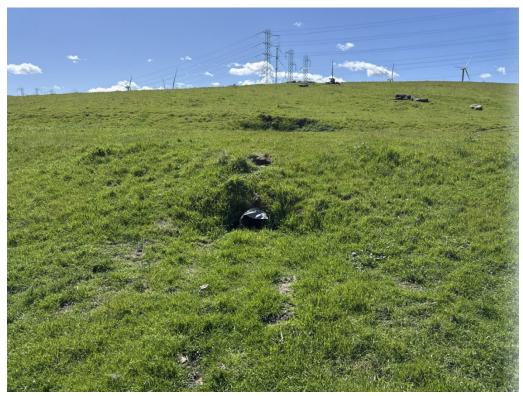
Photo 13: No aquatic resources observed at culvert outlet; facing south. Photo taken on March 18, 2025.

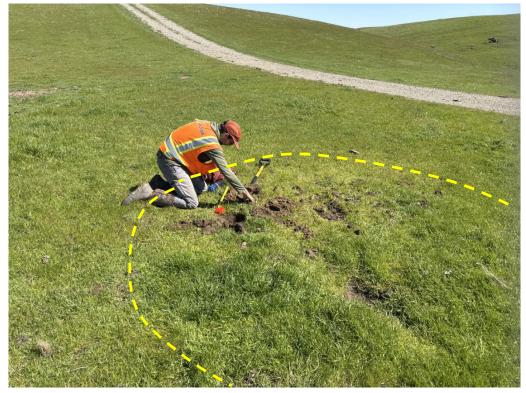
Photo 14: Overview of WET-2 at SP-7a. Photo taken on March 18, 2025, facing northeast.

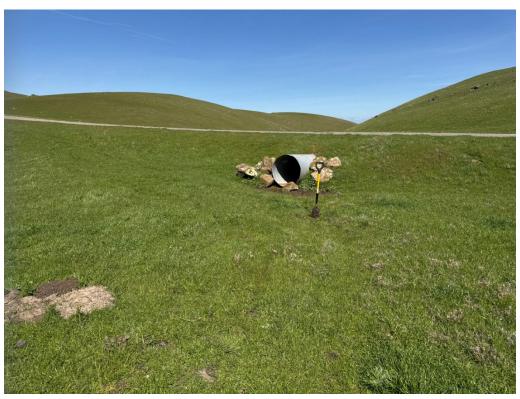
Photo 15: View of WET-3 at SP-8a. Photo taken on March 18, 2025, facing north.

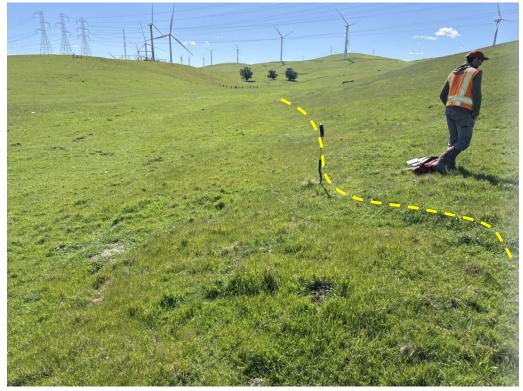
Photo 16: Photo taken at the delineated boundary of WET-3. The wetland is confined by the hillslope. Photo taken on March 18, 2025, facing south.

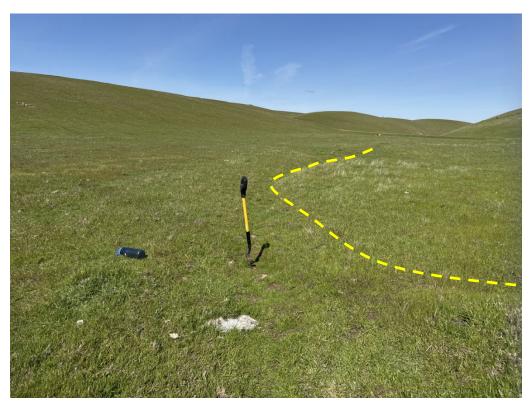
Photo 17: View from the southernmost portion of WET-4 at SP-9a. Photo taken on March 18, 2025, facing north.

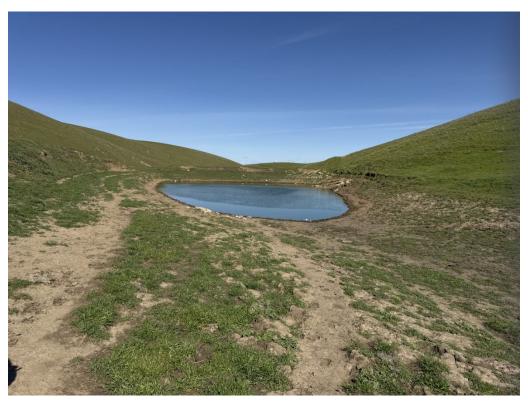
Photo 18: View of feature PND-1. Photo taken on March 18, 2025, facing northeast.

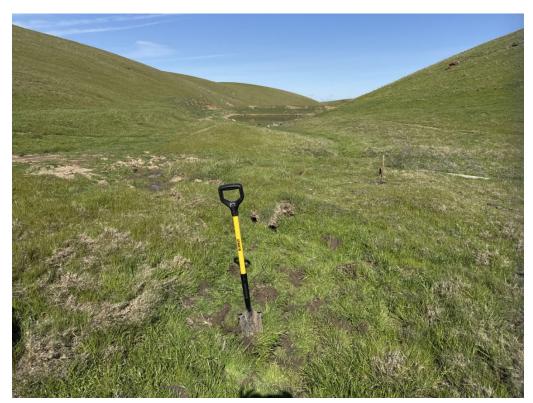
Photo 19: View of WET-4 facing northeast towards PND-1. Photo taken on March 18, 2025.

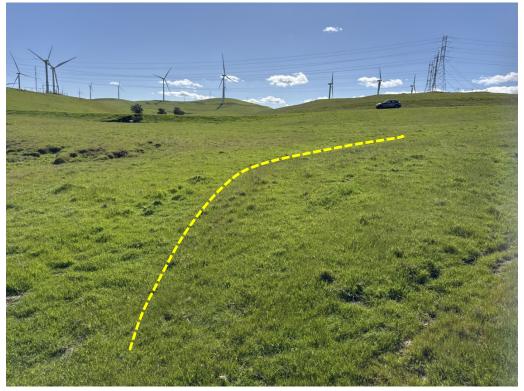
Photo 20: View of the delineated boundary of WET-4. WET-4 is visible on the left side of the photo confined by the hillslope on the right. Photo taken on March 18, 2025, facing southwest.
