# **MEMORANDUM**

Subject: Response to Post Scoping Set 2 Data Requests for Compass Energy Storage Project (24-

OPT-02)

Preliminary Hydraulic Report for Oso Creek Stabilization

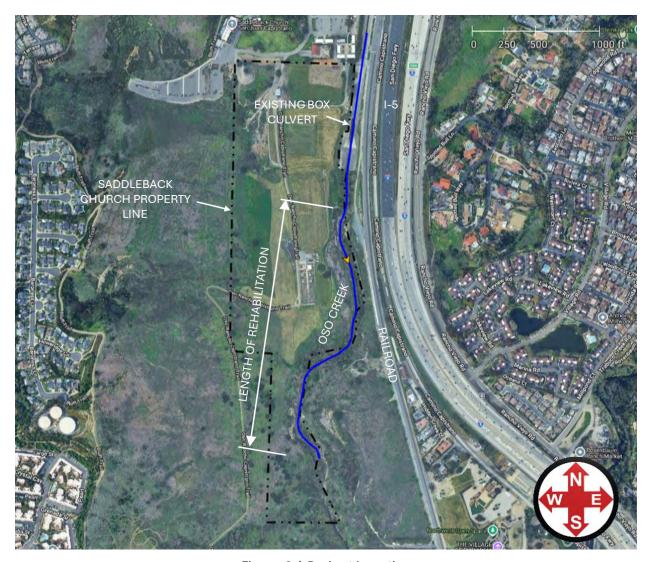
Figure 2 | Project Location

The Oso Creek Stabilization Project involves the repair and rehabilitation of approximately 2,600 linear feet of the Oso Creek channel, which we will refer to in this report as the "study reach". The study reach is located to the east of the Saddleback Church Rancho Capistrano property and west of the I-5 San Diego Freeway and the Southern California Regional Rail Authority (SCRRA) rail line within the city of San Juan Capistrano, California, as shown in **Figure 1** and **Figure 2**.

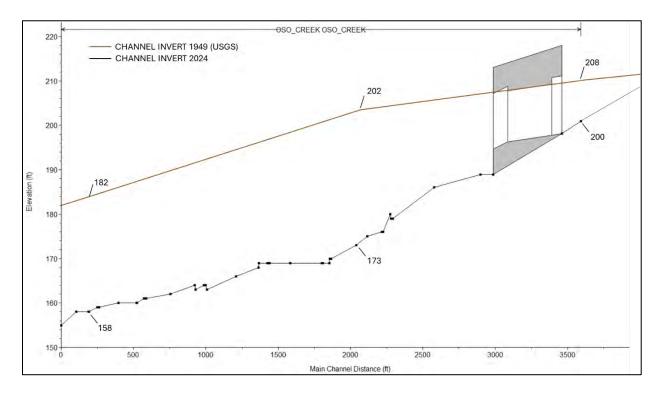
Figure 3 | Channel Profile 1949 vs. 2024 Comparison

Over the last 50 years, development within the Oso Creek watershed has increased significantly, decreasing the amount of sediment produced from within the watershed. With the increase in development came traditional means of flood control in the form of concrete channels and storm drain structures. The double box culvert was built in 1984 along with a series of concrete open channels upstream. This addition of the box culvert and concrete lined channels has increased flow velocities, erosion, and scour within the creek channel. We compared the existing Oso Creek study reach topography with topography from the USGS 7.5 minute topographic map from 1949. A profile of both sets of topography along the Oso Creek channel invert are shown in **Figure 3**. This shows that over the past 76 years the channel invert over the study reach has degraded by between 20 and 30 feet.

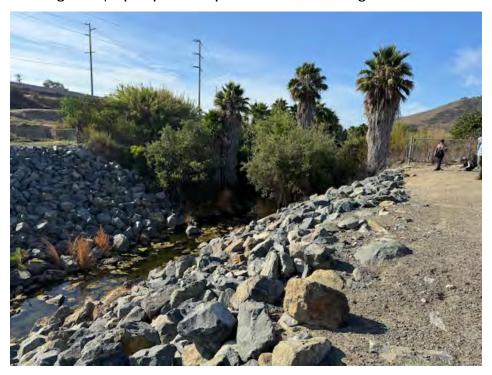
Figure 5 | Rip Rap Channel Transitions to Vegetated Channel with Rip Rap

Tory R. Walker Engineering (TRWE) conducted a site visit on August 21st, 2025 to assess the current physical characteristics of Oso Creek along the study reach. The existing double box culvert at the upstream end of the project site outlets to a rip rap-lined open channel (see **Figure 4**). The channel then transitions to a densely vegetated open channel lined with the same size rip rap scattered along the banks, which appears to be stable (see **Figure 5** and **Figure 6**). The creek then transitions to a natural channel without rock lining, at which point severe vertical and horizontal erosion begins and continues downstream.

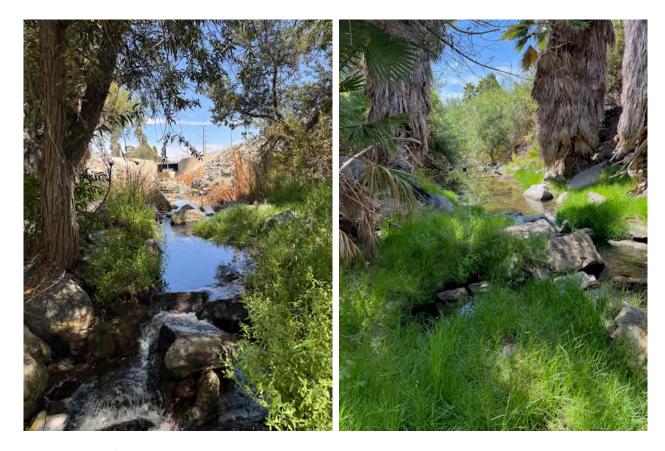
Figure 6 | Stable Vegetated Open Channel with Rip Rap Downstream of Culvert Outfall

At this point (approximately 700-feet downstream of the existing double RCB outfall) the channel has eroded downward into a clay layer. Both native and non-native vegetation are overgrown in various areas, causing re-direction of flows away from the channel thalweg (see **Figure 7**, which was taken within Oso Creek looking upstream). Existing native and non-native vegetation are overgrown along the eastern bank, directing flows toward the western bank, which has recently collapsed.

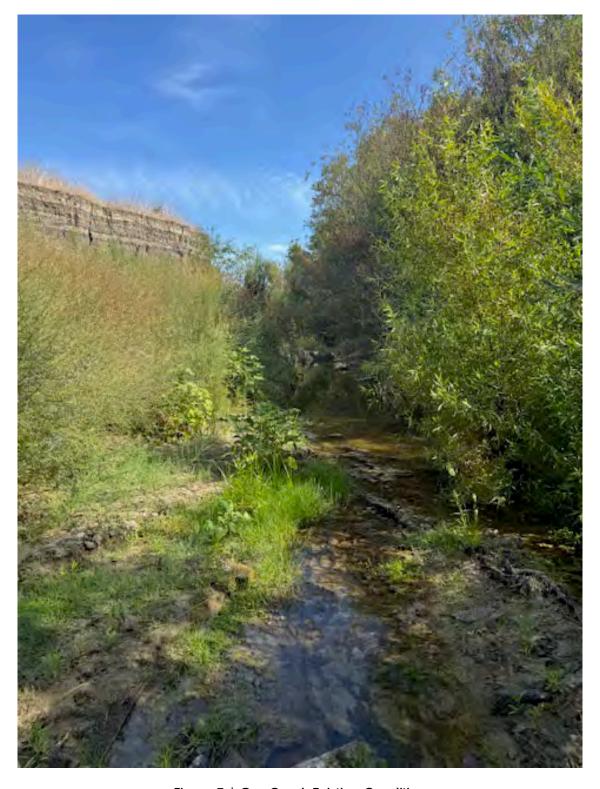
Figure 7 | Oso Creek Existing Condition

With time, these surface cracks are expected to deepen, eventually causing more bank failure. The channel at this location and continuing downstream is no longer protected by rock and is unstable and lacks proper bank vegetation in some areas. It is therefore susceptible to the high velocities that cause bank failure and horizontal migration as it continues downstream.

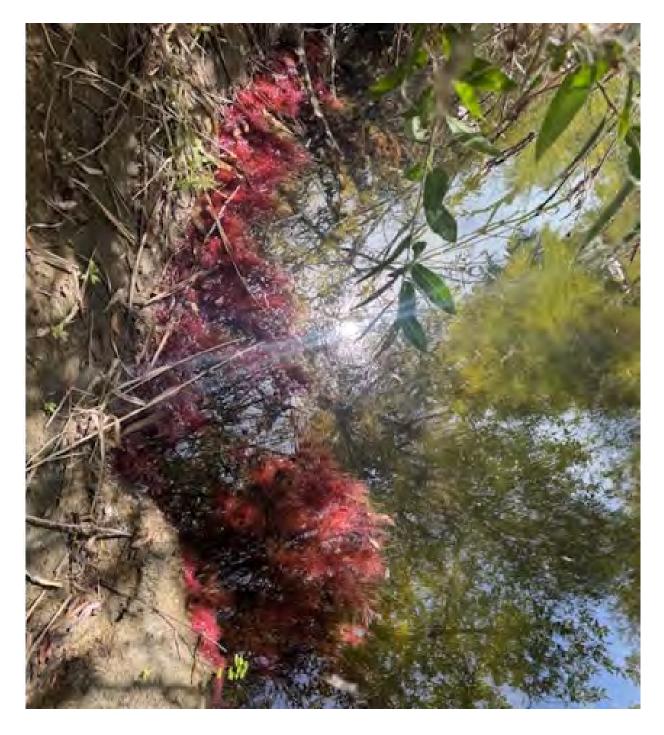
Figure 9 | Willow Roots Inside Channel

Plants such as Giant Reed (arundo donax) and willows were observed along the channel. Their shallow and compact roots force the water away towards the west bank, stabilizing the soil beneath them but also diverting flows to the opposite channel bank (see **Figure 9**). Riprap has been placed along the east side of the corridor along the railroad just south of the culvert outfall. This rip rap has somewhat stabilized the eastern slope of the channel along the railroad, leaving the western bank more vulnerable to ongoing collapse.

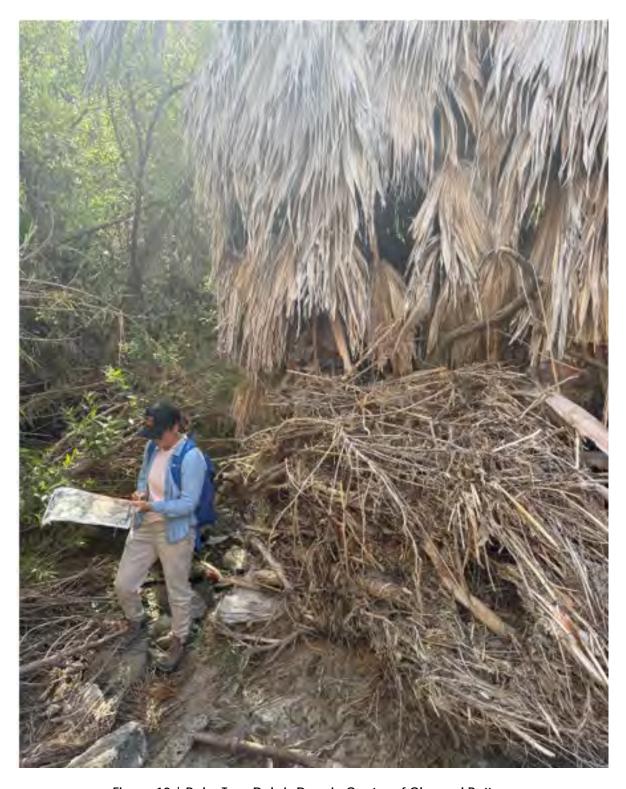
Figure 10 | Palm Tree Debris Dam in Center of Channel Bottom

Additionally, mature plants such as palms were found to be trapping debris that moved through the channel and had formed debris dams (see **Figure 10**). These overgrown plants form natural dams and barriers that re-direct high velocity flows around them and toward the banks, creating new flow paths as the water looks for a path around the blockage.

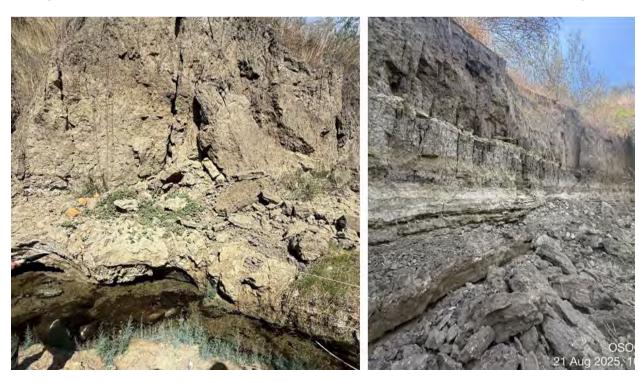
Figure 11 | Undercutting and Bank Collapse of Clay Soils

The team observed clay soils along the channel bottom and along the lower banks throughout the visited channel reach. These soils are highly erosive and experience erosion at the exposed toes of slope throughout the channel. As the toe erodes, the foundation of the slope is compromised, leading to bank collapse. Undercutting and collapse of the channel banks can be seen in **Figure 11**. This photo was taken toward the downstream end of the project reach and shows the lack of rock and deposited sediment in both the channel banks and bottom.

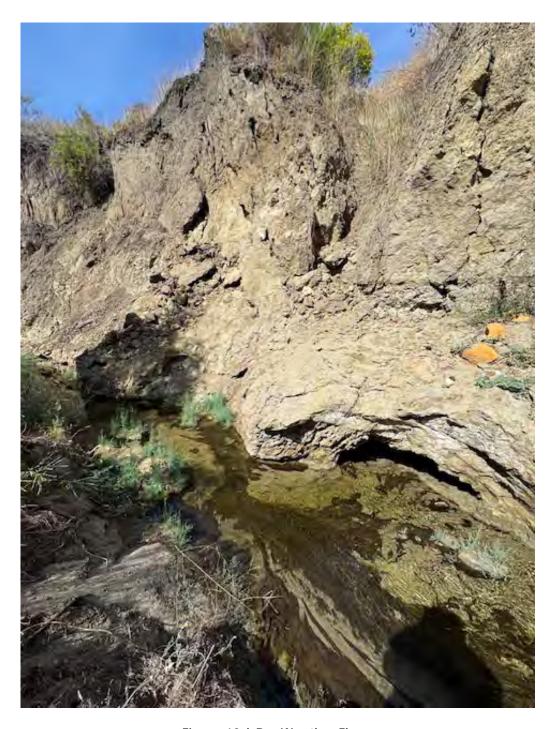
Figure 12 | Dry Weather Flows

Dry weather flows were observed during the site visit and were estimated to be approximately 1 cfs. These flows are considered a baseflow, as they occur year-round due to various sources throughout the watershed. This baseflow was clear and did not contain sediment (see **Figure 12**).

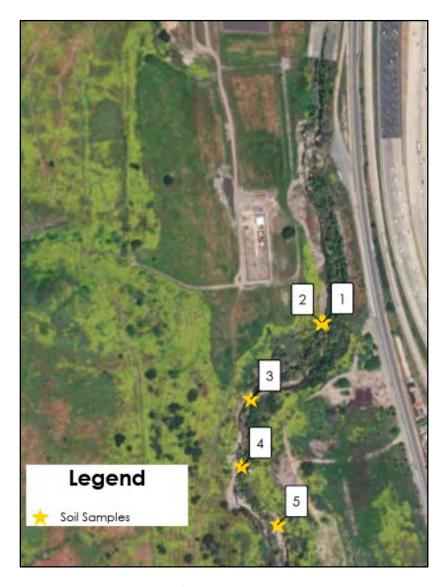
Figure 13 | Soil Sample Locations

The sieve analyses performed on the sediment samples confirmed the field observation that the channel bed was composed of clay and shows that the lower banks contain mostly clay. Locations where the sediment samples were taken can be viewed in **Figure 13**. Results of the sieve analysis are summarized in **Table 2**, and the gradation results are located in **Attachment 1**.

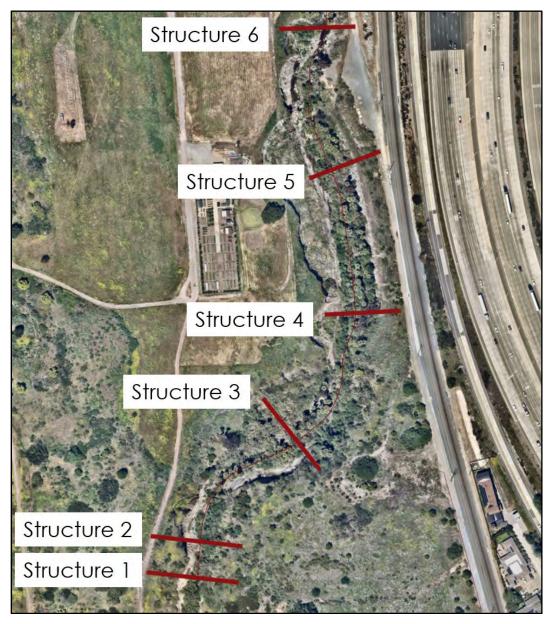
Figure 14 | Drop Structure Locations

The Manning's roughness coefficients were adjusted along the rehabilitated portion of the channel to reflect the large natural rock that would be placed along each drop structure and areas of bare graded soil before vegetation establishes. HEC-RAS results are in **Attachment 4**.

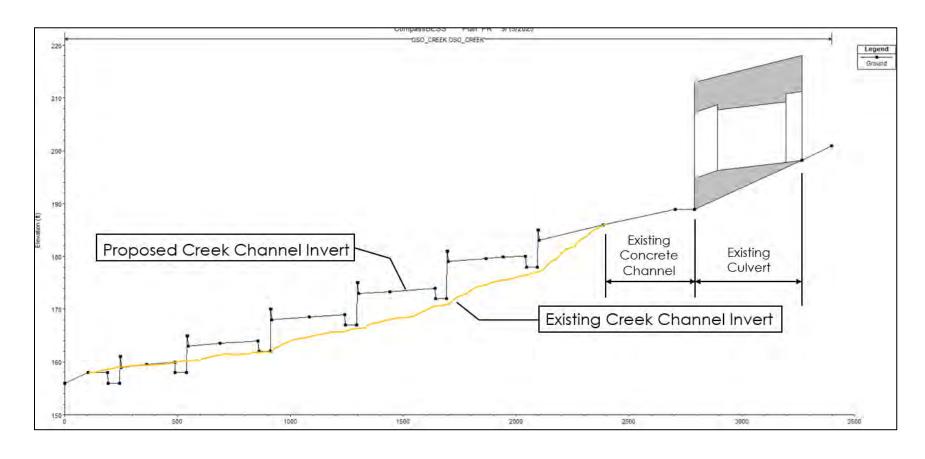
Figure 17 | Existing Vs. Proposed Channel Profile

Another important design feature will be elevating this highly degraded section of Oso Creek; this will allow reestablishment of a hyporheic zone in the creek channel bed. Taken together, these design features will stabilize the channel, reducing the risk of ongoing vertical and horizontal scour and bank collapse, and will provide habitat and water quality improvements.
