DOCKETED	
Docket Number:	24-OPT-02
Project Title:	Compass Energy Storage Project
TN #:	267930
Document Title:	Part 2 Supplemental Submittal_Attachment H_Lake and Streambed Alteration Agreement Application
Description:	N/A
Filer:	Erin Phillips
Organization:	Dudek
Submitter Role:	Applicant Consultant
Submission Date:	12/15/2025 1:52:59 PM
Docketed Date:	12/15/2025

Subject: Application for a Streambed Alteration Agreement for the Compass Energy Storage Project, Orange County, California

On behalf of Compass Energy Storage LLC (Applicant), Dudek submits the enclosed application for a Streambed Alteration Agreement for the Compass Energy Storage Project (project) located in Orange County, California.

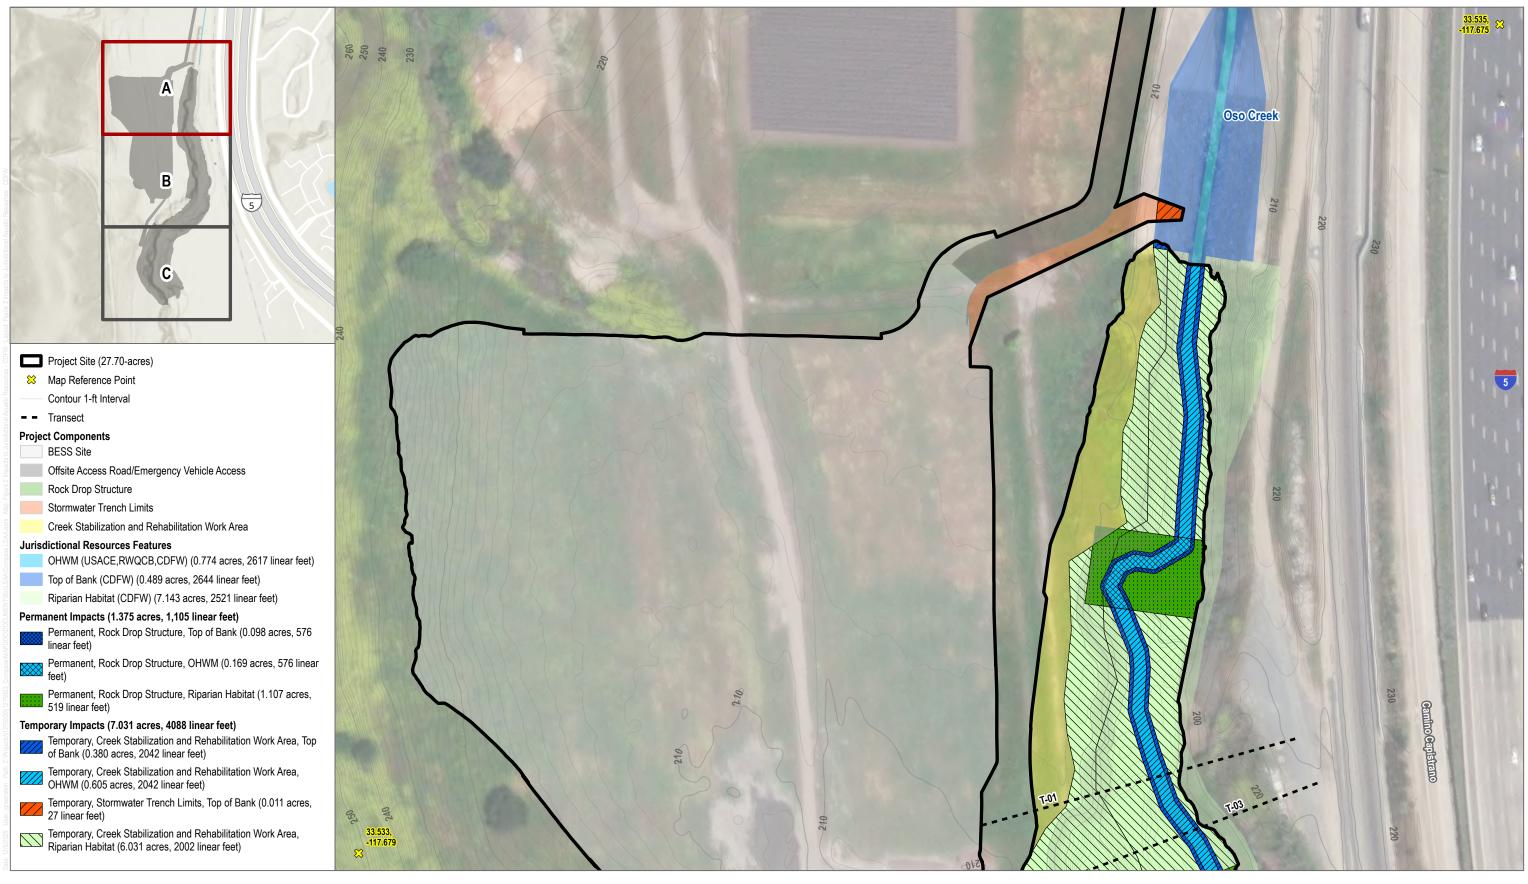
FIGURE 2A

Impacts to Jurisdictional Aquatic Resources - CDFW

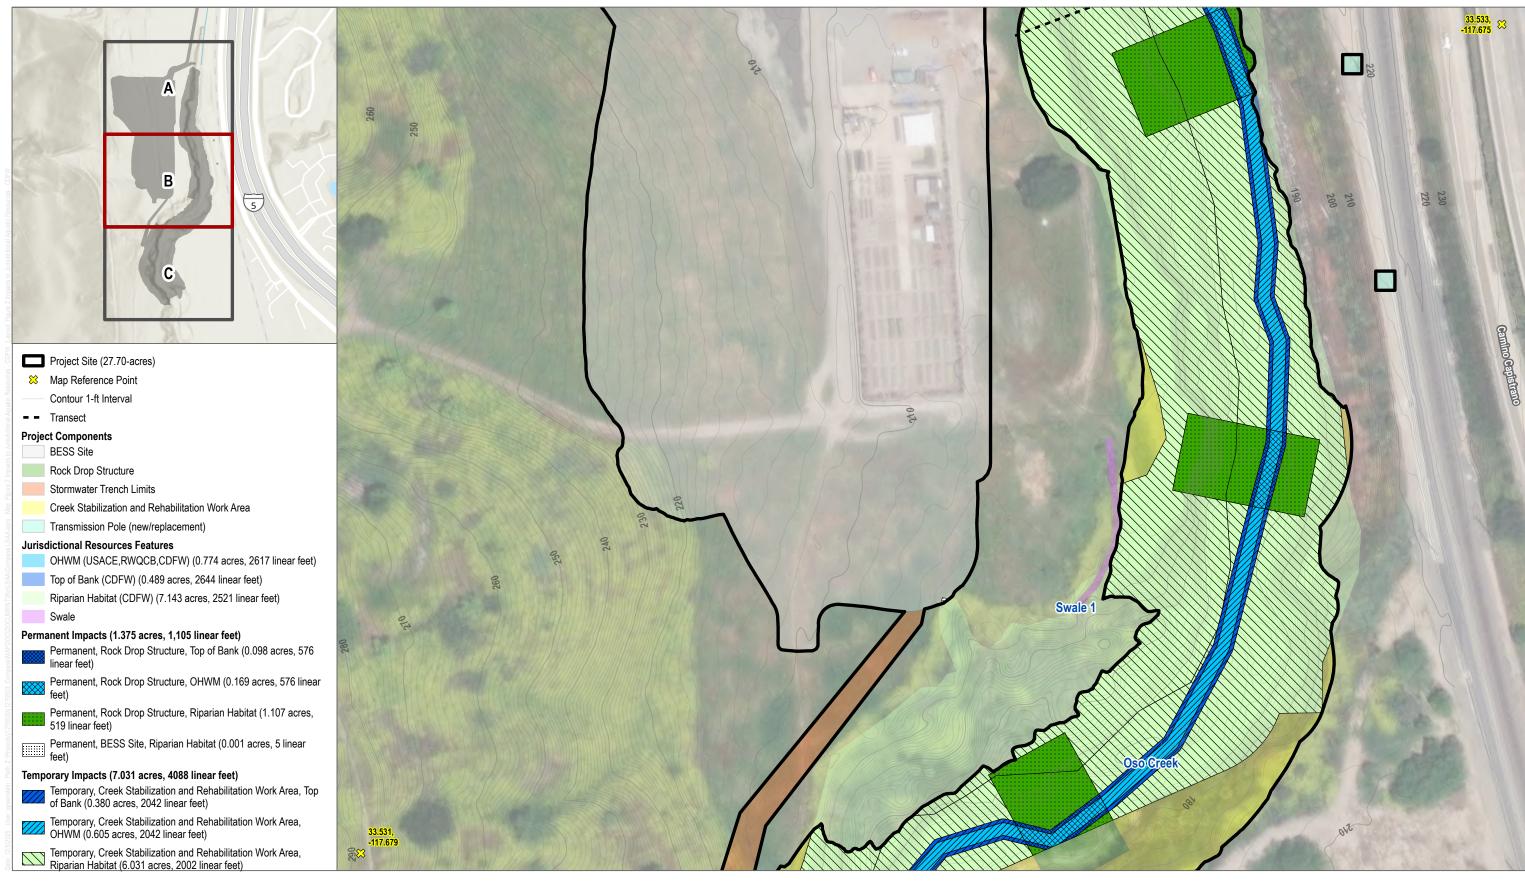
FIGURE 2B

Impacts to Jurisdictional Aquatic Resources - CDFW

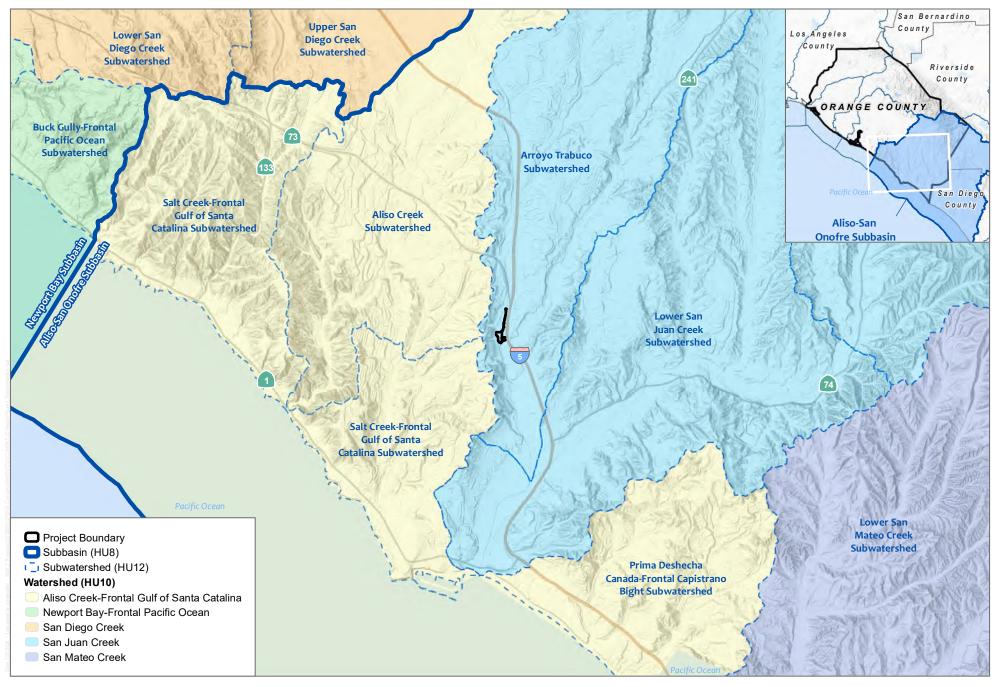
FIGURE 5 Watershed Map

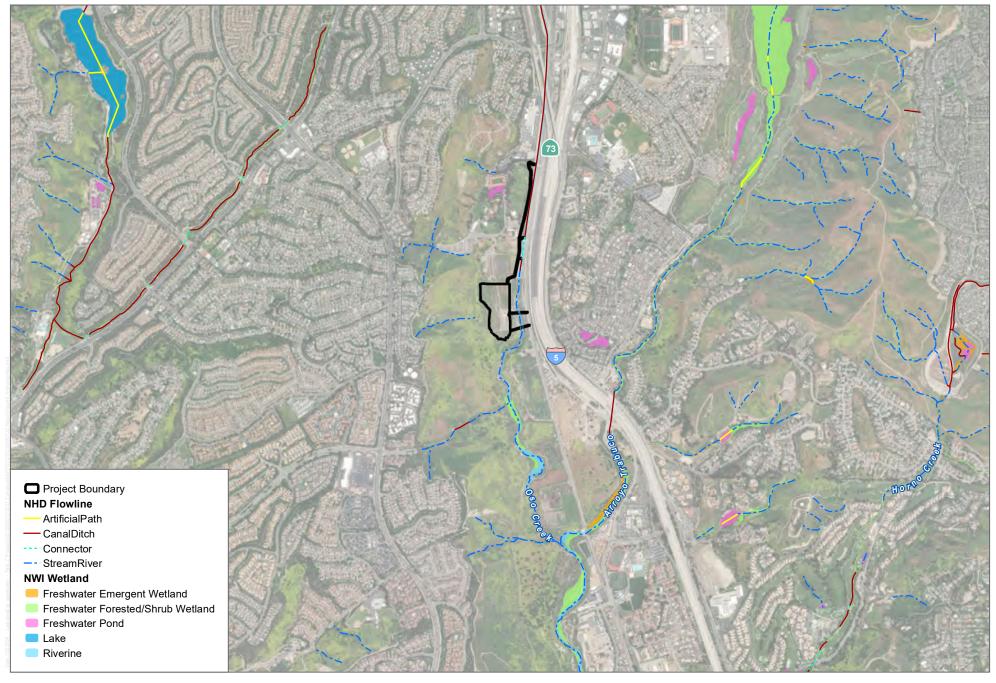
FIGURE 6
Hydrology Map

The Nation Hydrography Dataset (NHD) maps Oso Creek as a perennial stream feature which flows north to south along the eastern edge of the Project (Attachment A, Figure 6). An ephemeral drainage feature is mapped flowing across the southern portion of the Project, originating from a concrete lined channel at the southwestern corner of the site. This ephemeral feature flows northeast, eventually flowing into Oso Creek. One additional ephemeral stream feature is mapped on the western side of the Project, but it was not observed in the field. A review of the National Wetland Inventory (NWI) dataset revealed one wetland type, Riverine, occurs within the Survey Area. Oso Creek (R4SBC) habitat is classified as riverine, intermittent, streambed, and seasonally flooded. The ephemeral streams mentioned above are not shown in the NWI dataset.

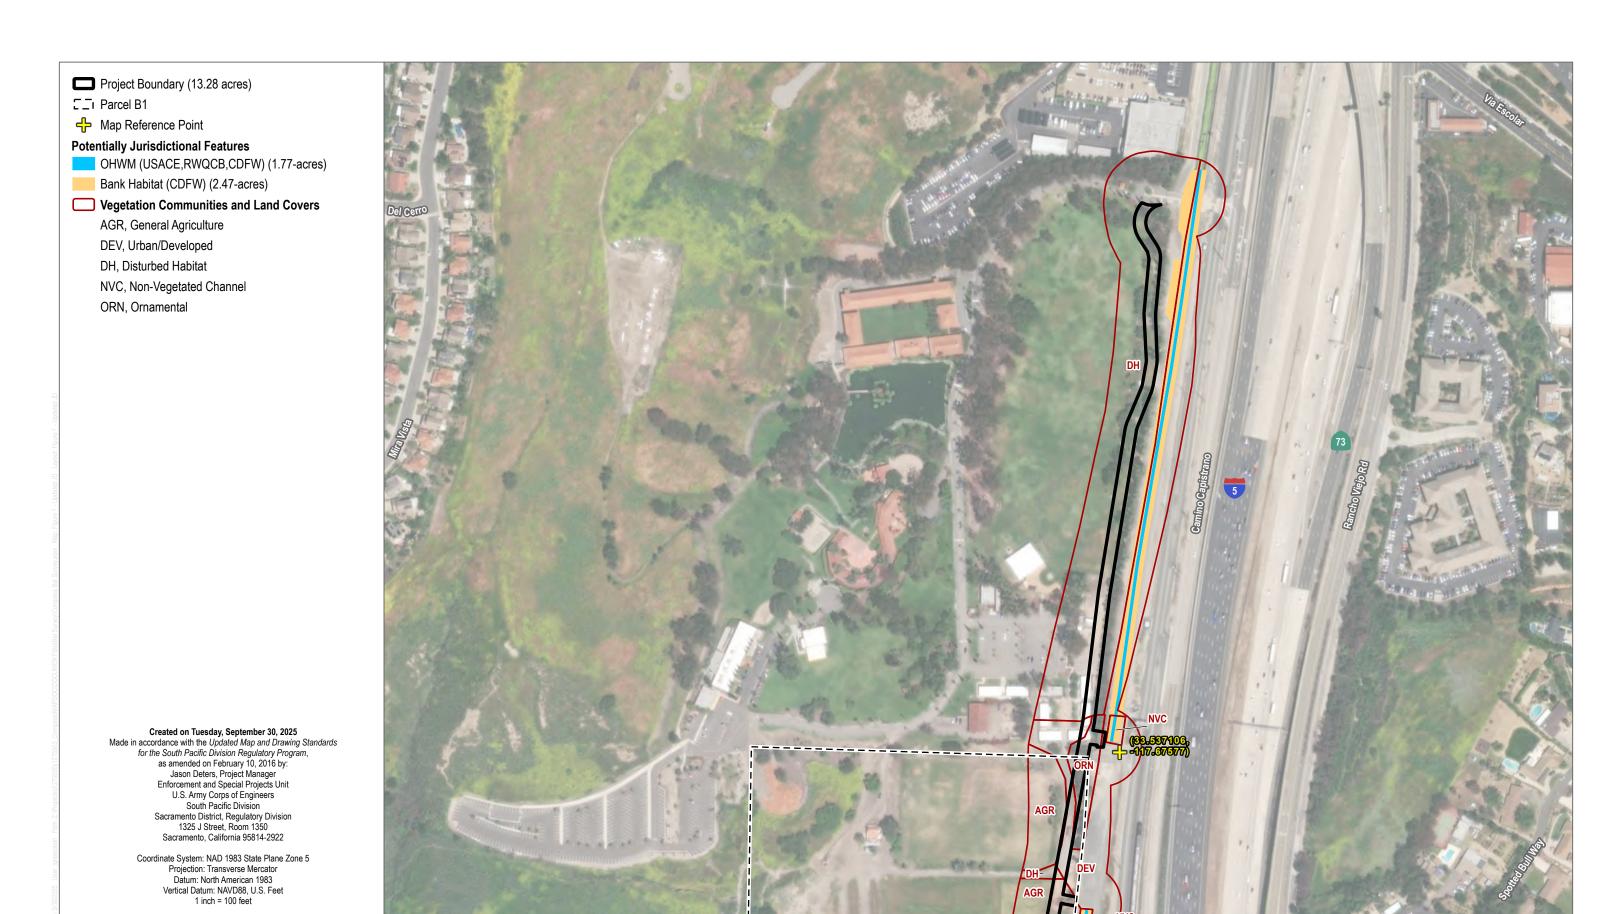
FIGURE 1A **Updated Jurisdictional Delineation**

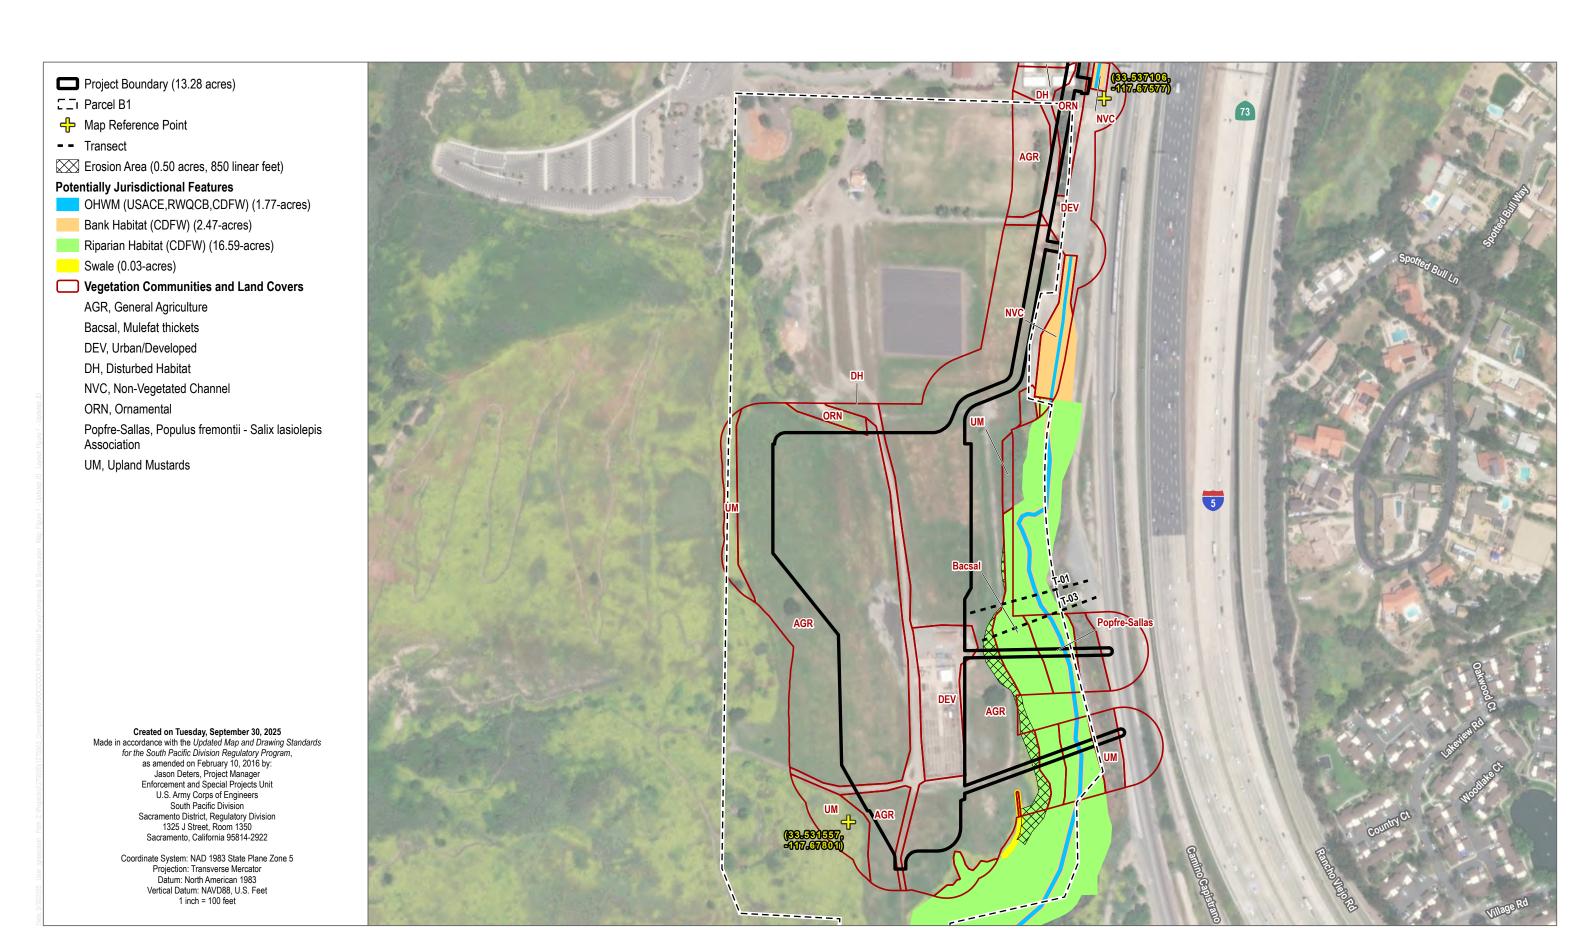
FIGURE 1B **Updated Jurisdictional Delineation**

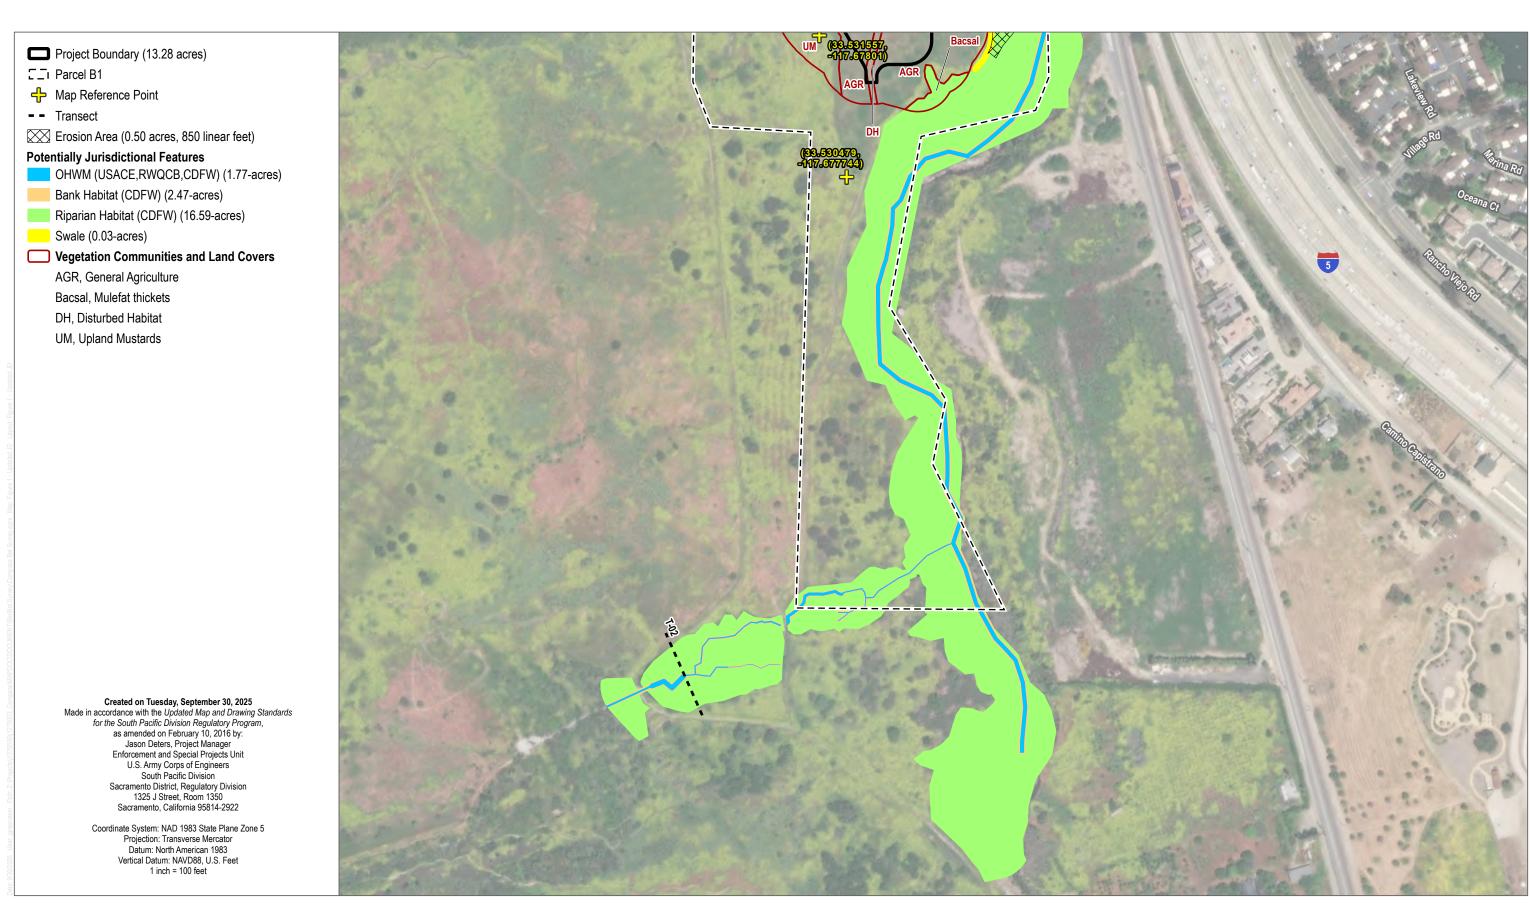
FIGURE 1C Updated Jurisdictional Delineation

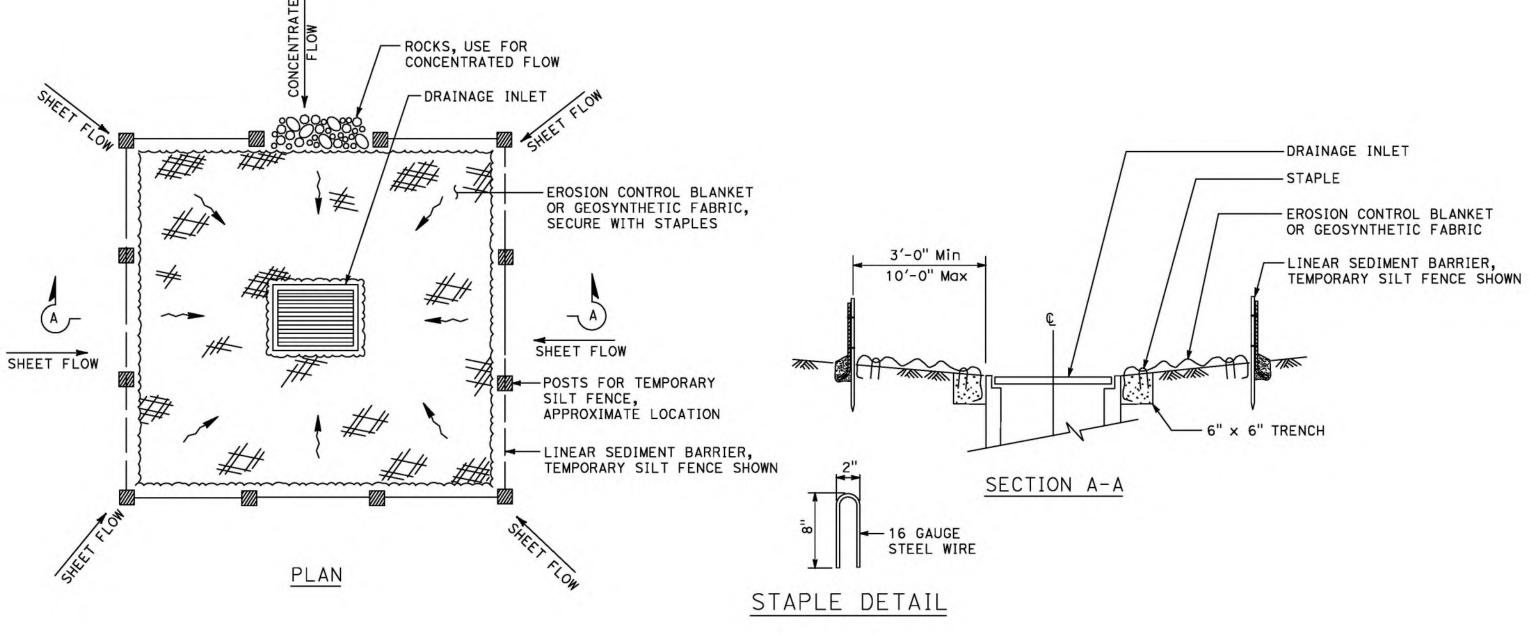
TEMPORARY DRAINAGE INLET PROTECTION, CALTRANS T61 (5)

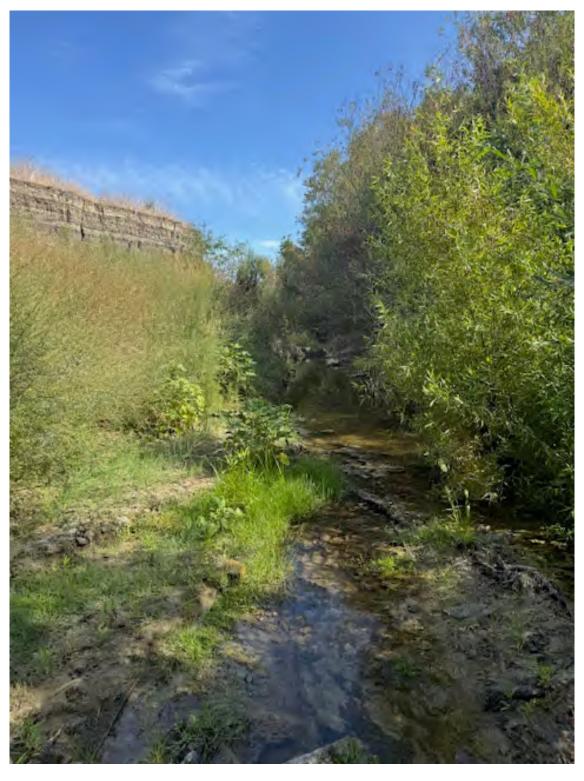
Figure 7 | Oso Creek Existing Condition

With time, these surface cracks are expected to deepen, eventually causing more bank failure. The channel at this location and continuing downstream is no longer protected by rock and is unstable and lacks proper bank vegetation in some areas. It is therefore susceptible to the high velocities that cause bank failure and horizontal migration as it continues downstream.

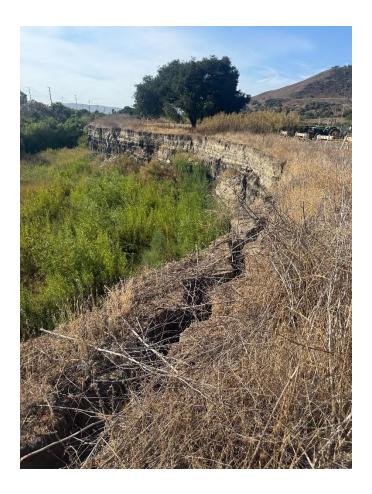
Figure 8 | Surface Cracks Along Channel Banks

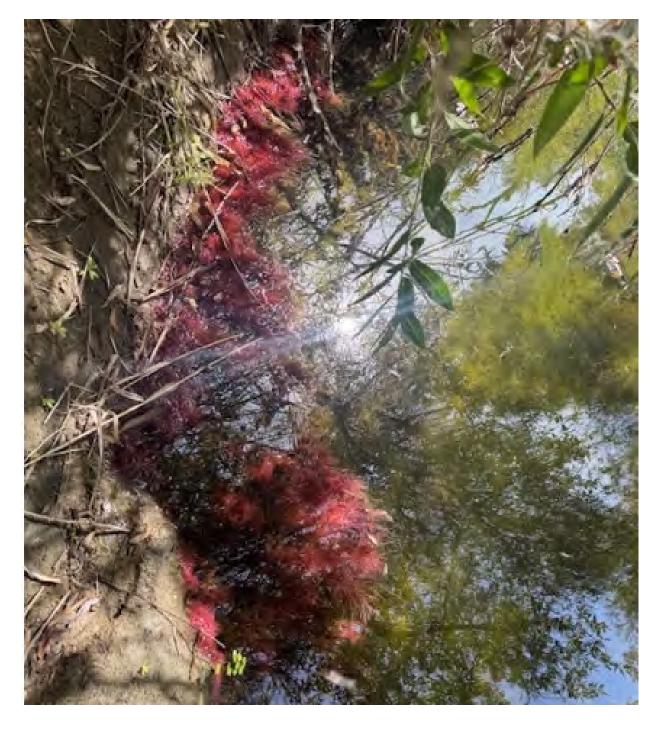
Figure 9 | Willow Roots Inside Channel

Plants such as Giant Reed (arundo donax) and willows were observed along the channel. Their shallow and compact roots force the water away towards the west bank, stabilizing the soil beneath them but also diverting flows to the opposite channel bank (see **Figure 9**). Riprap has been placed along the east side of the corridor along the railroad just south of the culvert outfall. This rip rap has somewhat stabilized the eastern slope of the channel along the railroad, leaving the western bank more vulnerable to ongoing collapse.

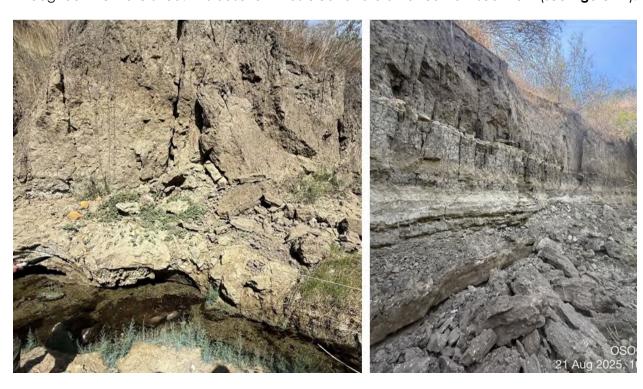
Figure 11 | Undercutting and Bank Collapse of Clay Soils

The team observed clay soils along the channel bottom and along the lower banks throughout the visited channel reach. These soils are highly erosive and experience erosion at the exposed toes of slope throughout the channel. As the toe erodes, the foundation of the slope is compromised, leading to bank collapse. Undercutting and collapse of the channel banks can be seen in **Figure 11**. This photo was taken toward the downstream end of the project reach and shows the lack of rock and deposited sediment in both the channel banks and bottom.

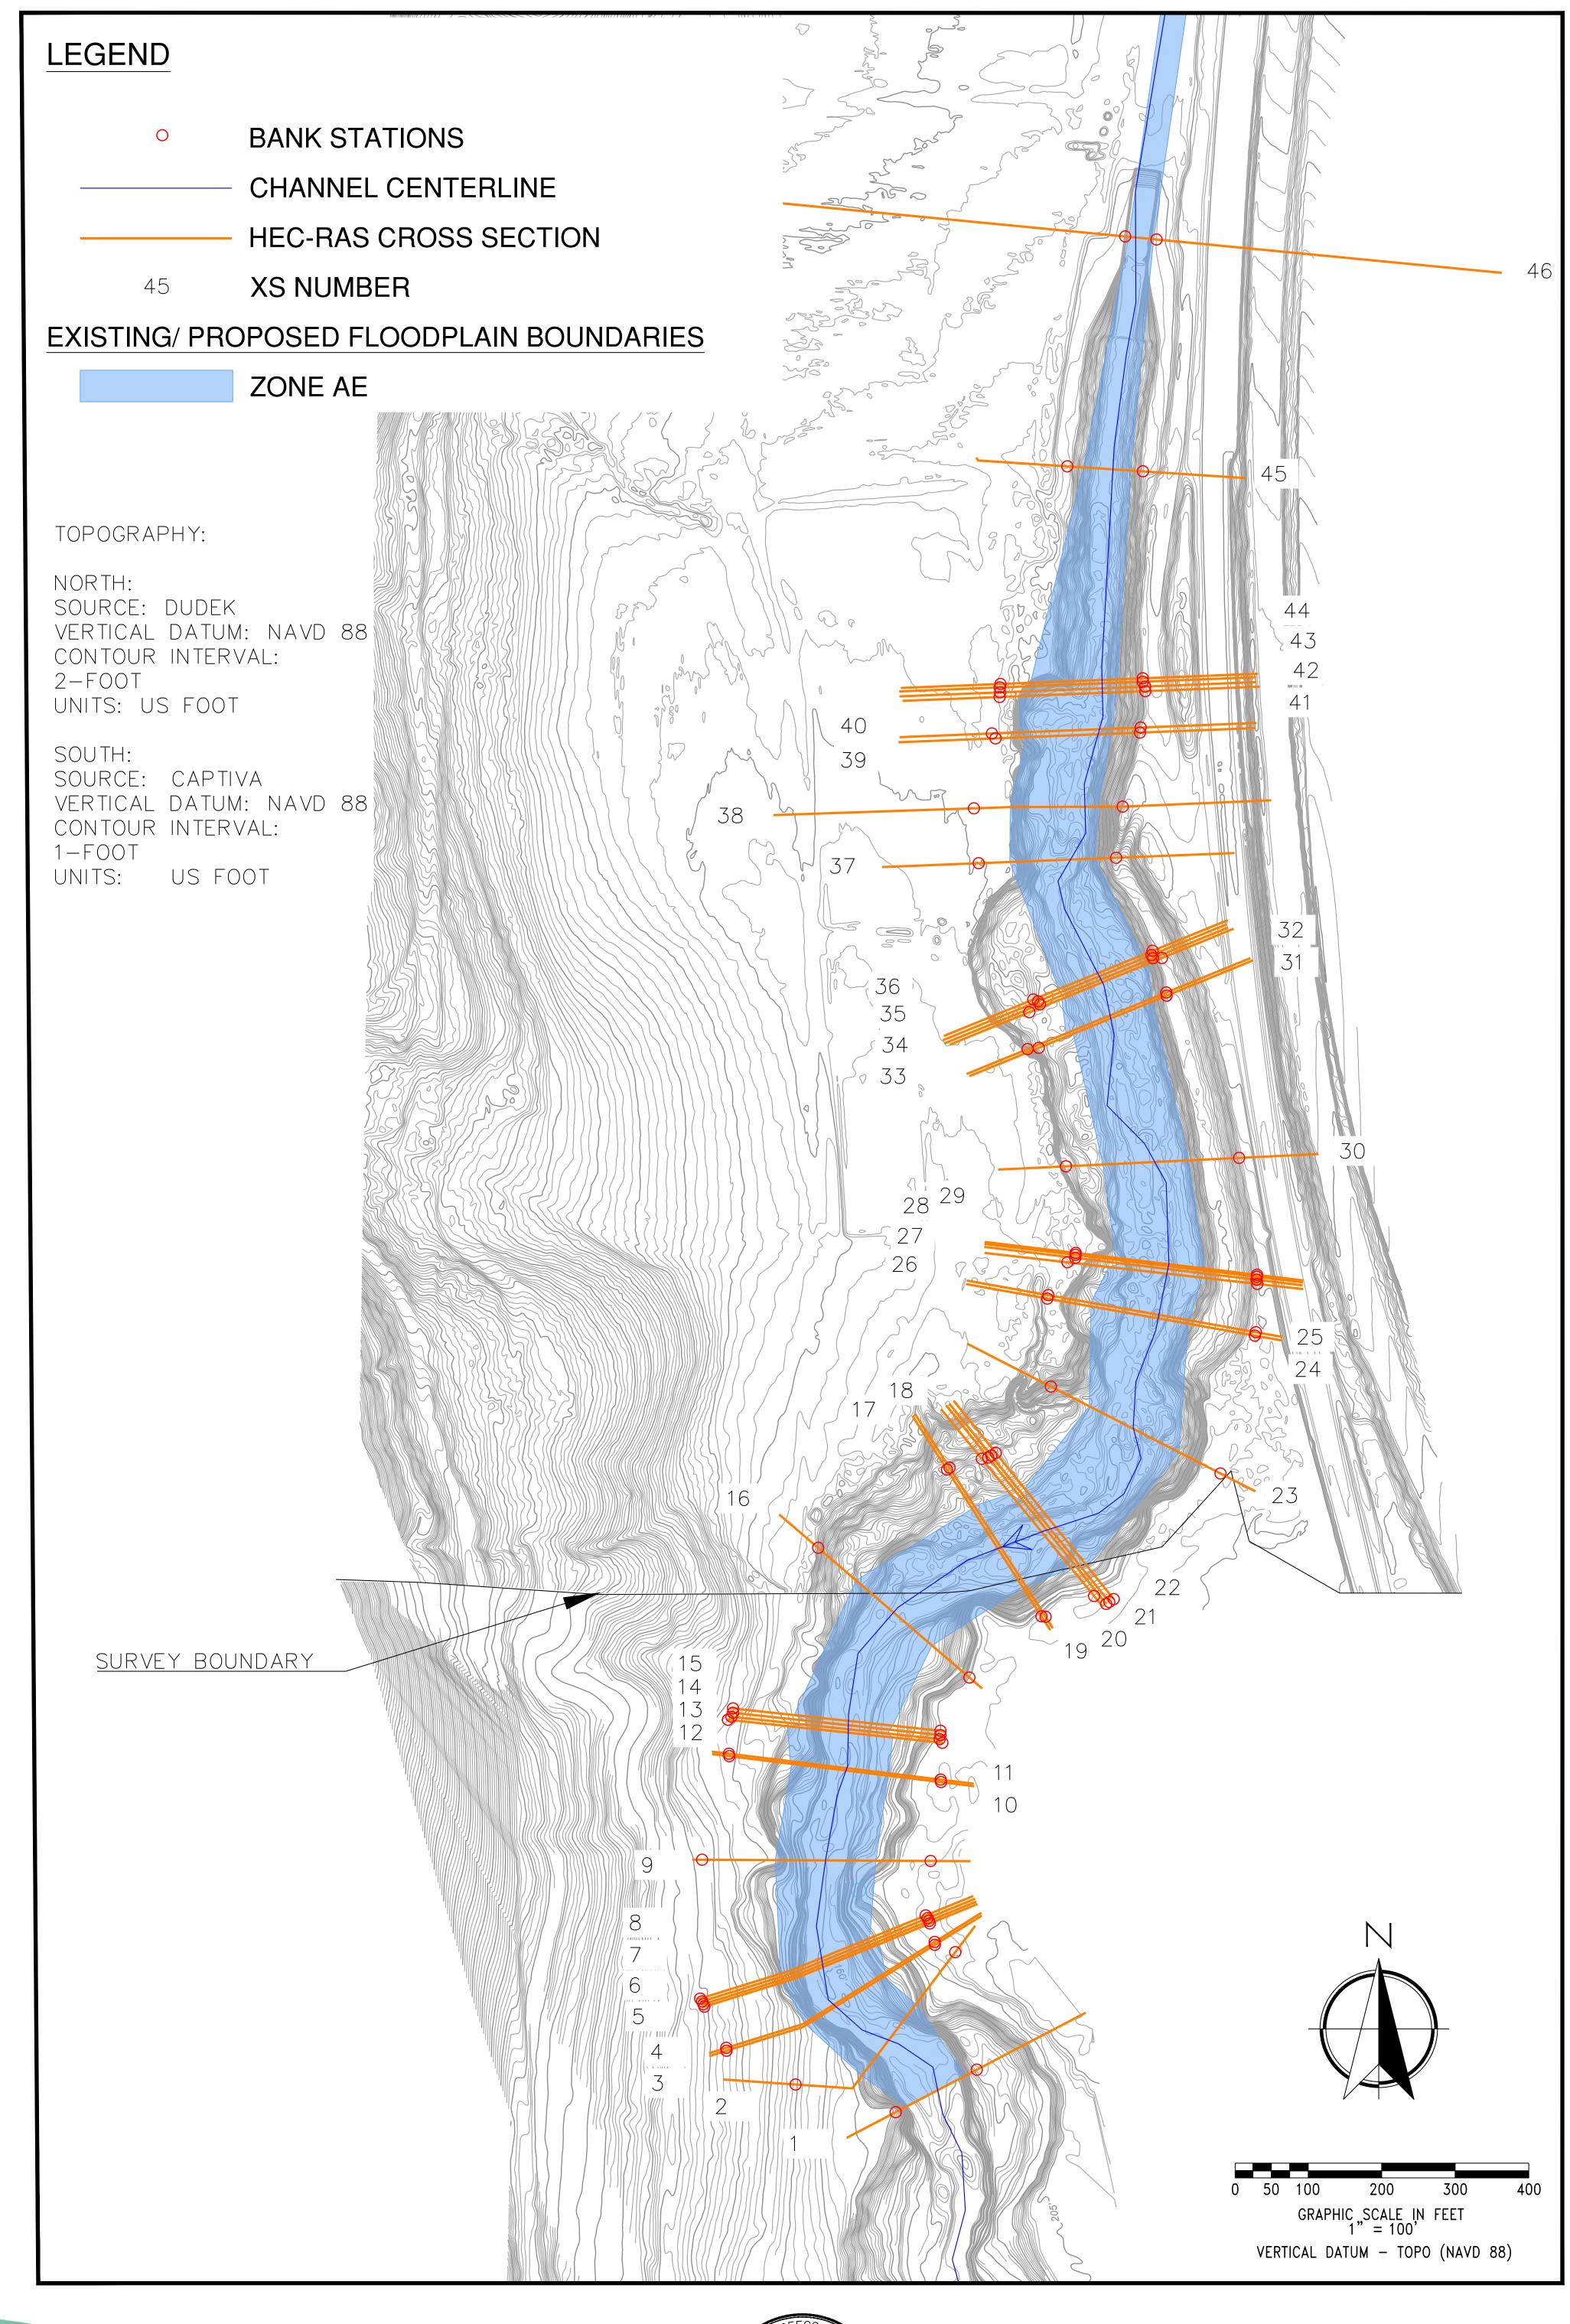
OSO CREEK HYDRAULIC WORK MAP SEPTEMBER 2025
