## **OCTA Comment Letter December 2025 Part One**

Subject: **Compass Energy Storage Project – San Juan Capistrano – Docket Number 24-OPT-02**

# SJC10 Rehabilitation Project Concepts

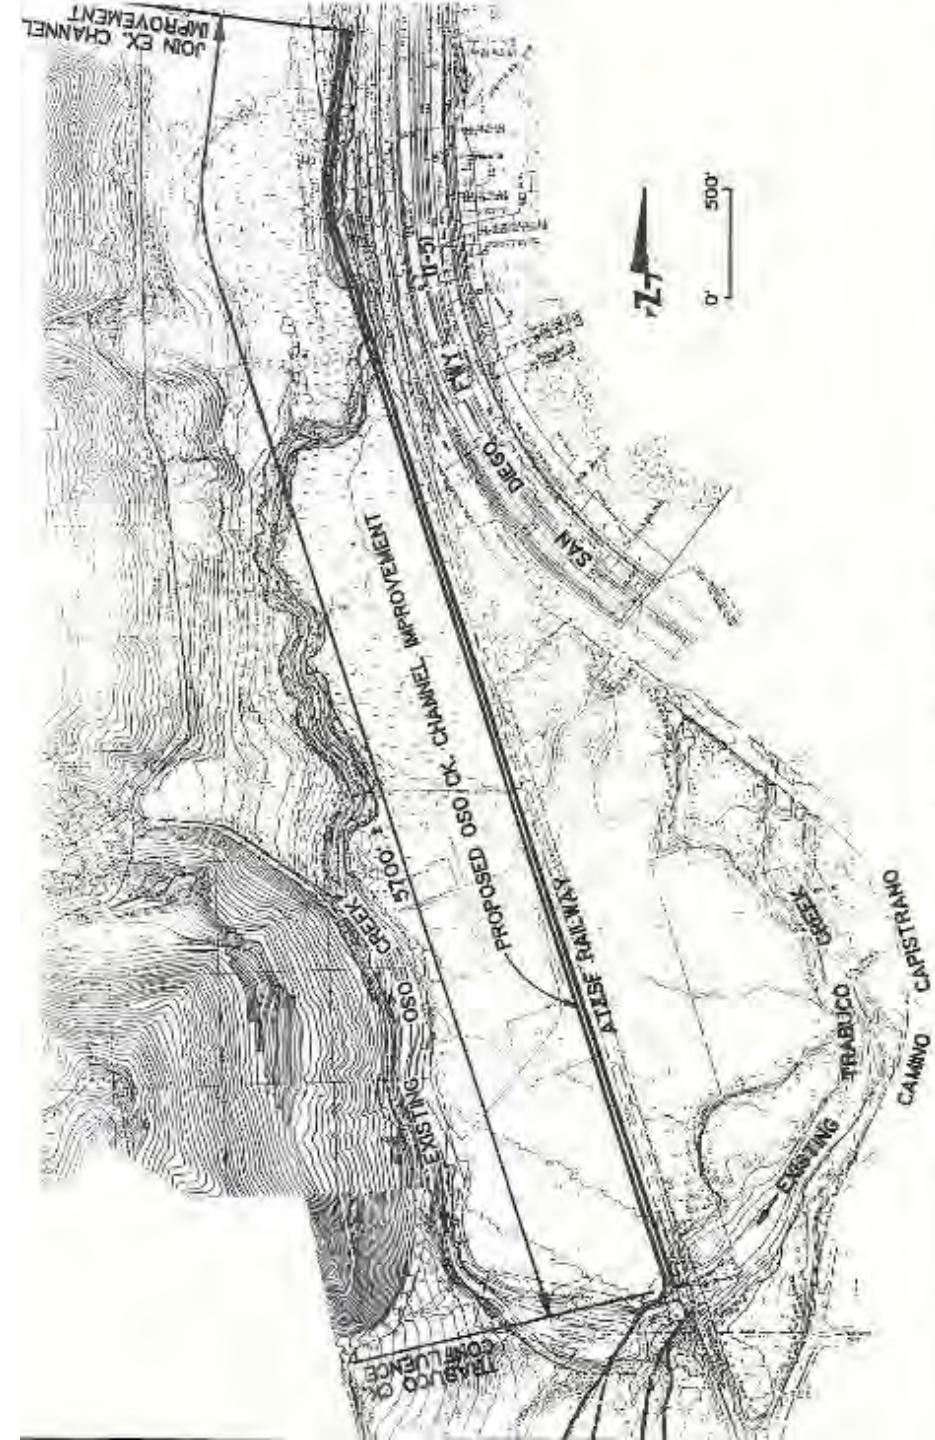
**Figure 12 Proposed Oso Creek Channel Alignment**

- “Erosion control measures shall be implemented immediately”
- Three alternatives for Oso Creek
  - Alt A – 34' W x 10' H reinforced concrete (R.C.) channel
  - Alt B – 18' W x 16'H R.C. channel
  - Alt C - 18' W x 16'H R.C. box culvert

<u>Alt. A:</u> 34'W x 10'H R.C. Channel:	\$4.67 million + 10.9 Acres of R/W (approximately \$820/LF)
<u>Alt. B:</u> 18'W x 16'H R.C. Channel:	\$4.86 million + 10.6 Acres of R/W (approximately \$850/LF)
<u>Alt. C:</u> 18'W x 16'H R.C. Box Culvert:	\$8.46 million + 10.5 Acres of R/W (approximately \$1,480/LF)

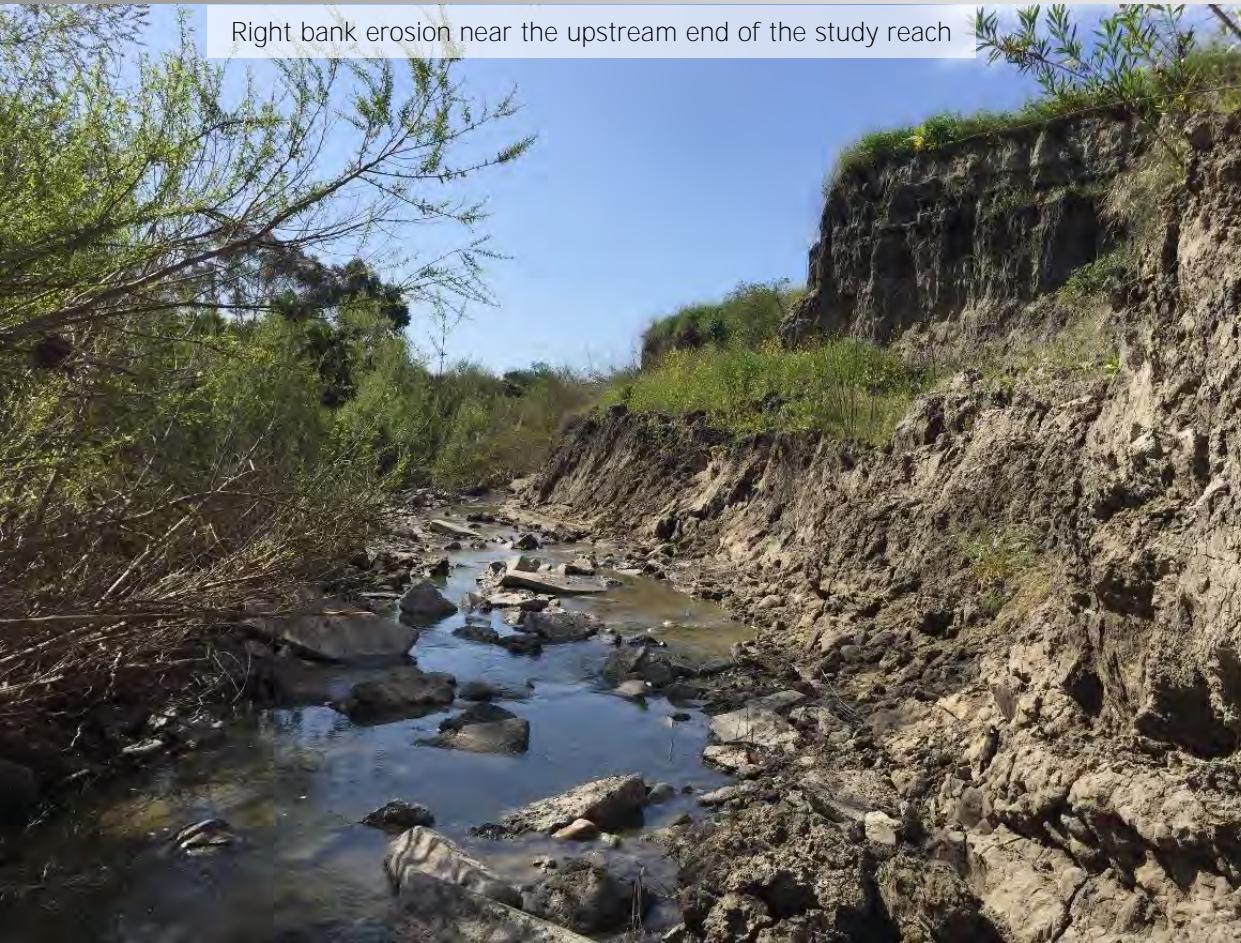
Right bank erosion near the upstream end of the study reach

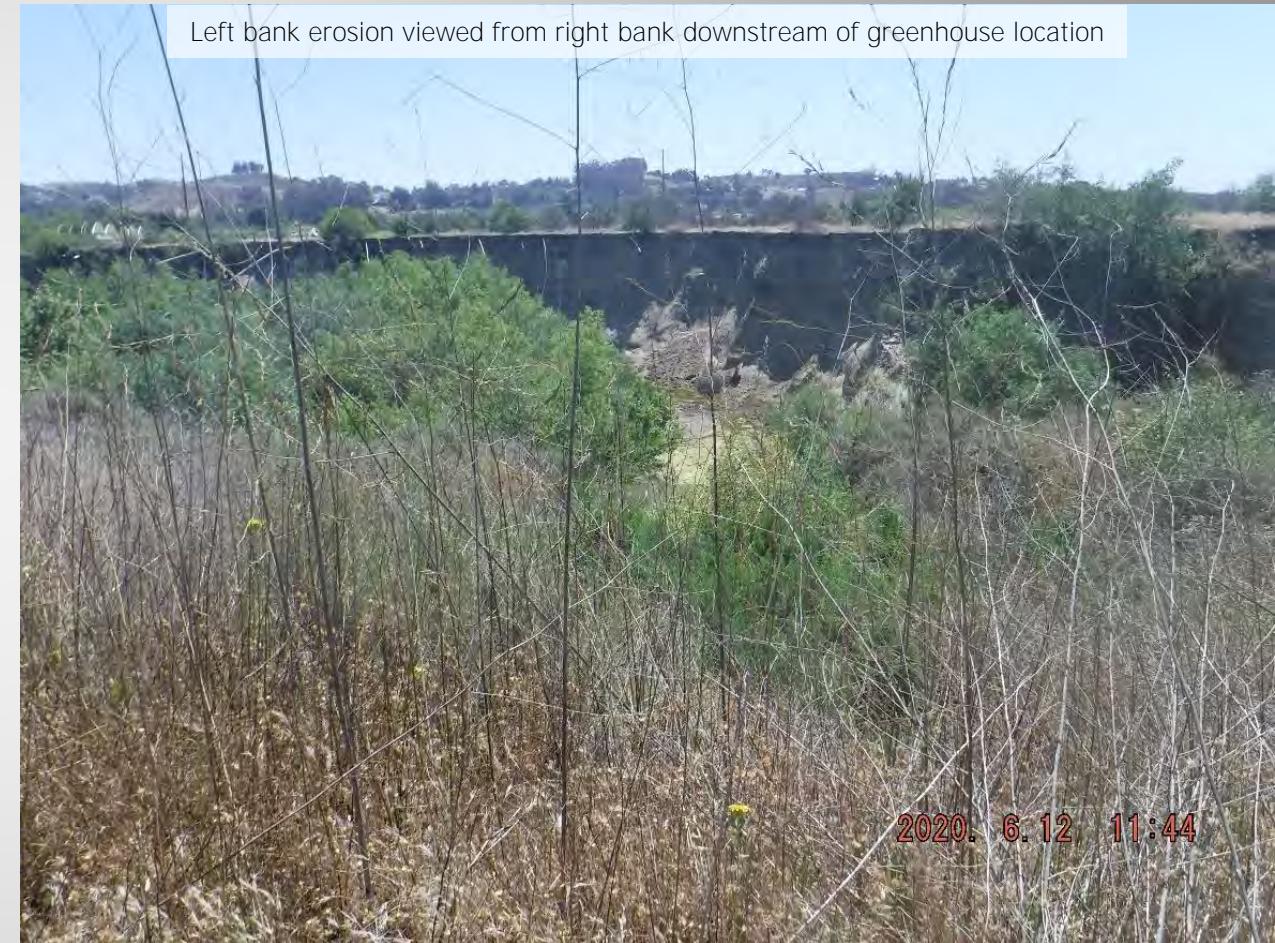
Left bank erosion viewed from right bank downstream of greenhouse location

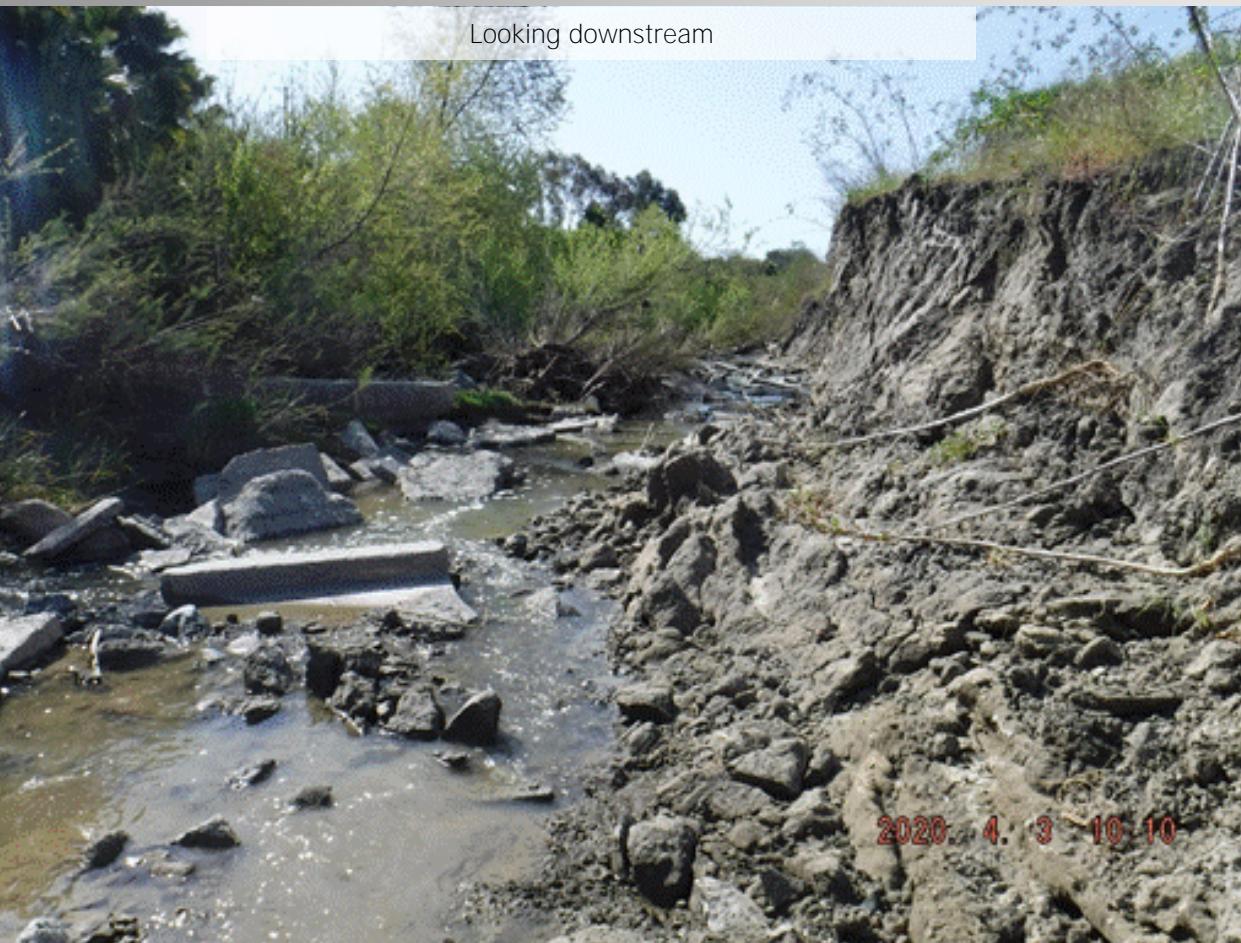
Looking downstream

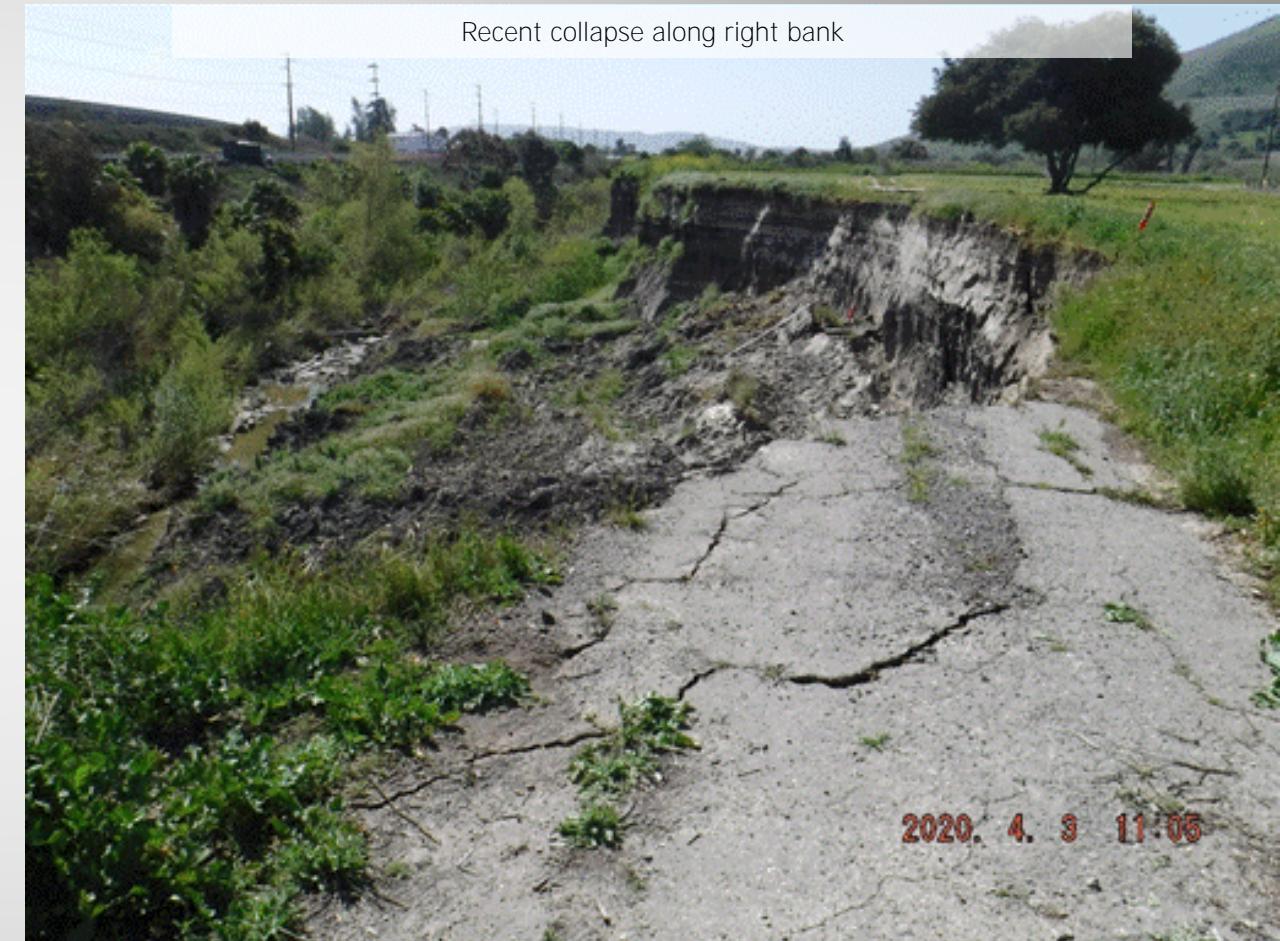
Recent collapse along right bank

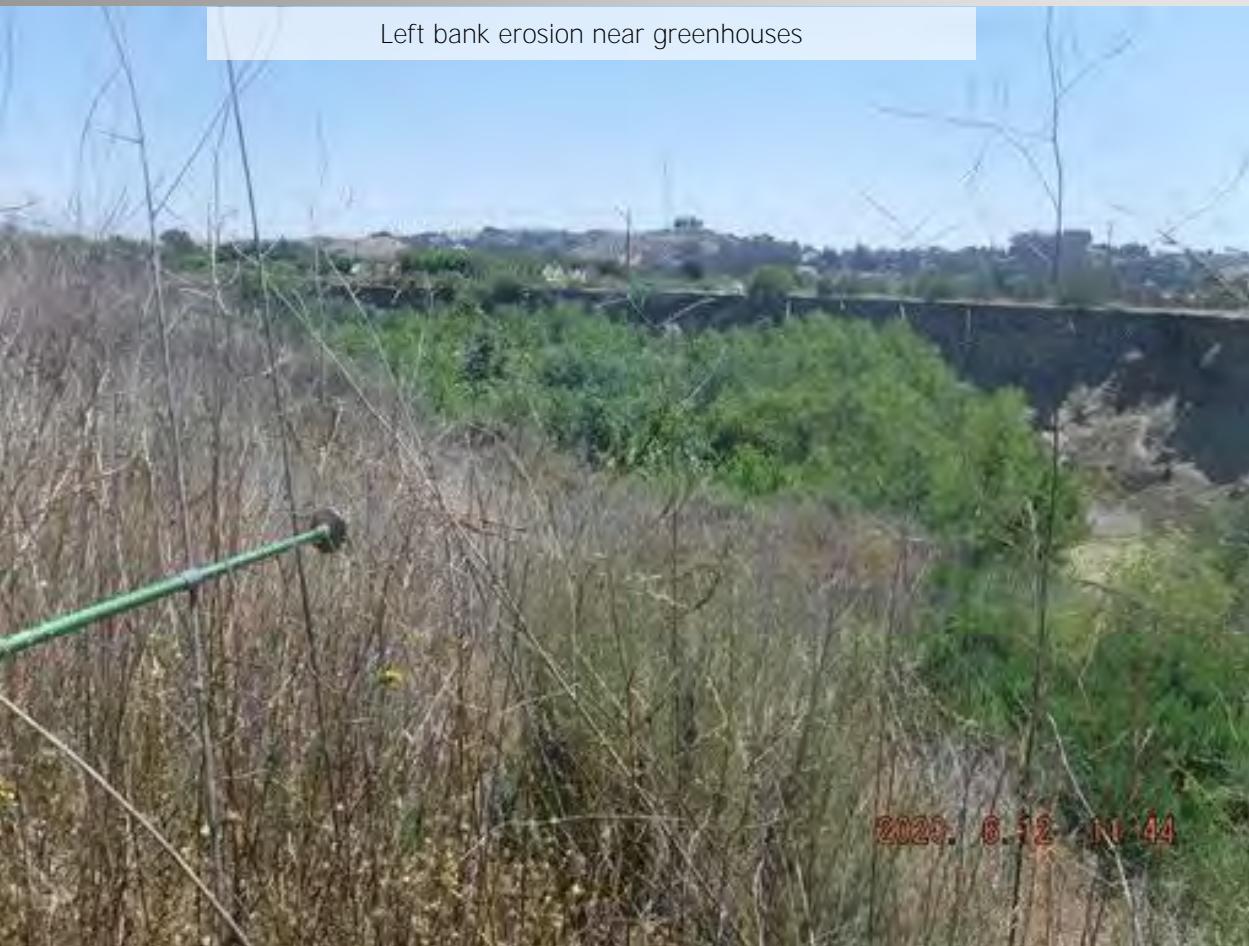
Left bank erosion near greenhouses

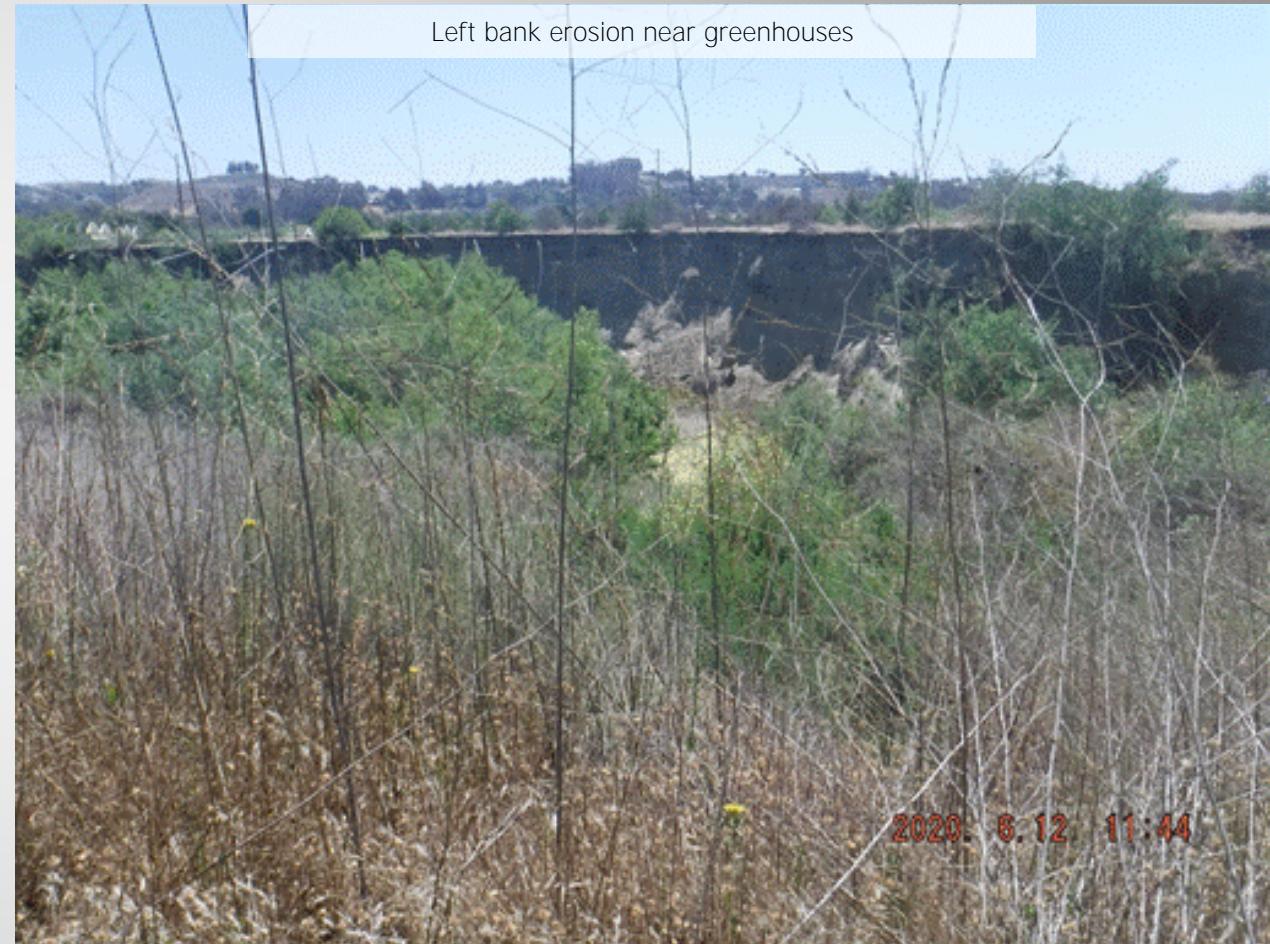
Left bank erosion near greenhouses

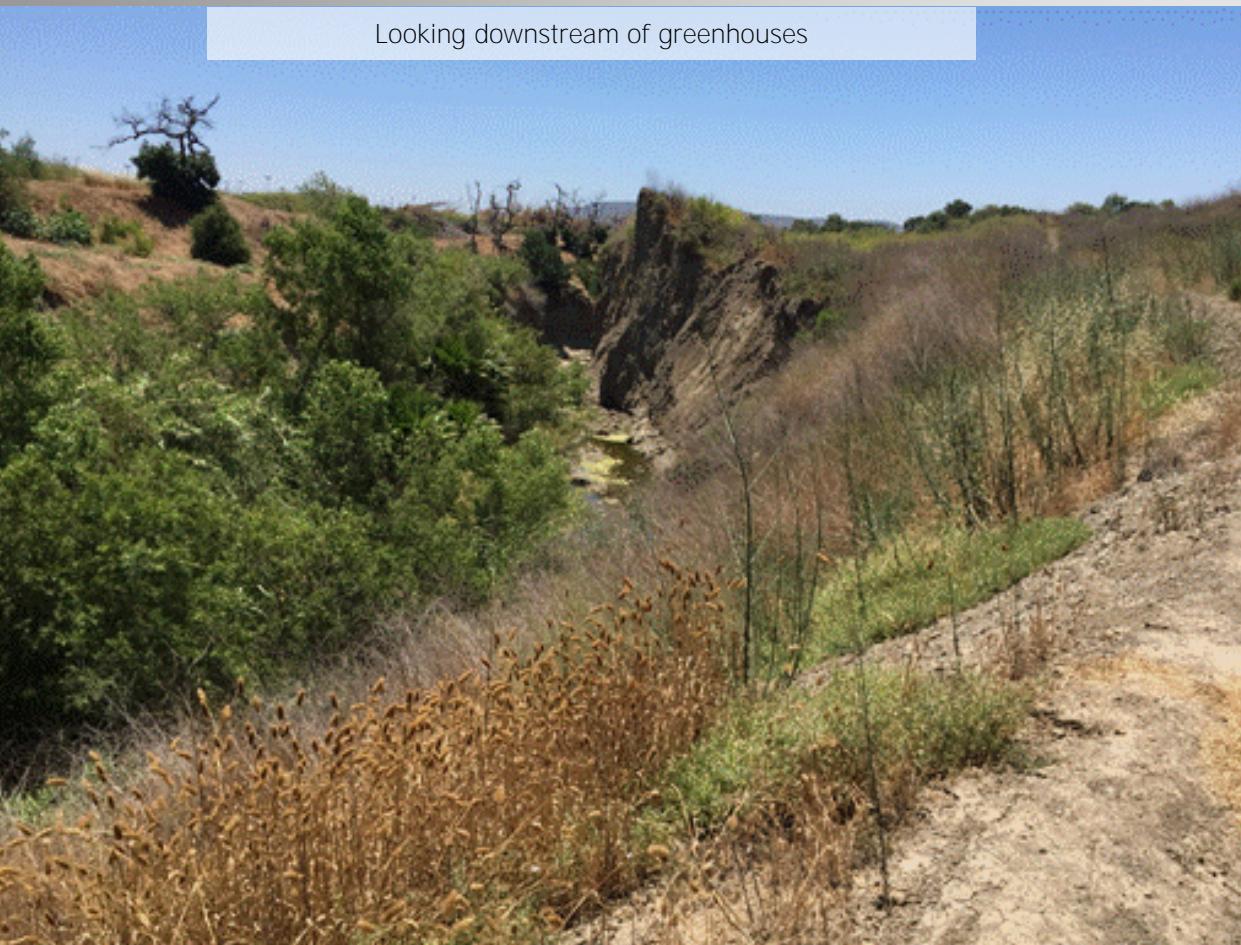
Looking downstream of greenhouses

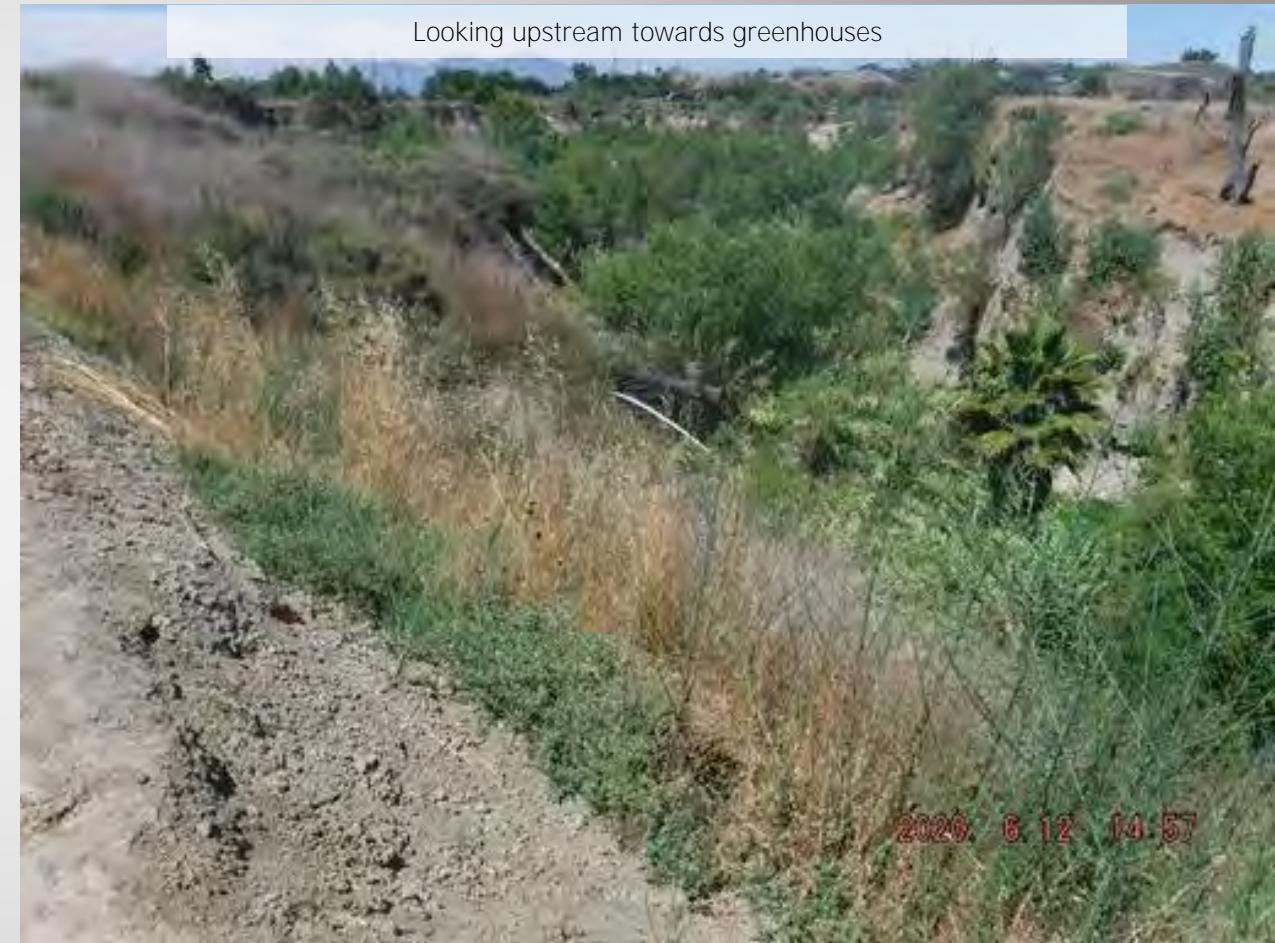
Looking upstream towards greenhouses

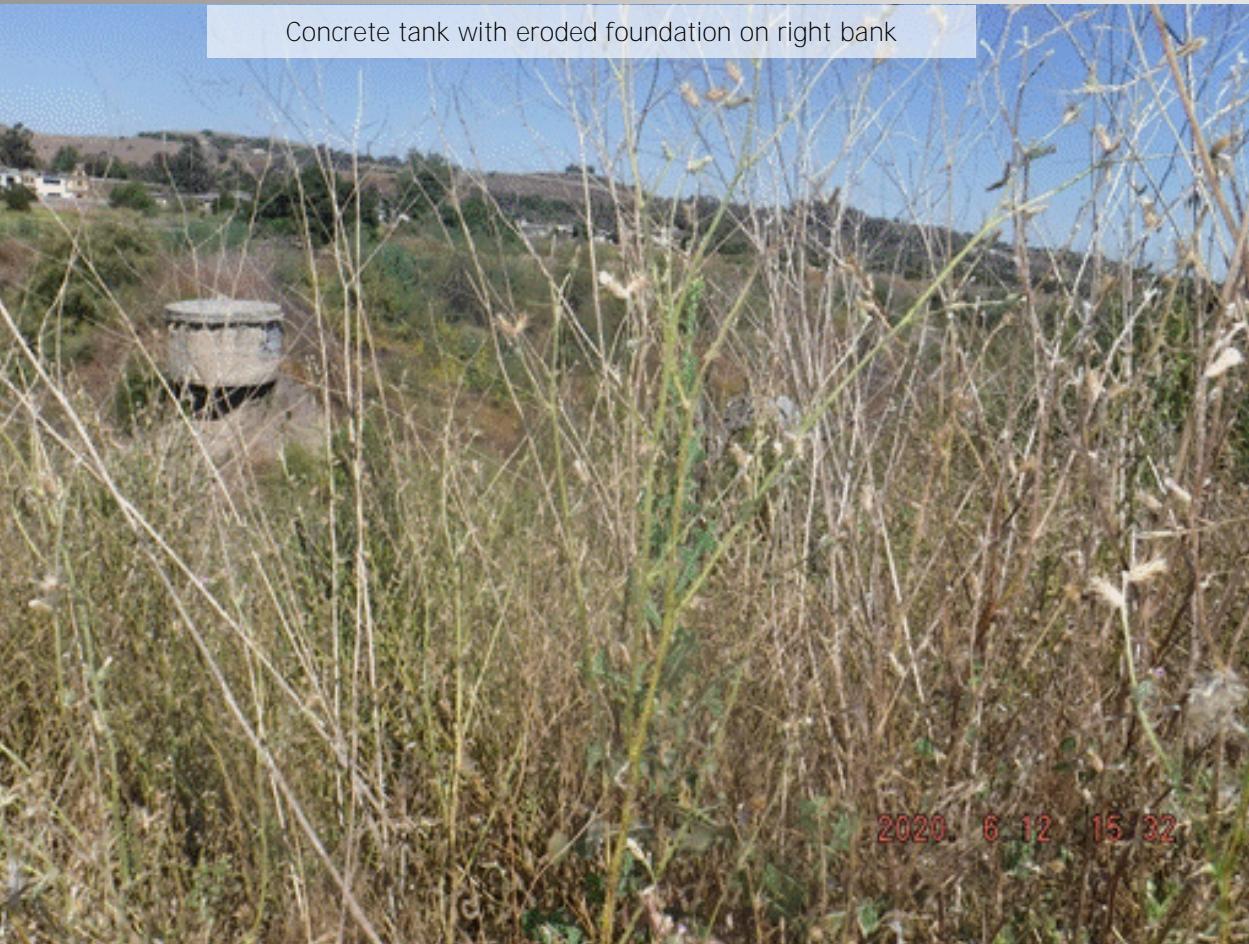
Concrete tank with eroded foundation on right bank

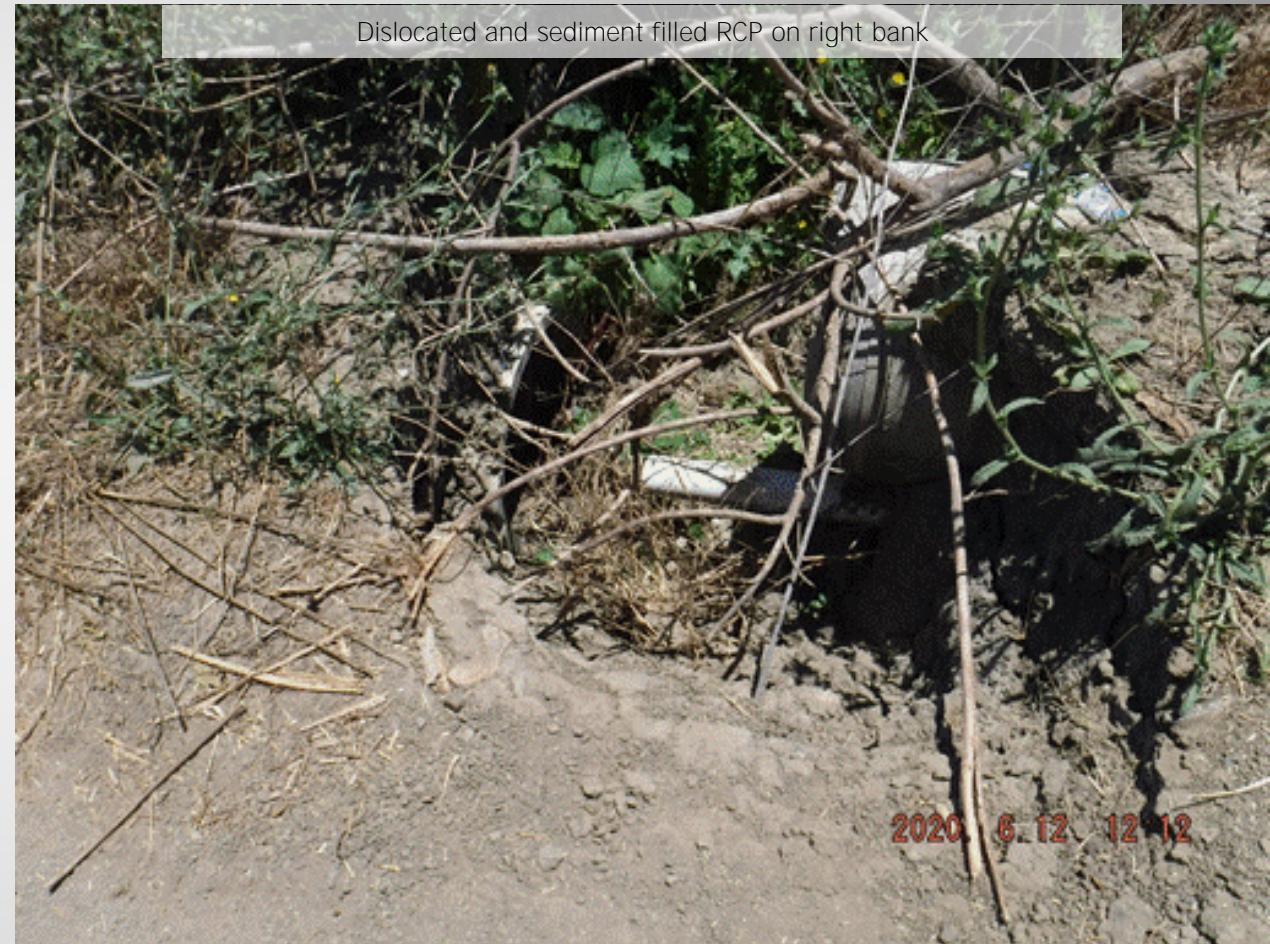
Dislocated and sediment filled RCP on right bank

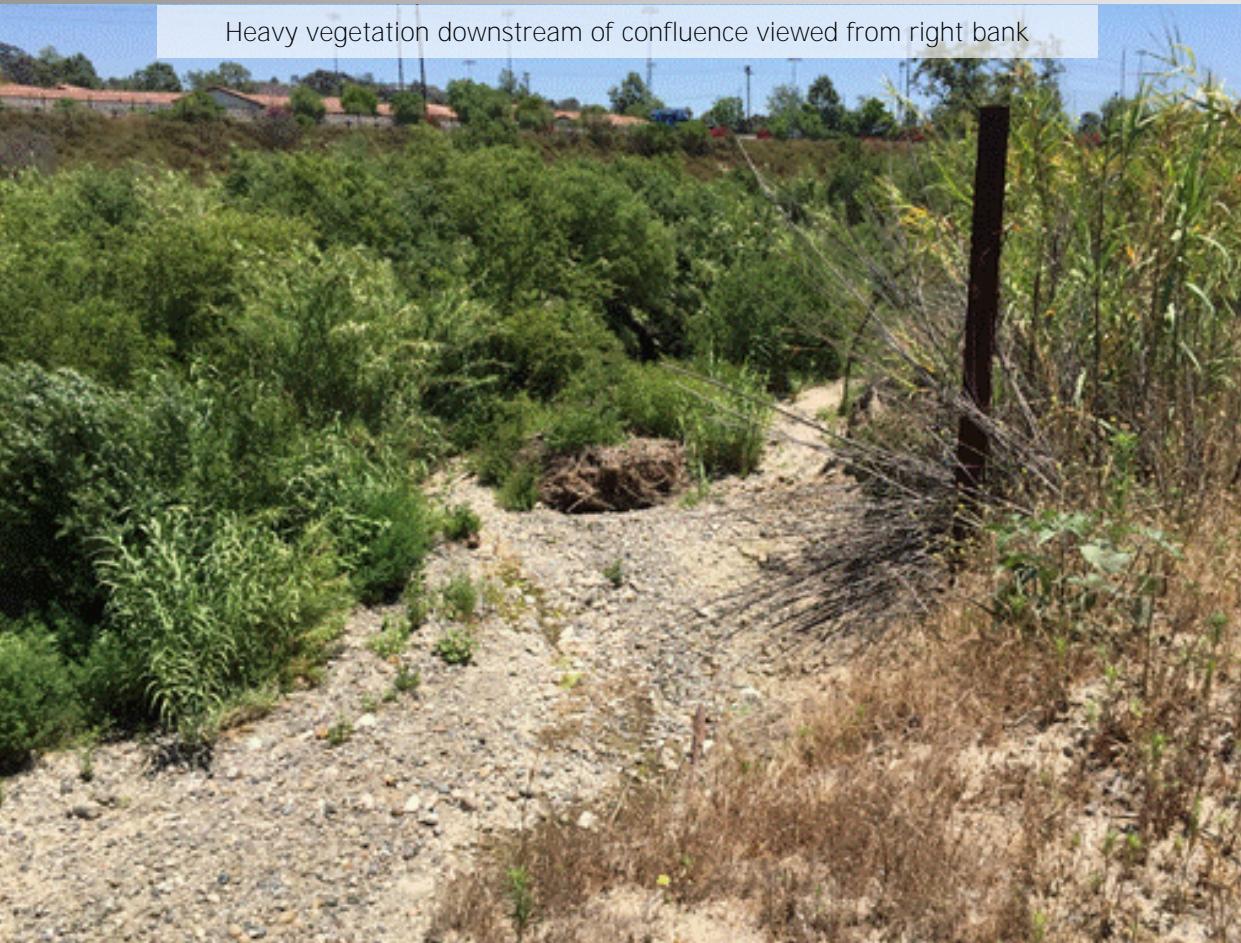
Heavy vegetation downstream of confluence viewed from right bank

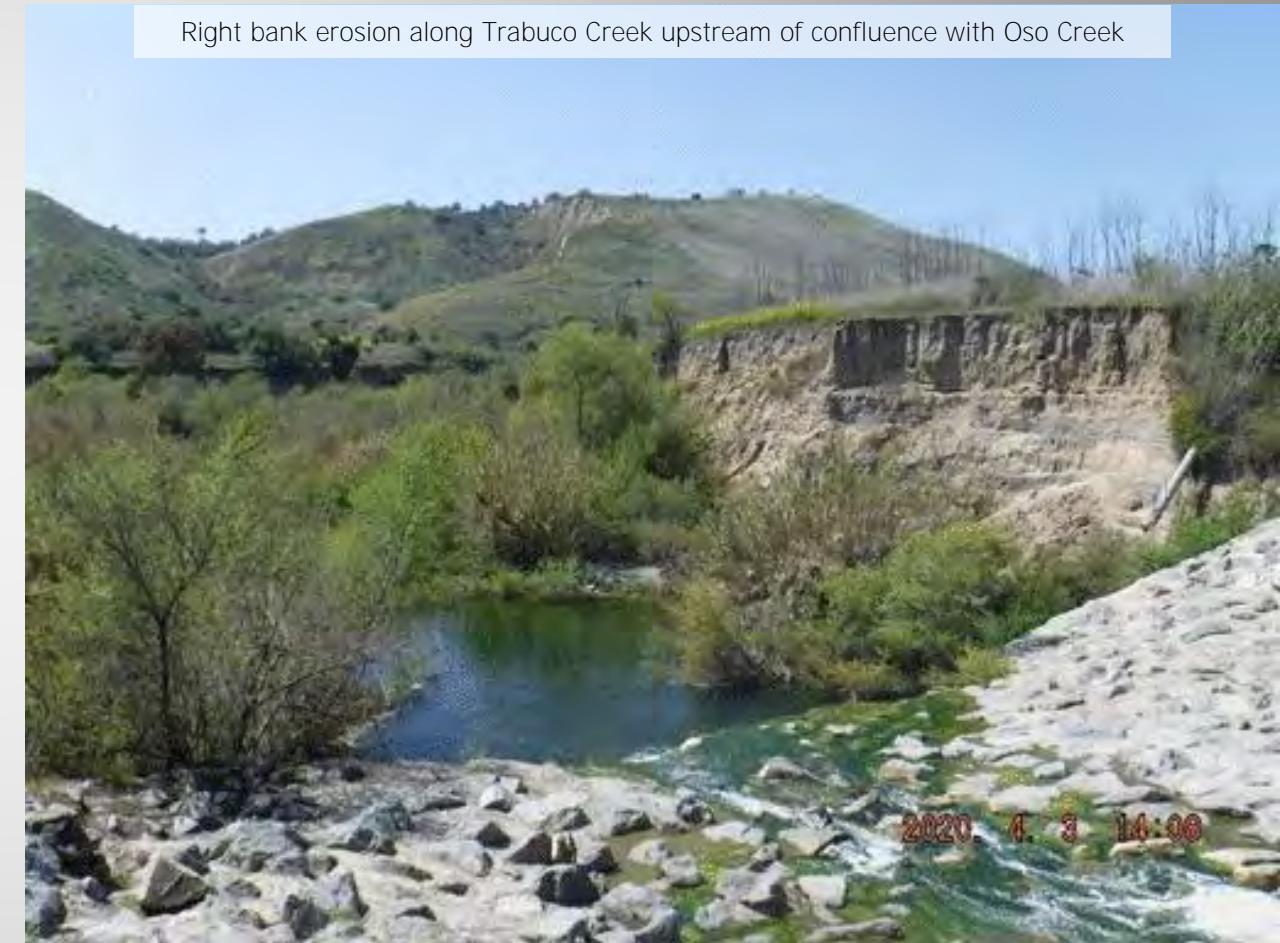
Right bank erosion along Trabuco Creek upstream of confluence with Oso Creek

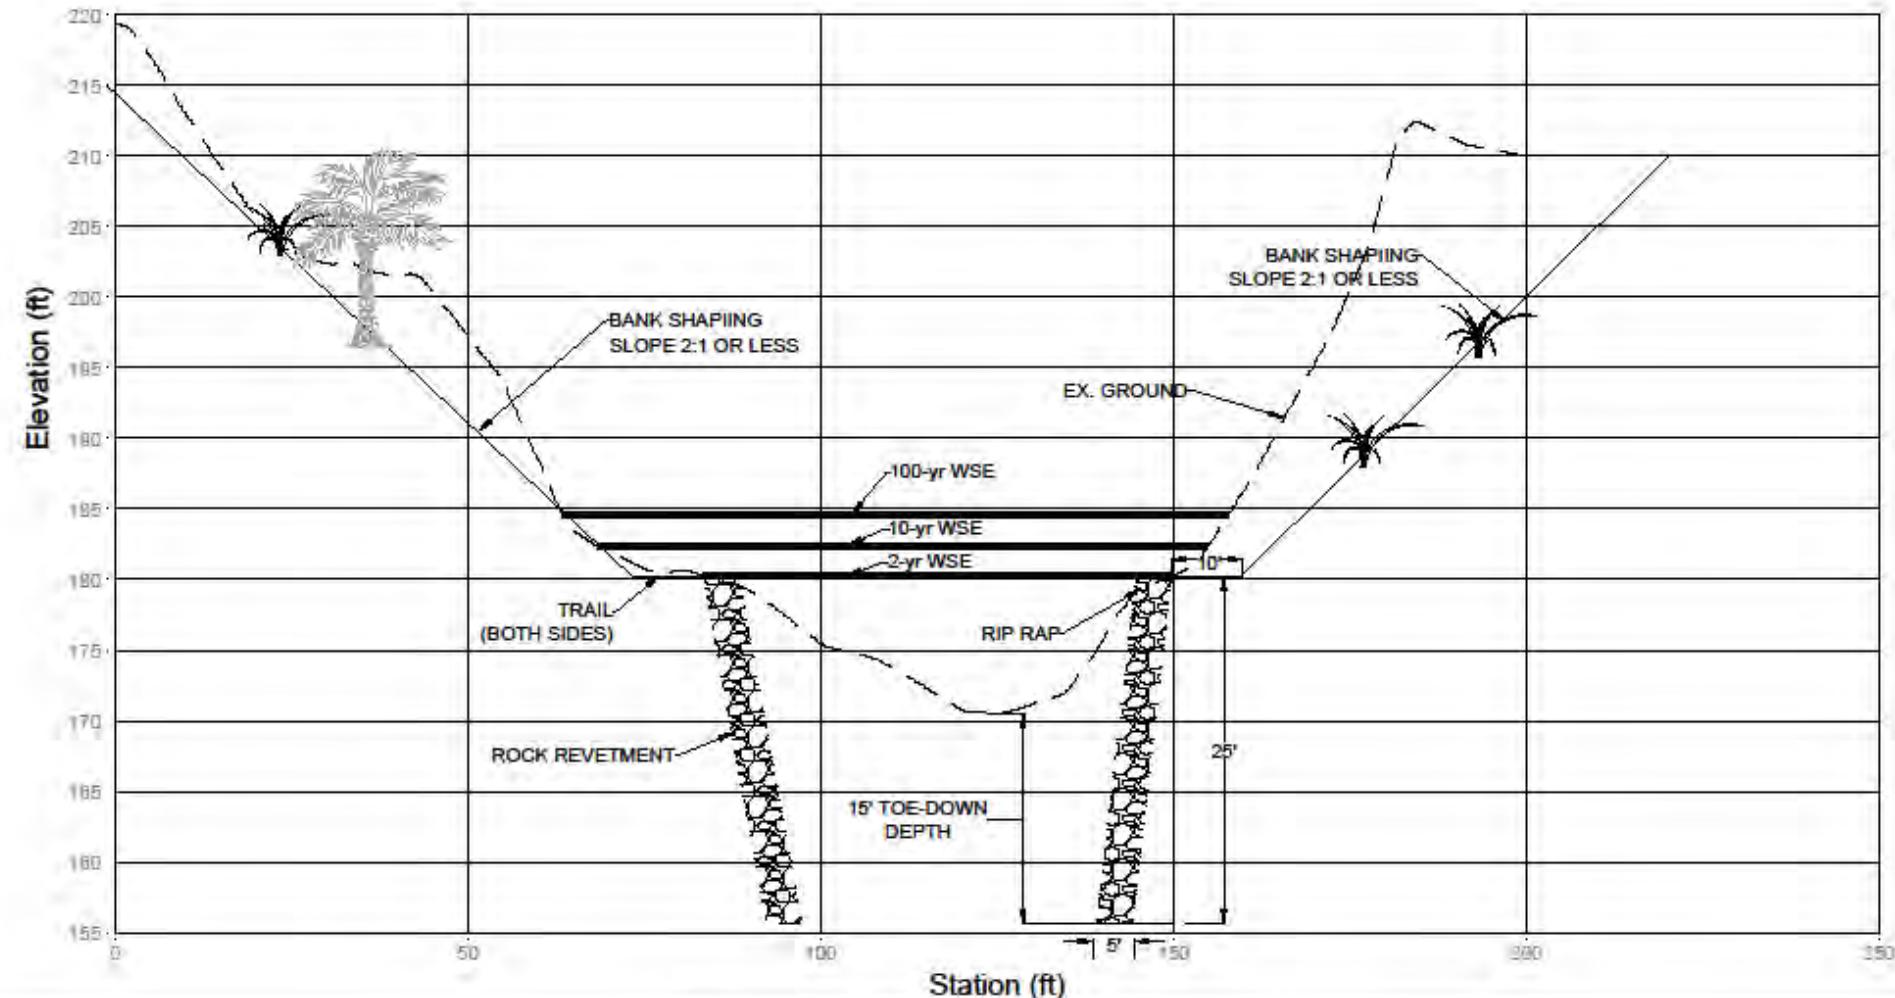
River Station 8200

# Concept #1: Rip Rap Revetment
