DOCKETED	
Docket Number:	26-OPT-01
Project Title:	Vaca Dixon Power Center Project
TN #:	268172-3
Document Title:	Appendix Y Biological Resources Technical Study_VDPC_Part 3 of 3
Description:	<p>Includes a Biological Resources Technical Study which analyzes the potential impacts of the Project and evaluates short and long term impacts of the Project to biological resources.</p> <p>Y.A Regulatory Framework; Y.B Species Compendia; Y.C Representative Site Photographs; Y.D Burrowing Owl Survey Report; Y.E Dry Season Large Branchiopod Protocol Sampling Results (2024); Y.F Wet Season Large Branchiopod Protocol Sampling Results; Y.G Large Branchiopod Habitat Assessment Report; Y.H Dry Season Large Branchiopod Protocol Sampling Results (2025); Y.I Crotch's Bumble Bee Survey Report; Y.J Aquatic Resources Delineation Report; Y.K Special-Status Species Evaluation Table; Y.L California Natural Diversity Database (CNDDB) Figure (scale1:6,000) (Confidential - submitted separately); Y.M United States Fish and Wildlife Service Meeting Minutes</p>

Biological Resources Technical Study

Aquatic Resources Delineation Report

Vaca Dixon Power Center Project

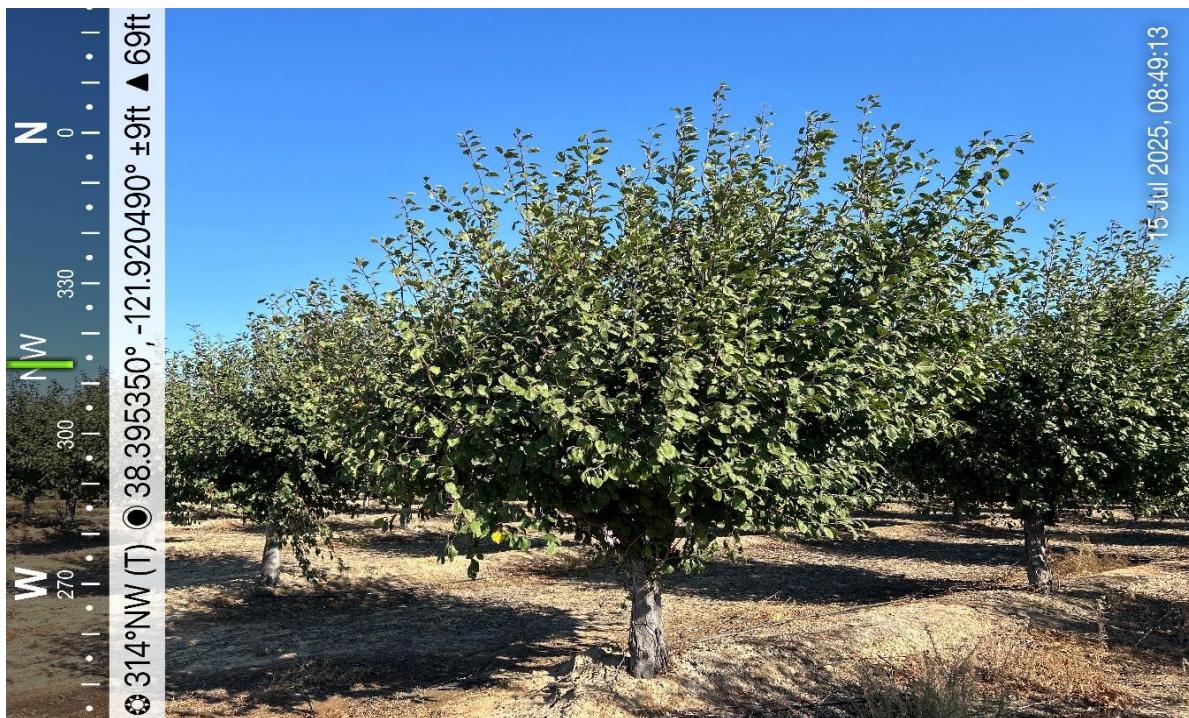
Photograph 1. Depiction of the Orchard, which encompasses the majority of the Project Area (aspect: northwest, July 15, 2025).

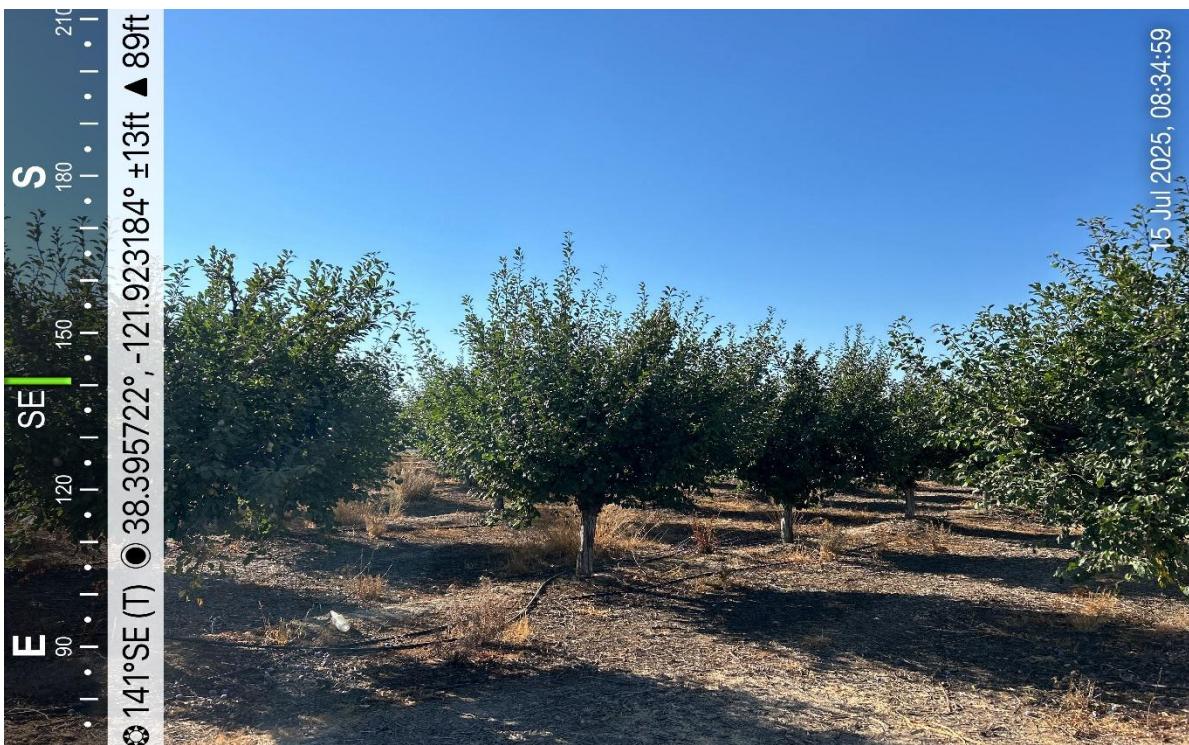
Photograph 2. Depiction of the Orchard, which encompasses the majority of the Project Area (aspect: southeast, July 15, 2025).

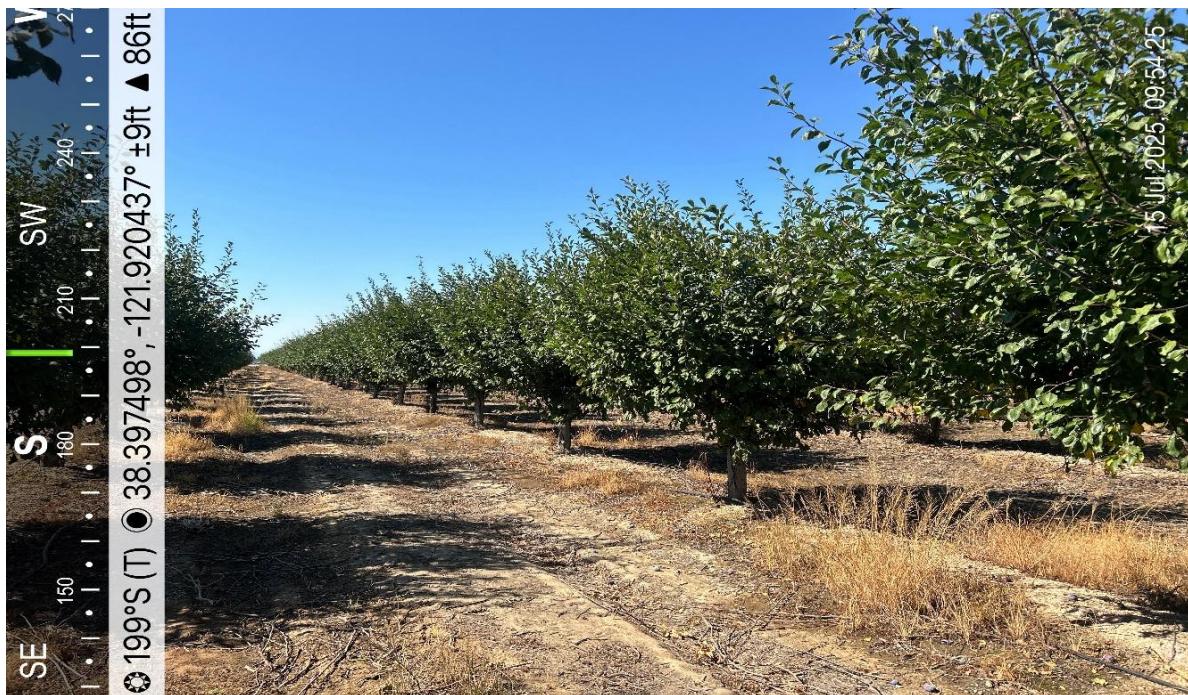
Photograph 3. Depiction of the Orchard, which encompasses the majority of the Project Area (aspect: south, July 15, 2025).

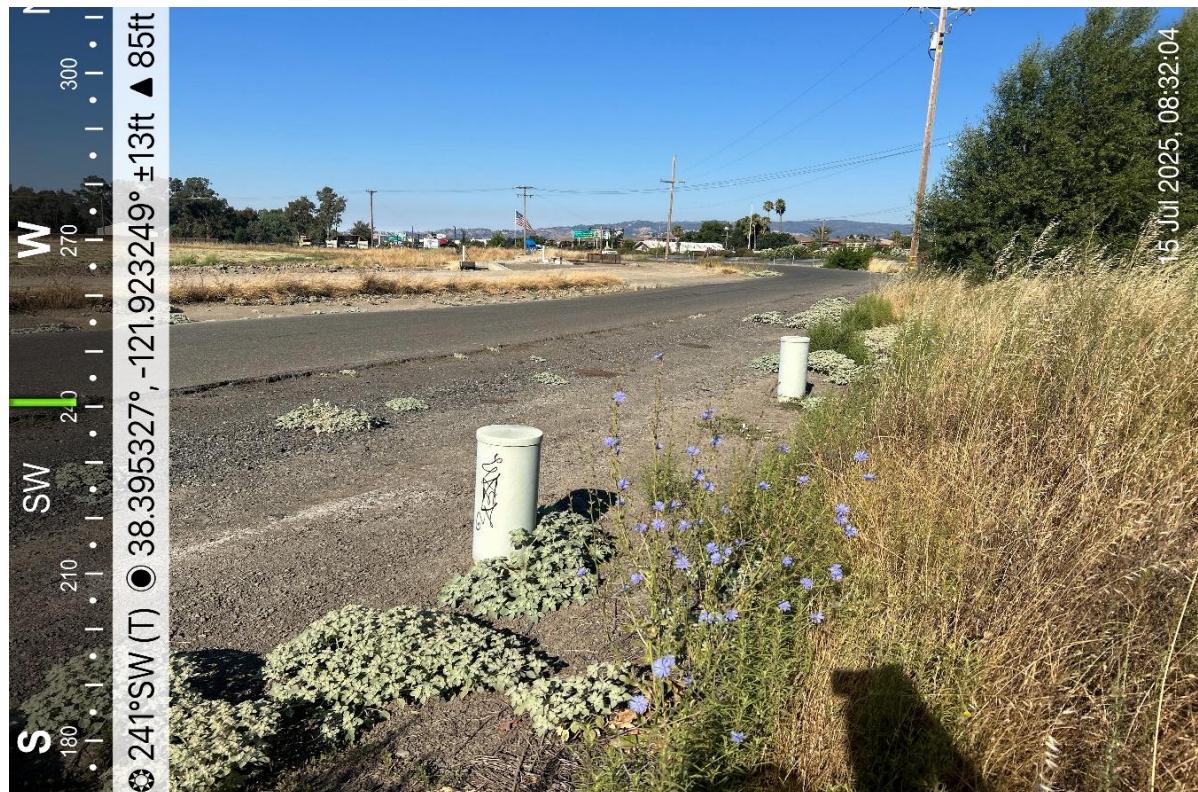
Photograph 4. Overview of the southwestern portion of the Project Area, depicting ruderal roadside vegetation (aspect: southwest, July 15, 2025).

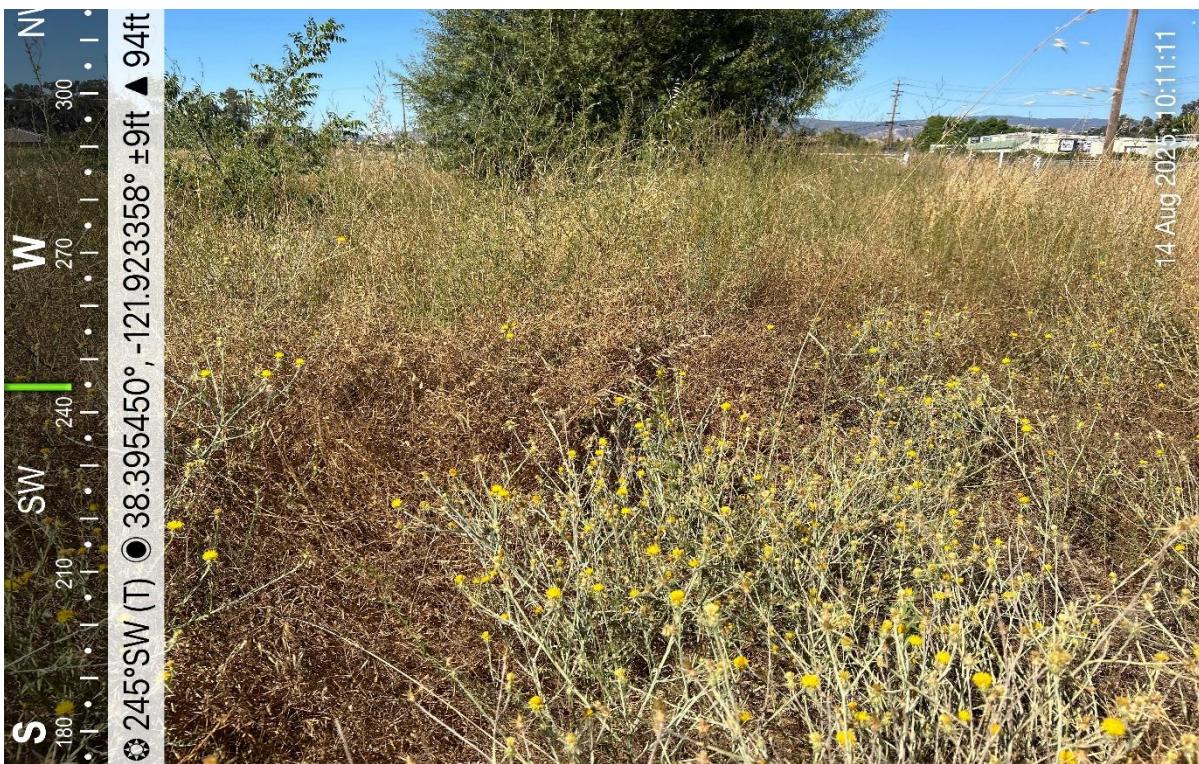
Photograph 5. Overview of the southwestern portion of the Project Area, depicting ruderal non-native vegetation (aspect: southwest, July 15, 2025).

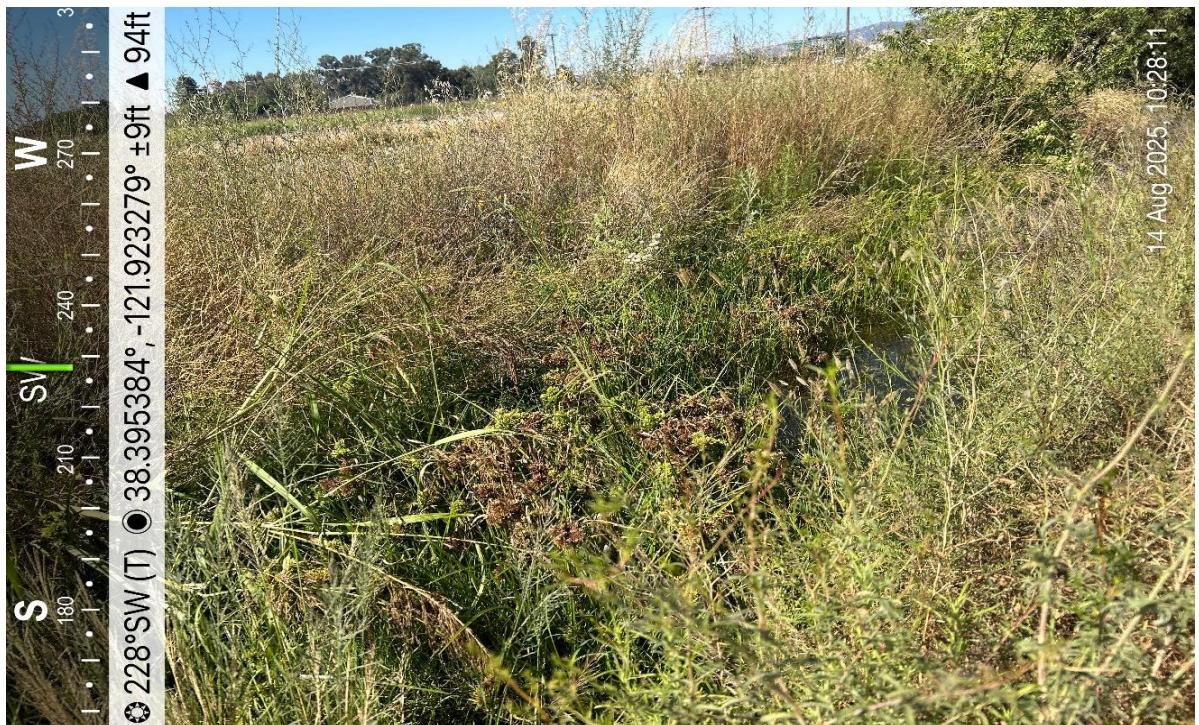
Photograph 6. Overview of the southwestern portion of the Project Area, depicting ruderal vegetation (aspect: southwest, August 14, 2025).

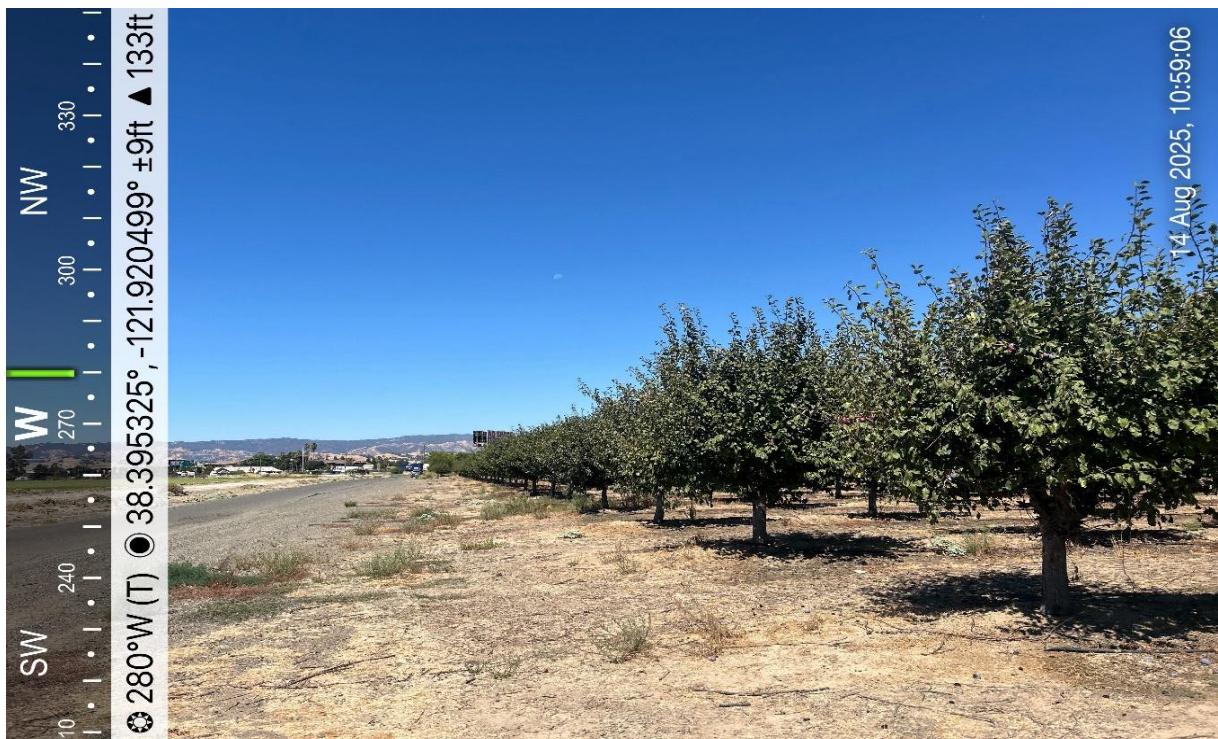
Photograph 7. Overview of the southern portion of the Project Area, depicting the disturbed/barren land cover type (aspect: west, August 14, 2025).

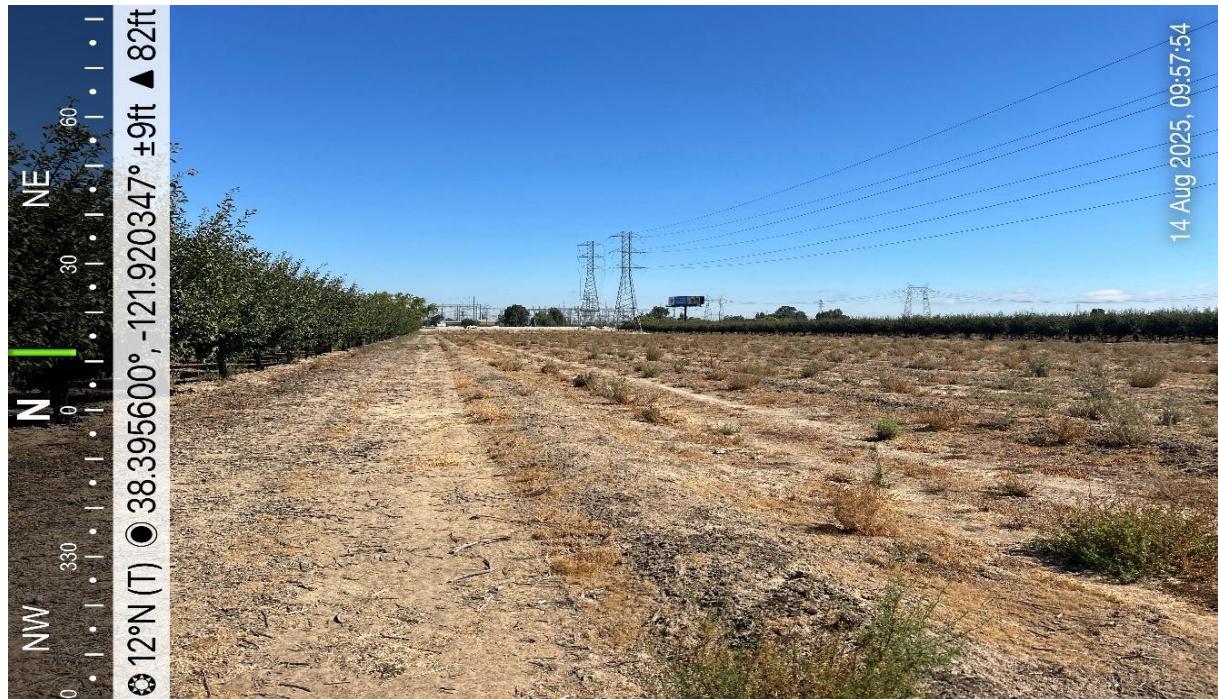
Photograph 8. Overview of the eastern portion of the Project Area, depicting disturbed/barren land cover type (aspect: north, August 14, 2025).

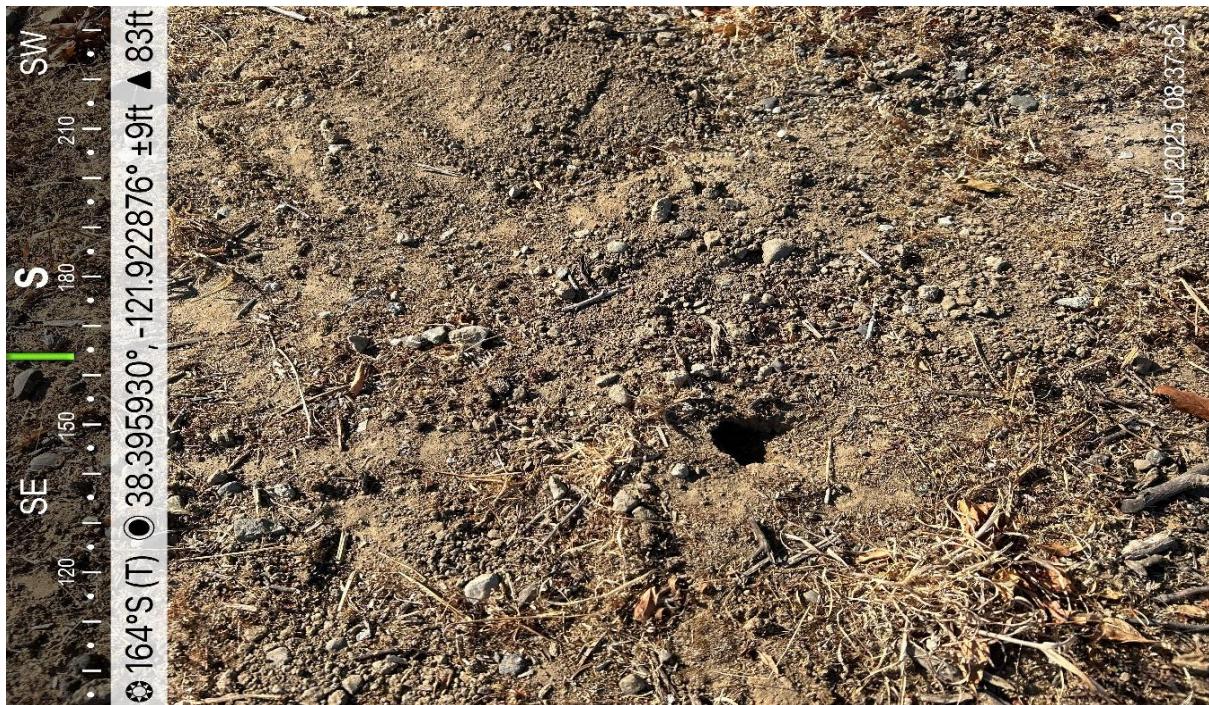
Photograph 9. Picture of a burrow depicting suitable nesting and overwintering habitat (aspect: south, July 15, 2025).

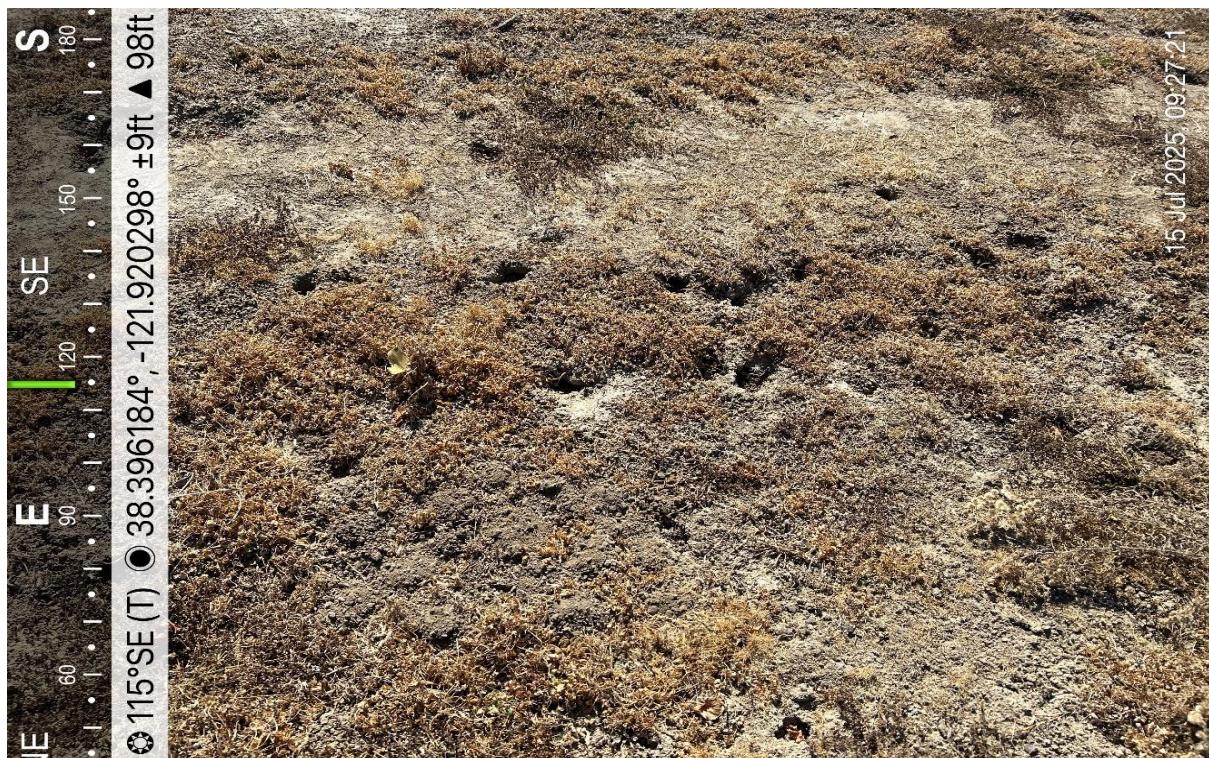
Photograph 10. Picture of a series of burrows depicting suitable nesting and overwintering habitat (aspect: southeast, July 15, 2025).

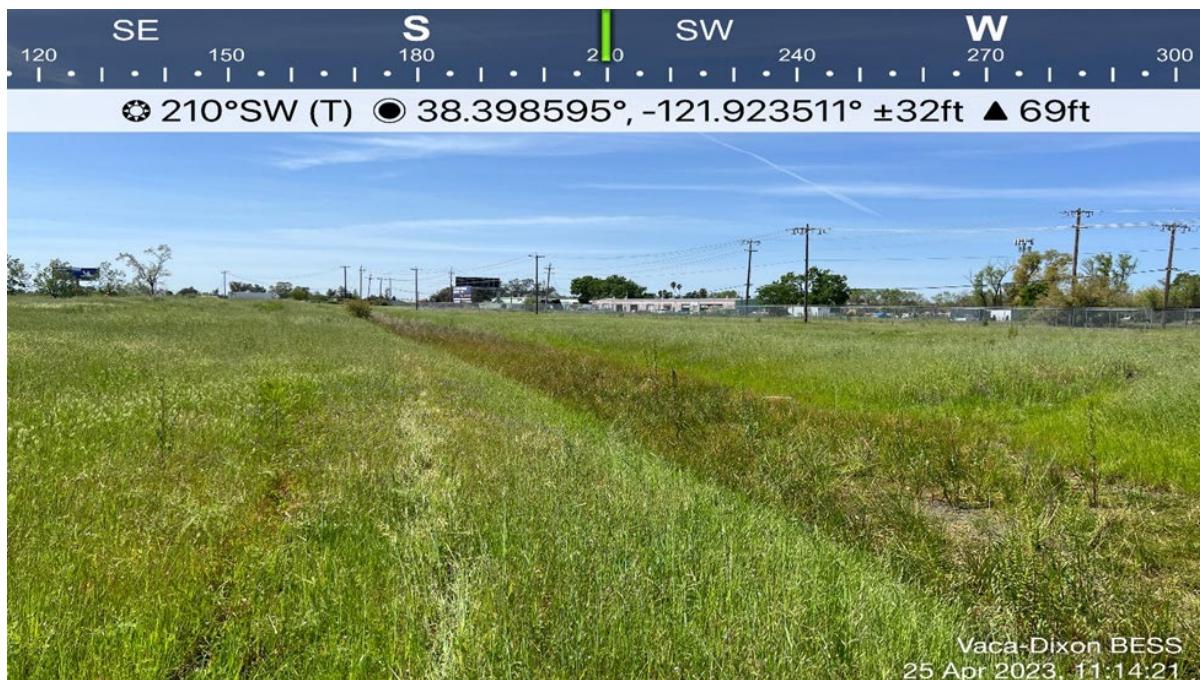
Photograph 1. View of the swale from the northern portion of the Biological Study Area, facing southwest. April 25, 2023.

One unnamed vegetated swale was documented within the northern extent of the BSA, identified as Swale in Figure 7a – Figure 7c (Appendix A). The width of the swale ranges from 20 feet to 35 feet wide, with the wider sections located at the north and south ends, as well as areas where the swale branches. The southern terminus of the swale meets at a culvert connecting to a ditch running parallel to I-80. The northern extent of the swale terminates north of the BSA boundary; however, a culvert was observed to the north, at Gibson Canyon Creek. The culvert is situated within 2 feet to 3 feet below the 100-year floodplain elevation of the creek, so there is potential for inundation and connection from the swale to the creek during a 100-year flood event when water may move from the creek into the swale; however, flows from the creek do not typically inundate the swale feature

No indicators of an OHWM were observed in the swale during the field surveys. Although there was a defined change in vegetation present within the swale, review of this feature in the field confirmed a lack of a defined bed and bank.

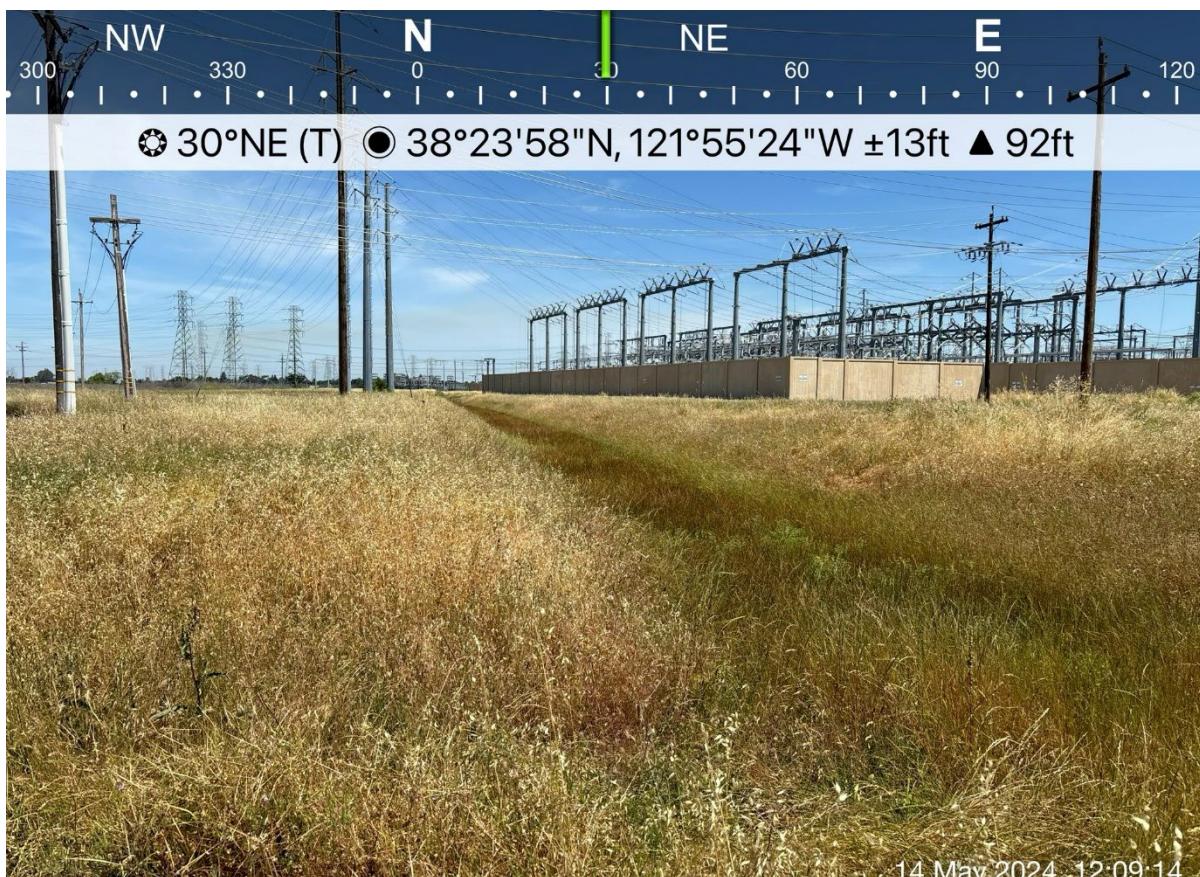
Photograph 2. View of the swale and non-native grassland within the Biological Study Area, facing northeast. PG&E Vaca-Dixon Substation shown on righthand side of photo. May 14, 2024.

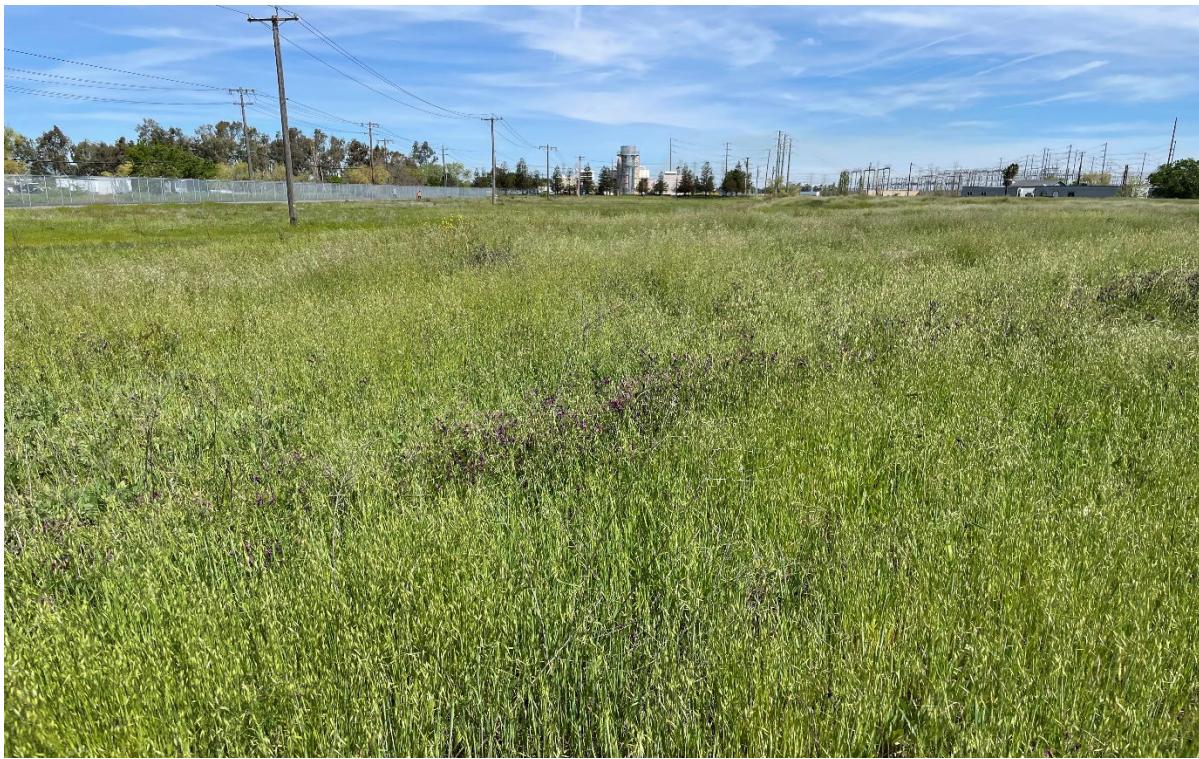
Photograph 3. View facing north of a portion of Seasonal Wetlands 1 and 2 (center and eastern portions of the photo). April 24, 2023.

Although no sample points were taken, Seasonal Wetland 1 (0.06 acre) and Seasonal Wetland 2 (0.01 acre) were noted during field surveys to occur in depressions with lower elevation relative to the surrounding areas and exhibited a change in vegetation relative to surrounding areas, similar to confirmed Seasonal Wetland 4 mentioned above, where a soil pit had verified the presence of hydric soil (i.e., SP 18: Depleted Matrix; "F3"). Vegetation occurring within these wetlands closely resembles that of the surrounding non-native grassland area, although additional species such as mousetail (*Myosurus minimus*) and common spikerush (*Eleocharis macrostachya*) were noted within the wetland areas, both classified as OBL species. OBL species are considered to almost always occur in wetlands. These wetlands are also distinguished from the surrounding grassland with the use of

historical aerial imagery, showing darker (i.e., wetter) areas in these locations. Based on observations recorded in the field and noted above, and the similarity of these wetlands to Seasonal Wetlands 3 and 4, hydrophytic vegetation and wetland hydrology indicators were assumed in Seasonal Wetlands 1 and 2.

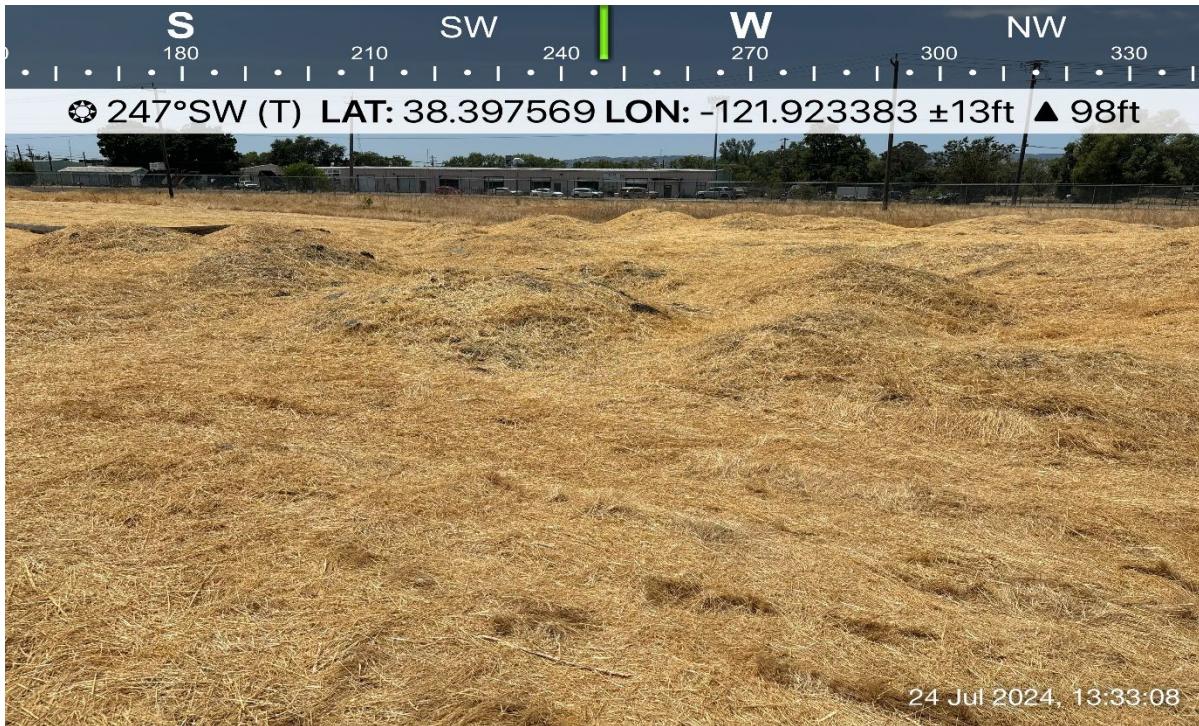
Photograph 4. View of Seasonal Wetland 3 after the grass had been mowed, facing west. July 24, 2024.

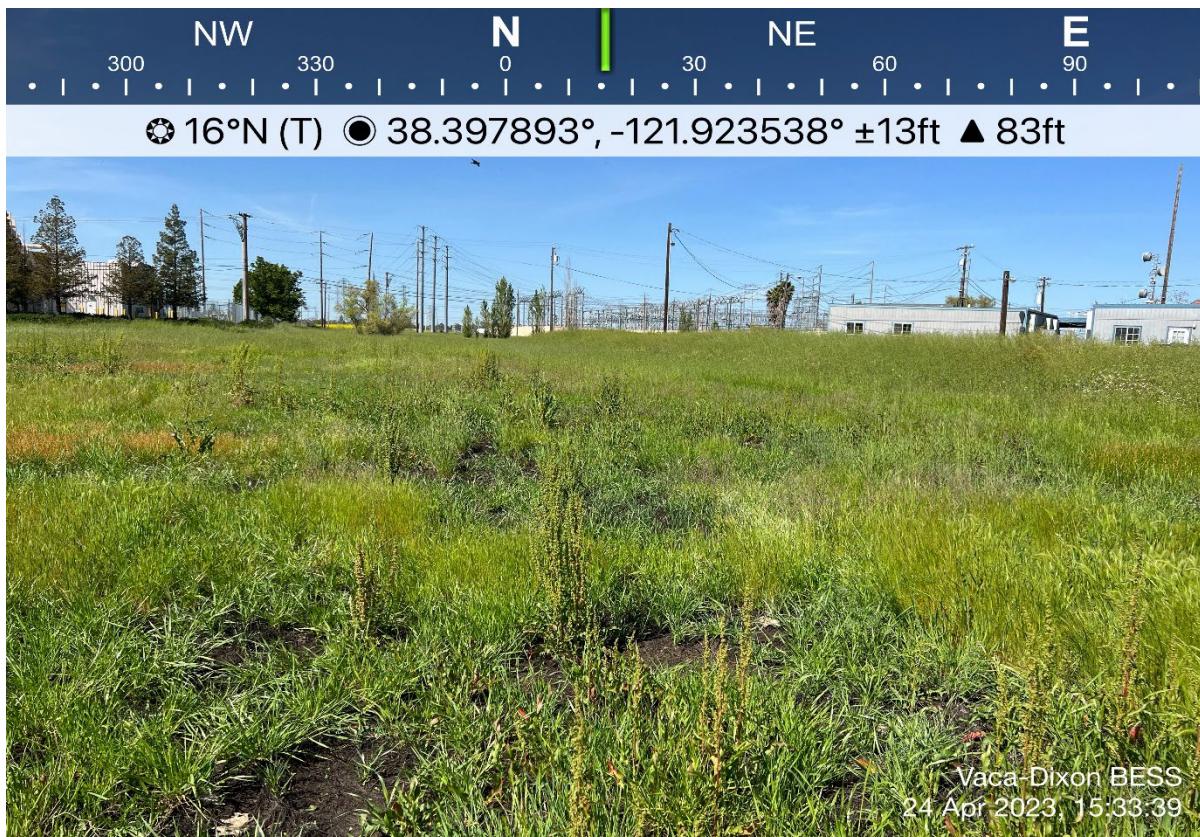
Photograph 5. View of Seasonal Wetland 4, facing north. April 24, 2023.

Data was collected from SP18 within Seasonal Wetland 4 (0.08 acre). The soil sample taken from the wetland area revealed hydric soils (i.e., Depleted Matrix; "F3"). Although Seasonal Wetland 4 was assumed to be a wetland during the 2023 ARD survey by the obvious change in vegetation and topography relative to the surrounding area, and how this wetland was observed to be occurring within a slight depression in the ground, vegetation had been mowed prior to the 2024 ARD survey and therefore could not be evaluated for presence or absence of positive indicators of hydrophytic vegetation. Despite the lack of vegetation, primary hydrology indicators were present in the wetland (e.g., biotic crust). Based on the similarity of the wetlands to each other and their similar sitting within the landscape, the presence of hydrophytic vegetation was assumed in Seasonal Wetland 3 (0.01 acre).

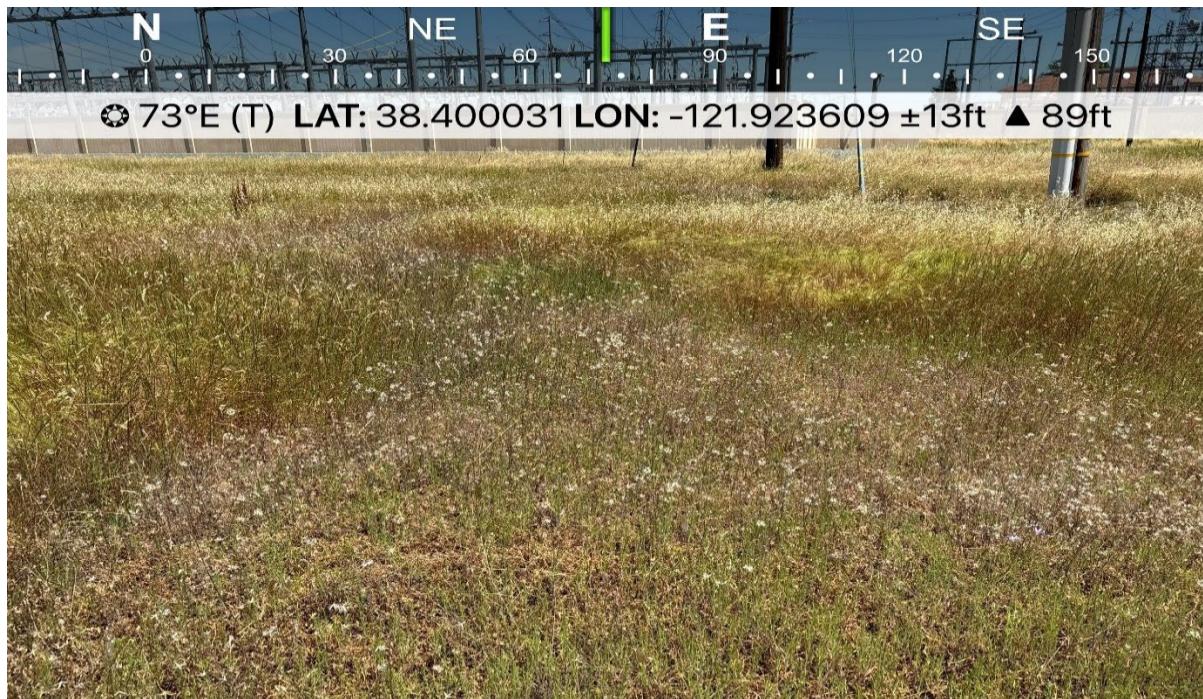
Photograph 7. View of the blow waves (*Achyranthes mollis*) in Seasonal Wetland 6, facing east. May 14, 2024.

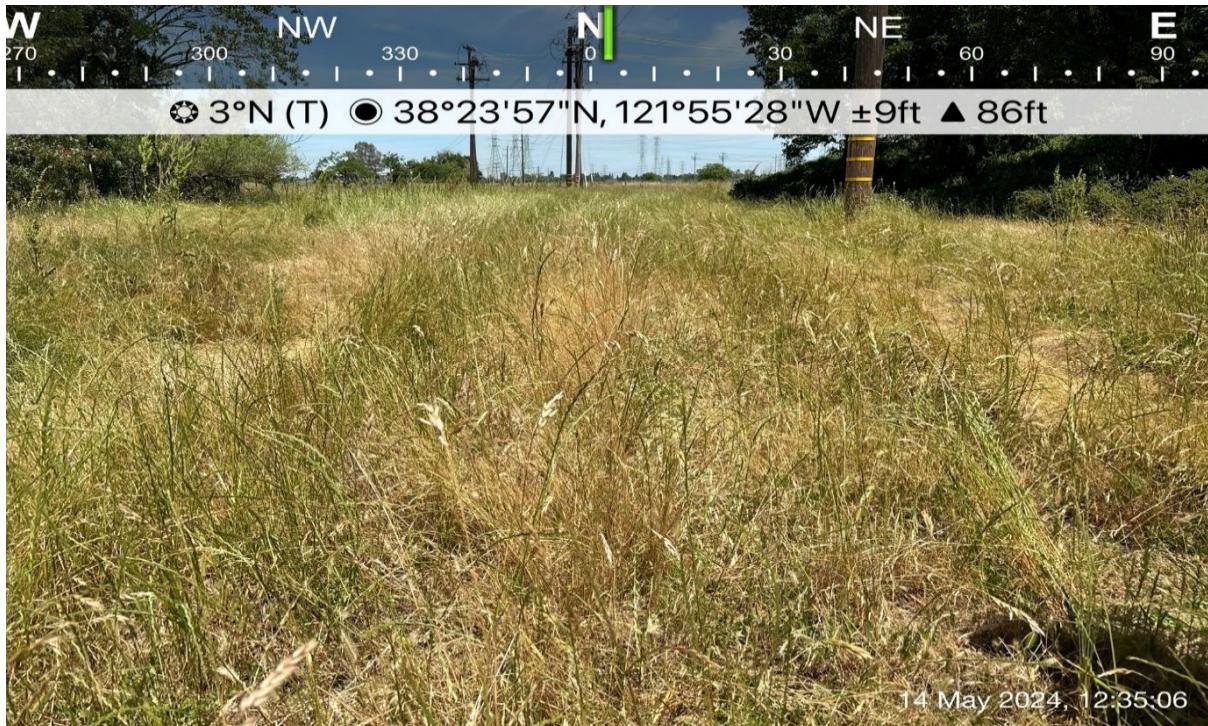
Photograph 8. View of Seasonal Wetland 8 prior to the grass being mowed, facing north. May 14, 2024.

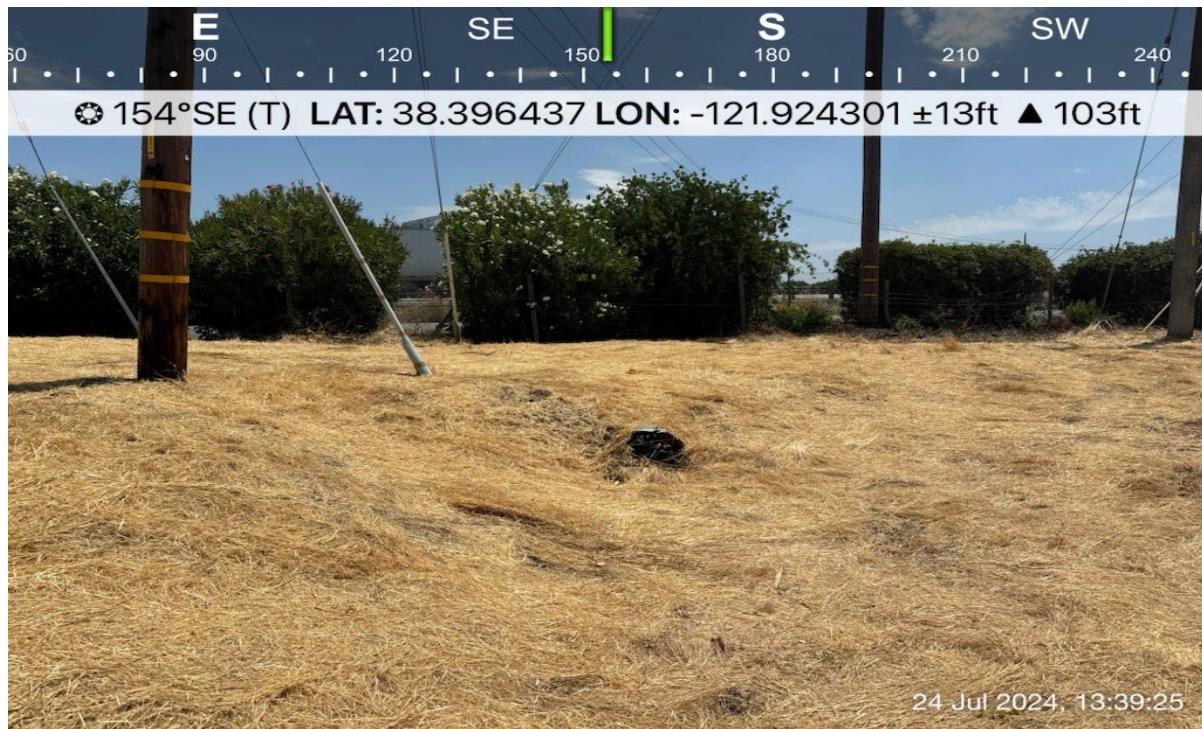
Photograph 9. View of culvert in the swale on the northern BSA, facing south. July 24, 2024.

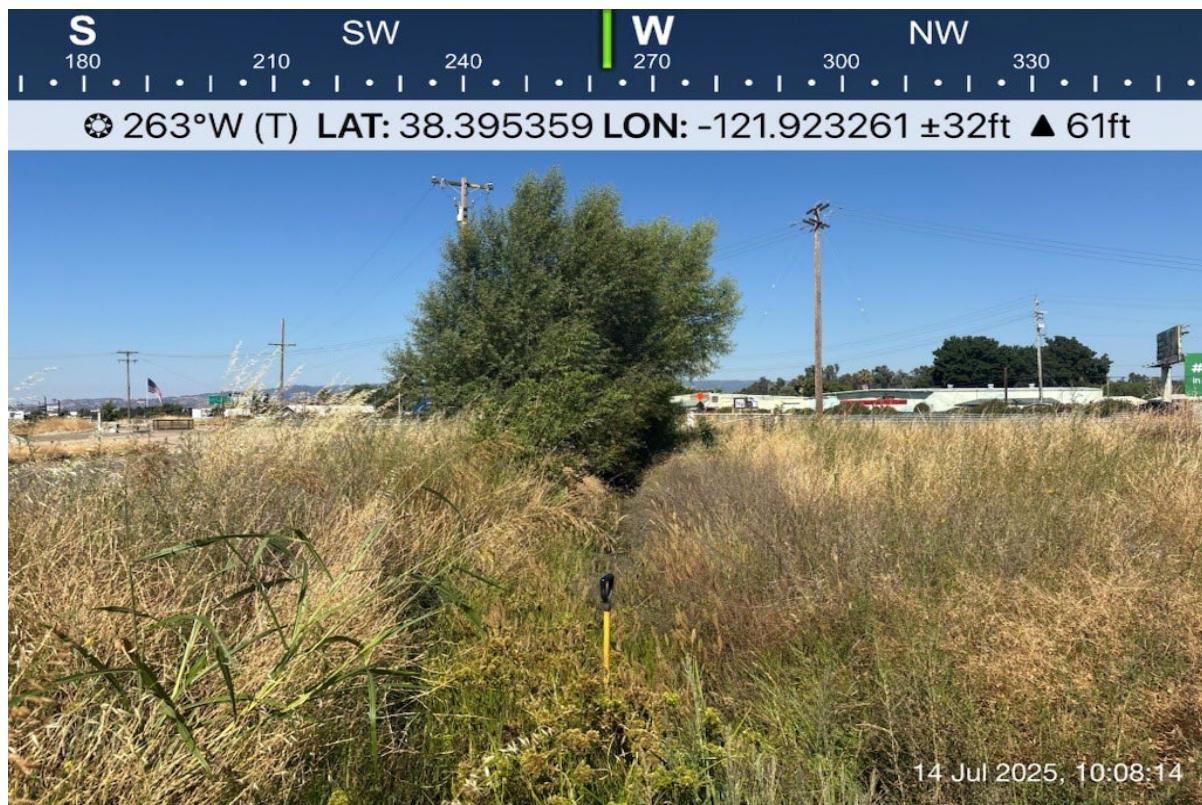
Photograph 10. View of Seasonal Wetland 9 on the southern BSA, facing west. July 14, 2025.

The BSA contains approximately 0.02 acre of fresh emergent wetland, consisting of Seasonal Wetland 9, found in the southwestern portion of the southern BSA on the BESS site. Though there is variation between the eastern and western portions of Seasonal Wetland 9, as cattails (*Typha* sp.) are a dominant species in the eastern portion whereas flat sedge (*Cyperus* sp.) are a dominant species in the western portion; this vegetation community most closely resembles the *Typha* (*angustifolia*, *domingensis*, *latifolia*) Herbaceous Alliance described by Sawyer et al. (2009) as these species are co-dominant in the herbaceous layer. Furthermore, this community may include emergent trees present at low cover, which are reflected in this feature as a single willow tree (*Salix* sp.). A standpipe is present at the western end of the wetland. Seasonal Wetland 9 contained water during the final burrowing owl protocol survey (July 14, 2025).

Paired wetland sample points were taken at Seasonal Wetland 9 (SP20 and SP21¹) on the BESS site area in the southern BSA. Hydrophytic vegetation, hydric soils, and hydrology indicators were present in SP20. Hydrophytic vegetation and hydrology indicators were absent from the soil sample taken to the north in SP21. Vegetation present within the wetland included a black willow tree (*Salix nigra*; OBL) and flatsedge (*Cyperus eragrostis*; FACW), California plantain (*Polypogon monspeliensis*; FACW), California loosestrife (*Lythrum californicum*; OBL), cattails (*Typha* sp.; OBL), and California plantain (*Plantago erecta*; no indicator), which was observed as an obvious change in vegetation relative to the surrounding area. Water was present in the western portion of the wetland, near a stand pipe that is also present in the wetland.

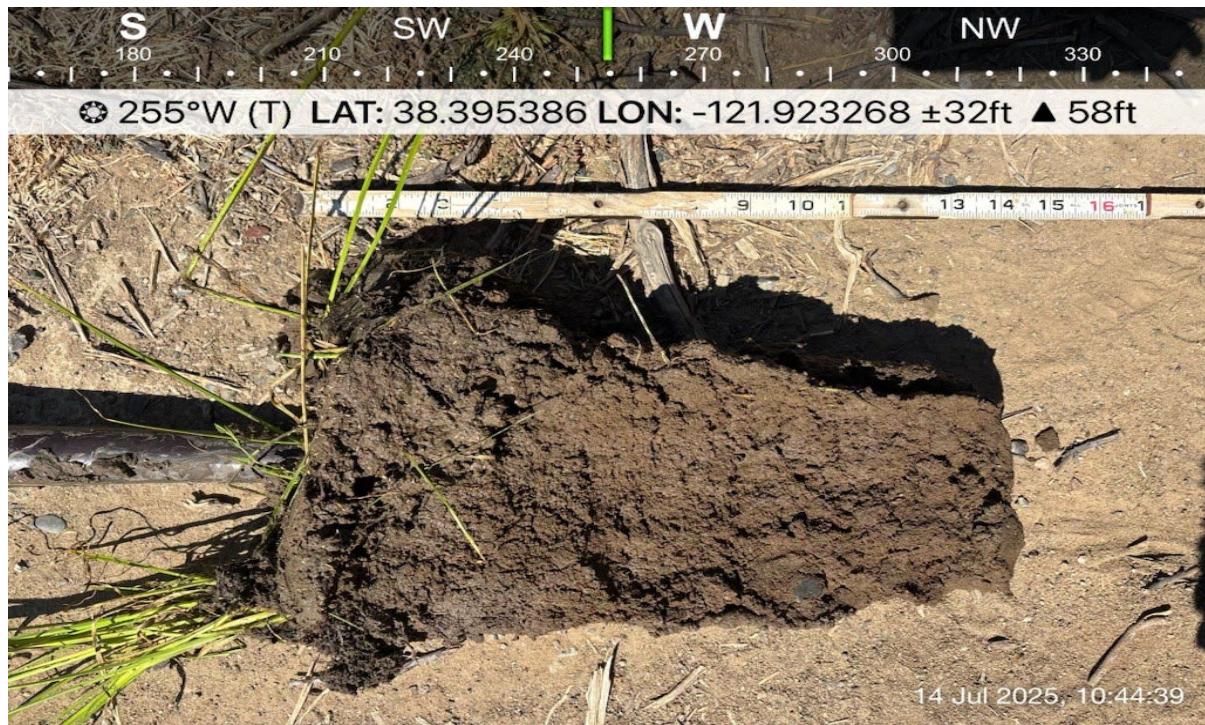
Photograph 11. View of SP20, taken from Seasonal Wetland 9. July 14, 2025.

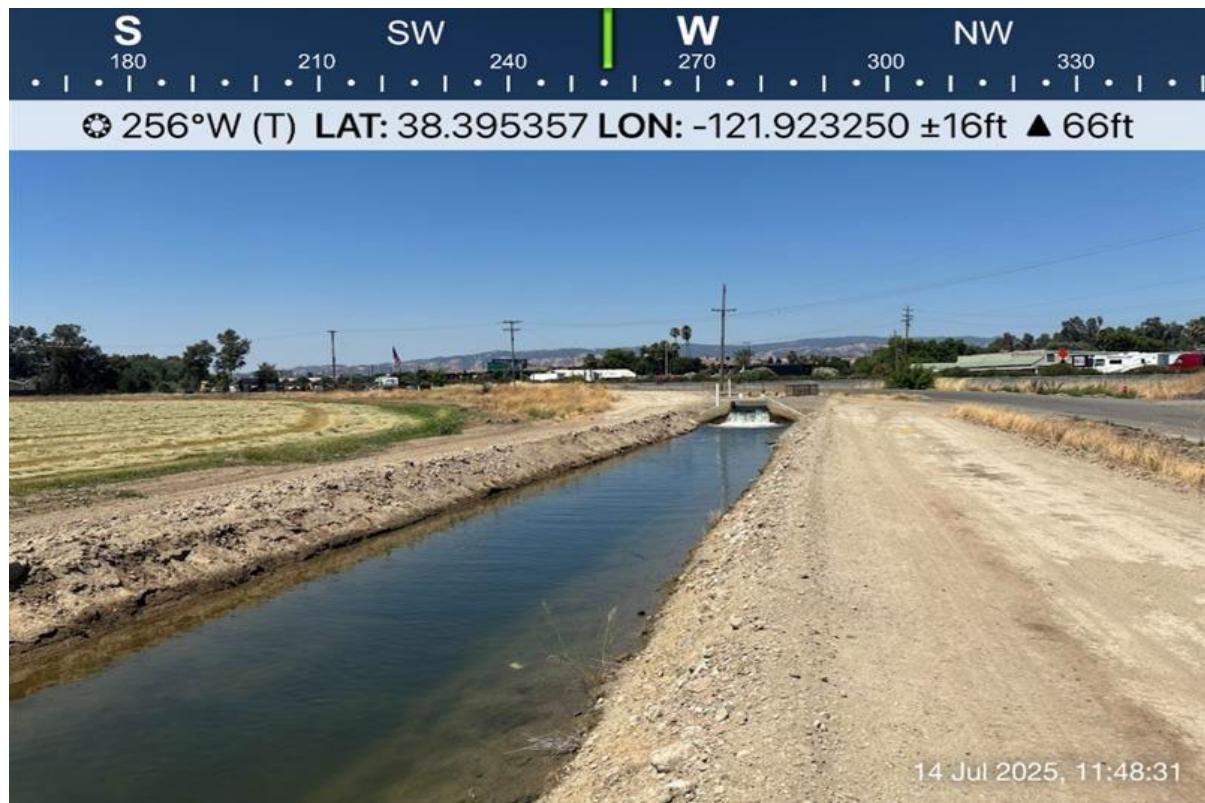
Photograph 12. View of Agricultural Ditch 1, south of the BSA, facing west. July 14, 2025.

Break in bank slope, sediment deposits, water currently absent for irrigation in Agricultural Ditch 2, water is present in Agricultural Ditch 1. Standard trapezoidal ditch.

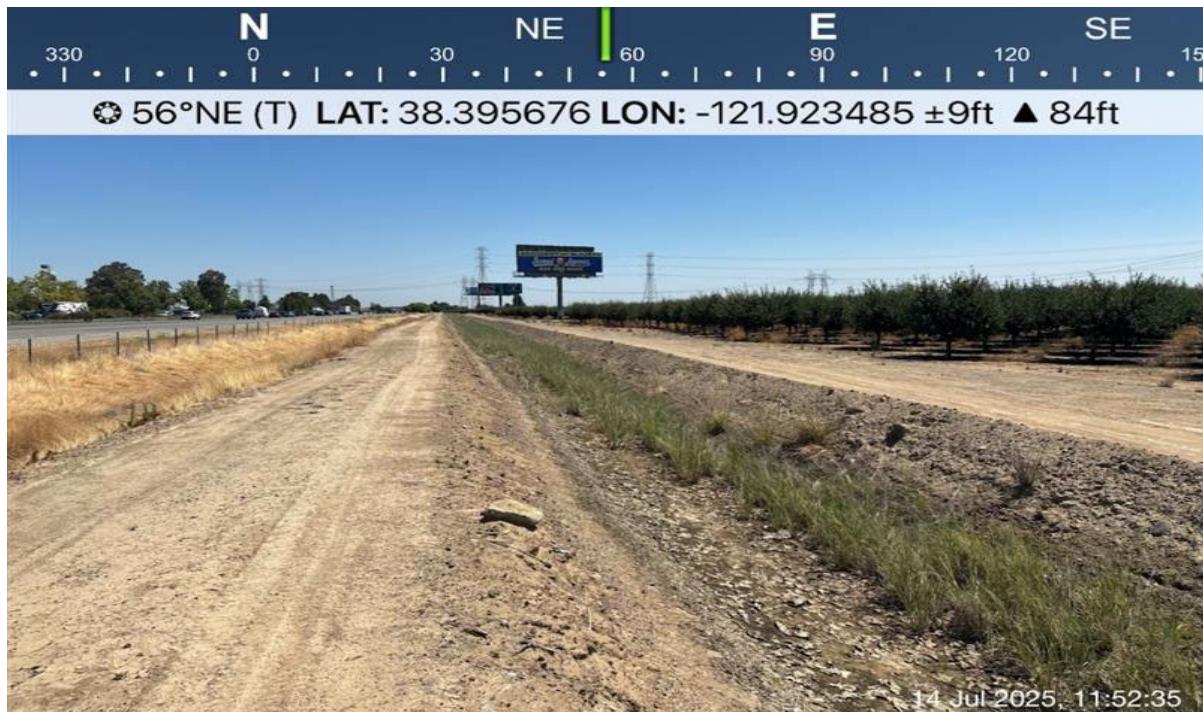
Photograph 13. View of Agricultural Ditch 2, northeast of the southern portion of the BSA, facing northeast. July 14, 2025.
