DOCKETED	
Docket Number:	26-OPT-01
Project Title:	Vaca Dixon Power Center Project
TN #:	268172-3
Document Title:	Appendix Y Biological Resources Technical Study_VDPC_Part 3 of 3
Description:	<p>Includes a Biological Resources Technical Study which analyzes the potential impacts of the Project and evaluates short and long term impacts of the Project to biological resources.</p> <p>Y.A Regulatory Framework; Y.B Species Compendia; Y.C Representative Site Photographs; Y.D Burrowing Owl Survey Report; Y.E Dry Season Large Branchiopod Protocol Sampling Results (2024); Y.F Wet Season Large Branchiopod Protocol Sampling Results; Y.G Large Branchiopod Habitat Assessment Report; Y.H Dry Season Large Branchiopod Protocol Sampling Results (2025); Y.I Crotch's Bumble Bee Survey Report; Y.J Aquatic Resources Delineation Report; Y.K Special-Status Species Evaluation Table; Y.L California Natural Diversity Database (CNDDB) Figure (scale1:6,000) (Confidential - submitted separately); Y.M United States Fish and Wildlife Service Meeting Minutes</p>

Biological Resources Technical Study

Aquatic Resources Delineation Report

Vaca Dixon Power Center Project

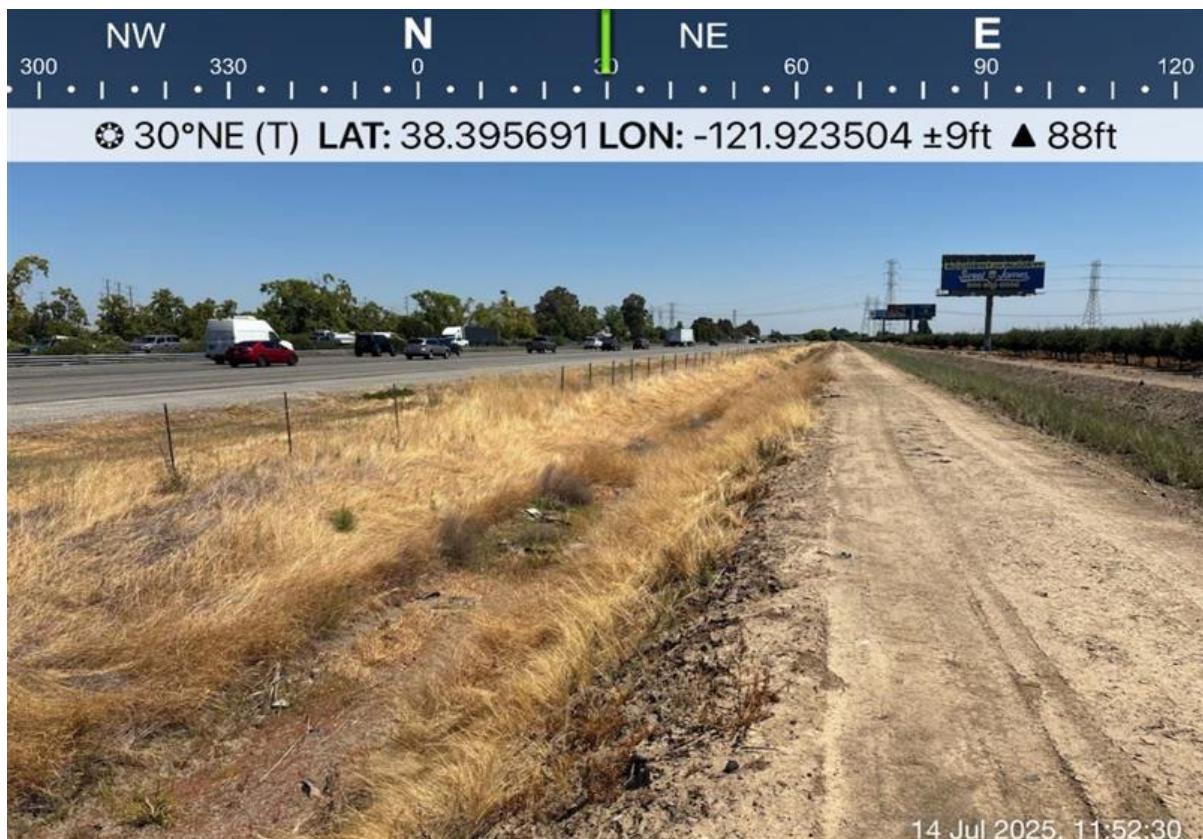
Photograph 14. View of Agricultural Ditch 3, northeast of the southern portion of the BSA and east of I-80, facing northeast. July 14, 2025.
