Soda Mountain Solar Project

Aquatic Resources Delineation and Impact Analysis

February 2026

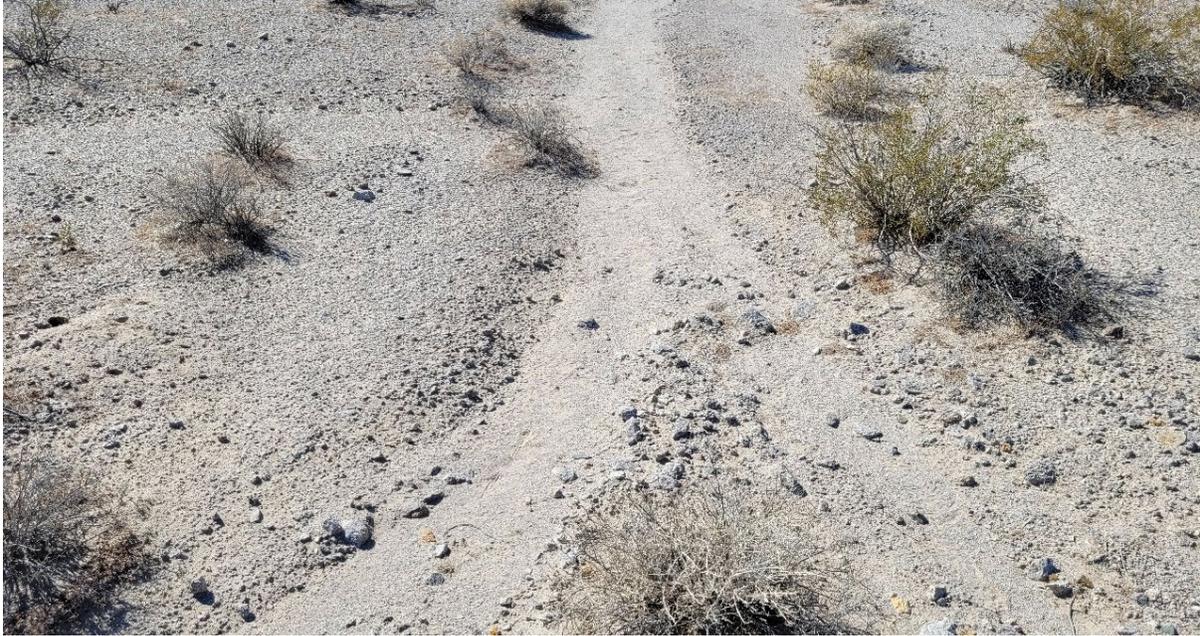
Photo Point E-4-1 (East Array). Northwestern facing representative photograph facing downstream of a small drainage exhibiting indicators of an OHWM.

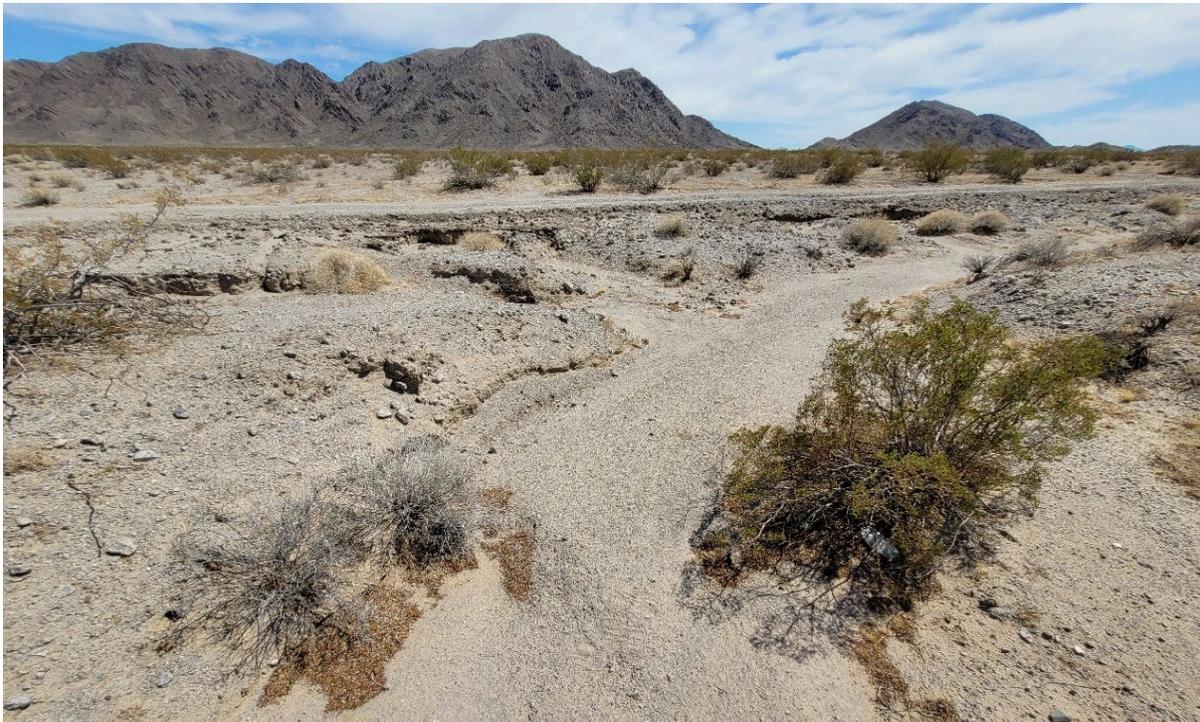
Photo Point E-6-3 (East Array). Southeast facing representative photograph of an upstream portion of a drainage exhibiting indicators of an OHWM.

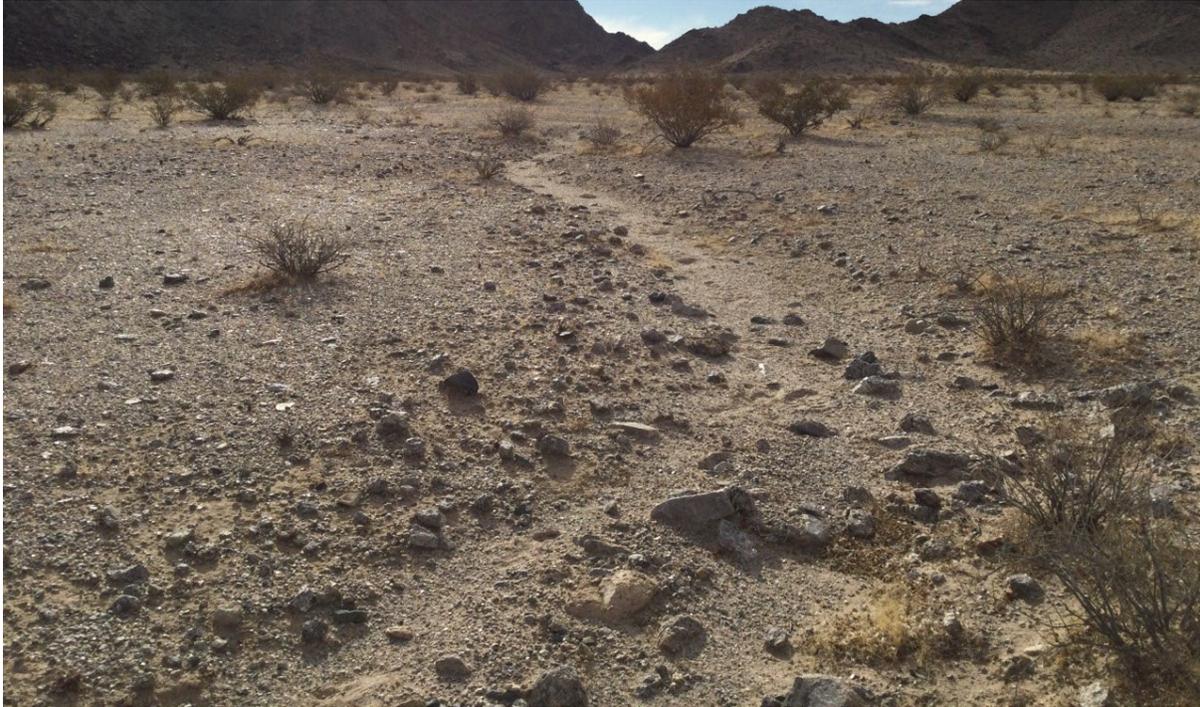
Photo Point E-11-3 (East Array). East facing representative photograph illustrating indicators of an OHWM, corresponding to the EK-003 Datasheet.

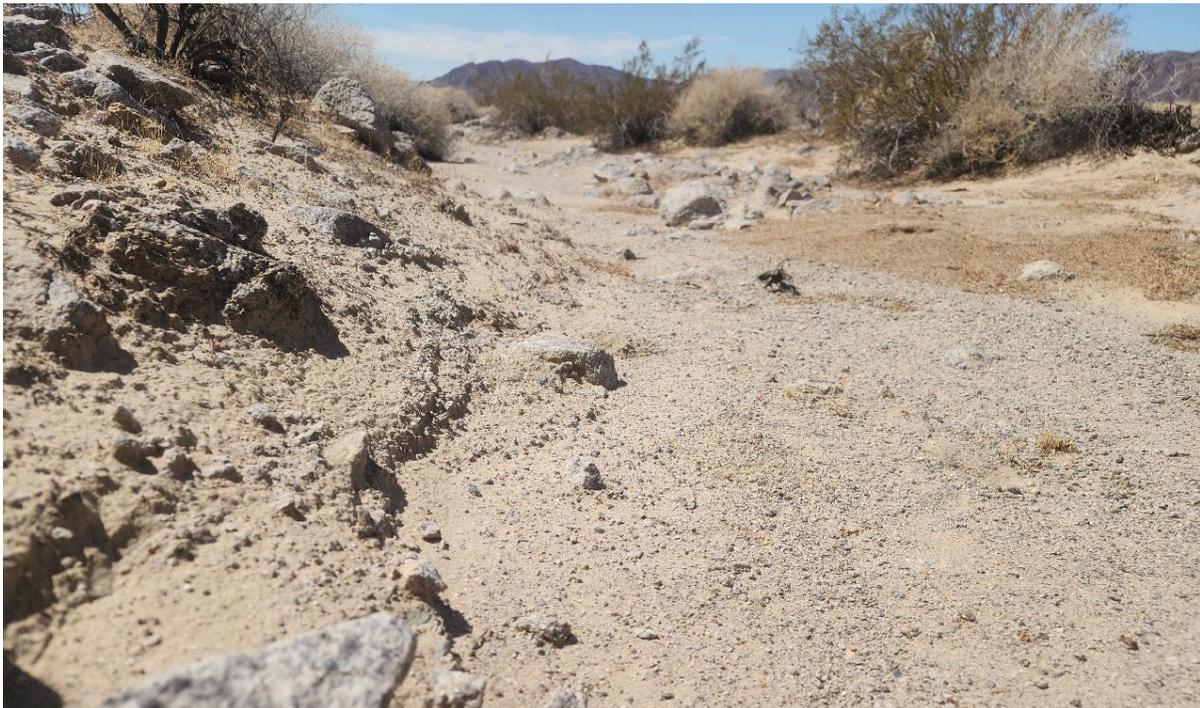
Photo Point E-7-3 (East Array). West facing representative photograph illustrating an OHWM and no riparian vegetation, corresponding to the ATG-004 Datasheet.

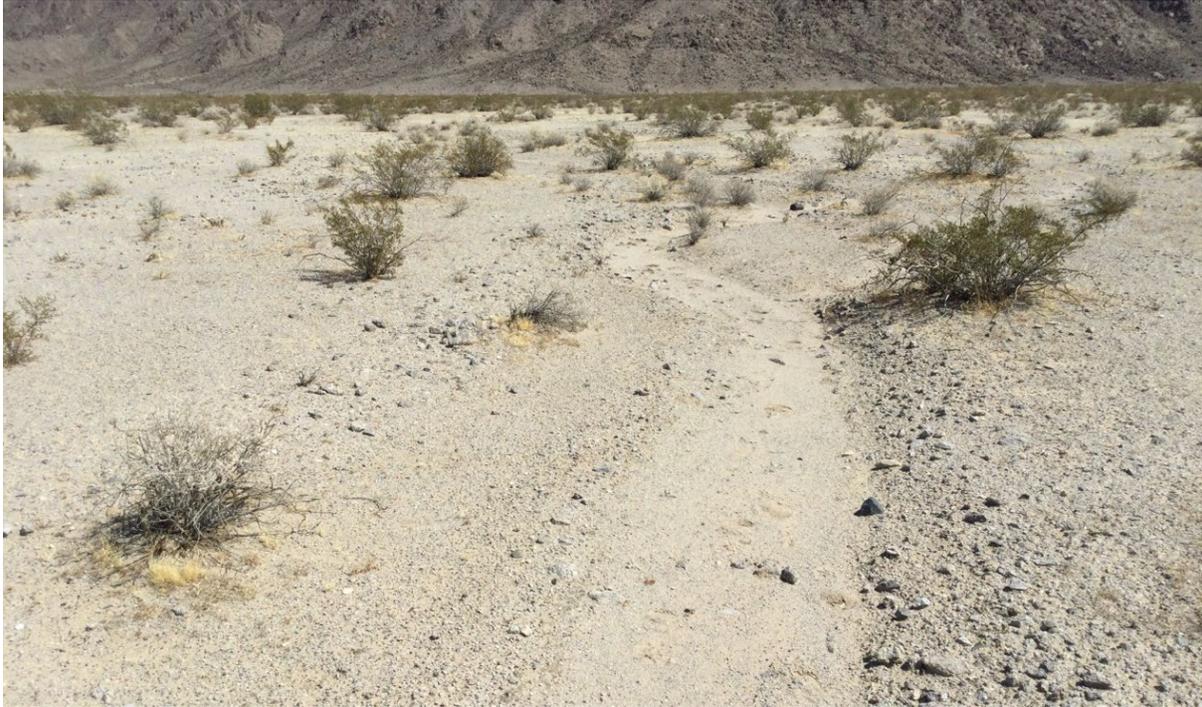
Photo Point E-9-2 (East Array). East facing representative photograph illustrating an upstream portion of a drainage exhibiting an OHWM and no riparian vegetation, corresponding to the EK-004 Datasheet.

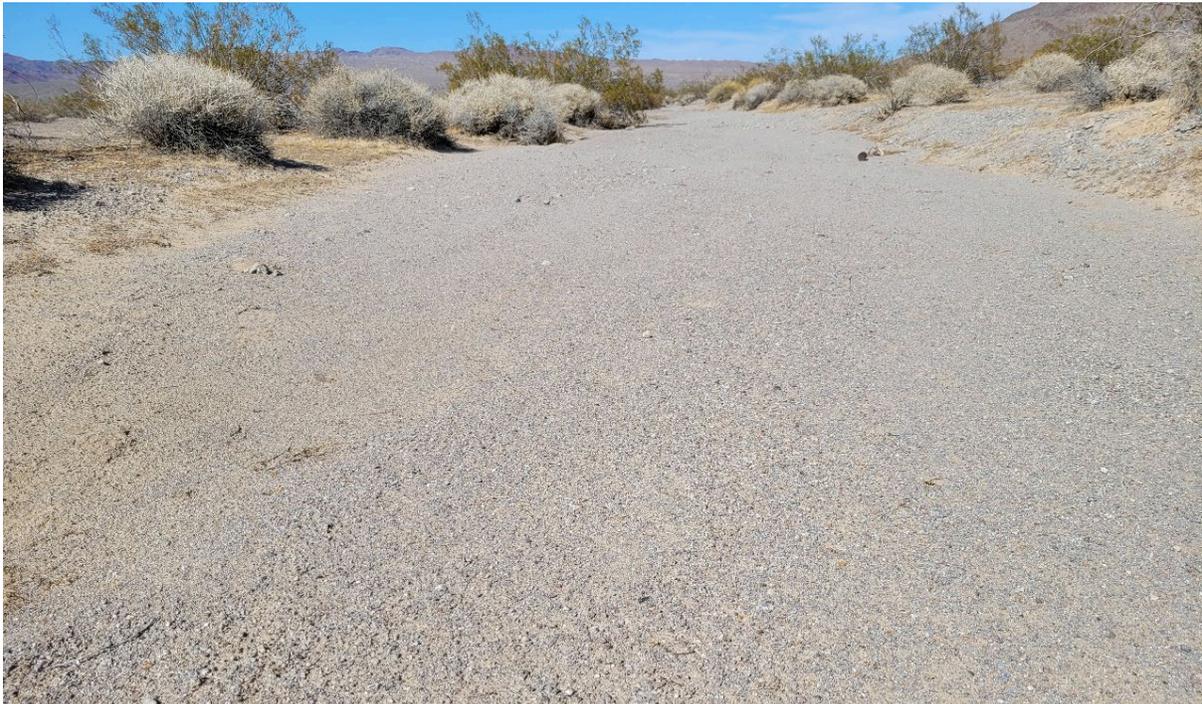
Photo Point E-5-3 (East Array). Northeast facing representative photograph illustrating indicators of an OHWM, corresponding to the KG-003 Datasheet.

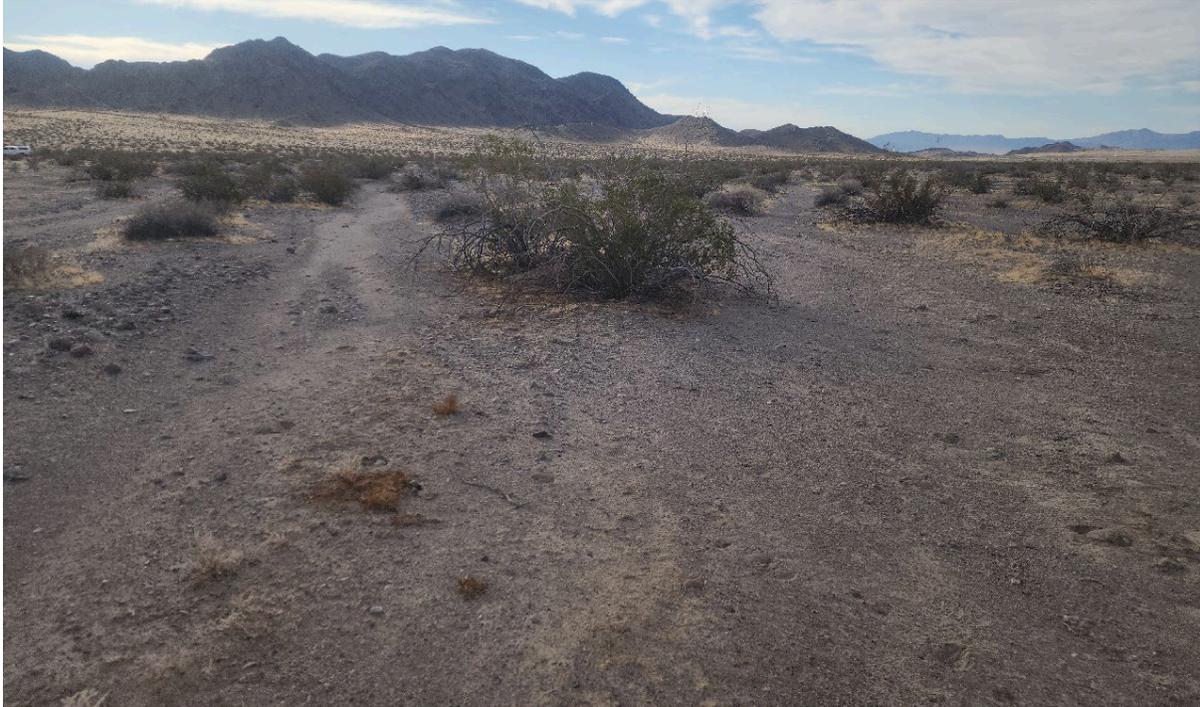
Photo Point S1-3-2 (South Array 1). East facing representative photograph illustrating an upstream portion of a drainage exhibiting an OHWM and no riparian vegetation, corresponding to the ATG-003 Datasheet.

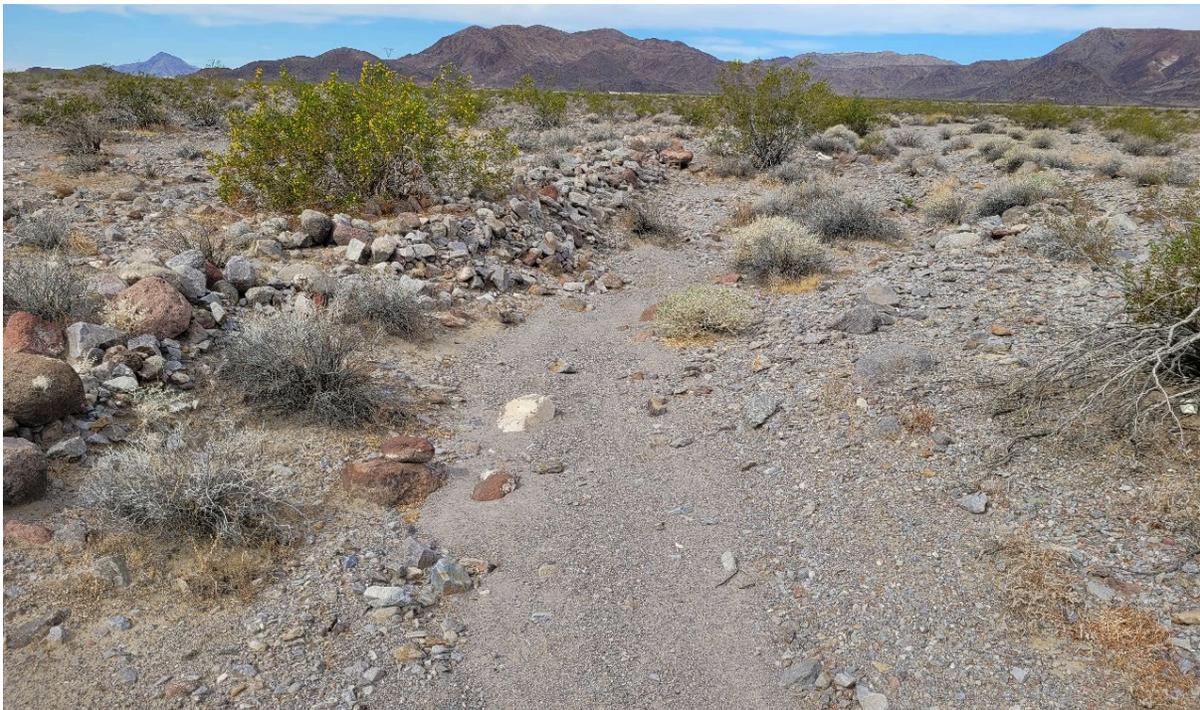
Photo Point S1-5-2 (South Array 1). Southwest facing representative photograph illustrating indicators of an OHWM, corresponding to the KG-001 Datasheet.

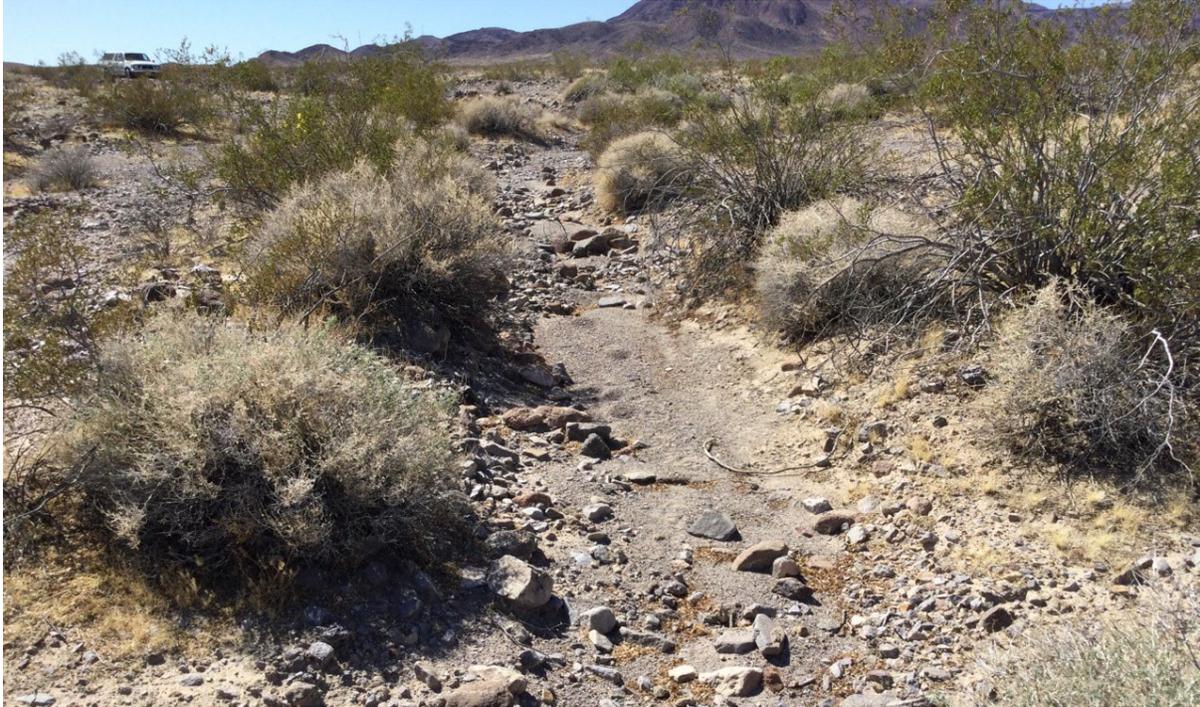
Photo Point S2-14-1 (South Array 2). West facing representative photograph of an upstream drainage feature exhibiting indicators of an OHWM.

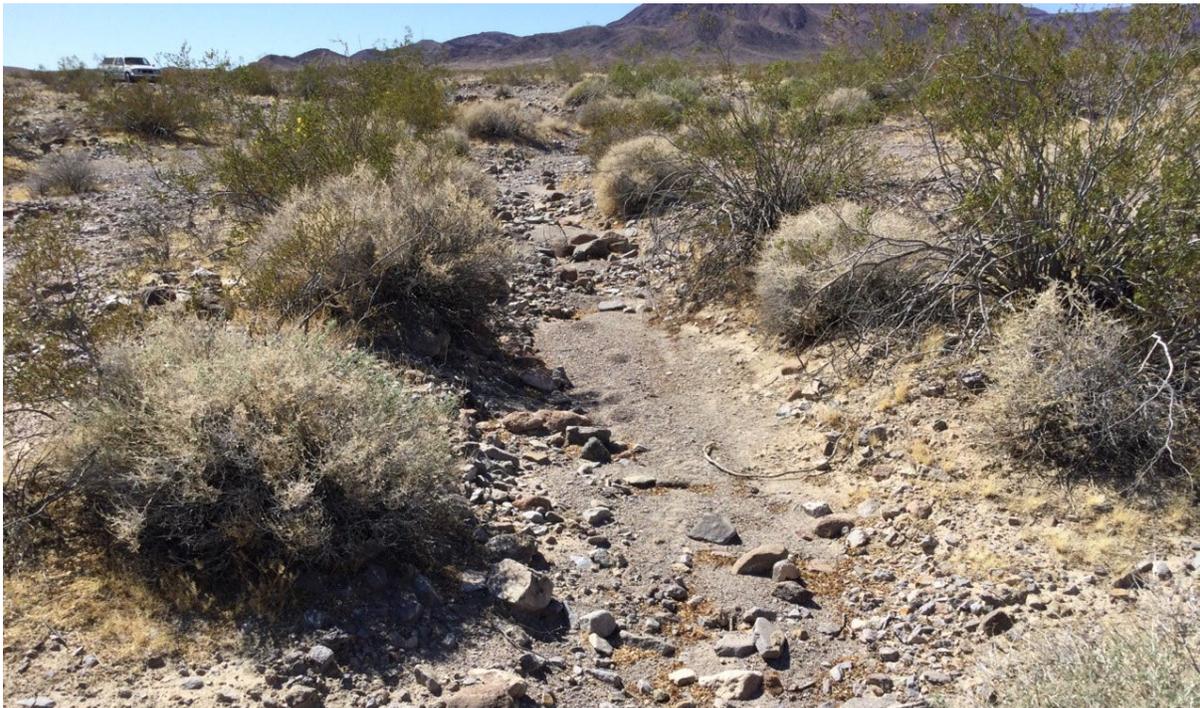
Photo Point S2-5-2 (South Array 2). East facing representative photograph of a downstream drainage feature exhibiting indicators of an OHWM, corresponding to the EK-001 Datasheet.

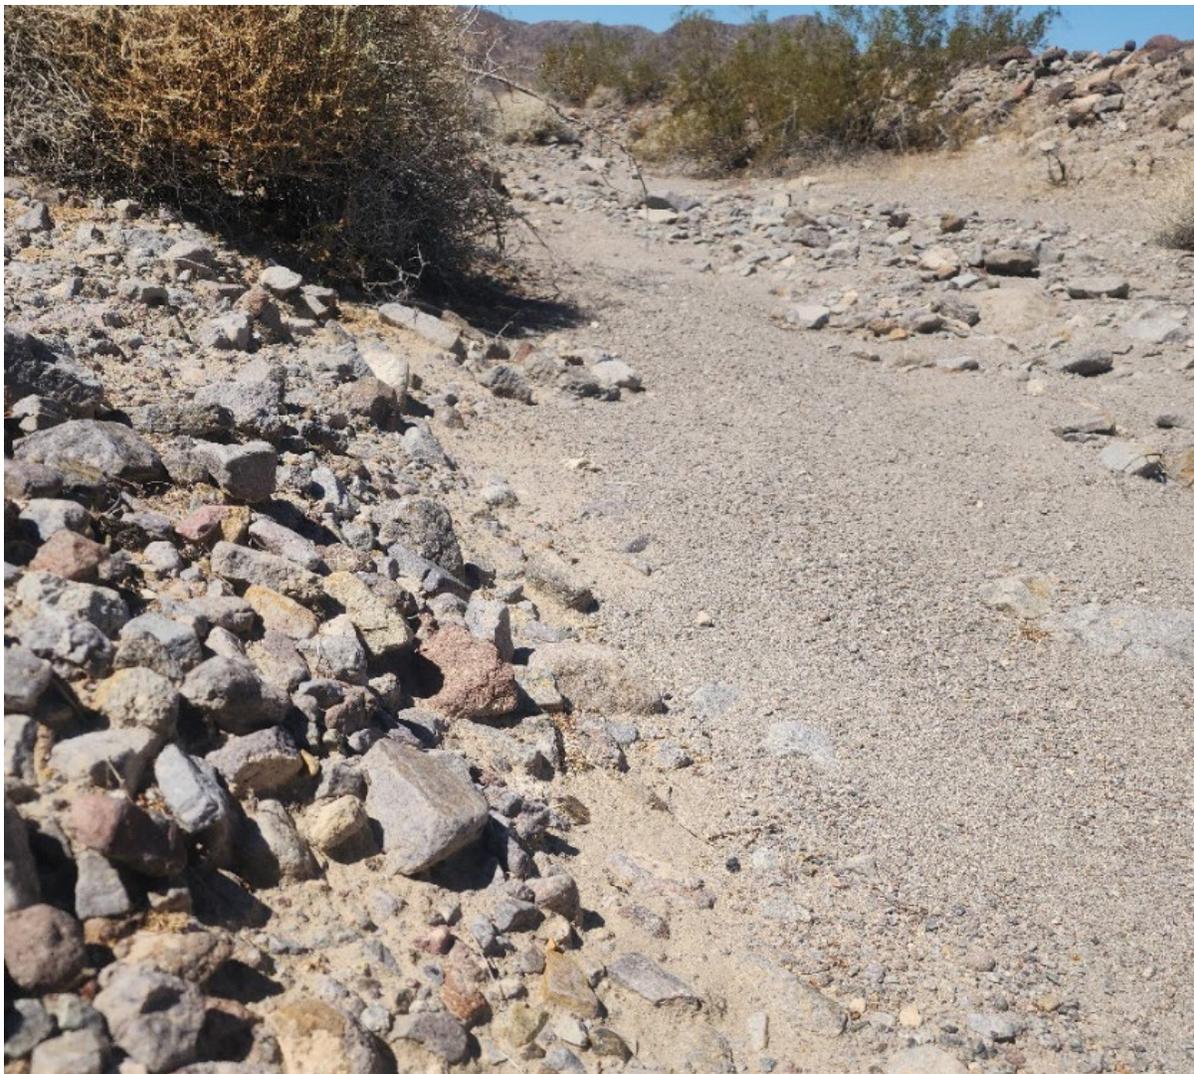
Photo Point S2-6-2 (South Array 2). West facing representative photograph of a drainage feature exhibiting indicators of an OHWM, corresponding to the ATG-002 Datasheet.

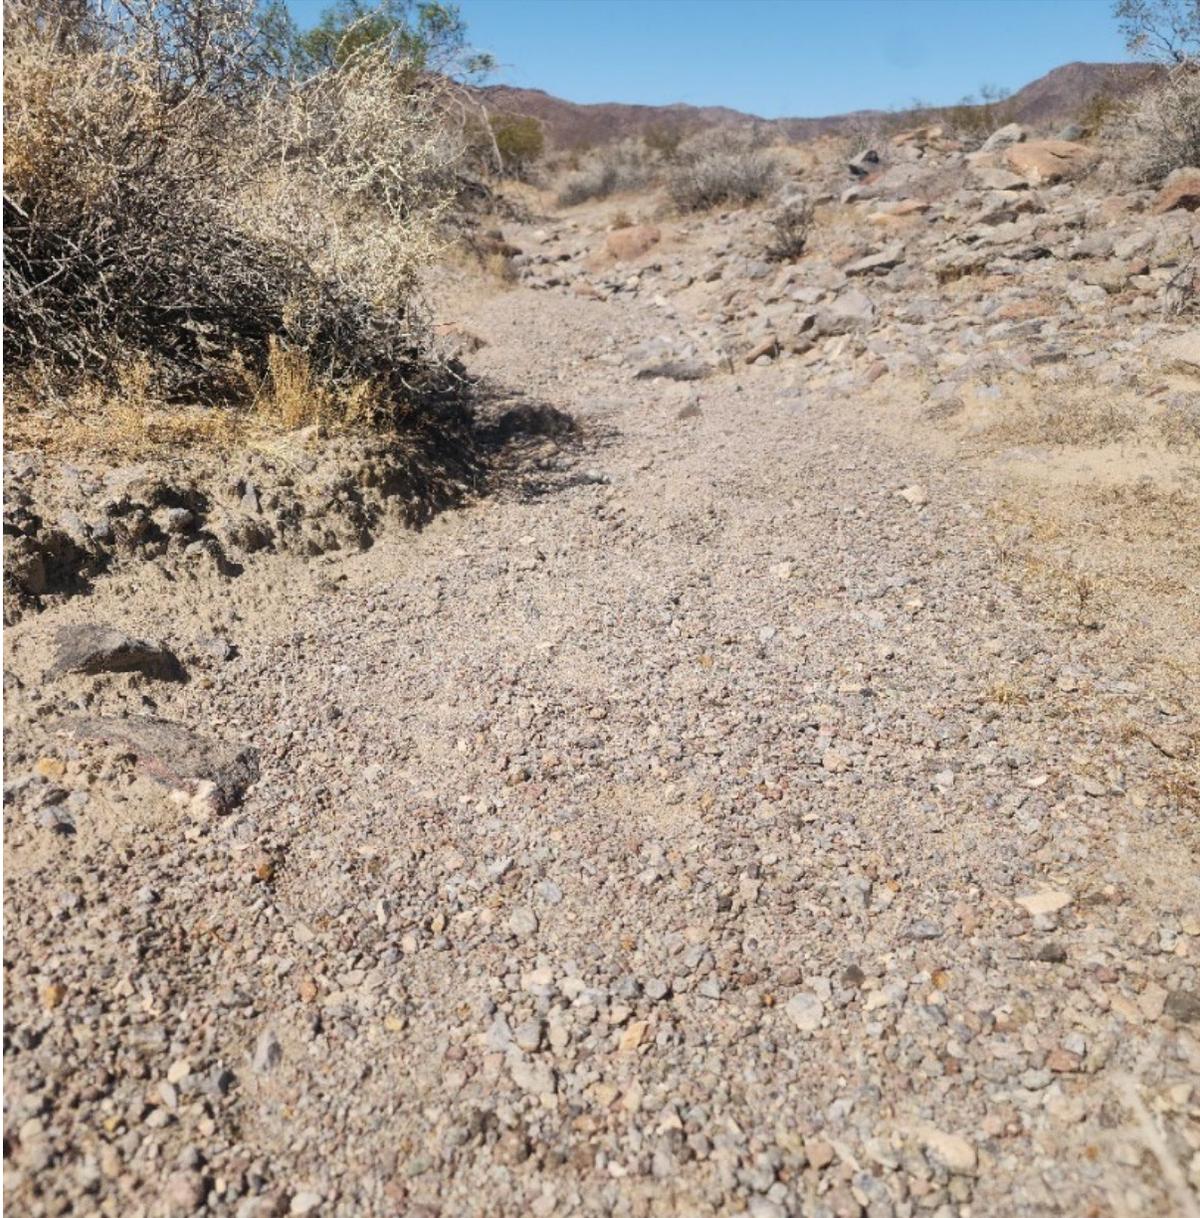
Photo Point S2-8-1 (South Array 2). East facing representative photograph of an downstream drainage feature exhibiting indicators of an OHWM, corresponding to the EK-001 Datasheet.

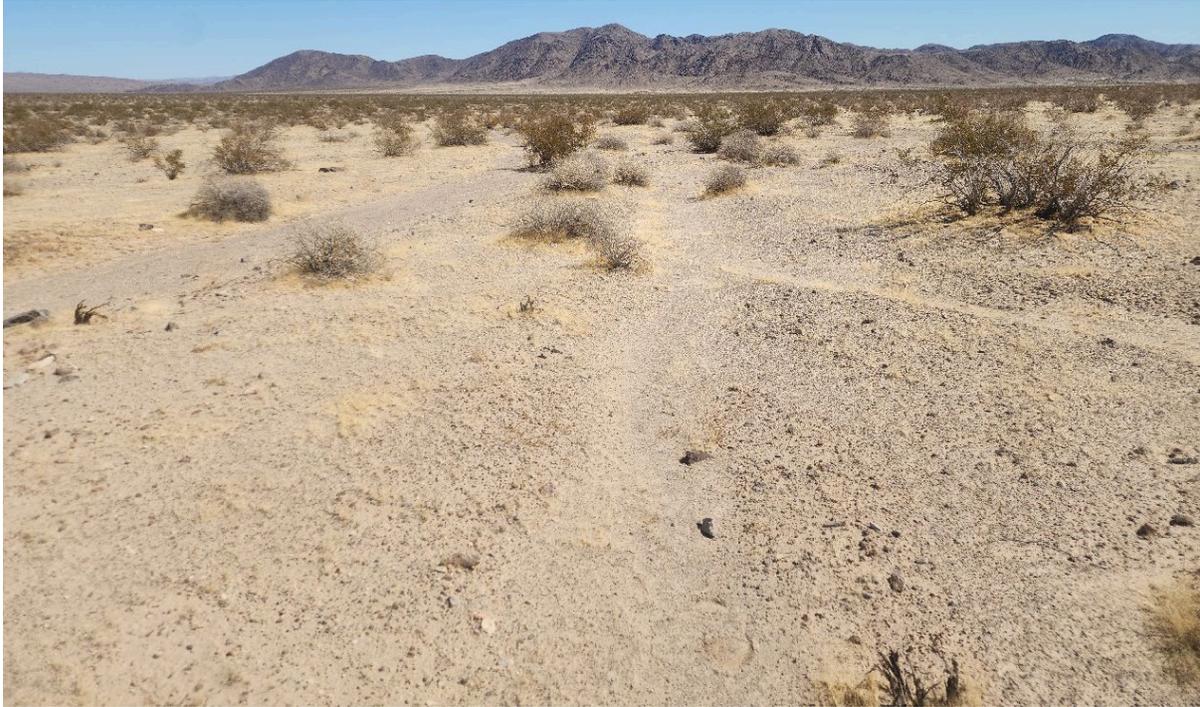
Photo Point S3-2-1 (South Array 3). Northeast facing representative photograph of drainages in the Study Area exhibiting weak indicators of a bed and bank and change in substrate.

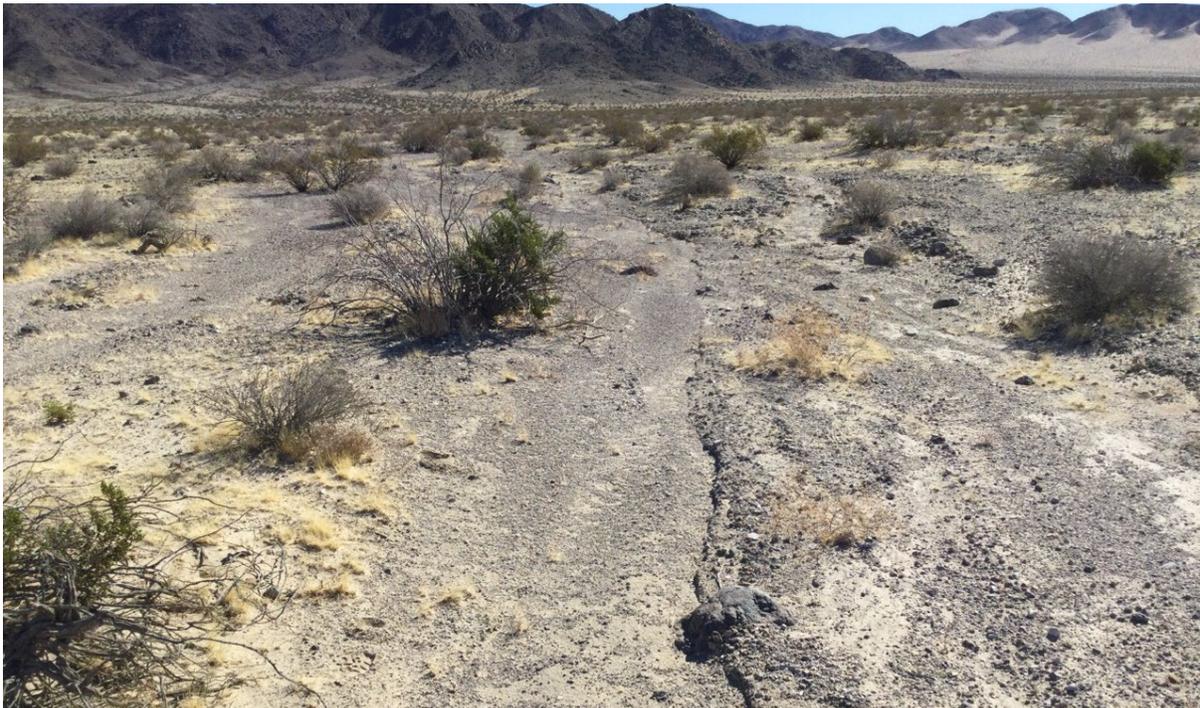
Photo Point S3-7-1 (South Array 3). East facing representative photograph of drainages in the Study Area exhibiting weak indicators of a bed and bank and change in substrate.

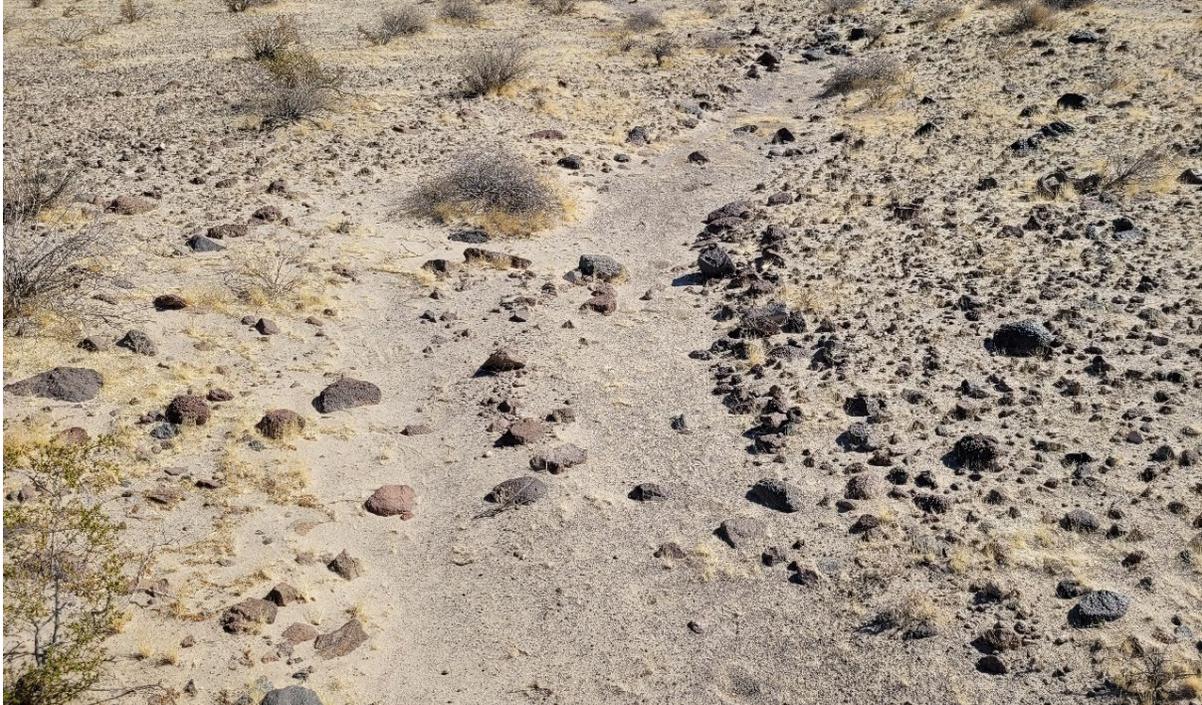
Photo Point S3-8-1 (South Array 3). Northeast facing representative photograph of drainages in the Study Area exhibiting weak indicators of a bed and bank and change in substrate.

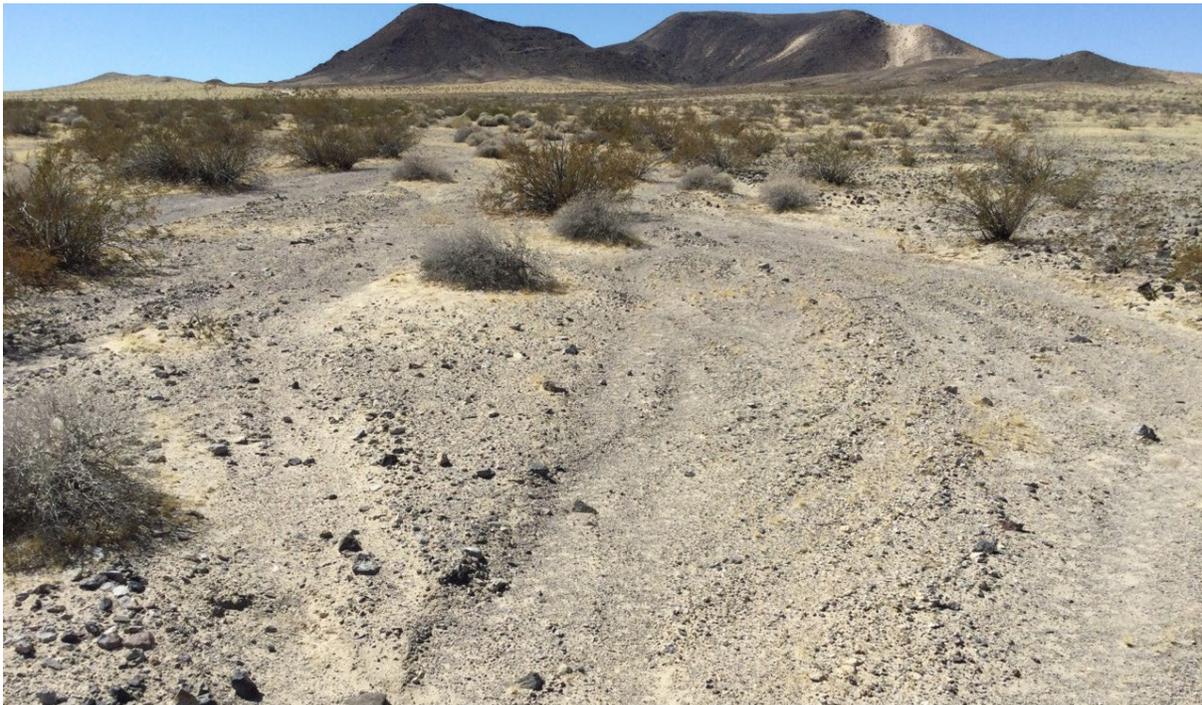
Photo Point S3-11-1 (South Array 3). West facing representative photograph of drainages in the Study Area exhibiting weak indicators of a bed and bank and change in substrate.

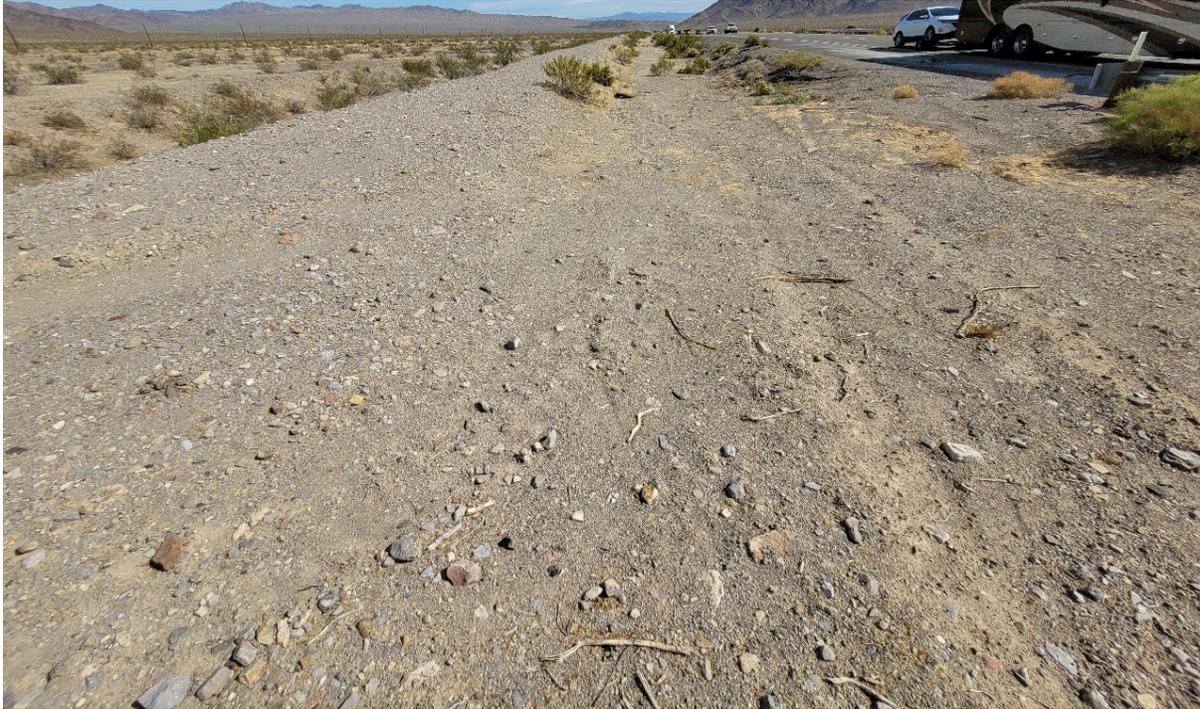
Photo Point T-1 (Gen-Tie Corridor). Northeast facing representative photograph illustrating a floodplain control ditch paralleling Interstate 15, facing downstream.

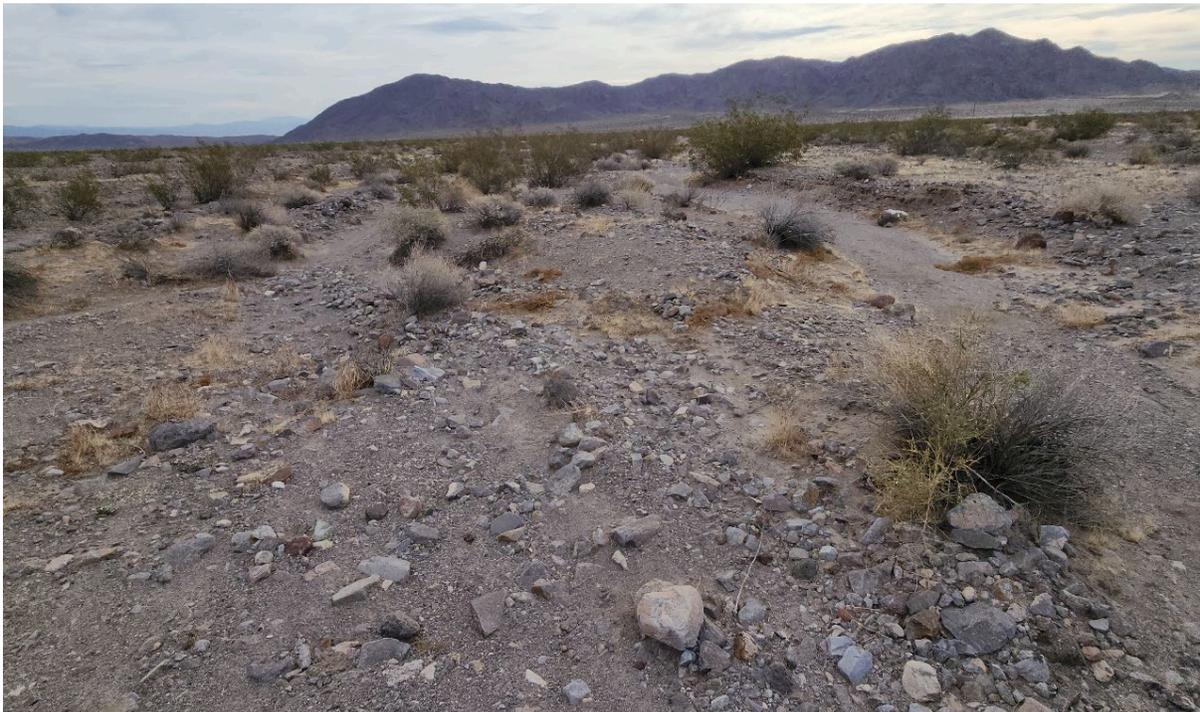
Photo Point T-11 (Gen-Tie Corridor). East facing representative photograph illustrating braided drainages, facing downstream.

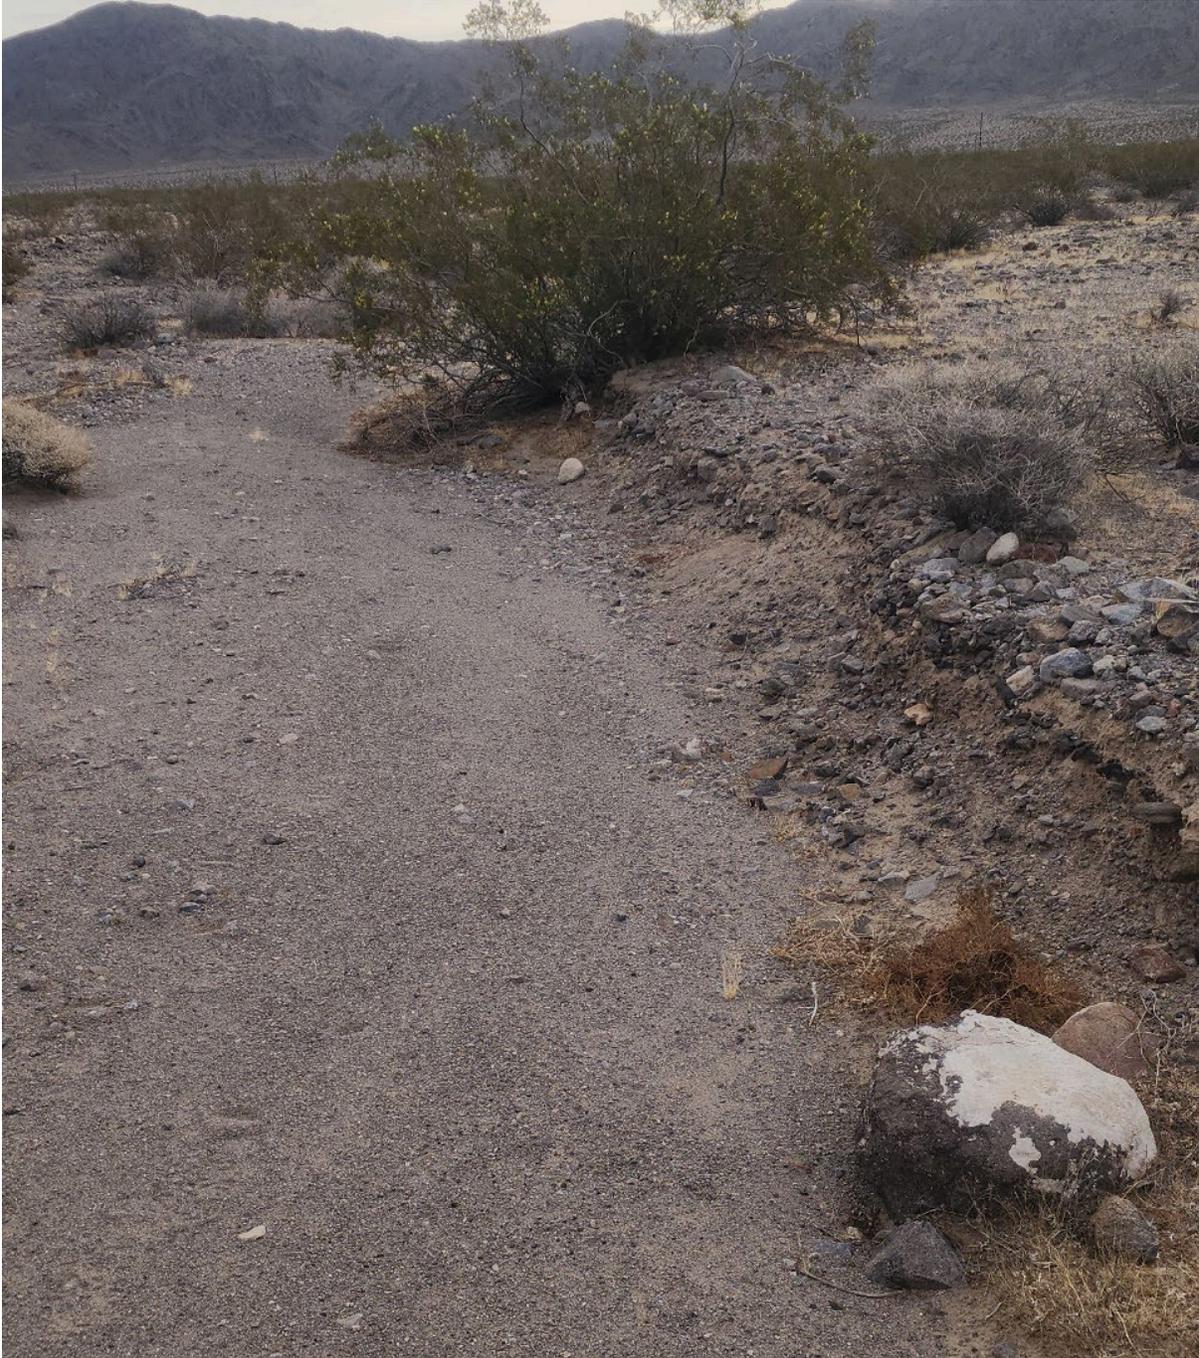
Photo Point T12 (Gen-Tie Corridor). East facing representative photograph illustrating indicators of an OHWM in a drainage feature, corresponding to ATG-005 Datasheet.

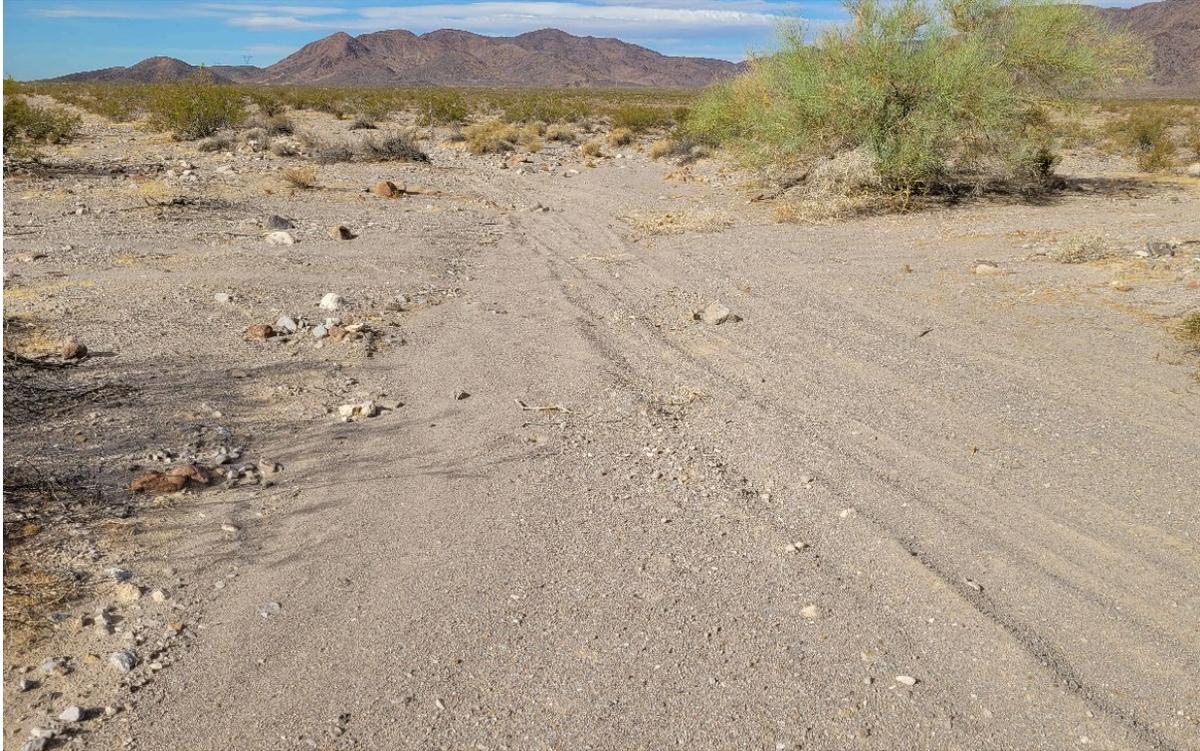
Photo Point T-5 (Gen-Tie Corridor). West facing view of drainage where indicators have been disturbed by vehicular activities.

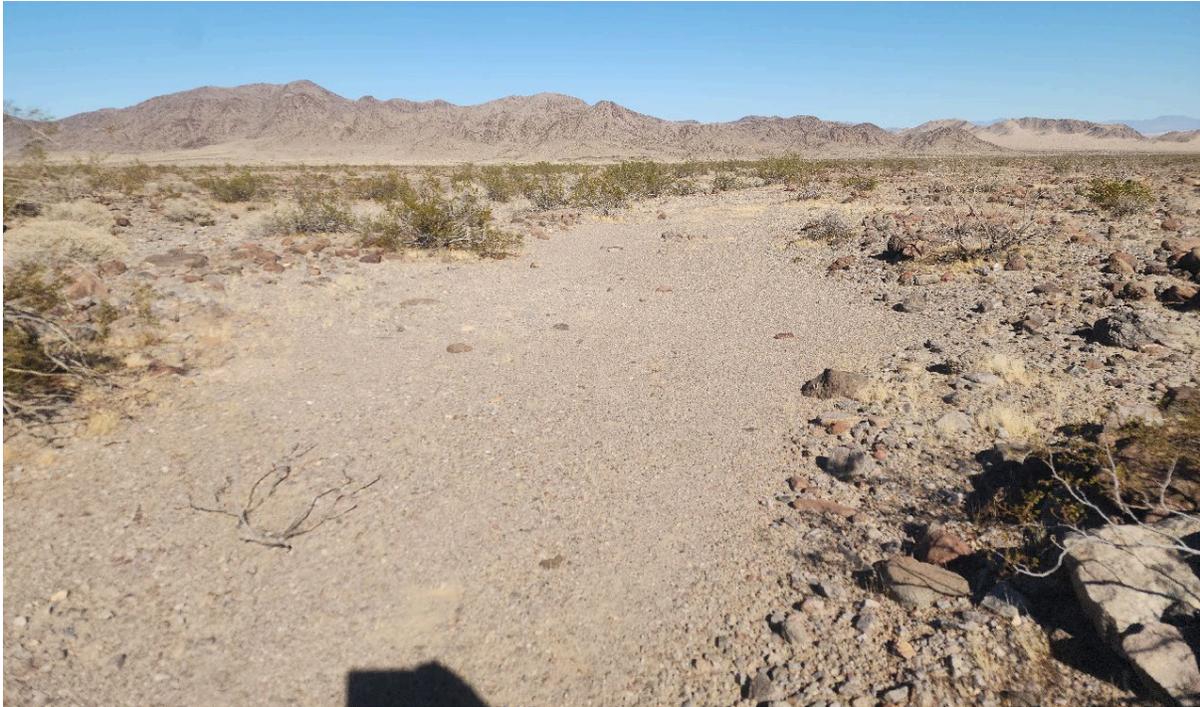
Photo Point S2-13-2 (South Array 2). East facing view of a representative area exhibiting indicators of historic sheet flow and swales and signs of desert pavement.
