Soda Mountain Solar Project

Aquatic Resources Delineation and Impact Analysis

March 2026

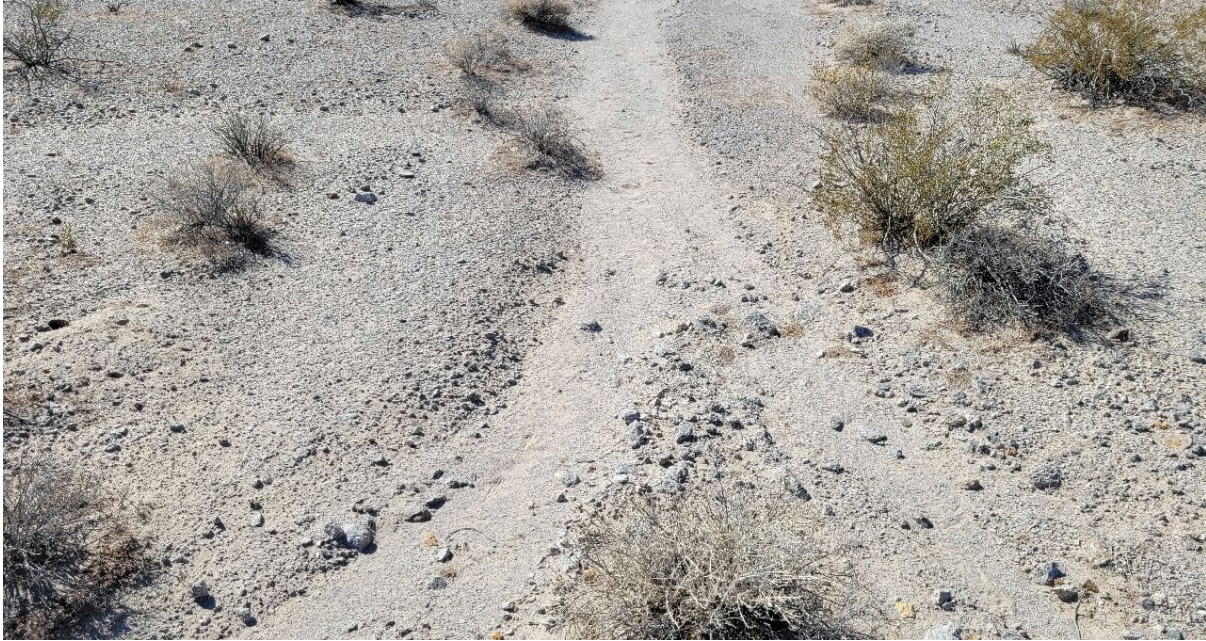
Photo Point E-4-1 (East Array). Northwestern facing representative photograph facing downstream of a small drainage exhibiting indicators of an OHWM.

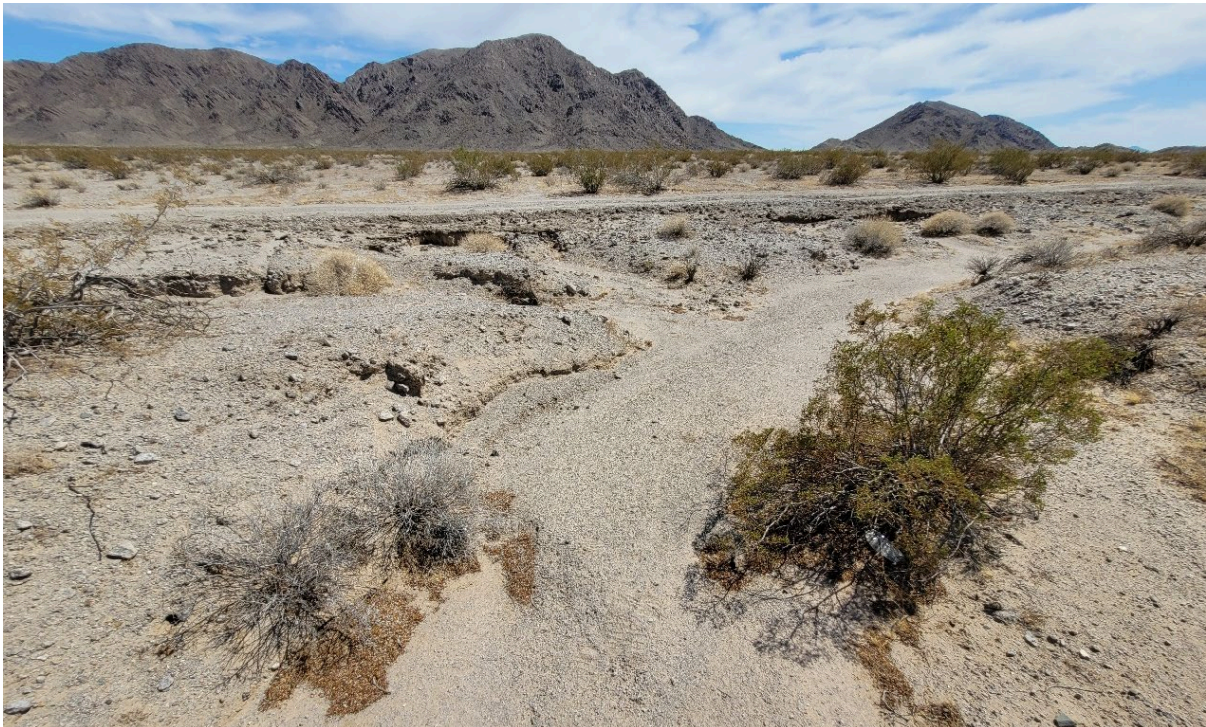
Photo Point E-6-3 (East Array). Southeast facing representative photograph of an upstream portion of a drainage exhibiting indicators of an OHWM.

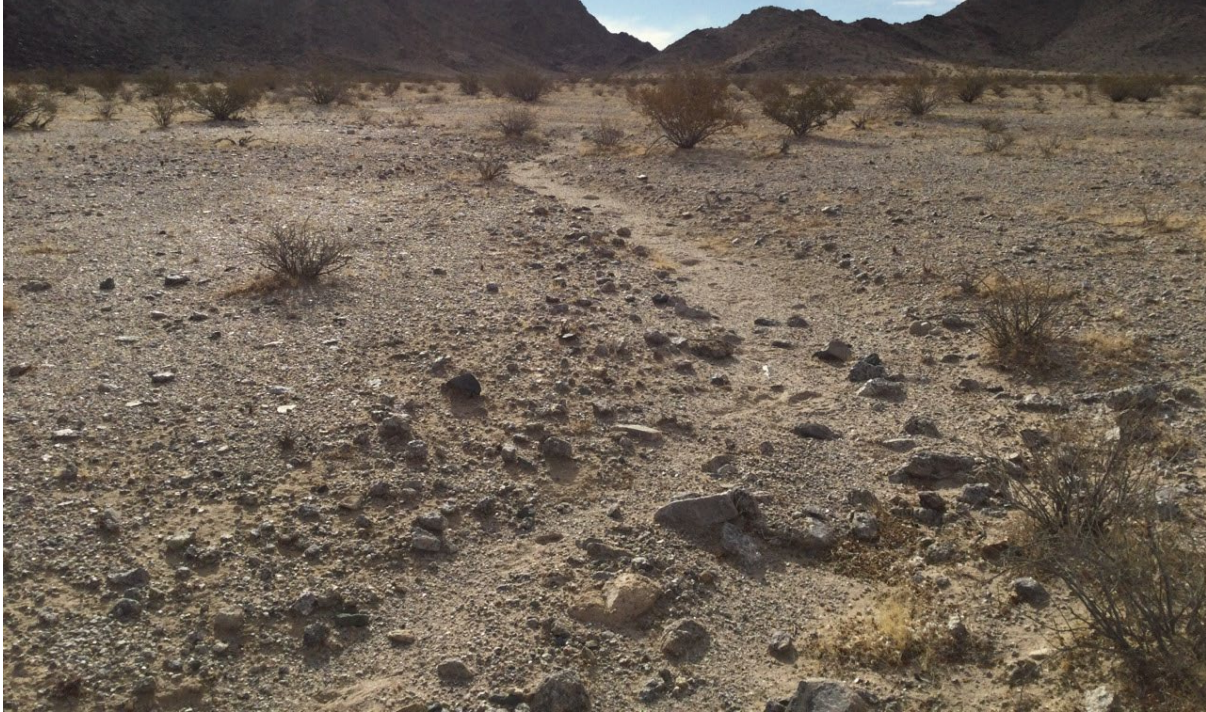
Photo Point E-11-3 (East Array). East facing representative photograph illustrating indicators of an OHWM, corresponding to the EK-003 Datasheet.

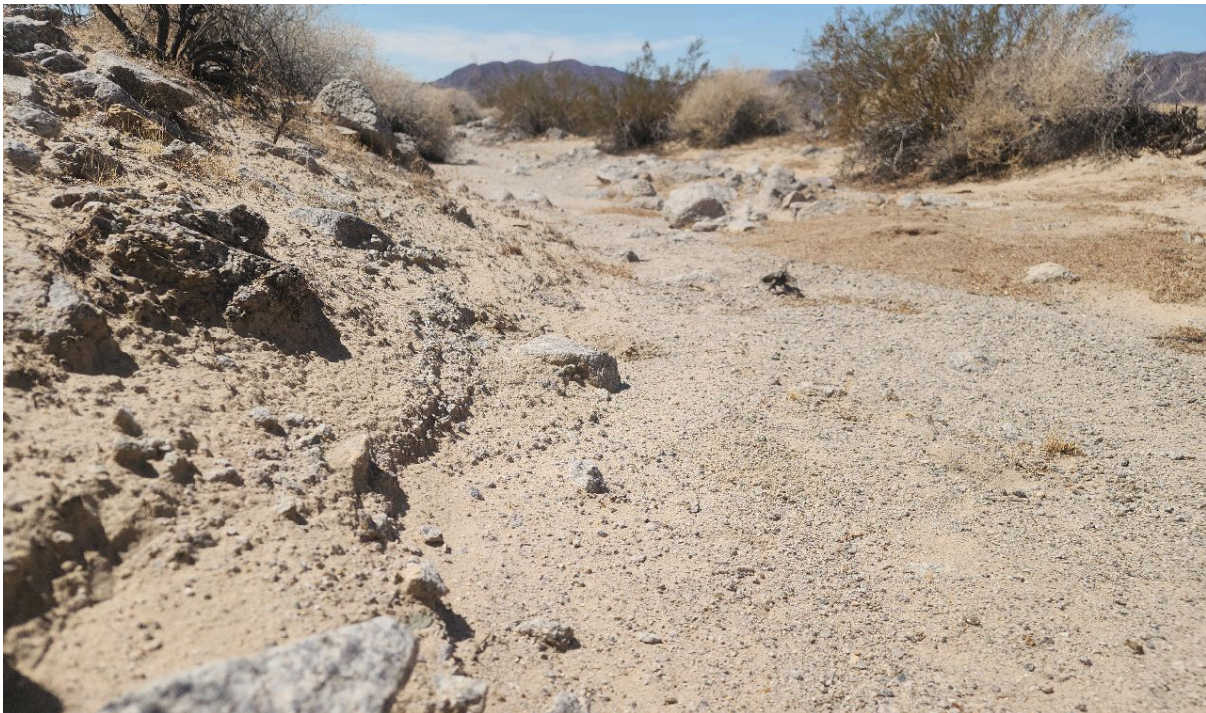
Photo Point E-7-3 (East Array). West facing representative photograph illustrating an OHWM and no riparian vegetation, corresponding to the ATG-004 Datasheet.

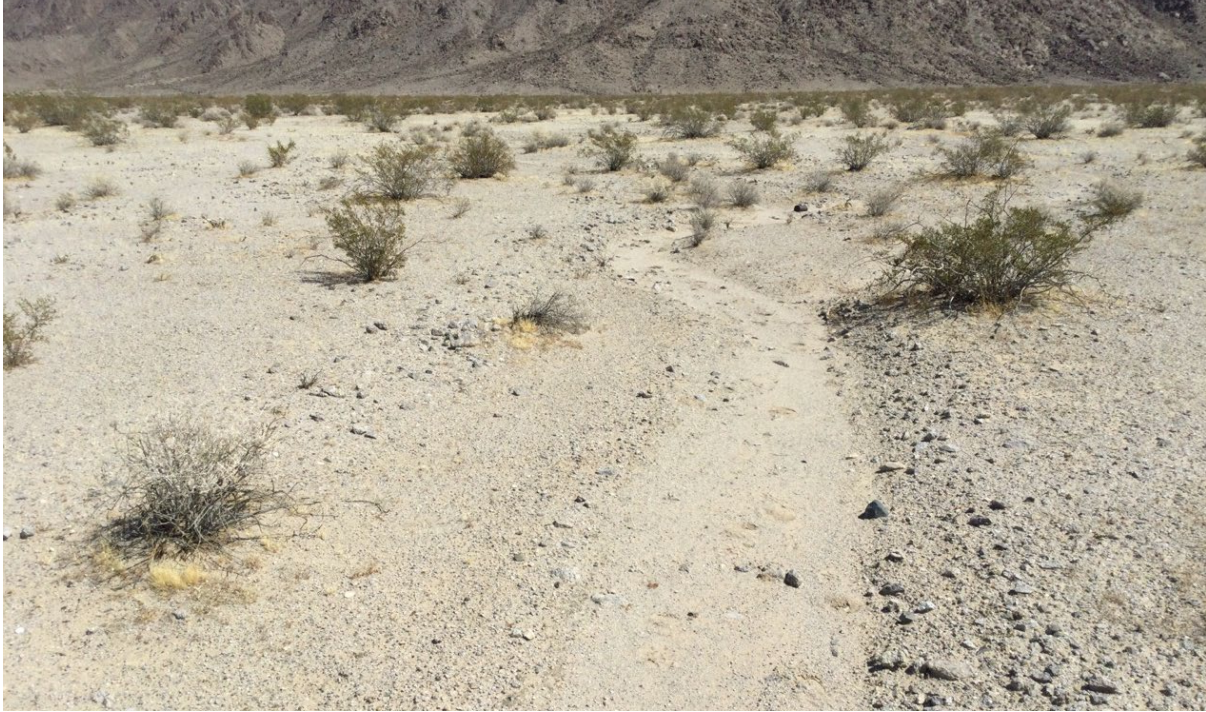
Photo Point E-9-2 (East Array). East facing representative photograph illustrating an upstream portion of a drainage exhibiting an OHWM and no riparian vegetation, corresponding to the EK-004 Datasheet.

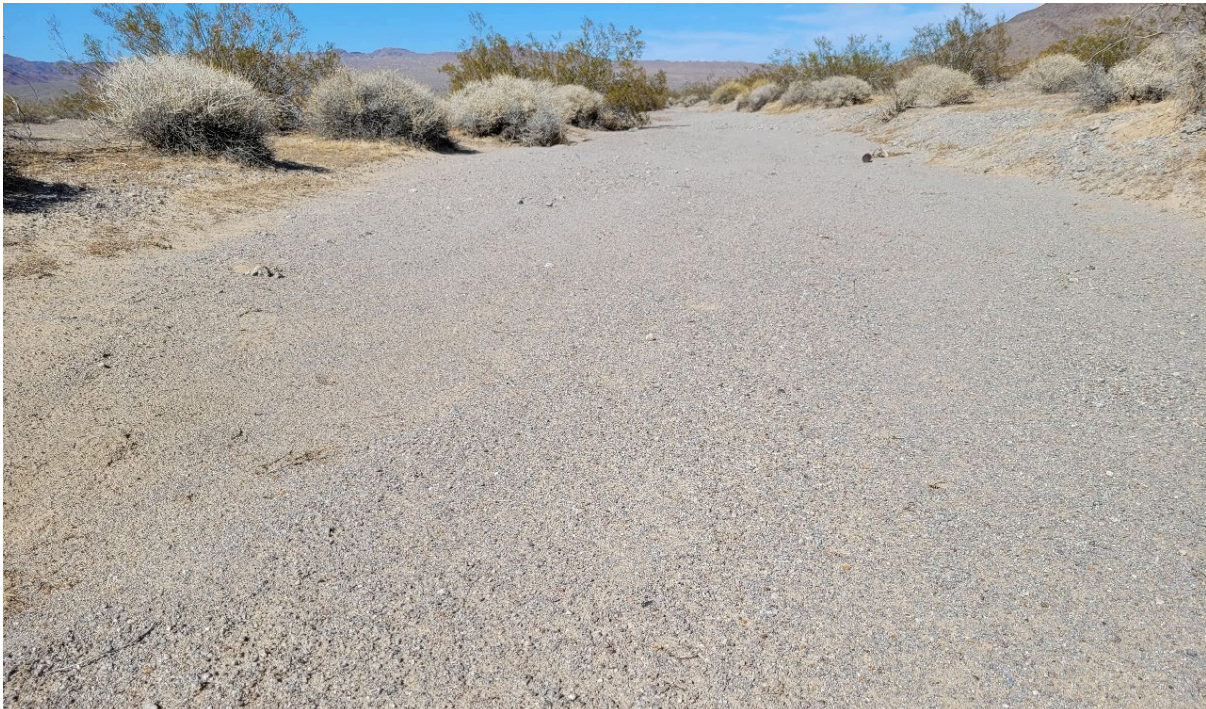
Photo Point E-5-3 (East Array). Northeast facing representative photograph illustrating indicators of an OHWM, corresponding to the KG-003 Datasheet.

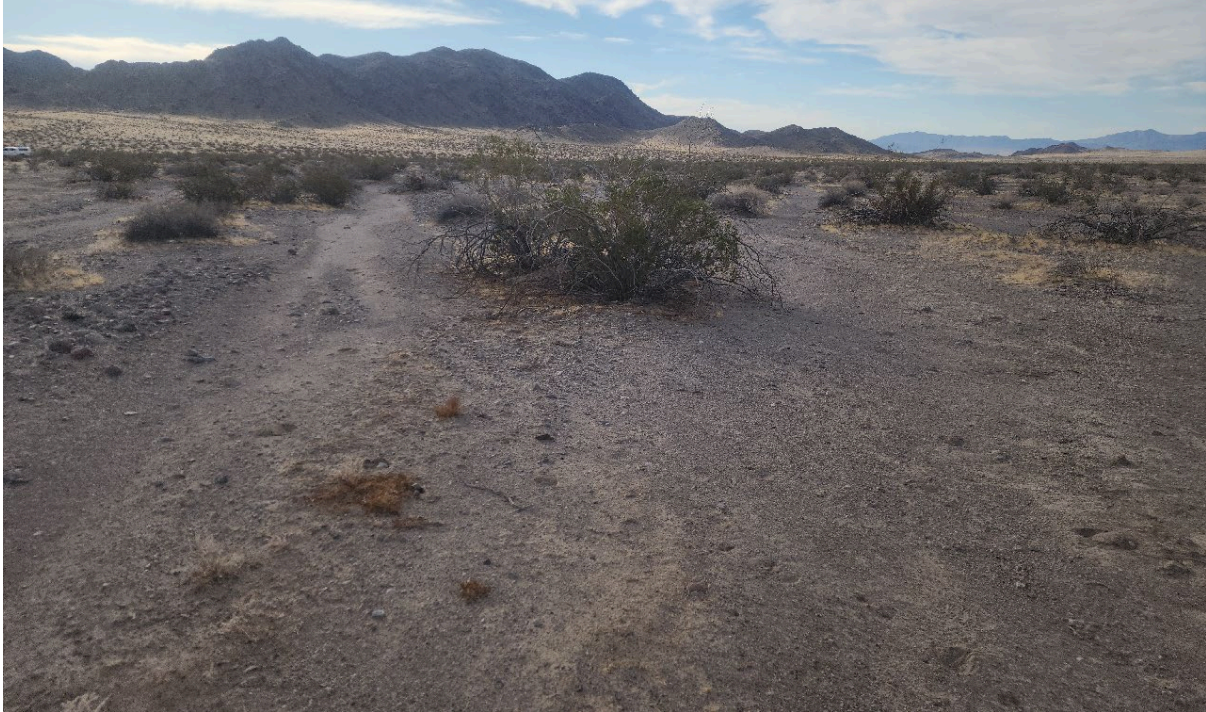
Photo Point S1-3-2 (South Array 1). East facing representative photograph illustrating an upstream portion of a drainage exhibiting an OHWM and no riparian vegetation, corresponding to the ATG-003 Datasheet.

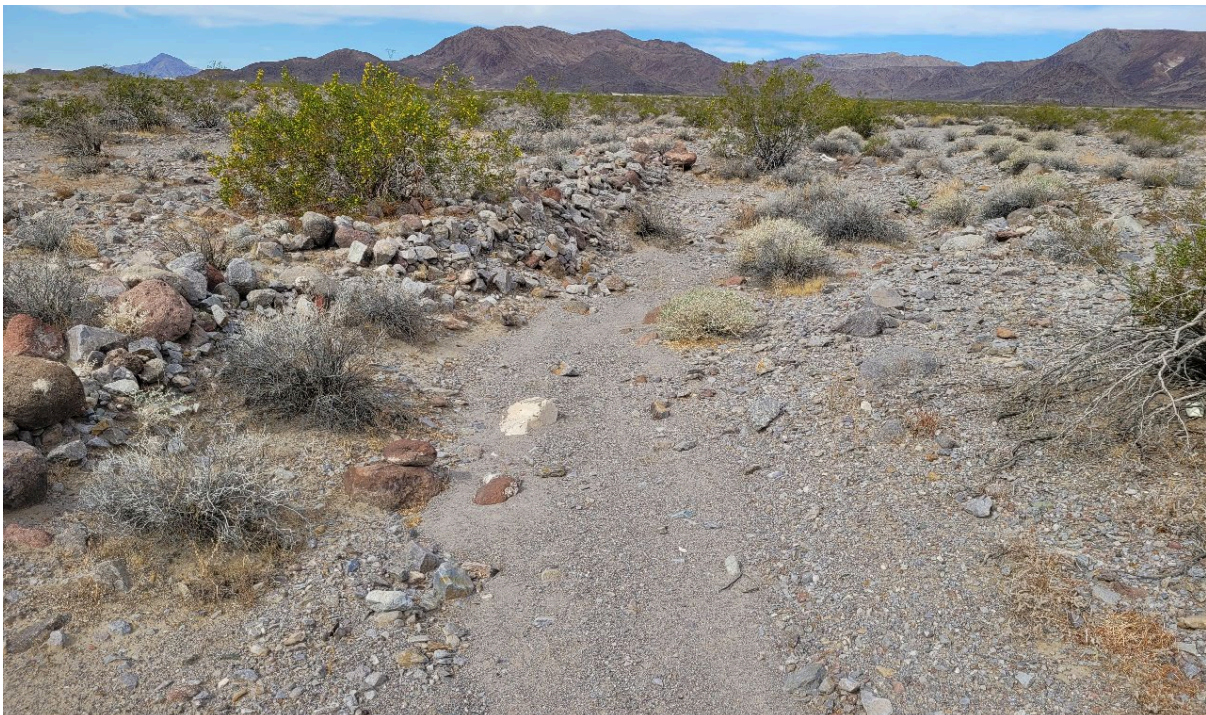
Photo Point S1-5-2 (South Array 1). Southwest facing representative photograph illustrating indicators of an OHWM, corresponding to the KG-001 Datasheet.

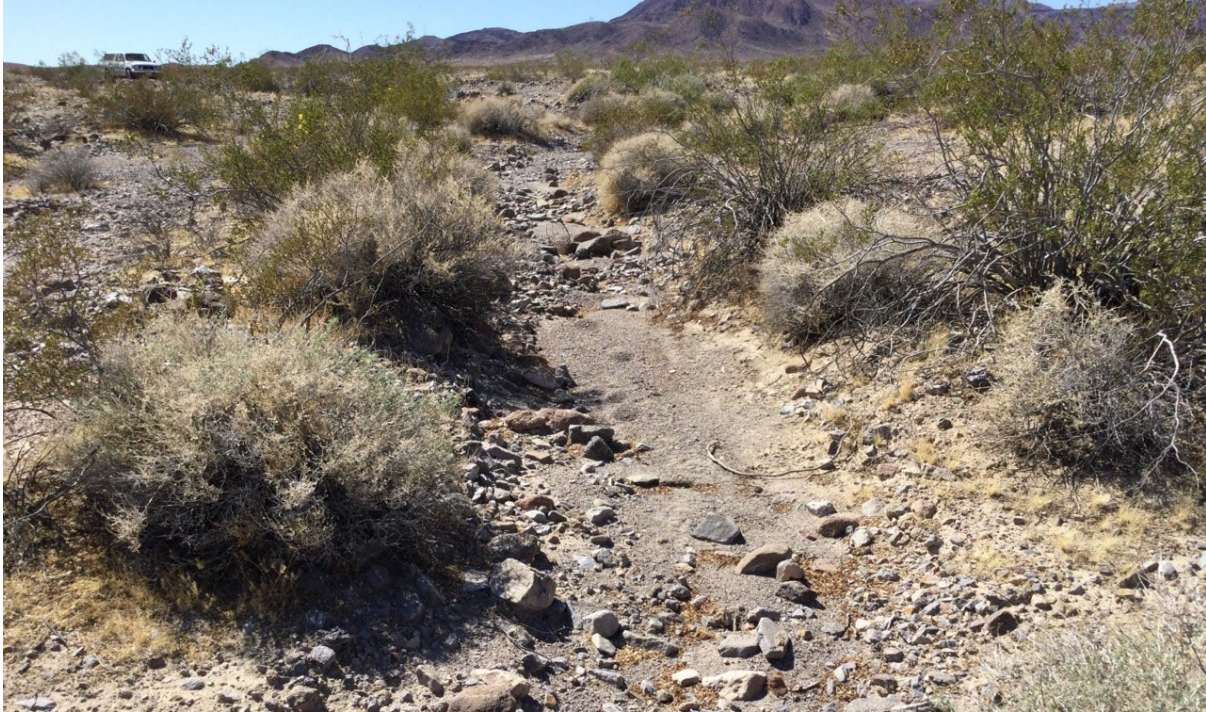
Photo Point S2-14-1 (South Array 2). West facing representative photograph of an upstream drainage feature exhibiting indicators of an OHWM.

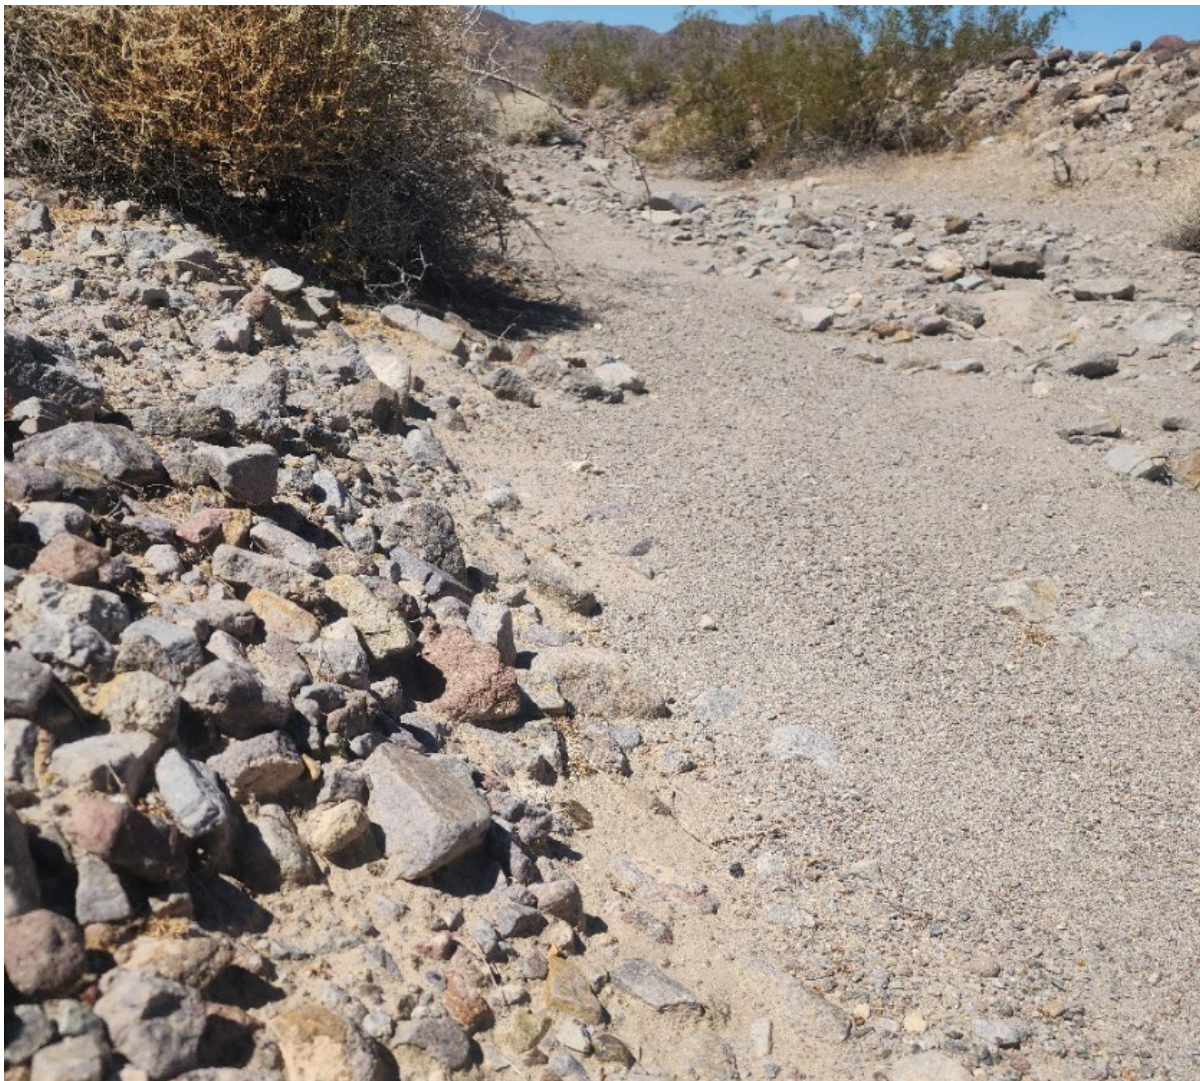
Photo Point S2-6-2 (South Array 2). West facing representative photograph of a drainage feature exhibiting indicators of an OHWM, corresponding to the ATG-002 Datasheet.

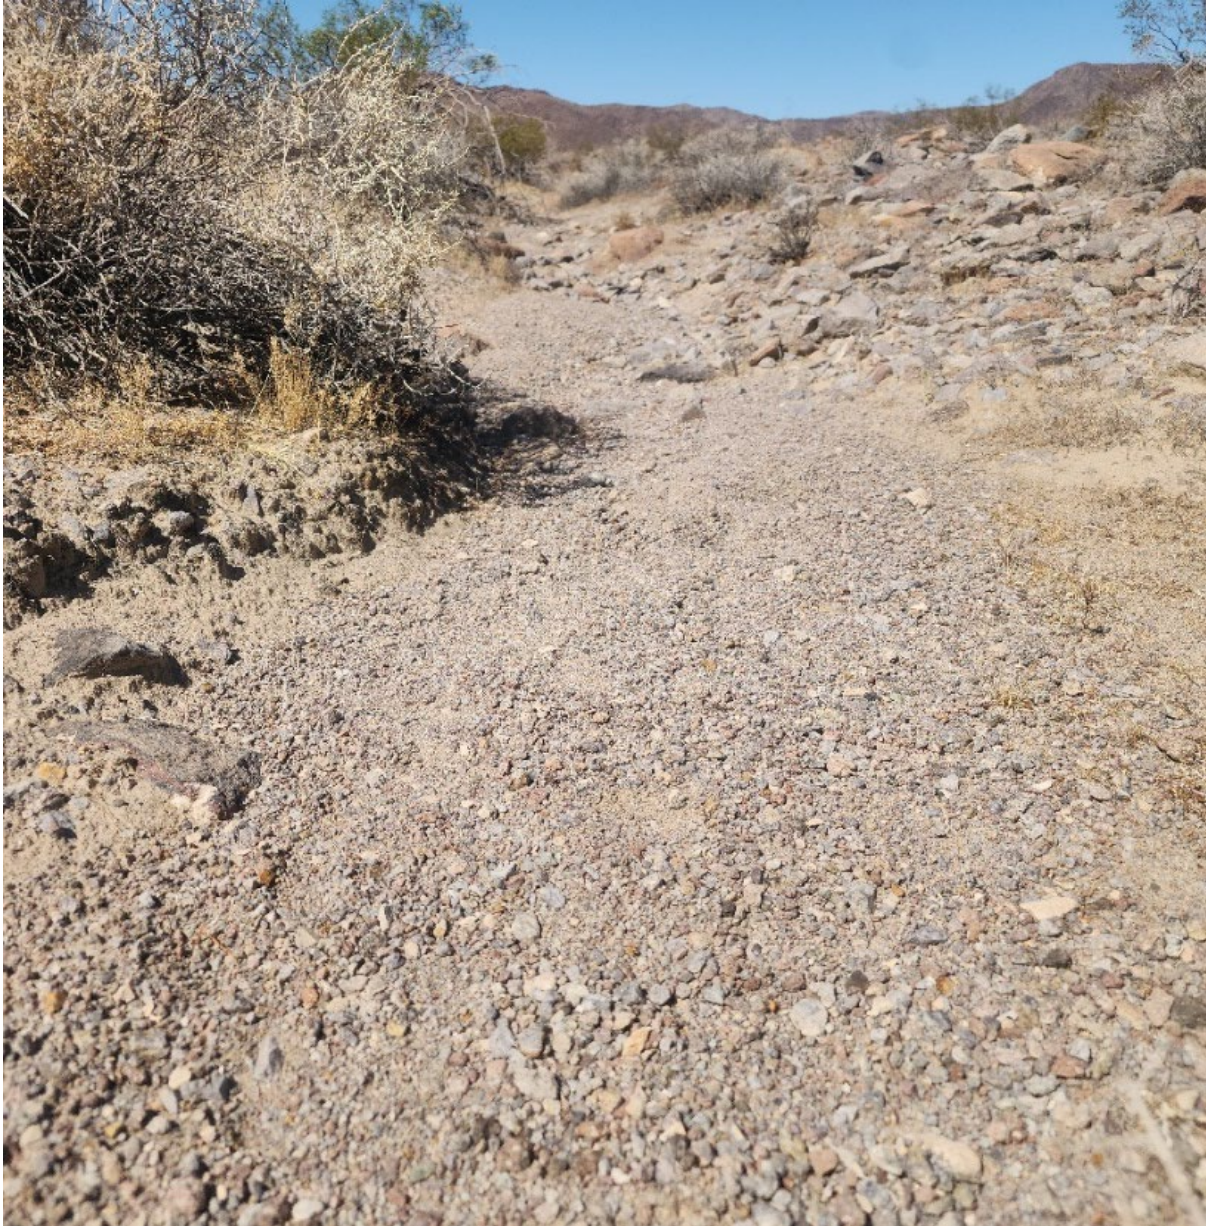
Photo Point S2-8-1 (South Array 2). East facing representative photograph of an downstream drainage feature exhibiting indicators of an OHWM, corresponding to the EK-001 Datasheet.

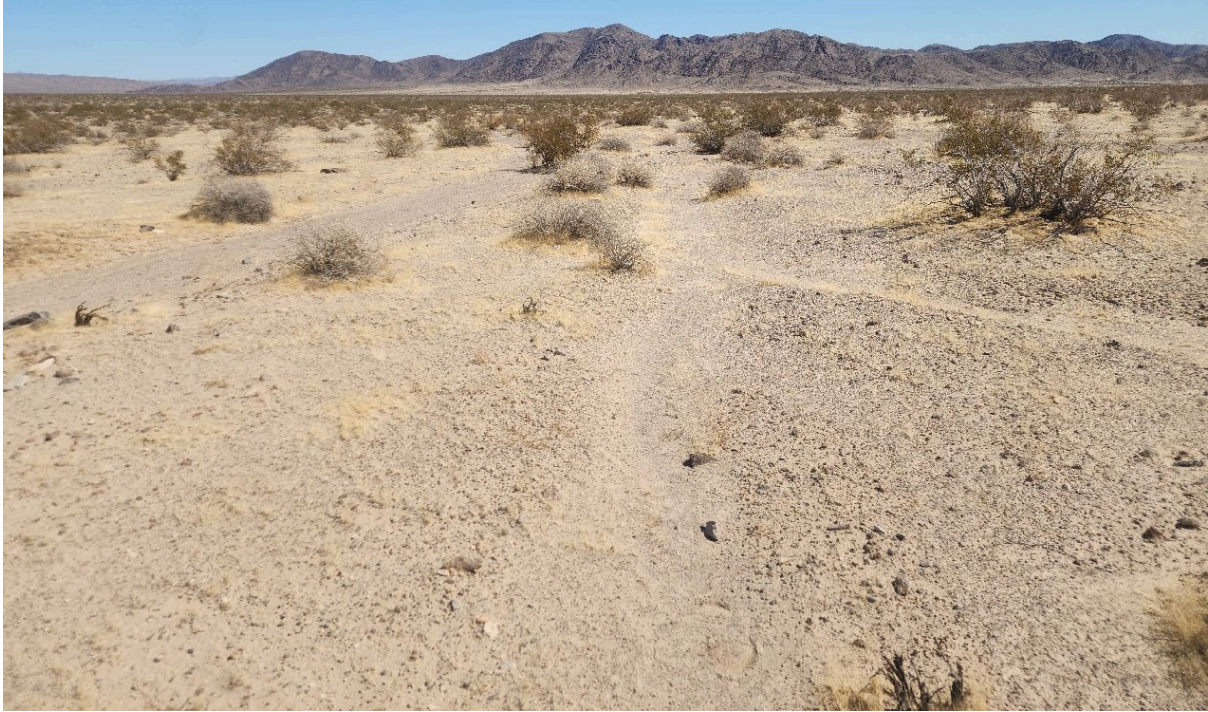
Photo Point S3-2-1 (South Array 3). Northeast facing representative photograph of drainages in the Study Area exhibiting weak indicators of a bed and bank and change in substrate.

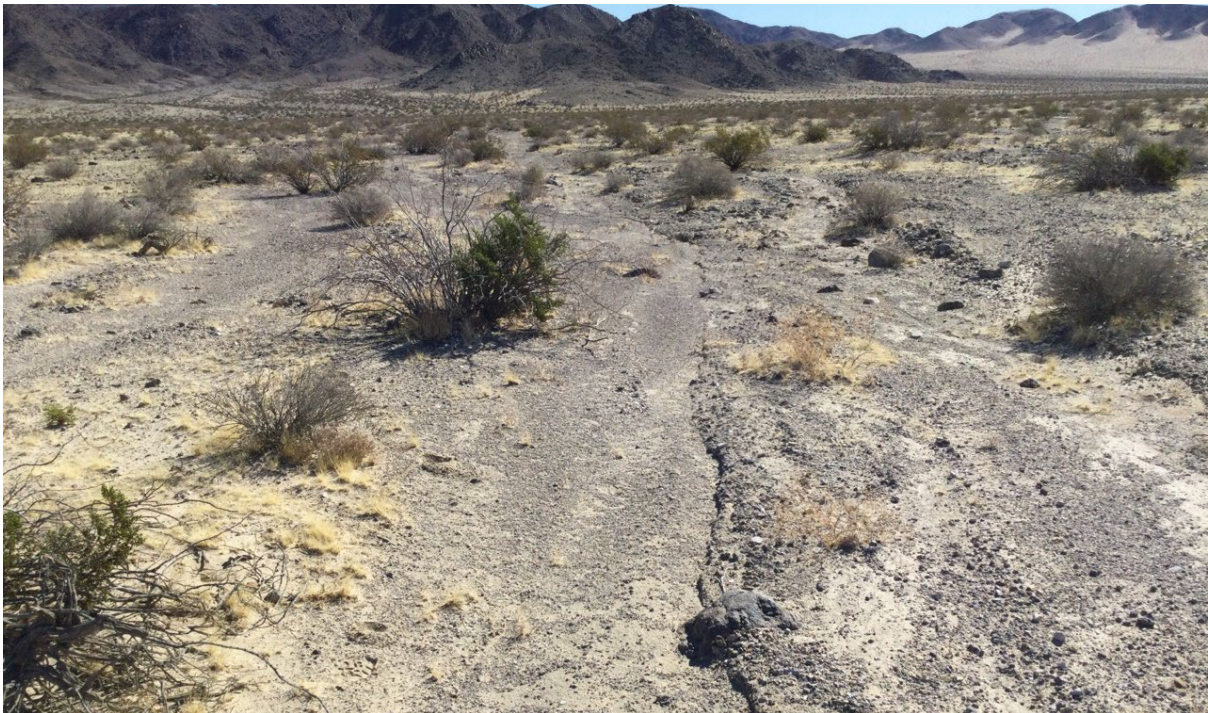
Photo Point S3-7-1 (South Array 3). East facing representative photograph of drainages in the Study Area exhibiting weak indicators of a bed and bank and change in substrate.

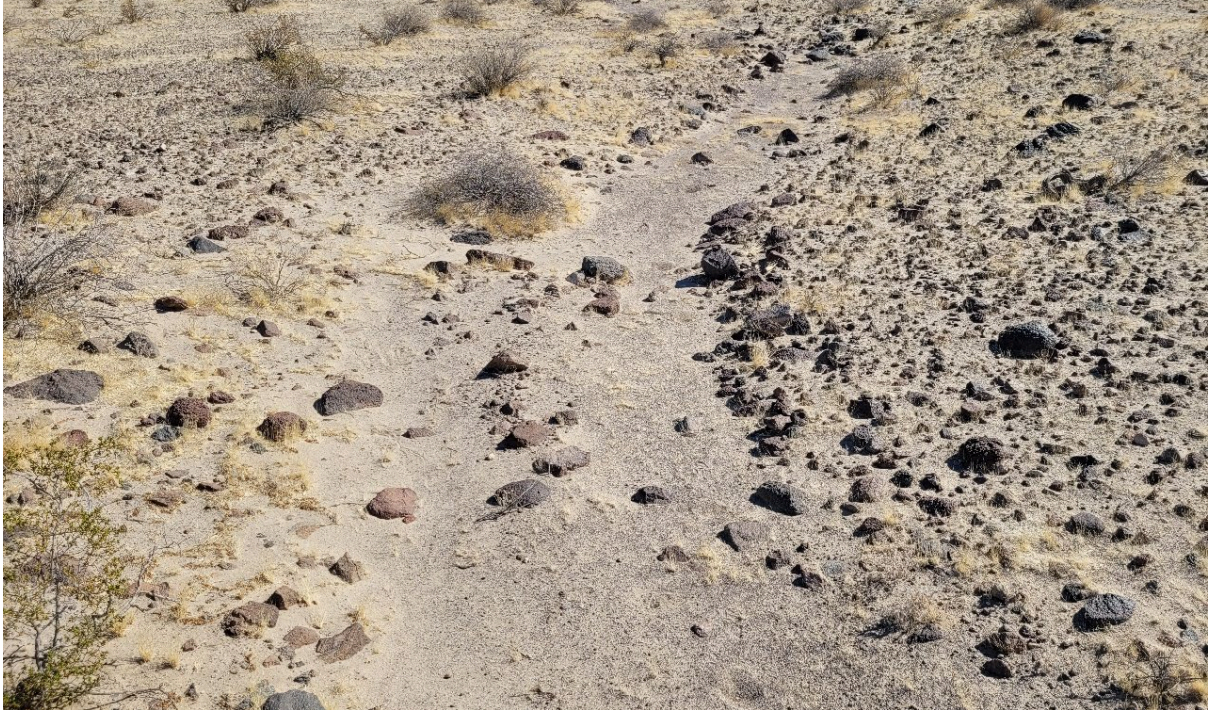
Photo Point S3-8-1 (South Array 3). Northeast facing representative photograph of drainages in the Study Area exhibiting weak indicators of a bed and bank and change in substrate.

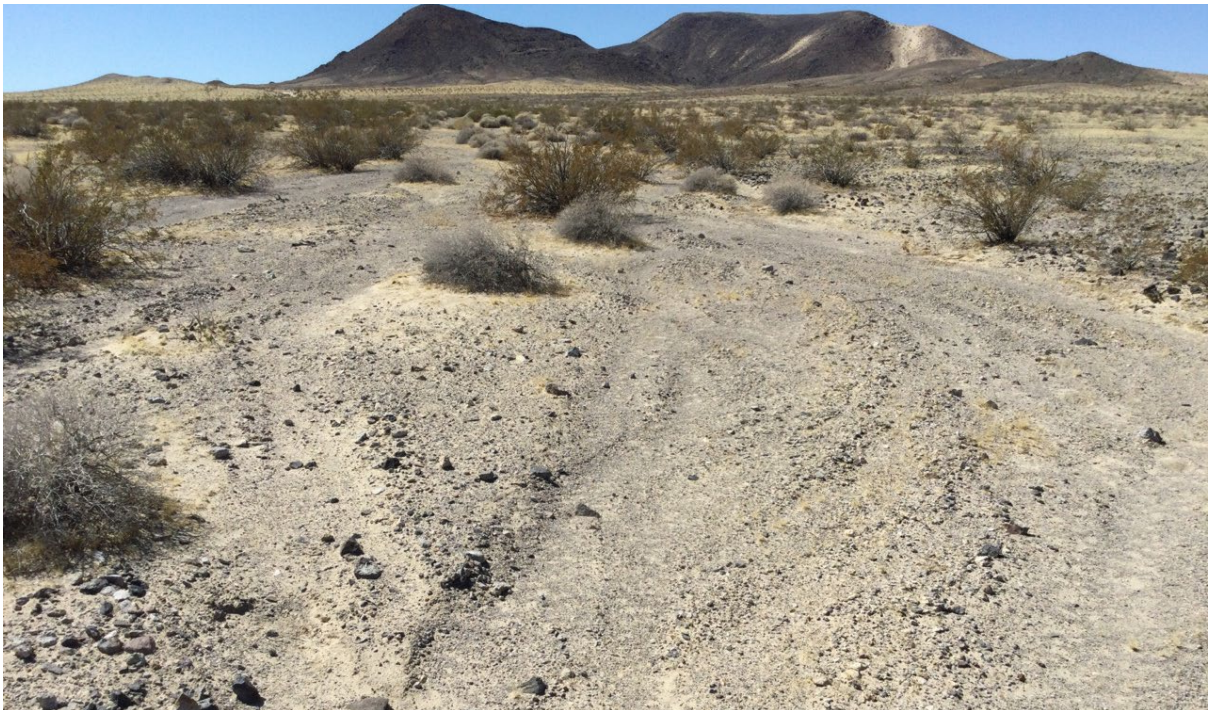
Photo Point S3-11-1 (South Array 3). West facing representative photograph of drainages in the Study Area exhibiting weak indicators of a bed and bank and change in substrate.

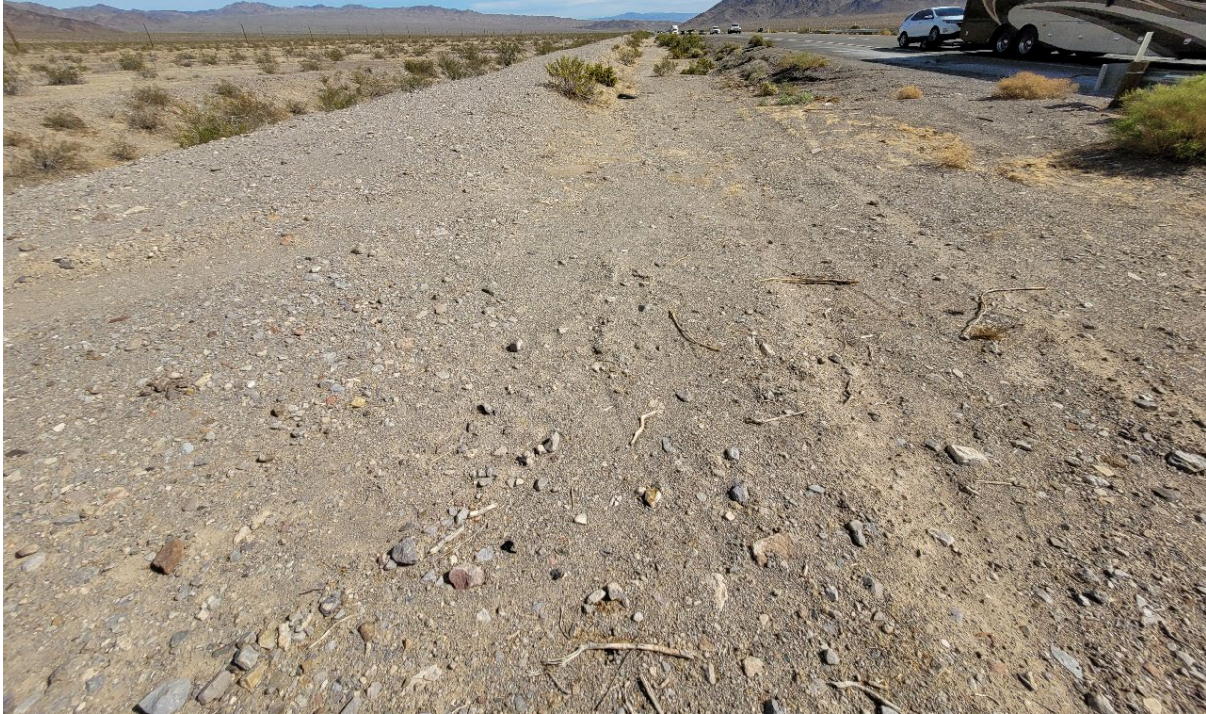
Photo Point T-1 (Gen-Tie Corridor). Northeast facing representative photograph illustrating a floodplain control ditch paralleling Interstate 15, facing downstream.

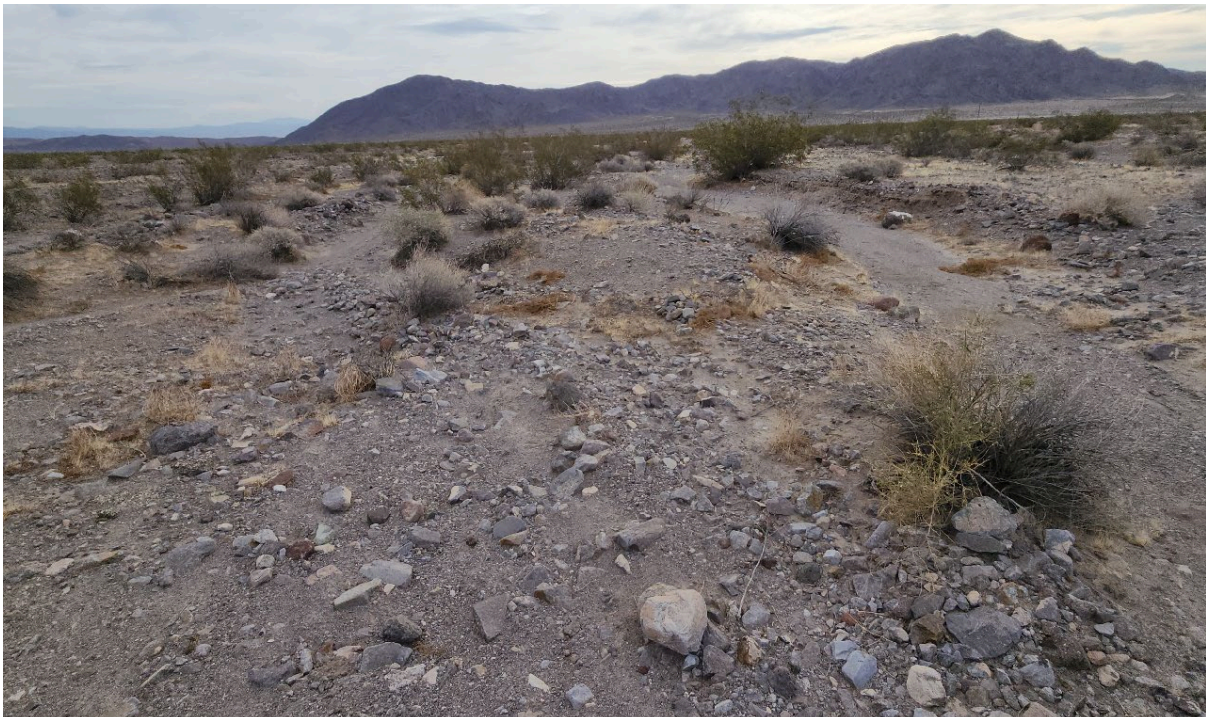
Photo Point T-11 (Gen-Tie Corridor). East facing representative photograph illustrating braided drainages, facing downstream.

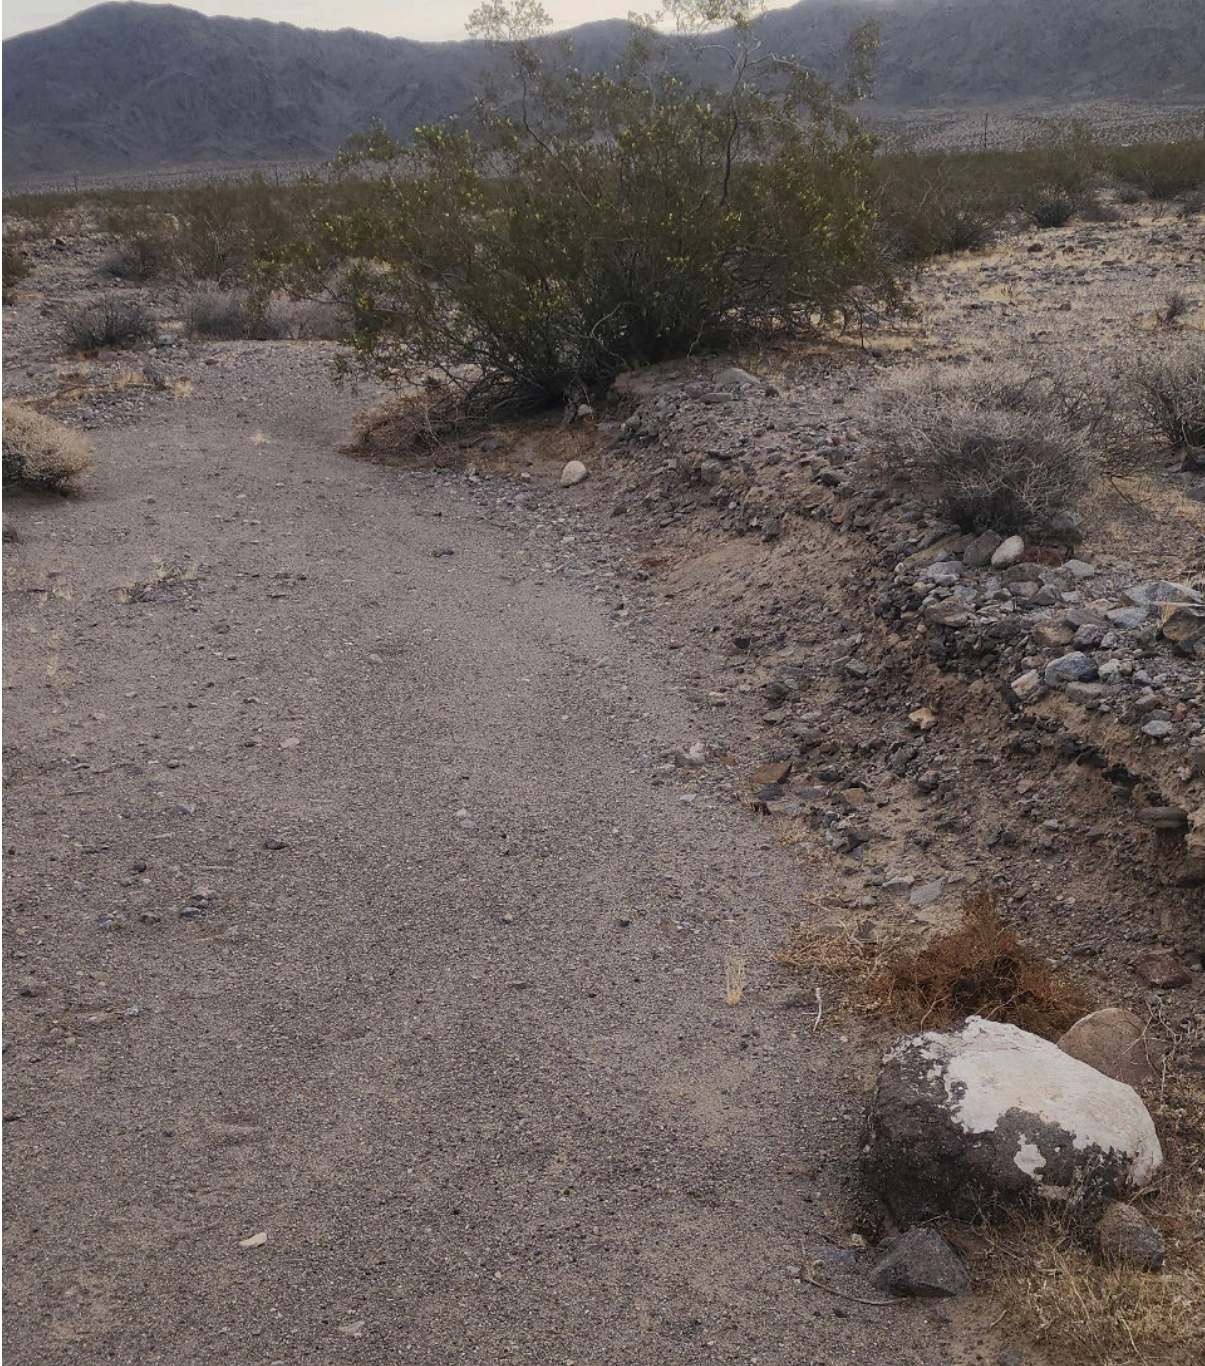
Photo Point T12 (Gen-Tie Corridor). East facing representative photograph illustrating indicators of an OHWM in a drainage feature, corresponding to ATG-005 Datasheet.

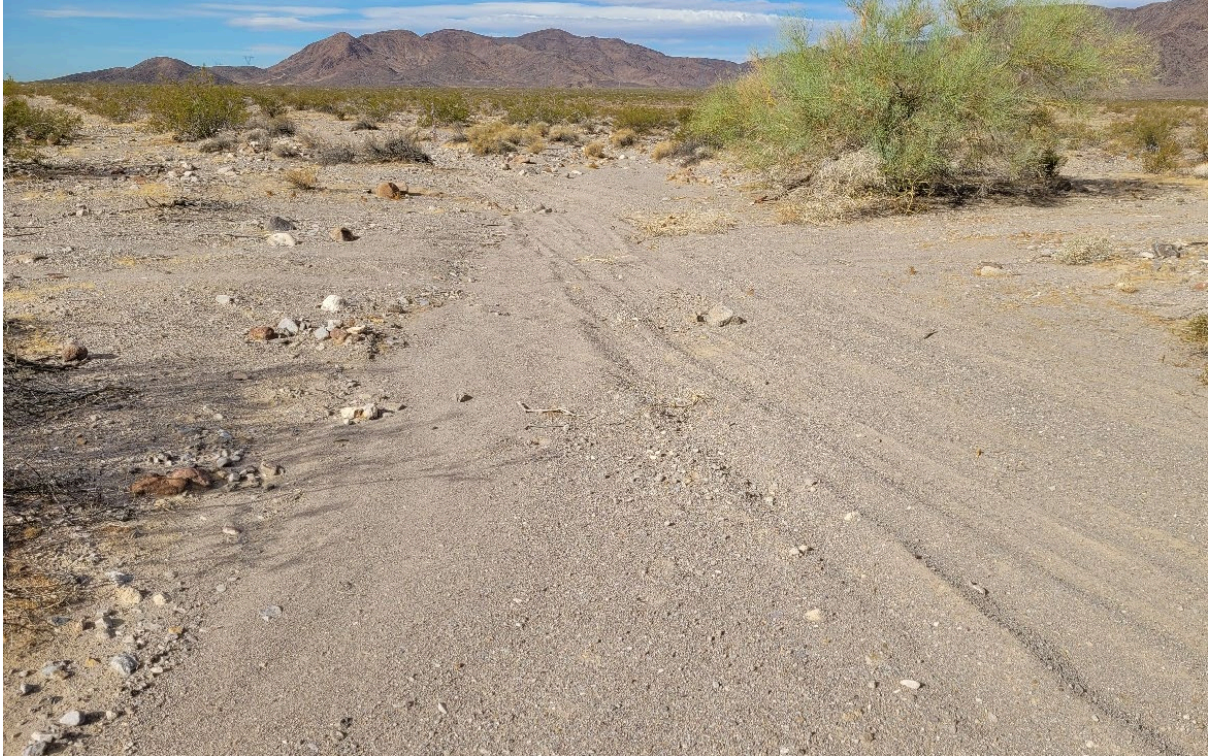
Photo Point T-5 (Gen-Tie Corridor). West facing view of drainage where indicators have been disturbed by vehicular activities.

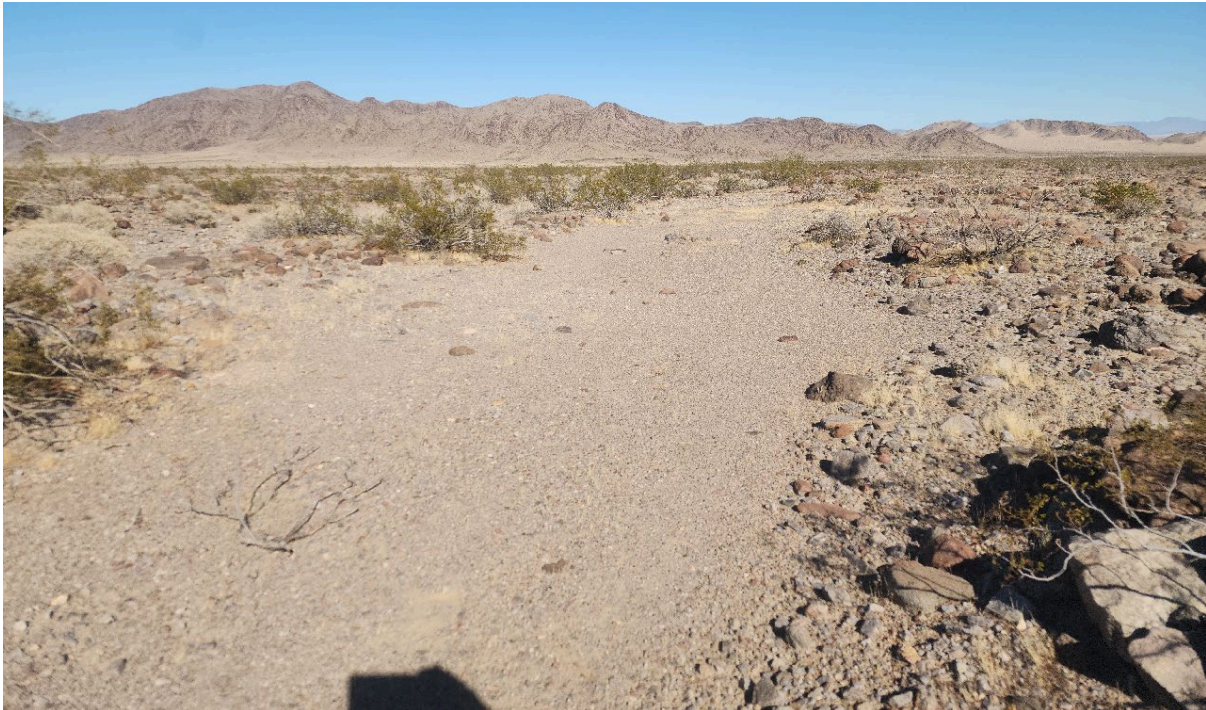
Photo Point S2-13-2 (South Array 2). East facing view of a representative area exhibiting indicators of historic sheet flow and swales and signs of desert pavement.
