Downstream Impact Report

***Seahawk Battery Storage
90 Minto Road, Watsonville, CA
APN 051-101-77***

Storm Water Control Operation and Maintenance Plan

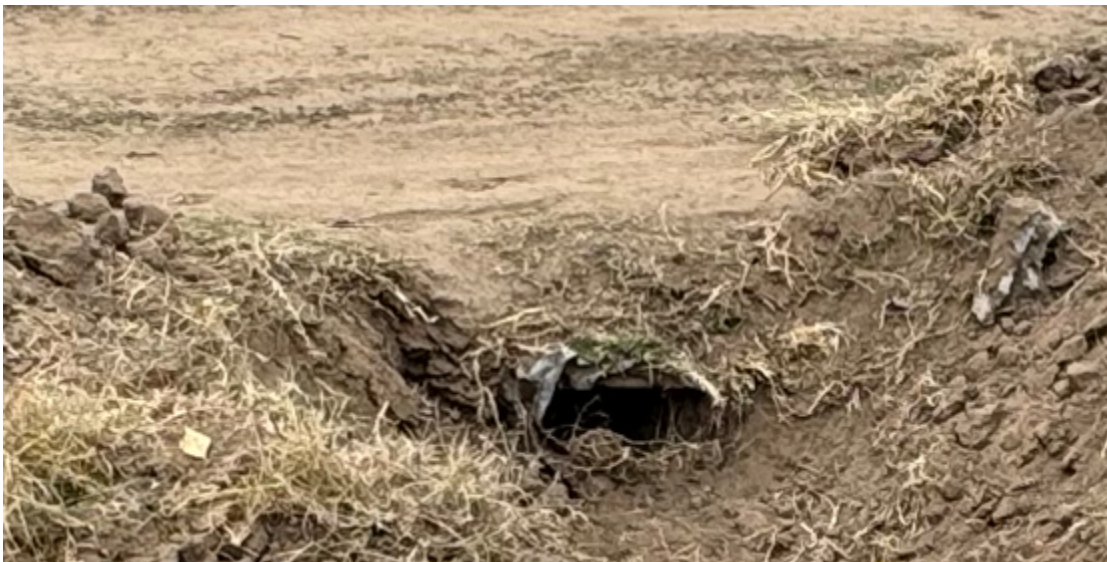
FIGURE 4: EXISTING 15-INCH CMP CULVERT

In evaluating the existing 15-inch CMP culvert, C2G has both visually inspected the pipe and have provided some calculations determining it's capacity.

In reviewing the condition of the existing 15-inch Culvert, damage has been identified at the pipe entrance, and appears to be smashed from the weight of a tractor and/or equipment and should be repaired by cutting and removing a portion of pipe, installing a coupler and extending a new potion of 15-inch pipe at the entrance of the pipe.

In reviewing the outfall of the 15-inch pipe, there appeared to be no damage and/or lack of maintenance (See image below). The pipe appeared to be clear of any debris and aligned with the existing flowline of the downstream swale. There was also no sign of erosion at or around the outfall. There are no recommendations for improvements at the outfall of the 15-inch pipe.

The existing 15-inch pipe has an approximate slope of 2%. Based on this information, C2G has conducted a capacity analysis which shows that the 15-inch pipe can convey up to 9.73 CFS, which exceeds the 10-year flow rate noted above.

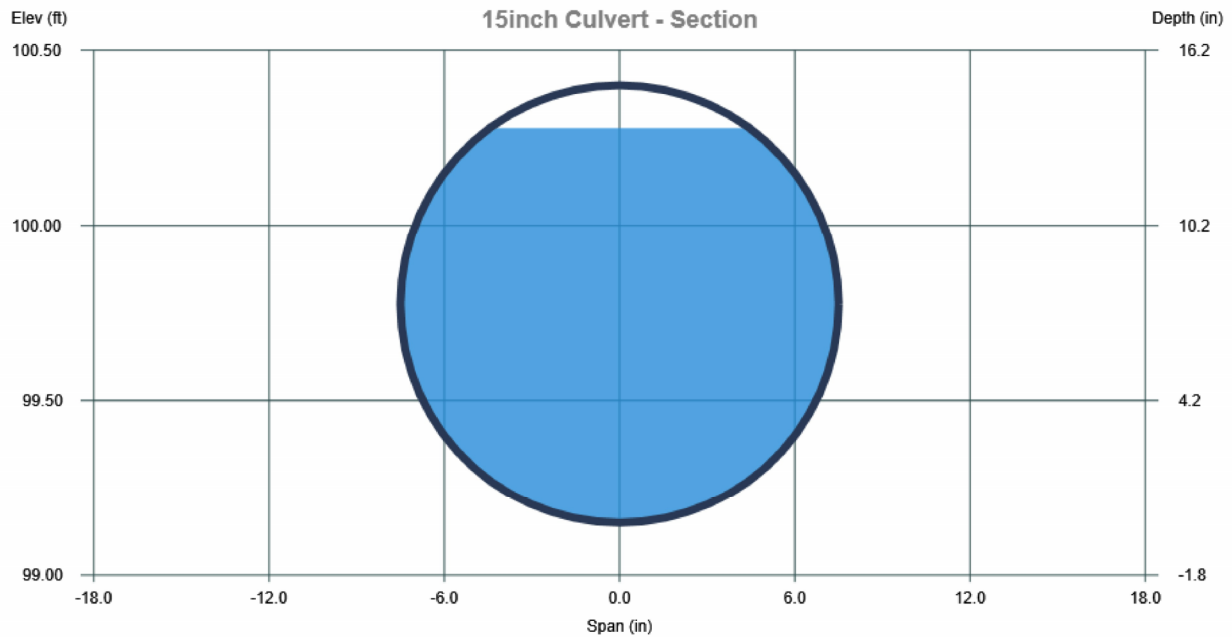
15inch Culvert

CIRCULAR PIPE

Diameter = 15.0 in
 Invert Elevation = 99.15 ft
 Pipe Slope = 2.000 %
 Manning's n = 0.013

Method = Q vs Depth
 Q Min = 0.19 cfs
 Q Max = 9.13 cfs
 Increments = 10

Flow	Depth	Area	Velocity	WP	n-value	Crit Depth	HGL	EGL	Max Shear	Top Width
(cfs)	(in)	(sqft)	(ft/s)	(ft)		(in)	(ft)	(ft)	(lb/sqft)	(ft)
9.73	13.5	1.16	8.37	3.12	0.013	14.2	100.3	101.36	1.40	0.75

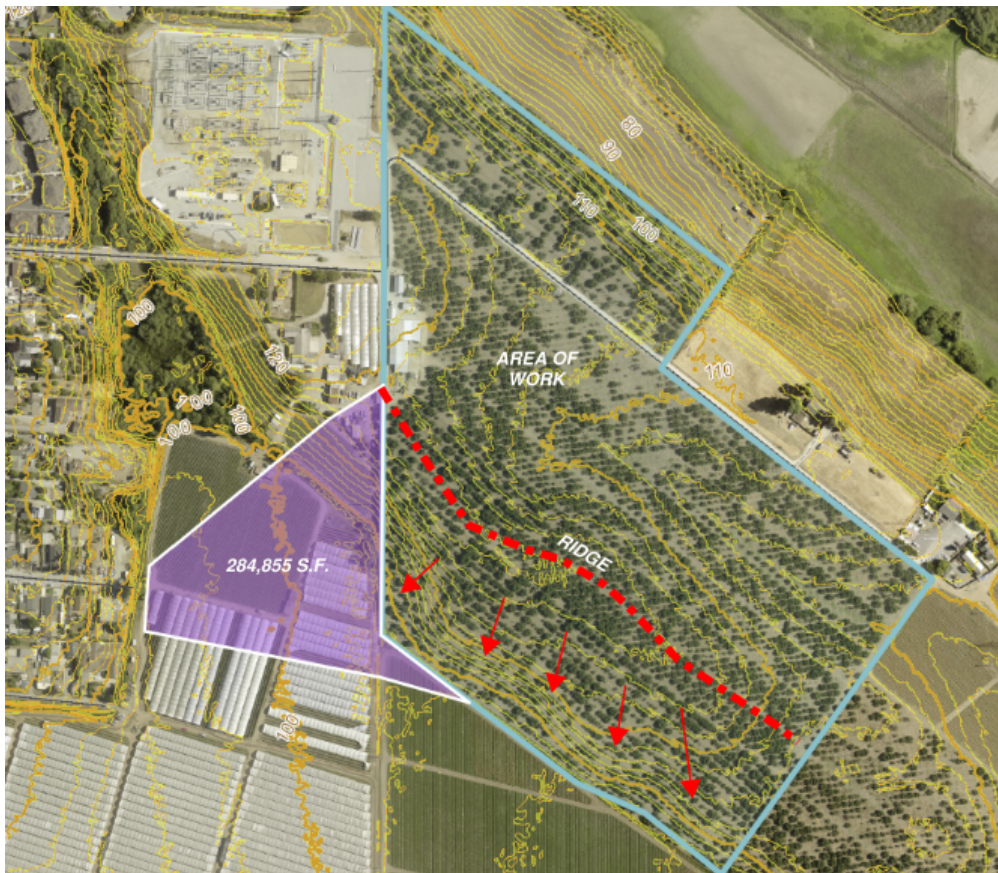
Existing conditions on the site result in runoff draining west to the southeast. There is no existing storm drains on or near the project site.

Stormwater run-on occurs west and south of the property. At the southwesterly corner of the property, approximately 6.5-acres drains to the project property. Based on the existing ridge, identified from the county contours, this portion of upstream run-on is diverted away from the area of work.
