## PHASE I ENVIRONMENTAL SITE ASSESSMENT

Bottle Rock Geothermal Facility  
7385 High Valley Road  
Cobb, Lake County, California 95426

**Open Mountain Energy**

**Wood**

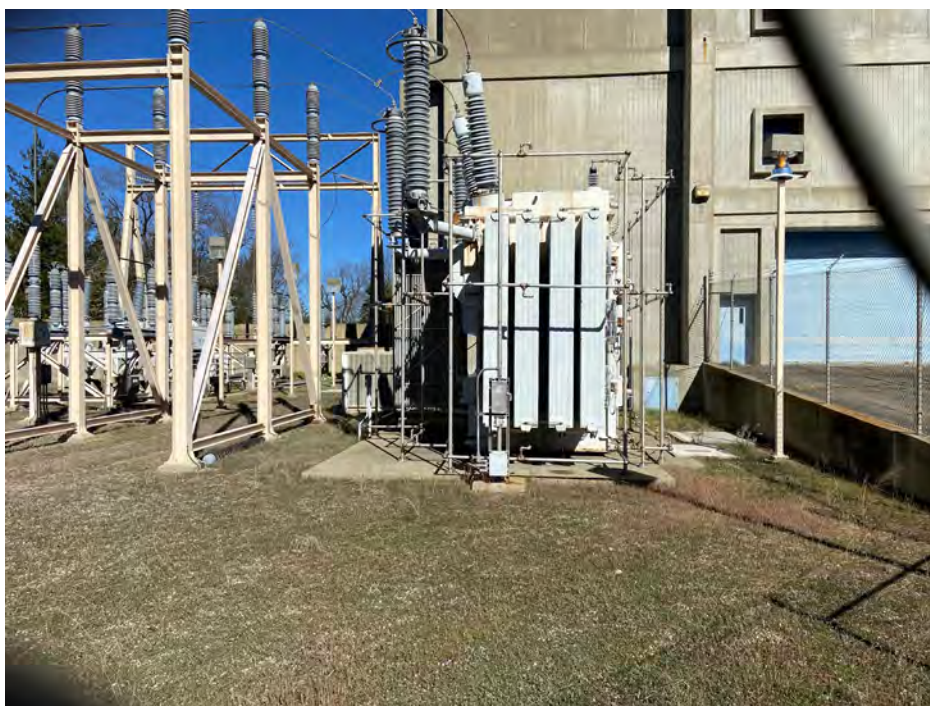
**Photo 3**

Wood observed four transformers on the Site associated with the power plant facility. Three of the transformers are owned by the Site and were installed sometime between 1983 and 1984, based on the attached name plates. One transformer is owned by PG&E and appears to have been recently installed. The transformers are located on concrete pads. A *de minimis* stain was observed on the concrete pad below the transformer located in the switchyard. No other concrete or soil stains were observed near the transformers.

View of the large transformer located in the switchyard area west of the Main Plant Building. Note small stain directly below the transformer on concrete pad. (facing west)

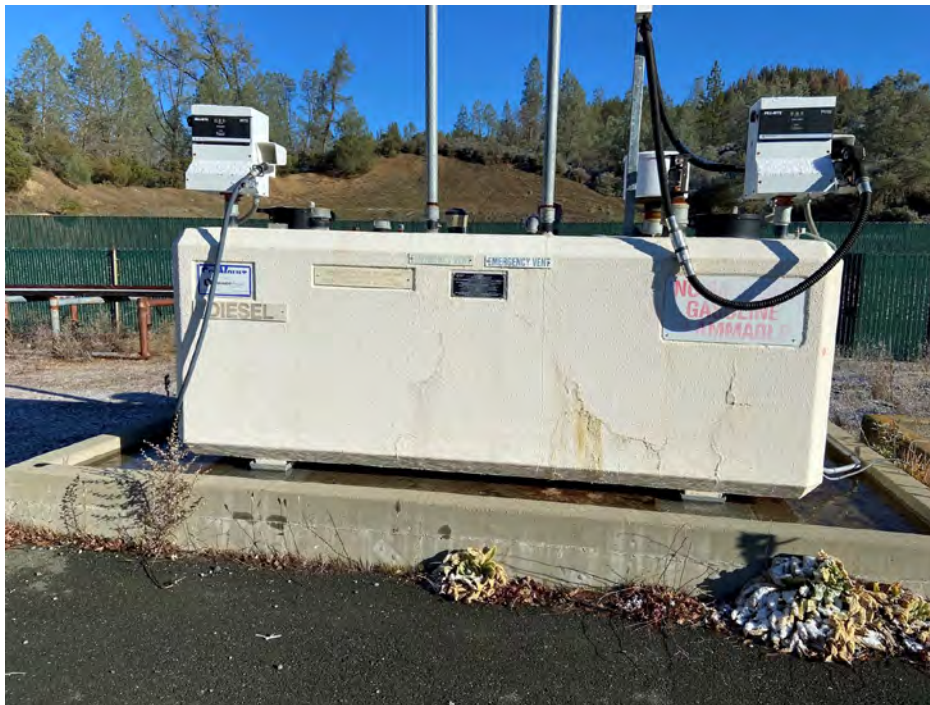
**Photo 5**

Wood observed several above ground storage tanks (AST) containing petroleum products on the Site. One diesel and gasoline compartmentalized AST was observed north of the Well Field Office Building, one diesel AST was observed east of the Well Field Office Building, one diesel AST was observed west of the backup generator building, and two lube oil tanks were observed in the Main Plant Building in the Turbine Hall area. In addition, 22 ASTs associated with the geothermal process were identified onsite and include: process water, Sodium Hypochlorite, Hydrogen Peroxide, Sodium Hydroxide, condensate, and/or Potassium Carbonate. Various drums of lubricants and oils, totes of various chemicals and smaller quantities of chemicals were identified around the power plant facility and associated buildings. The chemicals were stored on secondary spill containment pallets or in flammable cabinets. No staining of soil was observed near the ASTs and chemical storage areas.

View of a ConVault diesel and gasoline compartmentalized AST located north of the Wellfield Office Building. Note the concrete containment area below the AST (facing North)

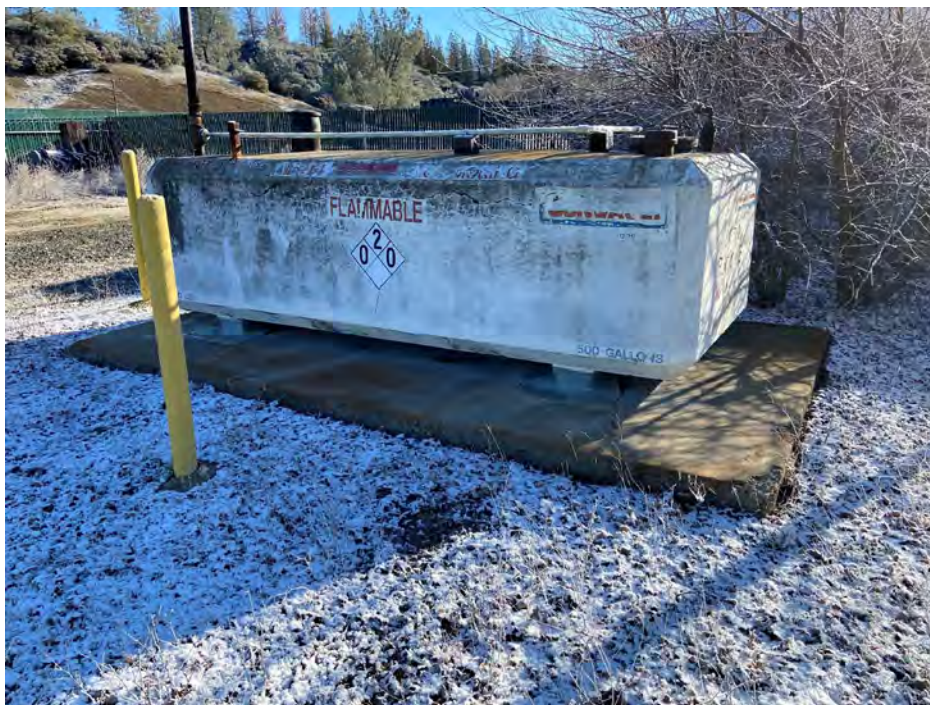
**Photo 6**

View of a ConVault diesel AST located east of the Wellfield Office Building. Note the concrete pad below the AST(facing east)

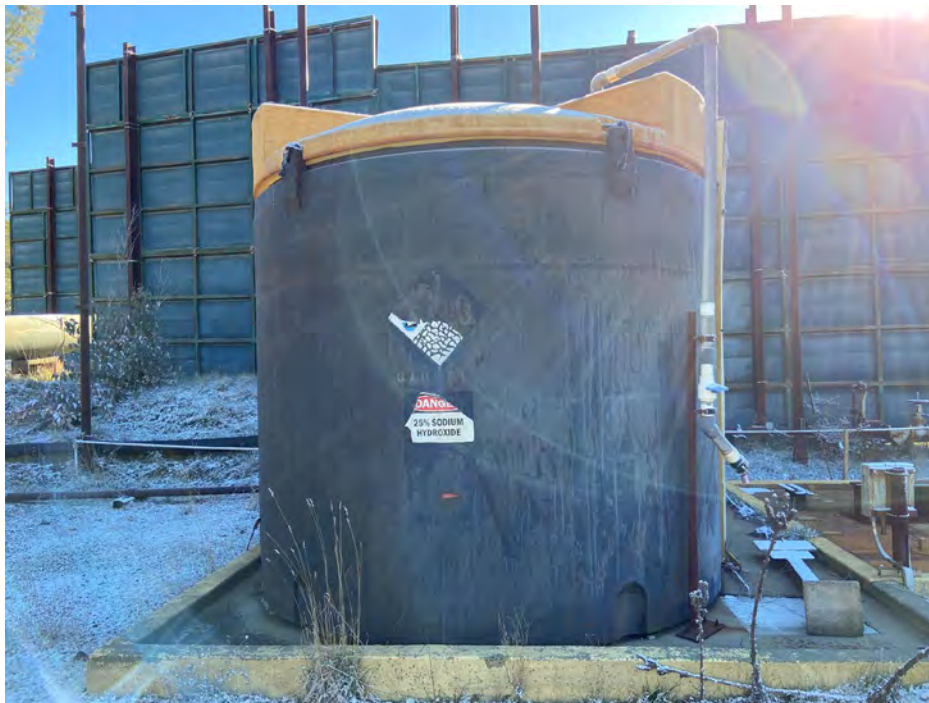
**Photo 8**

View of a typical non-petroleum AST located in a concrete containment area. This AST held Sodium Hydroxide. (facing east)

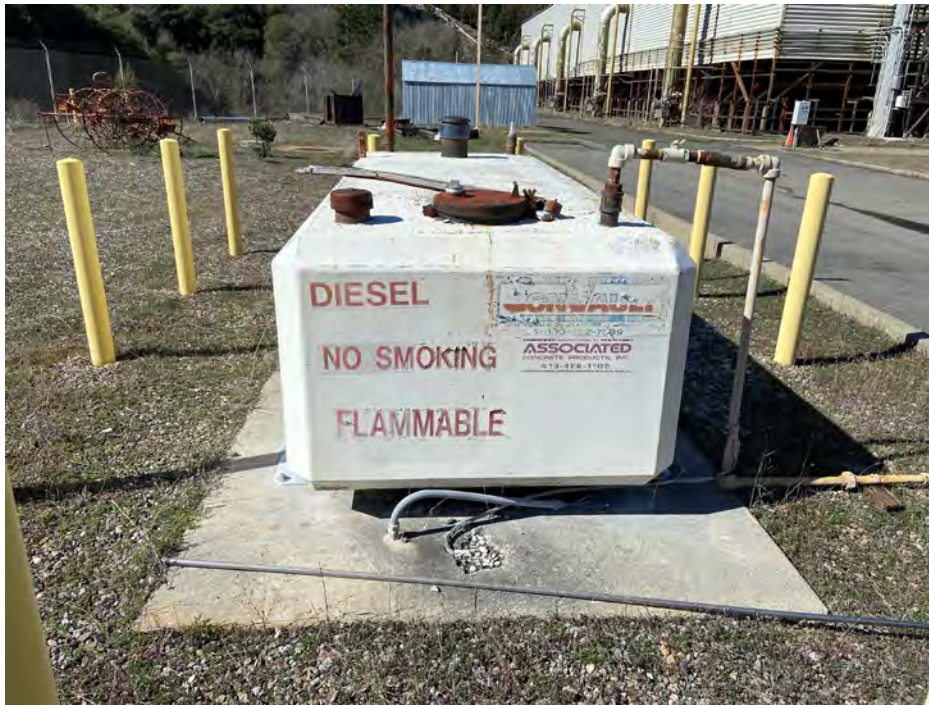
**Photo 9**

View of a ConVault diesel AST located west of the backup generator Building. Note the concrete pad below the AST(facing wet)

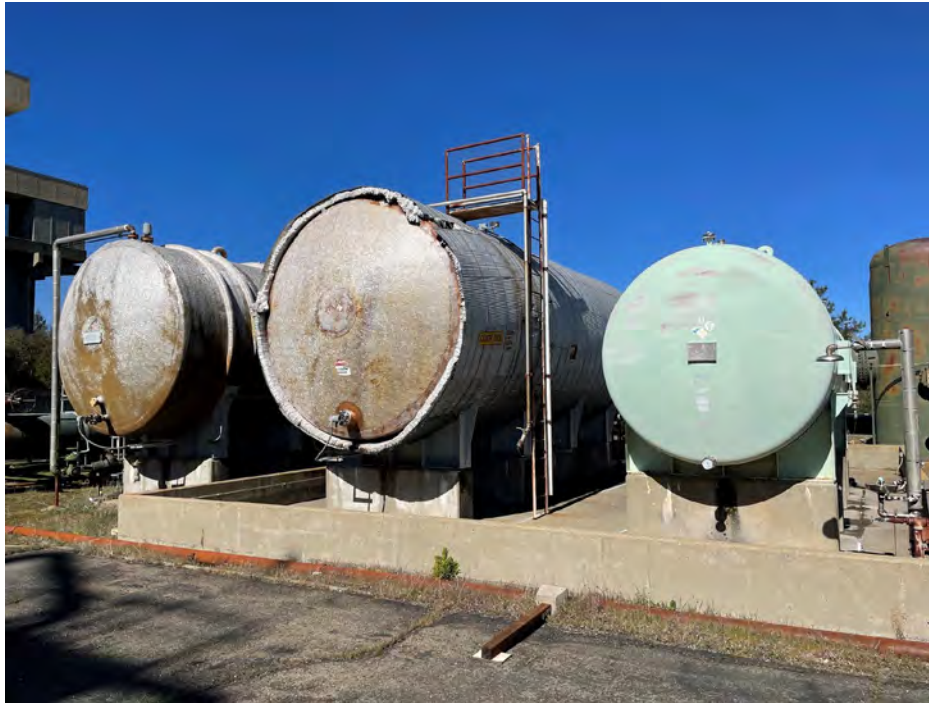
**Photo 11**

View of a typical non-petroleum AST located at the chemical storage area in a concrete containment area. The AST held Hydrogen Peroxide, Sodium Hydroxide, and water . (facing north)

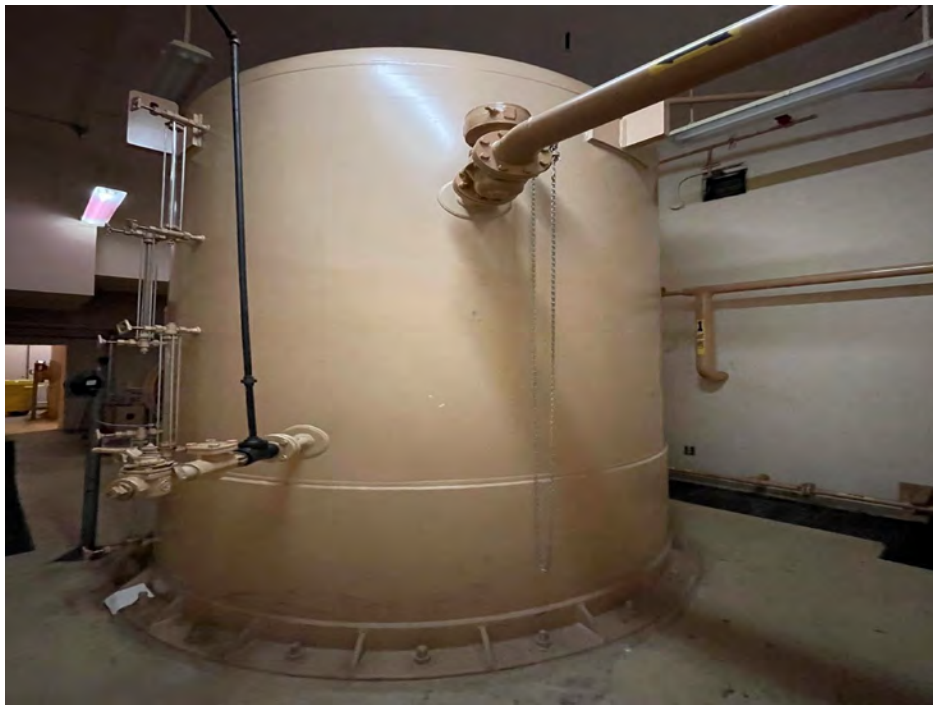
**Photo 13**

View of one of the 4,000-gallon lube oil tank for the turbine.

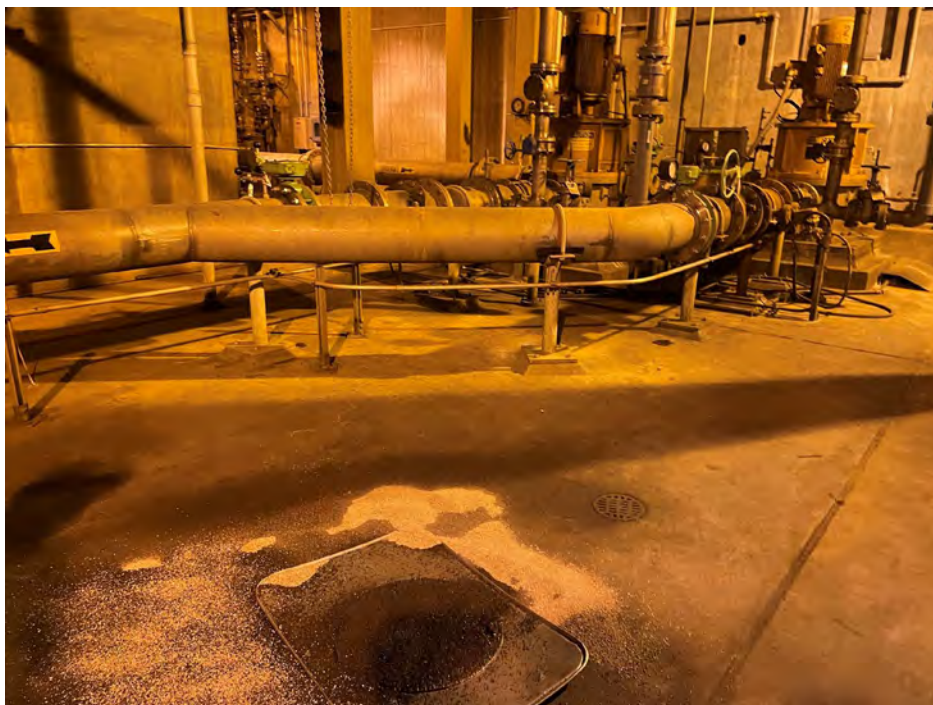
**Photo 14**

Various oil filled equipment was observed in the Main Plant Building and associated buildings. One area of staining, approximately four feet in diameter, was observed on concrete in the Main Plant Building below the turbine. The stain was being managed with a drip pan and absorbent material. Based on the active management of the stain and the stain being located on concrete Wood does not anticipate this stain to be an REC for the Site.

View of the four-foot diameter oil stain below the turbine inside the Main Plant Building.

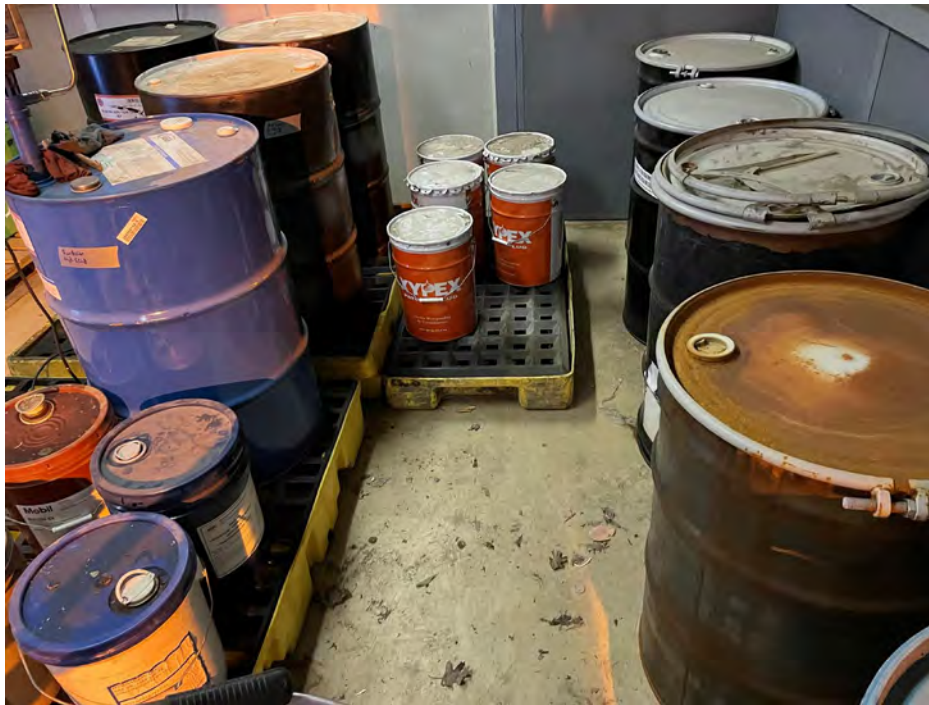
**Photo 15**

View of a typical storage area for containers and drums of oil.

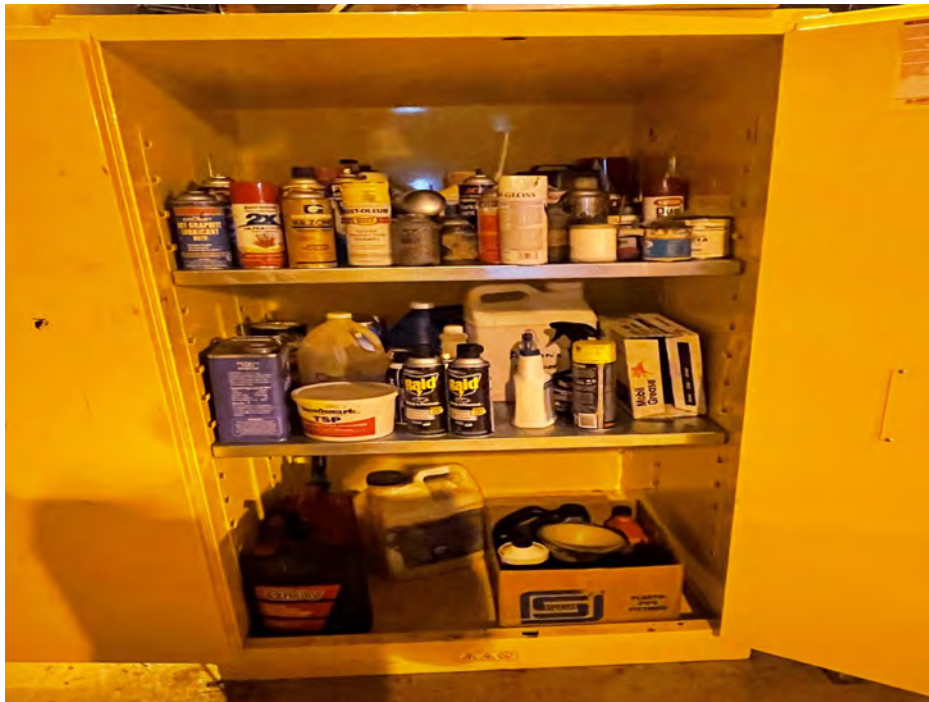
**Photo 16**

View of a typical storage area for chemicals in a flammable chemical cabinet.
