| <b>DOCKETED</b> | |
|---|---|
| <b>Project Title:</b> | Colusa Generating Station - Compliance |
| <b>Document Title:</b> | ANNUAL COMPLIANCE REPORT - 2025 |

**Subject: Colusa Generating Station (06-AFC-9)  
Condition of Certification COM-7 (BIO-2; HAZ-1; Noise-8; Soil and Water 2, 7, 8, 9;  
TLSN-3; VIS-1, 3; Waste-5 – Annual Operating Report**

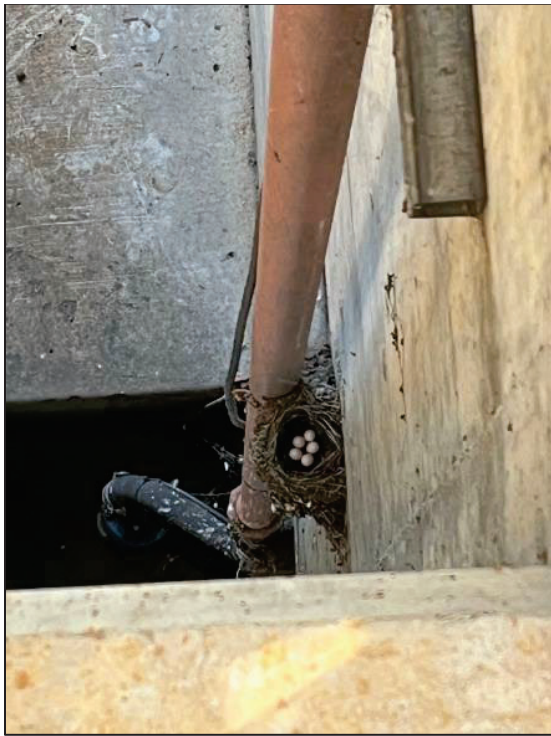
**Photo 1:** An active black phoebe nest with five eggs was found beneath the main steam pipe connected to the air-cooled condenser (ACC) on April 1, 2025.

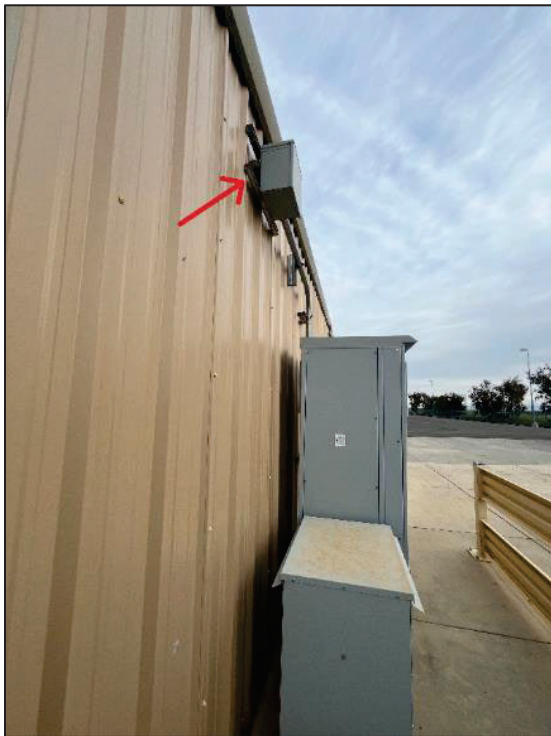
**Photo 2:** A house finch nest was found east of the warehouse behind a metal box on April 7, 2025. The Biological Monitor could not determine if the nest was being incubated or if it contained eggs.

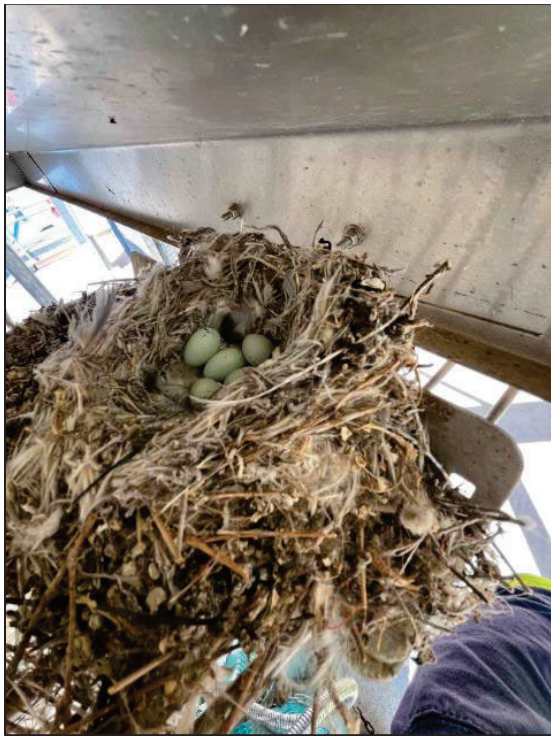
**Photo 3:** One active house finch nest containing eggs was found behind the CEMS1 building atop Airgas canisters on April 14, 2025.

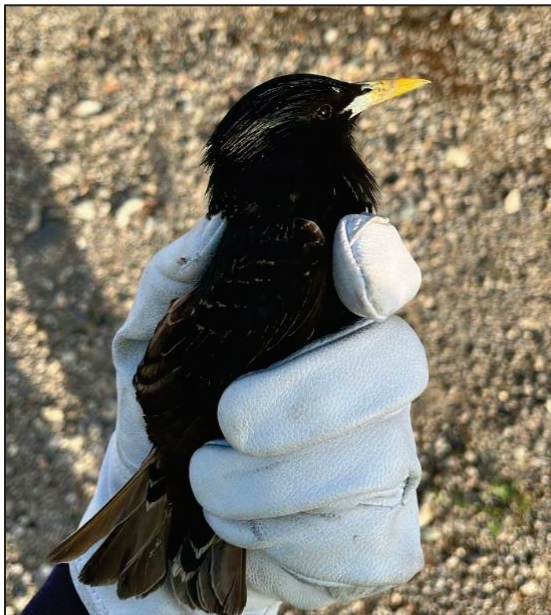
**Photo 4:** One European starling was removed from one of the pit traps next to the main entrance and released outside by the contractor sign-in trailer on April 16, 2025.

| Date | Biologist | Description |
|---|---|---|
| 4/16/2025 | BM Danny Rivas | The BM was onsite to conduct a rattlesnake and bat carcass survey at CGS. No rattlesnakes or bat carcasses were found during the interior survey of the facility. The exterior portion of the site survey was not performed. One adult European starling ( <i>Sturnus vulgaris</i> ) was removed from a pit trap near the main entrance and released outside by the contractor sign-in trailer (Appendix B, Photo 4). The BM recommended CGS staff check pit traps to make certain no rattlesnakes are present. |

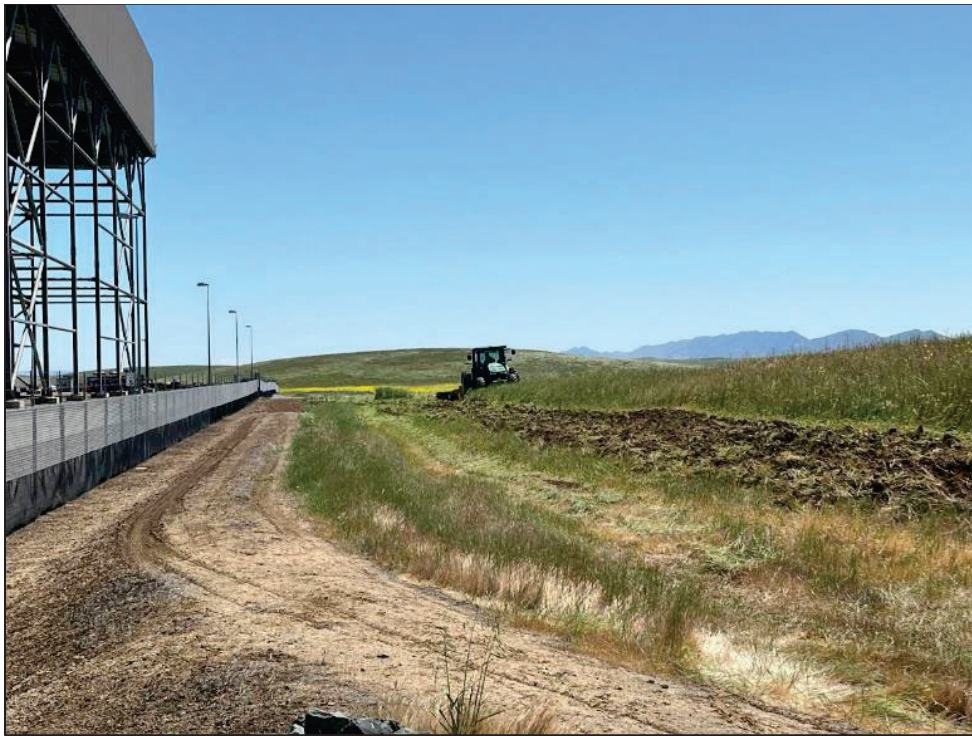
**Photo 5:** A Sierra Integrated Services vegetation management operator disking the grassland west of the ACC on April 28, 2025.

| Date | Biologist | Description |
|---|---|---|
| 4/28/2025 | BM Danny Rivas | The BM was onsite to monitor vegetation mowing and disking outside the fence and to survey for rattlesnakes (Appendix B, Photo 5). No bird nests were encountered during mowing or disking operations. During vegetation management, the BM contained and relocated four rattlesnakes, primarily found atop riprap near culverts. Rattlesnake #5 was found outside the fence north of the Delevan Substation under a snake board. Rattlesnake #6 was found near a culvert south of Noel Evans Road, and Rattlesnakes #7 and #8 were both found on the edge of a riprap pile beneath vegetation north of the perimeter road. One additional rattlesnake was observed in the riprap near where Rattlesnake #6 was found, but it avoided containment. One gopher snake ( <i>Pituophis catenifer</i> ) was found east of the triangle grass patch and relocated away from the vegetation clearing operations. |

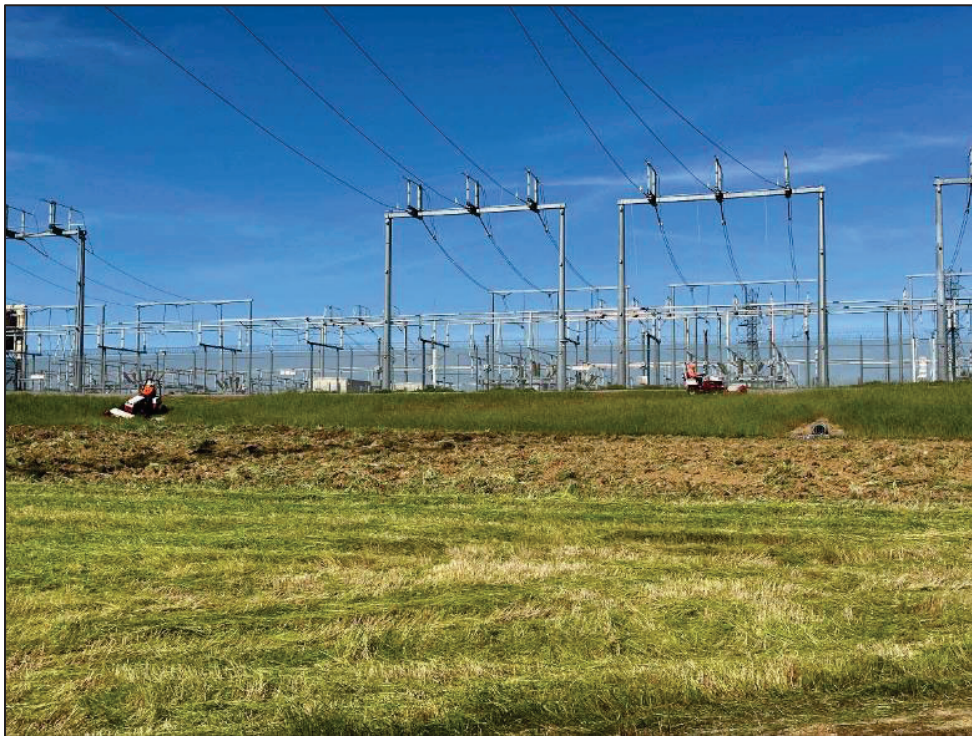
**Photo 6:** The Sierra Integrated Services vegetation management crew mowing the grass embankment east of the Delevan Substation on April 29, 2025.

| Date | Biologist | Description |
|---|---|---|
| 4/29/2025 | BM Danny Rivas | The BM was onsite to monitor vegetation mowing and disking outside the fence and to survey for rattlesnakes (Appendix B, Photo 6). No bird nests were encountered during mowing or disking operations. No rattlesnakes were contained. The rattlesnake observed on 4/28/2025 that avoided containment remained in the same spot under riprap. One gopher snake was found under a snake board south of the laydown yard outside the fence. |

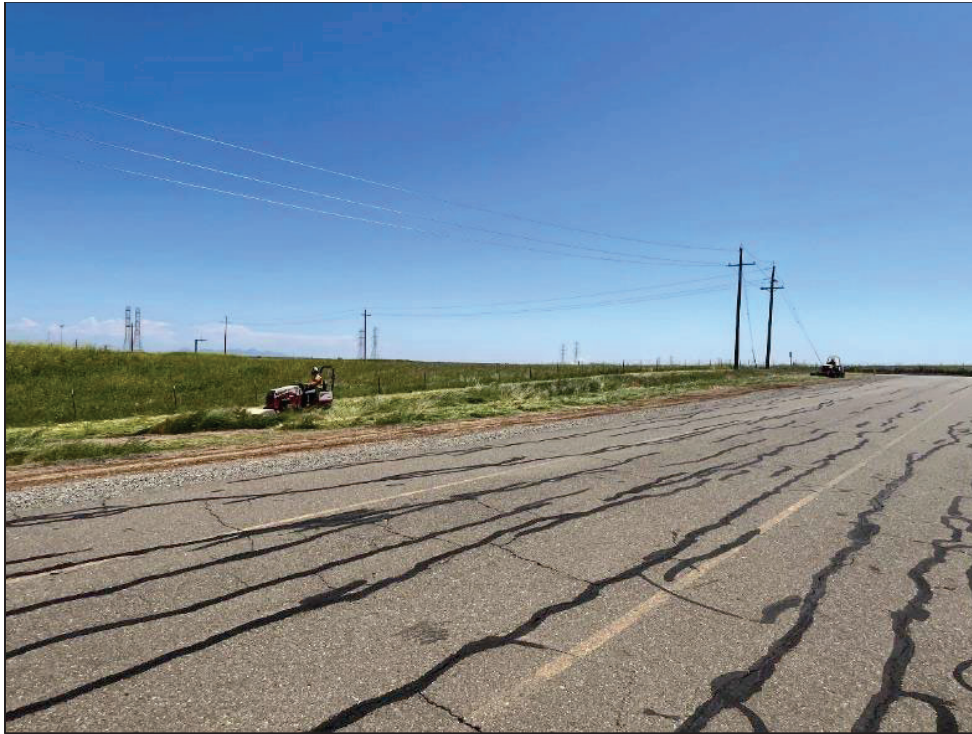
**Photo 7:** The Sierra Integrated Services vegetation management crew mowing the grass at the roadside of Dirks Road on April 30, 2025.

| Date | Biologist | Description |
|---|---|---|
| 4/30/2025 | BM Danny Rivas | The BM was onsite to monitor vegetation mowing and disking outside the fence on PG&E property and to survey for rattlesnakes (Appendix B, Photo 7). No bird nests were encountered during mowing or disking operations. Three rattlesnakes were contained outside the fence and relocated offsite. Rattlesnake #9 was found outside the fence south of the laydown yard; Rattlesnake #10 was found near the GCID bridge next to the traffic barrier; and Rattlesnake #11 was found near a culvert east of the Delevan Substation. Two additional rattlesnakes were observed near the GCID bridge, one under a traffic barrier and the other under riprap, but both avoided containment. One California kingsnake ( <i>Lampropeltis californiae</i> ) was found underneath a board northwest of the detention pond near the back access road. |

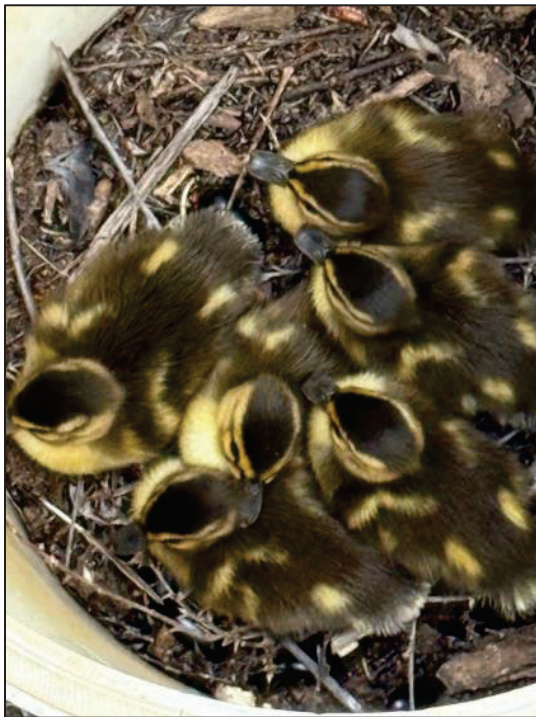
**Photo 8:** Six ducklings were found inside one of the pit traps at the back gate on May 7, 2025. All six ducklings appeared to be healthy and were returned to the adult female mallard at the detention pond west of the ACC.

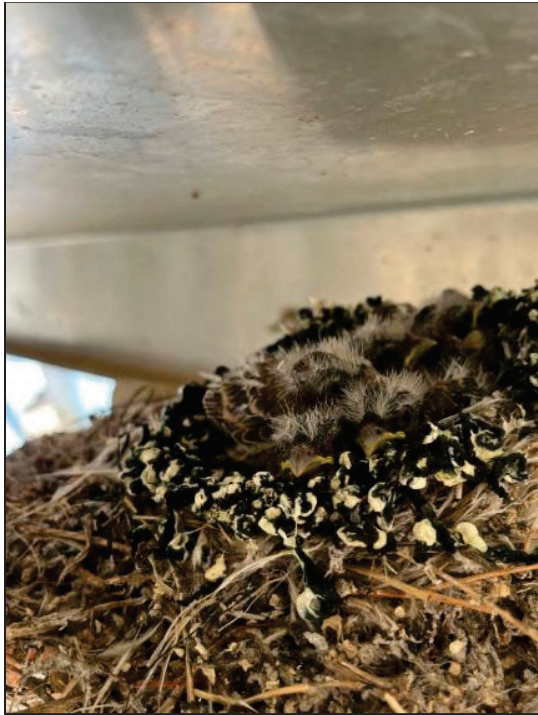
**Photo 9:** Five house finch nestlings at the reused nest north of the CEMS1 building showing some feather development on May 7, 2025.

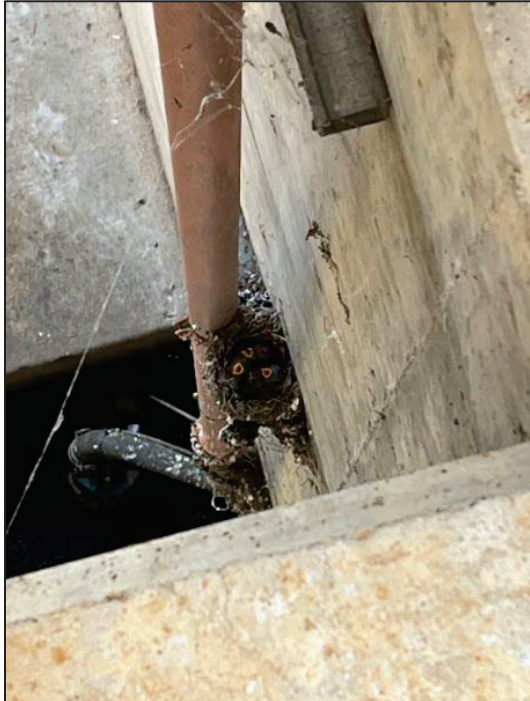
**Photo 10:** An active black phoebe nest with three chicks present was under the main steam exhaust pipe, north of the ACC on June 4, 2025. The nest was previously observed being incubated on the previous brood on April 1, 2025.

| Date | Biologist | Description |
|---|---|---|
| 6/4/2025 | BM Danny Rivas | The BM was onsite to conduct a rattlesnake and bat carcass survey at CGS. No rattlesnakes were found during the interior survey of the facility, and the exterior portion of the site survey was not performed. One desiccated <i>Myotis</i> sp. bat carcass and one old, unidentified bat carcass missing most of its distinguishing features were found under the ACC. The bat carcasses were collected, photographed, and disposed of onsite. One active black phoebe nest with chicks present was observed at the reused nest under the main ACC duct (Appendix B, Photo 10). |

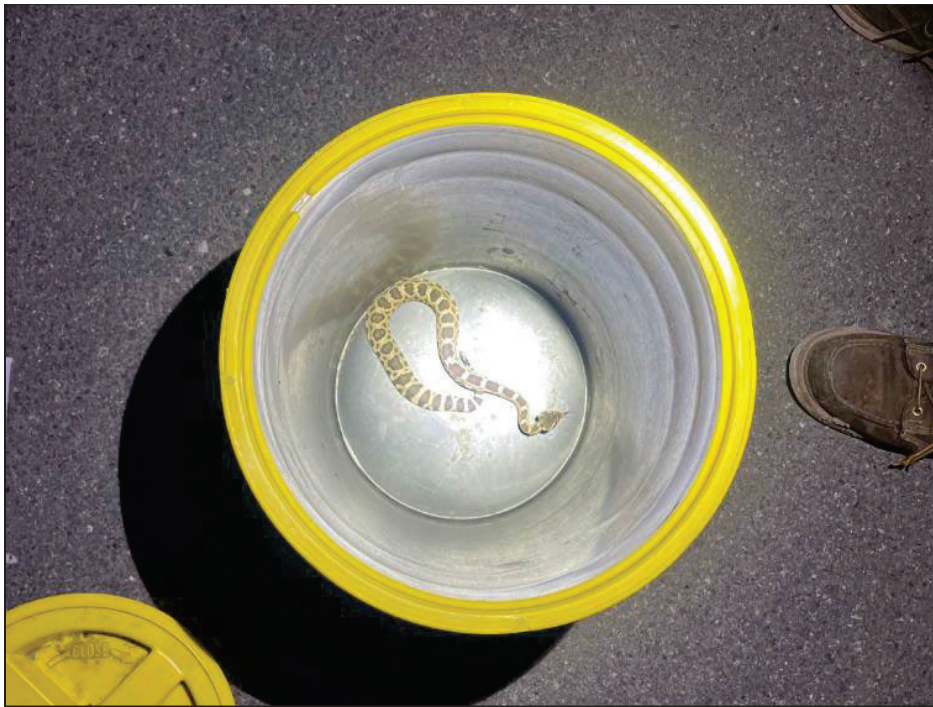
**Photo 11:** Rattlesnake #18 was found next to the control room at the northern entrance by CGS night staff on June 9, 2025. Rattlesnake #18 was contained in a locked cabinet onsite until June 11, 2025, when it was relocated offsite during a site visit.

| Date | Biologist | Description |
|---|---|---|
| 6/9/2025 | BM Danny Rivas | The BM was called onsite by the CGS control room to relocate Rattlesnake #18, a juvenile found next to the control room at the northern entrance by night staff (Appendix B, Photo 11). Rattlesnake #18 was contained in a locked cabinet onsite until 6/11/2025, when it was relocated offsite by the BM. |

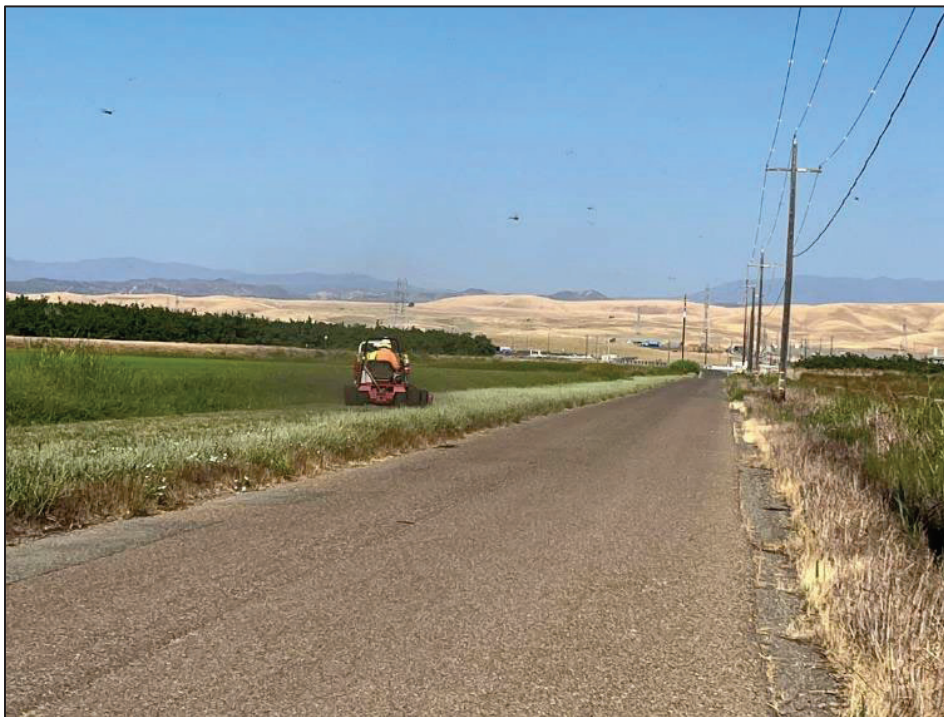
**Photo 12:** The Sierra Integrated Services vegetation management crew mowing the grass embankment east of the Delevan Substation on July 16, 2025.

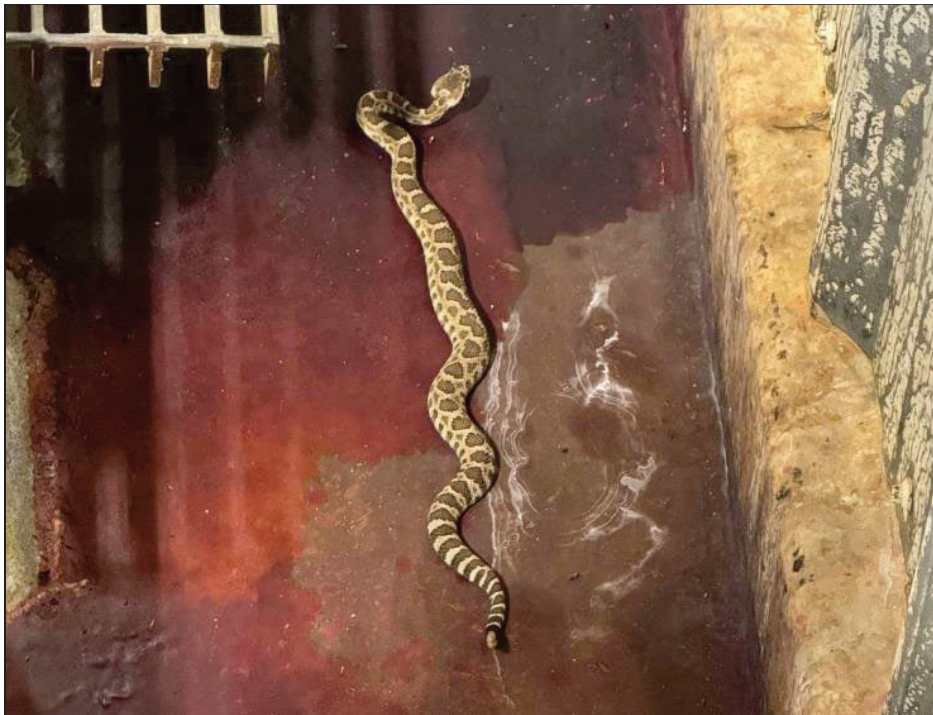
**Photo 13:** Rattlesnake #20 was found by CGS staff inside the water treatment building under the floor grating by the eye washing station and was contained on July 18, 2025. It was kept in a locked cabinet until it was relocated on July 23, 2025, during a site visit.

| Date | Biologist | Description |
|---|---|---|
| 7/18/2025 | BM Danny Rivas | The BM was called by the CGS control room to contain Rattlesnake #20, which was found by CGS night staff inside the water treatment building under the floor grating near the eyewash station (Appendix B, Photo 13). The rattlesnake was safely contained and left in a locked cabinet at the facility to be relocated on 7/23/2025. |

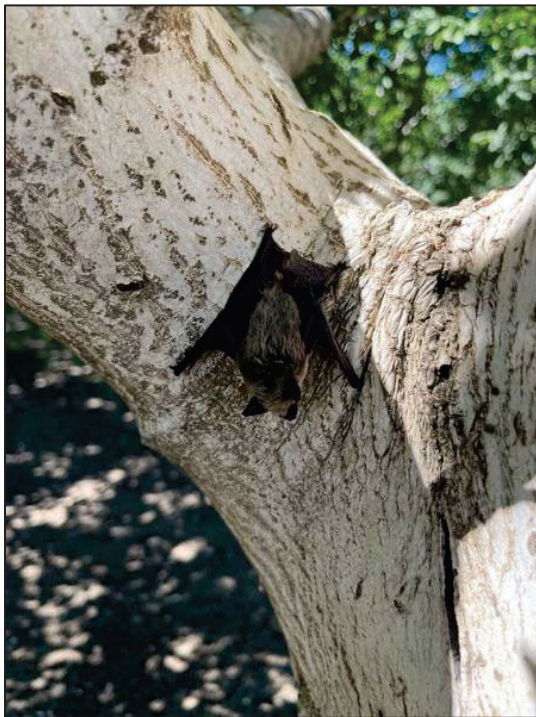
**Photo 14:** A live *Myotis* sp. bat was found grounded under the ACC and later relocated offsite to an orchard on Dirks Road on July 30, 2025.

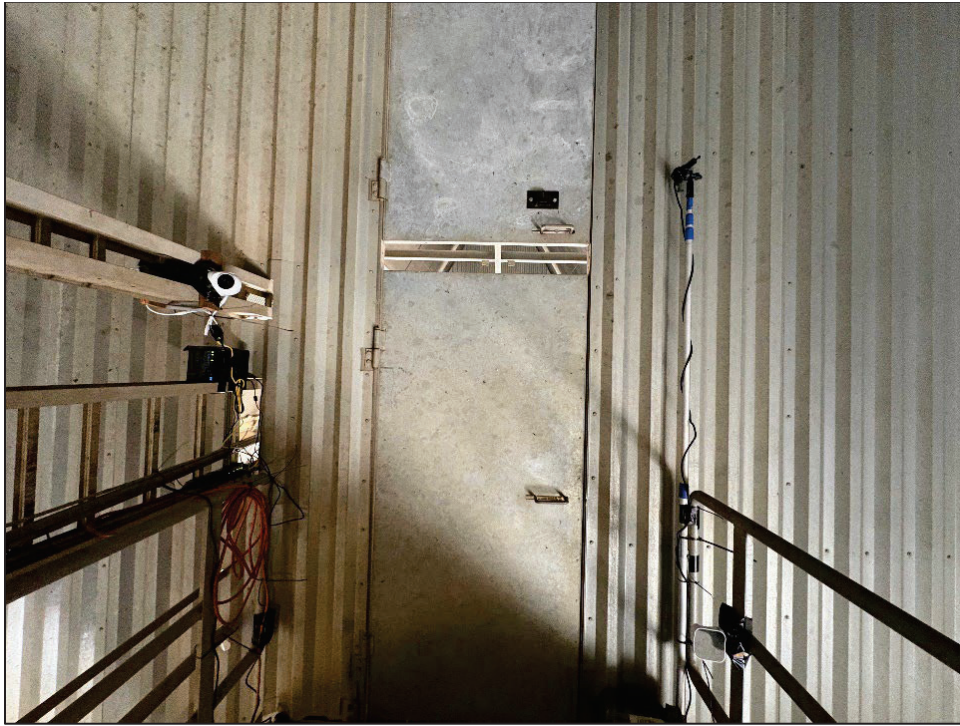
**Photo 15:** Mr. Bynes and Designated Biologist Scott Lindemann installed cameras and one acoustic bat detector in Street #4, Fan 5 (Fan 9045) within the ACC on August 20, 2025.

Mr. Byrnes visited CGS on August 22, August 27, September 3, and September 11, 2025, to check and calibrate bat surveillance equipment and download data from the acoustic detectors and cameras. On September 15, 2025, CGS Compliance Manager TJ Gomez confirmed exclusion netting to the ACC fans would begin installation and requested that Mr. Byrnes remove the bat monitoring equipment at the ACC. Mr. Byrnes removed the bat monitoring equipment on September 19, 2025. During the site visit, Mr. Byrnes found a live *Myotis* sp. bat in Street #4, Fan Room 2, and contained and relocated the bat offsite.
