Investigation Report of 2017 Turbine Failure and Fire

Delta Energy Center (98-AFC-03C)

INVESTIGATION REPORT	
Allegation(s)/Issue(a)	Steam turbine failure and fire at Calpine's Delta Energy Center (DEC) in Pittsburg, January 29, 2017.
Name of facility subject to investigation	Delta Energy Center 1200 Arcy Lane Pittsburg, CA 94565
Name of complainant (if appropriate)	N/A
Investigator(s)	<ul style="list-style-type: none">• Anwar Ali, STEP Division Compliance Project Manager (CPM)• Geoff Lesh, STEP Division Senior Mechanical Engineer

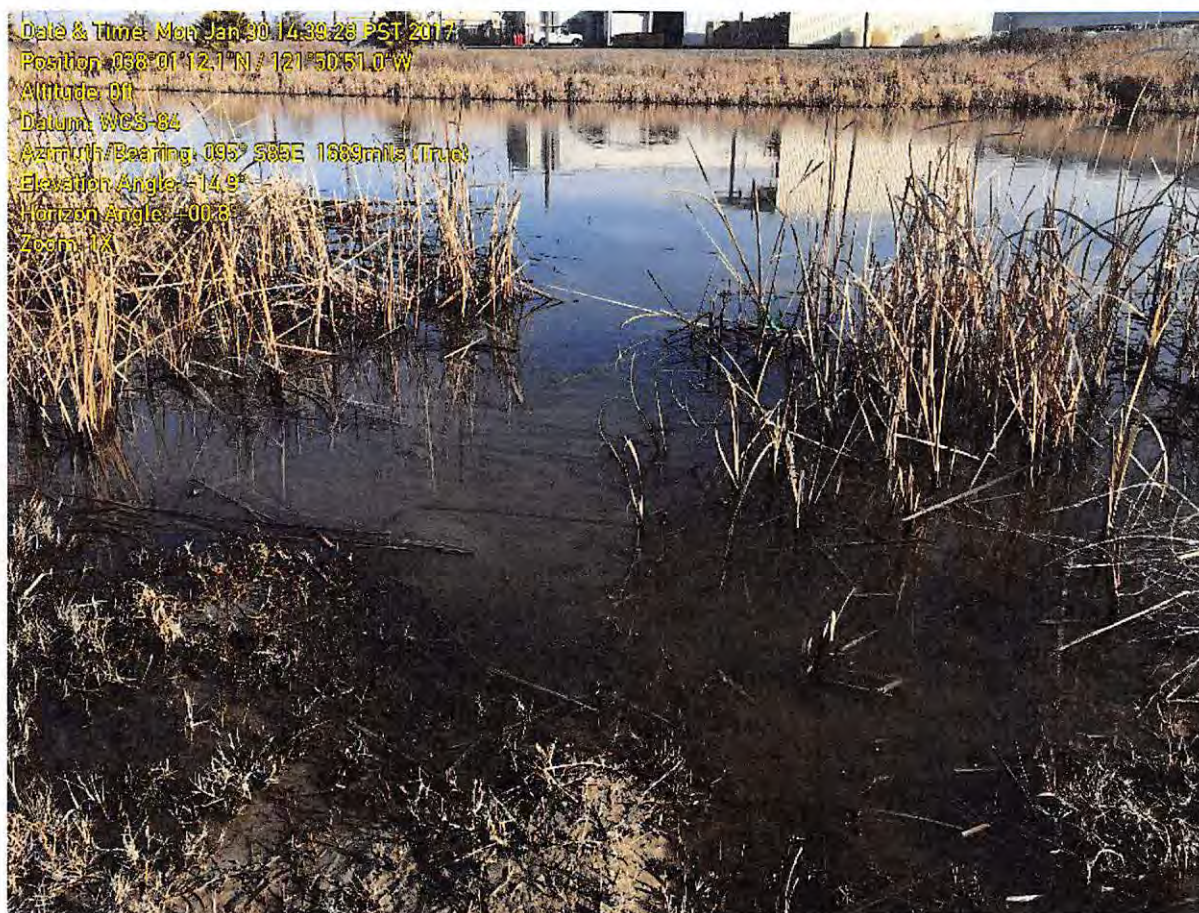
Surface water in portions of Dowest Slough downstream of the Delta Energy Center was observed to have a surface film consistent with oil (Photo 1), with the most visible film observed in unvegetated areas beneath and downstream of the BNSF Railway bridge crossing.

Photo 1. View from the west bank of Dowest Slough to the east showing saltgrass in the foreground and tule in midframe. Oily film presumed to be from the Calpine discharge is visible in midframe.

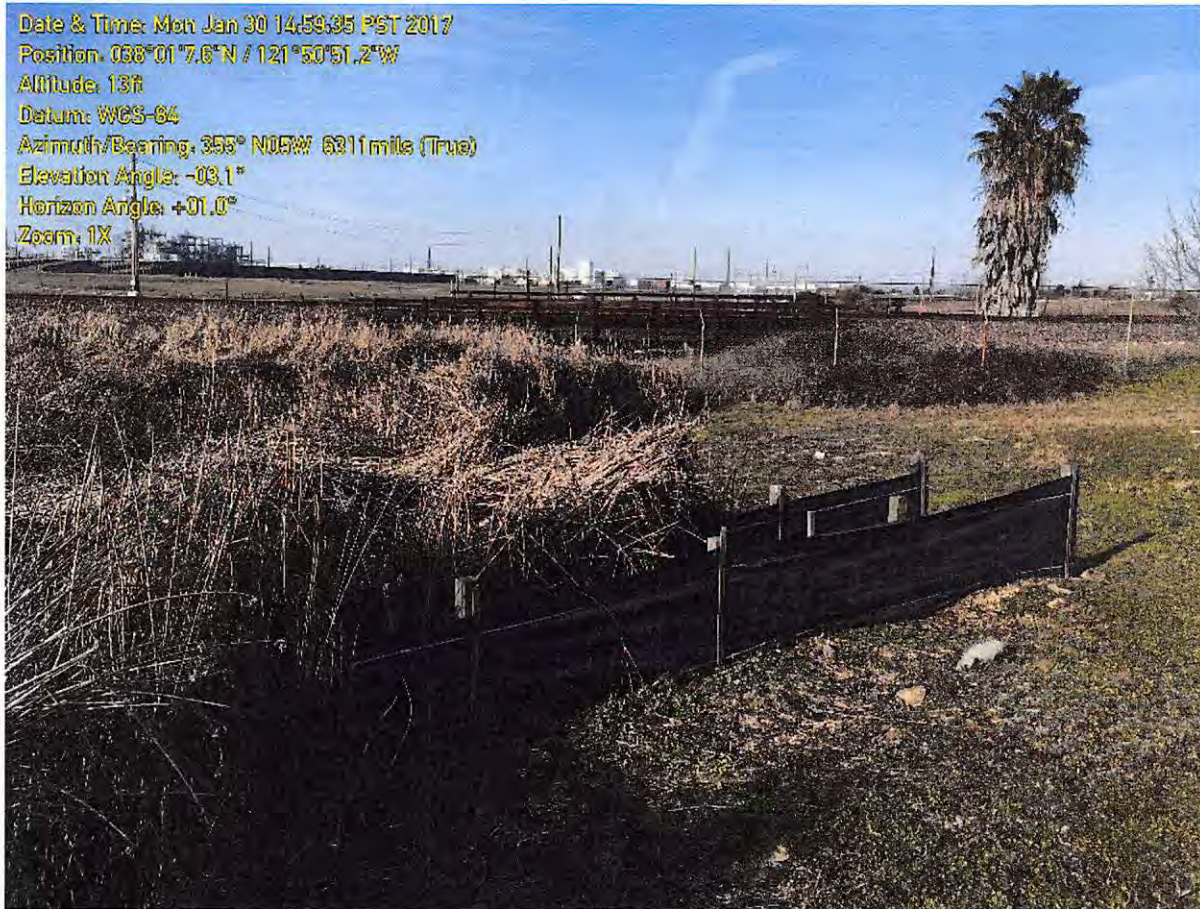
Calpine personnel indicated the location of the storm water outlet to Dowest Slough at Location A, as shown on Figure 1 (Photo 3). An unculverted access road spanning Dowest Slough to the south of the outlet appears to be functioning as a barrier limiting the current southward extent of oil migration (Figure 1 Location B, Photo 4). From the outlet, water was observed flowing north beneath the BNSF bridge crossing (Figure 1 Location C, Photo 5); however, surface water was observed flowing to the south from the easternmost of two approximately 72-inch diameter culverts at 5th Street (Location D, Photo 6), indicating a rising tide during the site visit. A faint sheen was observed in Kirker Creek at the East 3rd Street crossing (Photo 7), but it is unclear if this is related to the Calpine discharge.

Photo 3. View from the stormwater drain outfall to the north, showing Dowest Slough in the foreground and the BNSF Bridge crossing in the background. Silt fencing that borders the outfall is visible in midframe; however, the outfall is out of frame to the left (west).

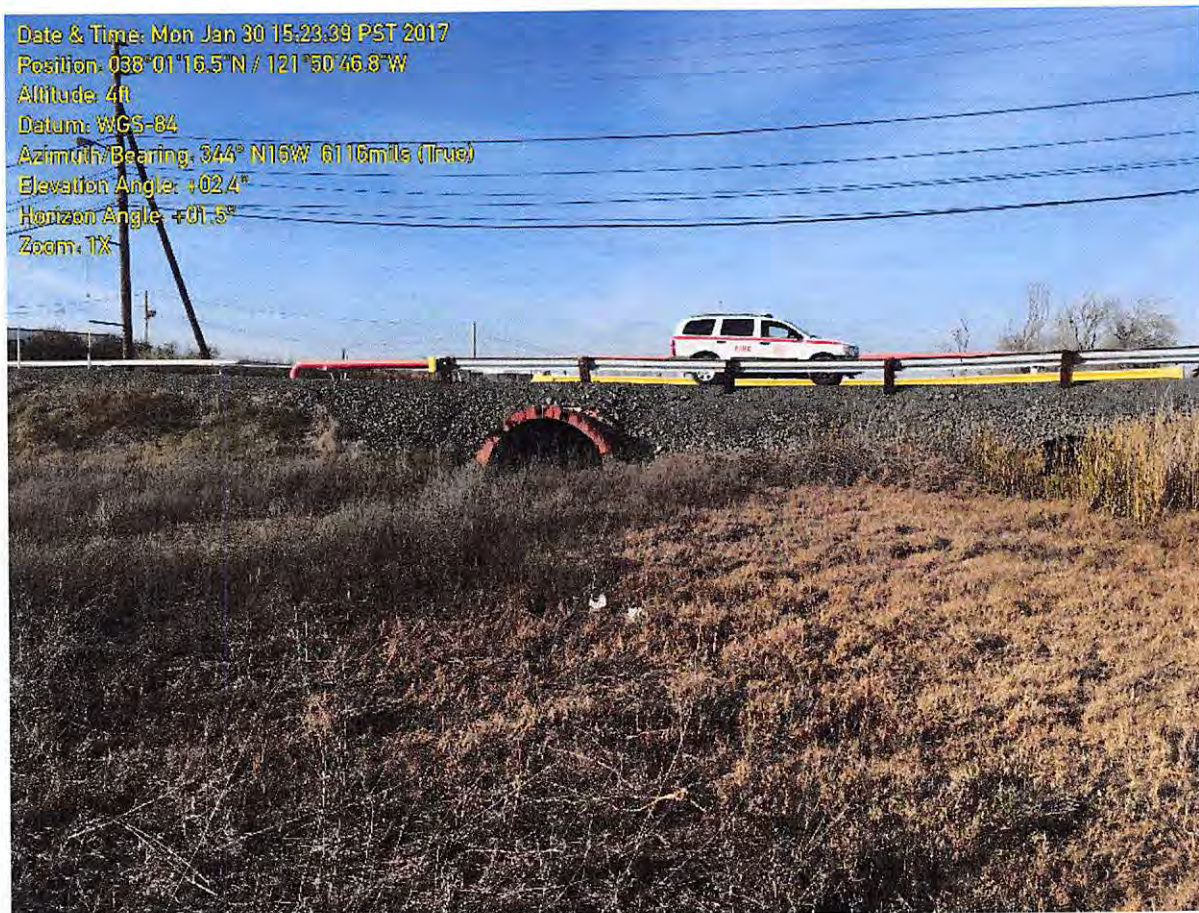
Photo 6. View to the north from Dowest Slough showing large culverts beneath East 5th Street. The culvert to the east is partially hidden behind tule and cattail that border the low flow channel. At the time of this photograph, flow to the south was observed through the east culvert.

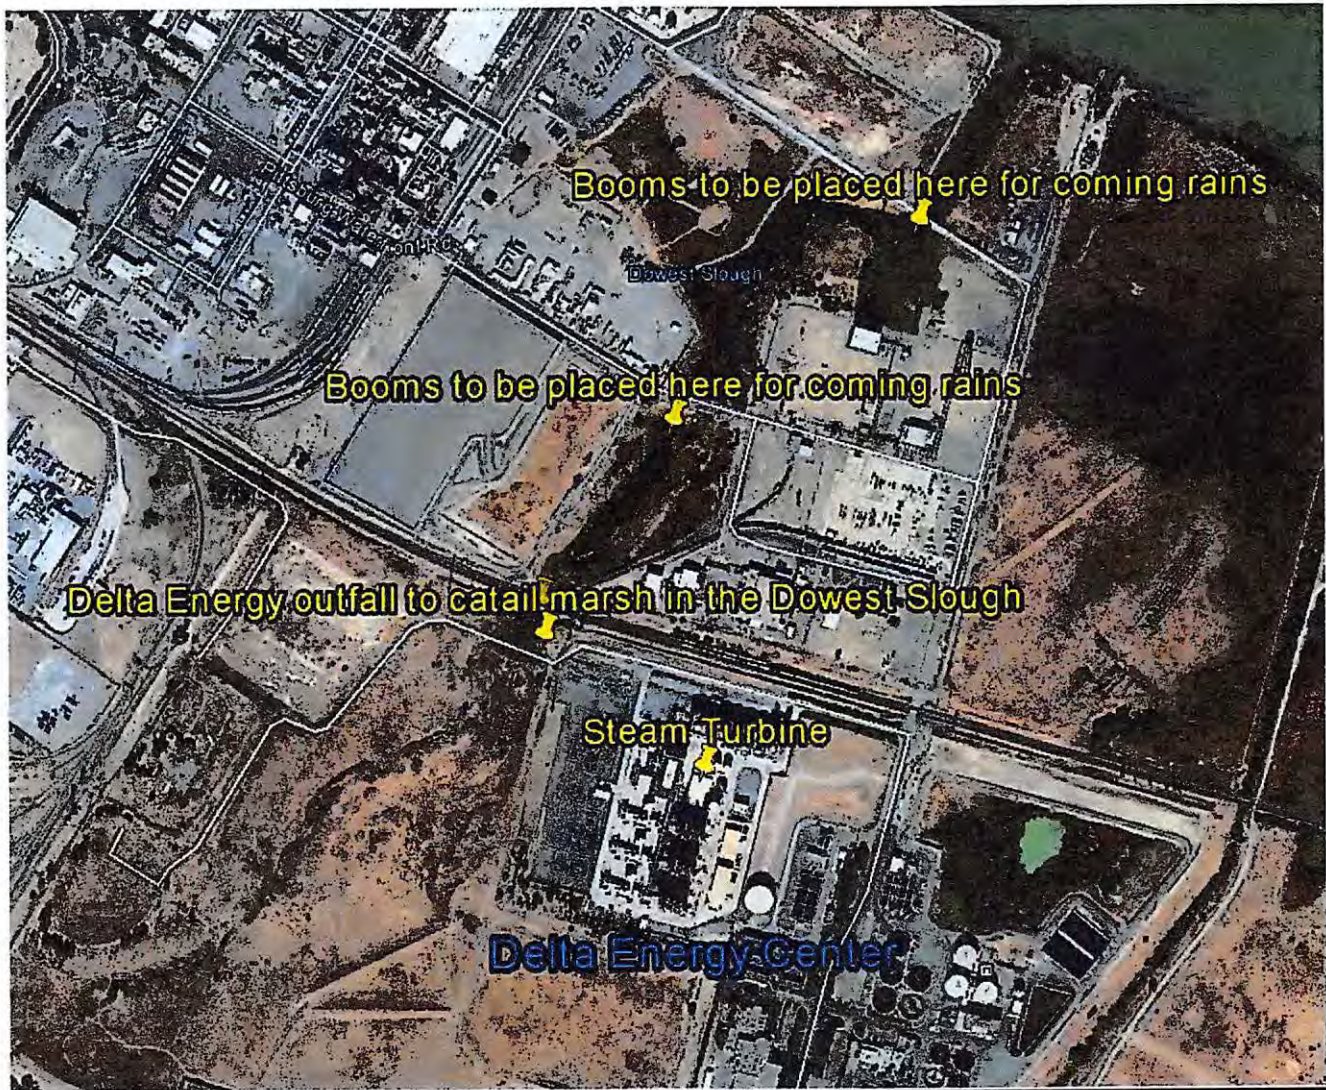
Figure 1. Site Map of Showing Locations of Storm Water Drains and Marshes Impacted by Lube Oil Spill

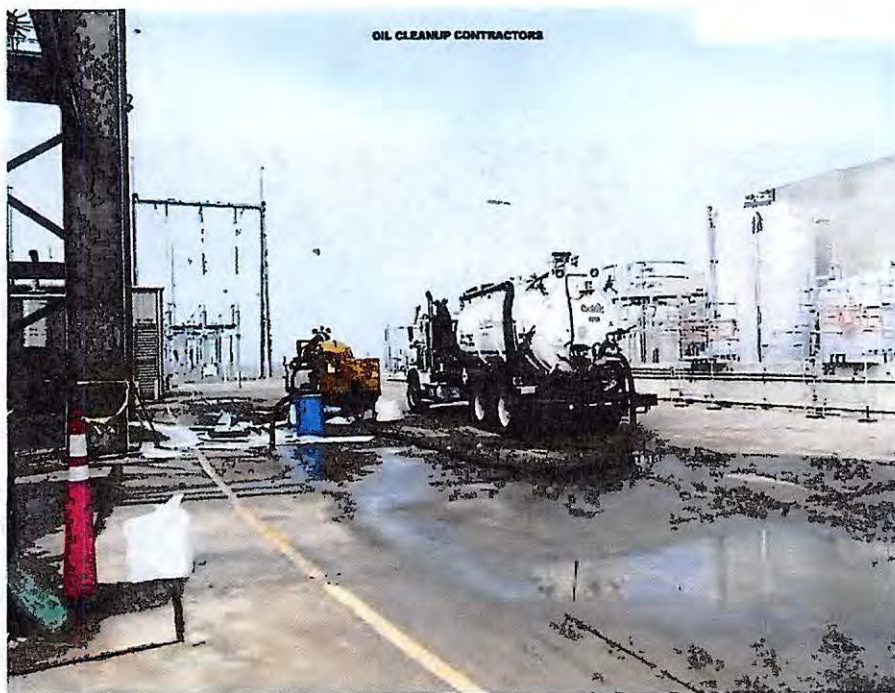
Figure 2. Lube Oil Cleanup Contractors Pressure Washing And Vacuuming Of Paved Areas

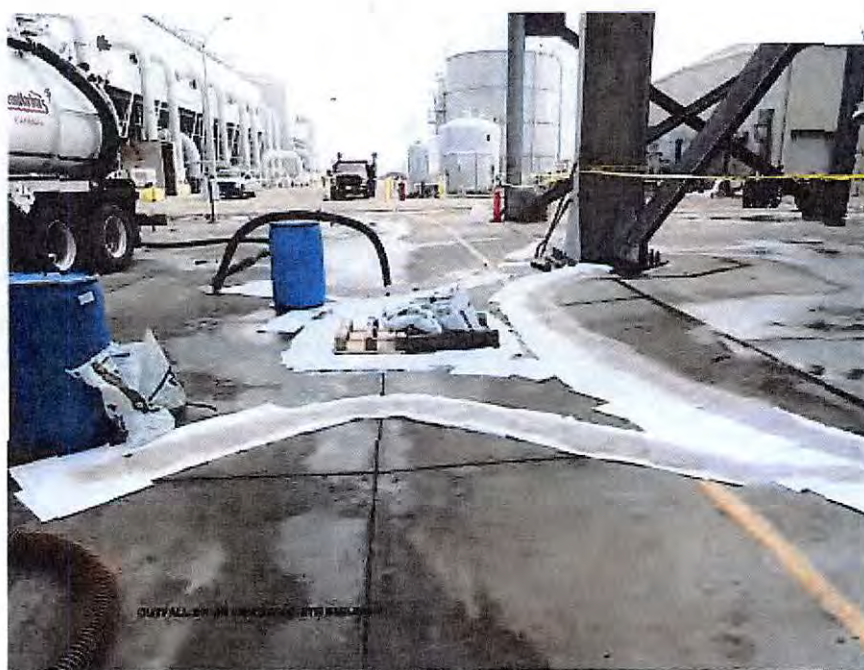
Figure 3. A Blocked Outfall Drain On West Side Of The Steam Generator Turbine Enclosure During Clean-up

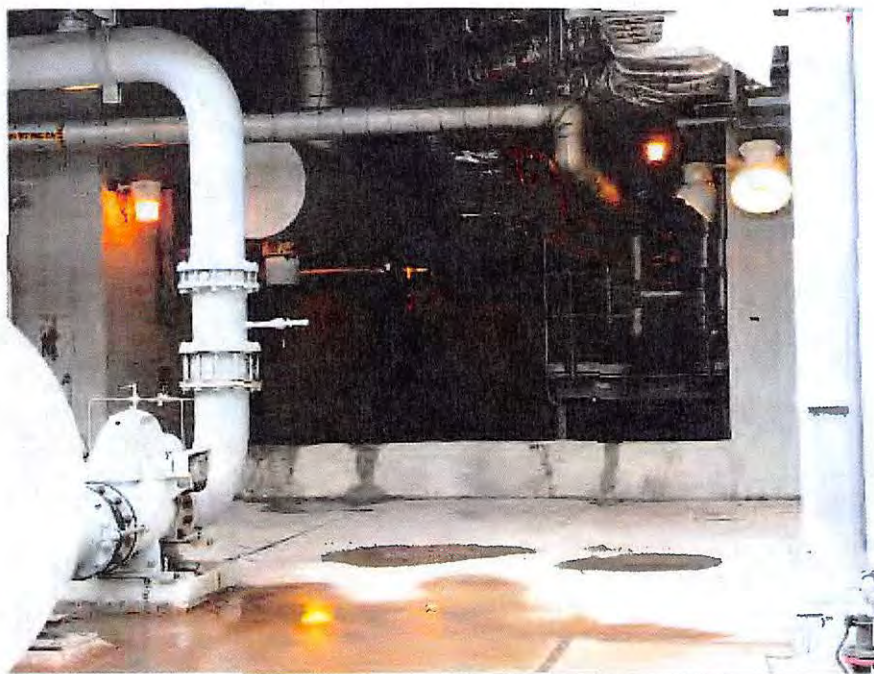
Figure 7. Steam Turbine Generator Main Lube Oil Tank

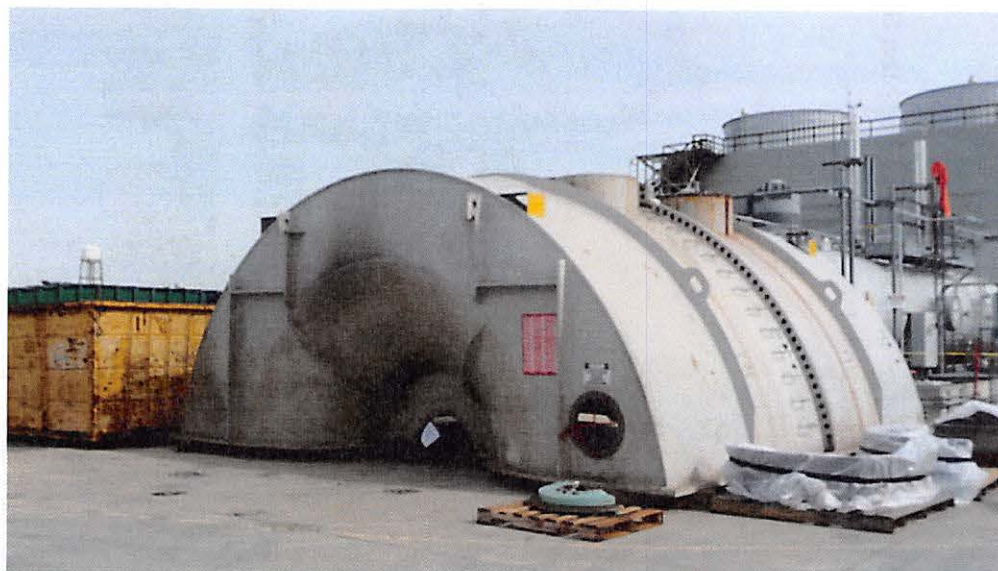
Figure 3. Steam Turbine Housing that has been removed

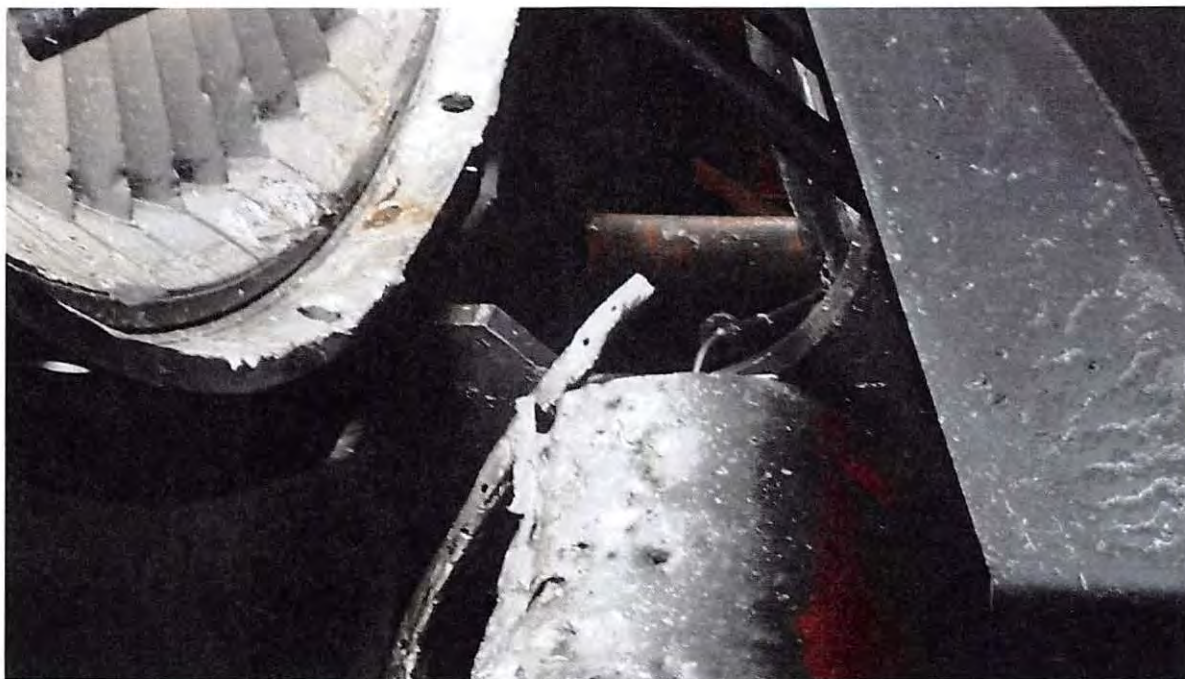
Figure 4. Outlet end of the Low Pressure Steam Turbine section showing damage to casing and entrance to steam condenser

- Staff performed an on-site review of the Calpine's RCA. The RCA did not determine the exact trigger for the event. However, it was determined that the first blade in the low pressure section (L-0) of the steam turbine failed. The report determined that erosion and pitting from cavitation caused subsurface fatigue cracks that weakened the blade. The extreme vibration resulting from imbalance in the rotating turbine due to the failure (breakage) of the blade at full speed caused propagating damage throughout the whole turbine and co-rotating equipment, including the generator. Destruction of shaft bearings lead to release of bearing lube oil and generator cooling hydrogen gas, both of which ignited and contributed to the subsequent fire. The RCA determined that sudden blade failure is the scenario supported by a combination of information (on-site, operational, and metallurgical). Metallurgical testing showed no evidence of physical manufacturing defects.

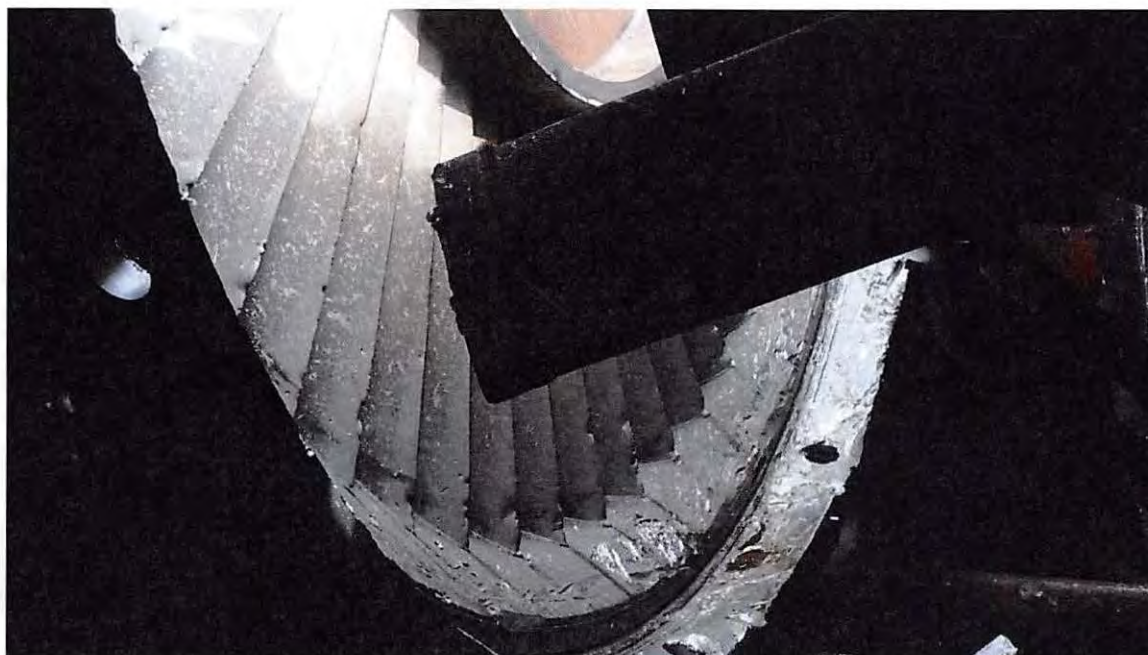
Figure 5. Another view of the damaged turbine blades

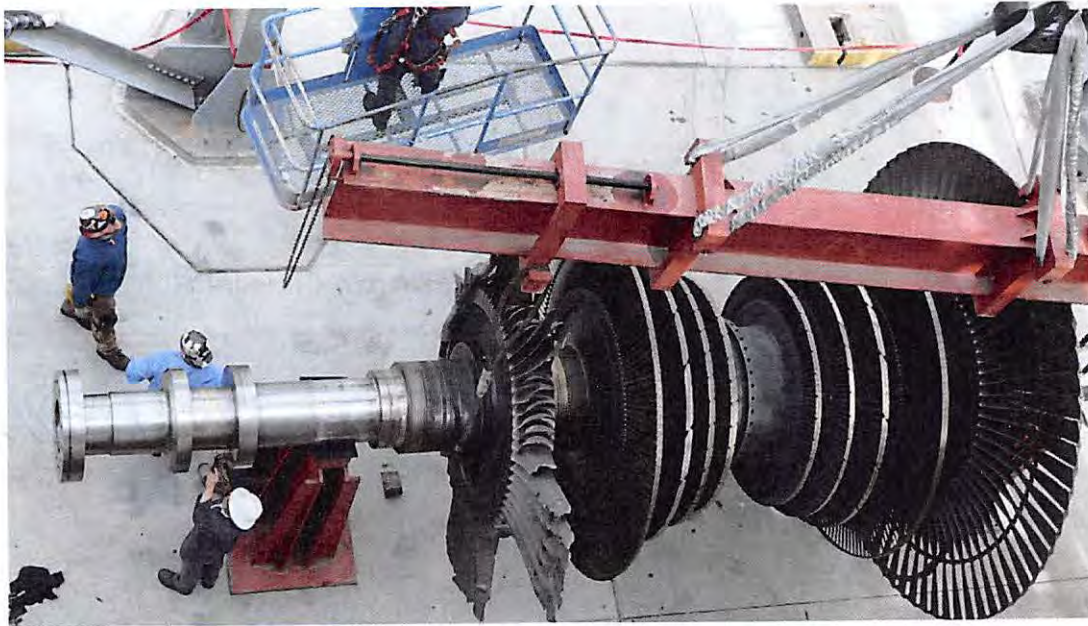
Figure 8. Steam Turbine Rotor removed for repair showing severely damaged blades

- Severe damage to the steam turbine generator; needs rotor replacement.
- Severe damage to the steam turbine; needs rotor and casing refurbished.
- No structural damage was apparent to the building and turbine foundation.
- The exact cause of the turbine failure and the sequence of events leading to the turbine failure were still unconfirmed at this point.
- Staff did not see any evidence that lube-oil and hydrogen gas had burned.
- Absorbent booms were deployed at the slough and the cleaning efforts to prevent further discharge of lubrication oil to the slough have been successful. Calpine's contractor was on site to ensure periodic replacement of the absorbent booms when needed and as directed by the CDFW, the lead agency for the lube oil discharge and clean-up effort.

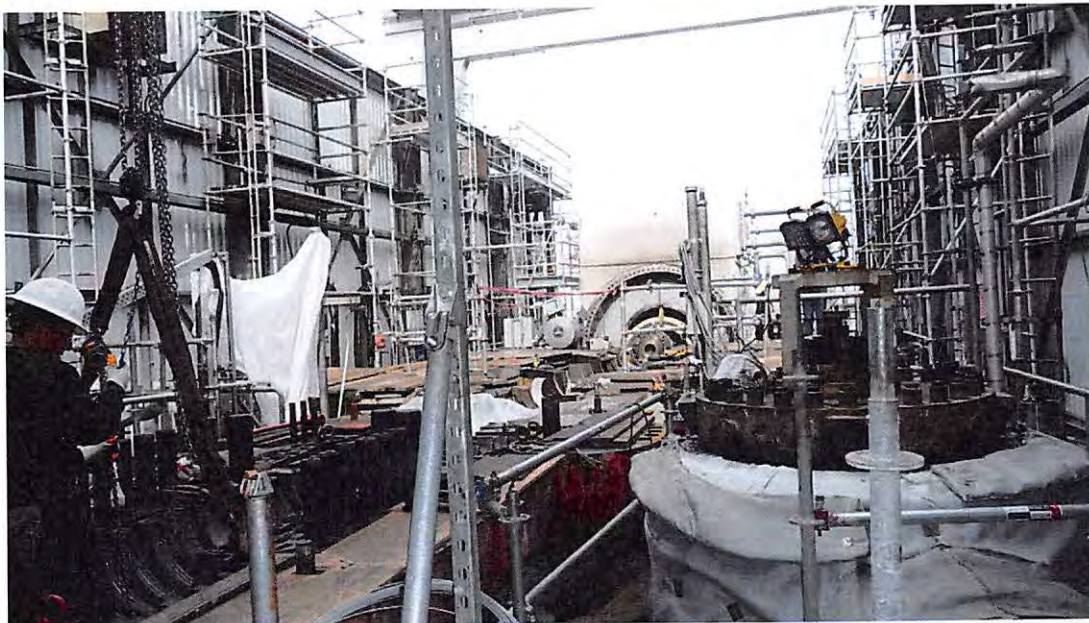
Figure 9. Steam Turbine Building with roof and steam turbine removed

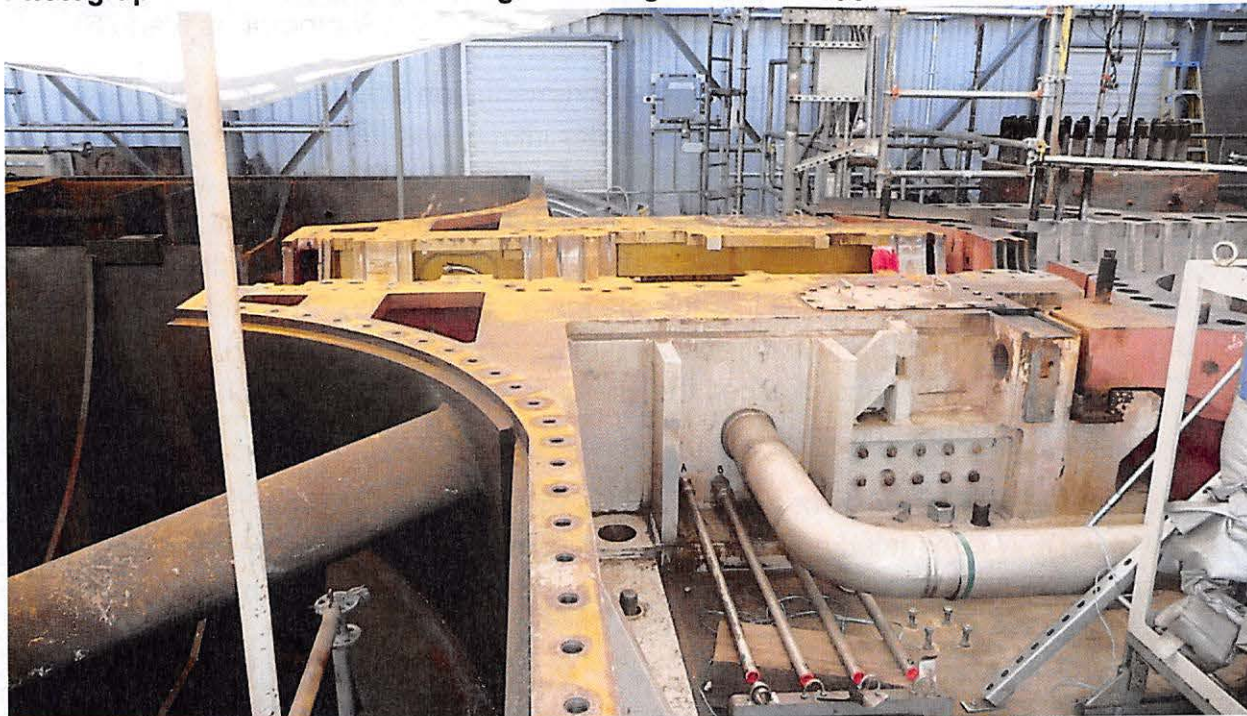
Photograph 1. View of Rotor Bearings Showing Rotor and Upper Casing Have Been Removed

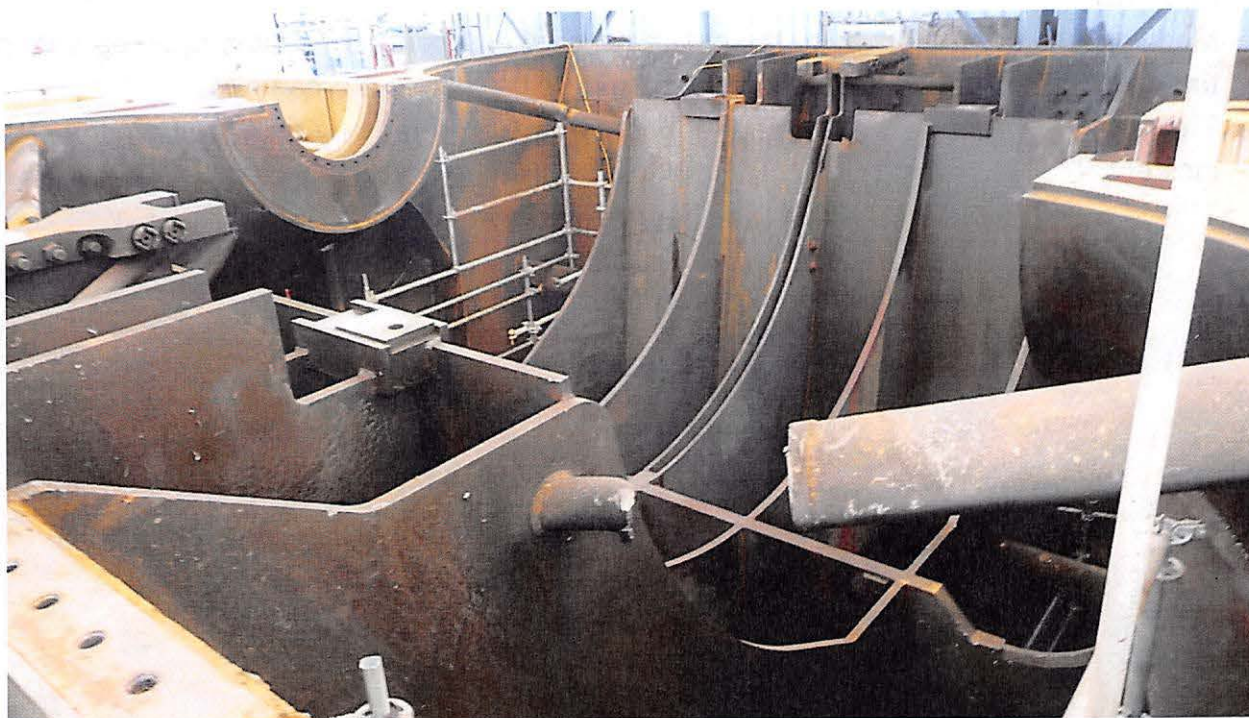
Photograph 2. View of Low Pressure Turbine Area Downward Steam Entrance to Condenser

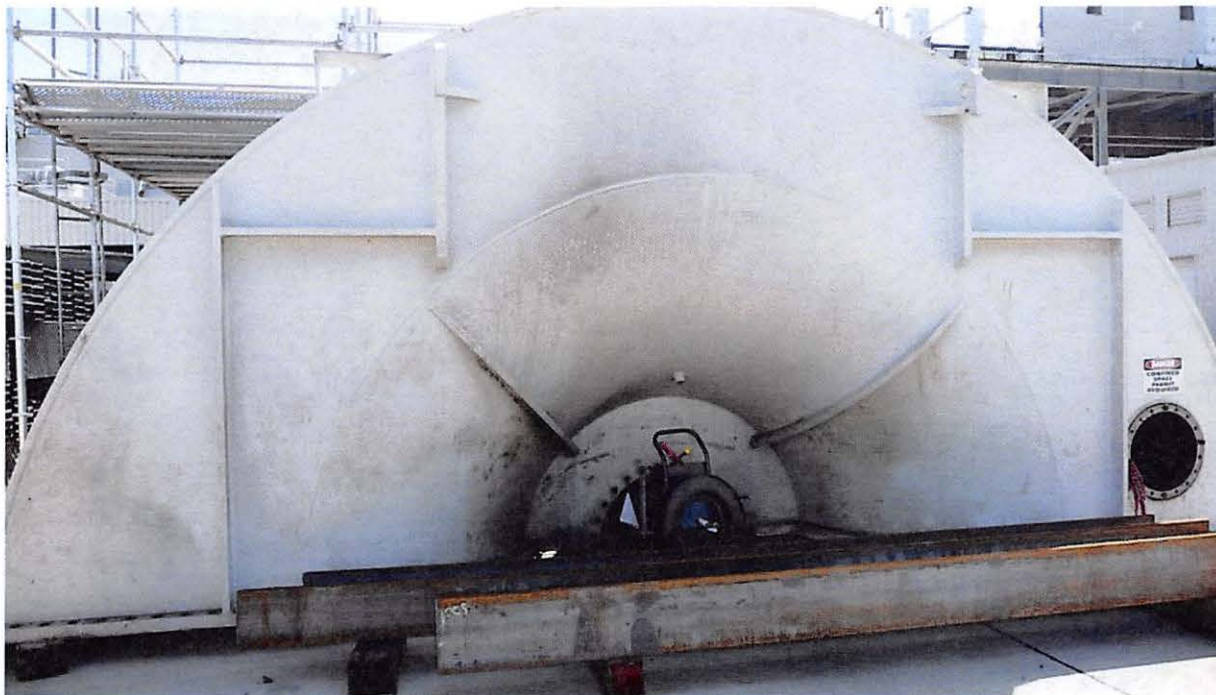
Photograph 3. Steam Turbine Enclosure Housing with Evidence of Smoke

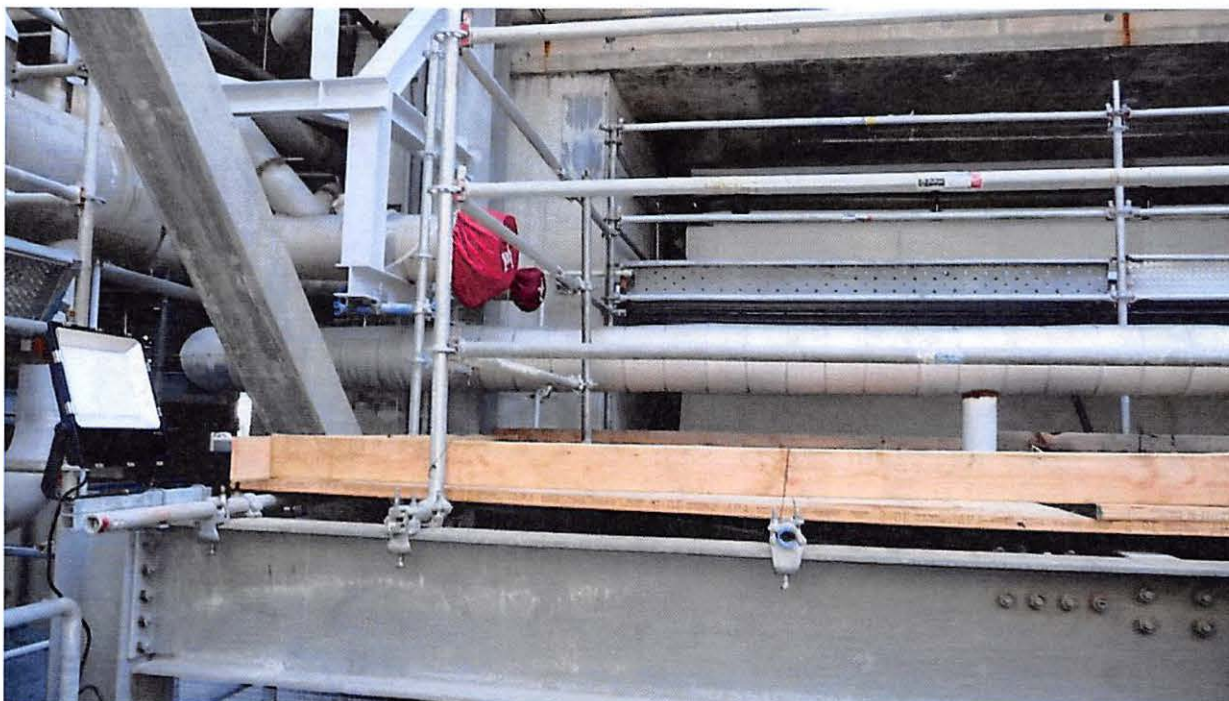
Photograph 4. Top to Bottom View of the Location for Blanking Plate Installation
