APPLICATION FOR CERTIFICATION
FOR THE PALEN SOLAR POWER
PROJECT

**CENTER FOR BIOLOGICAL DIVERSITY
SUPPLEMENT TO OPPOSITION TO MOTION TO REOPEN EVIDENTIARY
RECORD AND SCHEDULING ORDER**

Pursuant to 20 Cal. Code. Regs. § 1716.5 and the March 24, 2014 memo from Hearing Advisor Celli, Intervenor Center for Biological Diversity (“Center”) timely provides this *supplement* to our opposition to Palen Solar Holding LLC’s “Motion to Reopen Evidentiary Record and Scheduling Order”. Attached is a copy of a 2014 report prepared by the National Fish and Wildlife Forensics Laboratory on avian mortality at solar energy facilities in southern California that the Center received today through a Public Records Act request from the California Energy Commission. (“Avian Mortality at Solar Energy Facilities in Southern California: A Preliminary Analysis”, Rebecca A. Kagan, Tabitha C. Viner, Pepper W. Trail, and Edgard O. Espinoza National Fish and Wildlife Forensics Laboratory [hereinafter “Avian Mortality Report”].)

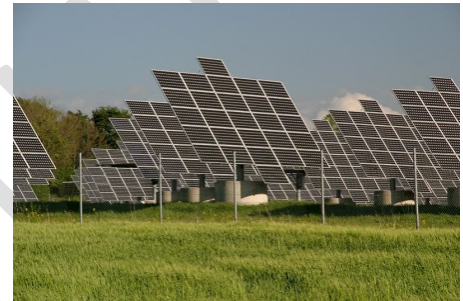
1) **Photovoltaic systems** directly convert the sun's light into electricity. The perceived threat to birds is associated with the presence of water ponds which attract birds and from traumatic impact with the photovoltaic cells. An example of this type of solar power plant is Desert Sunlight Solar Farm (AKA First Solar).

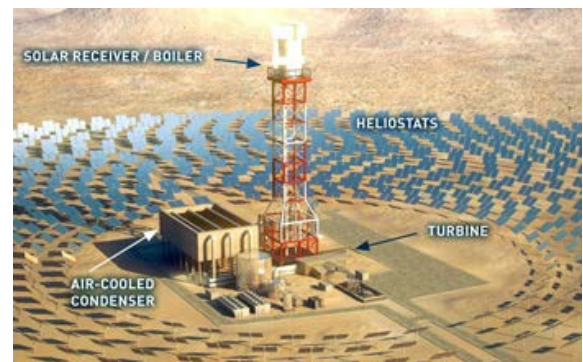
2) **Trough systems** are composed of parabolic mirrors which focus and reflect the sun to a tube that converts the heat from the sun into electricity. The perceived threat to birds is associated with the presence of water ponds which attract birds and from traumatic impact with the trough structures. An example of this type of solar power plant is Genesis Solar Energy Project.

3) **Solar power towers** use thousands of mirrors to reflect the solar energy to a tower, where water in a boiler is converted to steam, generating the electricity. The perceived threat to birds is associated traumatic impact with the mirrors and the danger associated with the heat produced by the mirrors. An example of this type of solar power plant is Ivanpah Solar Electric Generating System.

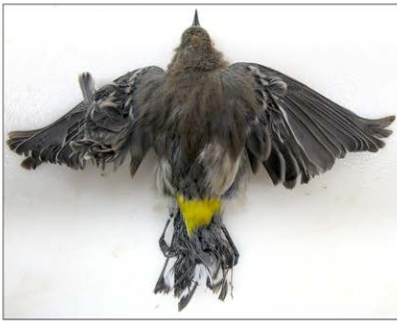
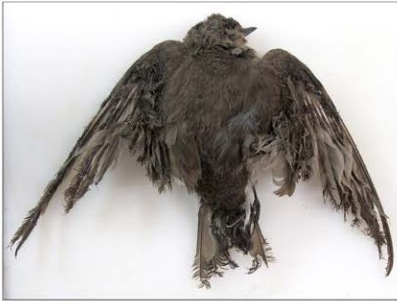
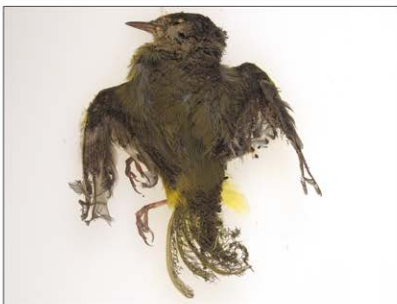
Birds with feather burns were graded based on the extent of the lesions. Grade 1 birds had curling of less than 50% of the flight feathers. Grade 2 birds had curling of 50% or more of the flight feathers. Grade 3 birds had curling and visible charring of contour feathers (Figure 1).

Figure 1: Three grades of flux injury based on extent and severity of burning. Grade 1 (top); Yellow-rumped Warbler with less than 50% of the flight feathers affected (note sparing of the yellow rump feathers). Grade 2 (middle); Northern Rough-winged Swallow initially found alive but unable to fly, with greater than 50% of the flight feathers affected. Grade 3 (bottom); MacGillivray's Warbler with charring of feathers around the head, neck, wings and tail.

Eight birds were assigned a feather damage Grade of 1 with curling of less than 50% of the flight feathers. Six of these had other evidence of acute trauma (75%). Five birds were Grade 2, including three birds that were found alive and died shortly afterwards. Of these birds, 2 (the birds found dead) also had evidence of acute trauma. Twenty-eight birds were Grade 3; with charring of body feathers. Of these birds, 21/28

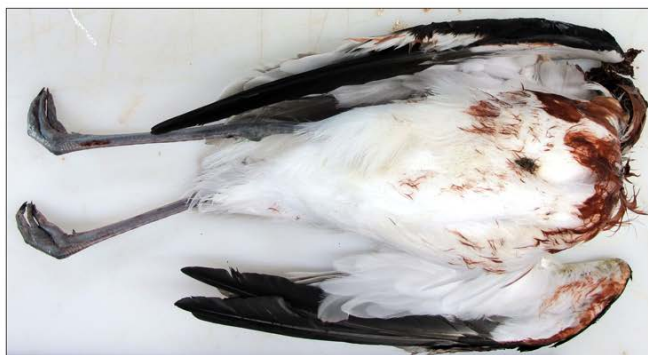
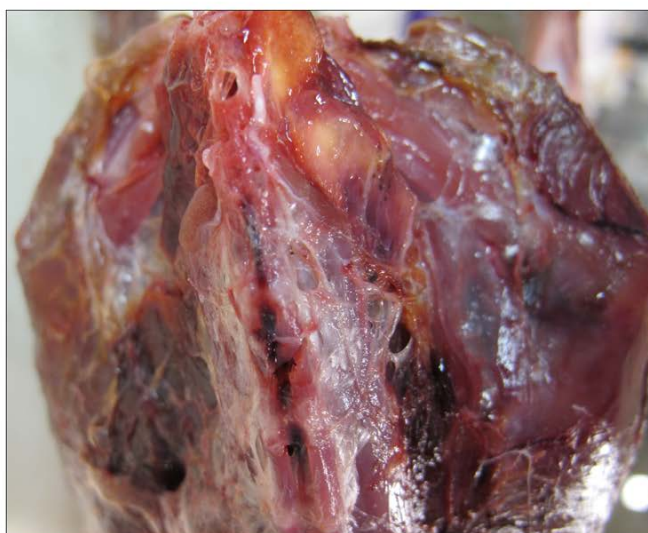
Blunt force impact trauma was determined to have been the cause of death for 19 Desert Sunlight birds including two Western Grebes (*Aechmophorus occidentalis*) and one each of 16 other species. Impact (blunt force) trauma is diagnosed by the presence of fractures and internal and/or external contusions. In particular, bruising around the legs, wings and chest are consistent with crash-landings while fractures of the head and/or neck are consistent with high-velocity, frontal impact (such as may result from impacting a mirror).

Predation was the immediate cause of death for 15 birds. Lesions supporting the finding of predation included decapitation or missing parts of the body with associated hemorrhage (9/15), and lacerations of the skin and pectoral muscles. Eight of the predated birds from Desert Sunlight were

Figure 2: Predation trauma (top) resulting in traumatic amputation of the head and neck (American Avocet) and impact trauma (bottom) causing bruising of the keel ridge of the sternum (Brown Pelican).

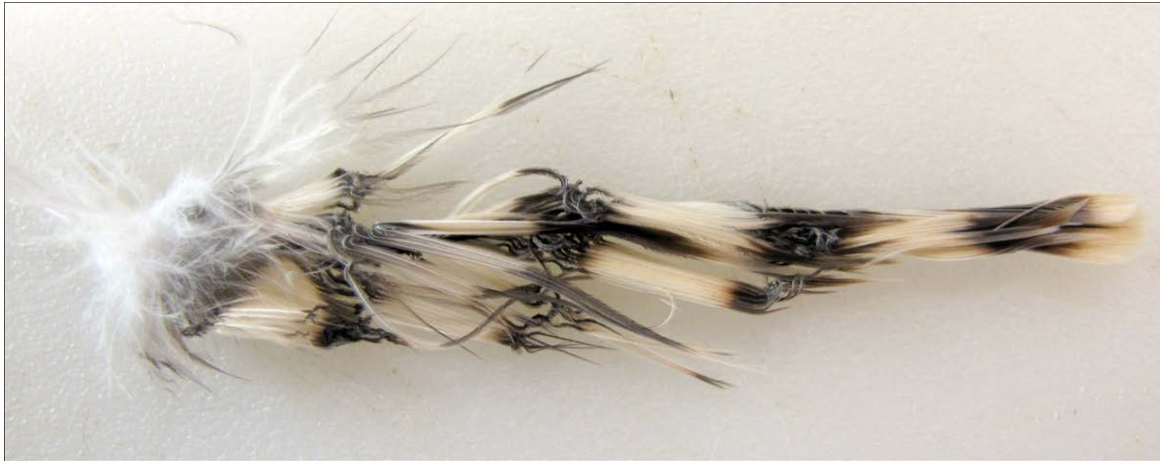
Figure 4: Feather from a Peregrine Falcon with Grade 2 solar flux injury. Note burning of dark feather bands with relative sparing of light bands.

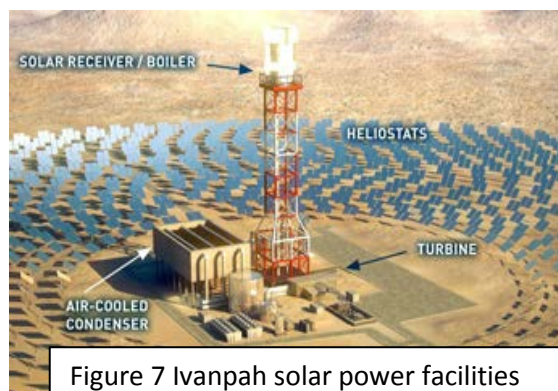
At the top of a 459 foot tall tower sits a boiler (solar receiver) that is heated by the sun rays reflected by 300,000 mirrors, called solar heliostats. When the concentrated sunlight strikes the boiler tubes, it heats the water to create superheated steam. The high temperature steam is then piped from the boiler to a turbine where electricity is generated (<http://ivanpahsolar.com/about> visited on 01/20/2014).

Figure 7 Ivanpah solar power facilities
<http://ivanpahsolar.com/about>

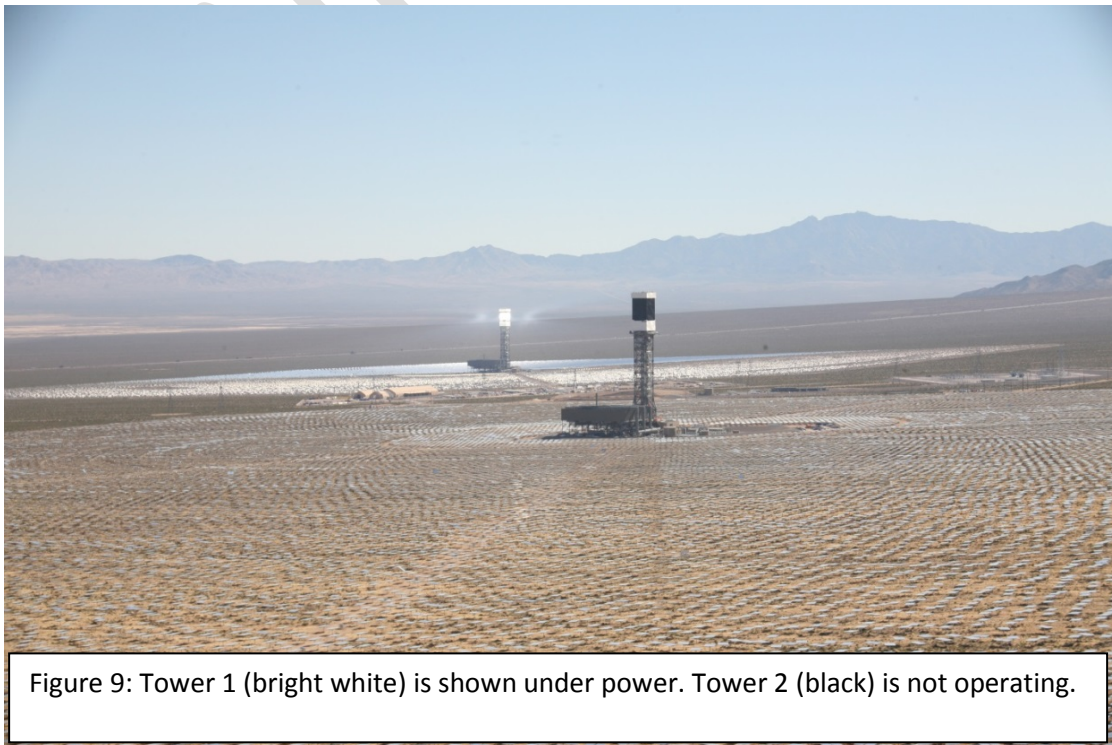
There is a phenomenon that occurs when the heliostats are focused on the tower and electricity is being generated. The phenomenon can be described as either a circle of clouds around the tower or, at times, a cloud formed on the side that is receiving the solar reflection. It appears as though the tower is creating clouds. Currently we propose two hypotheses of why this “cloud” is formed. The first hypothesis is simply the presumption that the high heat associated with towers is condensing the air, and forming the

Figure 9: Tower 1 (bright white) is shown under power. Tower 2 (black) is not operating.

clouds. The second hypothesis is that this phenomenon does not represent clouds at all rather it is a place in space where the heliostats that are not being used to generate heat are focused. Under this scenario, it is a place where the mirrors focus the excess energy not being used to generate electricity.

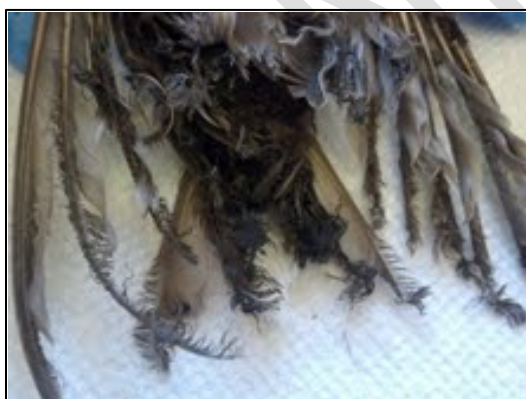
Many of the carcasses recovered from the Ivanpah Solar plant after the plant became operational showed singeing of feathers as shown in Figure 10.

Figure 10: Singed feathers from a Northern Rough-winged Swallow

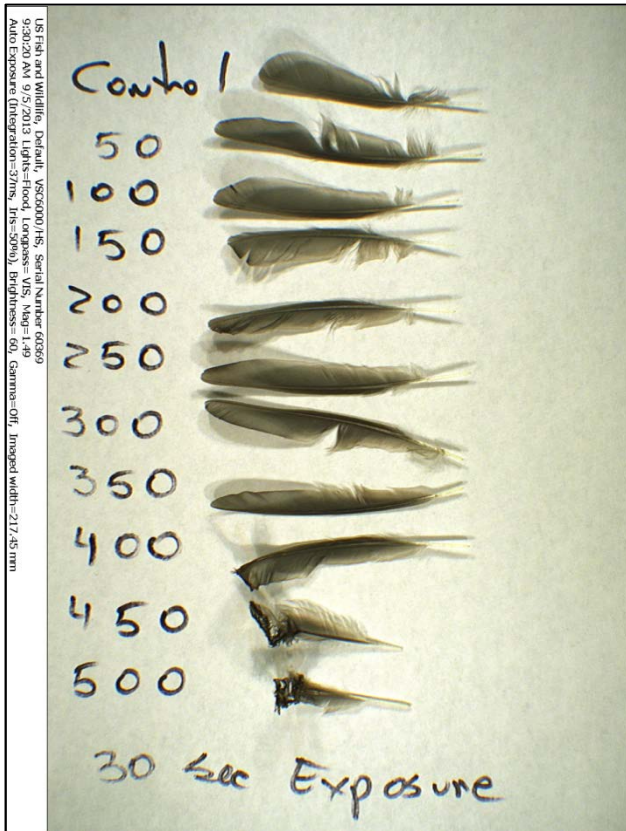
In order to investigate at what temperature feathers burn/singe, we exposed feathers to different air temperatures. Each feather was exposed to a stream of helium and air for 30 seconds. The results indicate that at 400° Celsius (752° Fahrenheit) after 30 seconds the feather begins to degrade. But at 450° and

Figure 11: Results of exposing feathers to different temperatures (in degrees Celsius)

500° Celsius (842° and 932° Fahrenheit respectively) the feathers singed as soon as they made contact with the superheated air (Figure 11). Therefore, when singed birds are found, it can be inferred that the temperatures in the solar flux at the time a bird flew through it was at least 400° Celsius (752° Fahrenheit). This inference is consistent with the desired operating temperature of a power tower solar boiler (482° Celsius).
