OCCIDENTAL OF ELK HILLS, INC.

CARBON DIOXIDE ENHANCED OIL RECOVERY PROJECT

CO₂ SUPPLY LINE AND PROCESSING FACILITY

PRELIMINARY JURISDICTIONAL DELINEATION OF WATERS OF THE UNITED STATES

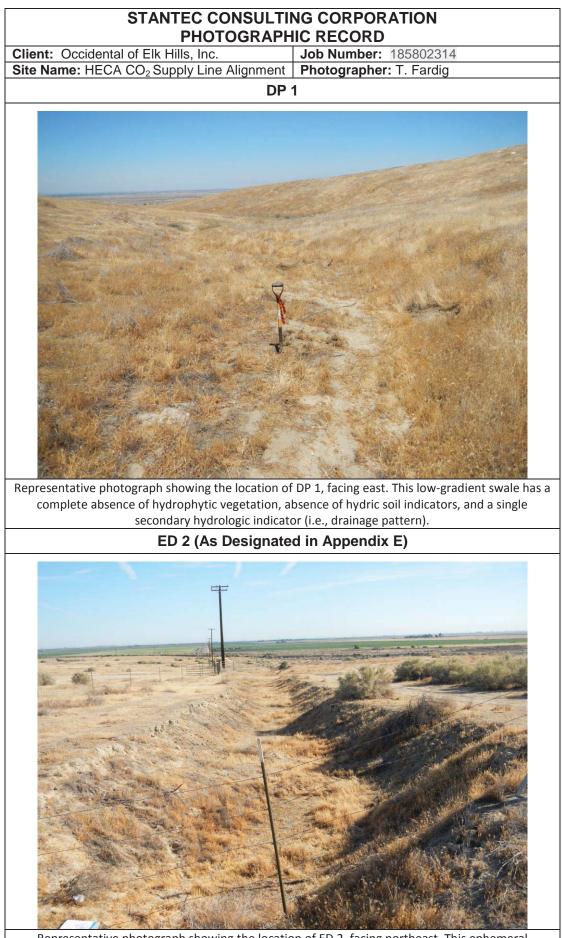
Representative photograph showing the location of ED 2, facing northeast. This ephemeral drainage has a defined bed and bank and a complete absence of hydrophytic vegetation and absence of hydric soil indicators. It contains a single secondary hydrologic indicator (i.e., drainage pattern). An Arid West Ephemeral and OHWM Datasheet for the feature ED 2 can be found in Appendix E.

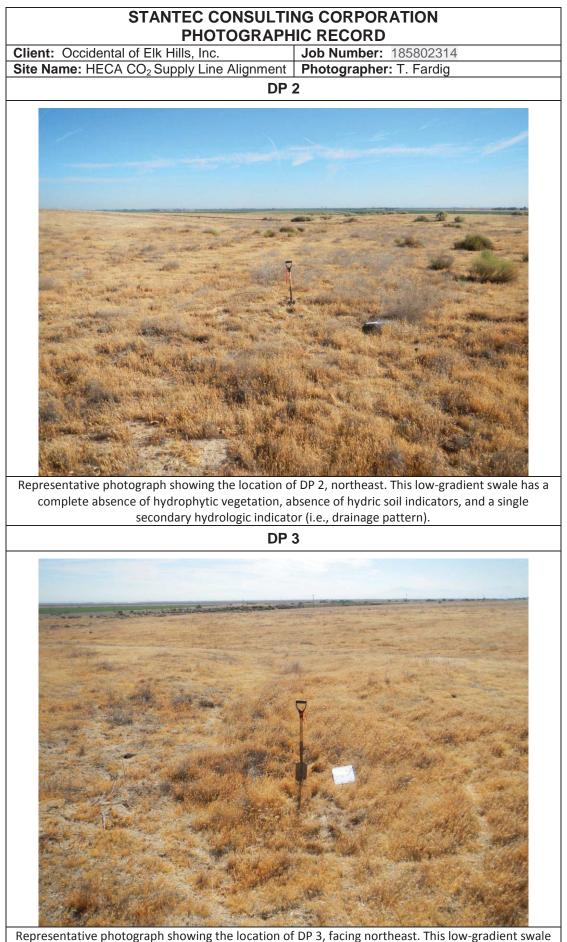
Representative photograph showing the location of DP 3, facing northeast. This low-gradient swale has a complete absence of hydrophytic vegetation, absence of hydric soil indicators, and a single secondary hydrologic indicator (i.e., drainage pattern).

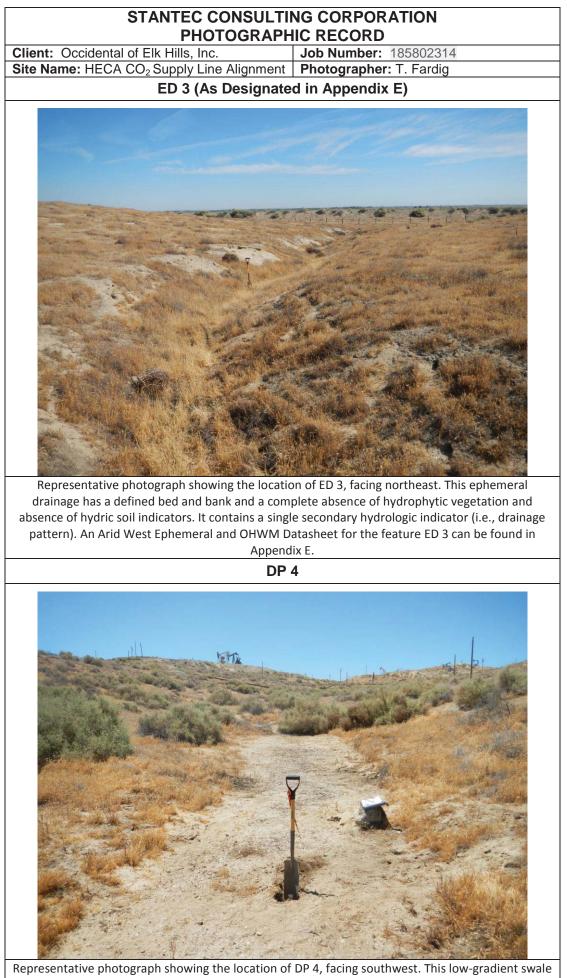
Representative photograph showing the location of DP 4, facing southwest. This low-gradient swale has a complete absence of hydrophytic vegetation, absence of hydric soil indicators, and a single secondary hydrologic indicator (i.e., drainage pattern).

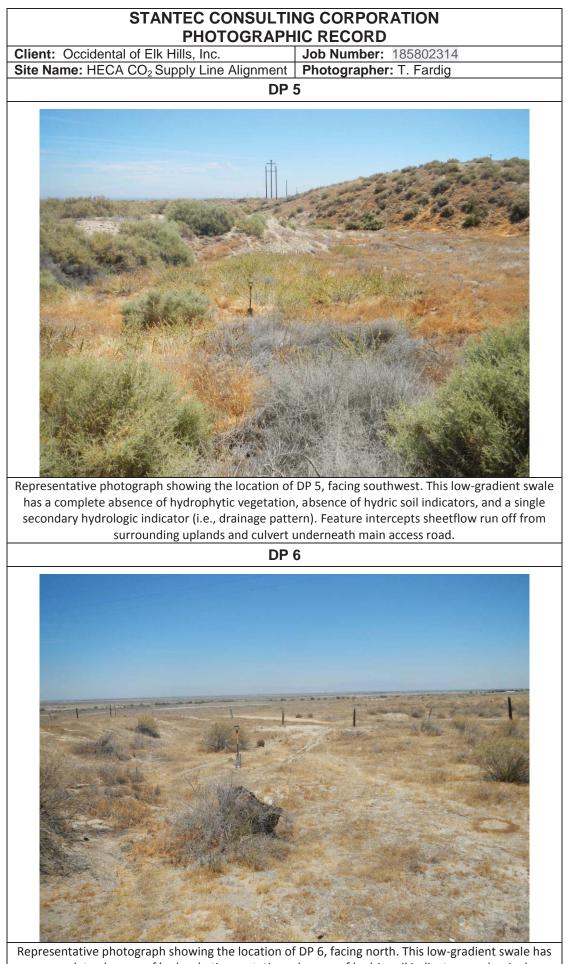
Representative photograph showing the location of DP 6, facing north. This low-gradient swale has a complete absence of hydrophytic vegetation, absence of hydric soil indicators, and a single secondary hydrologic indicator (i.e., drainage pattern).

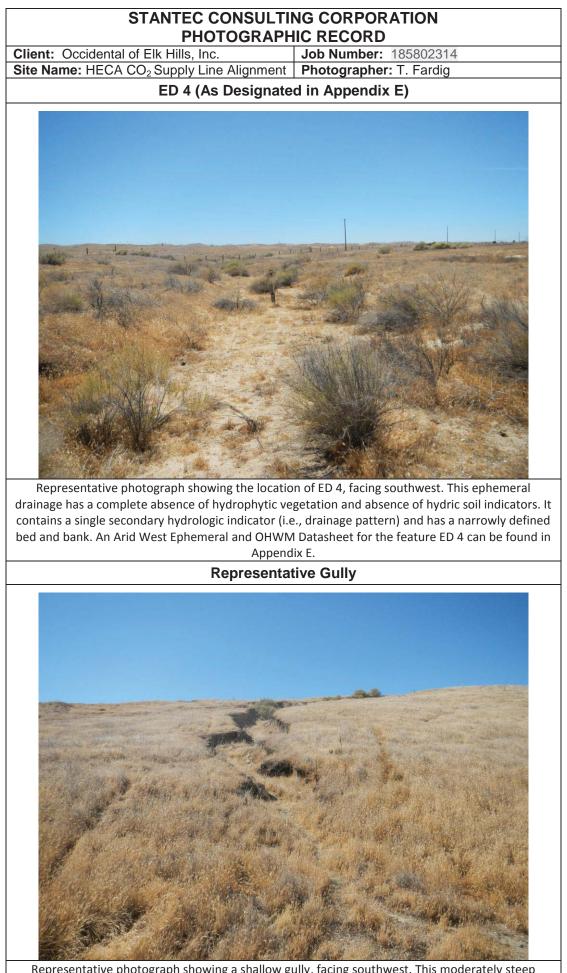
Representative photograph showing a shallow gully, facing southwest. This moderately steep gradient gully has a complete absence of hydrophytic vegetation and absence of hydric soil indicators. It contains a single secondary hydrologic indicator (i.e., drainage pattern). Erosional head cutting at top of feature.

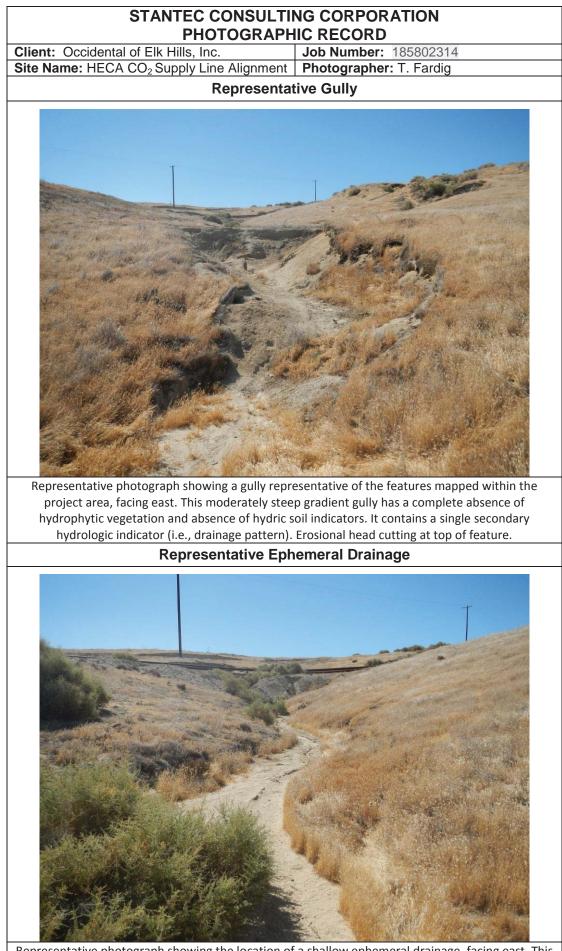
Representative photograph showing the location of a shallow ephemeral drainage, facing east. This ephemeral drainage has a complete absence of hydrophytic vegetation and absence of hydric soil indicators. It contains a single secondary hydrologic indicator (i.e., drainage pattern) and has a defined bed and bank.

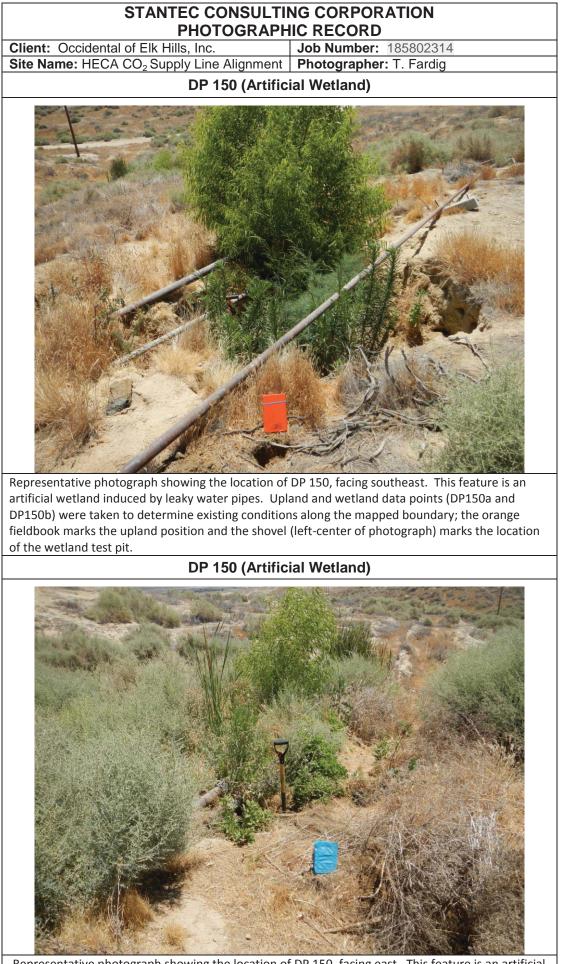
Representative photograph showing the location of DP 150, facing east. This feature is an artificial wetland induced by leaky water pipes. Upland and wetland data points (DP150c and DP150d) were taken to determine existing conditions along the mapped boundary; the Munsell field book marks the upland position and the shovel marks the location of the wetland test pit.

DP150b – Artificially induced wetland created by leaky water pipes. This feature is located in upland and occurs as a small basin beneath the pipes. Hydrologic inputs appear year-round/continuous, creating a suitable moisture regime to support a prevalence of hydrophytic species including black willow (*Salix gooddingii*; FACW), narrow-leaved cattail (*Typha angustifolia*; OBL), Coulter's horseweed (*Laennecia coulteri*; FAC), and rabbit's-foot grass (*Polypogon monspeliensis*; FACW). Mapped wetland boundaries were based on the limits of soil saturation. This feature occupied 0.008 acres of the Project area.

DP150d - Artificially induced wetland created by leaky water pipes. This feature is located downslope from DP150b and occurs as a linear feature confined to a narrow saturation zone. Hydrologic inputs appear year-round/continuous, creating a suitable moisture regime to support a prevalence of hydrophytic species including black willow (FACW), narrow-leaved cattail (OBL), Coulter's horseweed (FAC), rabbit's-foot grass (FACW), and Jersey cudweed (*Pseudognaphalium luteoalbum*; FAC). Mapped wetland boundaries were based on the limits of soil saturation. This feature occupied 0.008 acres of the Project area.
