RE: Data Response, Set 2J
Ivanpah Solar Electric Generating System (07-AFC-5)

Ivanpah Solar Electric Generating System (ISEGS) (07-AFC-5)

Data Response, Set 2J (Response to: Project Description and Soil & Water Resources)

Preliminary Results
Vegetation Response to Simulated Mowing
Ivanpah Valley, California

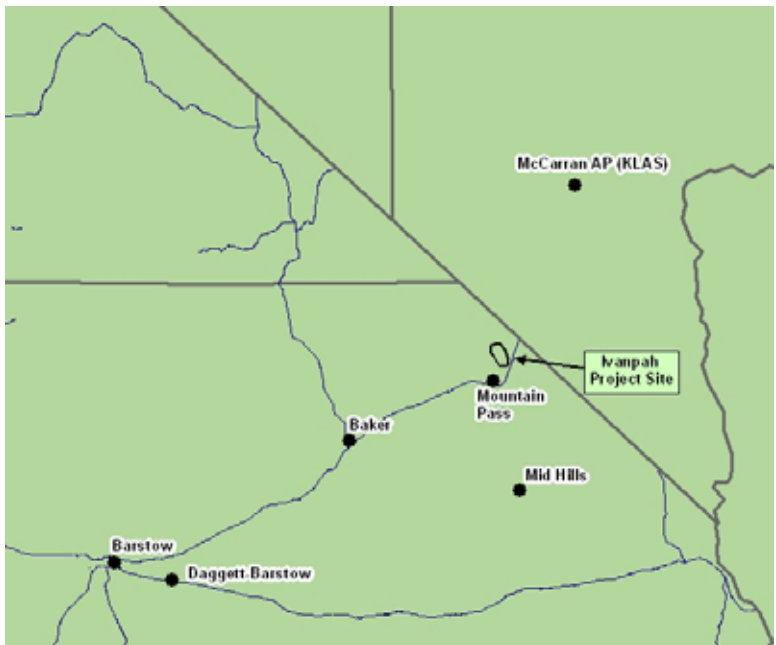
Figure 2. Precipitation stations near the ISEGS project site.

Rainfall data available from nearby stations was consulted to place into context the degree of regrowth observed for the clipped plants. This is an important step in our understanding because if the antecedent precipitation is low or high has a direct bearing on the performance of regrowth. A rain gage is currently being added to the weather station operated in Ivanpah Valley, so surrogate regional weather. Weather stations with records that were complete through April include Dagget-Barstow, McCarran Airport and Mid Hills. These stations are visible on Figure 2. The data are presented in Table 4.

Rainfall at all three stations was below average and the closest station, Mid Hills, had the lowest recorded rainfall of the three, 69%. Thus, as indicated by these data, regrowth of the test plants was less than would be expected were average rainfall conditions present. Average to above average rainfall is expected to produce even more vigorous recovery than was noted.

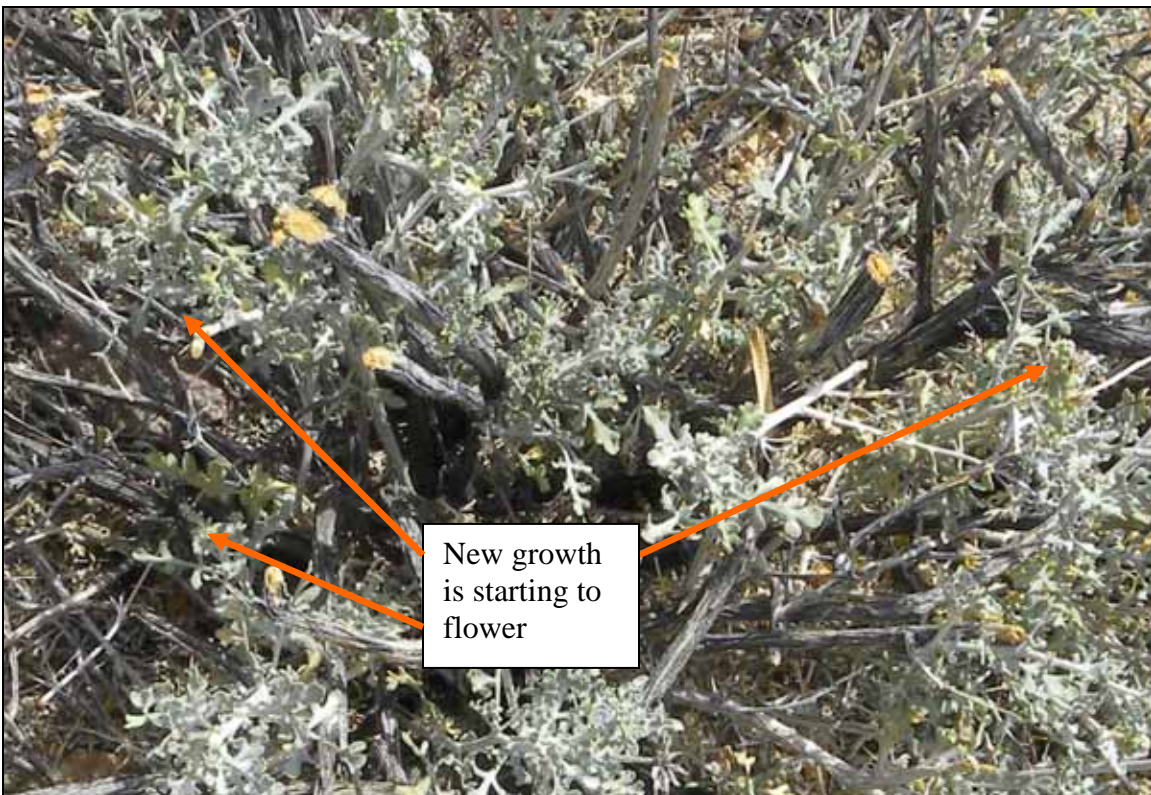
Site 8 (Sites 1-7 were not relocated during the April 28th, 2009 revisit)

Rating: 4

Burrobush: Most pale green growth is new. Buds are starting to flower.

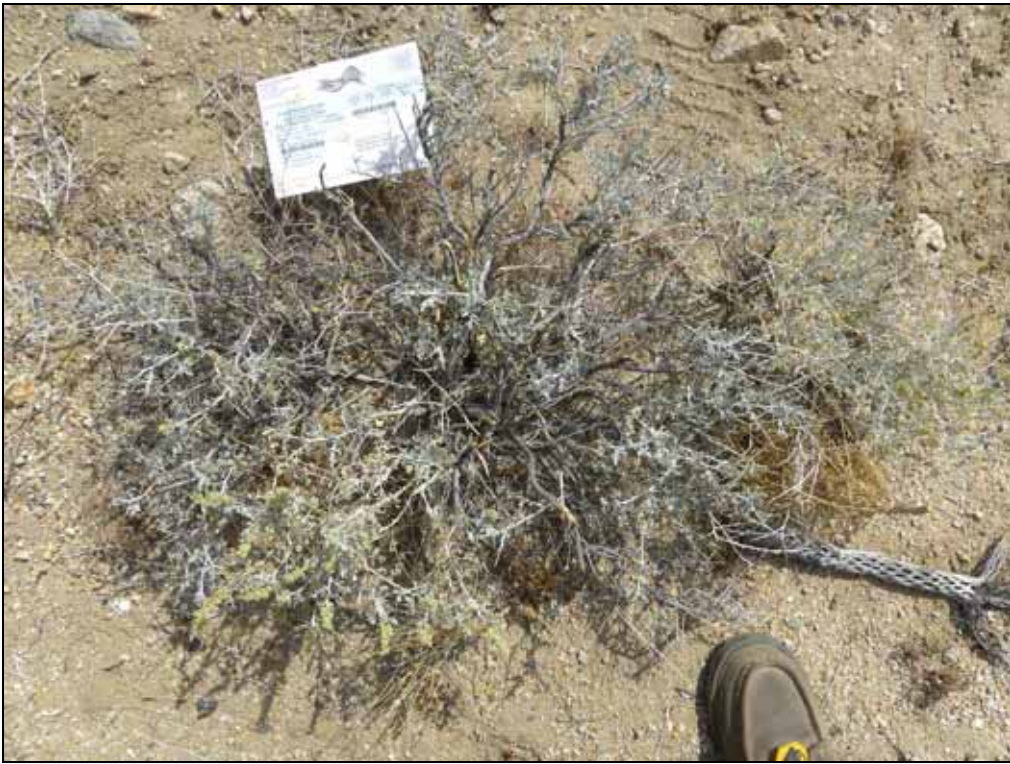
Site 9

Rating: 4

Burrobush: A small bush with very vigorous growth.

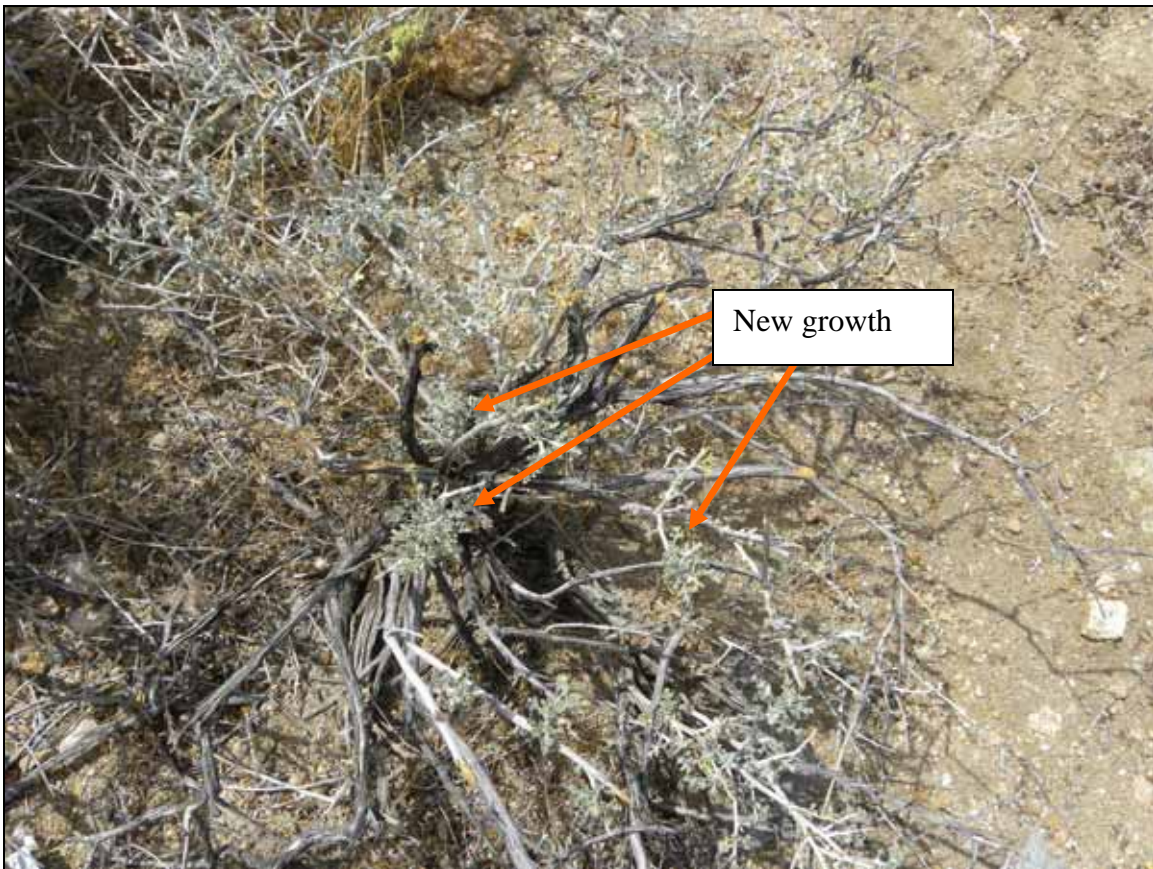
Site 10

Rating: 3

Burrobush: A very small bush with new growth and flowers present.

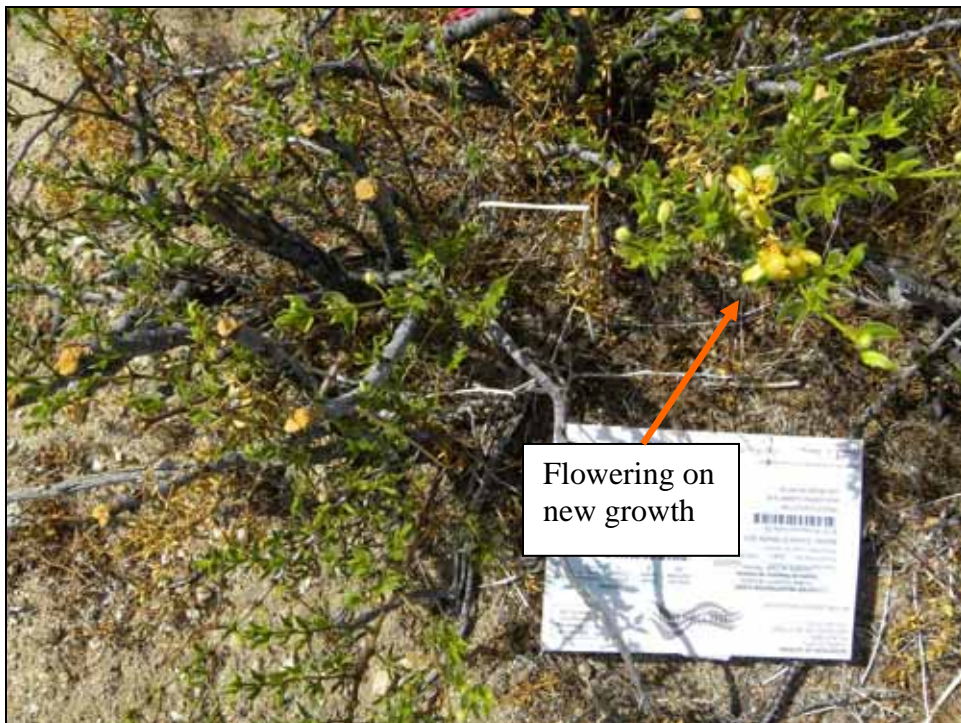
Site 11

Rating: 4

Creosote bush and burrobush: Bright green new growth with flowering. The burrobush located within the cut creosote showed a burst of growth suggesting relaxed competition from the creosote bush.

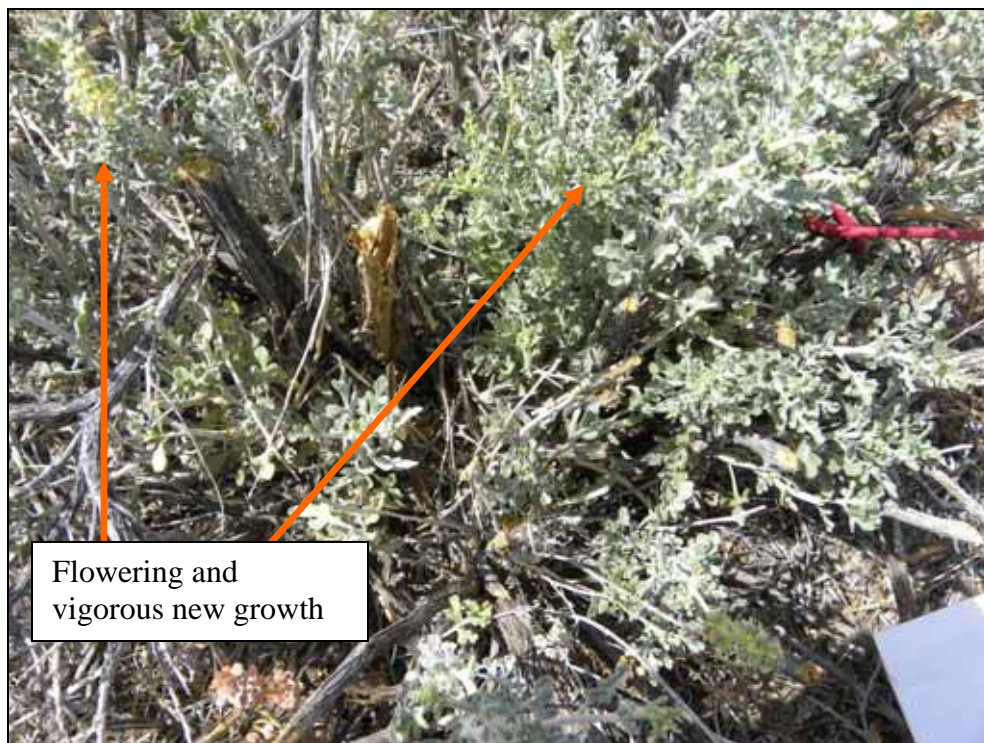
Site 12

Rating: 4

Burrobush: Large bush with vigorous growth and flowering.

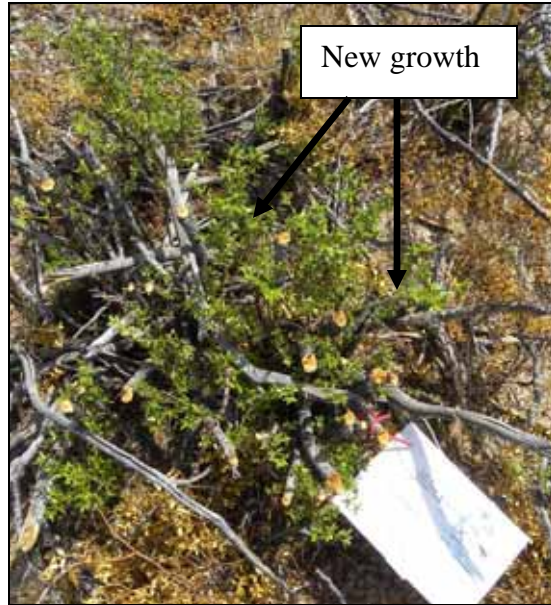
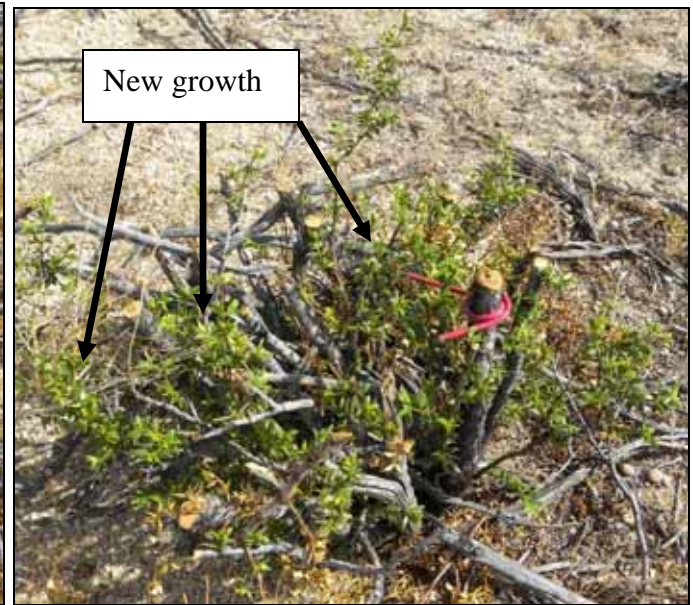
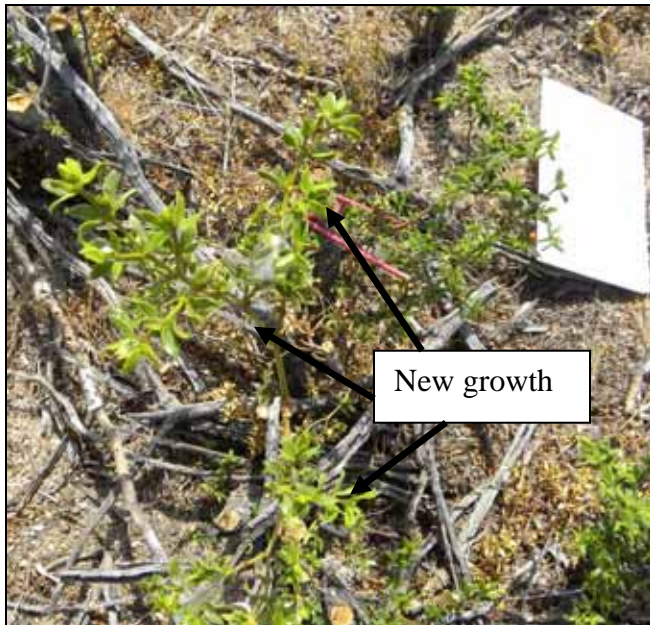
Site 13

Rating: 3

Creosote bush: Six bases in the clone are evaluated separately. The burrobush located in creosote bush 4 shows a burst of growth suggestive of relaxation of competition due to the creosote bush cutting.

Creosote bush showed vigorous growth, however, the six individuals arrayed in a clone were given a “3” (vigorous, but not very vigorous) simply because they were not as vigorous as several of the other test species—for example, they were not actively flowering and the new growth hardly exceeded the cut stem surfaces as was seen for cheesebush and burrobush. The vigor rating of “3” or “4” could be debated, however, since the new growth was highly verdant.

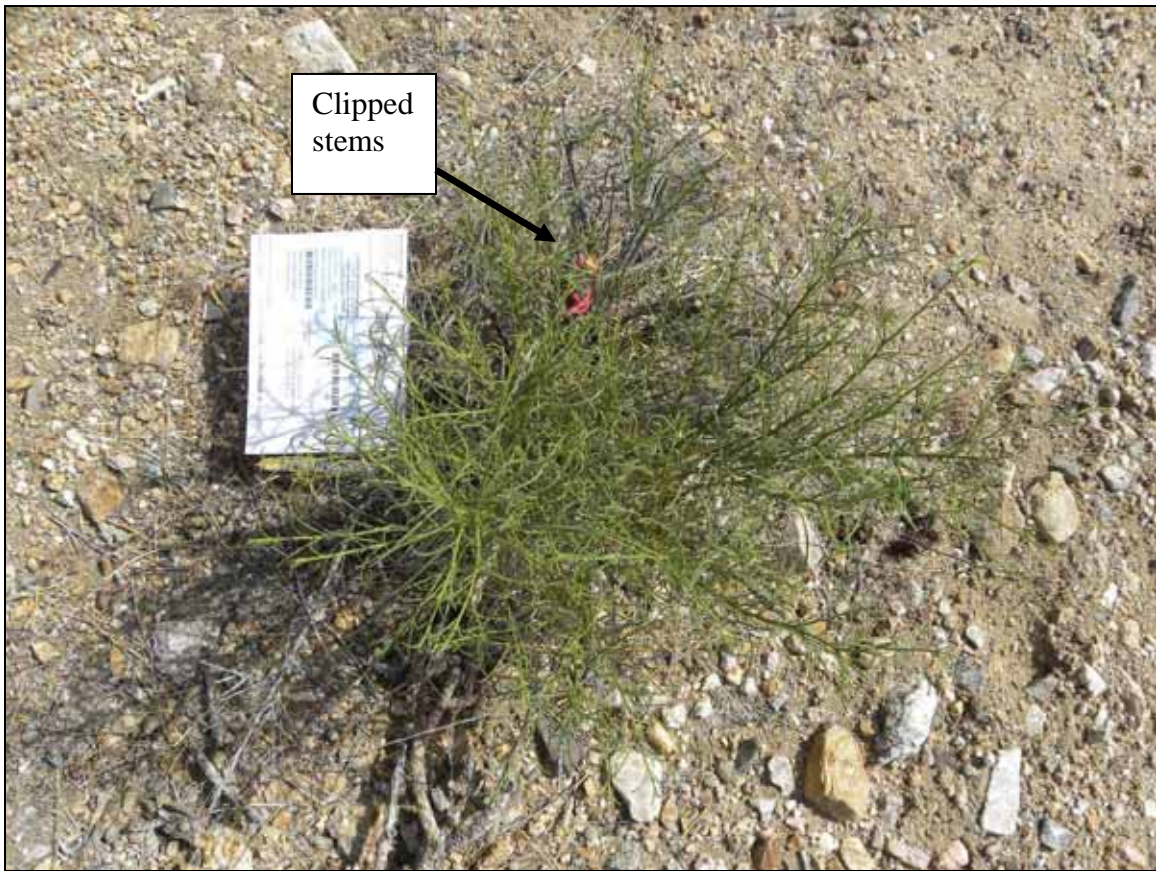
Site 14

Rating: 4

Cheese bush: Small bush with vigorous new growth.

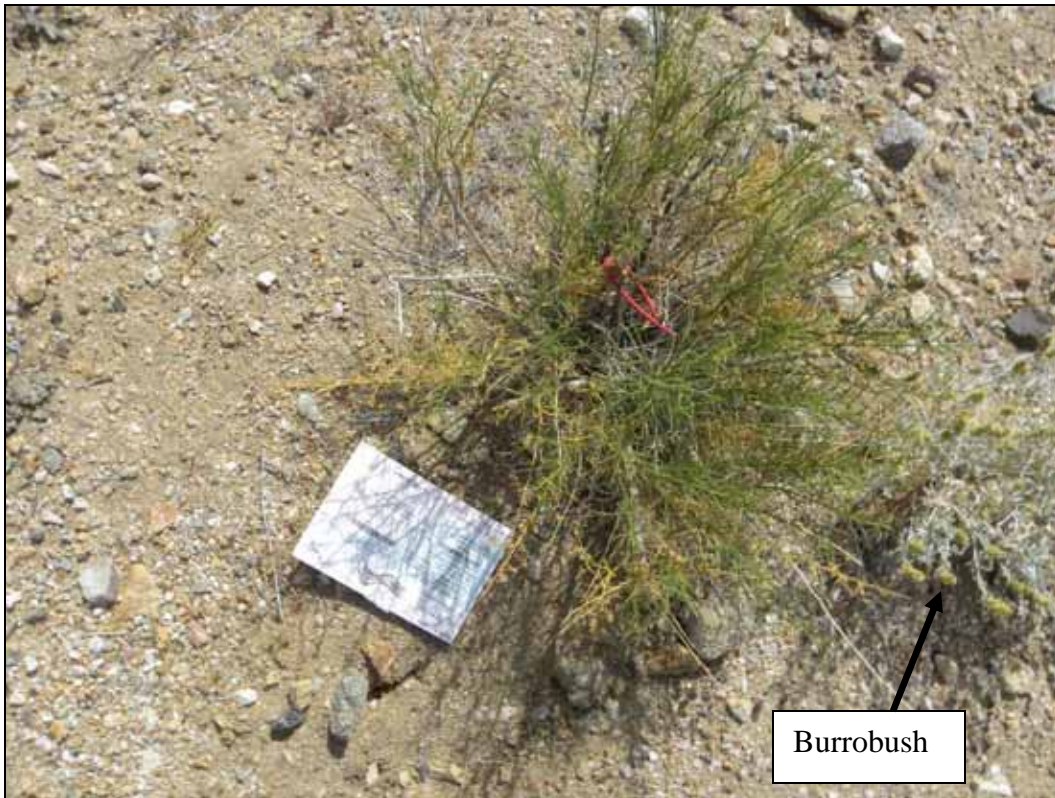
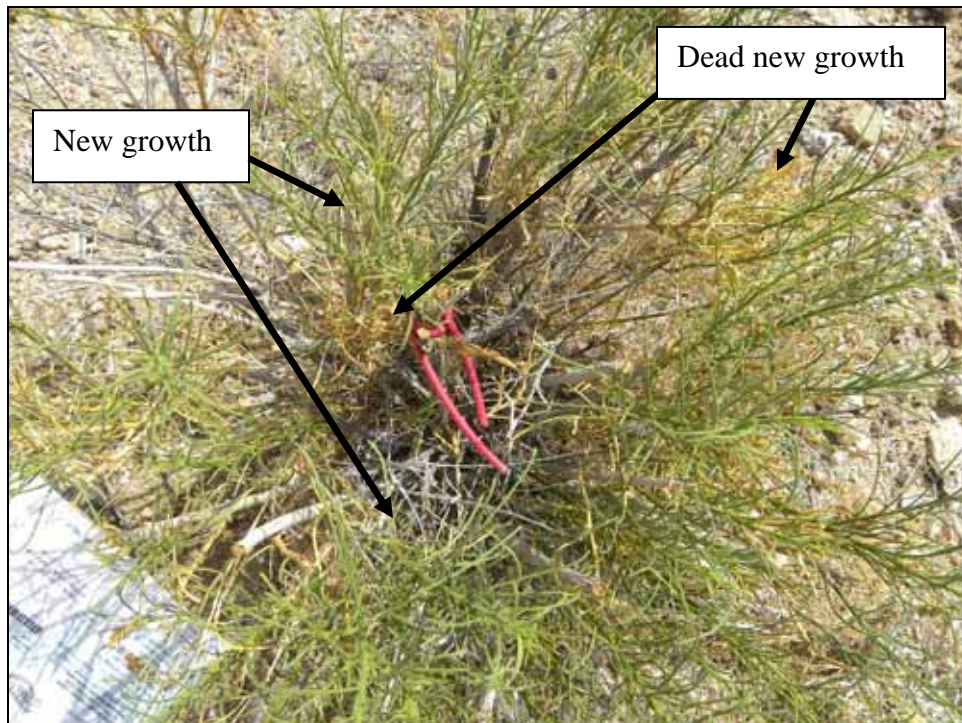
Site 15

Rating: 3

Cheese bush: Small bush with somewhat chlorotic new growth and some new branching has died.

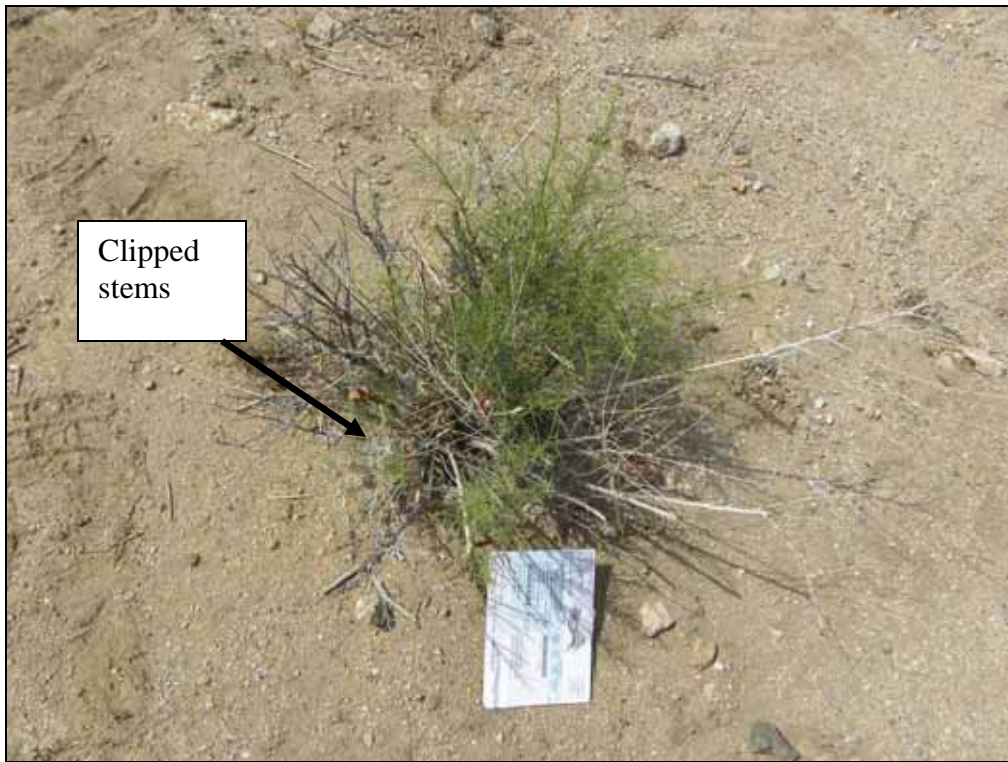
Site 16

Rating: 4

Cheese bush: Vigorous new growth with flowers.

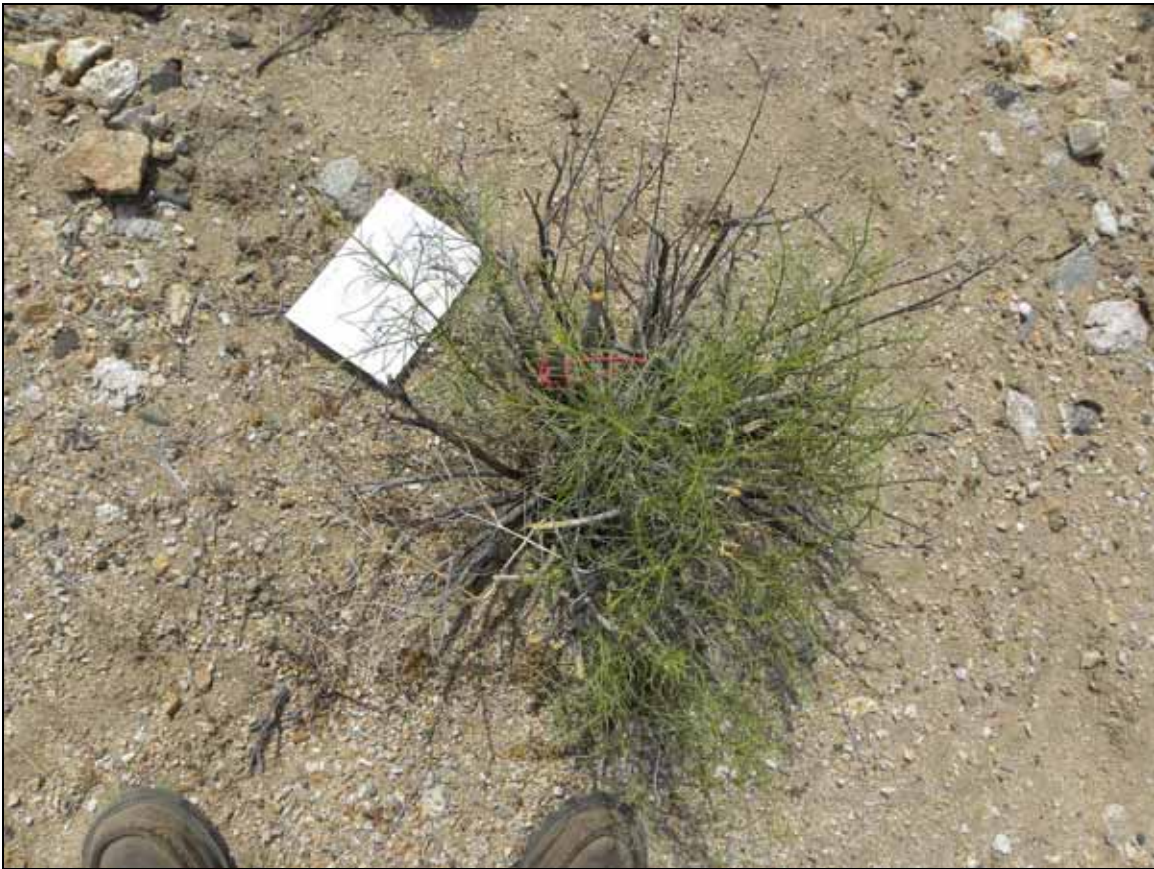
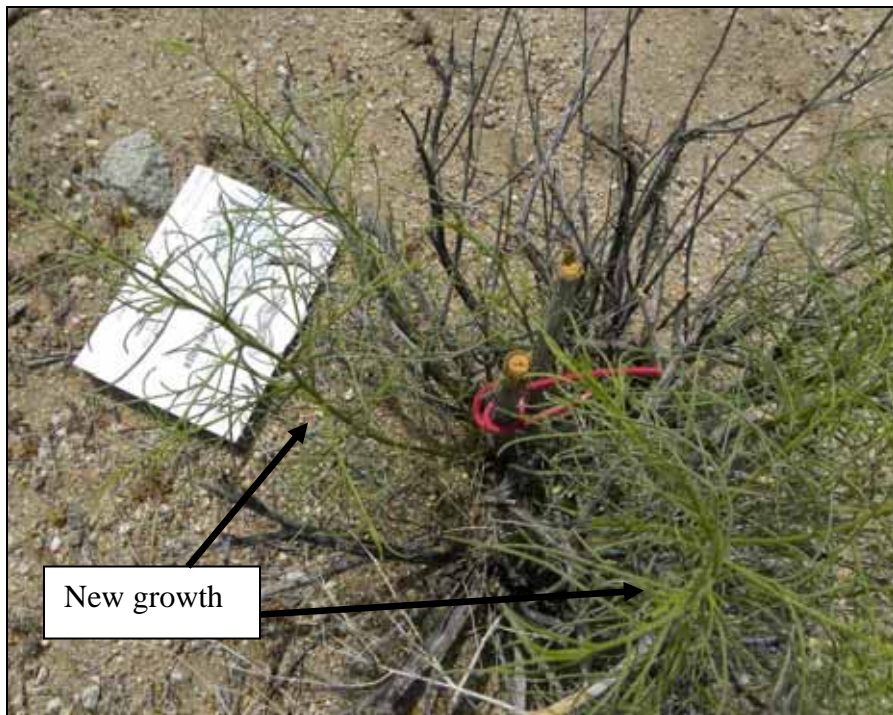
Site 17

Rating: 4

Cheese bush: Small bush with new growth.

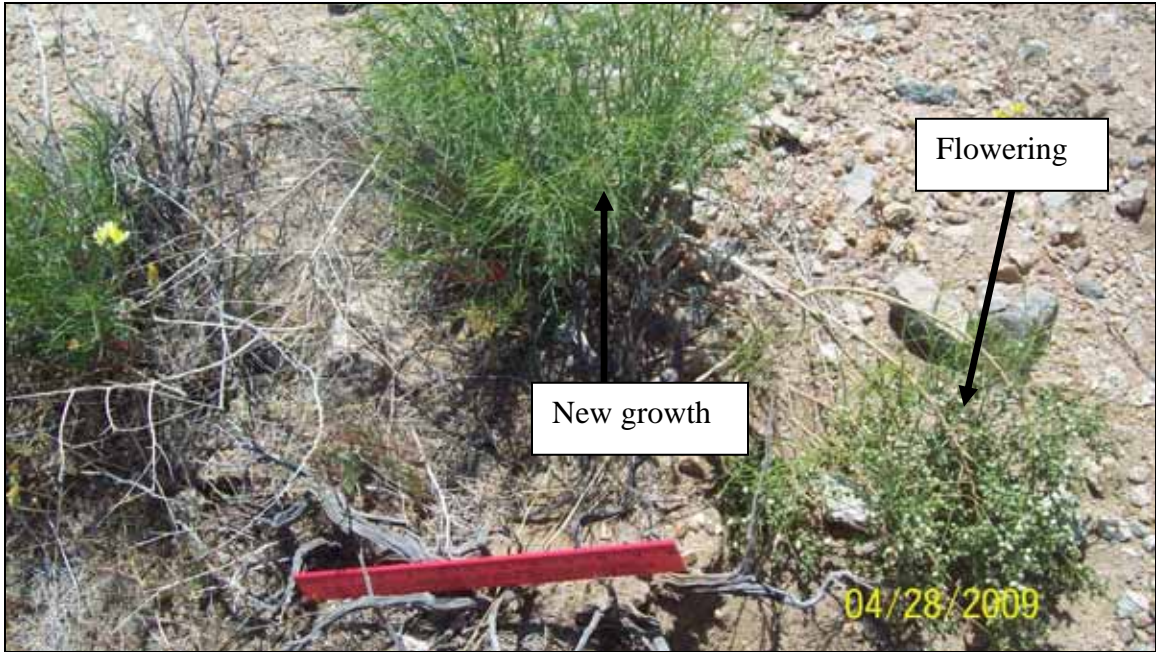
Site 18

Rating: 4

Cheese bush: Very vigorous bright green new growth and flowering on uncut decumbent stem.

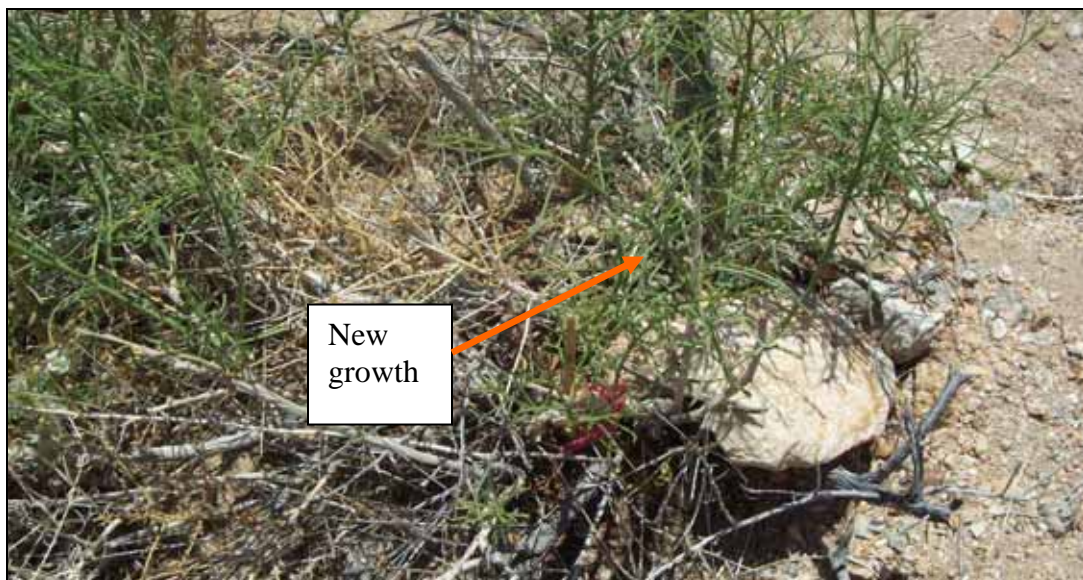
Site 19

Rating: 4

Cheese bush: Very vigorous growth easily exceeds lengths of cut stems.

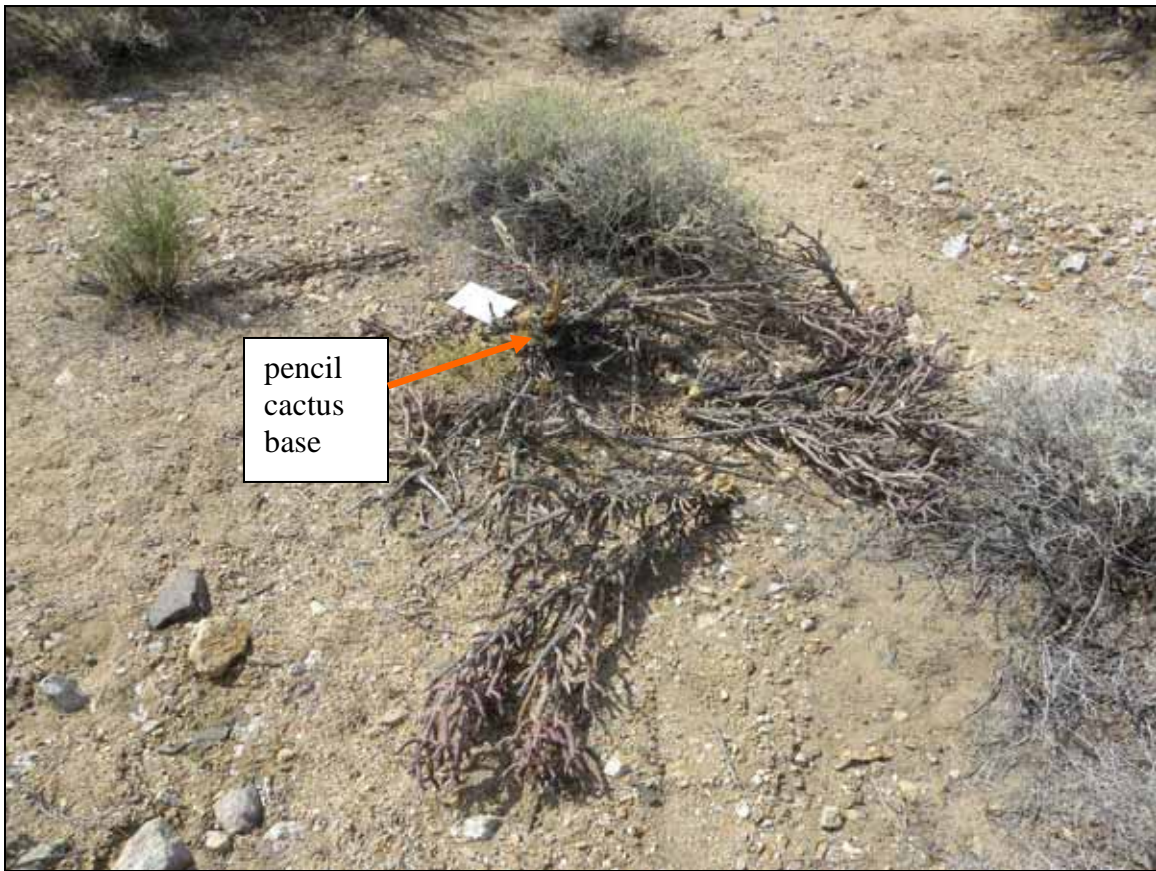
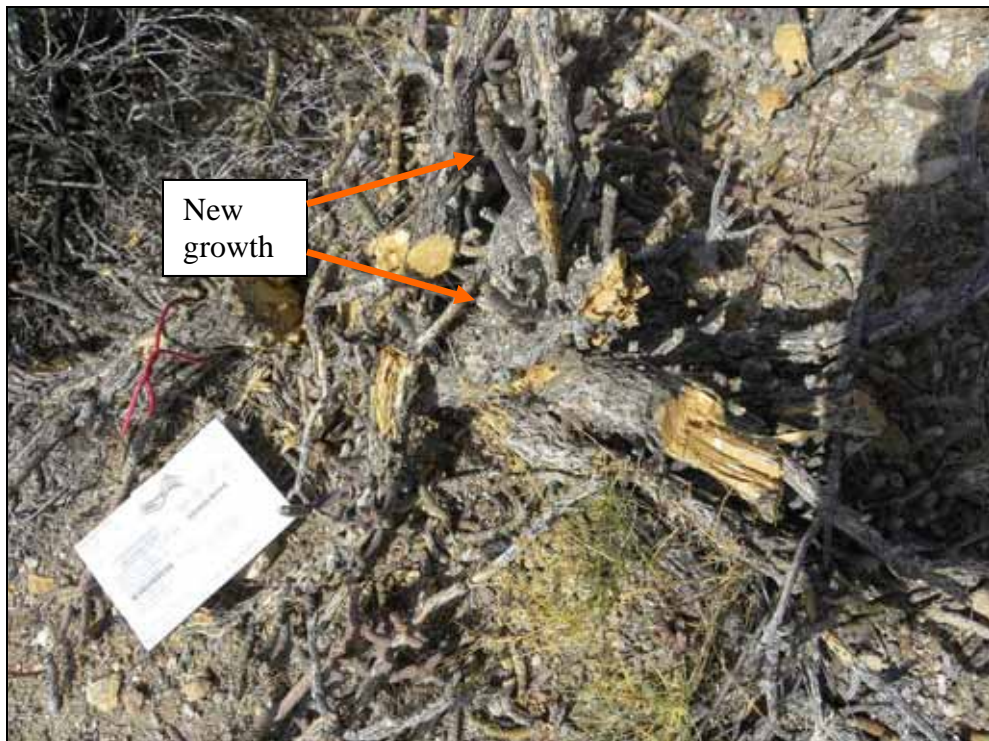
Site 20

Rating:3

Pencil Cactus: New growth is starting from stem base.

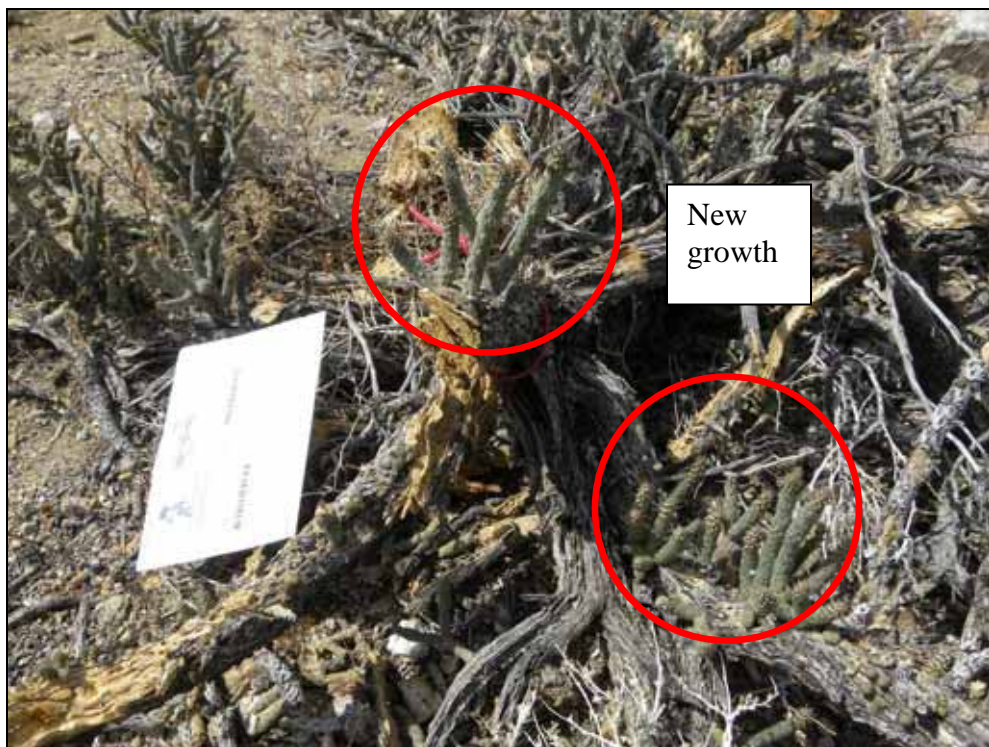
Site 21

Rating: 4

Pencil Cactus: Vigorous new growth from remaining stem bases.

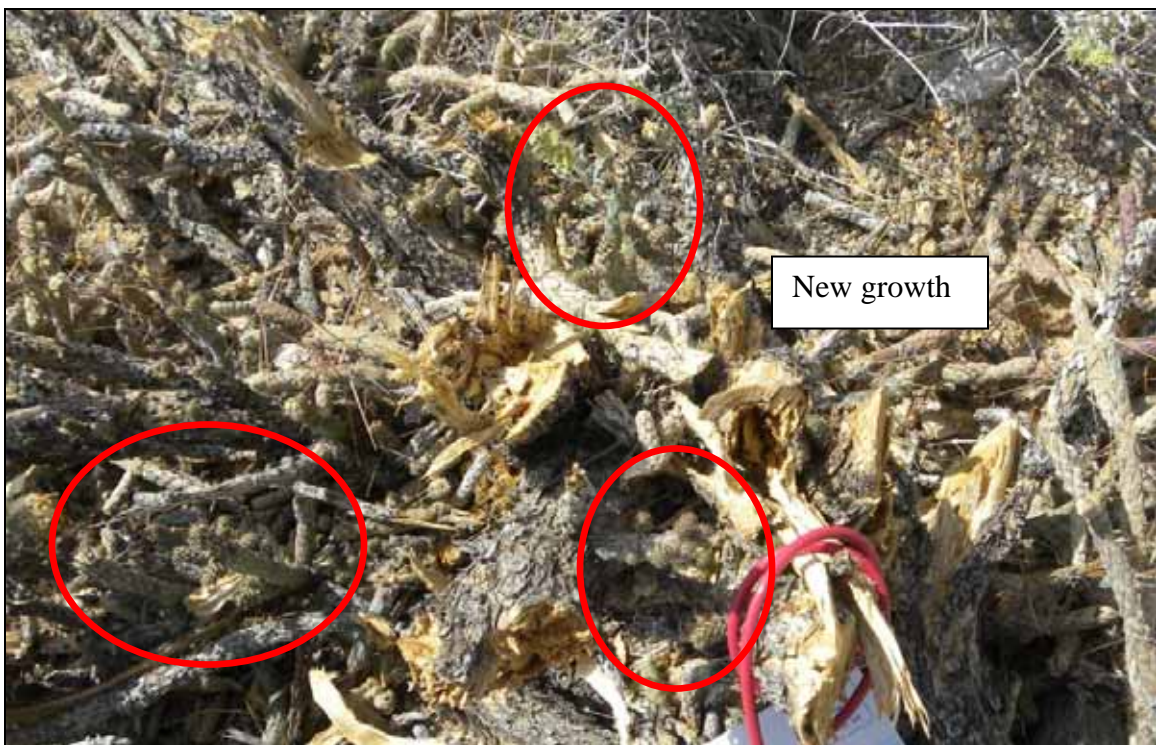
Site 23

Rating: 4

Pencil Cactus: New growth around the base of the cut cactus.

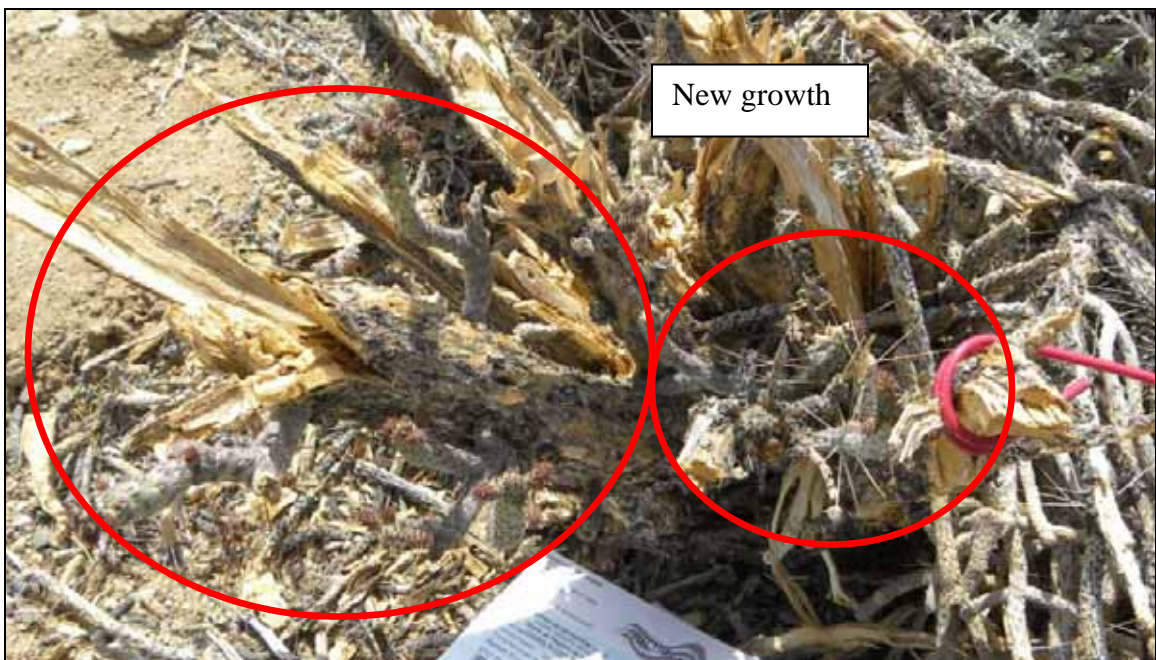
Site 24

Rating: 4

Pencil Cactus: Vigorous new growth at the stem base.

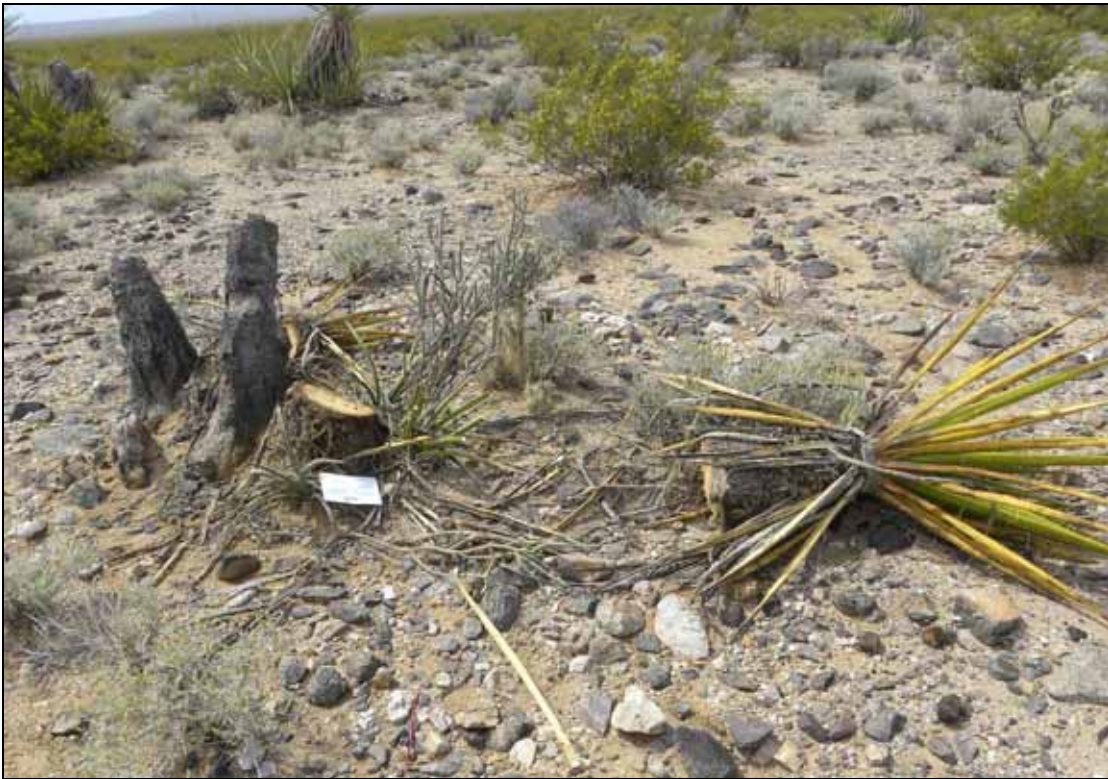
Site 25

Rating: 1

Mojave Yucca: No new growth on the 5 shoots.

Mojave yucca are known to be relatively slow growing. On two of the three relocated individual yuccas, there was recognizably green leaf tissue on two. For the single-stem yucca that was sawn off, no green tissue remained, however, judging from the appearance of the other yucca this plant was given a rating of “1”, alive but with no new growth evident. The survivorship for “mown” yucca will await reevaluation in April, 2010, since this species is expected to take up to a year to initiate new buds and leaf growth.

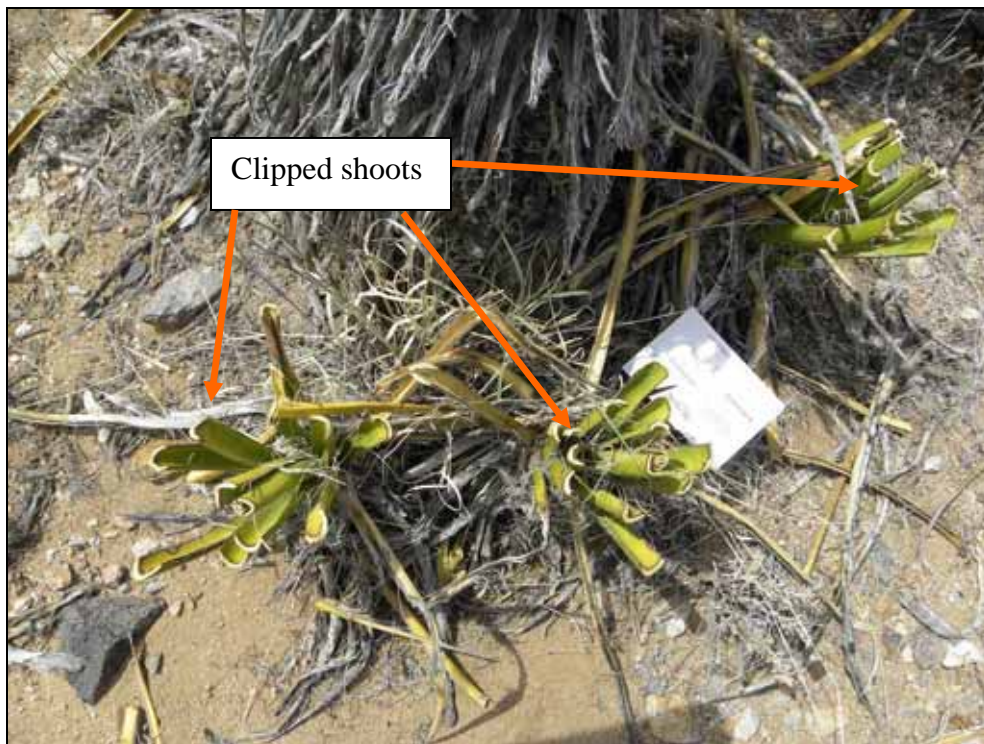
Site 26

Rating: 1

Mojave Yucca: No new growth has occurred.

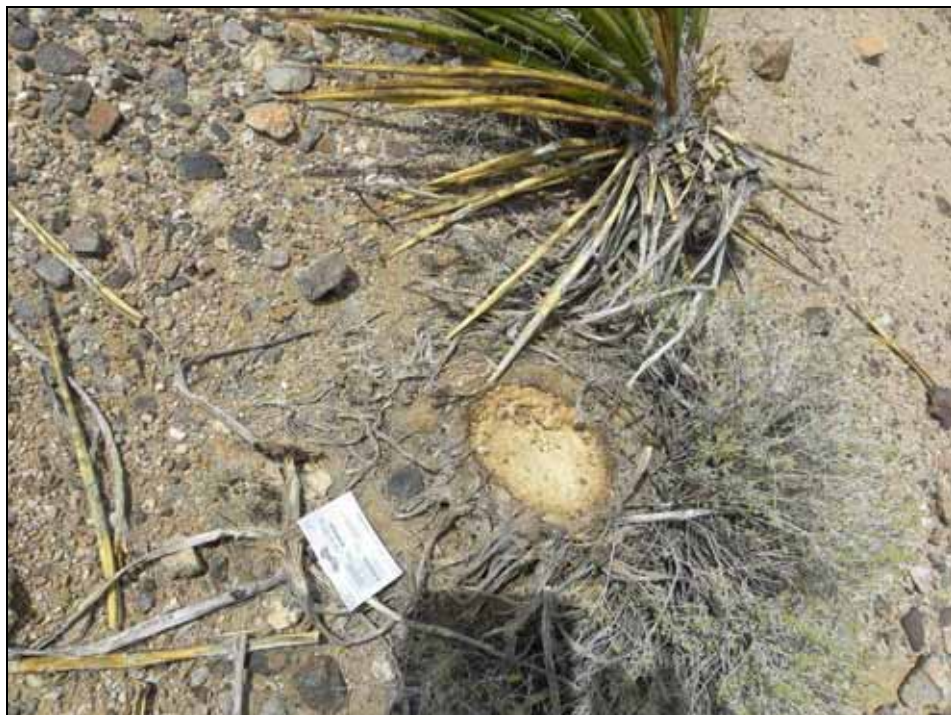
Site 27

Rating: 1

Mojave Yucca: No new growth has occurred.

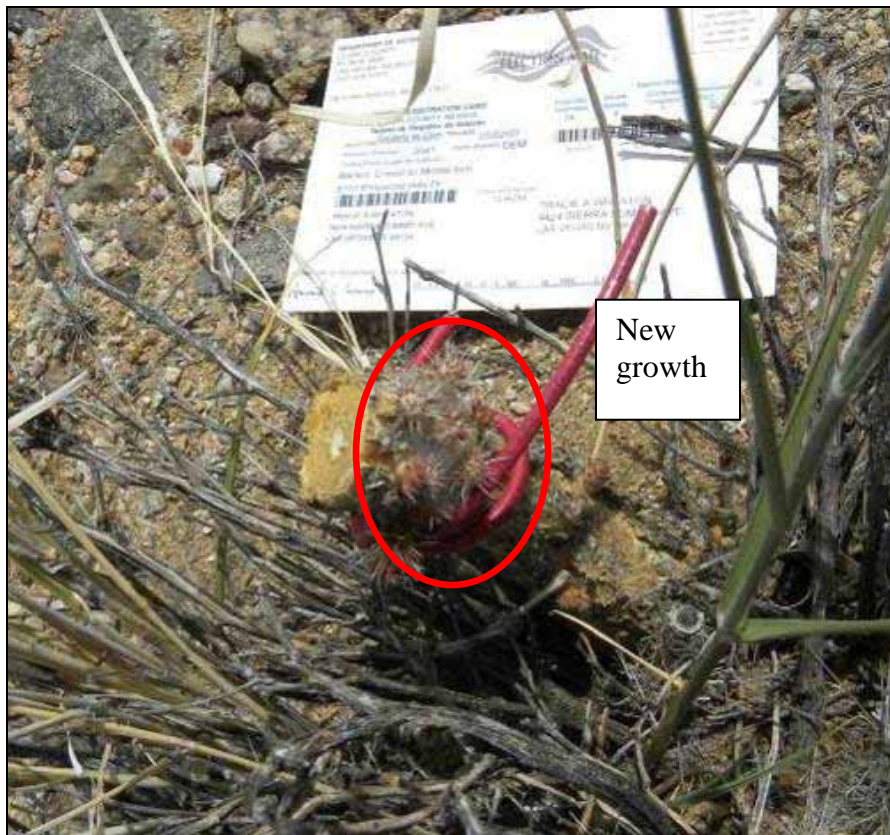
Site 28

Rating: 4

Silver Cholla: New growth around the cut stem base.

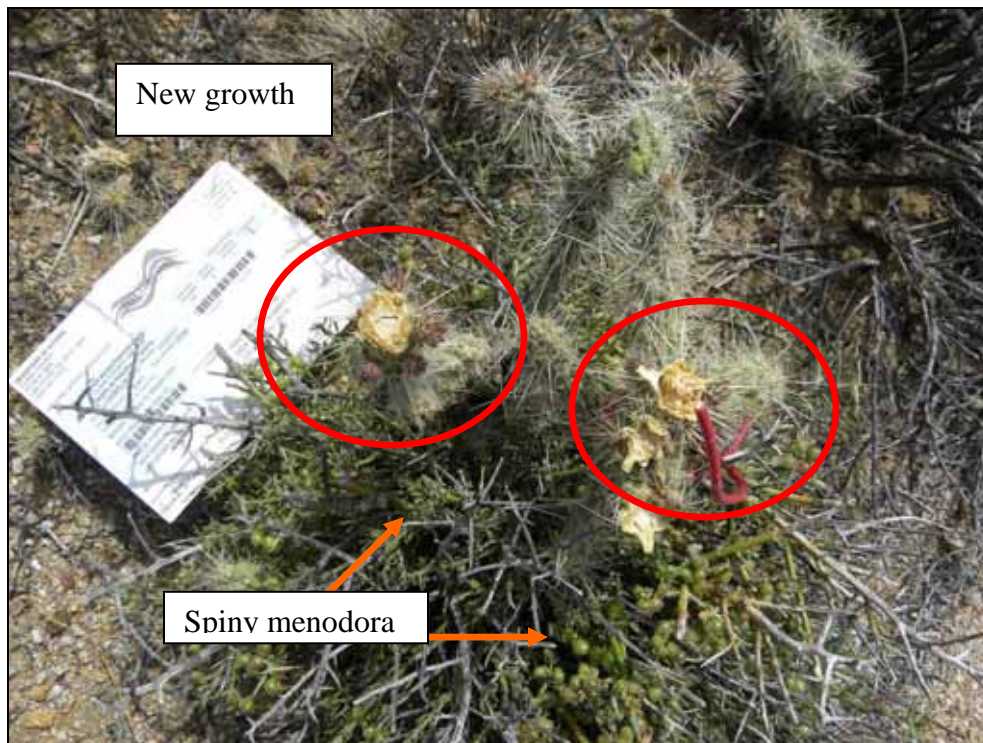
Site 30

Rating: 3

Silver Cholla: New growth has just initiated from the cut stem base. Competitive effects may exist from the spiny menodora and surrounding vegetation.

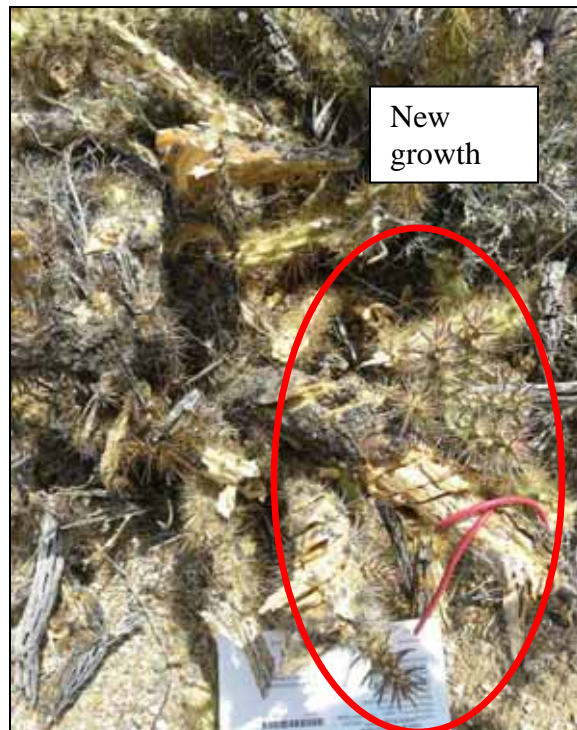
Site 31

Rating: 4

Silver Cholla: Vigorous new growth on the cut stem base.
