RE: Data Response, Set 2J
Ivanpah Solar Electric Generating System (07-AFC-5)

Ivanpah Solar Electric Generating System (ISEGS) (07-AFC-5)

Data Response, Set 2J (Response to: Project Description and Soil & Water Resources)

Preliminary Results
Vegetation Response to Simulated Mowing
Ivanpah Valley, California

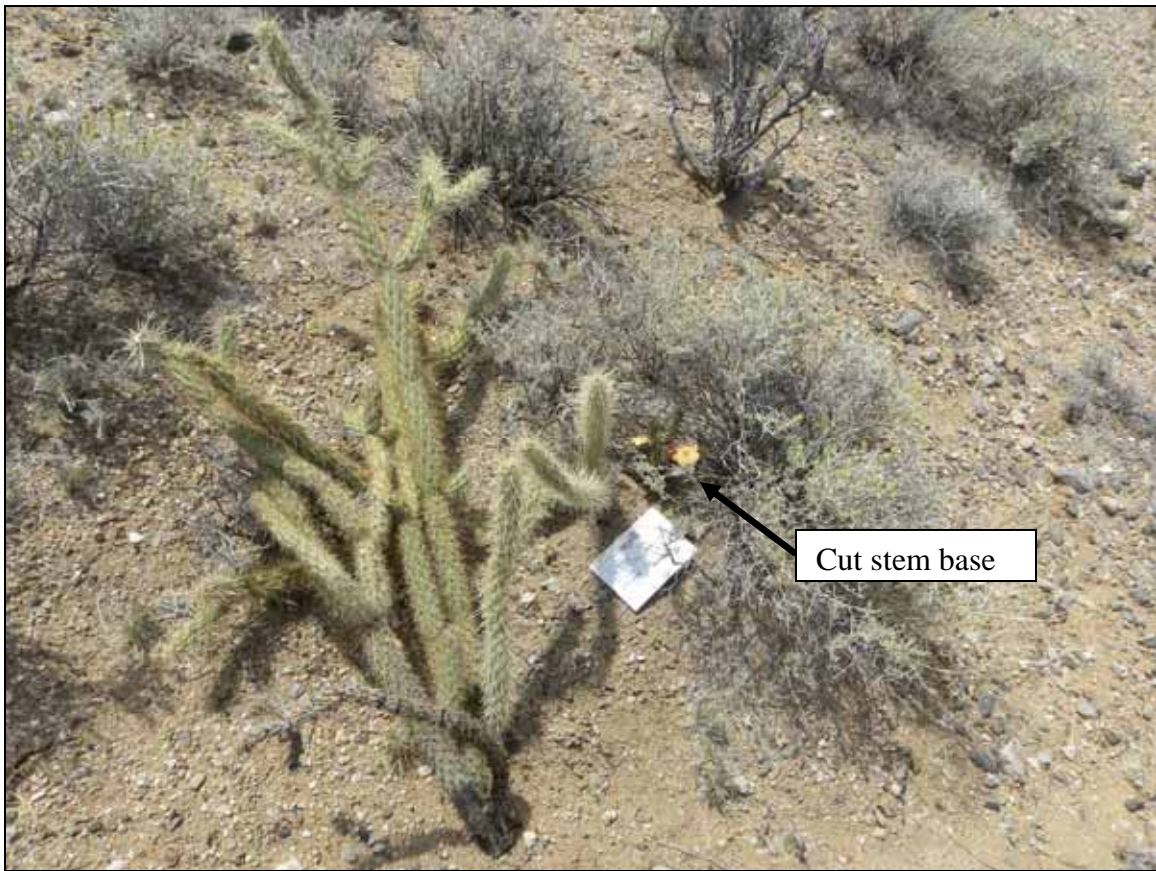
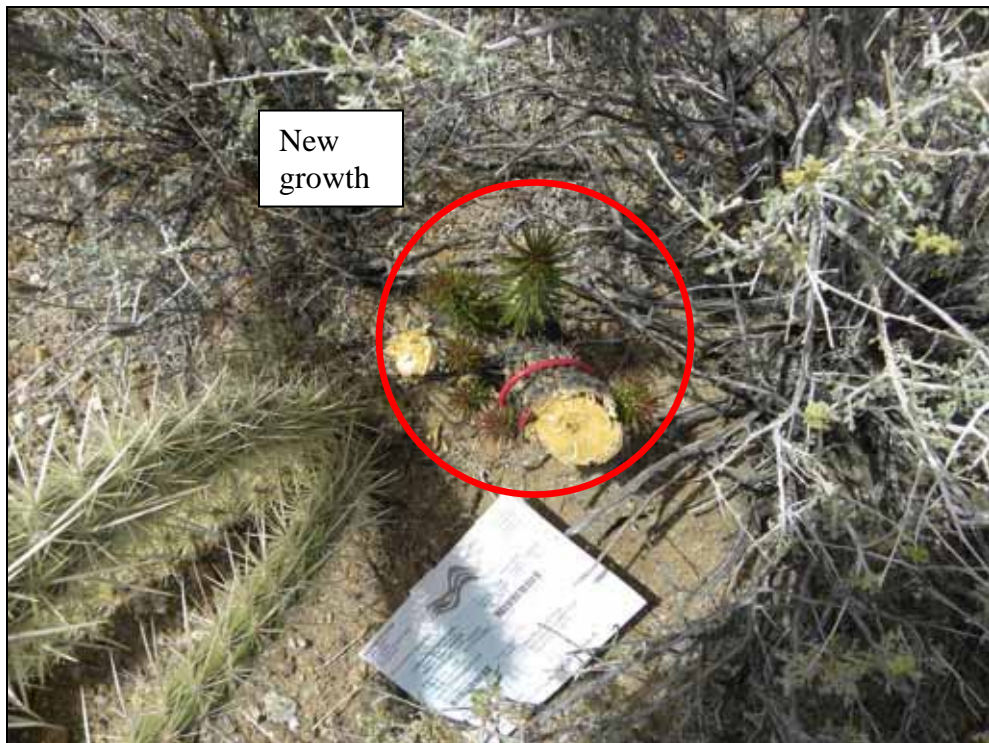
Site 32

Rating: 4

Silver Cholla: Vigorous new growth on the cut stem base.

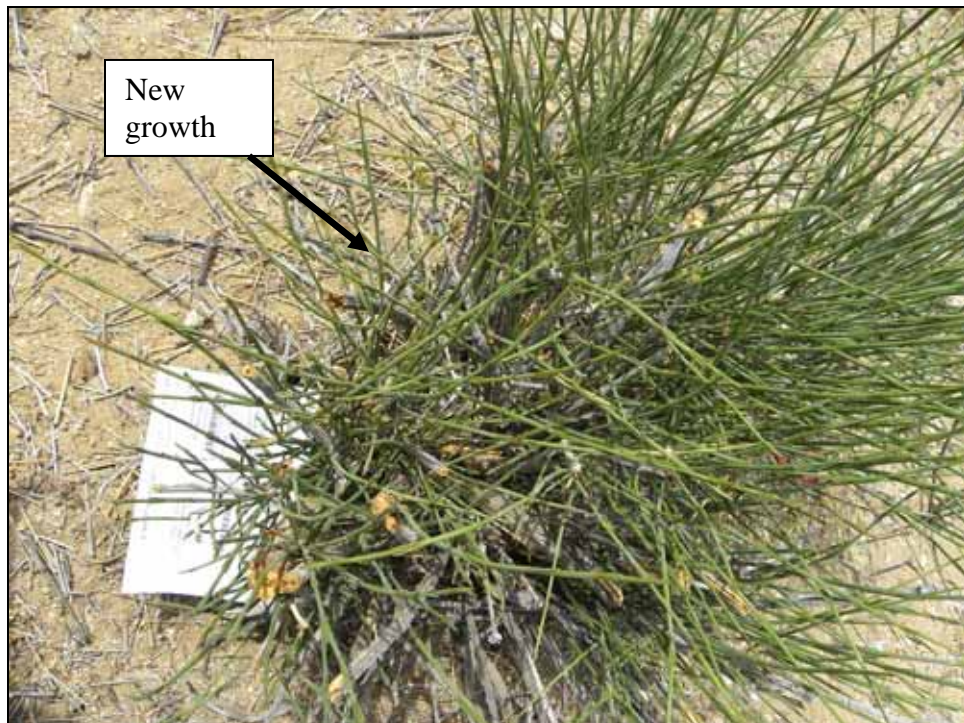
Site 34

Rating: 4

Nevada Mormon Tea: Vigorous growth from numerous cut stems.

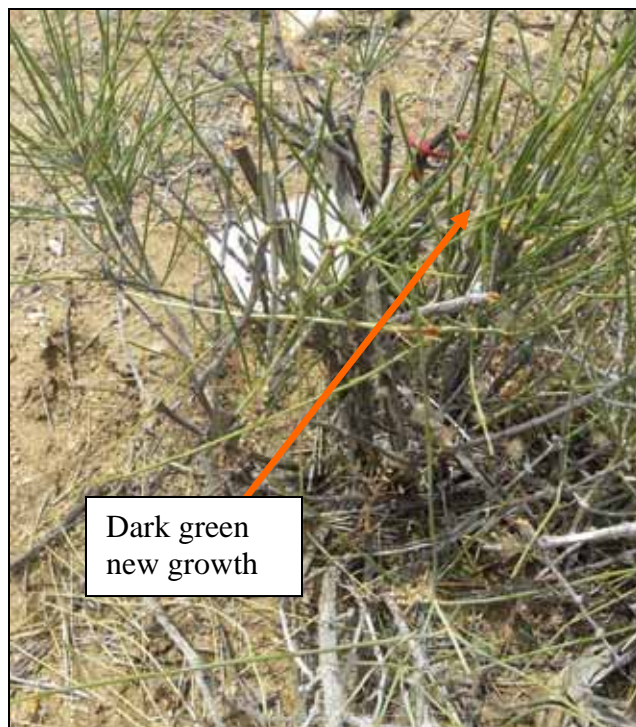
Site 35

Rating: 3

Nevada Mormon Tea: Small bush with growth from cut stems.

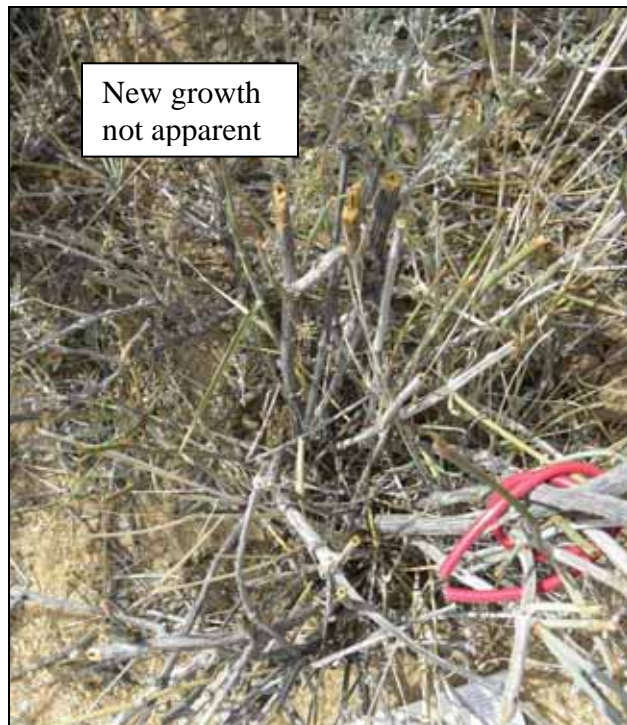
Site 36

Rating: 1

Nevada Mormon Tea: No new growth is evident. This plant is potentially affected by the adjacent burrobush.

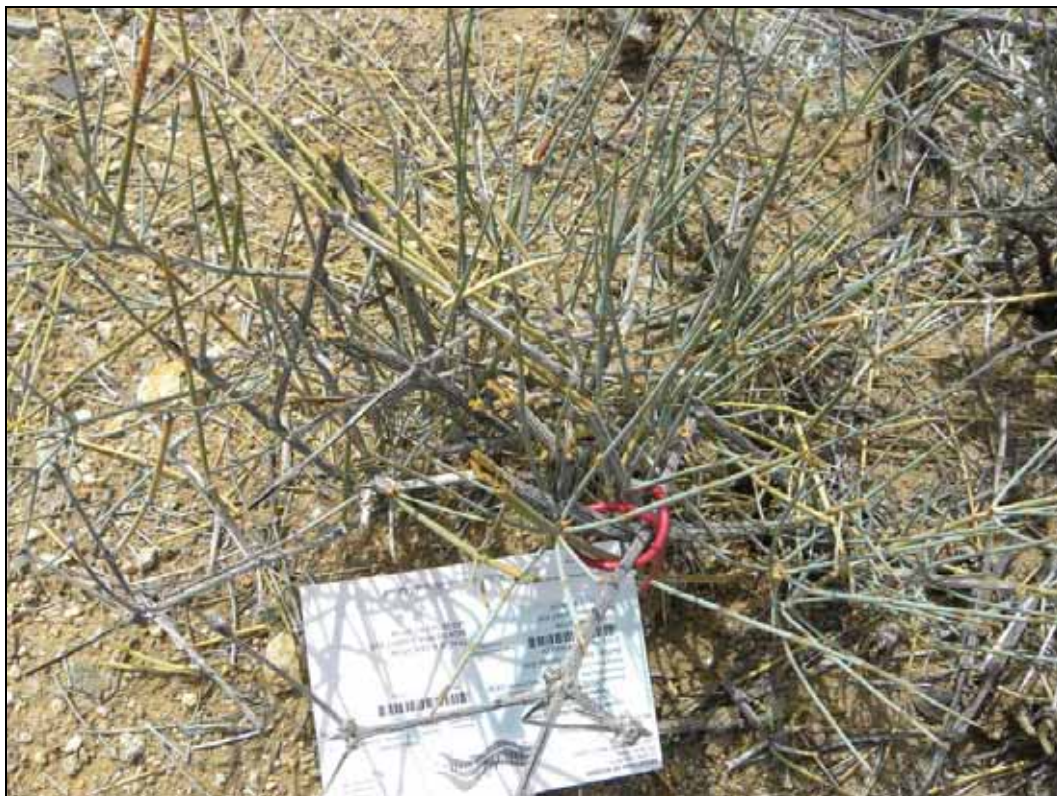
Site 37

Rating: 1

Nevada Mormon Tea: New growth is not evident.
