Docket Number:	09-AFC-07C
Project Title:	Palen Solar Power Project - Compliance
TN #:	202538
Document Title:	Exh. 3107 Kagan et al 2014
Description:	Avian mortality Report
Filer:	Ileene Anderson
Organization:	Center for Biological Diversity
Submitter Role:	Intervenor
Submission Date:	6/23/2014 3:46:50 PM
Docketed Date:	6/23/2014

Avian Mortality at Solar Energy Facilities in Southern California: A Preliminary Analysis

Rebecca A. Kagan, Tabitha C. Viner, Pepper W. Trail, and Edgard O. Espinoza
National Fish and Wildlife Forensics Laboratory

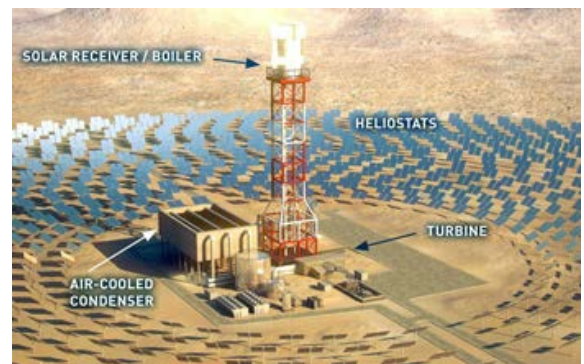
1) **Photovoltaic systems** directly convert the sun's light into electricity. The perceived threat to birds is associated with the presence of water ponds which attract birds and from traumatic impact with the photovoltaic cells. An example of this type of solar power plant is Desert Sunlight Solar Farm (AKA First Solar).

2) **Trough systems** are composed of parabolic mirrors which focus and reflect the sun to a tube that converts the heat from the sun into electricity. The perceived threat to birds is associated with the presence of water ponds which attract birds and from traumatic impact with the trough structures. An example of this type of solar power plant is Genesis Solar Energy Project.

3) **Solar power towers** use thousands of mirrors to reflect the solar energy to a tower, where water in a boiler is converted to steam, generating the electricity. The perceived threat to birds is associated traumatic impact with the mirrors and the danger associated with the heat produced by the mirrors. An example of this type of solar power plant is Ivanpah Solar Electric Generating System.

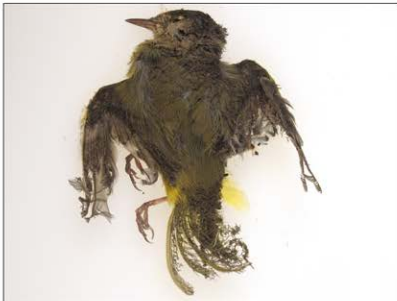
Birds with feather burns were graded based on the extent of the lesions. Grade 1 birds had curling of less than 50% of the flight feathers. Grade 2 birds had curling of 50% or more of the flight feathers. Grade 3 birds had curling and visible charring of contour feathers (Figure 1).

Figure 1: Three grades of flux injury based on extent and severity of burning. Grade 1 (top); Yellow-rumped Warbler with less than 50% of the flight feathers affected (note sparing of the yellow rump feathers). Grade 2 (middle); Northern Rough-winged Swallow initially found alive but unable to fly, with greater than 50% of the flight feathers affected. Grade 3 (bottom); MacGillivray's Warbler with charring of feathers around the head, neck, wings and tail.

Eight birds were assigned a feather damage Grade of 1 with curling of less than 50% of the flight feathers. Six of these had other evidence of acute trauma (75%). Five birds were Grade 2, including three birds that were found alive and died shortly afterwards. Of these birds, 2 (the birds found dead) also had evidence of acute trauma. Twenty-eight birds were Grade 3; with charring of body feathers. Of these birds, 21/28

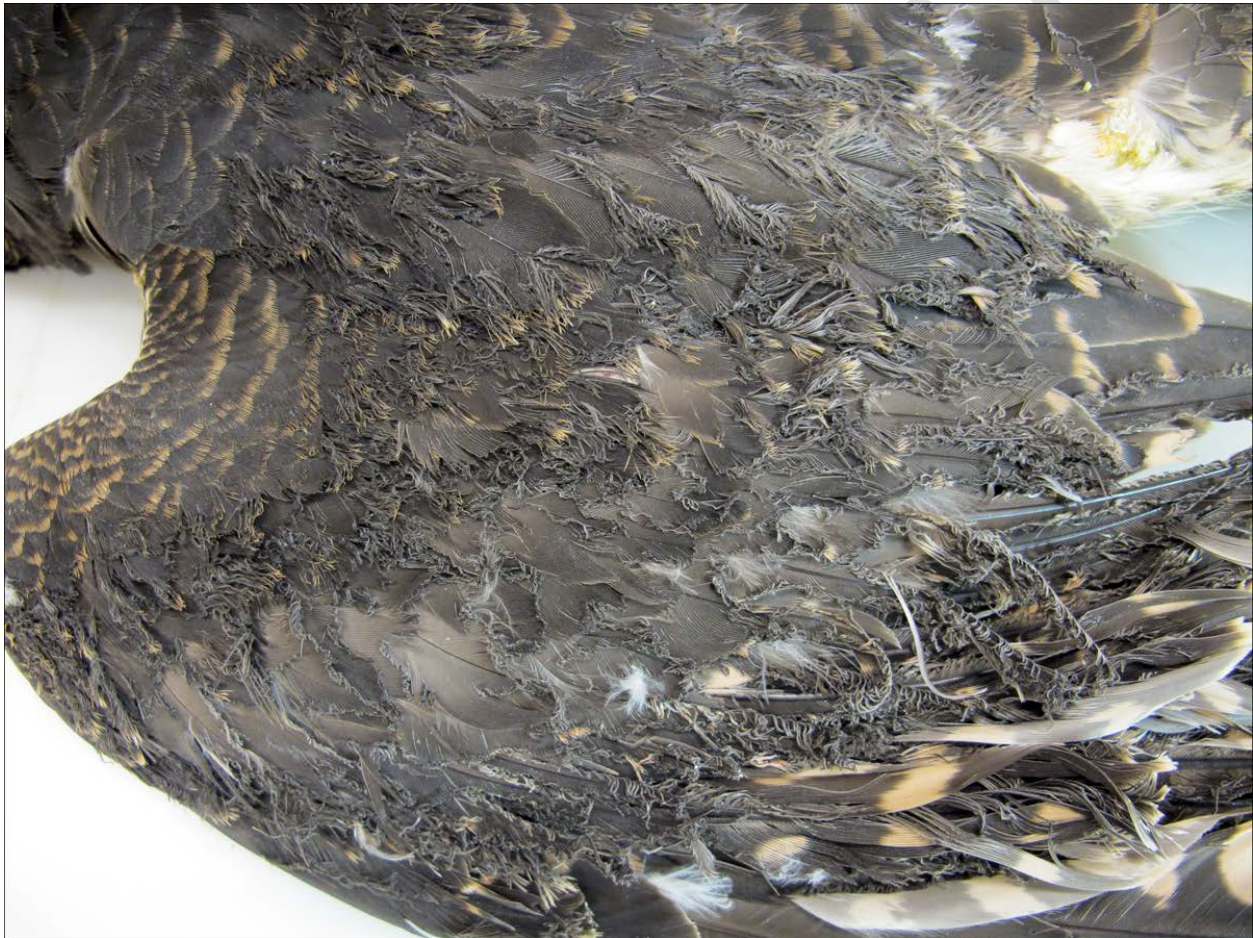
Figure 5: The dorsal aspect of the wing from a Peregrine Falcon (the same bird as shown in Figure 4) with Grade 2 lesions. Note extensive curling of feathers without visible charring. This bird was found alive, unable to fly, emaciated and died shortly thereafter. These findings demonstrate fatal loss of function due to solar flux exposure in the absence of skin or other soft tissue burns.

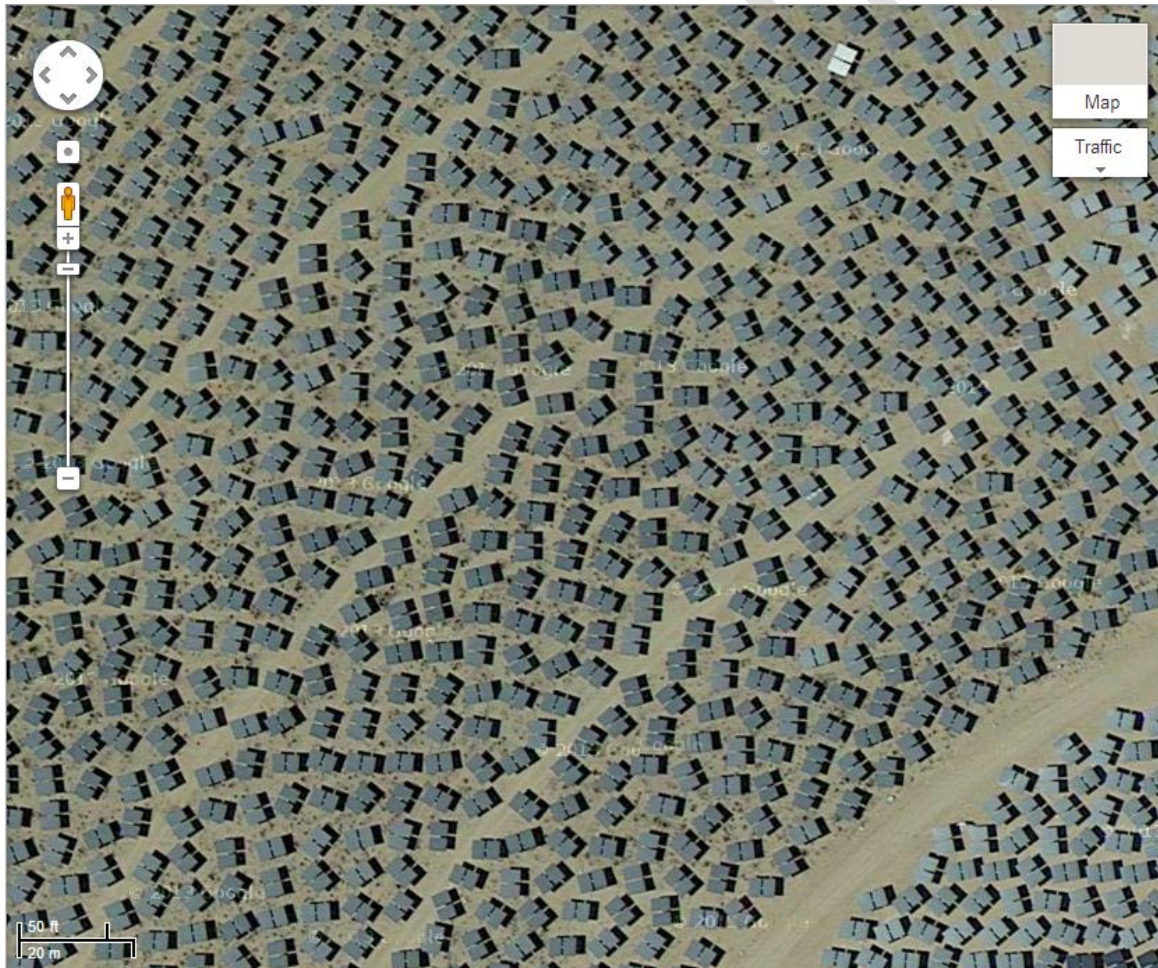
Figure 6: The Ivanpah Solar Electric Generating System as seen via satellite. The mirrored panels are 5 x 8 feet.

The mirrors and photovoltaic panels used at all three facilities are movable and generally directed upwardly, reflecting the sky. At the Ivanpah facility, when heliostats are oriented vertically (typically for washing or installation, personal communication, RAK) they appear to pose a greater risk for birds. Of the eight birds reported found under a heliostat, heliostats were vertically-oriented in at least 5 cases. (D Klem Jr., DC Keck, KL Marty, AJ Miller Ball, EE Niciu, and CT Platt. 2004. Effects of window angling, feeder placement, and scavengers on avian mortality at plate glass. *Wilson Bulletin*, 116(1):69-73; D Klem Jr. 2006. Glass: A deadly conservation issue for birds. *Bird Observer* 34(2):73-81; D Klem Jr. 1990.

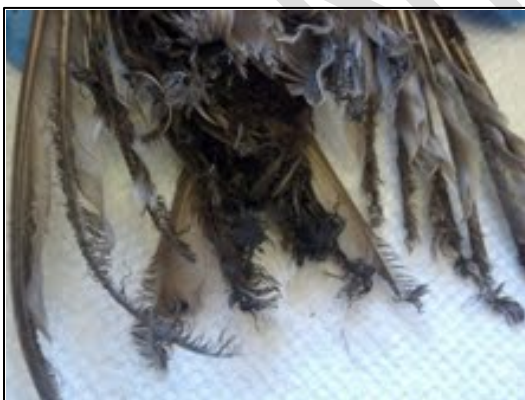
Many of the carcasses recovered from the Ivanpah Solar plant after the plant became operational showed singeing of feathers as shown in Figure 10.

Figure 10: Singed feathers from a Northern Rough-winged Swallow
