Docket Number:	09-AFC-08C
Project Title:	Genesis Solar Energy Project
TN #:	203638
Document Title:	Genesis 2014 Annual Compliance Report, Part 2
Description:	Annual Report on Operational Activities for 2014 (March 7-December 31
Filer:	Eric Veerkamp
Organization:	Nextera Energy Resources
Submitter Role:	Applicant
Submission Date:	2/9/2015 1:34:49 PM
Docketed Date:	2/9/2015

GENESIS SOLAR, LLC
BLYTHE, CALIFORNIA

Site Orientation Guide

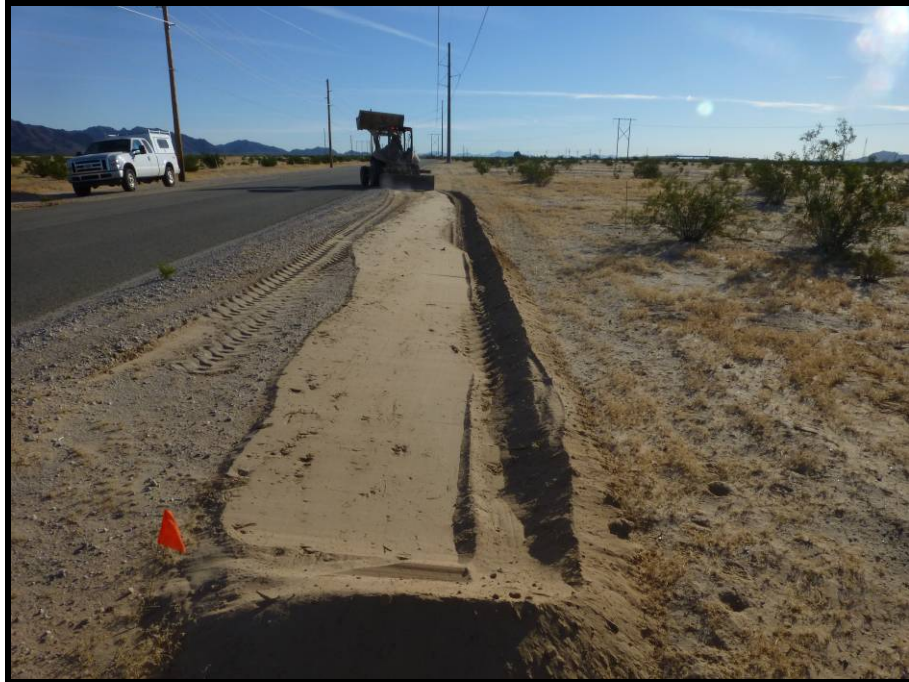
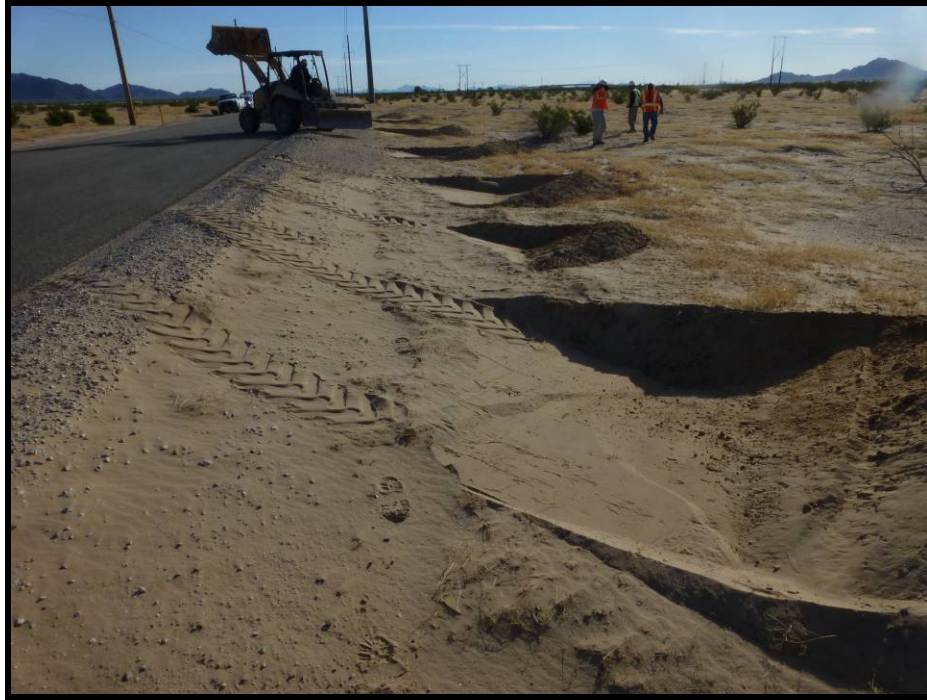
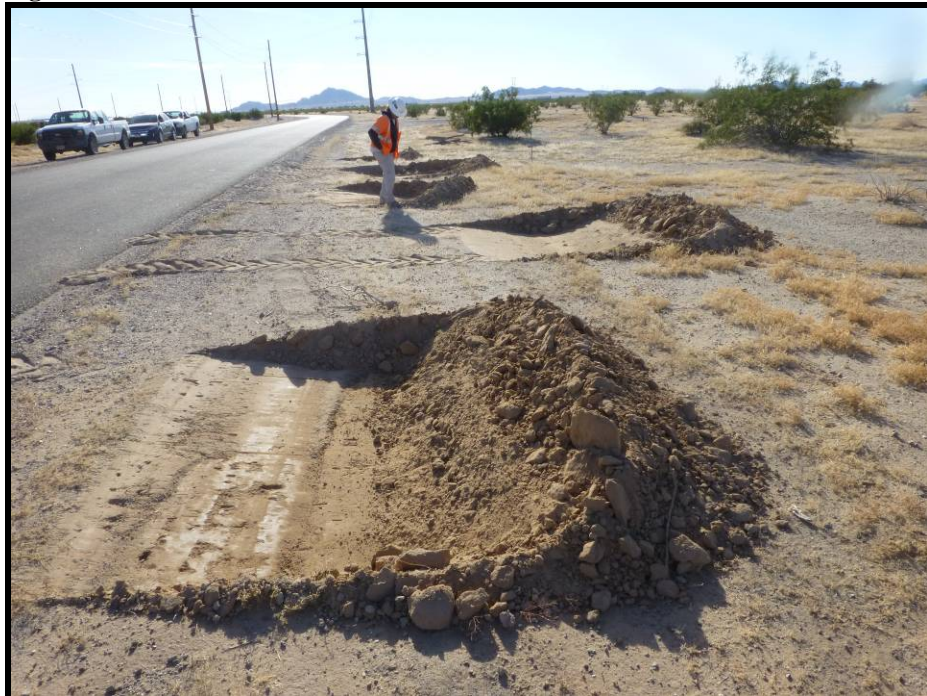
FIGURE 1 – Swales created to capture moisture, sediment and seed on the southern access road shoulder.

The creation of surface roughness and swales in Fall 2013 to retain moisture and collect seed and sediment resulted in high revegetation success along the southern road shoulder. While a few individuals of native shrubs had grown in response to winter rains the previous year, the enhanced microtopography appeared to engender a much higher response. It also included the specific colonizers and annuals that were in the seed mix, all of which are present locally, but not nearly in the abundance observed in the restored areas. Growth of other native annuals was also high and together with the perennials will promote a functioning community. Figure 3 shows representative photographs taken in October 2014.

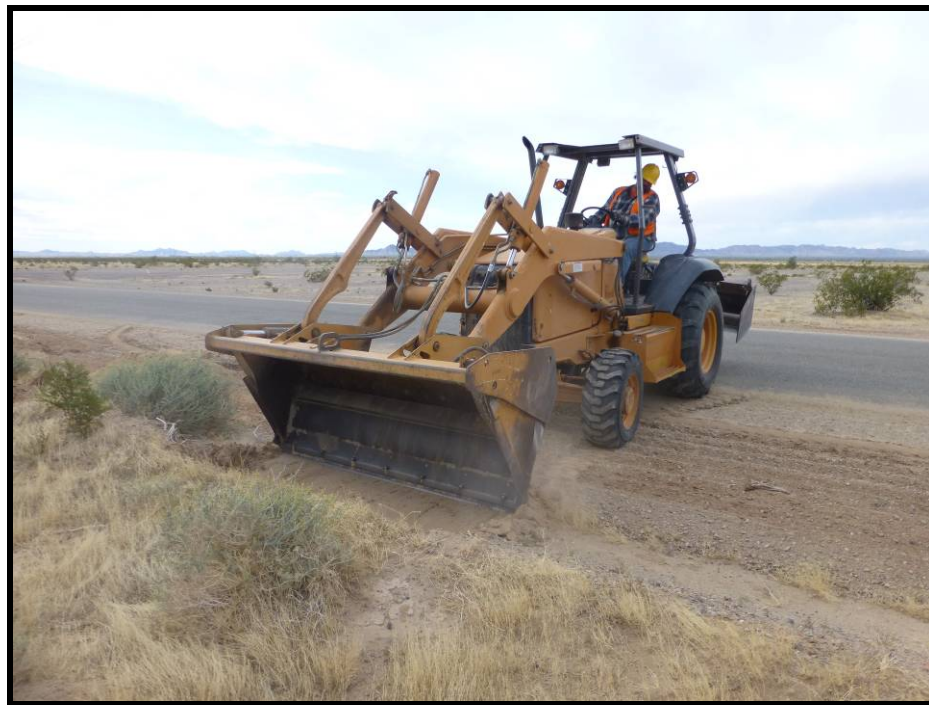
Figure 2a. The gannon spreading the topsoil berm over the ripped, decompacted shoulder

In 2014 and after much debate, Genesis Solar, LLC, decided to leave the wooden pole distribution line in place in the northern (eastern) road shoulder. Restoration of this side of the road originally had been postponed until after the poles were removed. After the decision to leave the poles in place, restoration began in March 2014. Based on the very successful experimental techniques employed the previous fall (see *Revegetation Success*, below), we used a gannon to first rip the compacted road shoulder to approximately 8", then pull and spread the topsoil windrow back onto the shoulder, and finally create a very roughened surface of swales, depressions and furrows (Figure 2). These microtopographical features were attendant to hydrology and soil types, and also were varied to create a more natural, less systematic, outcome. We also created more swales and roughened areas on the southern shoulder and ripped the pole pads. Cobble riprap was placed in two locations where runoff across the road tended to be high and the road shoulder repeatedly washed out. No seeding was implemented on either shoulder because seeding is best accomplished in autumn⁷.

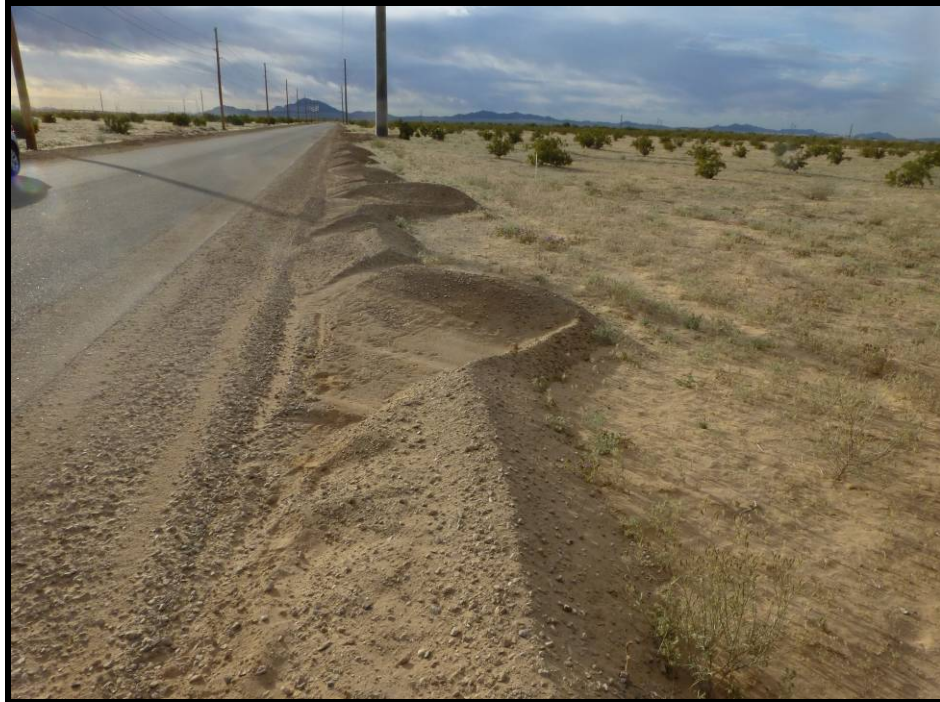
Figure 2b. Another type of swale/berm configuration.

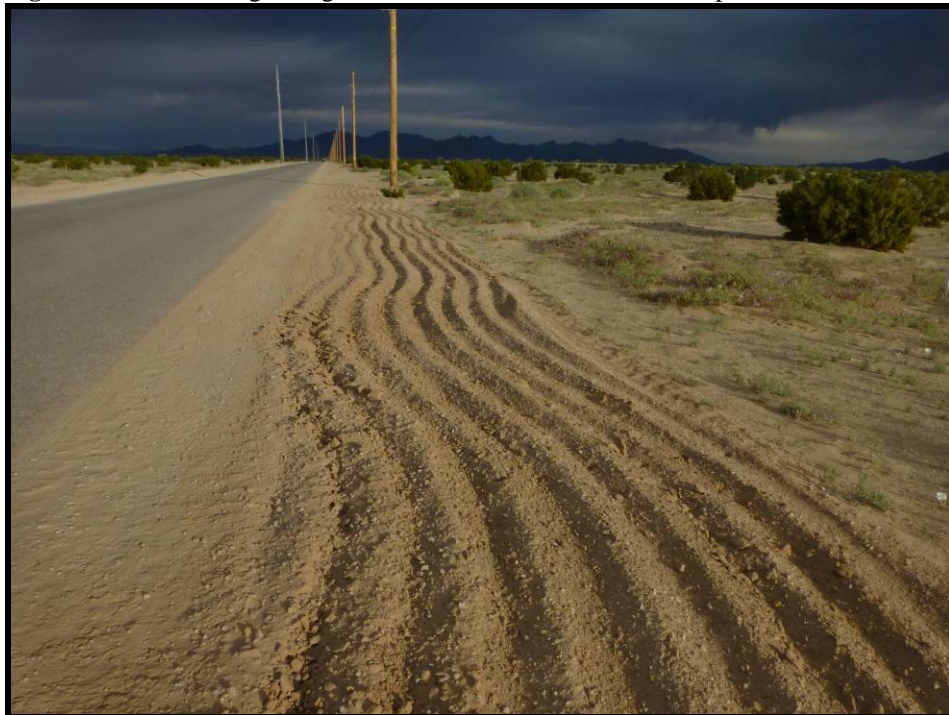
Figure 2c. Surface roughening to create sediment and moisture traps.

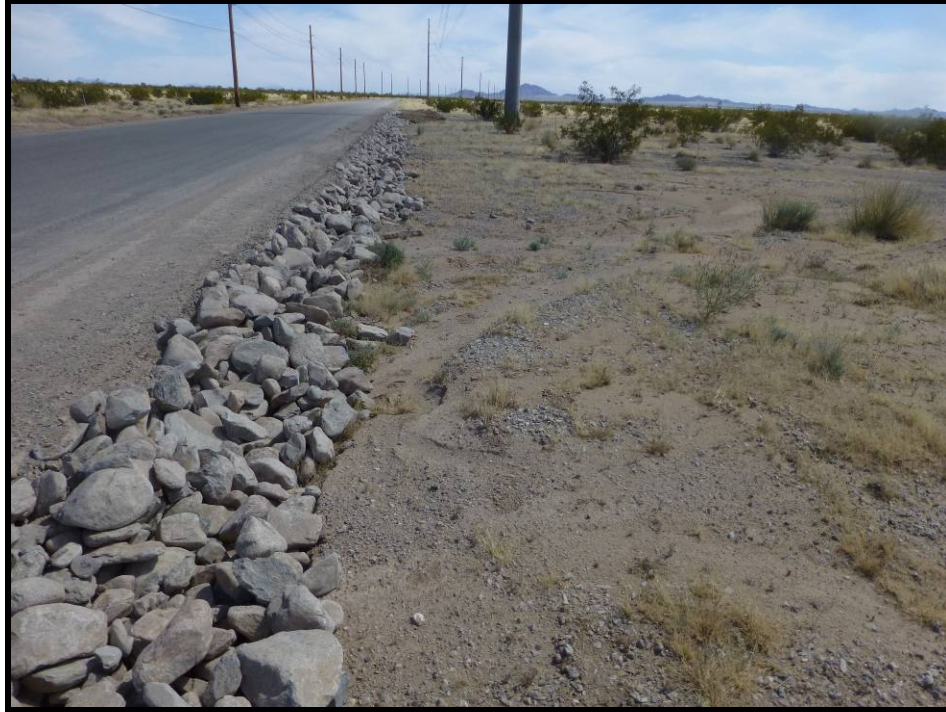
Figure 2d. Cobble riprap to protect the road shoulder and slow flow in high- flow drainages.

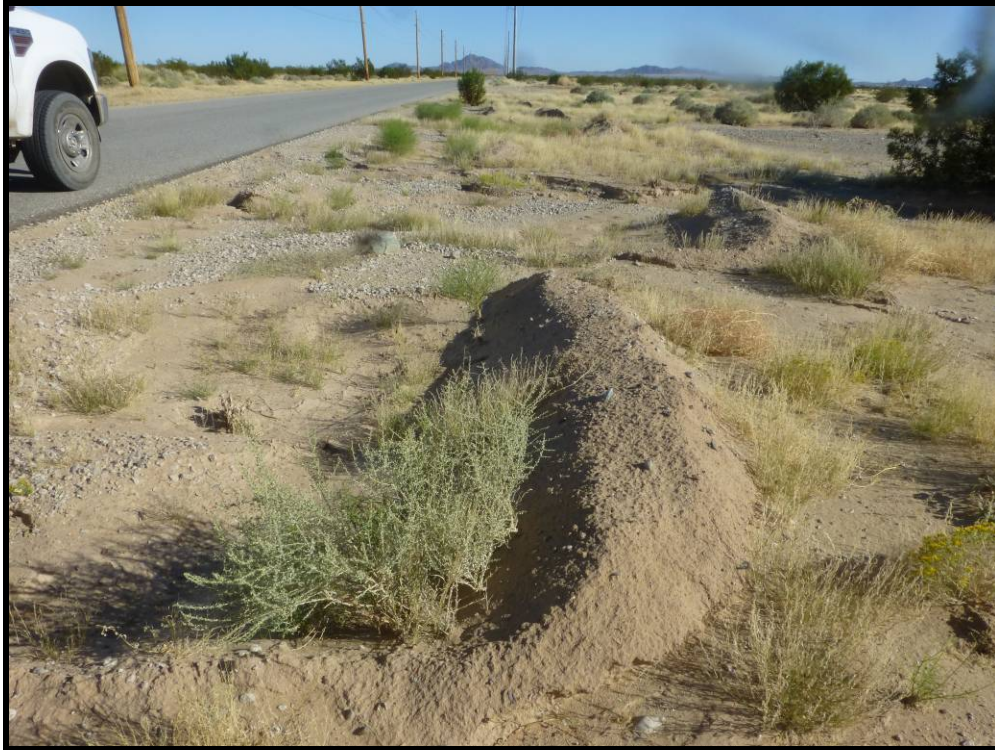
Figure 3a. High growth of seeded shrub species in created berms and swales.

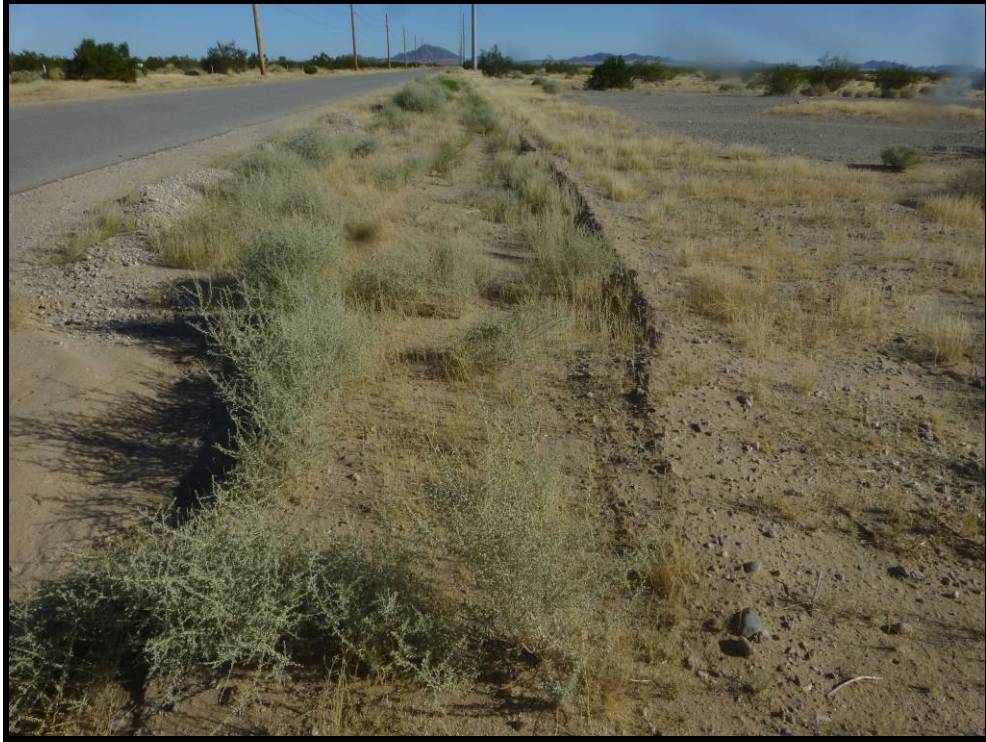
Figure 3b. Another example of high growth of seeded shrub species in a long, linear swale.

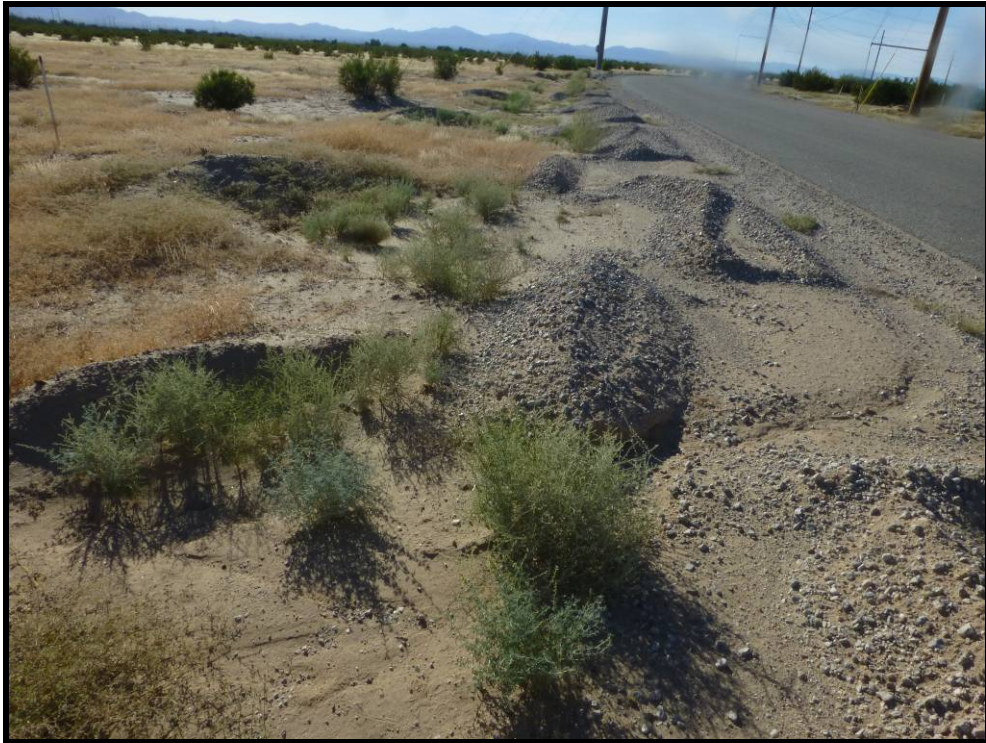
Figure 3c. Another example of high growth of seeded shrub species in created berms and swales. The berms and swales nearer the road were created in March 2014, as compared to the more vegetated swales created in Fall 2013.

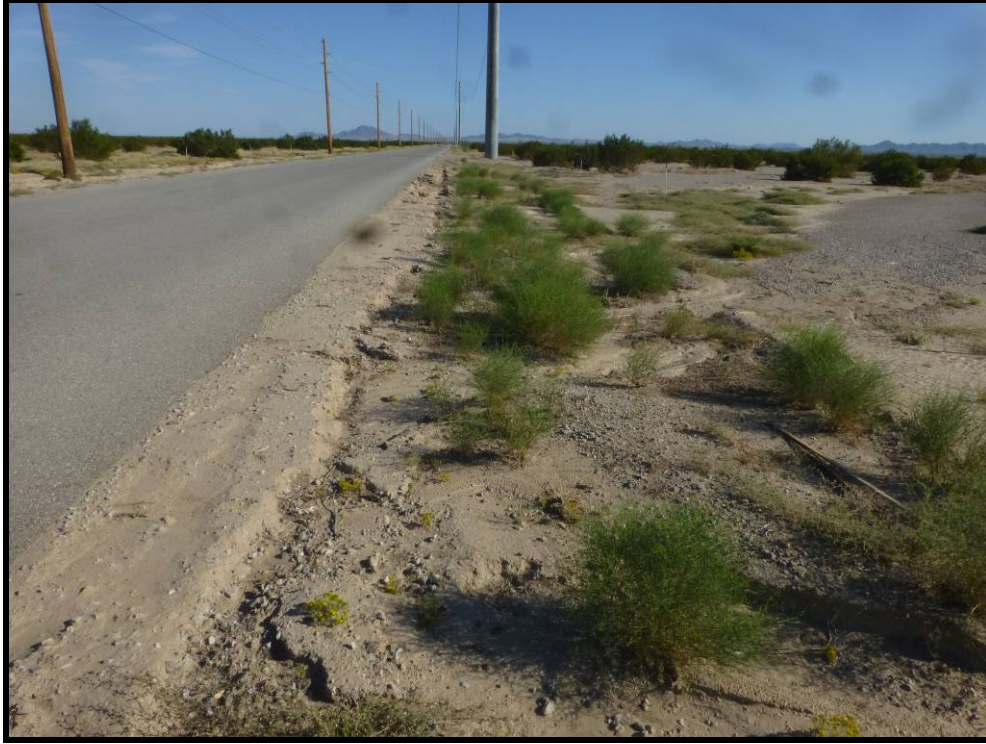
Figure 3d. Good growth of *Ambrosia salsola* in an area of high water flow.

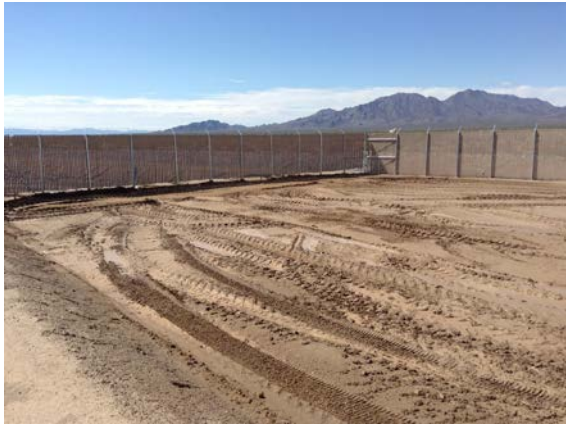
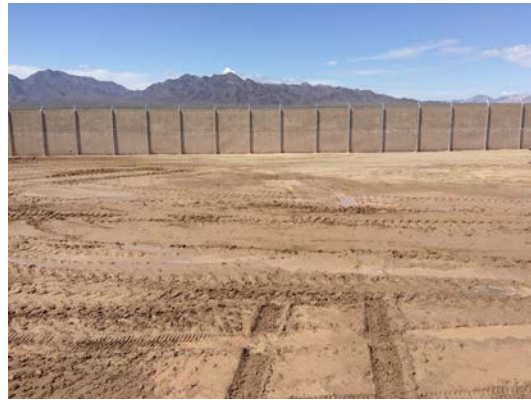
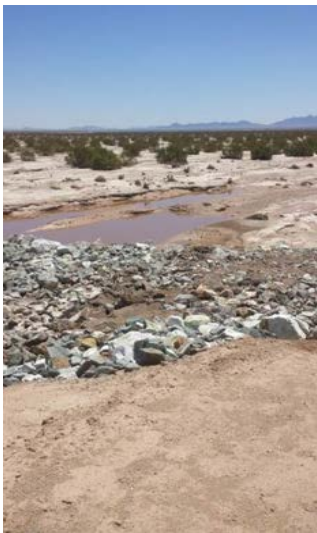
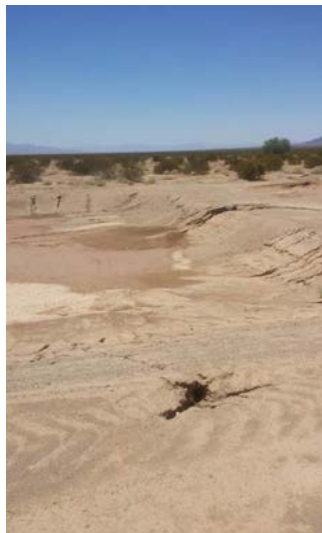
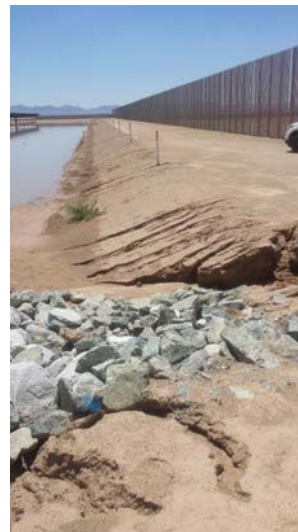
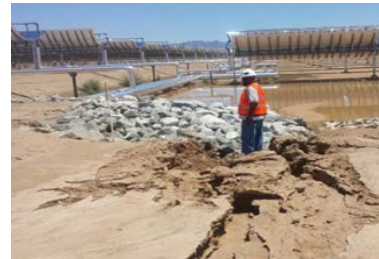
Repairs to erosion at the northwest end of Unit 1 was noted and repaired. See photos.

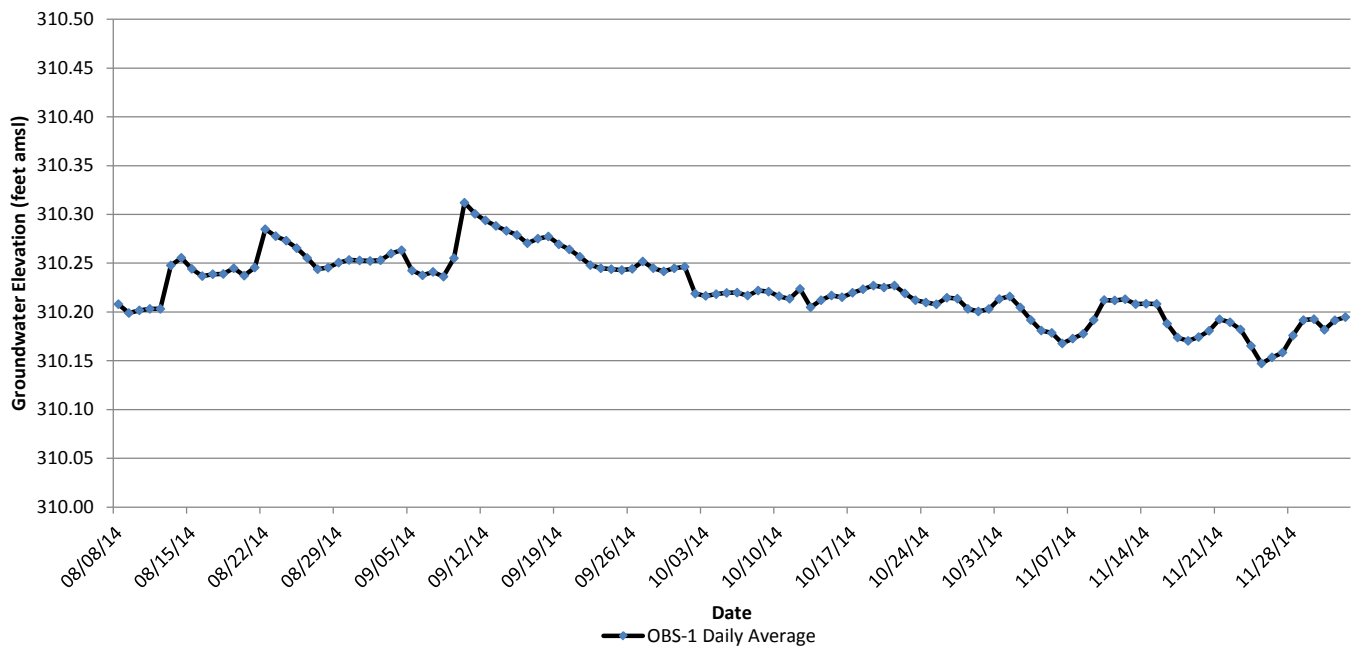
OBS-1 Daily Average - Fourth Quarter 2014
