Subject: Rice Solar Energy Project (09-AFC-10C)
Condition of Certification COM-7
Monthly Compliance Report #6

Rice Solar Energy Project

February 1-28, 2014

Monthly Compliance Report #6

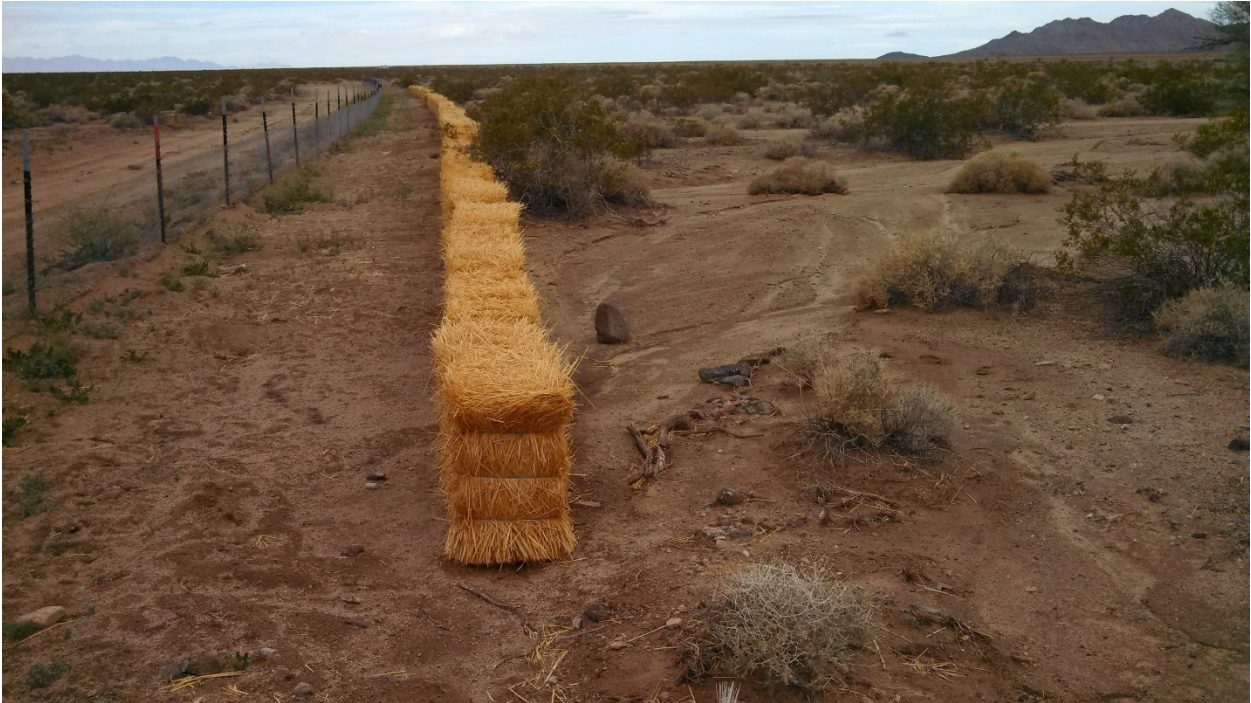
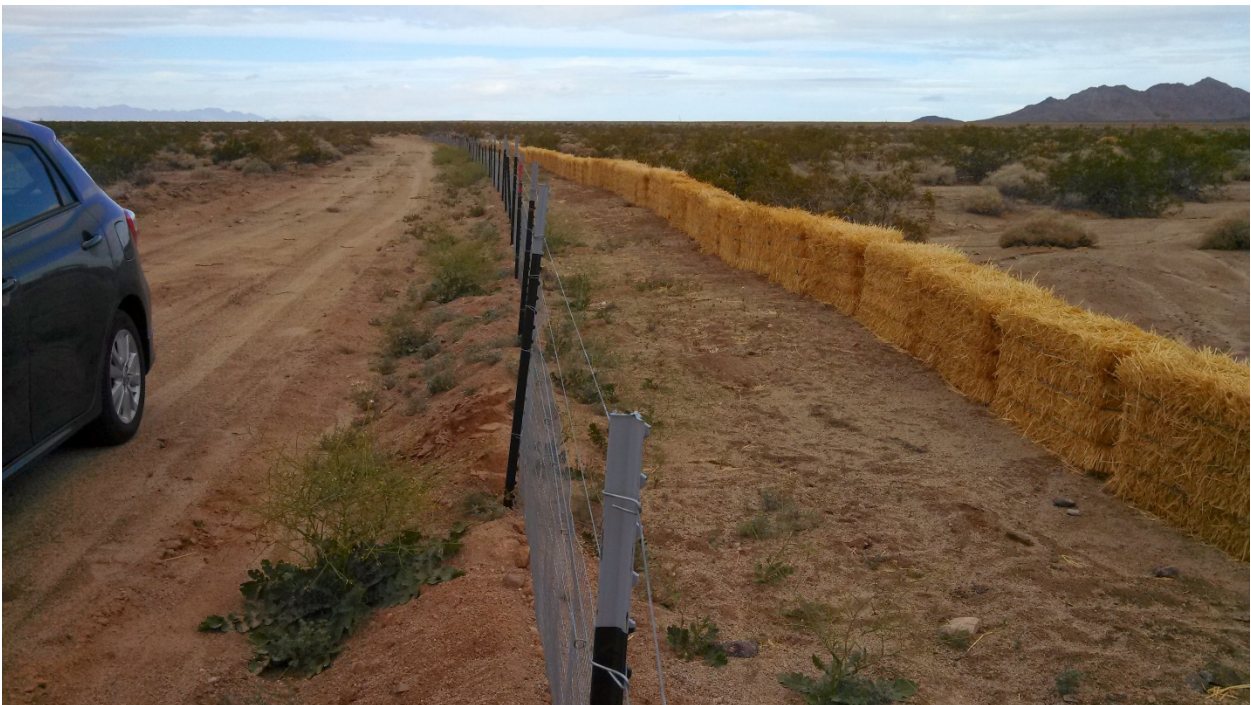
LOCATION 1. UTM 702853 E, 3772871 N, DATUM WGS 83

Location 1. BMPs previously put in place to protect the fence from runoff concentrated in the channel, which contains flows that cross Highway 62 to the north of the site, were effective in reducing flow velocities, eliminating concentrated flows and redirecting stormwater to the east. The fence downstream of the channel was unaffected.

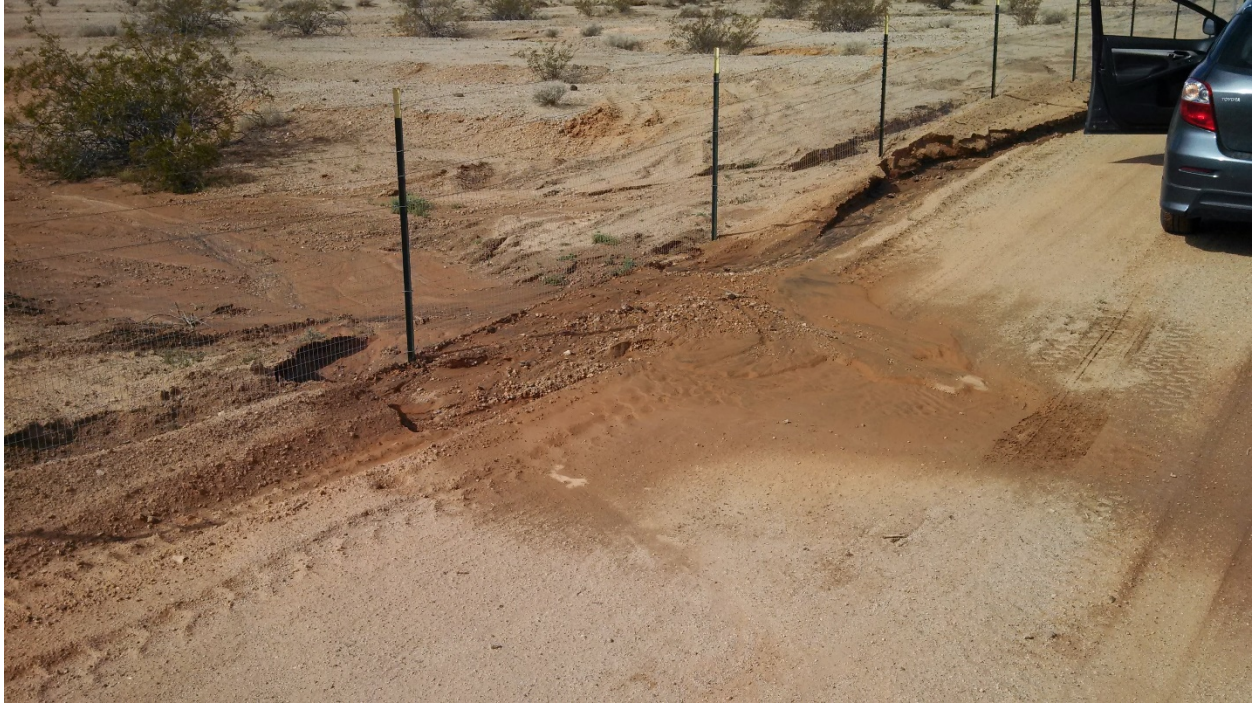
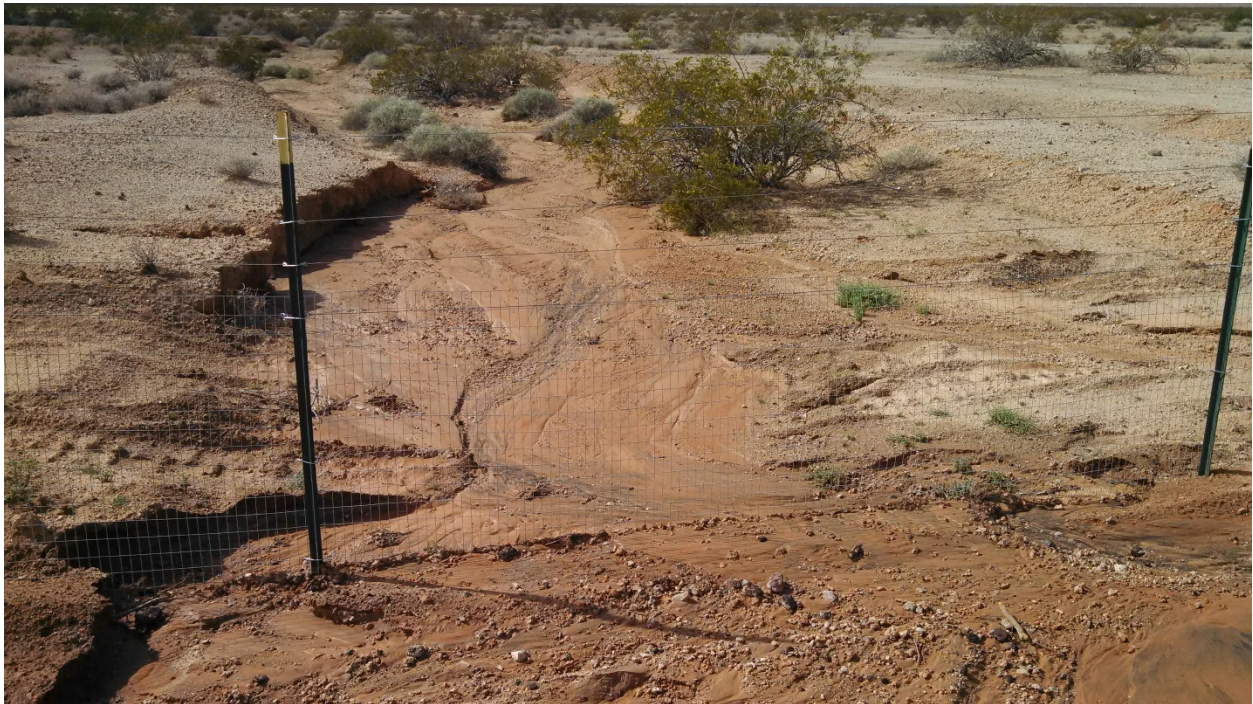
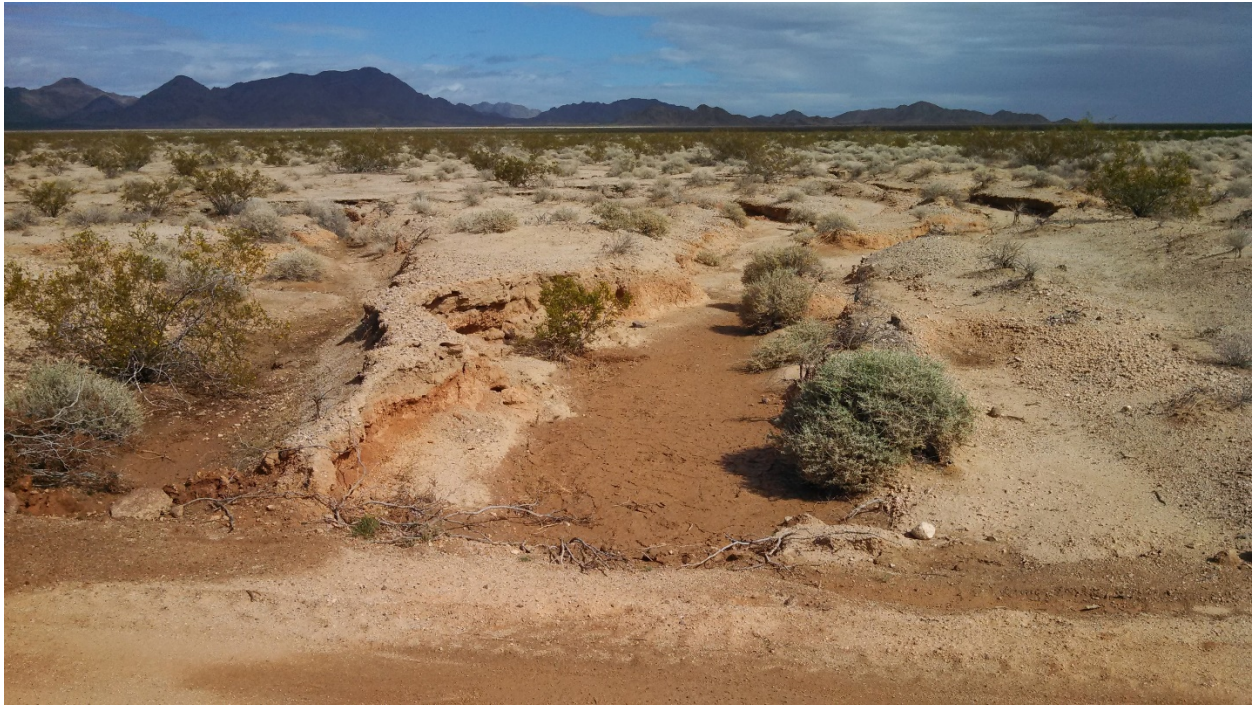
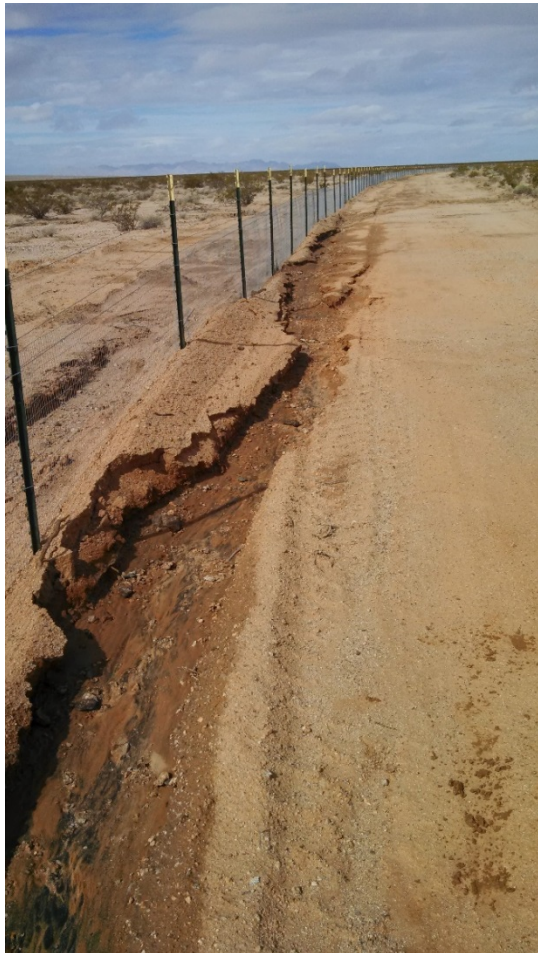
LOCATION 2. UTM 701777 E, 3770406 N, DATUM WGS 83

Location 2. The majority of water entering the site from the north and northwest converged immediately upstream of the fence and was conveyed away from the site in this location. Minor erosion was noted outside of the fence.

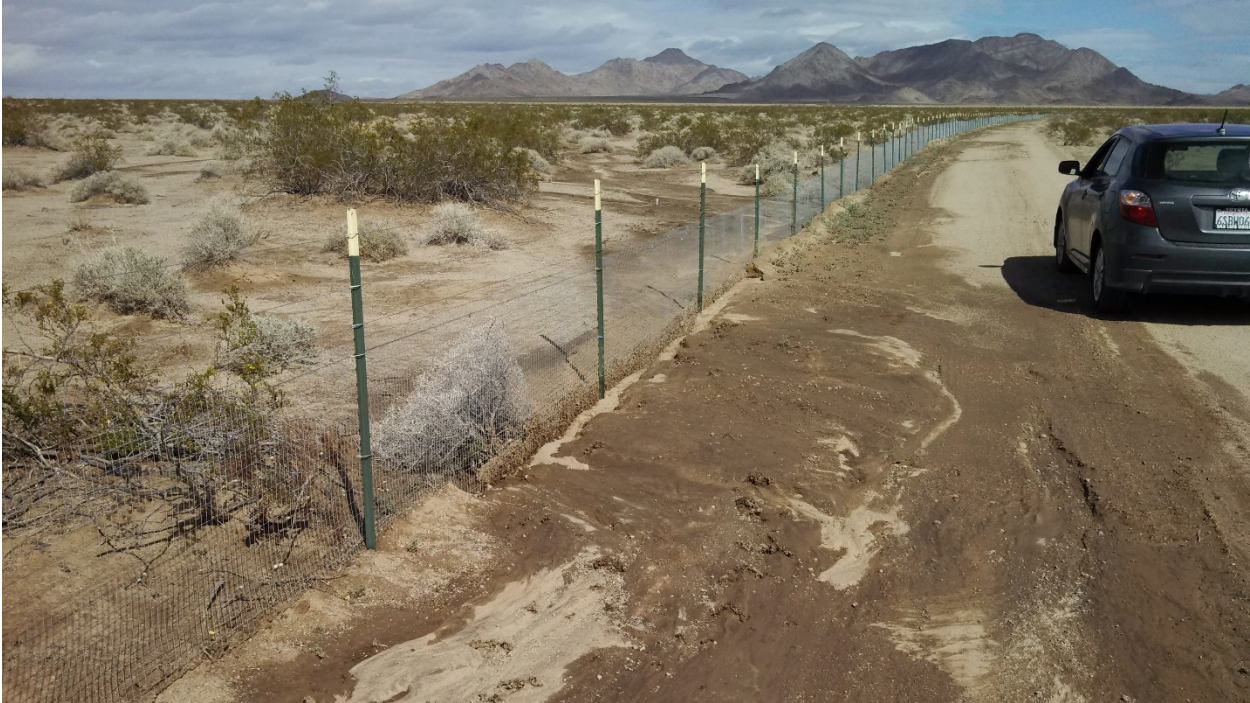
LOCATION 3. UTM 700993 E, 3771758 N, DATUM WGS 83

Location 3. Runoff entering site from wash channel generally flowed south along the inside of fence.

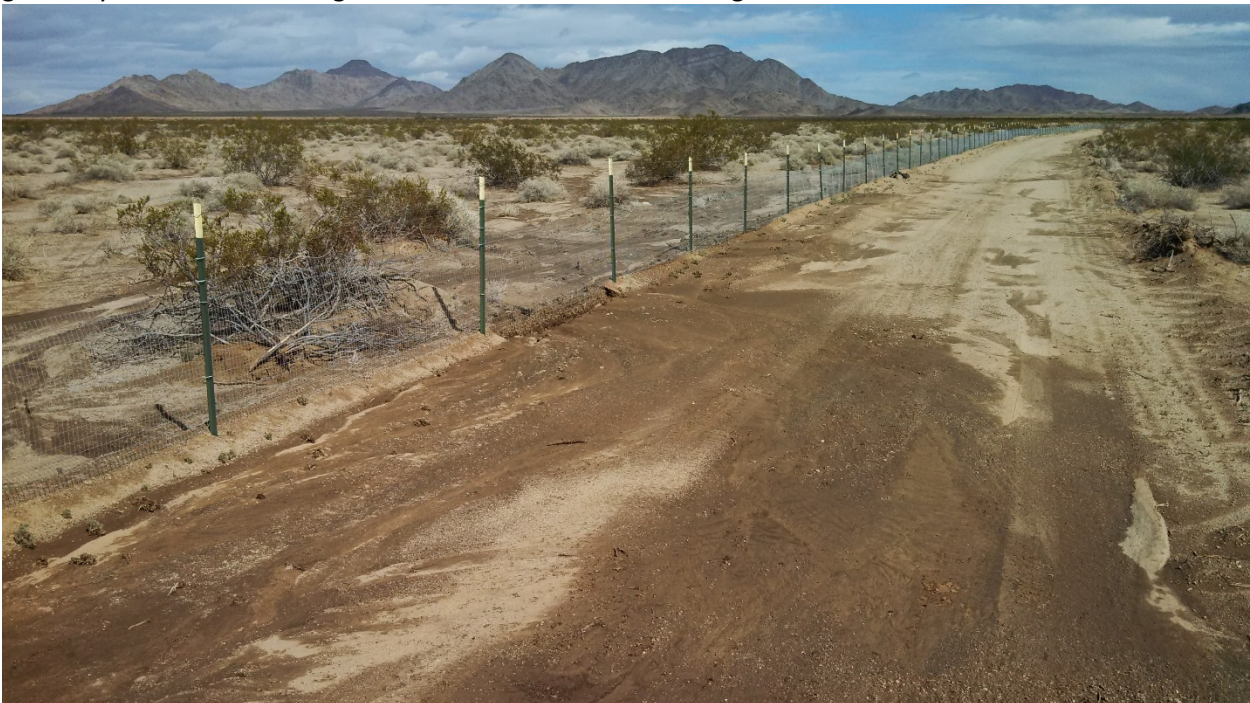
LOCATION 4. UTM 701073 E, 3772109 N, DATUM WGS 83

Location 4. Runoff from the wash channel to the north flowed along the outside of the fence and then entered the site at this location. However, the functionality of the fence was not compromised. Runoff generally flowed south along the inside of fence after entering the site.

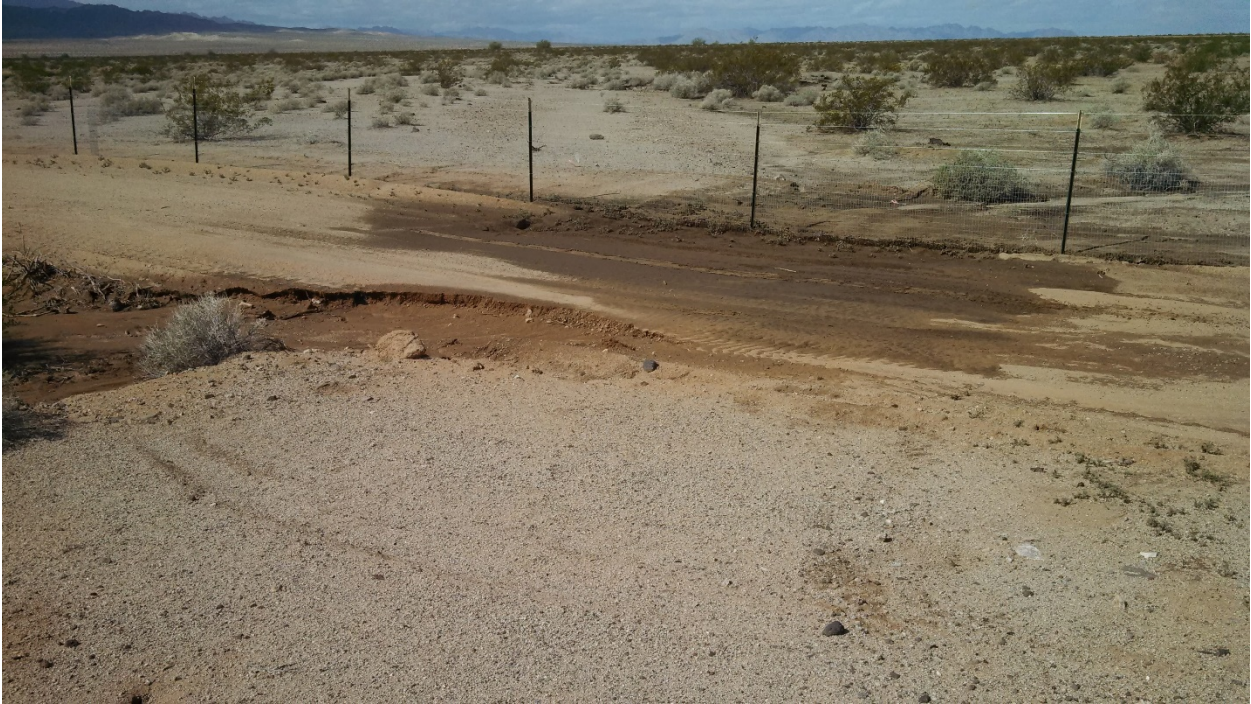
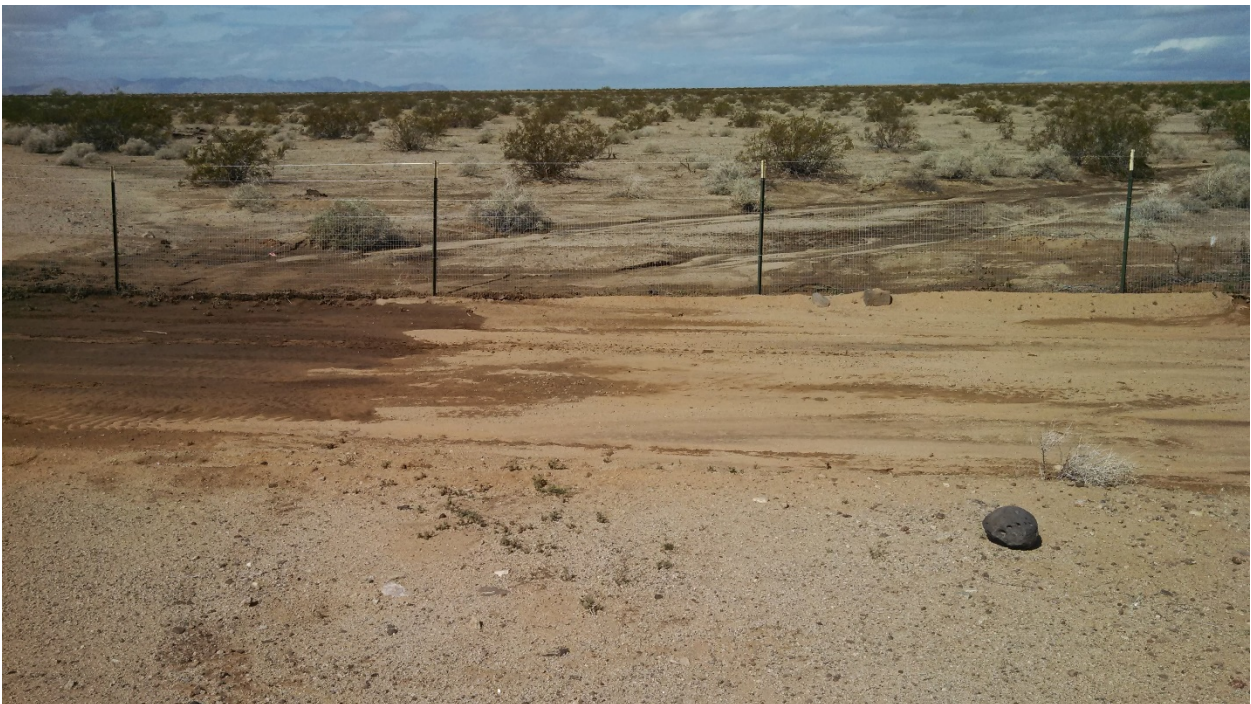
LOCATION 5. UTM 700993 E, 3771758 N, DATUM WGS 83

Location 5. The wash channel crosses the road at this location. Erosion patterns will be continuously monitored to ensure that the integrity of the roadway and/or fence isn't significantly undermined.

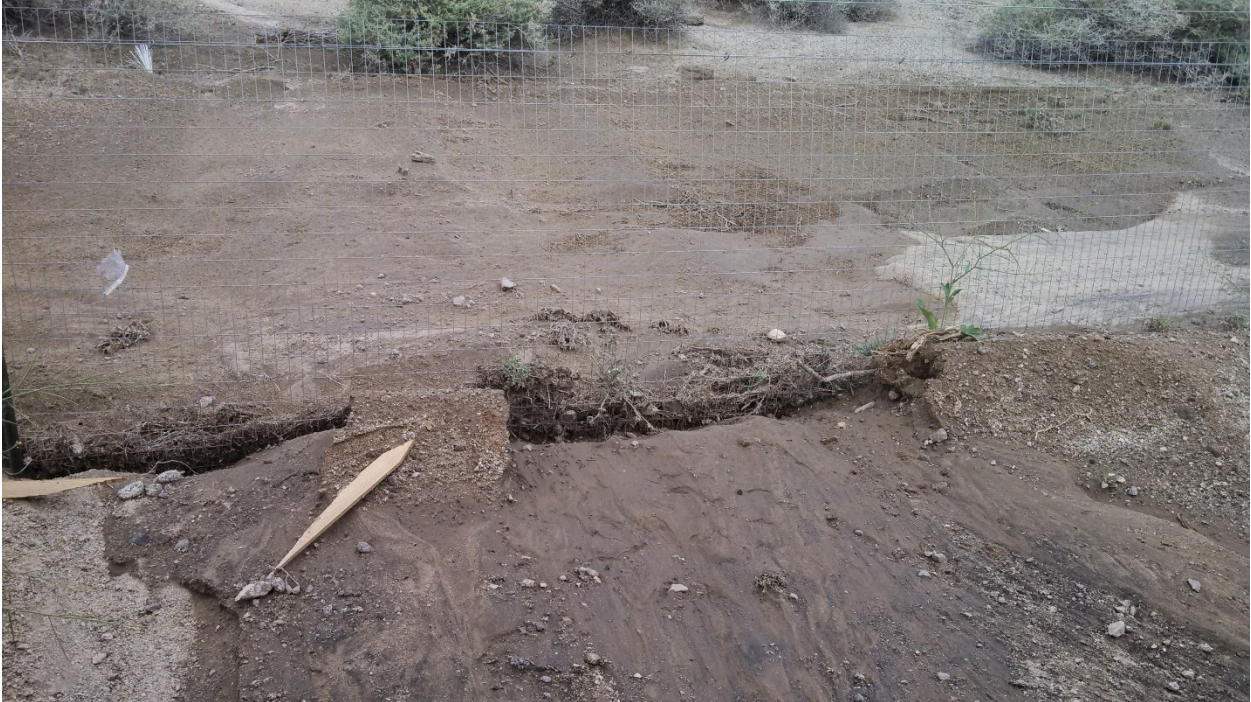
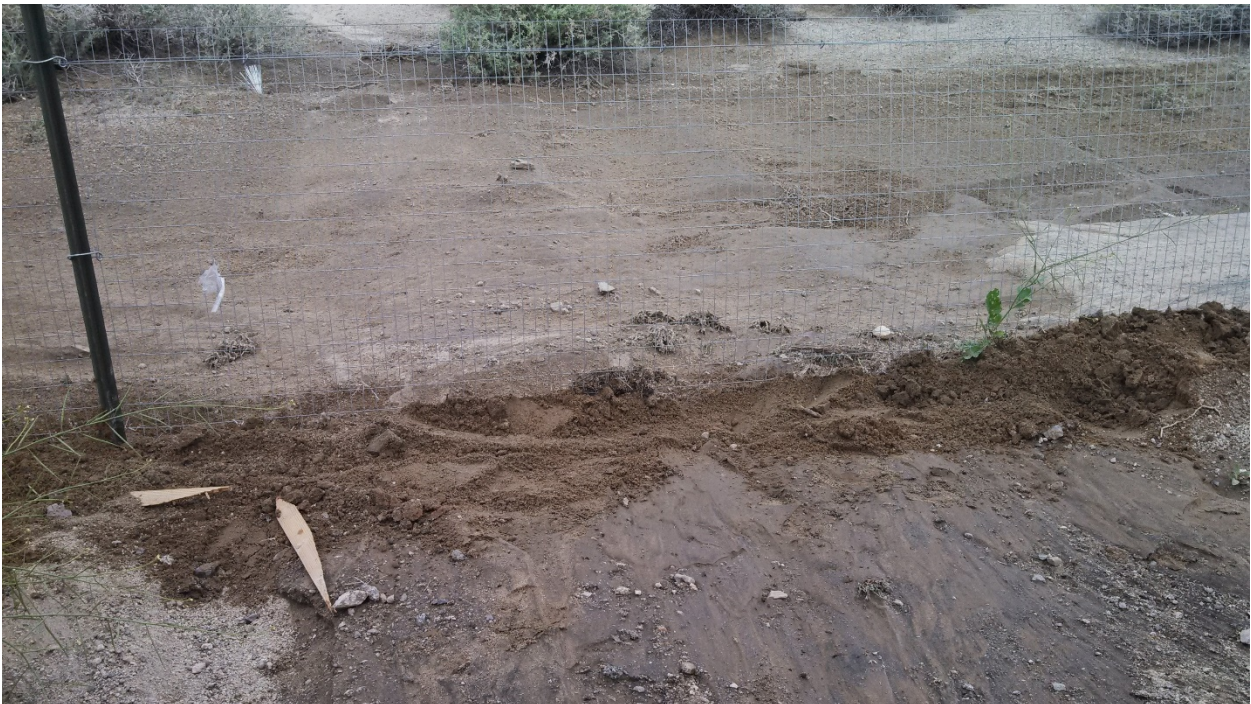
LOCATION 6. UTM 701818 E, 3772863 N, DATUM WGS 83

Location 6. Runoff from wash channel to the north eroded some material from the base of the fence. A section was backfilled by inspecting biologist.

WASHOUT BACKFILLED

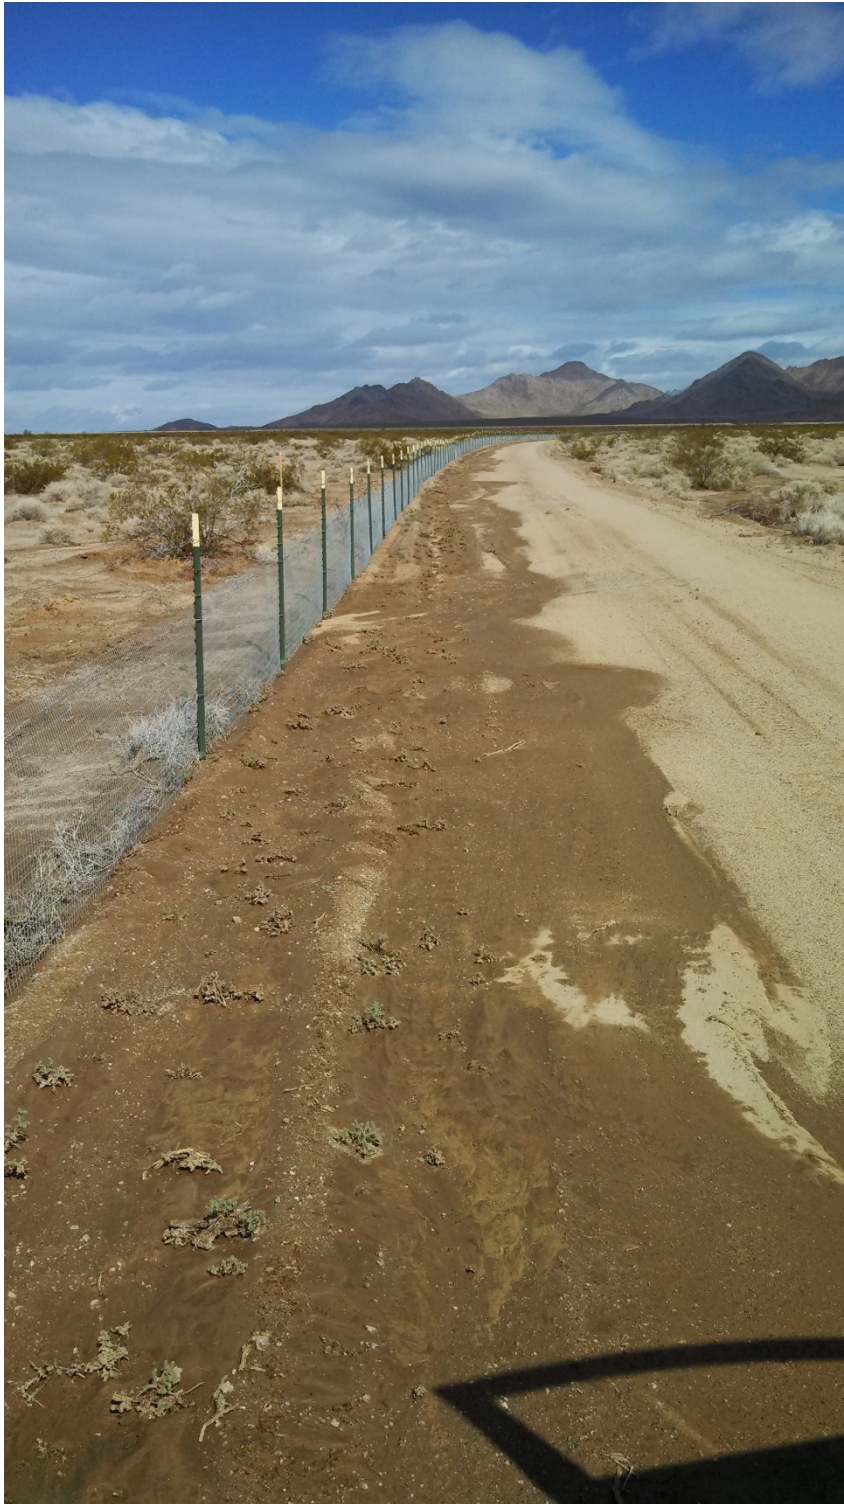
TYPICAL RUNOFF PATTERN ALONG THE MAJORITY OF THE WESTERN FENCELINE (BETWEEN LOCATIONS 2 AND 6).
VIEW NORTH
