**RE: Site Sampling Analysis
Mojave Solar Project
Harper Dry Lake
San Bernardino County, CA**

Site Material Sampling Report

Mojave Solar Project

Harper Dry Lake

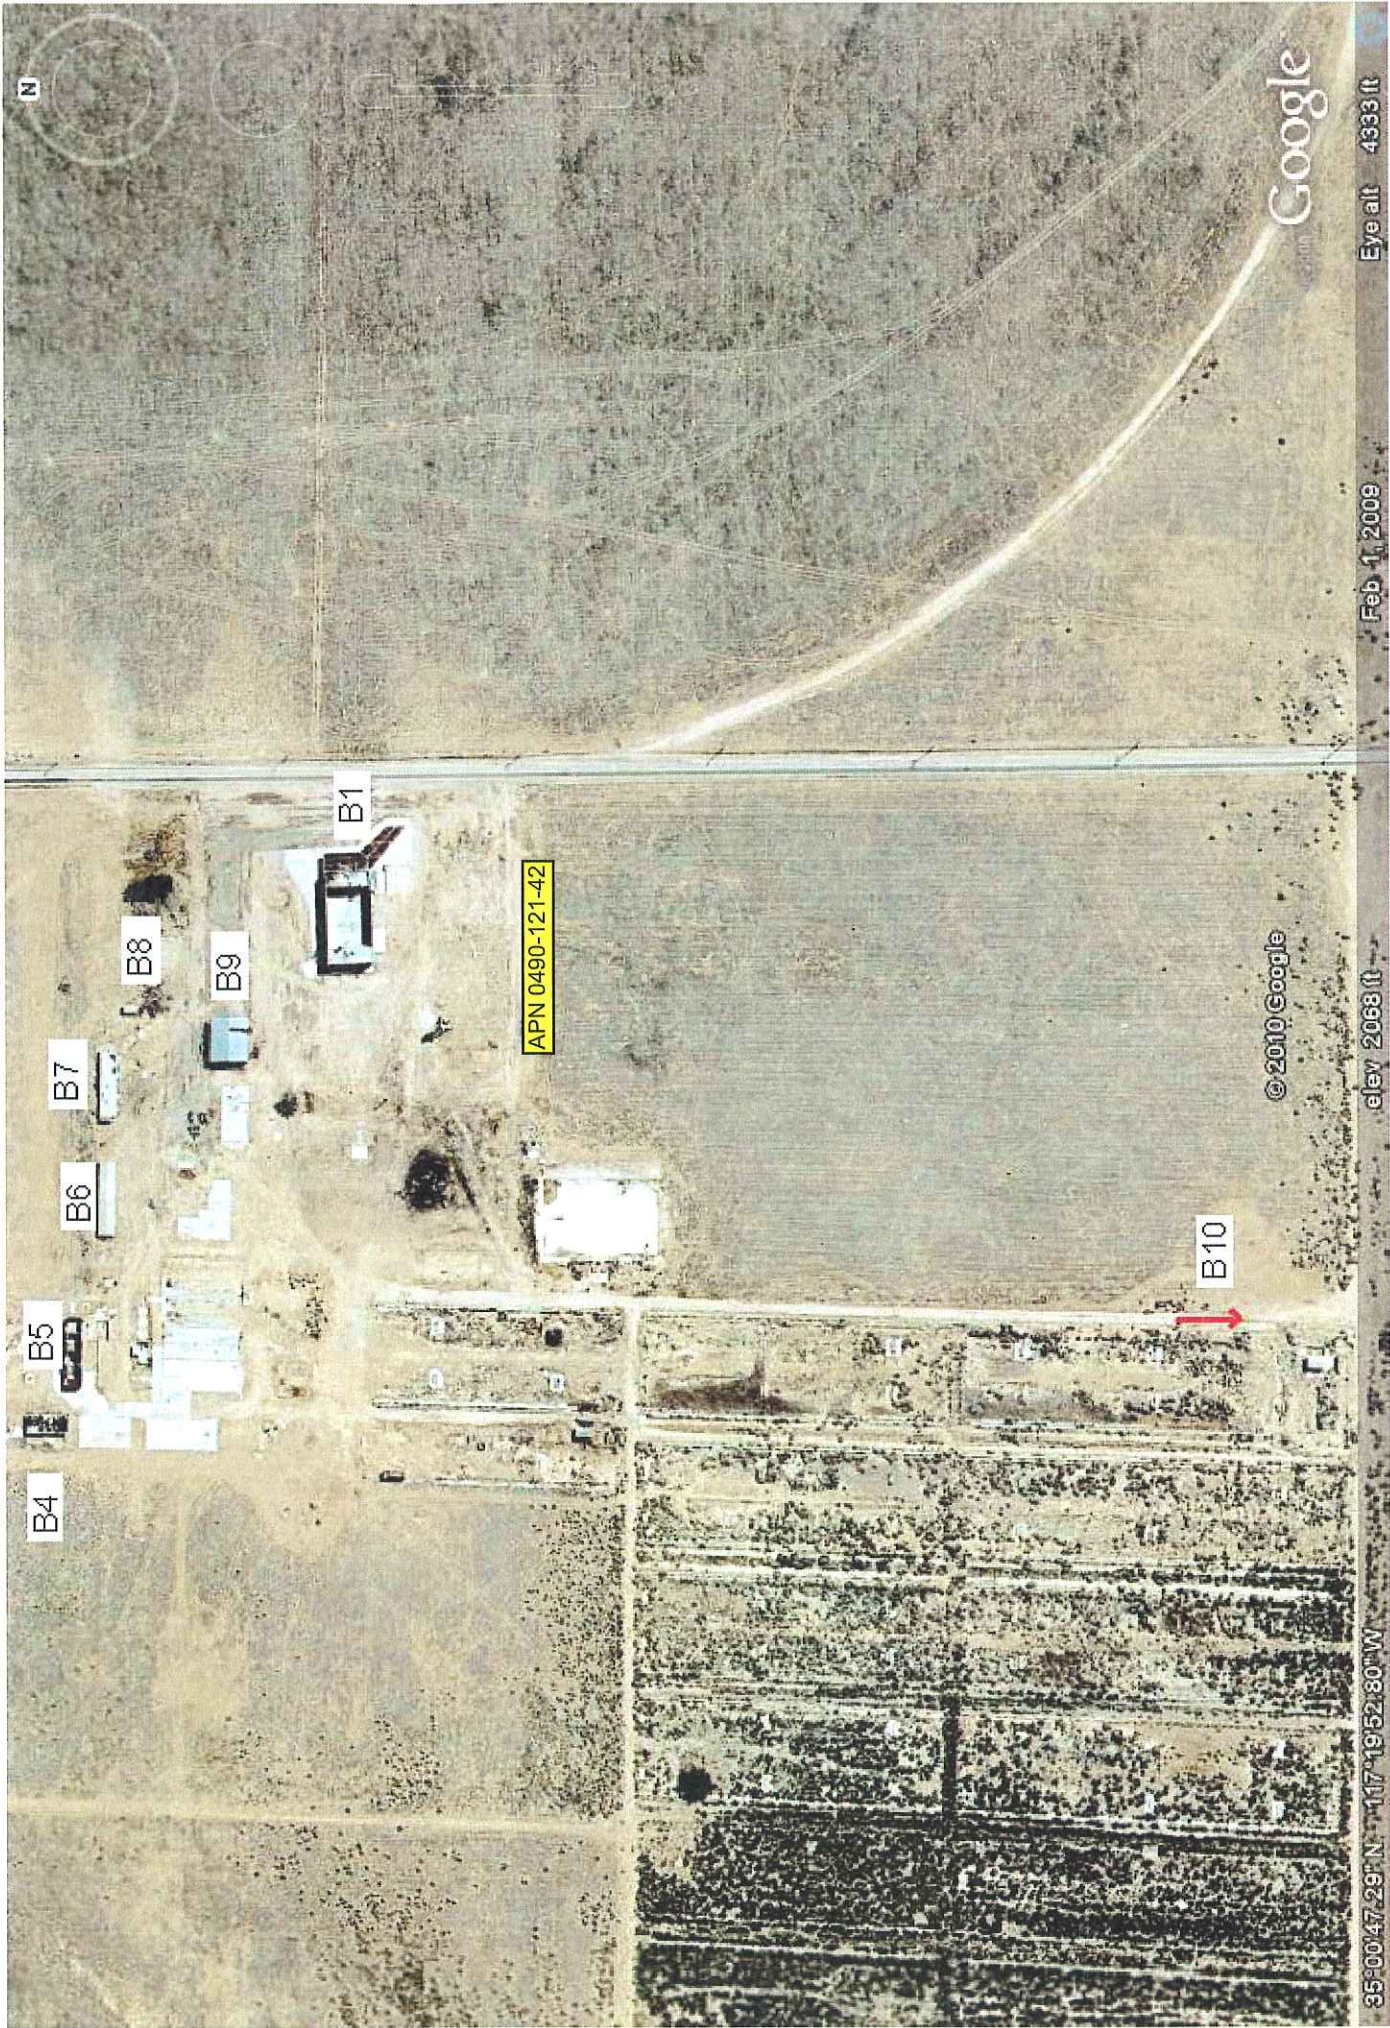
APN 0490-121-42

APN	PHASE I INFORMATION	SAMPLING PLAN	TEST(S)	SAMPLING RESULTS
0490-121-42	Previous Cattle Farming	(1-3) – Pesticides / Herbicides	USEPA 8081A / USEPA 8151A	Not Detected – Pesticides & Herbicides
	Existing Concrete Structure – Store	(A) – Lead / Asbestos	EPA 6020 / USEPA 600/M4-82-020	Portions contain greater than 1% Asbestos Portions contain greater than 1.0 mg/cm ² ppb Building B1
	Vent Pipes @ South Store Wall	(B) – Hydrocarbons	USEPA 8015M	Not Detected
	Previous Fuel Islands @ Store Front	(C) – Hydrocarbons	USEPA 8015M	Positive for Hydrocarbons
	Previous UG Aviation Fuel Tank – 30’ North of Store	(D) – Hydrocarbons	USEPA 8015M	Positive for Hydrocarbons
	Previous AG Fuel Tanks – Rear of Store	(E) – Hydrocarbons	USEPA 8015M	Not Detected
	Existing Wood Structures – Various	(F) – Lead / Asbestos	EPA 6020 / USEPA 600/M4-82-020	Portions contain greater than 1% Asbestos Portions contain greater than 1.0 mg/cm ² ppb Buildings B4, B5, B6, B7, B9, & B10

LEAD AND ASBESTOS SAMPLING LOCATIONS

- All asbestos containing material ("ACM") has to be abated. Under Federal law, ACM is defined as material comprised of greater than 1% asbestos if it is or has the potential to become friable. Friable is defined as material that can be crumbled by hand pressure and releasing asbestos fibers, or asbestos fiber release is from mechanical means (i.e., "hard" demo).

- The lead-based paint ("LBP") has to be properly managed. This can be done as a simple removal (e.g., door and door/window frames), or more detailed (i.e., exterior paint on former General Store). Upon demolition of this building some LBP will be released to the ground. The soil should be sampled to ensure it does not become impacted above regulatory action limits. This type of removal would be less expensive than LBP removal prior to demolition.

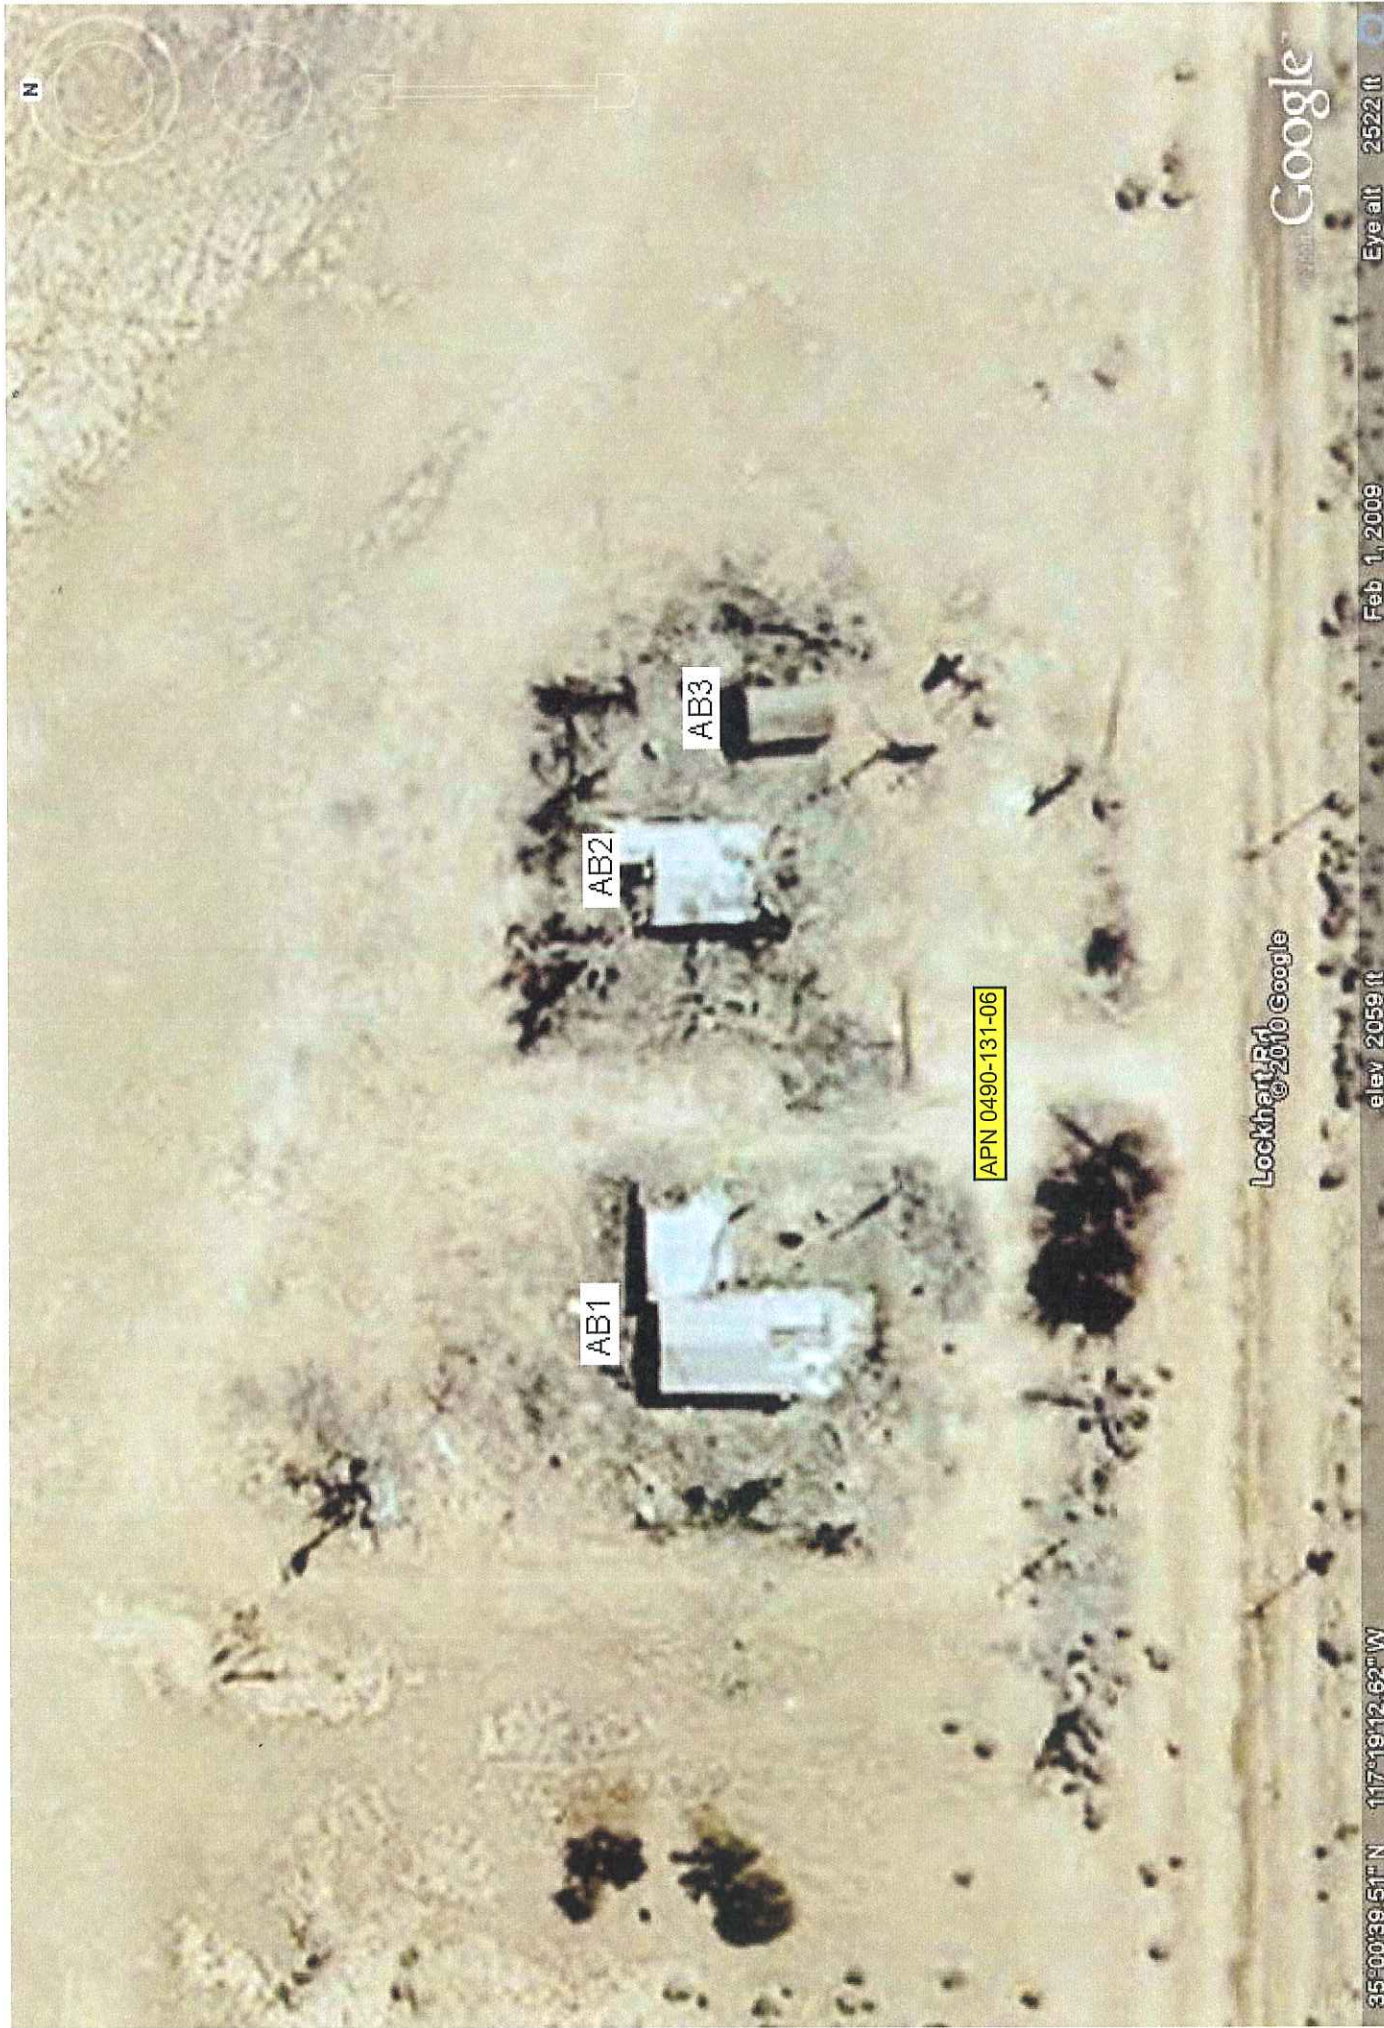
APN 0490-131-06

0490-131-06	Wood Structures @ SW Corner – Vacant Homes	(G) – Lead / Asbestos	EPA 6020 / USEPA 600/M4-82-020	Portions contain greater than 1% Asbestos Portions contain greater than 1.0 mg/cm ² ppb Buildings AB1, AB2, & AB3
	Vacant – Fallow Agriculture	(6) – Pesticides / Herbicides	USEPA 8081A / USEPA 8151A	Not Detected – Pesticides & Herbicides
0490-131-07	Vacant – Fallow Agriculture	(5) – Pesticides / Herbicides	USEPA 8081A / USEPA 8151A	Not Detected – Pesticides & Herbicides
0490-131-08	Vacant – Fallow Agriculture	(4) – Pesticides / Herbicides	USEPA 8081A / USEPA 8151A	Not Detected – Pesticides & Herbicides
0490-131-11	Vacant – Fallow Agriculture	(7) – Pesticides / Herbicides	USEPA 8081A / USEPA 8151A	Not Detected – Pesticides & Herbicides
0490-131-12	Wood Structures @ South – Vacant Farm Buildings	(H) – Lead / Asbestos	EPA 6020 / USEPA 600/M4-82-020	Portions contain greater than 1% Asbestos Portions contain greater than 1.0 mg/cm ² ppb Buildings HB2 & HB4

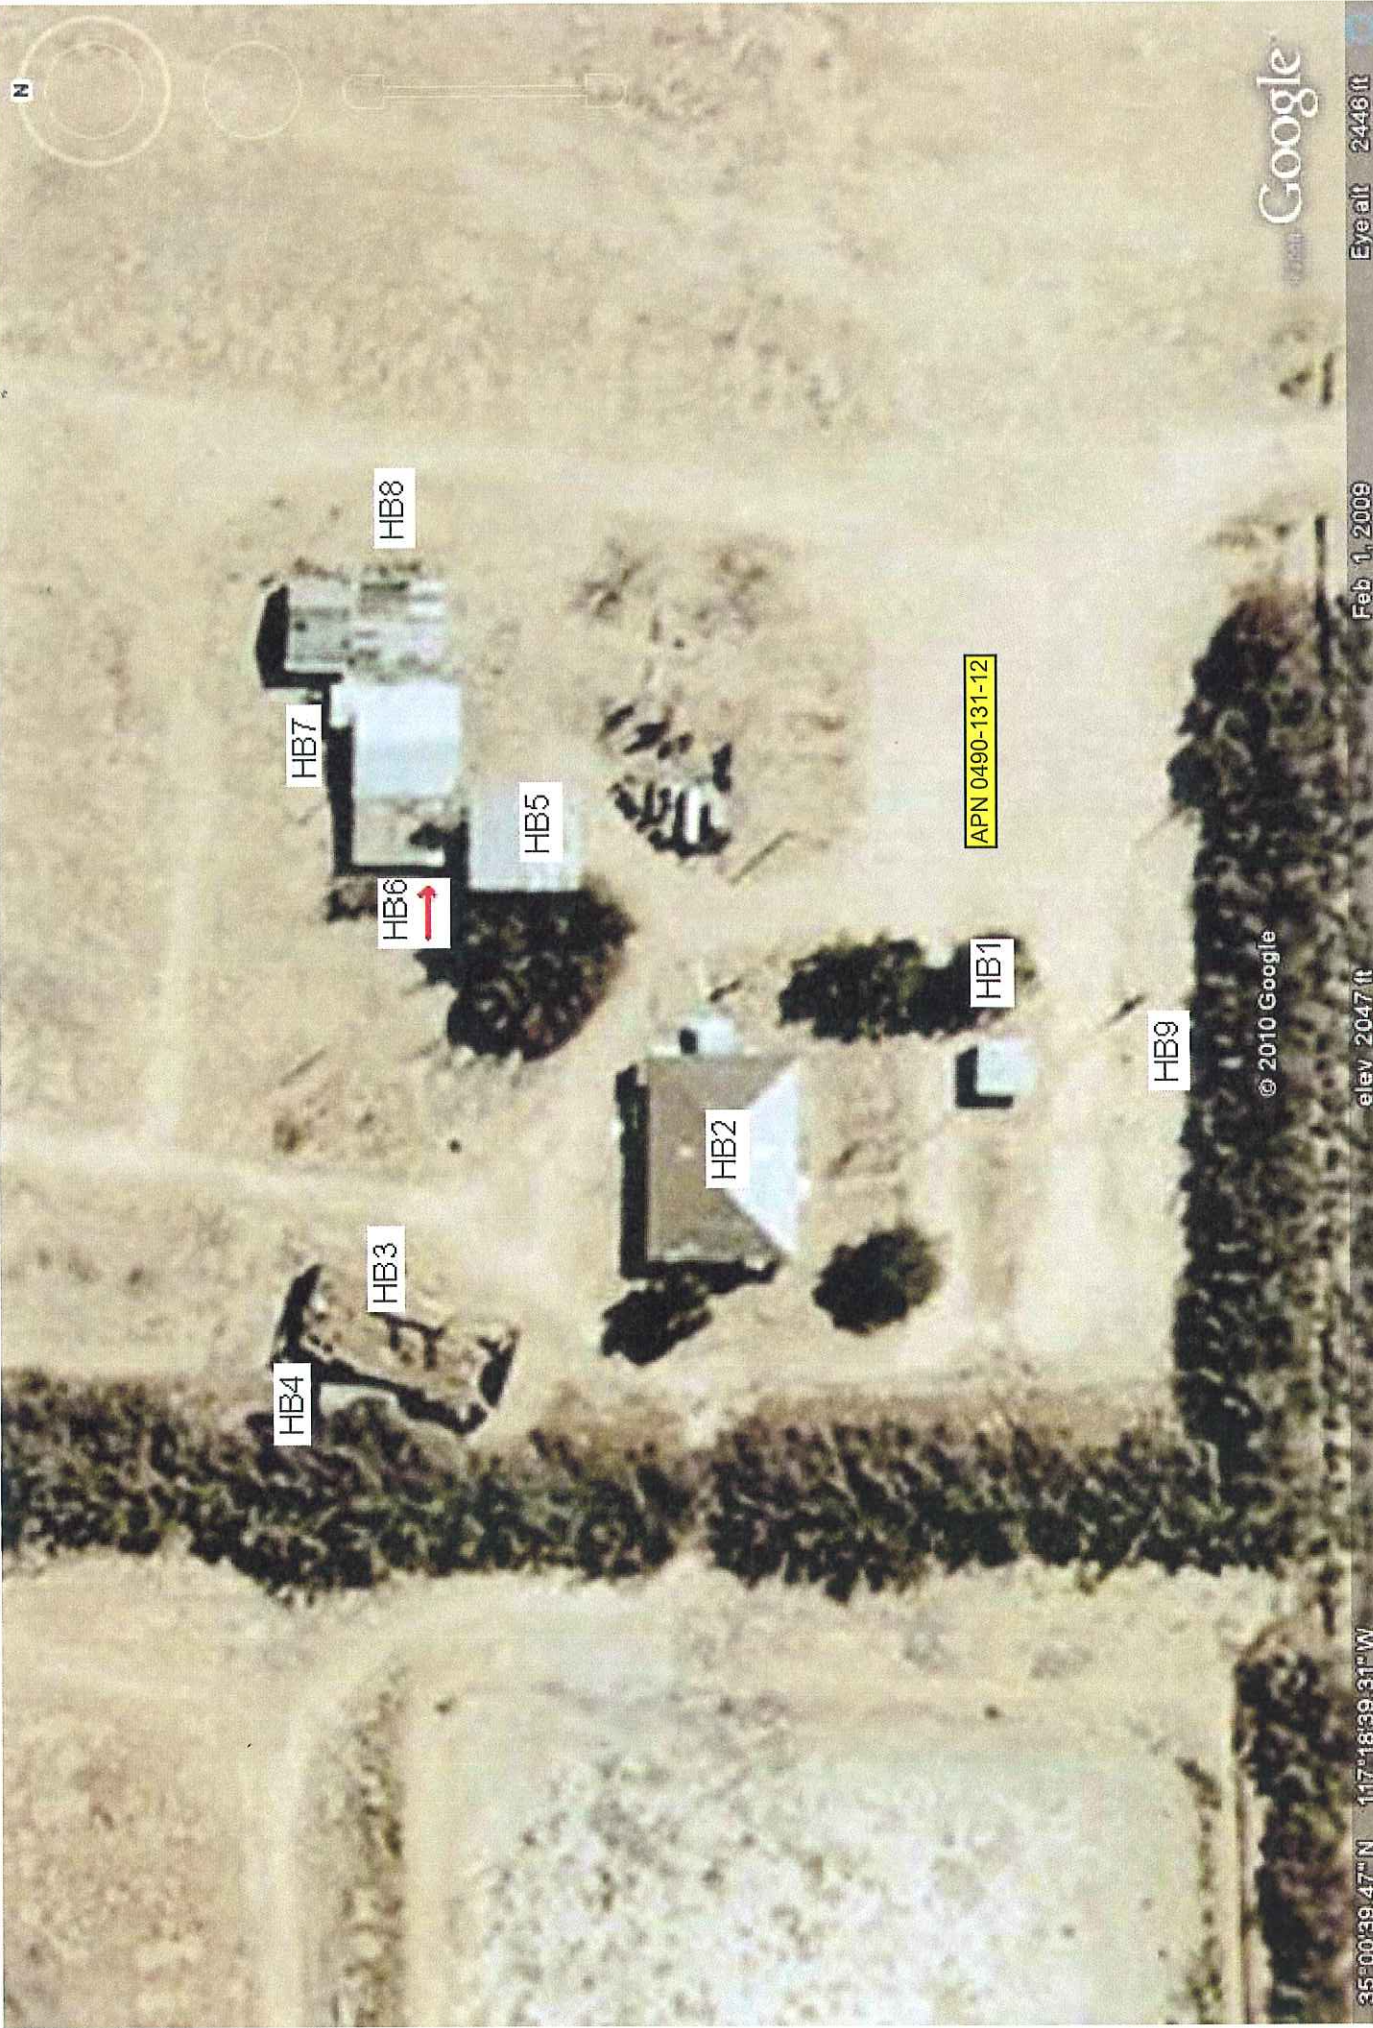
APN 0490-131-12

- 1 Fuel leak at former fuel dispenser island; entire piping should be investigated per County Fire regulations
- 1 Fuel leak at former northern AV gas tank
- 1 Transite piece exterior southwest corner
- 1 Transite pieces exterior southwest corner
- 1 Drum storage in basement
- 1 West from building; two stage clarifier
- 1 Potential for lead solder in 4" cast iron pipe joints
- 1 Elevator brake shoes likely asbestos
- All Fluorescent light ballasts need to be inspected for PCBs
- 5 South exterior waste grease and oil drums
- 6 Herbicide bag inside building
- 8 West from building; potential former hydraulic lifts with hydrocarbon building-up
- HB5 Potential former Mechanic's Pit in garage

- The general store's former fueling system should be investigated, as well as the former aviation fuel ("AV") tank on the northern side of the building. Mitigation procedures should be interfaced with the appropriate governing agencies having jurisdiction over the project site.

- The hazardous materials/wastes located in the General Store's basement and by Building 5 need to be properly managed and disposed/recycled.

An abatement and remediation plan should be developed and instituted to properly dispose of the listed materials at the site. This plan should be prepared and instituted to complete this work in an orderly fashion and prior to the commencement of demolition and construction activities in the affected areas.
